November 29, 2010

Re: Five Year Building Envelope Warranty Review

"Aqua at the Park" - 550 Pacific Street, Vancouver, BC

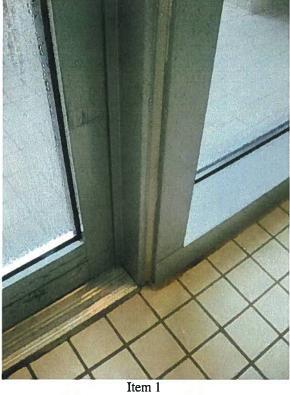
Item/ Photo	Sample Location	Deficiency Description	Corrective Action
1	Pool	Discolored interior sealant at base of window at pool room.	Remove and replace sealant as required.

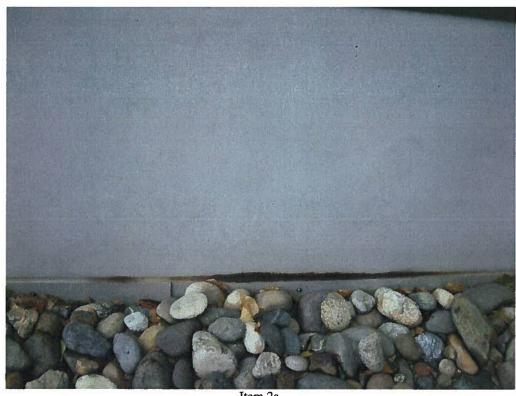
Item 2a Five year building envelope warranty review

Item/ Photo			Corrective Action
2a 2b	Podium level	Discolored sealant between reglet flashing and concrete wall.	Remove and replace sealant as required

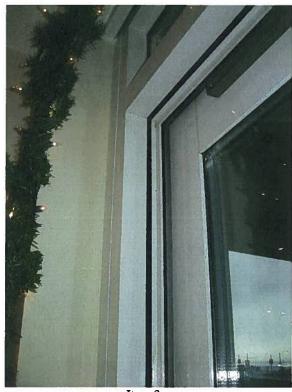
Item 3a Five year building envelope warranty review

Item/ Photo	Sample Location	Deficiency Description	Corrective Action
3a 3b	805 1705 2208	Misaligned balcony swing doors. Doors do not lock and when closed, the perimeter gaskets are not fully compressed.	We note that doors may be improperly hung and should be adjusted.
		The owner of suite 805 states during the summer months, the door is most difficult to close.	_
4a 4b	805 1705	Sealant adhesion failure at the inside corner cap between the window wall and the balcony swing door.	Remove and reseal the corner cap.
5	2605	Paint stains on window wall frame at balcony.	This is an aesthetic issue and will not affect the building performance. Remove paint from frame.

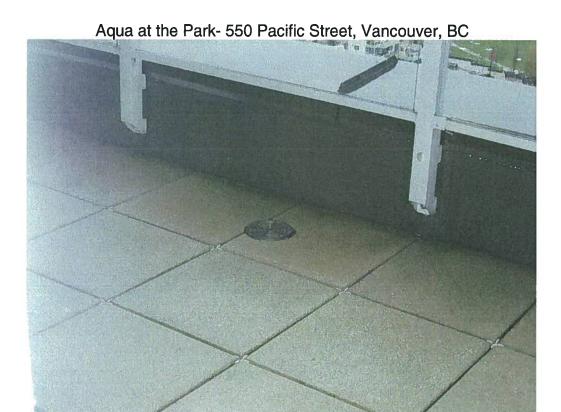
Item 6a

Item/ Photo	Sample Location	Deficiency Description	Corrective Action
6a 6b	2605	The Owner brought the following concerns to our attention:	Monitor the balcony slab drain to ensure the drain is free of debris

(a) the balcony drain body was higher than the surface of the slab resulting in pooling outside of the sliding door. As such, modifications to the drain were made. We reviewed the balcony and observed no pooling.	to prevent pooling. MH reviewed this suite previously and issued a report dated March 17, 2010. A recommendation to review the corridor make-up system was made. This may alleviate the air drafts.

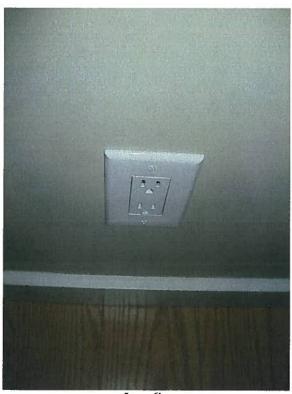
Item 6b
Five year building envelope warranty review

- (b) a draft of air is evident through the electrical outlet in the master bedroom.	Further review of the bathroom exhaust duct and hood are required. We recommend consulting a mechanical engineer.
	outside can be heard	- the owner states noise from the outside can be heard from the exhaust vent duct at the main bathroom.	Balcony sliding door to be adjusted as required.

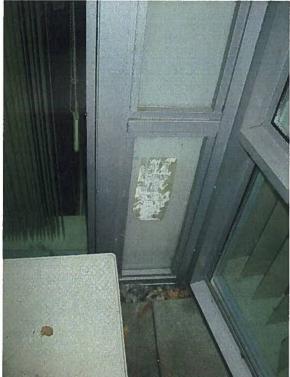
Item 7

- the balcony sliding door is difficult to close and requires adjustment.	
7	307	Window description sticker on opaque panel adjacent to balcony door.	Remove window description sticker from opaque panel.
8a 8b	307 1205	Visible rubber gasket at side jamb of balcony door.	Realign rubber gaskets where required.
9	307	Balcony door65 handle loose and door does not lock.	Adjust door handle and replace defective hardware.
10	2208	Owner states there is a cold draft coming from living room windows.	Ensure window operables are fully latched top and bottom. Further review may be required to determine source of draft.
11	2208	We observed a stain on the living room ceiling. Owner confirmed they have not seen any moisture around the staining.	Further review is required to determine the source of the stain. This appears to be an internal source of moisture.
12	Podium level	Exposed self-adhesive membrane below the door threshold.	Protect the exposed self-adhesive membrane from U.V. degradation. This can be done with metal flashing.

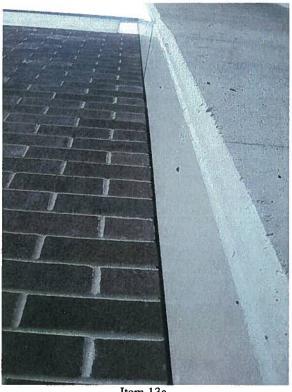
Item 13a Five year building envelope warranty review

Item/ Photo	Sample Location	Deficiency Description	Corrective Action	
13a 13b	Podium level	Missing sealant at joint between brick assembly and metal flashing. We note a vertical sealant joint on the other end of the brick.	Install sealant between dissimilar assemblies.	
14a 14b	Podium level	Foam backer rod visible below window sill metal flashing.	Trim backer rod where exposed.	
15	Podium level, outside of TH	Inconsistent sealant installation between structural shelf-angle and brick.	Install sealant between shelf angle and top of brick.	
16	Deck outside	Broken tile at the edge of the deck, outside of the pool.	Replace broken tile.	
	of pool	At the same location, we observed the sealant was stained.	Remove and replace sealant as required.	
17	Podium level, outside of TH	Algae stain on surface of exterior planter wall and surface of brick.	Remove algae stains from top of planter walls and from surface of brick as part of regular maintenance.

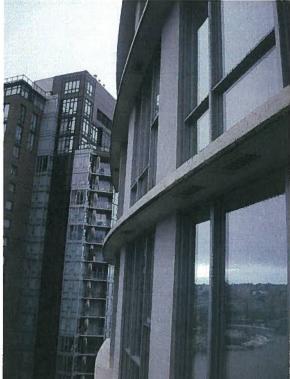
Item 18a

18a 18b	Typical	Algae stain at edge of slab and on balcony surface.	Remove algae stains from concrete as part of regular maintenance.	
19	Typical	Lint observed in dryer vents.	Clean vents as part of regular maintenance.	
20	Mech. Rm. roof	Vegetation obstructing the roof drain screen.	Remove vegetation from roof drain screens to ensure free drainage.	
21	21 Mech rm roof We note the bottom of the roof drain pipe is directly on the roof ballast. At the same location, we observed the sealant at the base of wall flashing is discolored.		We recommend installing a splash pad (i.e. paver) below the drain	
			Remove and replace sealant as required.	
22	Main roof canopy	We note the top of the concrete surface at the canopy above the roof access door was stained. The concrete appears to be coated.	Clean concrete surface as part of regular maintenance.	
23	Main roof	Dislodged mechanical louver.	Reinstate mechanical louver.

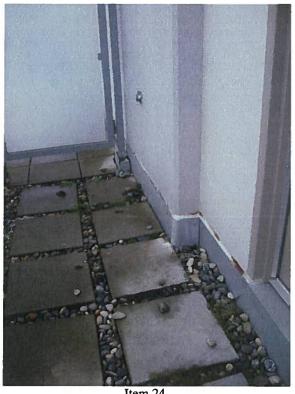
Item 24
Five year building envelope warranty review

Item/ Photo	Sample Location	Deficiency Description	Corrective Action
24	Main roof	Moss growth on surface of roof pavers and on roof ballast.	Remove moss from pavers and roof ballast as part of regular maintenance.
25	Parkade Stall #36	We note a leak above parking stall no. 36. The leak appears to be plumbing related.	Coordinate with a plumber to address leak.
26	Podium level	We note efflorescence on the surface of the brick below the balcony guard wall saddle.	Remove efflorescence and monitor location for leaks.
27 no photo	1006	The owner reported that rain pours from the balcony above. This suite was not reviewed. However, the slope from the balcony should be reviewed ensure water is draining away from the building.	
28 no photo	2008 2501 1805 2508 1205 2207	The owner reported that the balcony door does not close properly.	This suite was not reviewed. However, the condition of the balcony swing door appears to be similar to item 1. The door may be improperly hung and requires adjustment.
