# **Structural Warranty Review For The Compton**

**1316 West 11<sup>th</sup> Avenue, Vancouver, British Columbia**

McCuaig and Associates Engineering Ltd.

Date: March 18, 2011

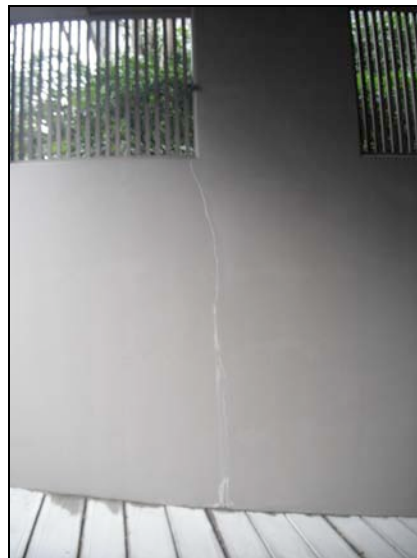
A ramp provides access to the underground parking area. The exterior walls on both sides of the ramp have numerous vertical cracks that have been sealed with flexible sealant. Above the ramp the major structural loading on these walls is due to the horizontal pressure from the soil that is retained by the walls. The orientation of the cracks suggests that they were initiated as a result of volumetric changes rather than structural loading. Fresh efflorescence, pooled water, and rust stains were observed at some cracks – refer to Photo 1. The concrete in the vicinity of the rust stains and efflorescence was probed and found to be sound. The rust stains suggest that the deterioration process described in Section 4 has begun, although observations suggest that the process has not advanced enough to warrant immediate concerns. We consider this issue to be related to a localized failure of waterproofing components; therefore this issue will be revisited in Section 7.

**Photo 1 - Cracked Ramp Wall With Efflorescence**

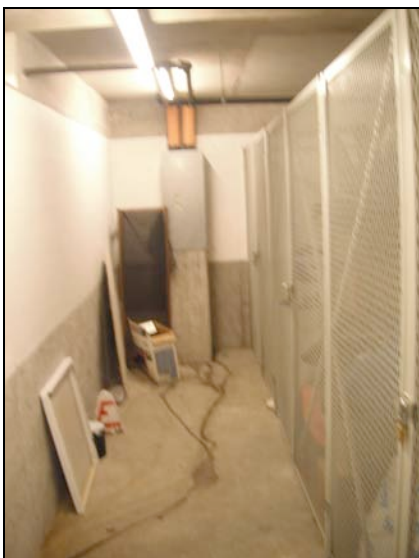
There are two pipes that pass through this room's ceiling. Water is leaking through the slab openings that the pipes pass through – see Photo 2. Note the water stains on the floor. The stains on the floor suggest that water regularly pools against the storage room wall. If the water is passing through the opening in the slab rather than through the slab, the assembly will not likely suffer any damage as a result of this water ingress and water related damage would be confined to items that may be stored in the room.

**Photo 2 - Water Ingress At P2 Storage Room**

Further investigation is recommended to determine the source of the leakage and to evaluate the leak's effect on the performance of adjacent assemblies.

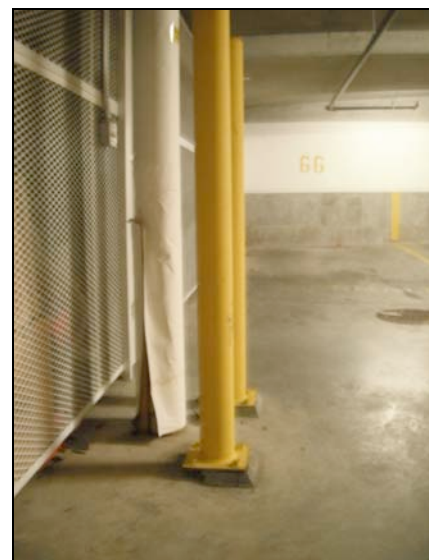
Refer to Photo 3 – which shows two concrete filled steel bollards that are intended to protect a water pipe from vehicle impact. Each bollard bears on a mortar bed, which bears on the P2 floor slab. There does not appear to be any mechanical connection between the mortar beds and the floor slab. The mortar beds have deteriorated and the bollards move easily when shaken. We are of the opinion that in their present state, the bollards would not be capable of resisting a reasonable vehicle impact.

**Photo 3 - Damaged Bollard Support At P2**

The existing mortar should be removed and discarded. The existing bollards can then be placed directly on the floor slab. If the existing bolts are not damaged it may be possible to re-use them. If the existing bolts cannot be re-used, new expansion bolts should be used to fasten the bollards directly to the slab. The diameter of the new bolts should match the diameter of the existing bolts. The new bolts should embed approximately 3 inches into the floor slab.

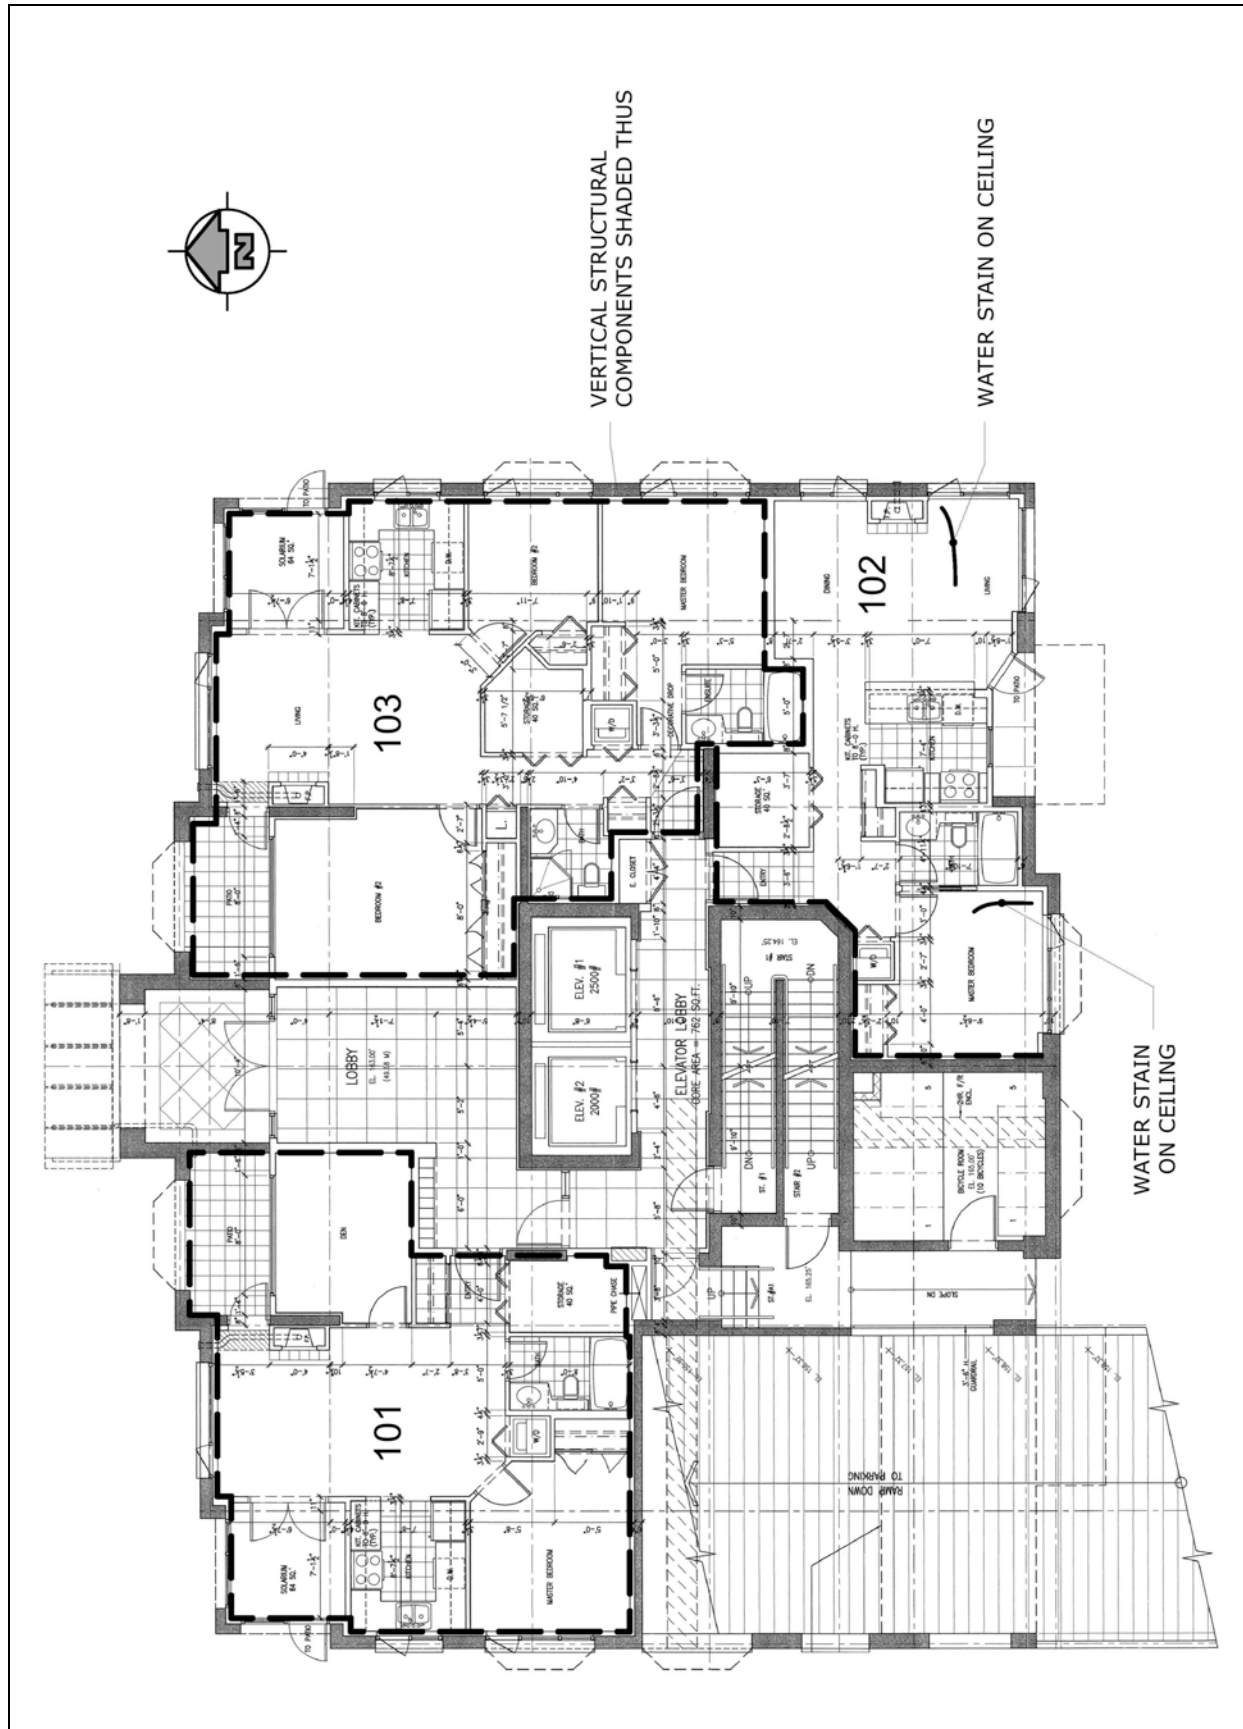
Figure 2 – Ground Floor Plan

A water stain was observed on the ceiling above the living room – refer to Figure 2 on page 17 for location. The proximity of the water stains suggests that water may be entering the building from the exterior.

A water stain was observed on the ceiling above the master bedroom, adjacent to the ensuite bathroom wall – refer to Figure 2 on page 17, which was developed from the original architectural drawing – ground floor plan, for location. The proximity of the water stain suggests the source of the water may be either a plumbing line or the exterior.

Retain a qualified consultant to conduct a detailed investigation of the exterior of the building in the vicinity of the water stain.

Retain qualified consultants to review the plumbing drawings and to conduct a detailed investigation of the exterior of the building in the vicinity of the water stain.
