# **Building Envelope Maintenance Report**

**January 2012**

**The Compton  
1316 West 11<sup>th</sup> Avenue  
Vancouver, BC**

**LMS 4382**

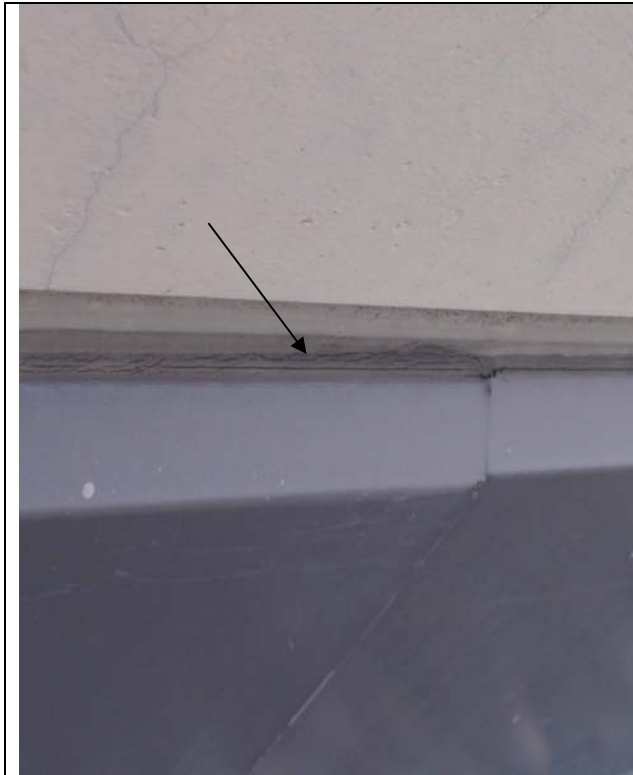
The cap flashings at the roof perimeter were in good condition around the building. Roof penetrations also appeared in good condition. In a number of locations, sealant along the top edge of the gumlip flashing at the base of the mechanical room walls has separated and should be replaced (Photo 1). Minor cracking as well as paint deterioration were also noted at the mechanical room walls. These items will be dealt with in more detail in the paint and concrete sections of the report. Organic growth was present on the back side of the decorative concrete arch on the North elevation of the building and should be cleaned as part of an ongoing maintenance program (Photo 2).

**Photo # 1 – Sealant separation at gumlip flashing**

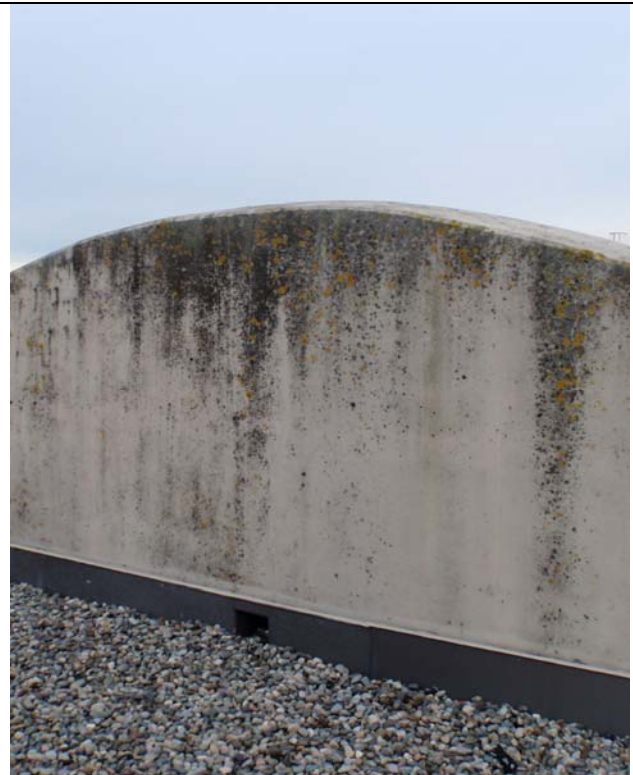
**Photo # 2 – Organic growth on concrete wall**

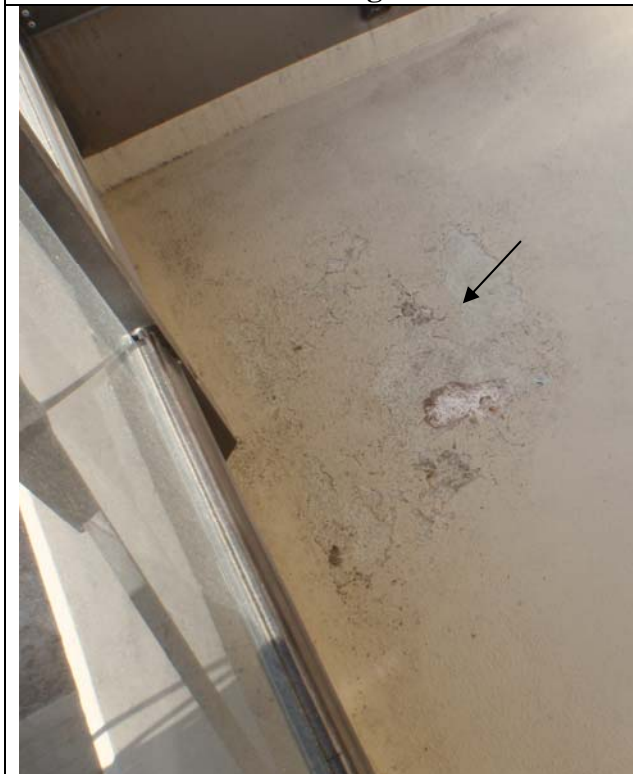
In the majority of areas, the balconies appeared in good condition at this time. There were however two locations noted where the balcony membrane has blistered and is peeling (Photo 3). These areas should be recoated in a timely manner. In two locations around the building, scupper pipes were noted as missing and should be repaired (Photo 4).

**Photo # 3 – Peeling of balcony membrane**

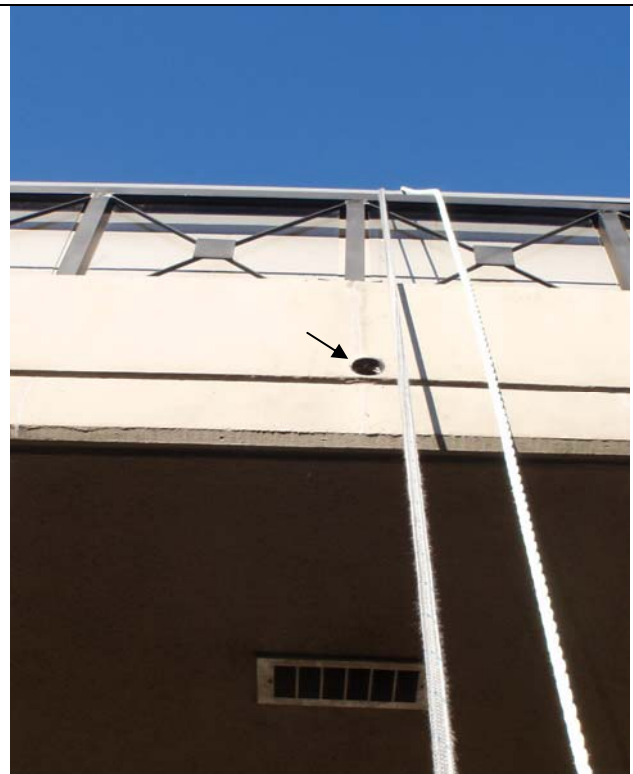
**Photo # 4 – Missing scupper drain pipe**

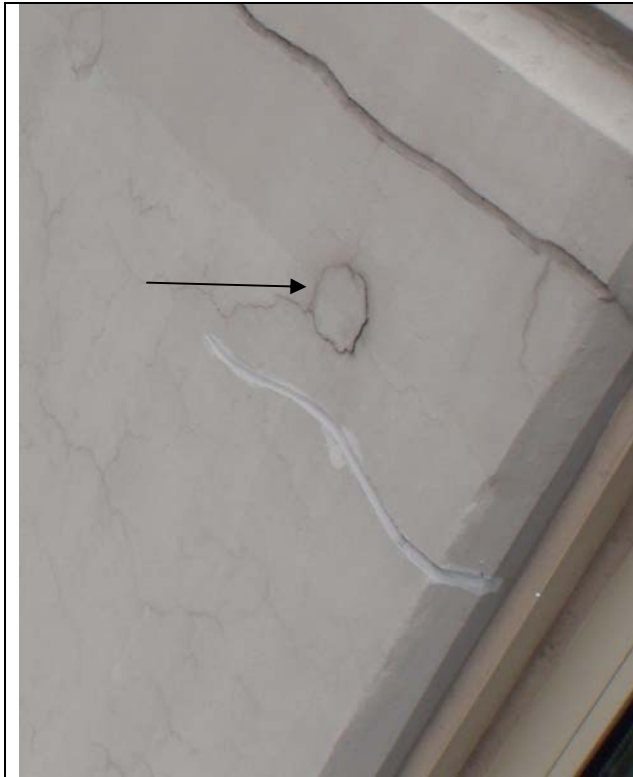
As noted on the elevation drawings, notable cracks in the concrete are present in just a few locations around the building. In one location, a small concrete patch is spalling and should be repaired (Photo 5). There is also one location on the North elevation where a small area of rebar is exposed and should be protected (Photo 6). Hairline cracks are present in a number of wall locations, as well as at the back of reveals (Photo 7). These cracks are not large enough to warrant grinding and caulking but could be treated with a good paint coating.

**Photo # 5 – Spalling concrete patch**

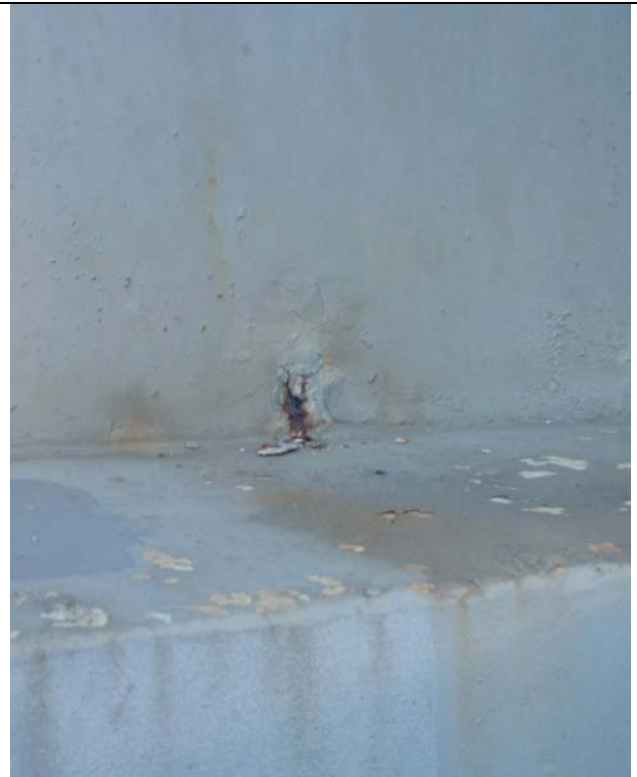
**Photo # 6 – Exposed corroded rebar**

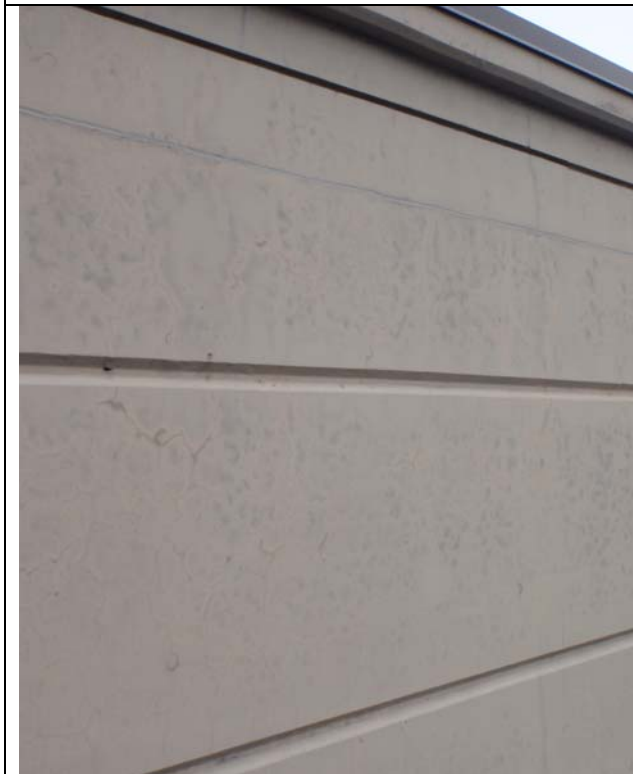
**Photo # 7 – Faded paint and hairline cracks**

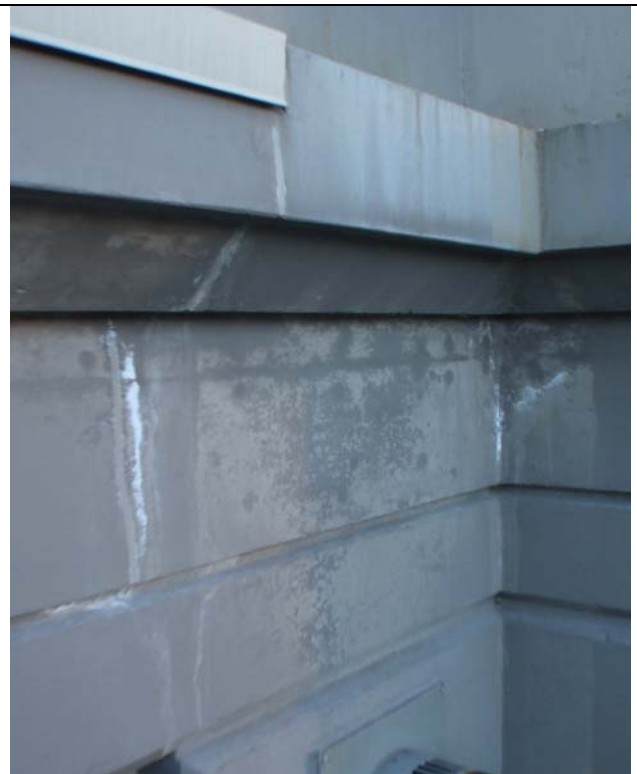
In some locations efflorescence staining is present (Photo 8) beneath the concrete eyebrow above the third floor. Efflorescence staining can occur where fine cracks are present in the eyebrow. The paint coating on the concrete eyebrows has blistered and is peeling in a number of locations (Photo 9). Coating of the eyebrows with a two part polyurethane membrane will reduce the amount of organic growth in these areas as well as bridging any existing cracks. Recoating of the eyebrows should be considered as a future maintenance item.

**Photo # 8 – Efflorescence staining below eyebrow**

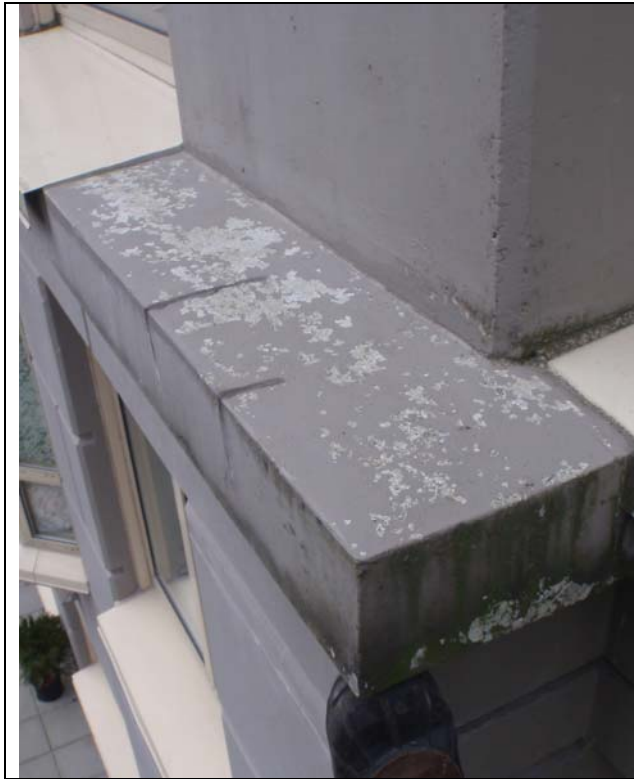
**Photo # 9 – Peeling paint at concrete eyebrow**

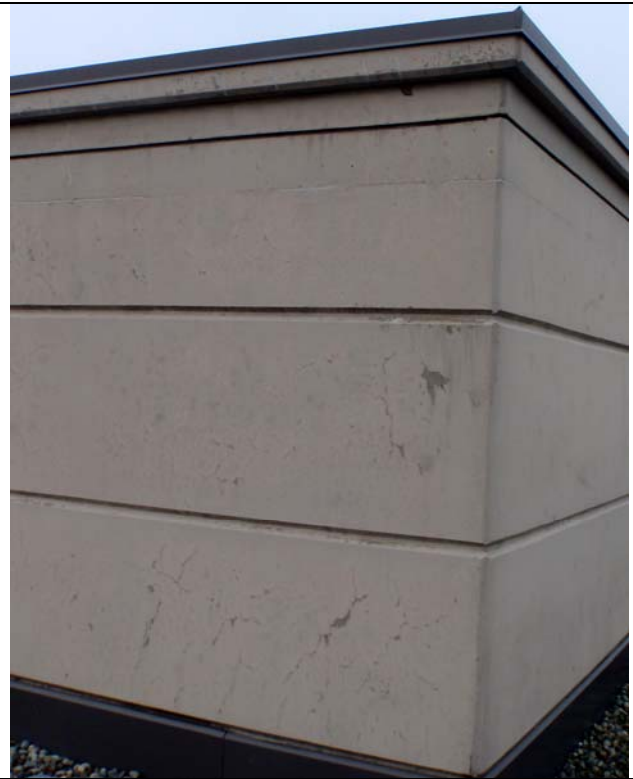
**Photo # 10 – Peeling paint at mechanical room**

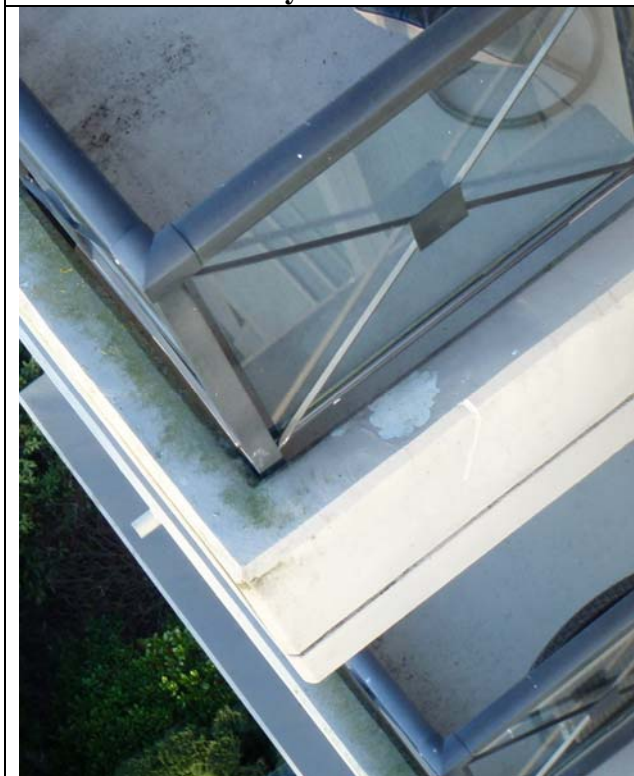
The concrete walls of the Compton have been coated with an acrylic based paint. At this time paint on the exterior of the building is showing signs of age such as fading and checking and repainting should be contemplated. The greatest area of deterioration noted was on the roof top mechanical room walls (Photo 10). In these areas the paint is severely degraded, and a number of hairline cracks in the wall are visible. Repainting in this area should be carried out when practical and repainting of the remaining exterior walls should be investigated at this time. Paint was also noted as peeling in some eyebrow and upstand wall cap locations (Photo 11).

**Photo # 11 – Peeling paint at upstand wall cap**

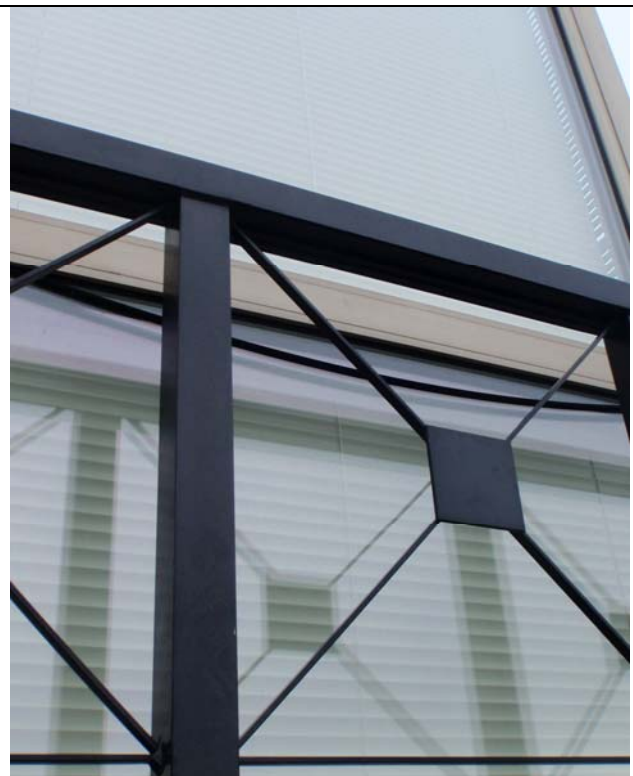
**Photo # 12 – Loose gasket at window mullion**

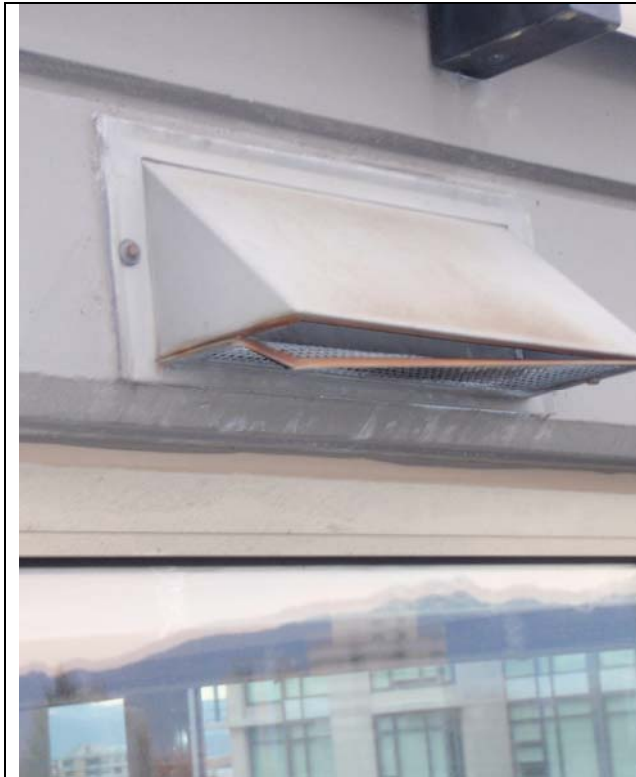
Where observed the majority of the balcony soffit vents and exterior hooded vents appeared clear. Minor lint accumulation was noted in one location only. In a number of locations, vent screens were noted as missing, or bent. These covers should be repaired or replaced as part of an ongoing maintenance program (Photo 13).

**Photo # 13 – Bent dryer vent screen**

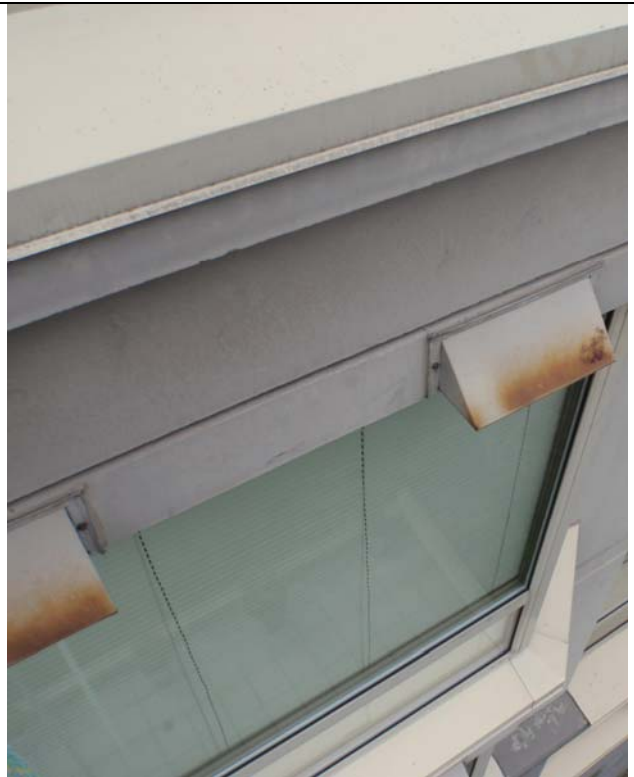
Corrosion of the vent hoods on exterior walls was common on the East elevation of the building (Photo 14). The vent hoods can be primed and painted as part of an exterior repainting program.

**Photo # 14 – Corroded vent covers**

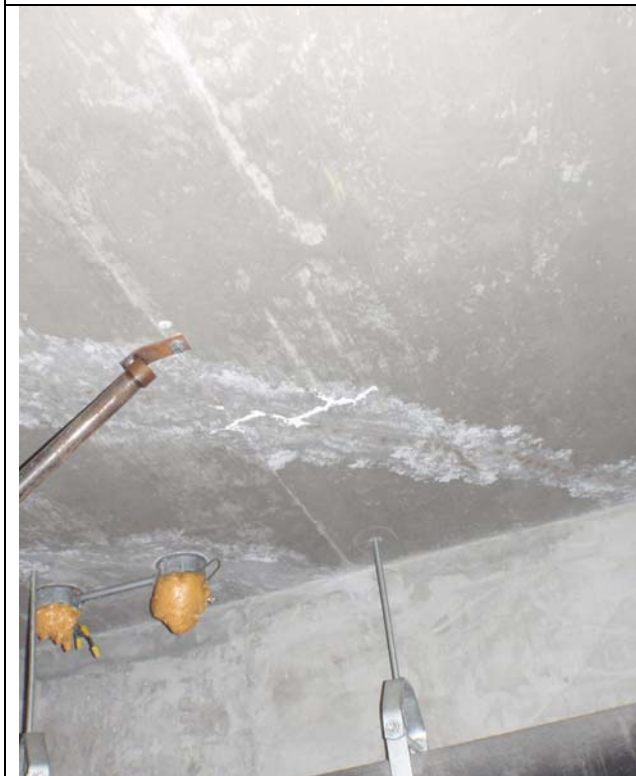
**Photo # 15 – Crack in parkade ceiling**

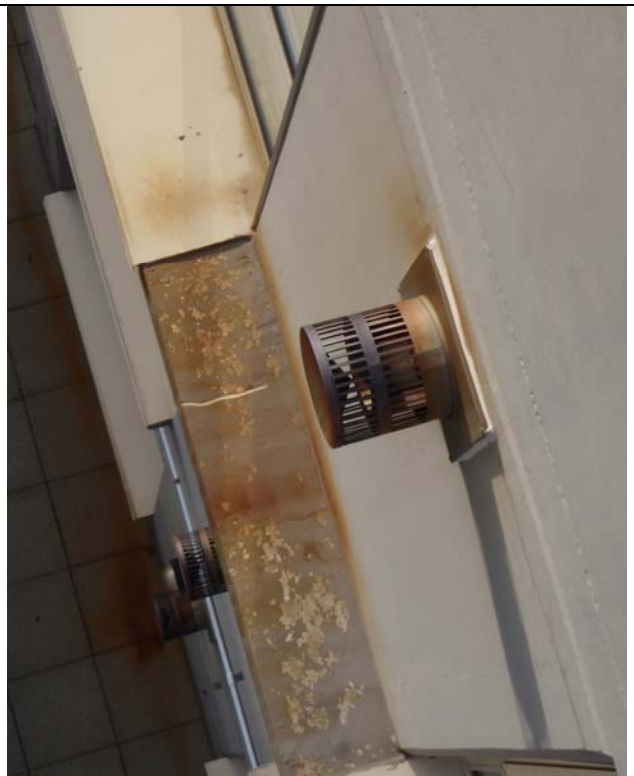
Corrosion of fireplace vent covers was common around the building (Photo 16). Rust staining was also present on flashings and eyebrows beneath the fireplace vents.

**Photo # 16 – Corrosion at fireplace vent**

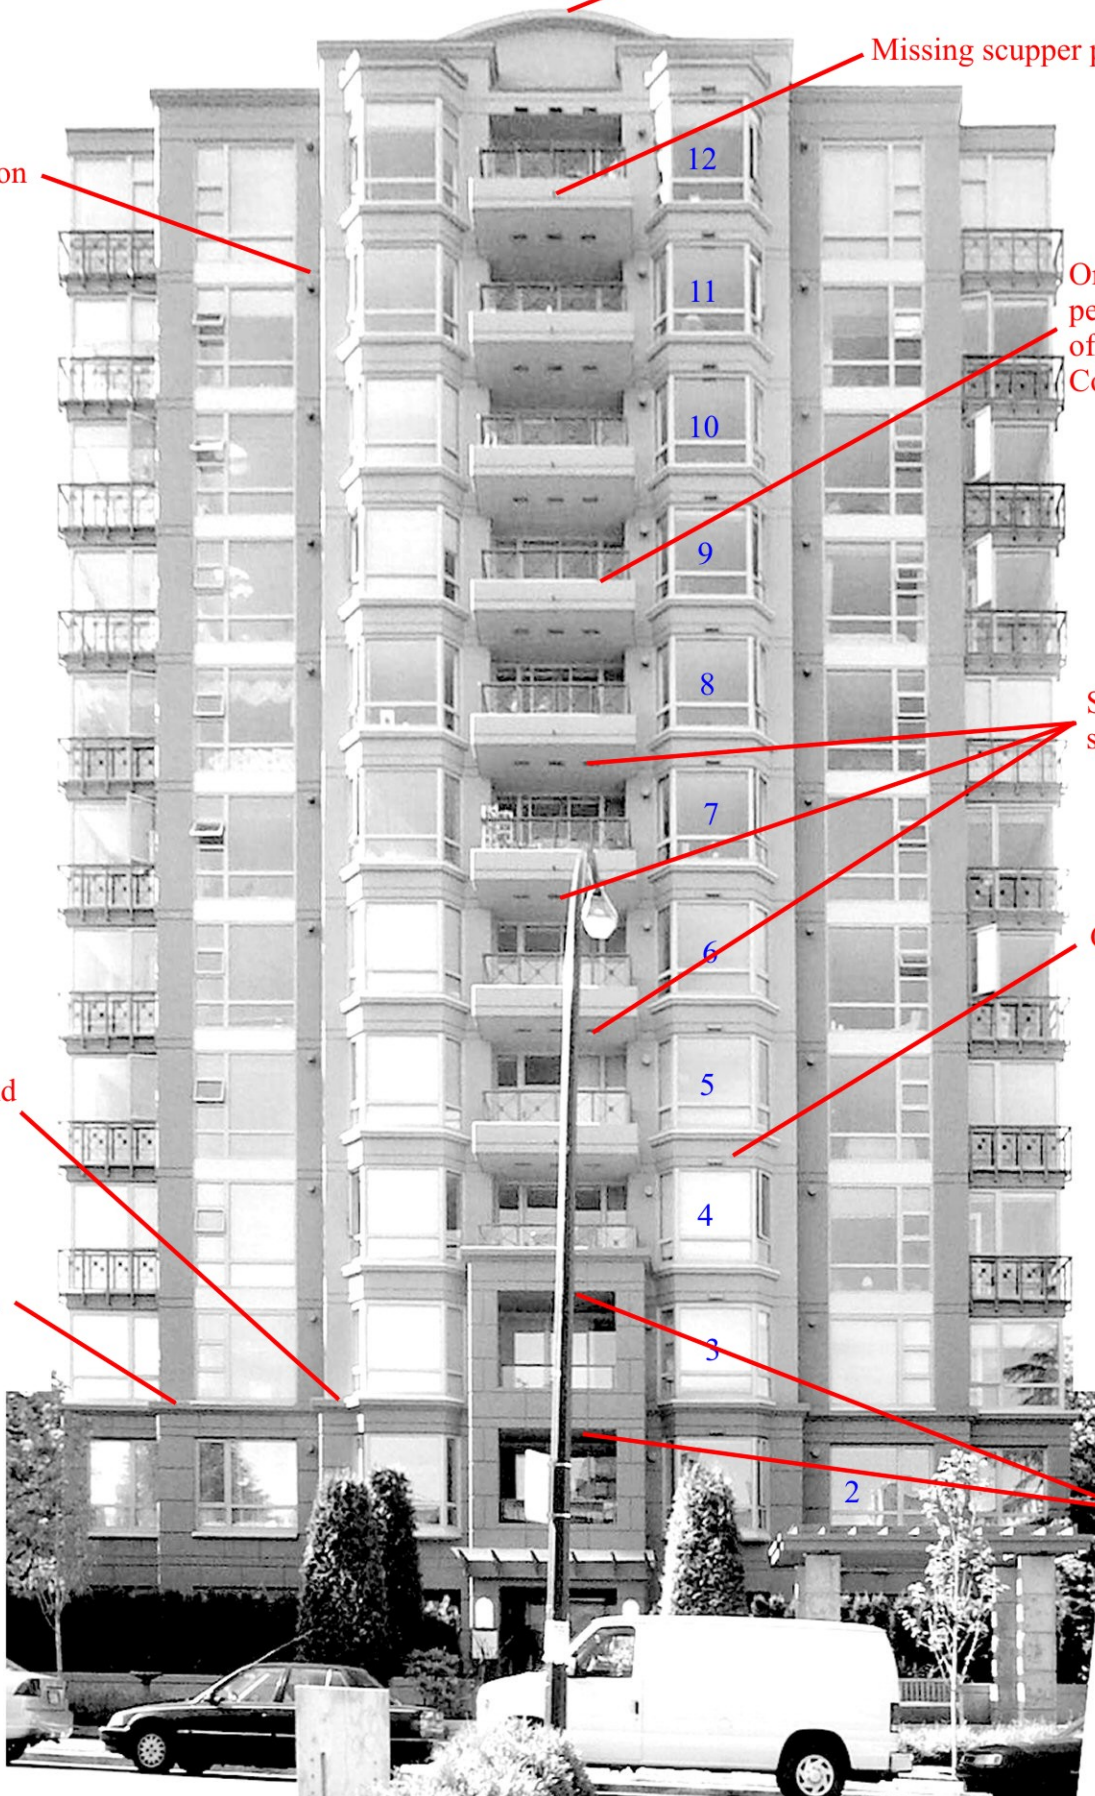
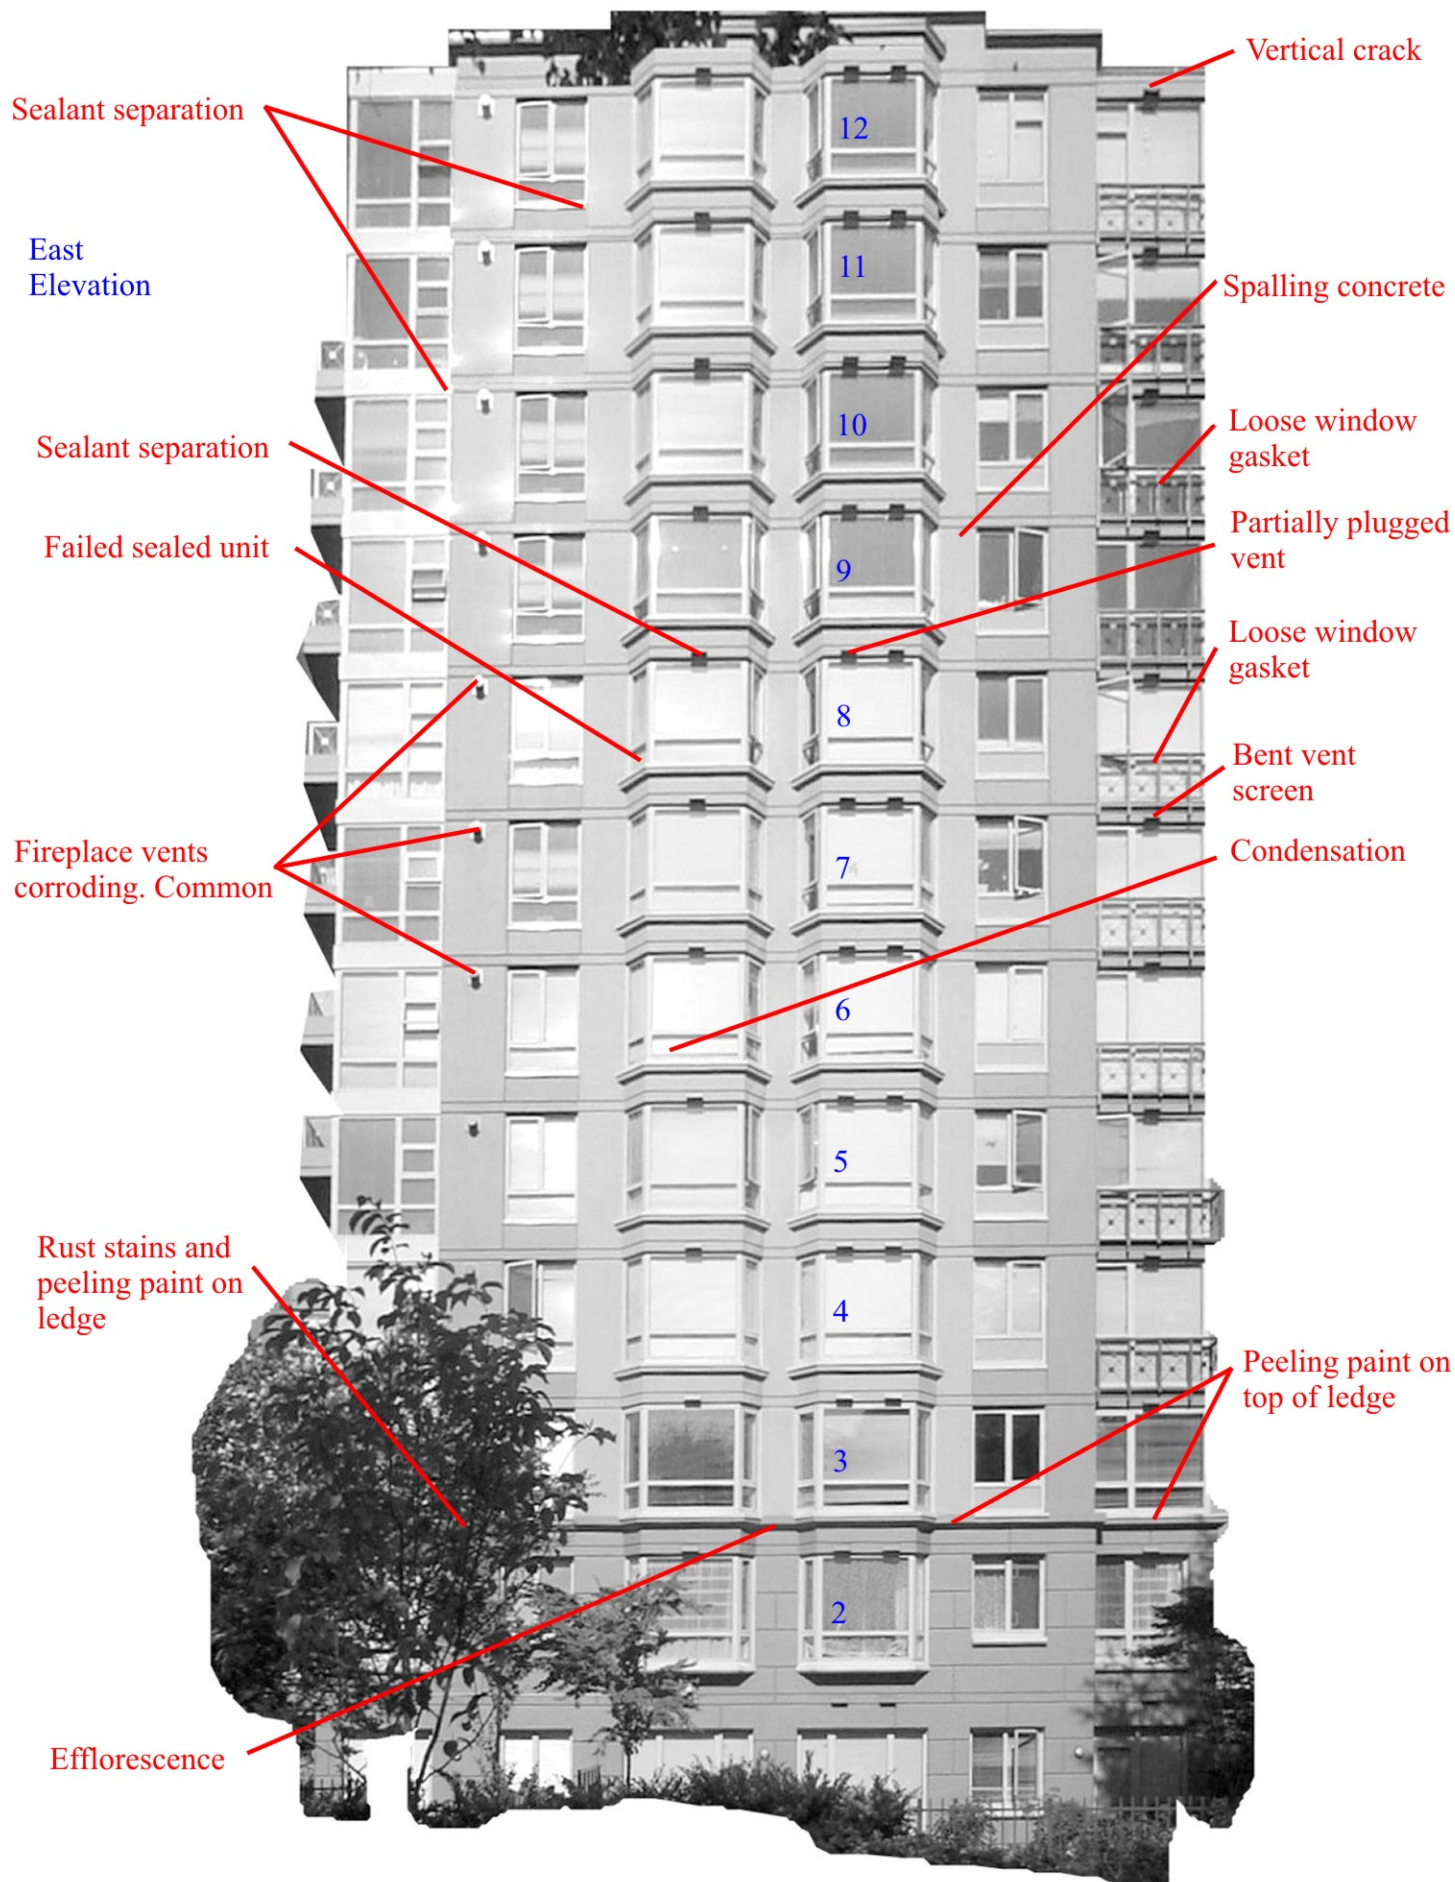
North Elevation

Missing scupper pipe

Staining at  
soffit vents

Crack in reveal

Organic growth

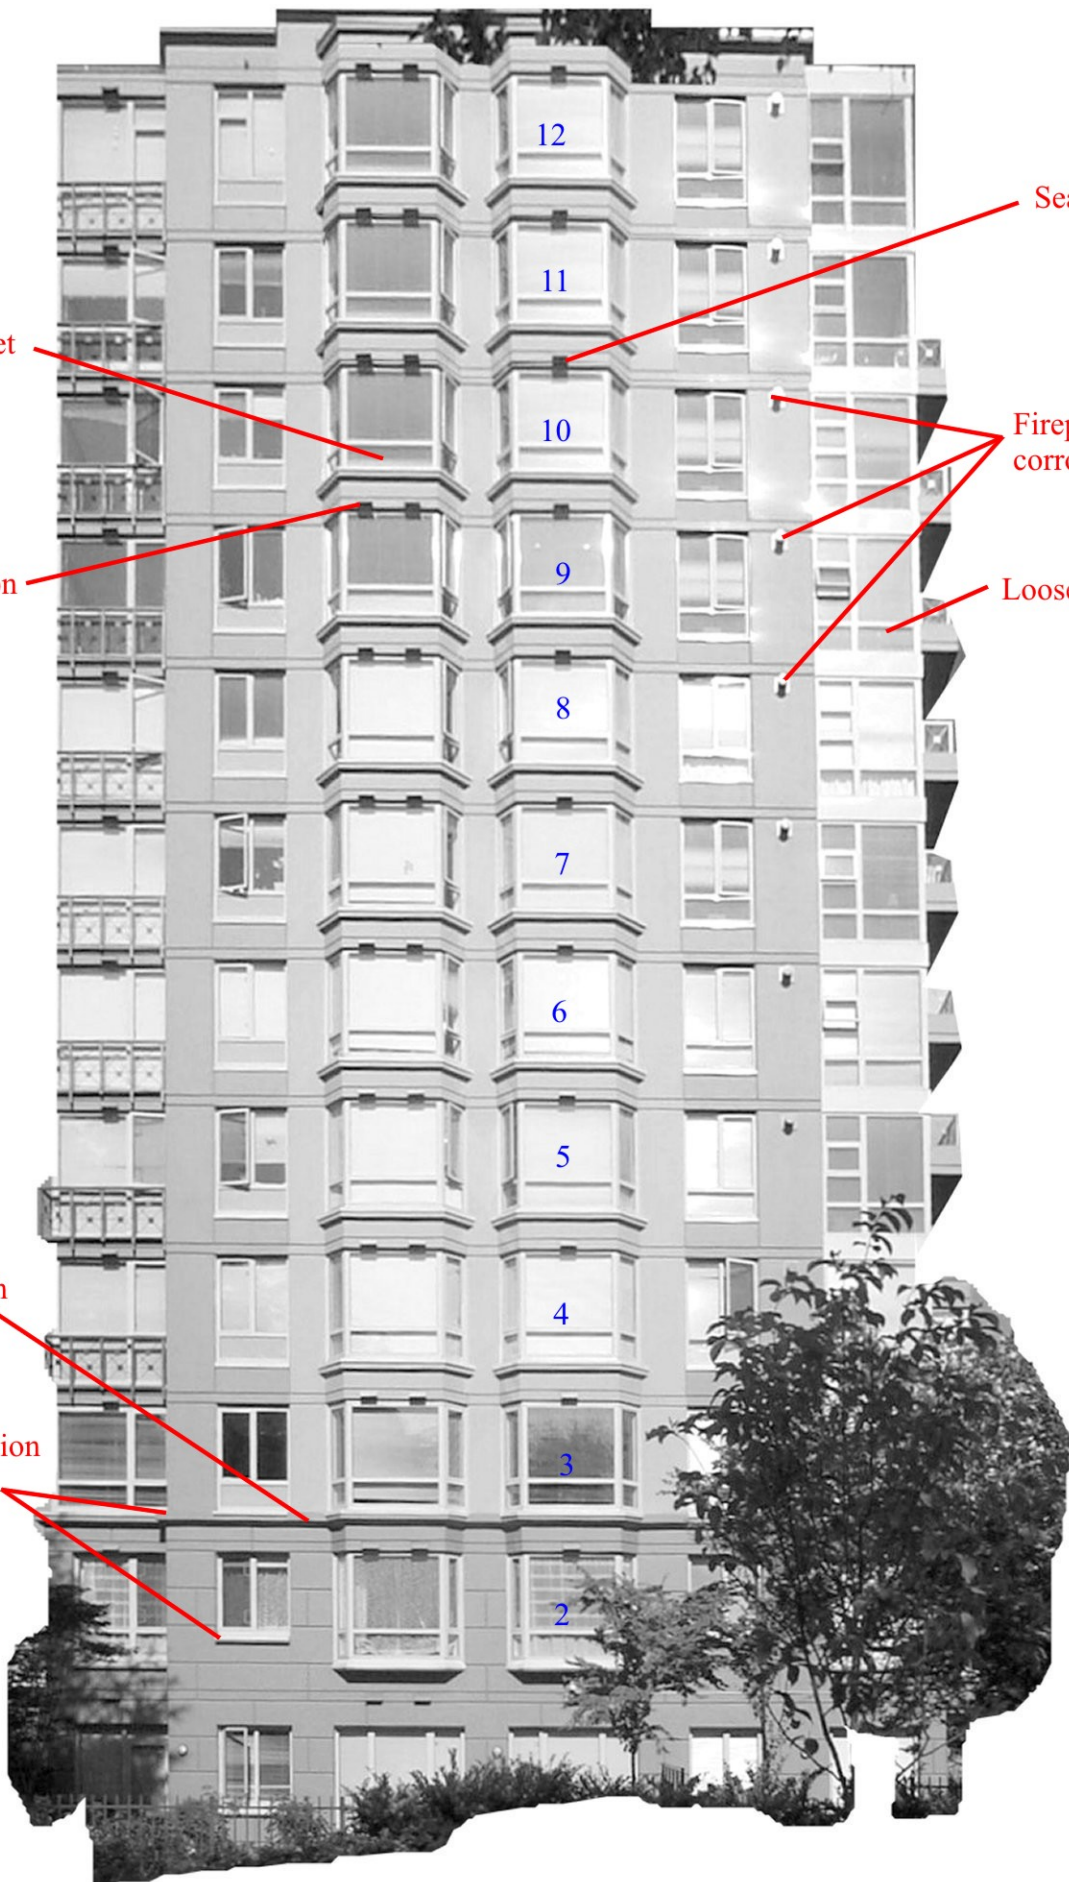
West  
Elevation

Loose gasket

Fireplace vents  
corroding. Common

Organic growth  
on ledge

Sealant separation  
at flashing  
termination
