# **Building Envelope Maintenance Report**

**May 2010**

**The Compton  
1316 West 11<sup>th</sup> Avenue  
Vancouver, BC**

**LMS 4382**

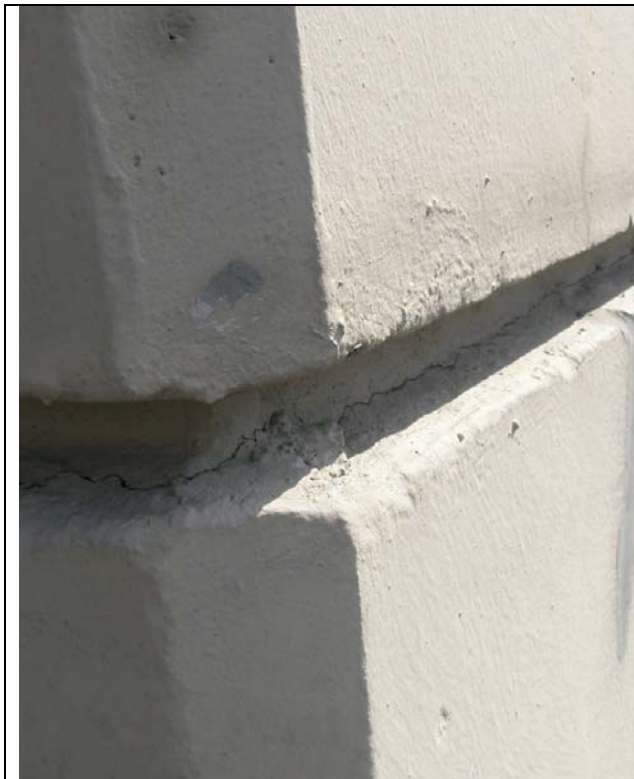
Previous crack repairs are visible around the building. In these locations the crack repairs appear in good condition with no signs of crack extension or sealant failure. There are however, areas where new cracks are present. The majority of these new cracks occur at horizontal reveals in the concrete (Photo 1). Small voids in the concrete at the base of the reveals were also noted in some locations (Photo 2 – 3). In one location, rusting was noted at the back of the reveal, and it appears a piece of reinforcing steel may be exposed behind the paint coating (Photo 4). Sealant should be applied in this area to minimize the possibility of further corrosion and possible damage to the concrete.

**Photo # 1 – Crack at back of reveal**

It should be noted that on many new concrete buildings it is now common practice to caulk these reveals during original construction as this is a location where cracking frequently occurs. As this is a problem that may get worse over time, consideration should be given to caulking these reveals at the Compton.

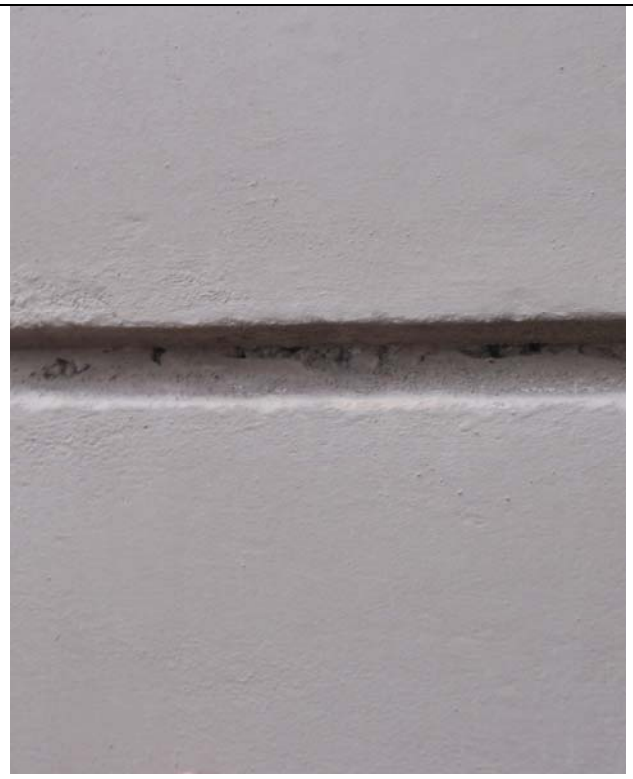
**Photo # 2 – Voids in concrete at back of reveal**

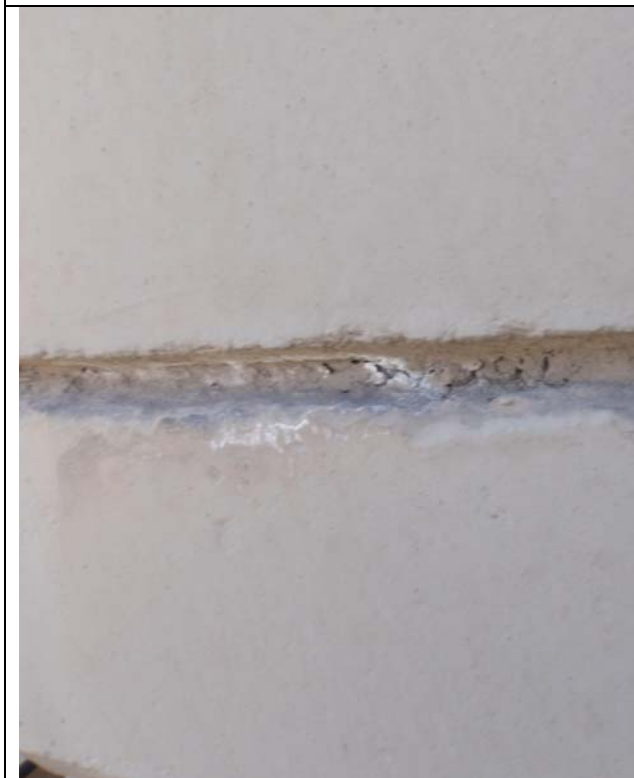
**Photo # 3 – Voids with efflorescence**

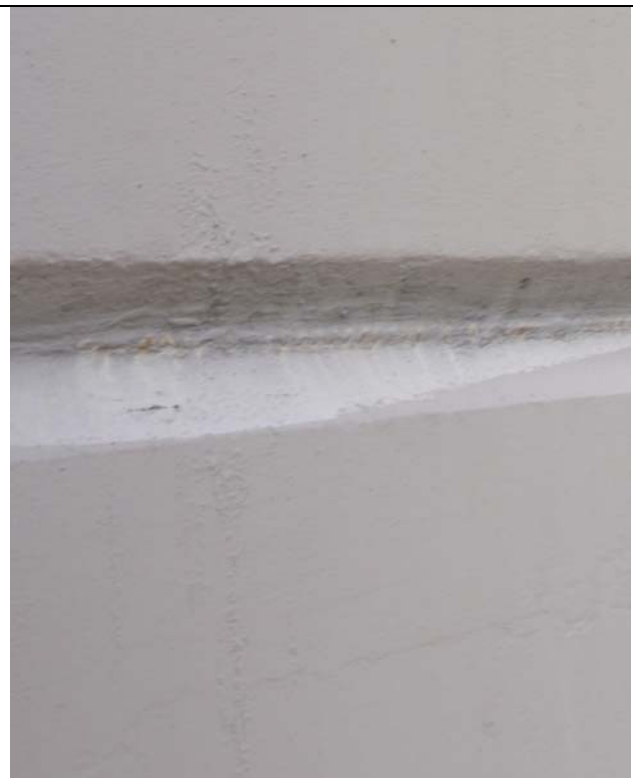
**Photo # 4 – Corrosion at back of reveal**

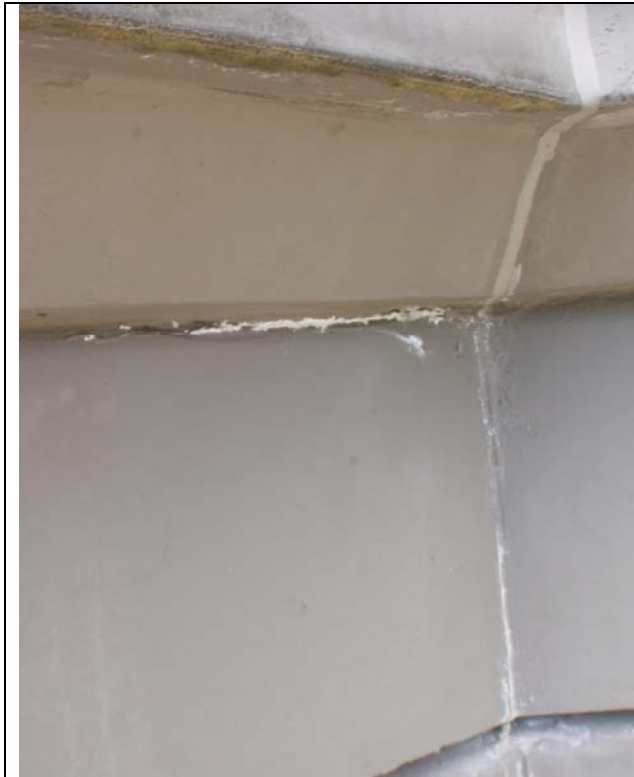
In some locations efflorescence staining is present (Photo 5). Where these stains occur near a crack, they can be an indication that moisture is exiting from the crack. Where present, cracks should be ground out and sealed in a timely manner in order to reduce the potential for future degradation of the concrete.

**Photo # 5 – Efflorescence staining below concrete ledge**

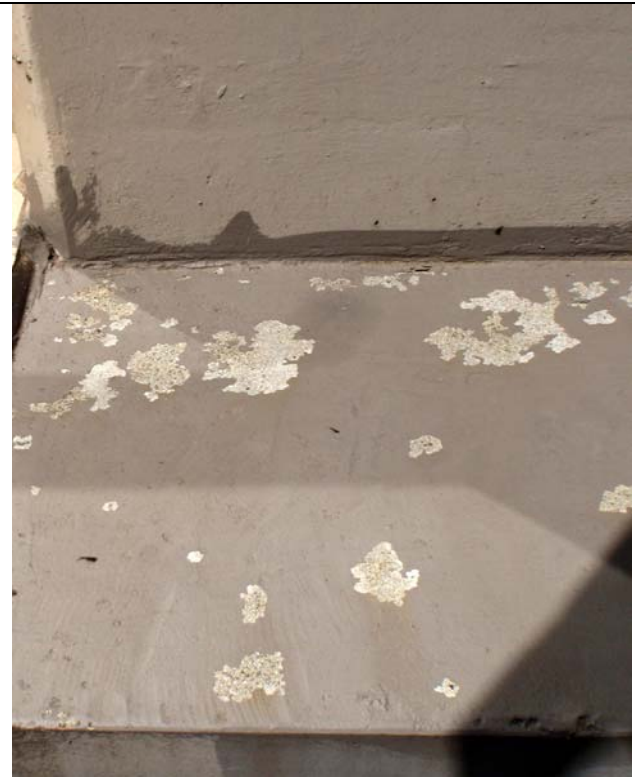
The concrete walls of the Compton have been coated with an acrylic based paint, which generally appeared in good condition. There are however some areas where the paint / membrane on horizontal ledges was observed to be peeling (Photo 6 - 7). Paint was also noted a fading irregularly in one location on the North elevation (Photo 8). Areas of peeling and fading paint have been noted on the attached renderings and should be repaired as soon as practical.

**Photo # 6 – Peeling paint at concrete ledge**

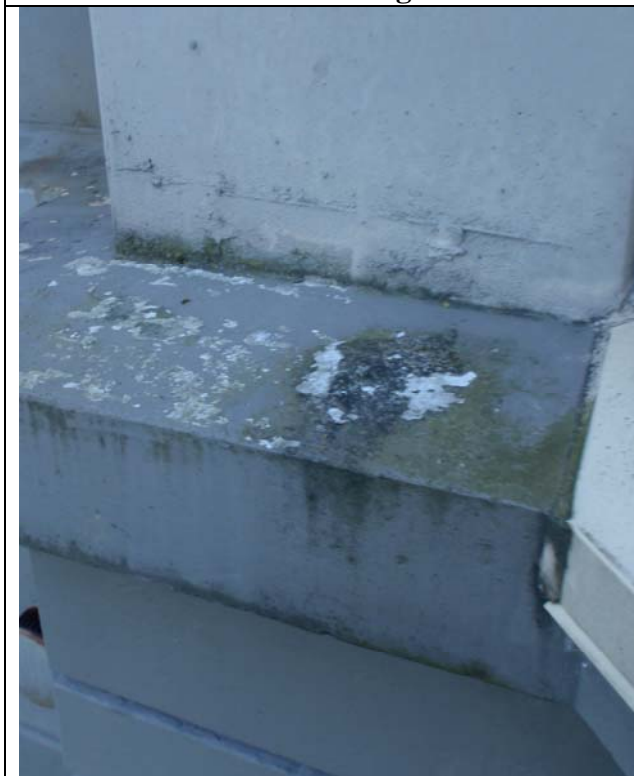
**Photo # 7 – Peeling paint at concrete ledge**

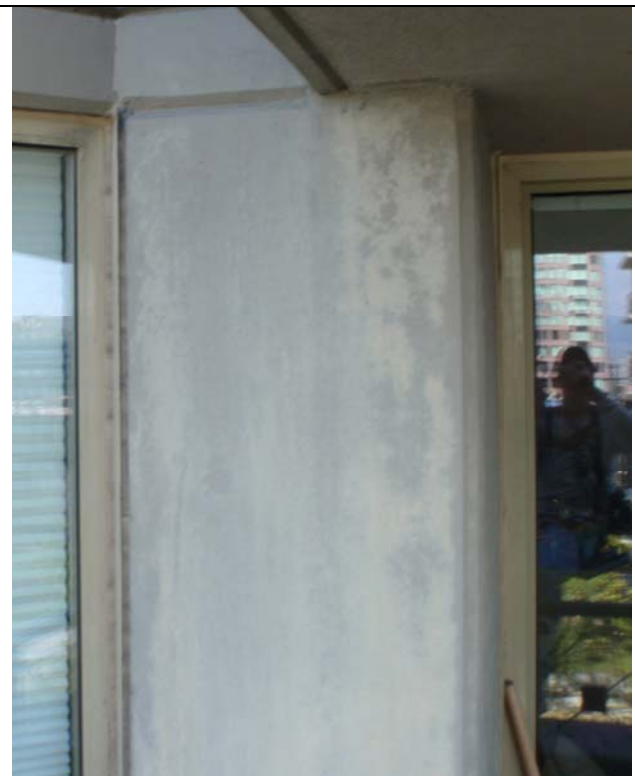
**Photo # 8 – Faded paint on concrete wall**

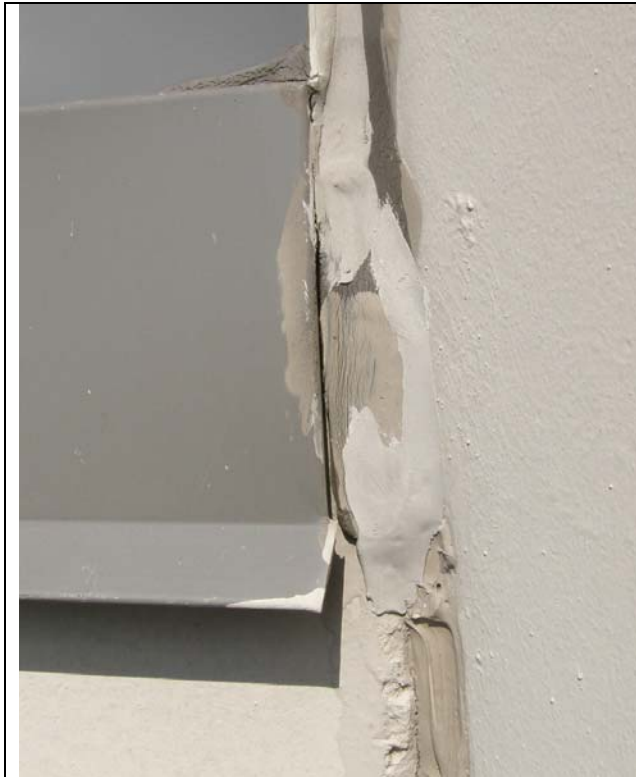
At the Compton, the majority of the sealant was in good condition and performing as intended. Sealant separation was observed in a few locations as noted on the attached elevation photographs (Photo 9 – 10). Sealant should be repaired in these areas as soon as practical.

**Photo # 9 – Sealant separation at flashing**

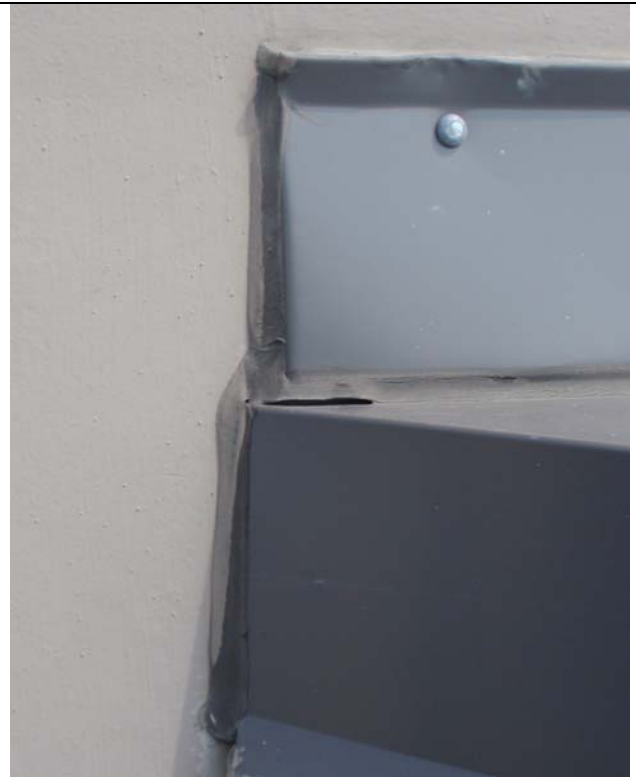
**Photo # 10 – Sealant separation at flashing**

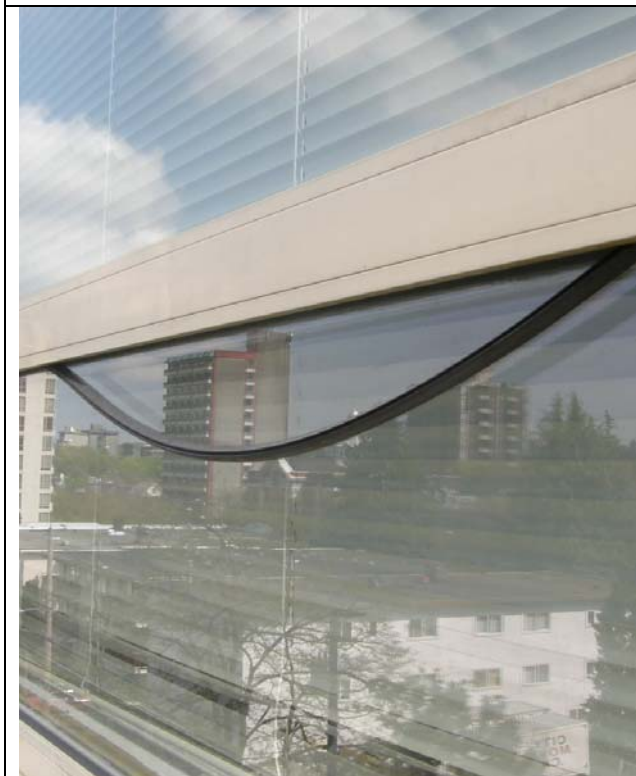
In general the window units appeared in good condition, however there are some isolated issues which should be dealt with at this time. In a few locations, the rubber splines between the window frame and the glazing have fallen out of place, or are missing (Photo 11). These splines should be replaced or reinstalled where possible. In three locations, sealed glazing units had failed (Photo 12). These units should be replaced in a timely manner. While it is likely the manufacturers' original warranty has expired, it is possible that a 10 year warranty may have been given, and the strata may want to check the documentation handed over at the time of construction regarding the window warranty.

**Photo # 11 – Loose window spline**

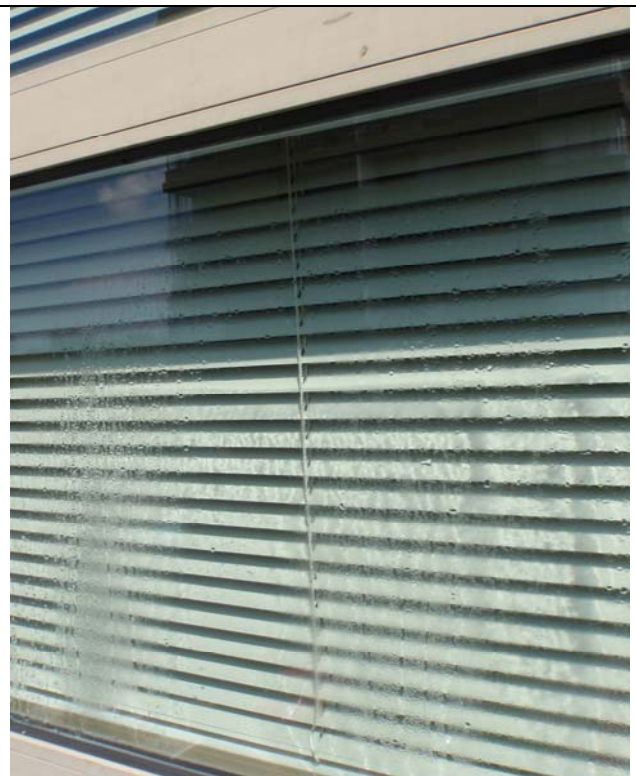
**Photo # 12 – Failed sealed glazing unit**

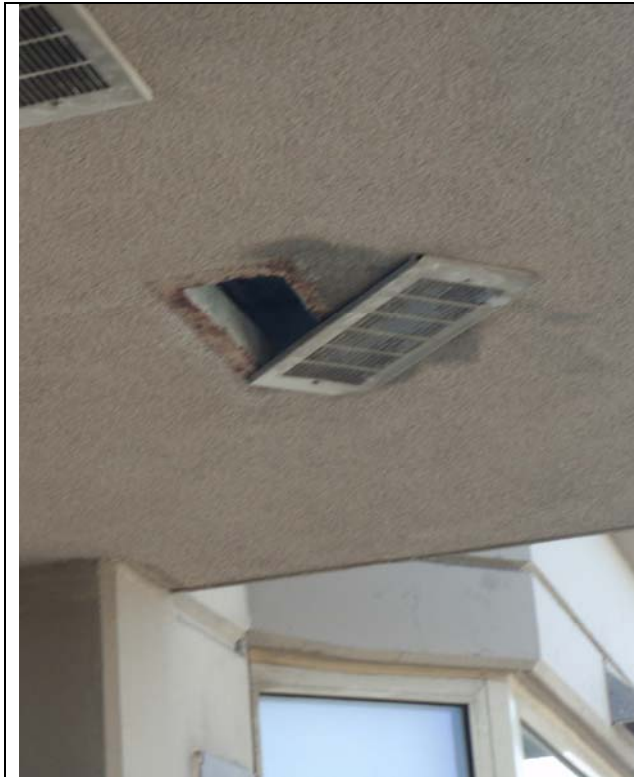
Where observed the balcony soffit vents and exterior hooded vents appeared clear. In one location on the North elevation the soffit vent screen was partially detached, while in another location on this elevation the cover was fully detached. These covers should be refastened as soon as practical (Photo 13). In a few locations, vent hoods appeared damaged, and should be repaired or replaced (Photo 14).

**Photo # 13 – Loose vent cover**

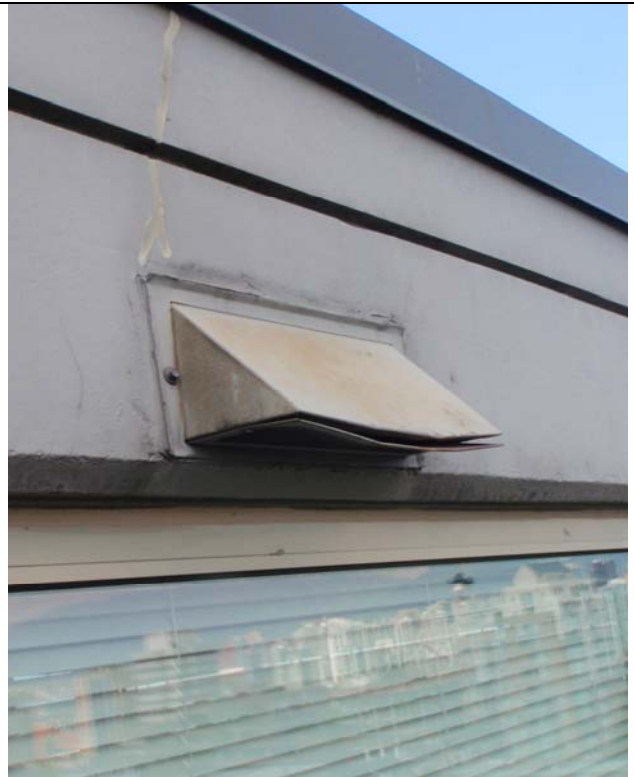
**Photo # 14 – Damaged vent hood**

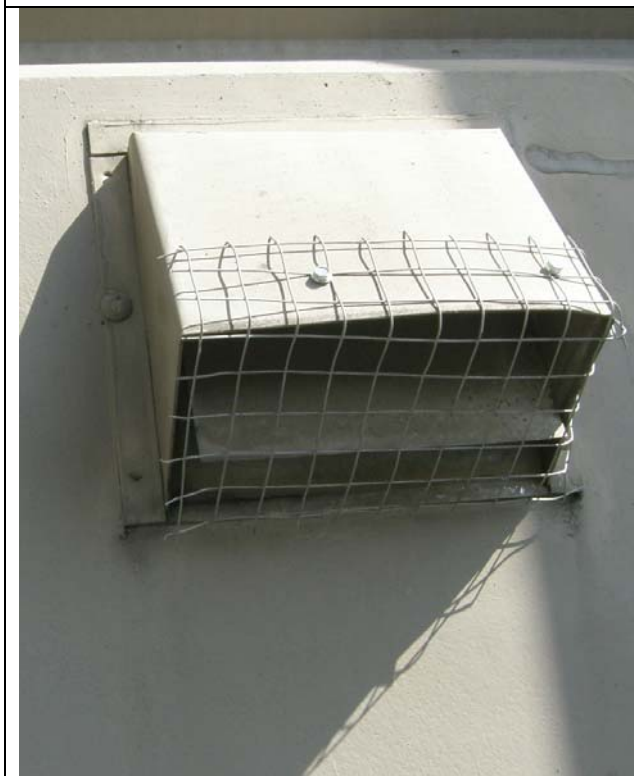
In a number of wall vent locations, metal mesh screens have been installed over the vent hoods. In some locations, the screen has been positioned such that it is impeding the operation of the vent hood flapper (Photo 15). The screens are also very loosely secured in some locations. When conducting any maintenance work on the building, these screens should be adjusted to allow for the proper operation of the vent flapper valves.

**Photo # 15 – Mesh impeding vent flapper**

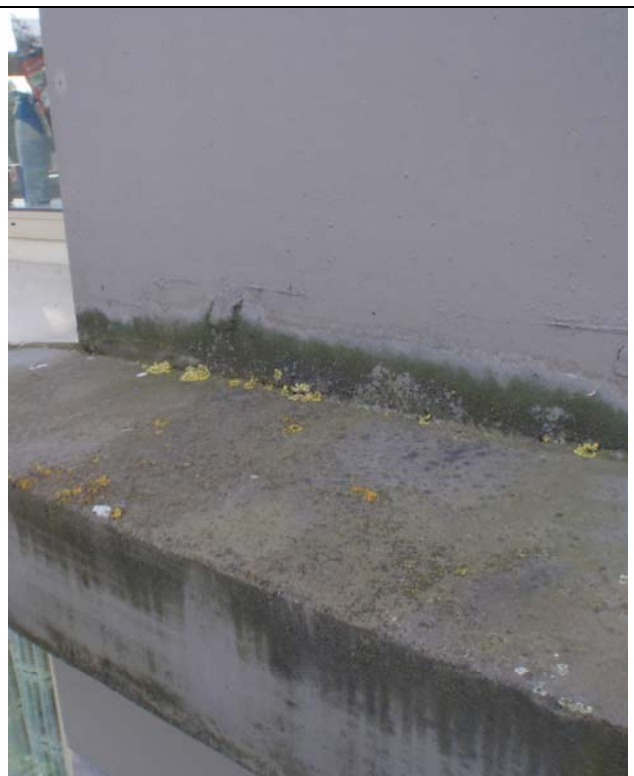
In one location, water was present behind the cover of a wall mounted light fixture. Sealant should be applied at the top of the cover perimeter. Organic growth was present on a number of concrete ledges (Photo 16). These areas should be cleaned as a part of an ongoing maintenance program.

**Photo # 16 – Organic growth on concrete ledge**

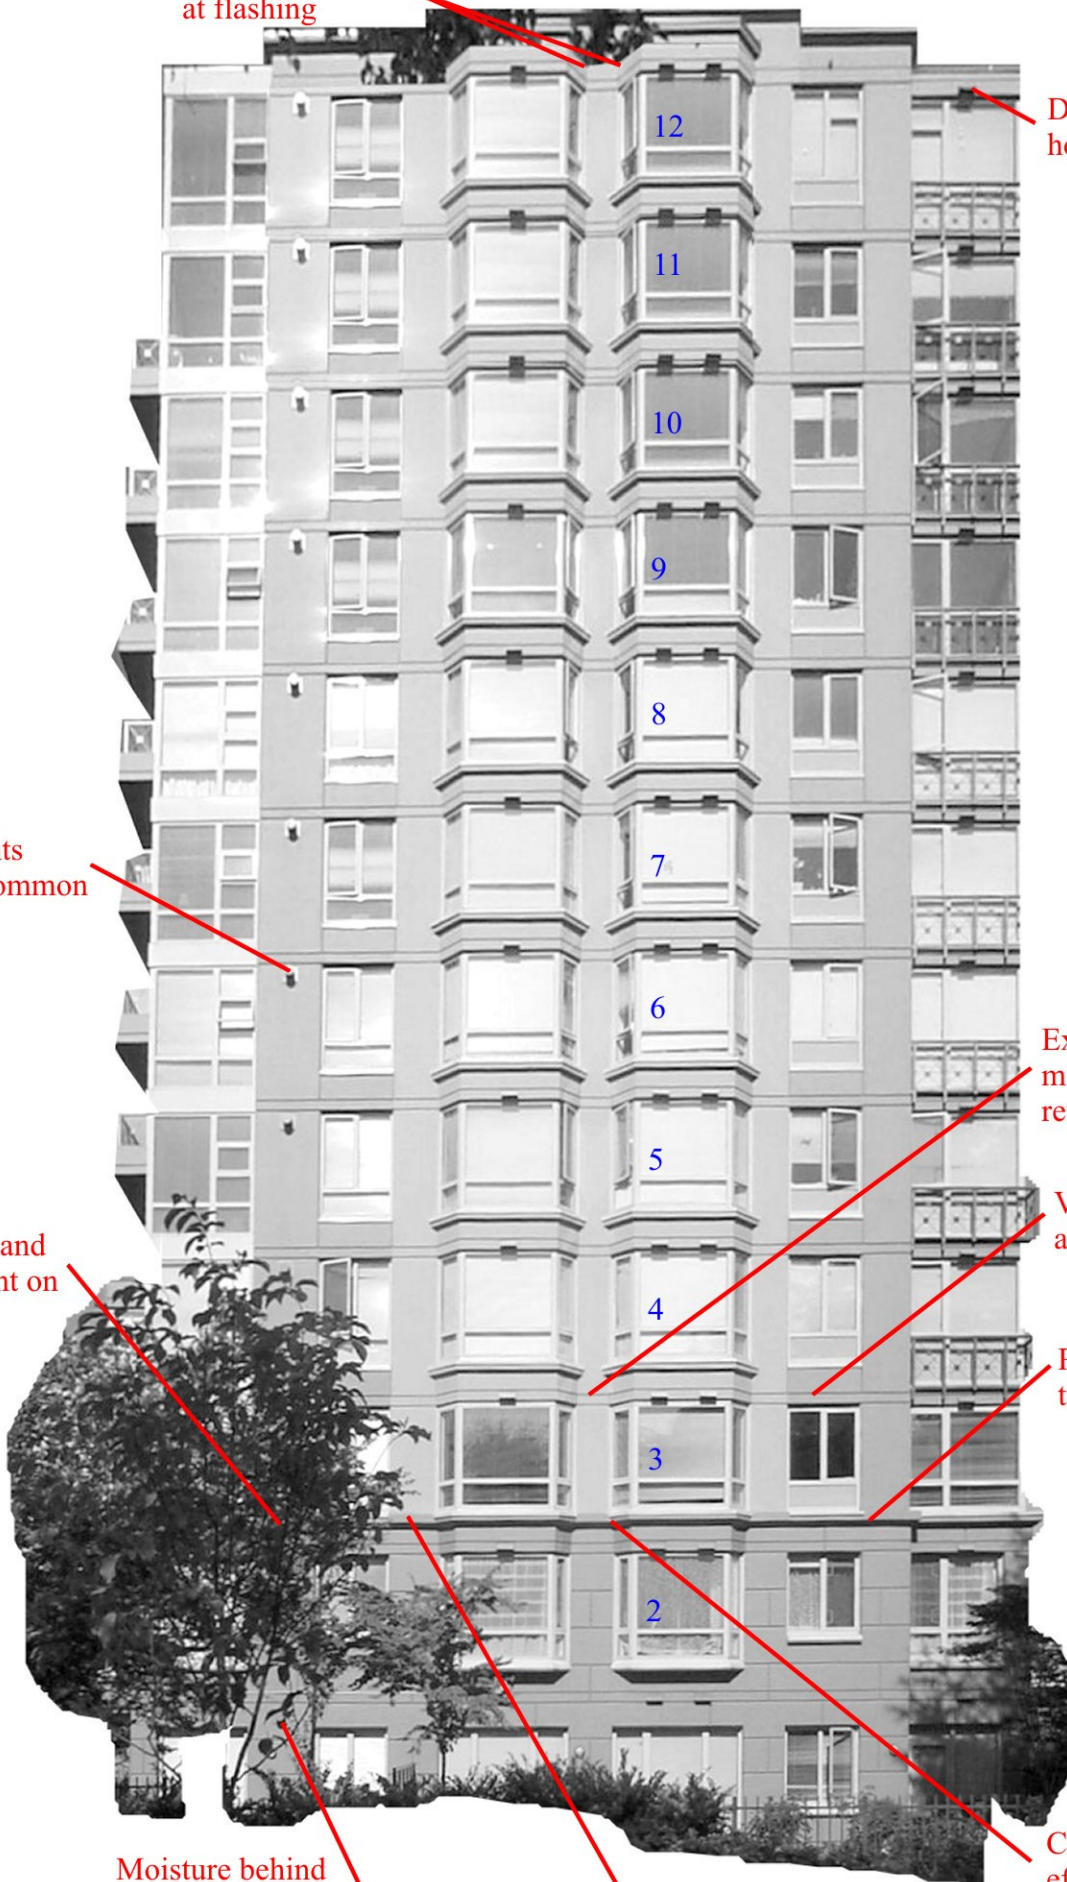
East  
Elevation

Sealant separation  
at flashing

Damaged vent  
hood

Fireplace vents  
corroding. Common

Exposed rebar and  
missing paint in  
reveal

Voids in concrete  
at back of reveal

Rust stains and  
peeling paint on  
ledge

Peeling paint on  
top of ledge

Moisture behind  
light fixture

Crack and small  
hole in ledge

Crack with  
efflorescence

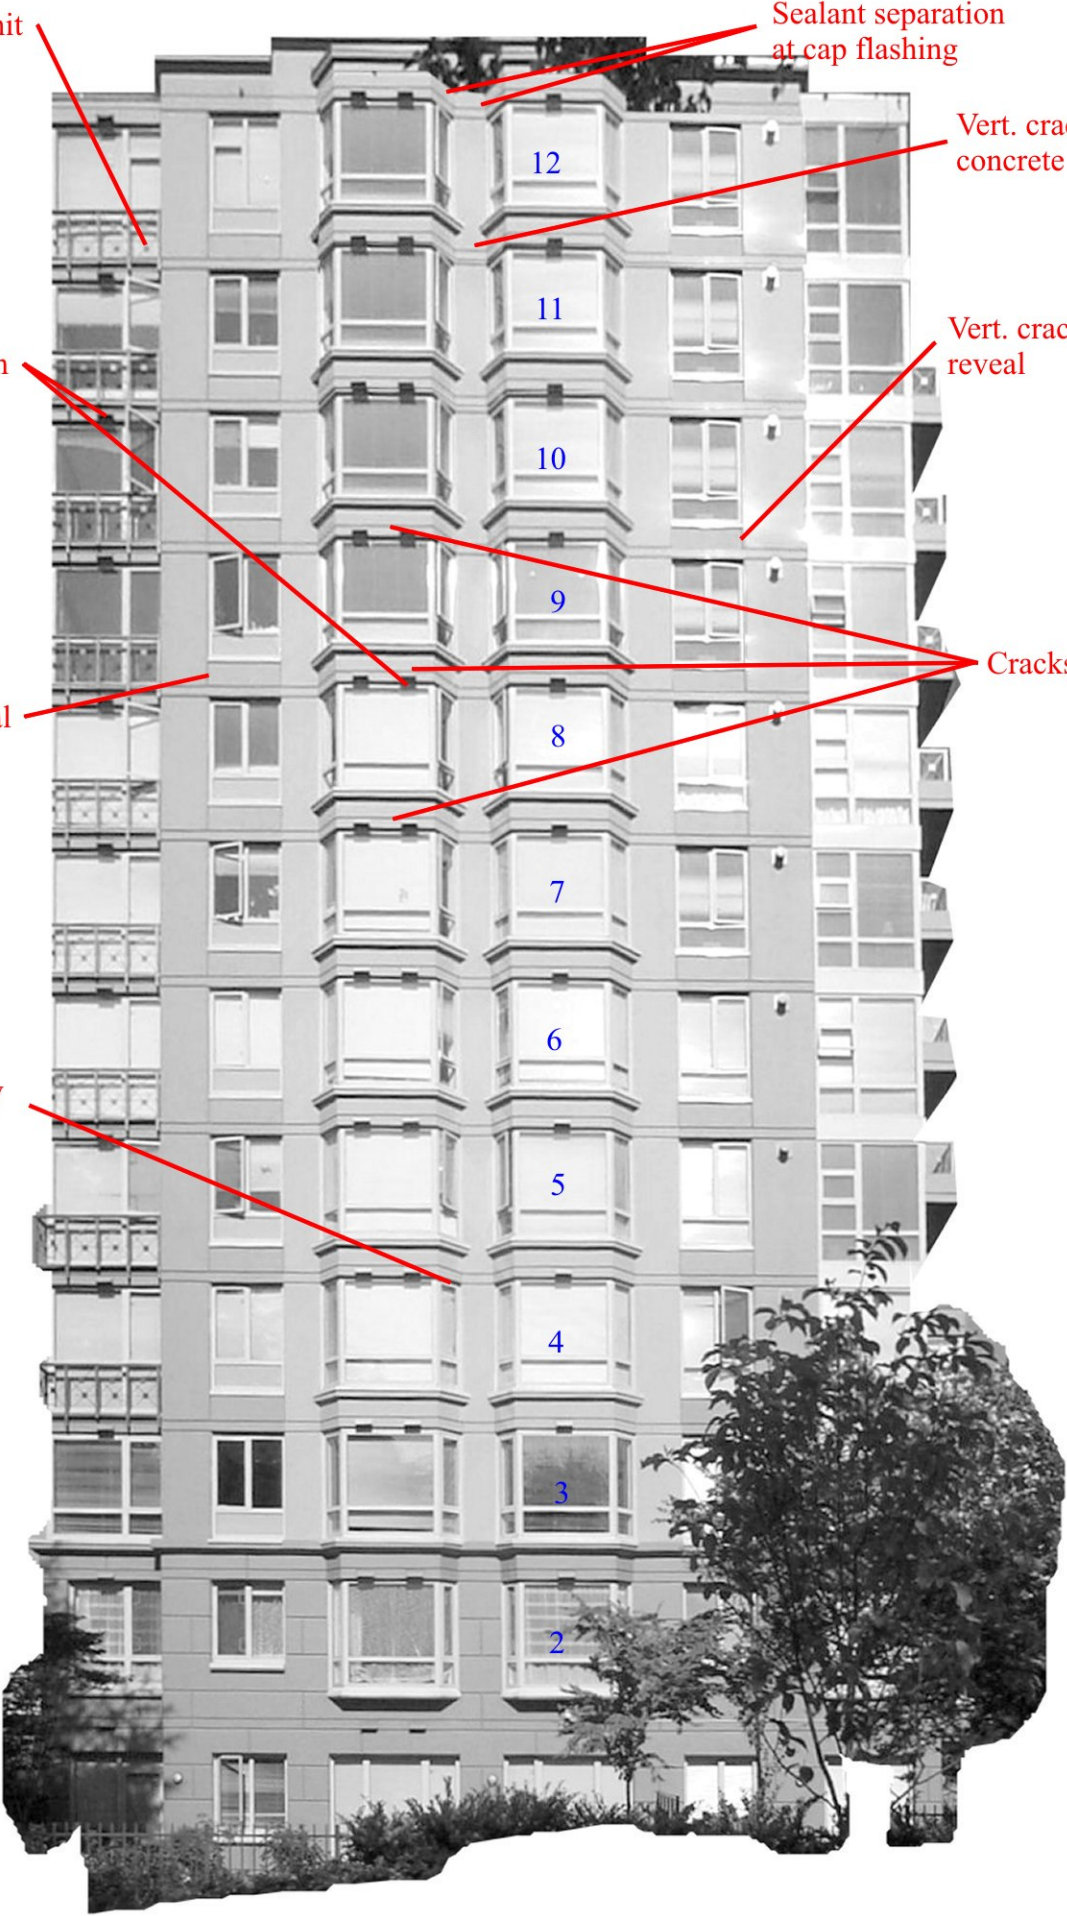
West  
Elevation

Vert. crack in  
concrete

Sealant  
separation  
at vent

Vert. crack in  
reveal

Crack in reveal

Cracks in reveal

Loose window  
spline
