XTR Building Services Ltd

“Exterior building envelope review & maintenance”

C/O Vancouver Condominium Services The Savoy- 928 Richard Street, Vancouver B.C

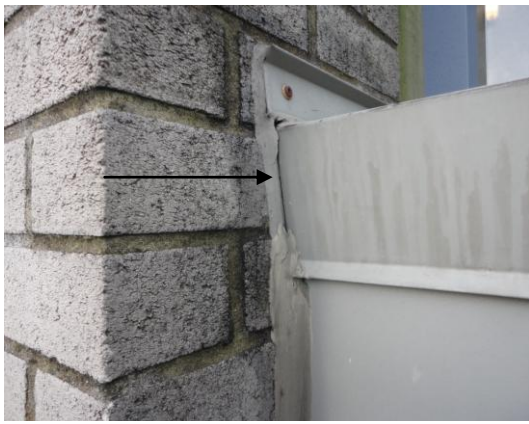
South Elevation: Drop # 1 At roof level sealant failure at cap flashing saddles. Organic growth on exterior brick.
•

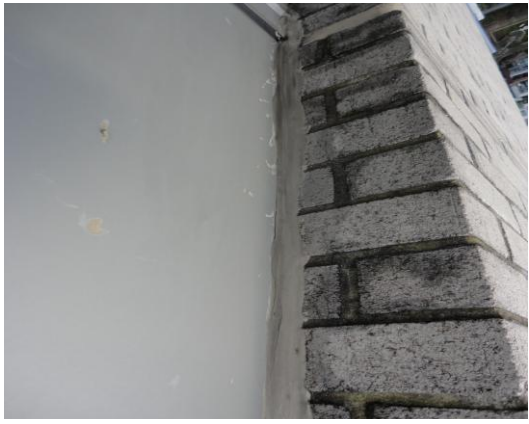
South Elevation: At roof level sealant failure at metal to brick.
•

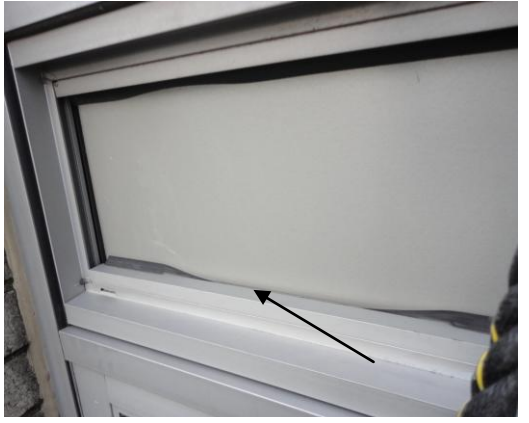
32 nd Floor PH: Rubber window gasket out of place.

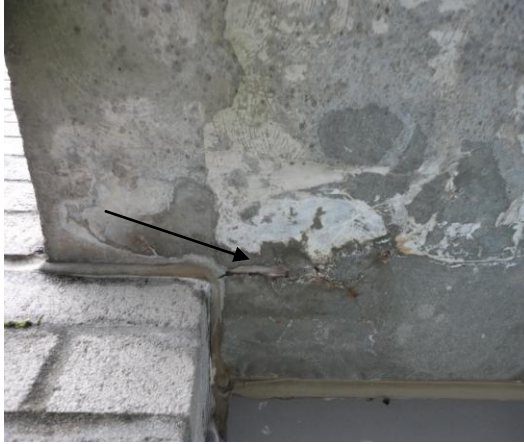
<p>31st floor: Moisture in concrete and exposed forming left in concrete. Missing sealant at balcony saddle common along entire run. Sealant at the saddle connection would prevent water at this location.</p>
<ul style="list-style-type: none"> •

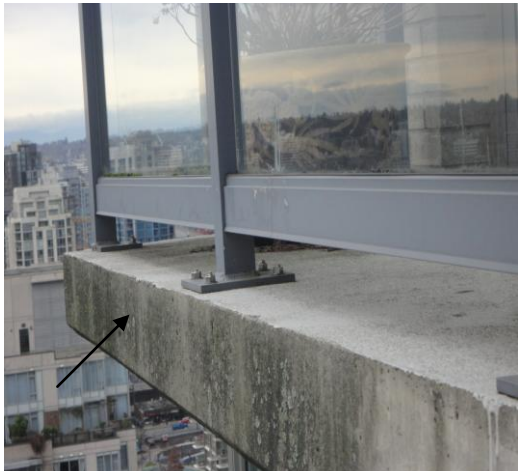
<p>31st floor: Organic growth on balcony face and decks.</p>
<ul style="list-style-type: none">•

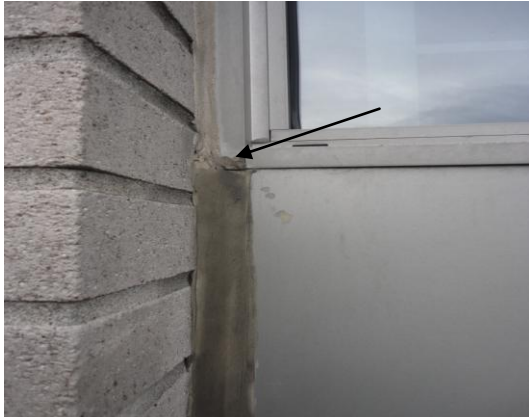
<p>30th floor: Caulking failures at metal panels between floors.</p>
<ul style="list-style-type: none">•

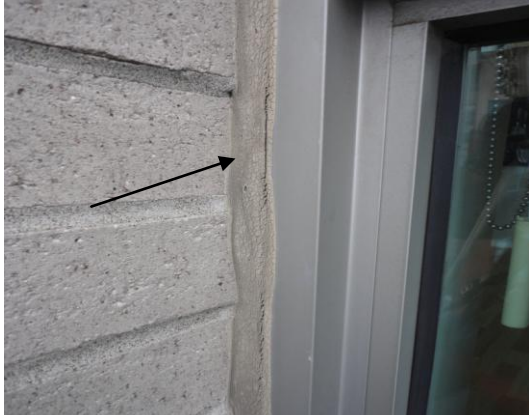
<p>29th floor: Sealant failure at window frame to brick transitions. Typical along entire run.</p>

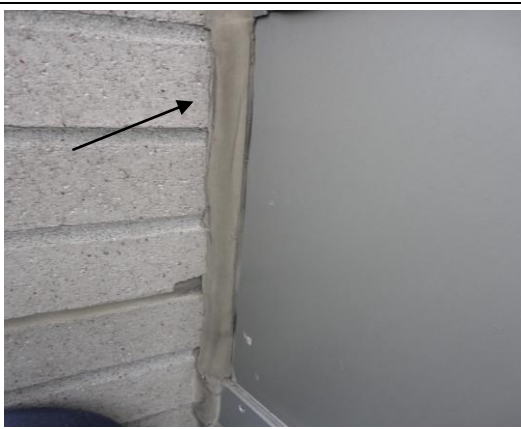
<p>29th floor: Sealant failure at brick to panel transitions between floors.</p>
•

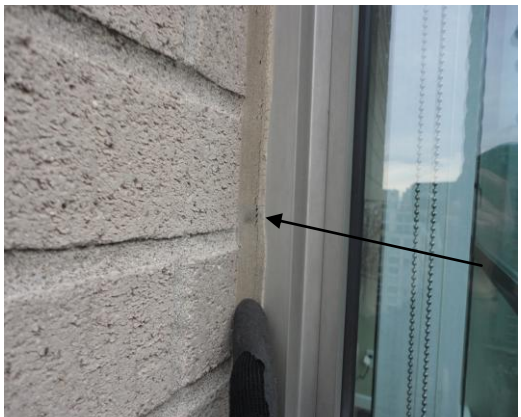
<p>25th floor: Sealant failure at window to brick transition typical to this run.</p>
•

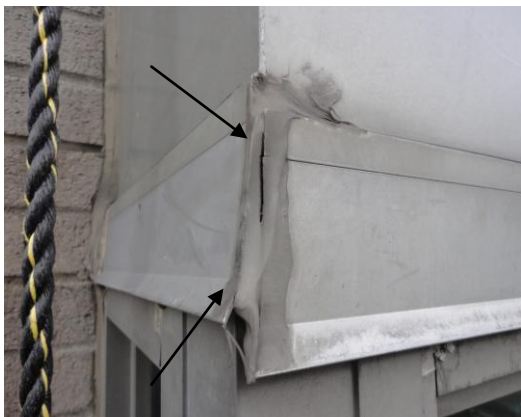
<p>19th floor: Failed sealant repair by others at outside corner of window bay. The wrong type of sealant was applied.</p>
•

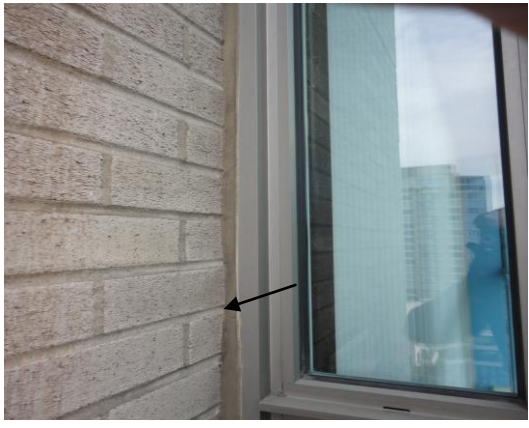
16 th floor: Typical sealant failure at window frames.
•

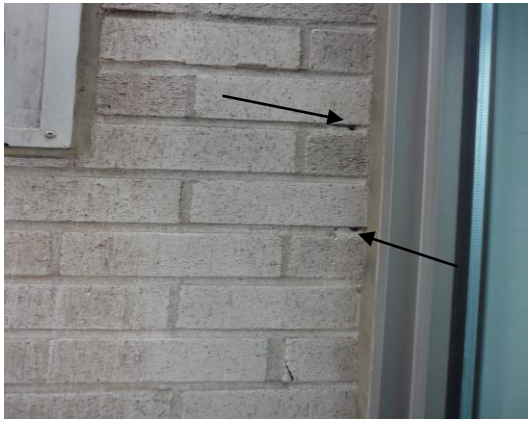
16 th floor holes in brick.
•

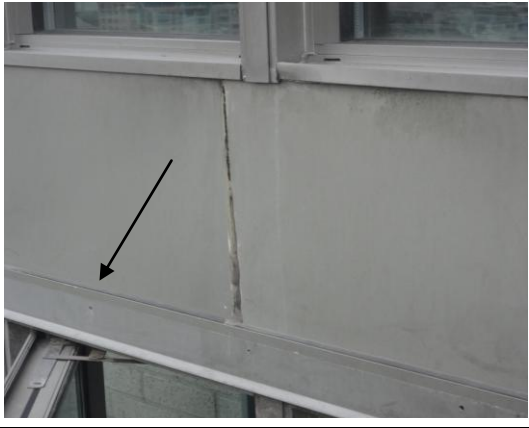
14 th floor: Missing sealant at window header.
•

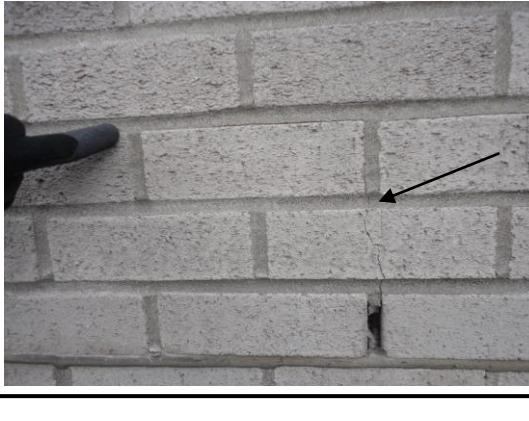
14 th floor: Crack in brick.

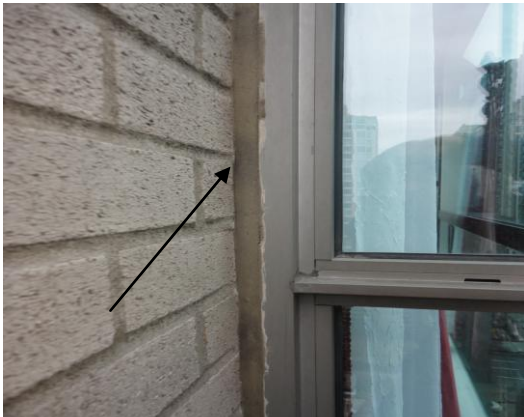
A photograph showing a close-up of a window jamb on the 13th floor. The window frame is white, and the surrounding wall is made of light-colored bricks. A black arrow points to a vertical gap between the window frame and the brickwork, indicating a sealant failure.	<p>13th floor sealant failure at window jamb.</p>
<ul style="list-style-type: none">•

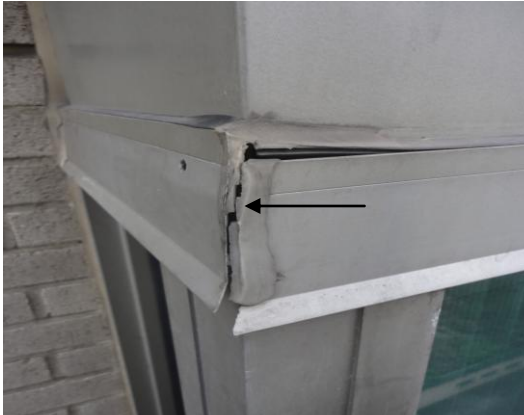
A photograph showing a close-up of the outside window frame on the 12th floor. The window frame is white, and the surrounding wall is made of light-colored bricks. A black arrow points to a gap between the window frame and the brickwork, indicating a sealant failure.	<p>12th floor: Sealant failure at outside window frame. Interior silicone applied by others.</p>
<ul style="list-style-type: none">•

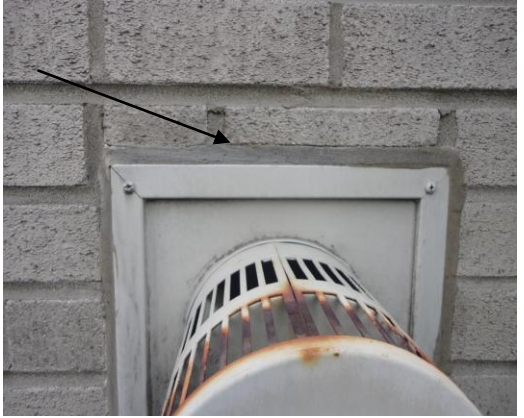
A photograph showing a close-up of a vent perimeter on the 11th floor. The vent is white and has a circular opening with a metal grate. The surrounding wall is made of light-colored bricks. A black arrow points to a gap between the vent frame and the brickwork, indicating a sealant failure.	<p>11th floor: Sealant failure at vent perimeter (pin holes and cracking of existing sealant)</p>

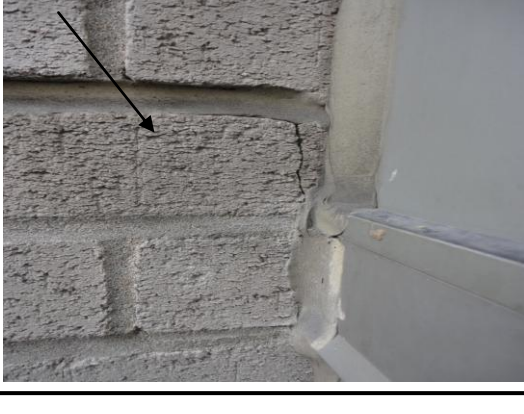
A photograph showing a close-up of a sealant failure and a crack in the brick on the 11th floor. The brick is light-colored and has a vertical crack. The sealant is white and has failed, creating a gap between the brick and the window frame. A black arrow points to the crack in the brick.	<p>11th floor: Sealant failure and crack in brick.</p>

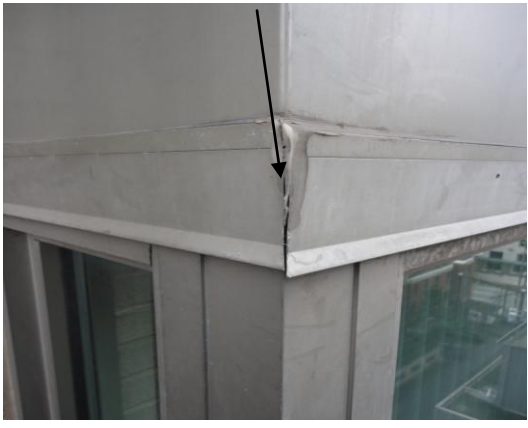
<p>10th floor: Sealant failure at outside corner typical along this run.</p>
•

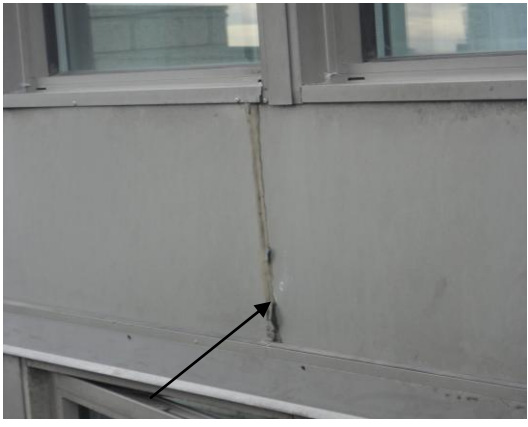
<p>10th floor: Sealant failure at panel joint and peel & stick membrane behind is melting.</p>
•

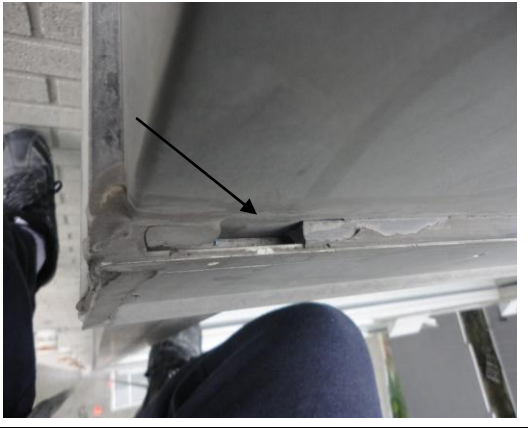
<p>10th floor: Clear silicone applied at bottom of panel has failed where rubber gasket is missing.</p>
•

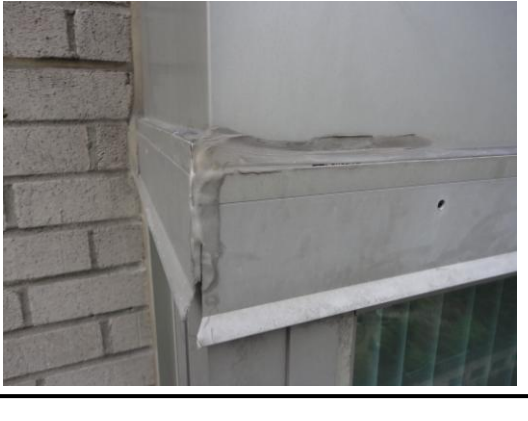
<p>8th floor: Typical sealant failure at outside window corner.</p>

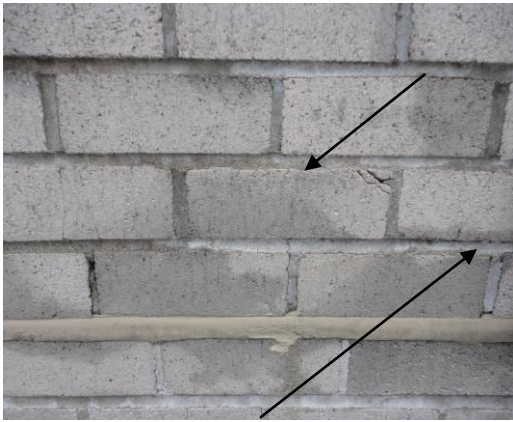
<p>East Elevation drop #2: 30th floor:</p> <p>Multiple cracks in the brick work.</p>
<ul style="list-style-type: none"> •

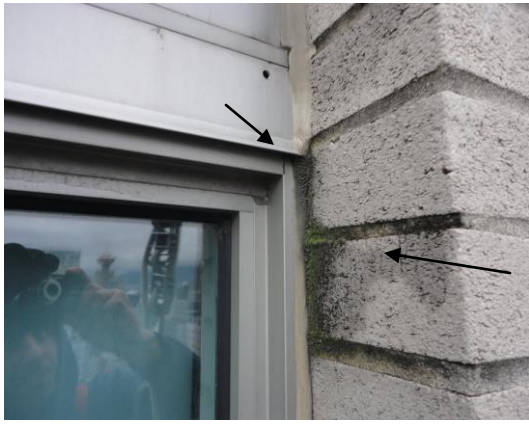
<p>27th floor: Sealant failure at window jamb and at panel. Algae growth and water retention at brick veneer.</p>
•

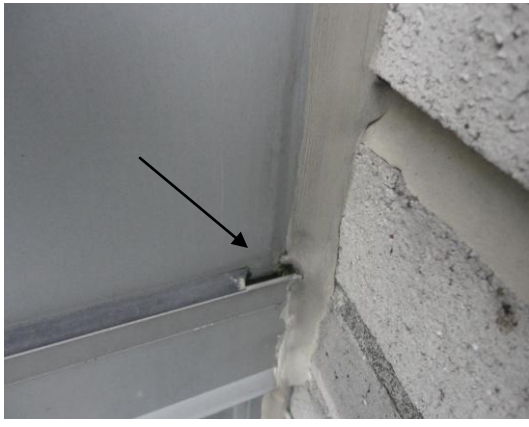
<p>27th floor: Panel gasket is short and should be sealed.</p>
•

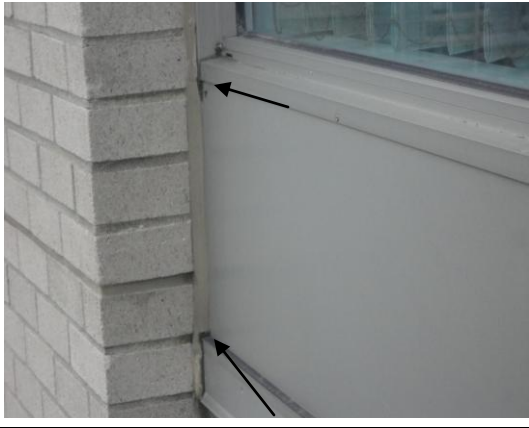
<p>26th floor: Selant failure at window jamb and panel. Typical along this run.</p>
•

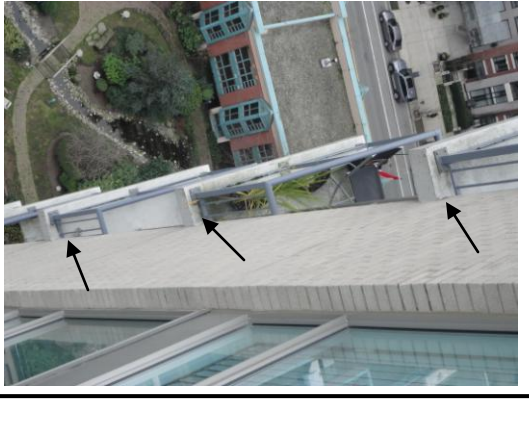
<p>26th floor: Sealant missing at all saddle connections along this run.</p>

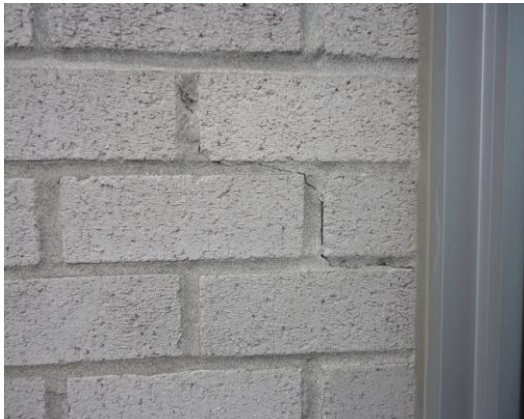
23 rd floor: Crack in brick veneer.
•

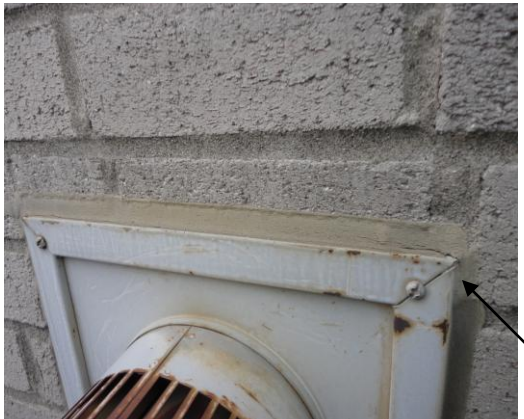
23 rd floor: Sealant failing at vent perimeter.
•

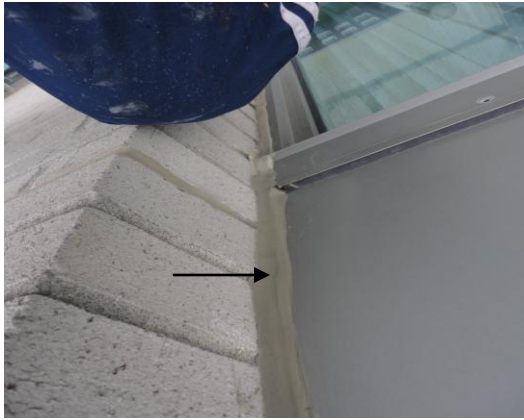
23 rd floor: Sealant failure at window jamb typical along this run.
•

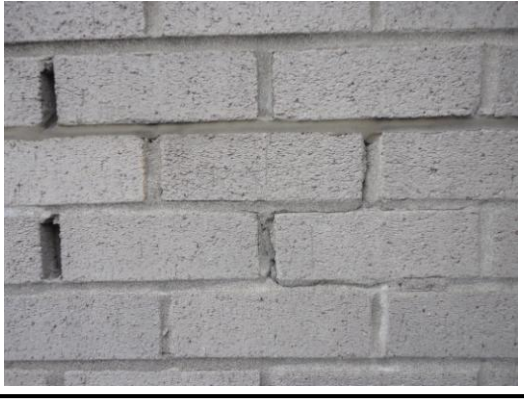
22 nd floor: Crack in brick veneer.

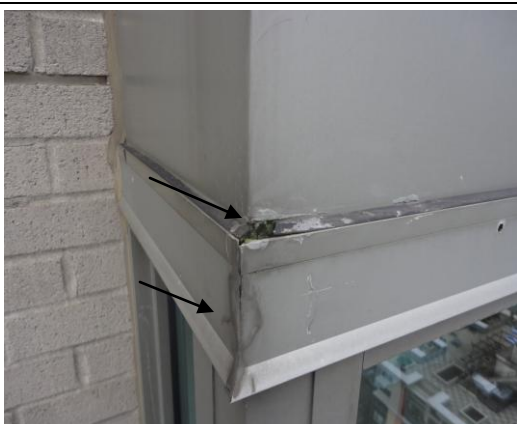
22 nd floor: Sealant failure and gasket to short at transition joint.
•

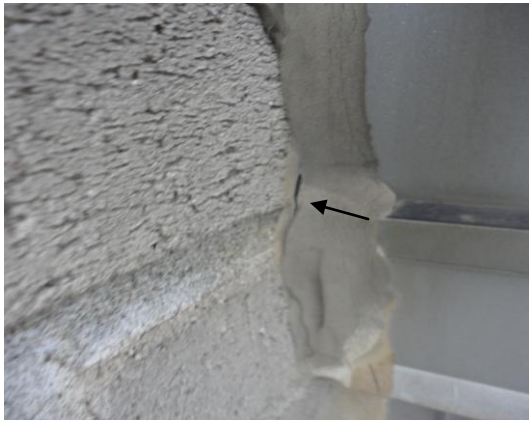
<p>19th floor: Failed sealant at metal panel to brick typical along this run.</p>
•

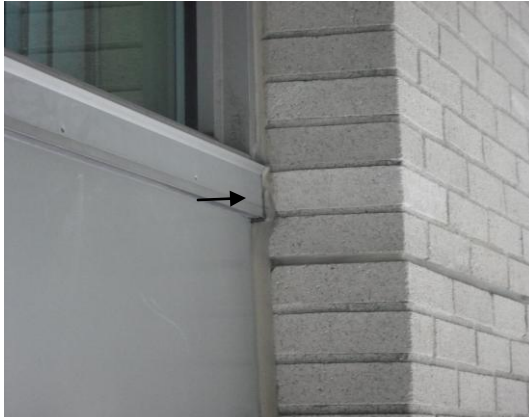
<p>19th floor: Sealant failure at panel to brick.</p>
•

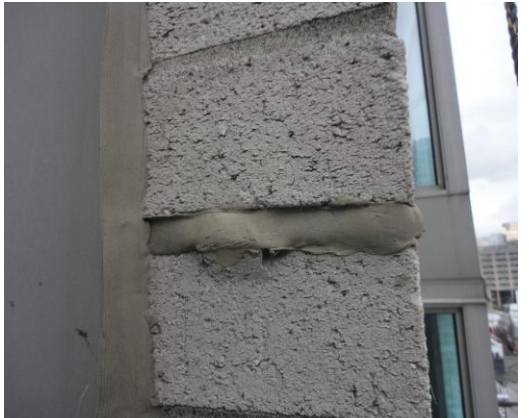
<p>18th floor: Failed sealant at brick to brick joints typical along this run.</p>
•

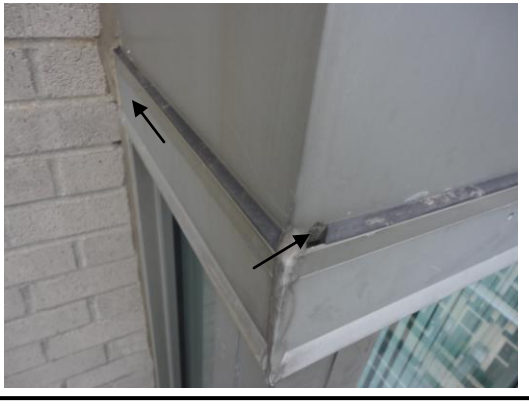
<p>17th floor: Sealant failure at panel to brick. Gasket at window header short.</p>

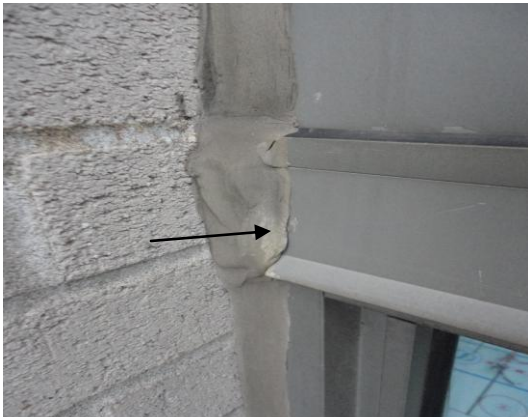
A close-up photograph showing a grey metal panel meeting a brick wall. A black arrow points to a significant gap and peeling of the white sealant at the junction.	<p>16th floor: Sealant failure at metal panel to brick.</p>

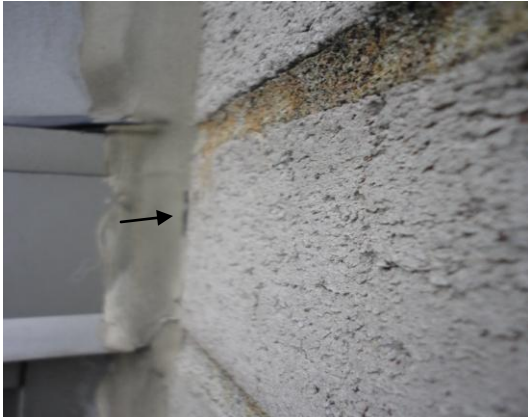
A close-up photograph of a window opening. A black arrow points to a vertical gap where the sealant has failed between the window frame and the brickwork.	<p>16th floor: Sealant failure at panel right side of window opening.</p>

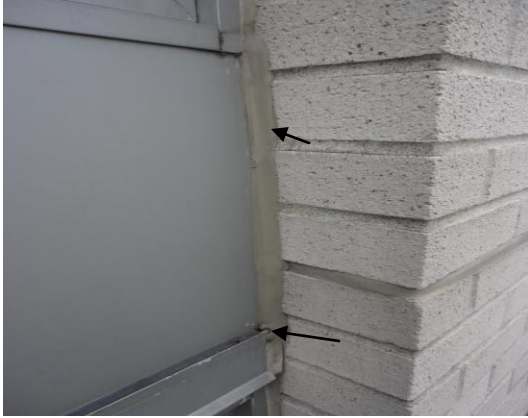
A photograph showing a grey metal panel adjacent to a brick wall. Two black arrows point to gaps in the sealant at the top and bottom of the panel's edge.	<p>15th floor: Sealant failure at panel</p>

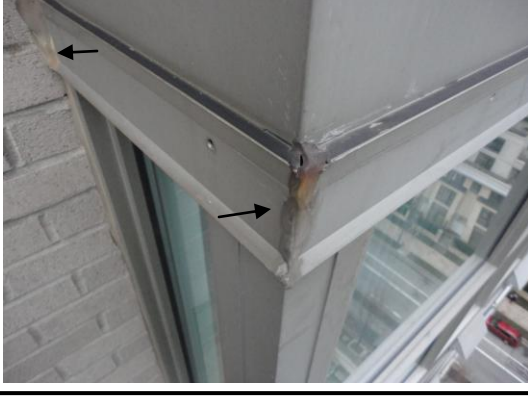
A photograph of a window corner on the 14th floor. Two black arrows point to areas where the sealant has failed at the junction of the metal panel, a vent, and the window frame.	<p>14th Floor: Failed sealant at metal panel, vent and window frame.</p>

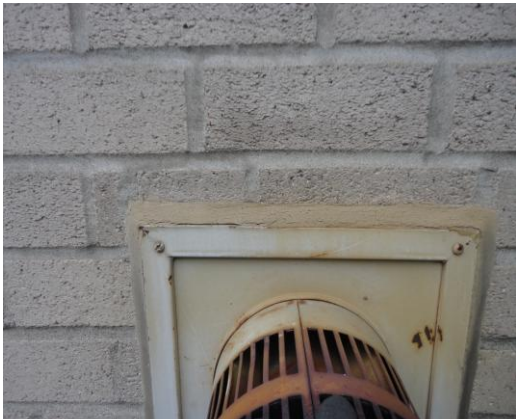
14 th floor: Failed sealant at vent
•

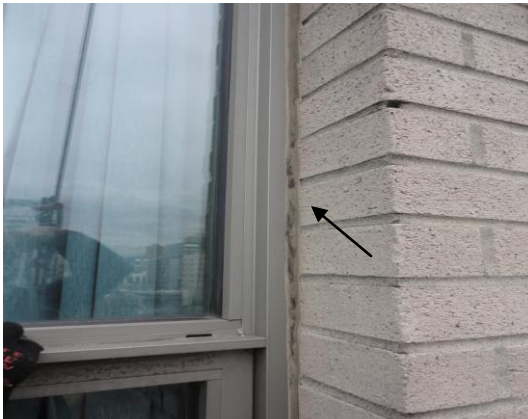
13 th floor: Failed sealant at window jambs and meta panel transitions.
•

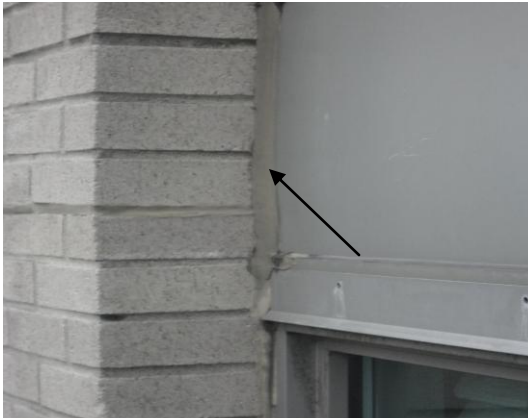
13 th floor: Failed sealant at panel
•

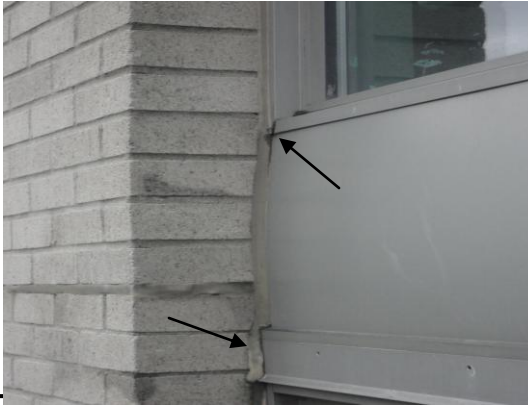
12 th floor: Sealant failures at jamb detail.

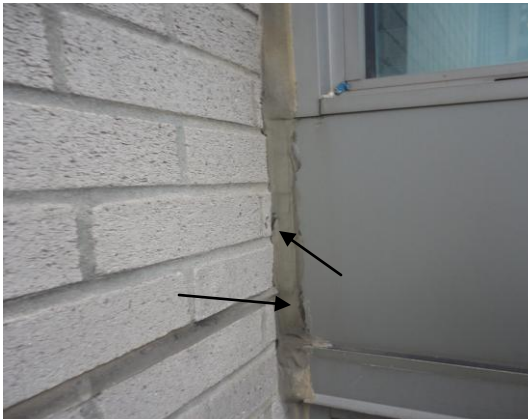
10 th Floor: Failed sealant at panel
•

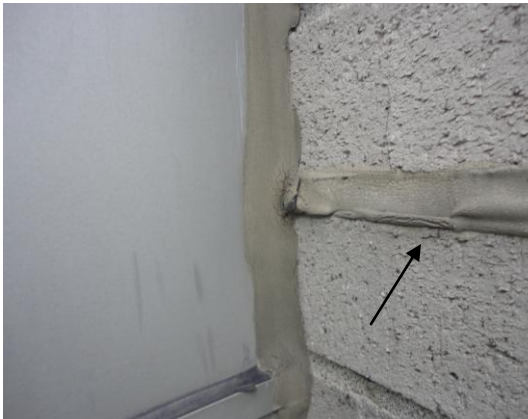
9 th floor: Sealant failure at brick to brick joints.
•

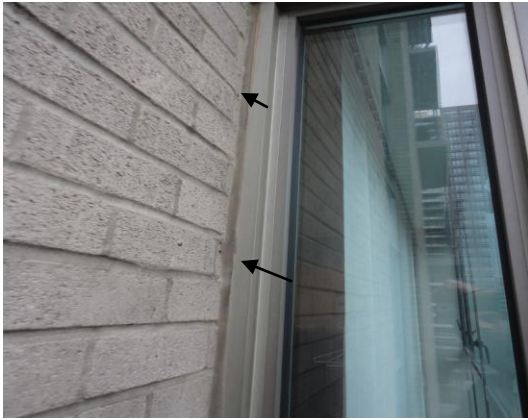
8 th floor: Failed sealant at jamb.
•

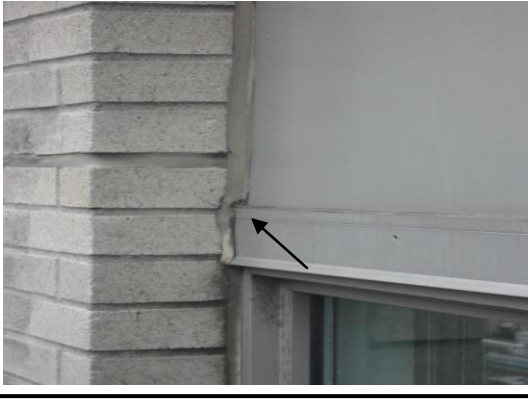
7 th floor: Failed sealant at jamb.

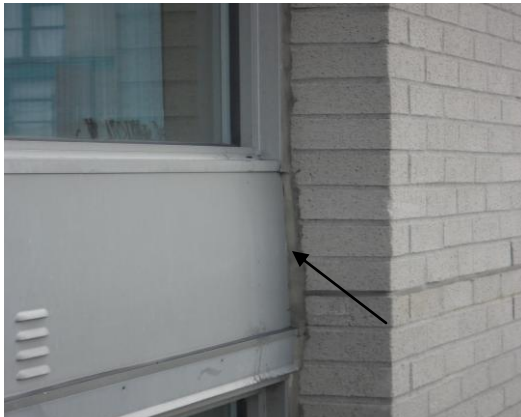
<p>29th floor: Failed sealant at panel to brick joints typical.</p>
•

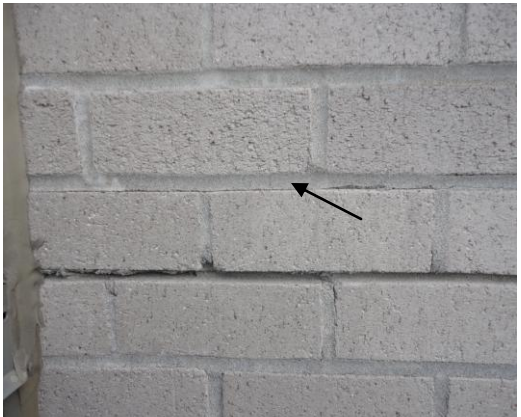
25 th floor : Crack in brick
•

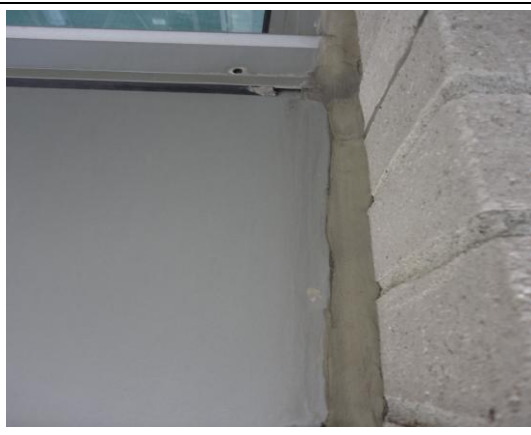
19 th floor: Failed sealant at panel
•

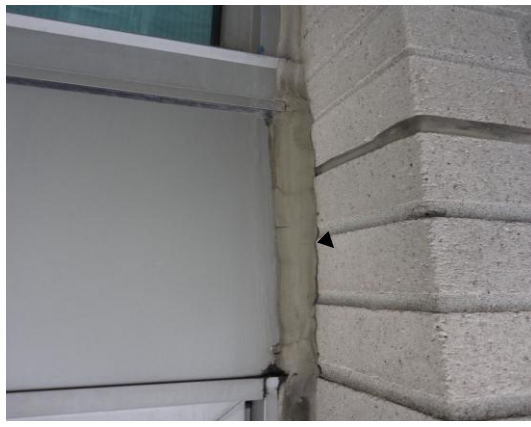
18 th floor: Failed sealant at panel
•

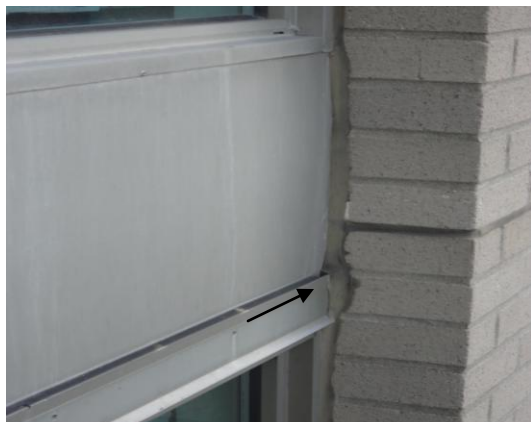
17 th floor: Sealant failing at panel.
•

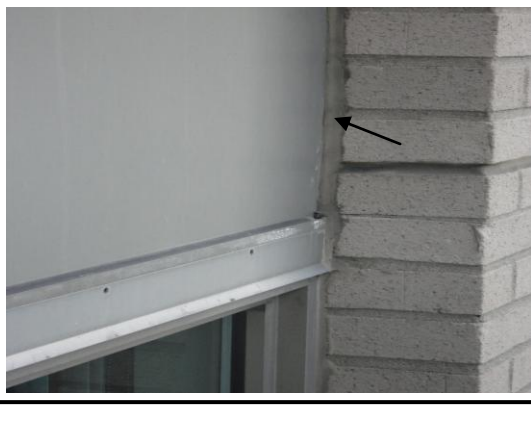
16 th floor: Sealant failure at panel.

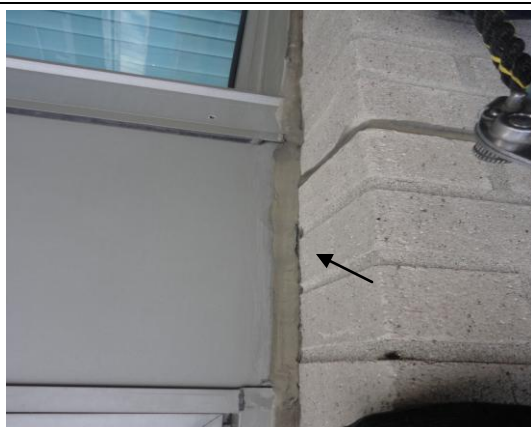
<p>15th floor: Sealant failure at panel to brick.</p>
•

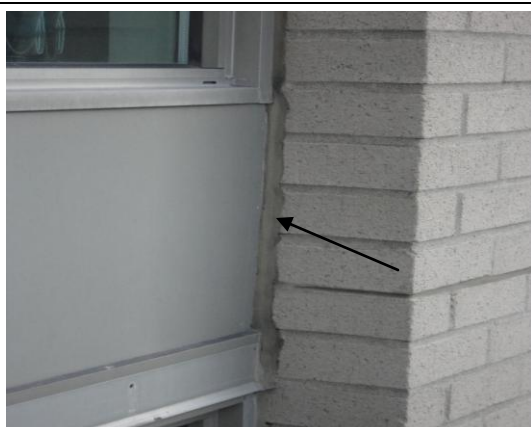
<p>13th floor: Failed sealant at window jamb and at panel.</p>
•

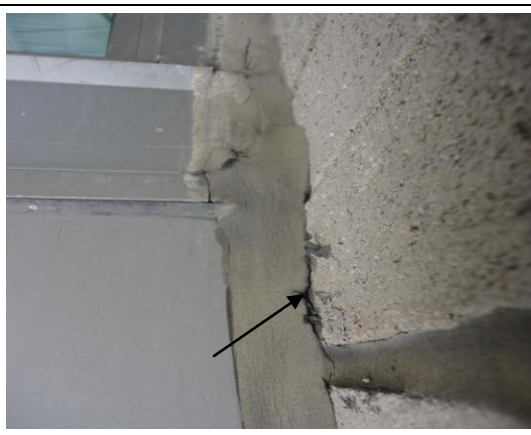
<p>12th floor-4th floor: Sealant failure at jamb and at panel transitions.</p>
•

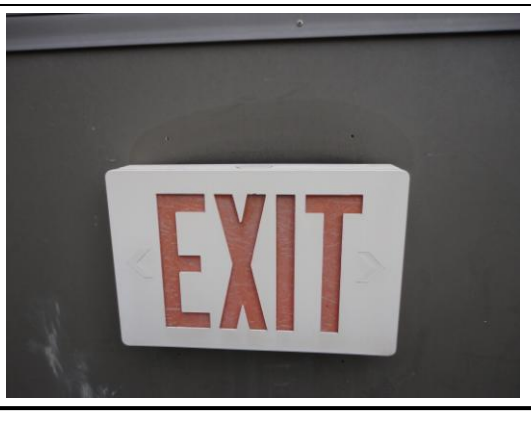
<p>3rd floor: Sealant missing at perimeter of sign and 4 holes in panel.</p>

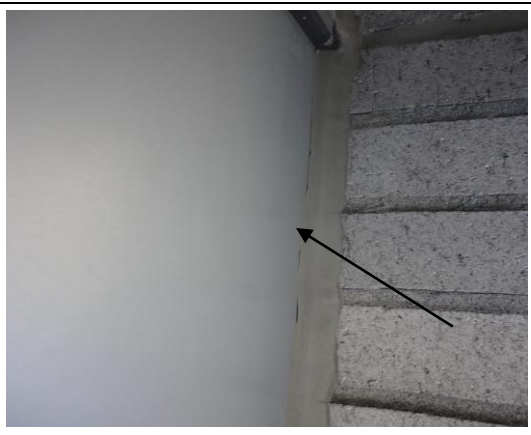
<p>West Elevation Entrance Drop #4: 32nd floor: Failed sealant at panel.</p>
<ul style="list-style-type: none">•

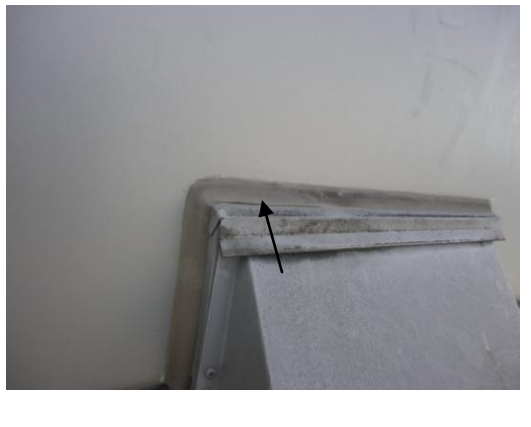
<p>32nd floor: Failed sealant at vent.</p>
<ul style="list-style-type: none">•

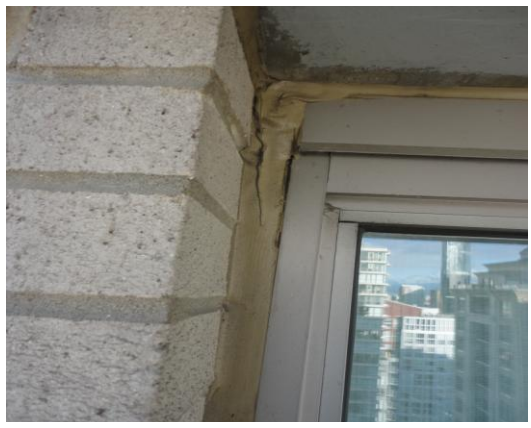
<p>30th Floor: Failed sealant at jamb.</p>
<ul style="list-style-type: none">•

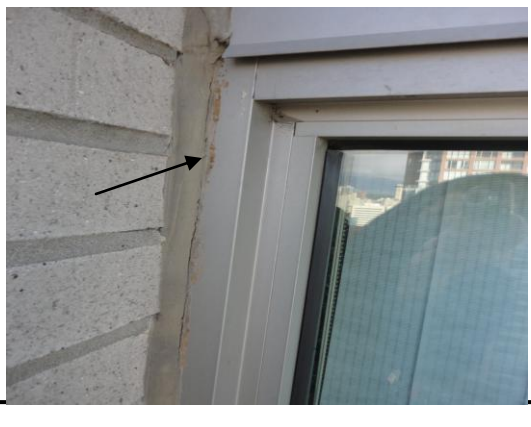
<p>29th floor: Failed sealant at window jamb.</p>

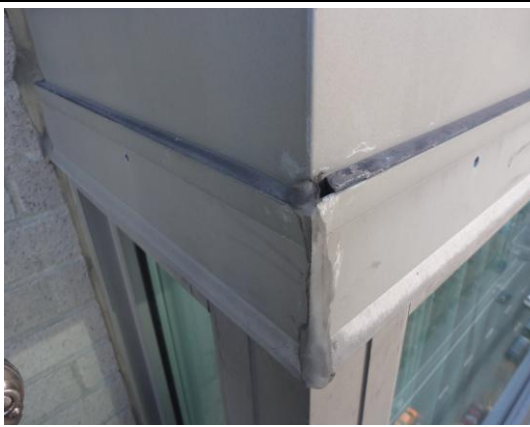
<p>21st floor: Sealant failure at rubber gasket repair.</p>
<ul style="list-style-type: none">•

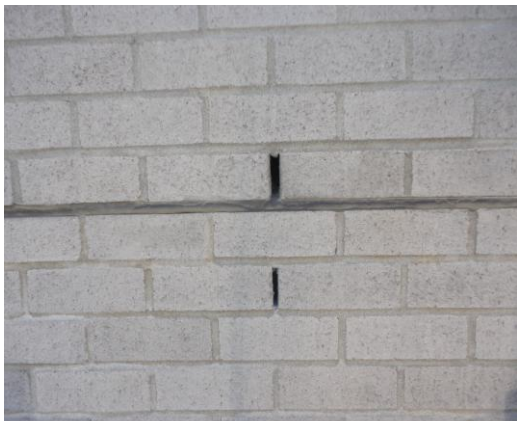
<p>21st floor: Sealant failure at brick to brick joint.</p>
<ul style="list-style-type: none">•

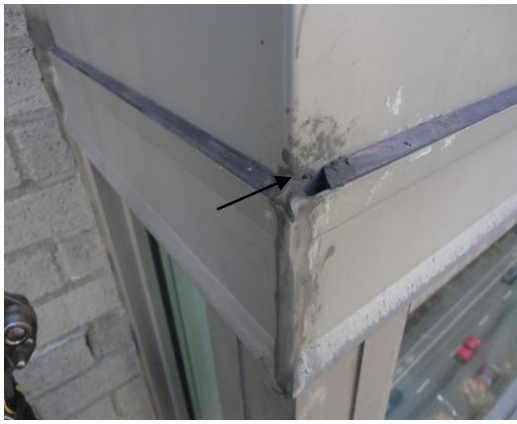
<p>19th floor: Sealant failure at rubber gasket repair by others.</p>
<ul style="list-style-type: none">•

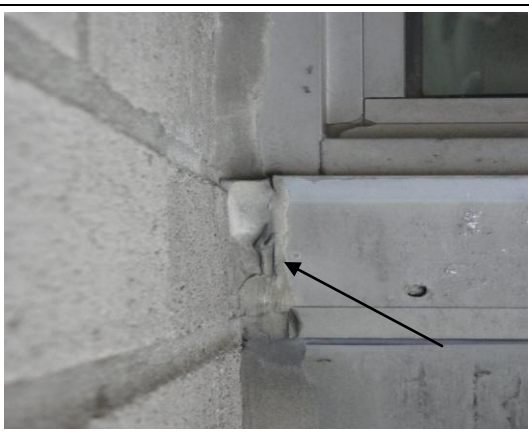
12 th floor: Failed sealant at window jamb.
•

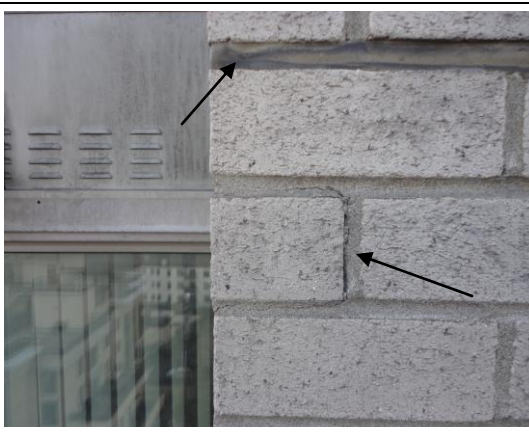
12 th floor: Failed sealant at joint and crack in brick veneer.
•

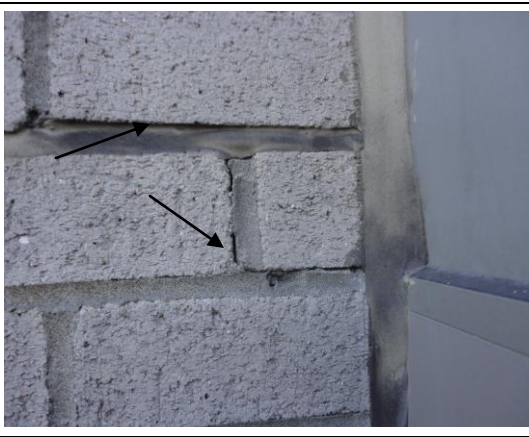
11 th floor: Failed sealant at brick to brick joint and crack in brick veneer.
•

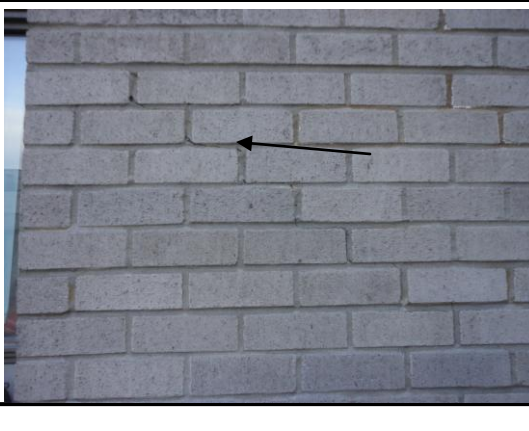
7 th floor: Poor picture crack in brick veneer
