## **APPENDIX A - PHOTOGRAPHS**

**Appendix A - 1188 Richards Street Photos**

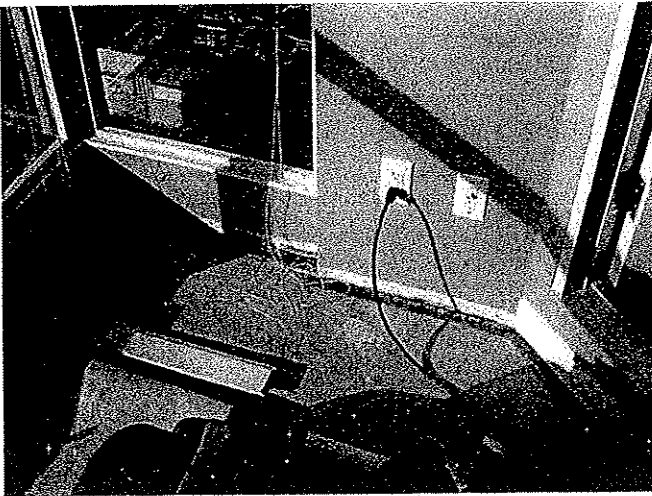
101 1608 south east corner of living room at leak

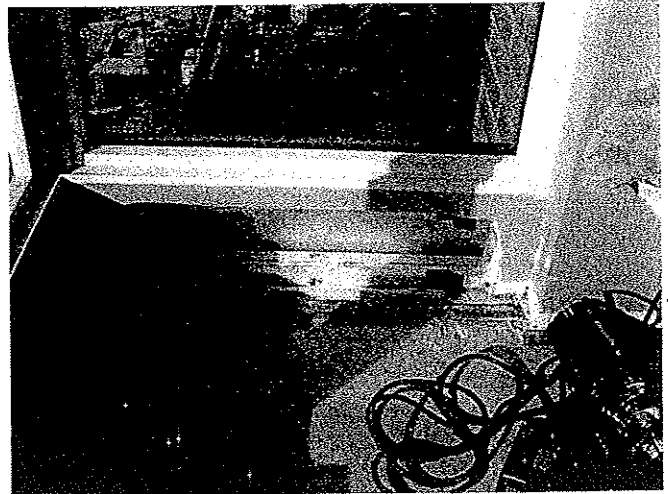
102 1608 Interior finishes removed at spandrel

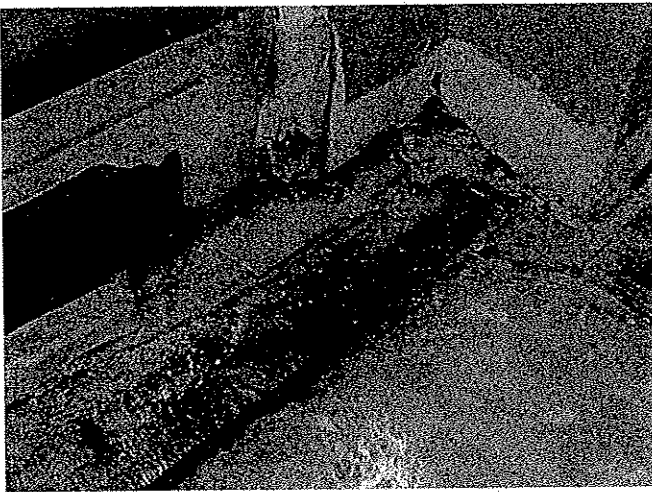
103 1608 Moisture damage at window sill, south east

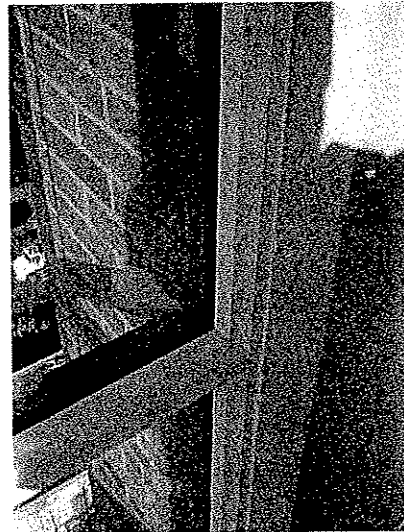
104 1608 Staining on brock adjacent to interior leak

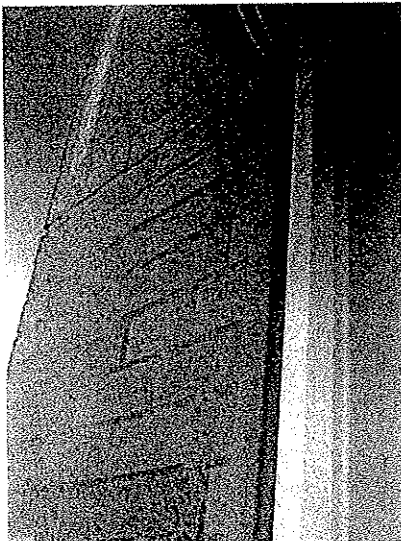
105 1608 Further staining at window adjacent to

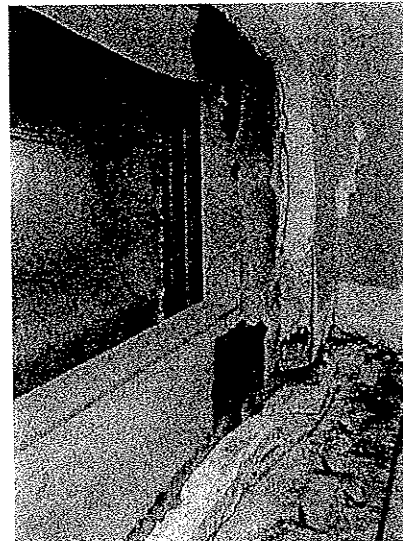
106 1608 showing insulation on back of spandrel pan

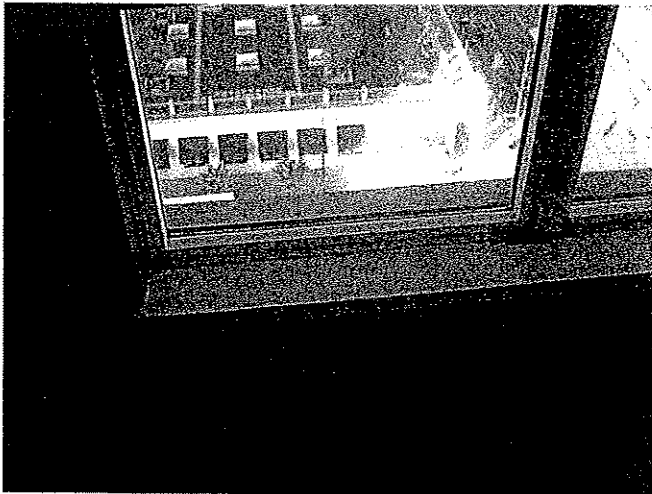
109 1608 Moisture damage on window sill

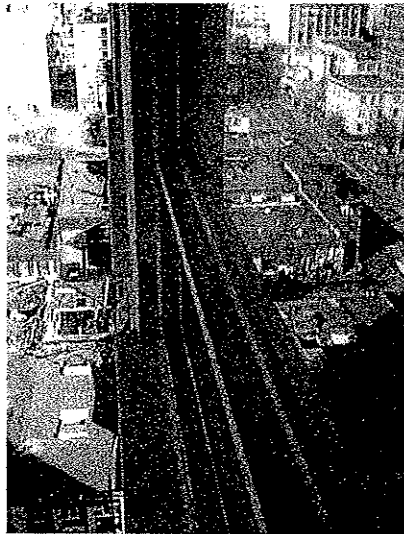
110 1608 Window at south bedroom

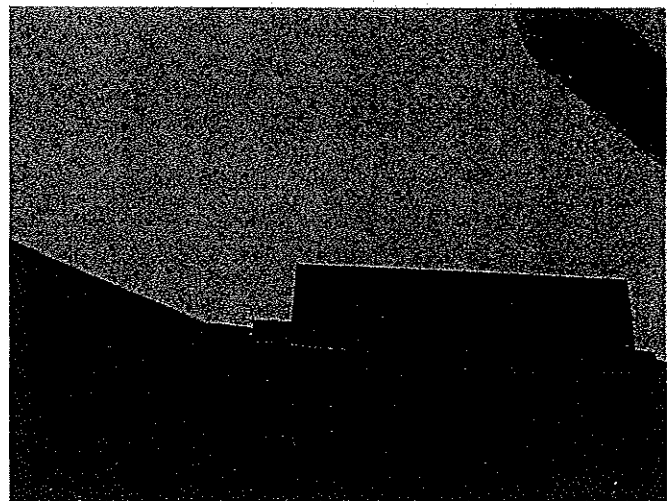
112 1608 Vent above window

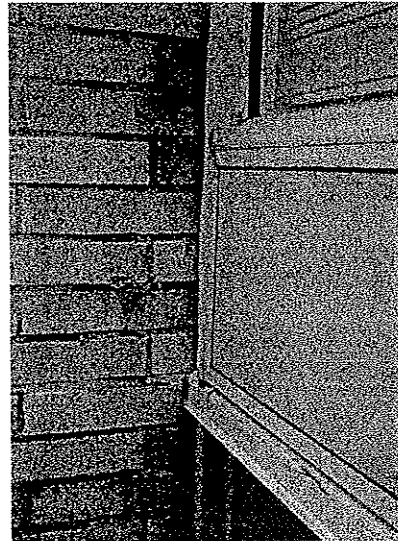
202 Moisture at brick to window transition

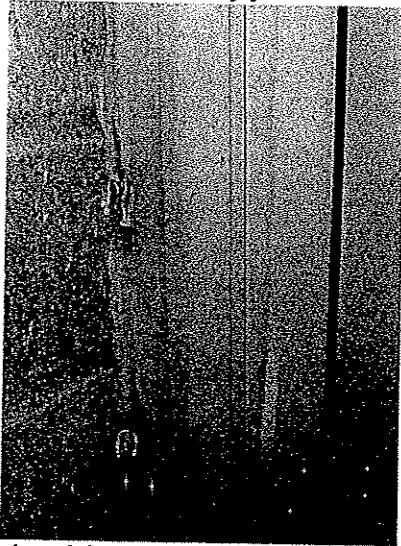
203 Sealant failure at window to brick transition

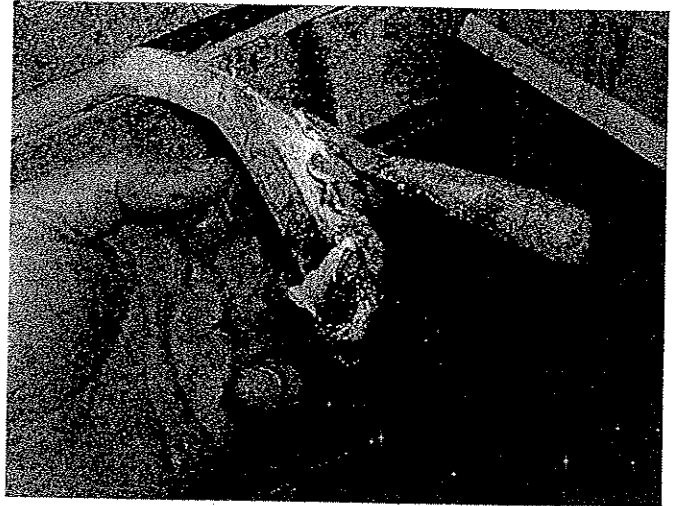
204 Sealant and backer rod at shelf angle

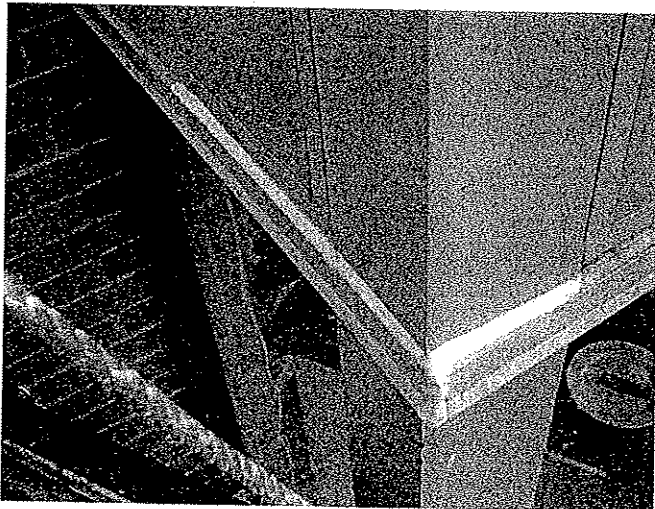
207 Additional caulking at window head, south east

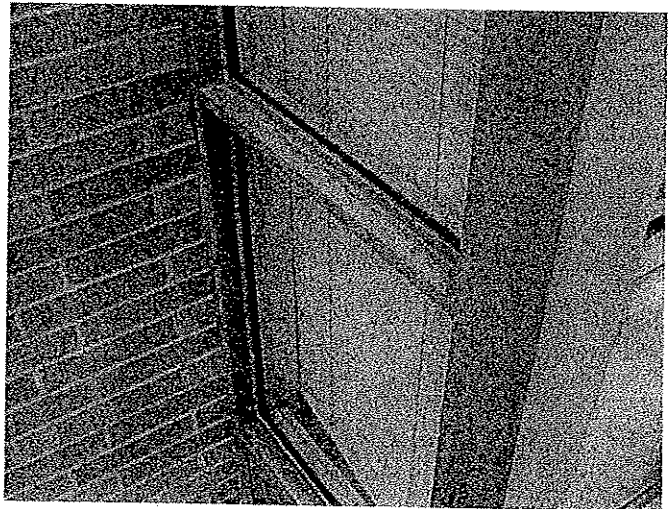
208 Discolouration of window finish at 12th floor

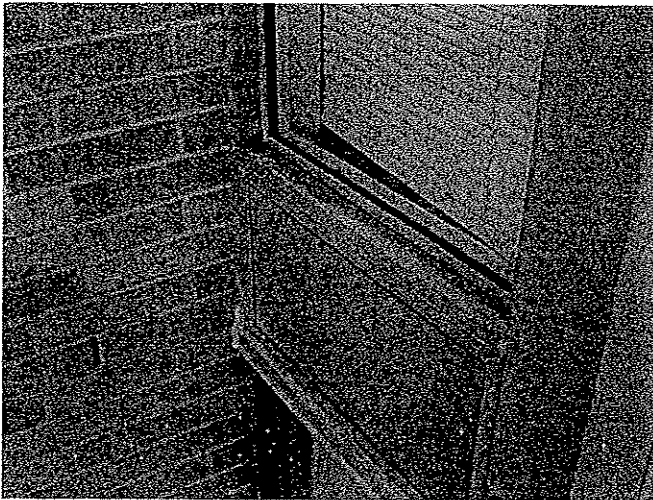
209 Moisture accumulation on window frame at 8th

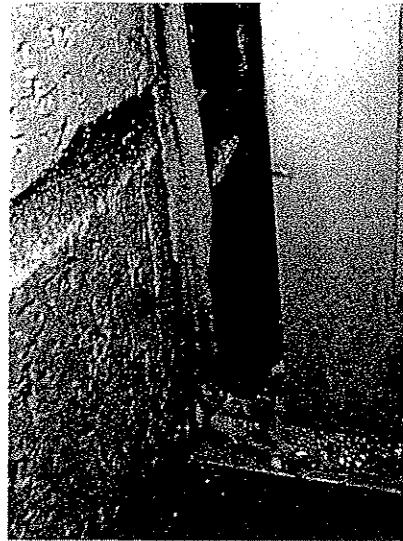
210 Moisture behind sealant at leak location of 1608

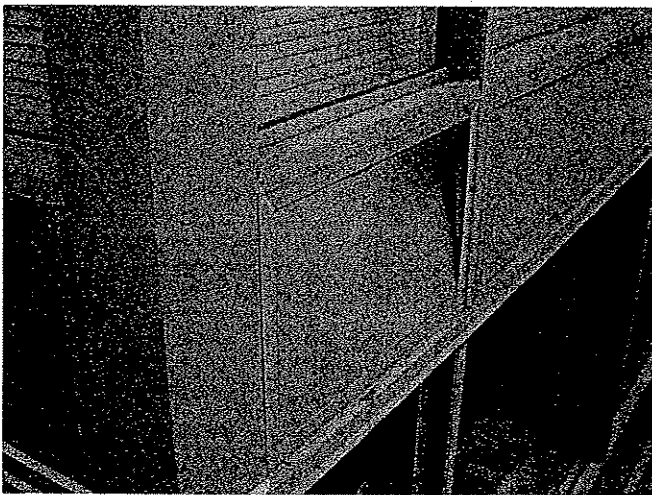
211 Spandrel damage at lower floor, south east

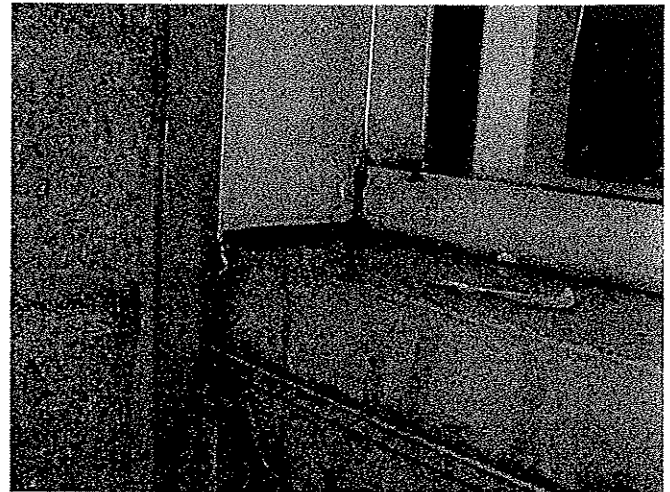
212 Water accumulation at window frame

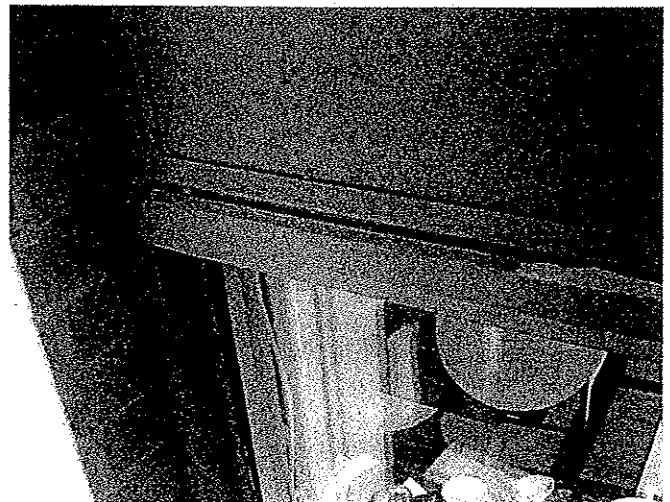
302 General view of window head below 1608

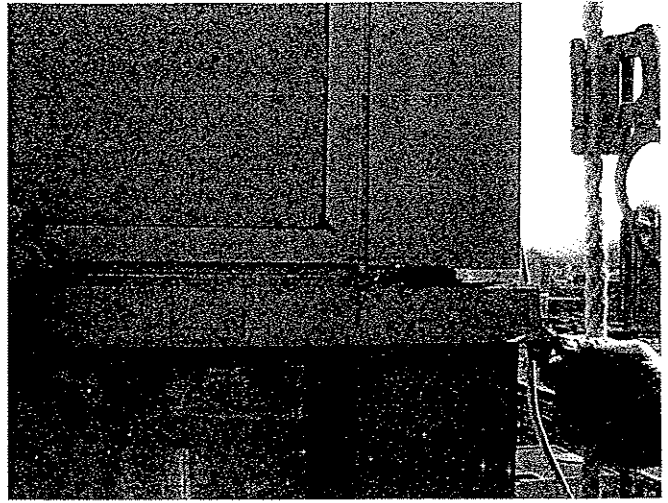
304 1608 lower 1cm of corner mullion removed

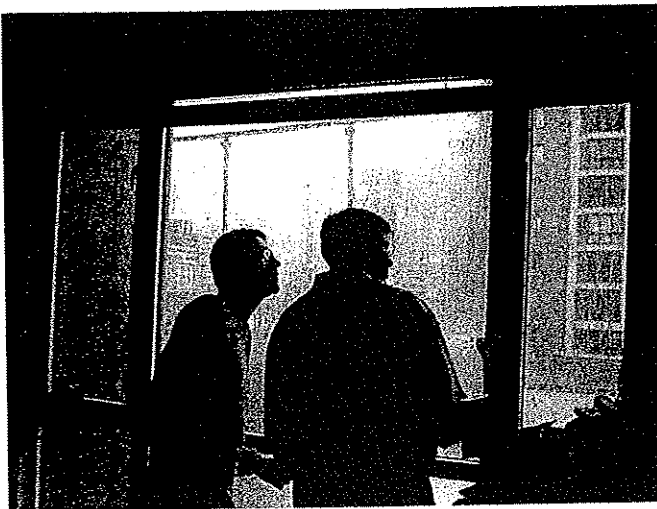
406 Window test #1 at window wall, unit 605

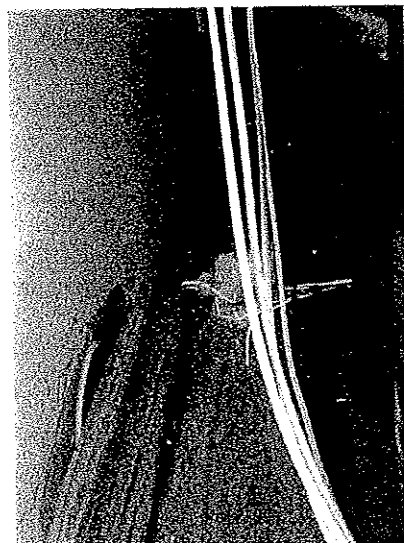
407 Moisture ingress at floor, test #1

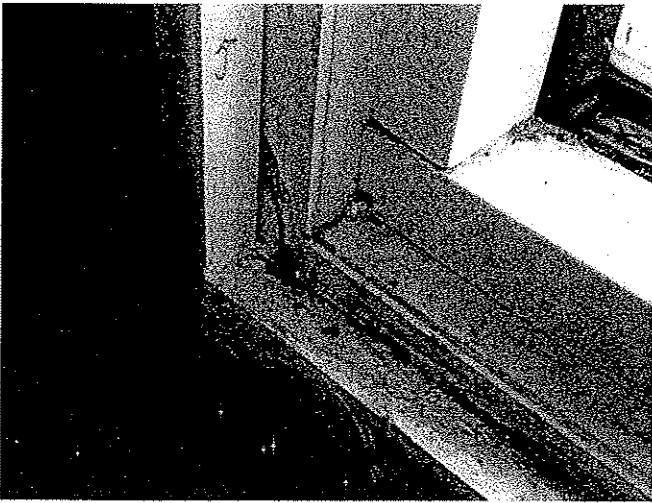
408 Water ingress at window frame, test #1

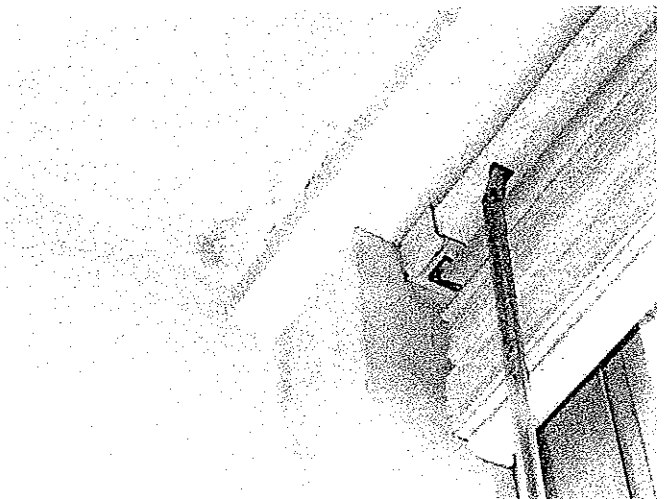
413 Previous water stain in unit 505 (did not leak

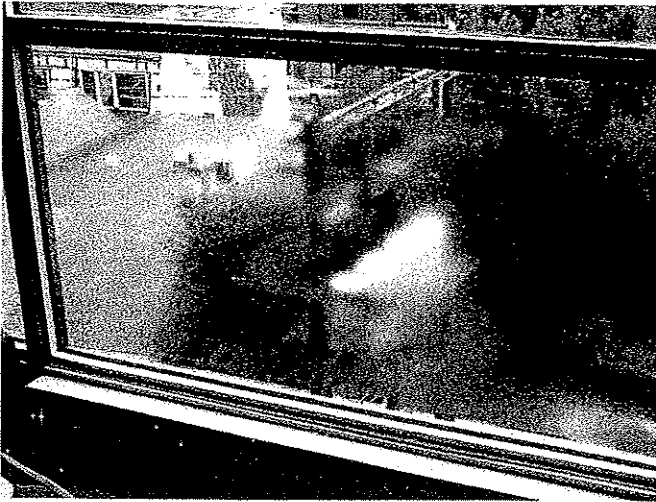
414 Failed seal in window unit, suite 505.

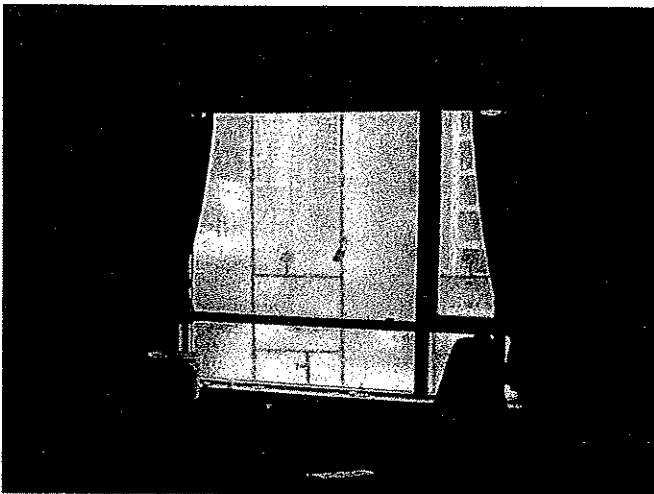
416 Window test #2, suite 605 at punch window in

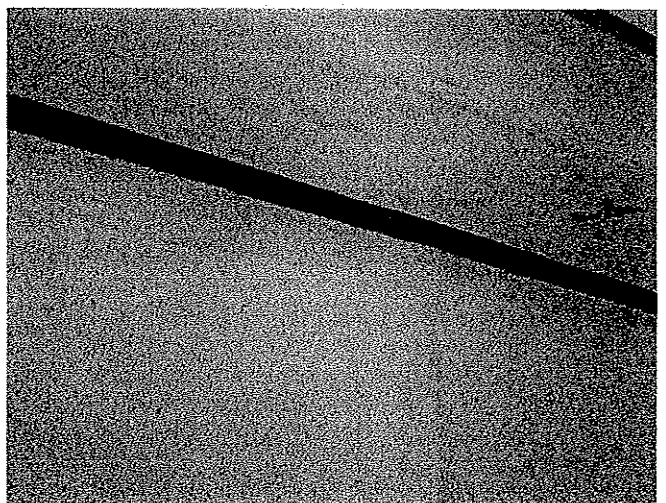
419 Water ingress under the window sill, test #2

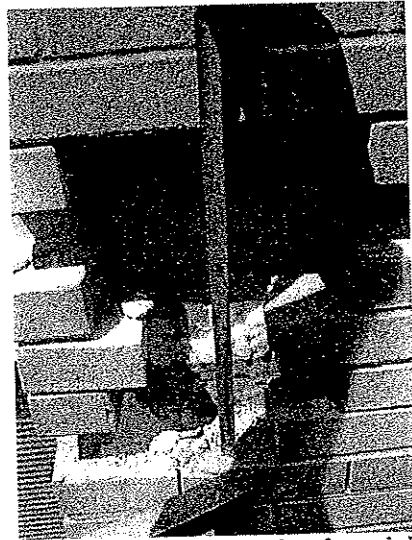
501 1608 brick removal, no ties for minimum 28

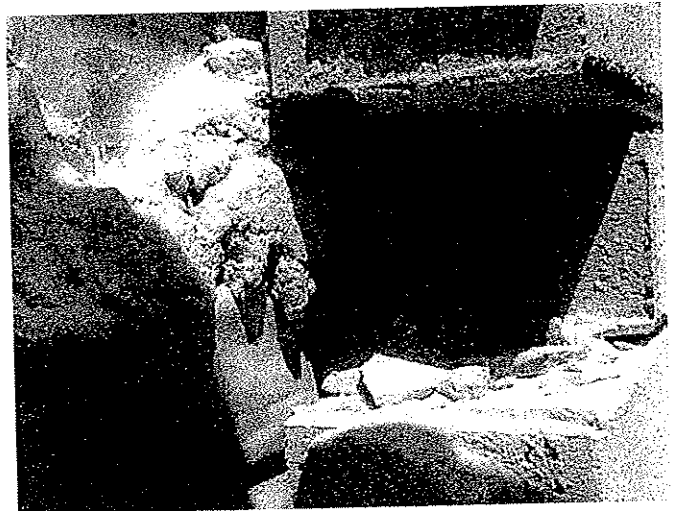
503 1608 Brick removal showing mortar droppings

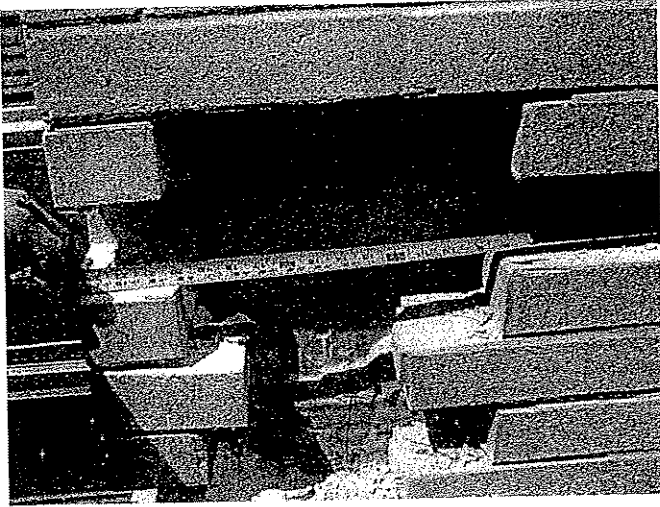
504 1608 Brick removal, no masonry ties across

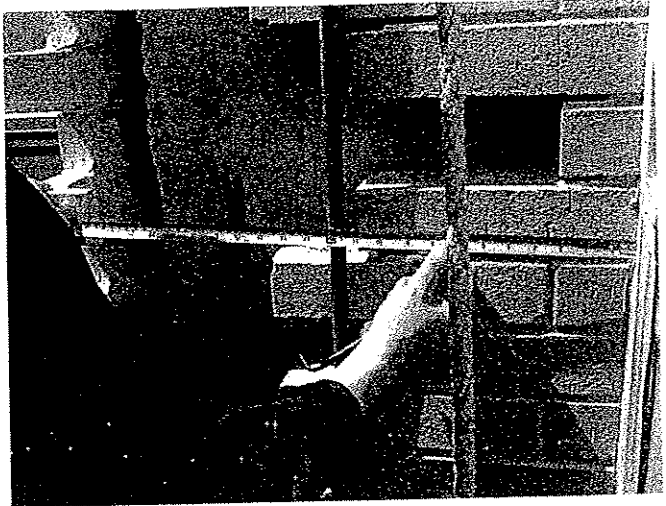
601 16th Floor masonry removal at shelf angle

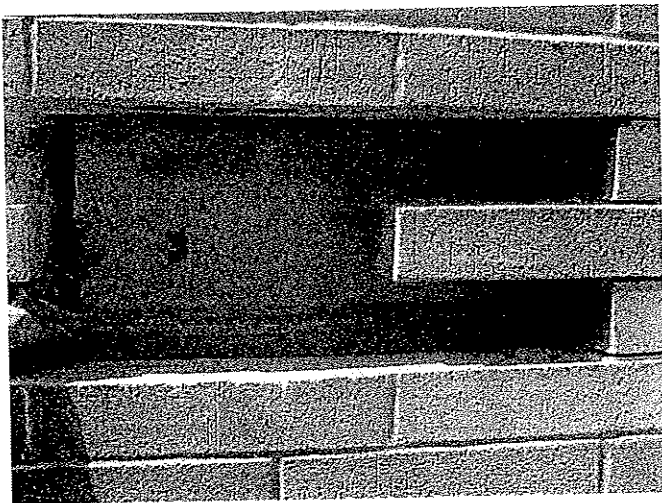
602 16th floor masonry removal below upper shelf

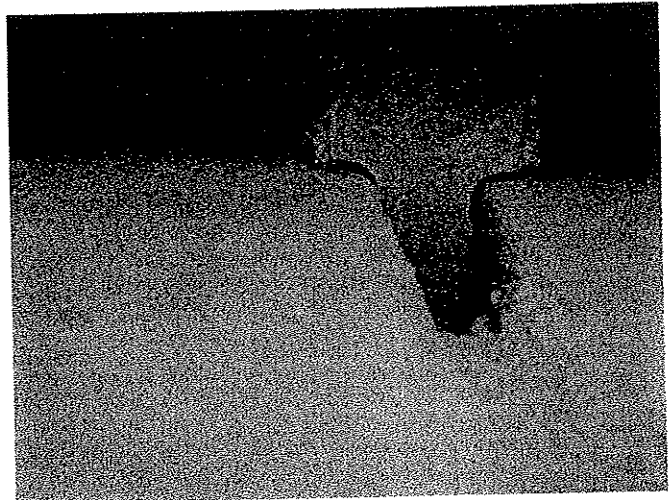
603 Dove tail masonry tie at the 3rd masonry course

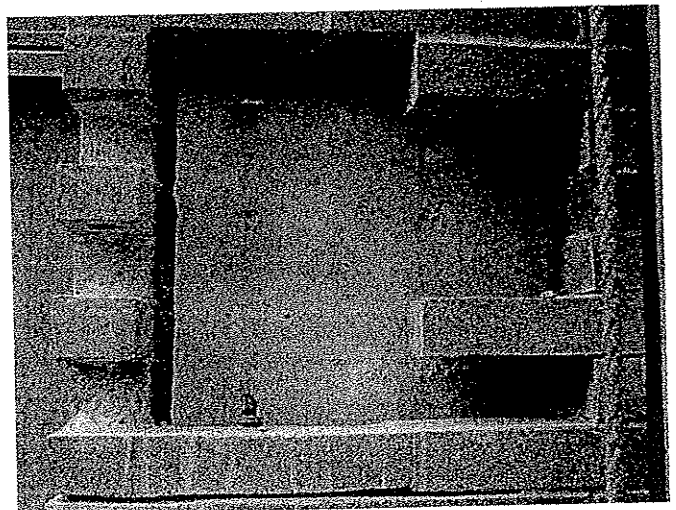
702 Dove tail ties at upper third of masonry region

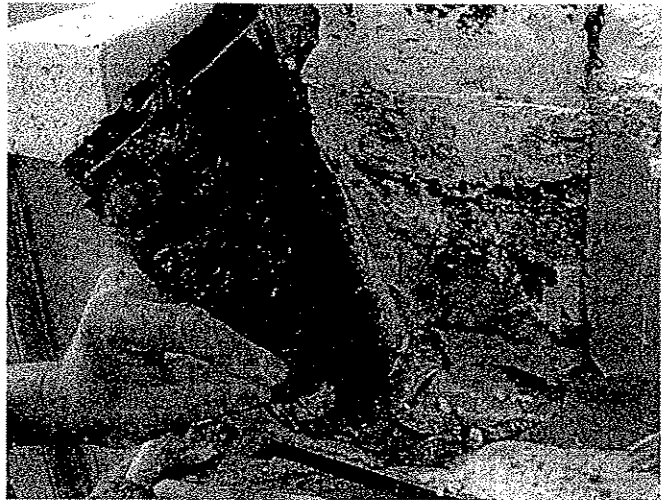
704 Blueskin membrane partially removed at shelf

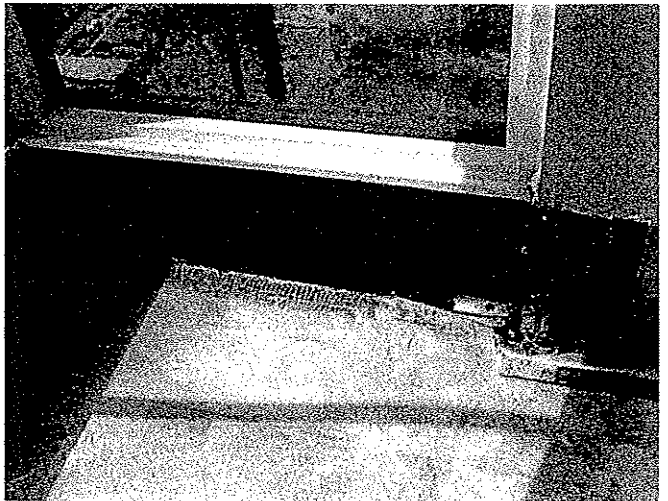
708 Region dry at conclusion of test

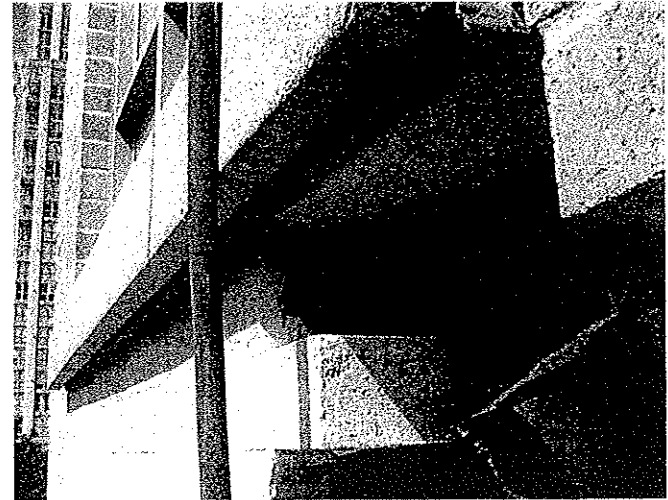
804 Precast window sill at brick veneer wall

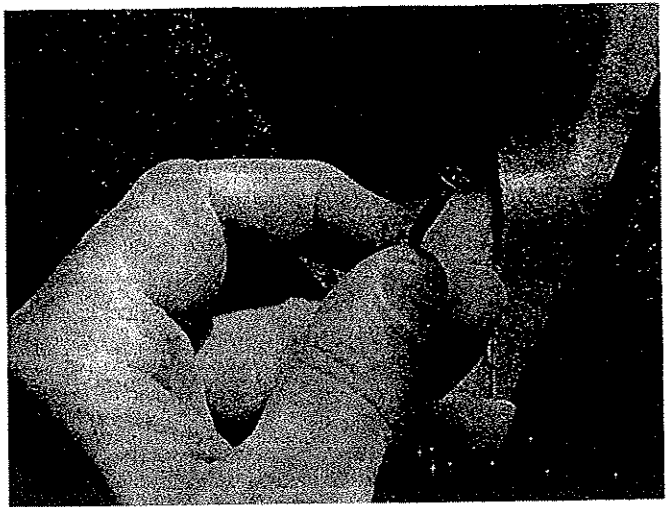
807 Exterior GWB fastener

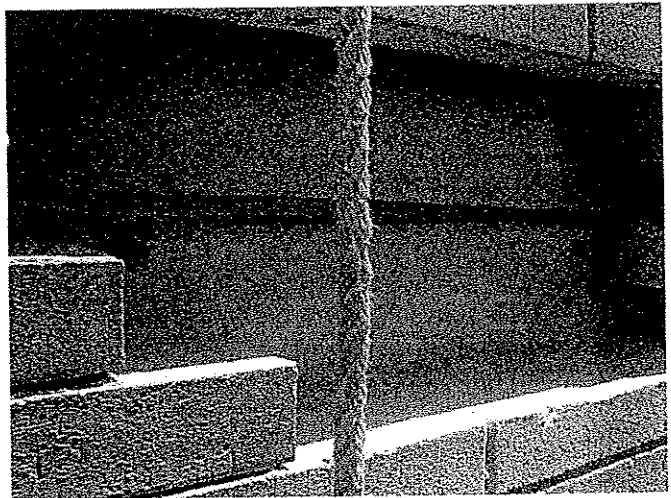
809 Two foot horizontal tie spacing

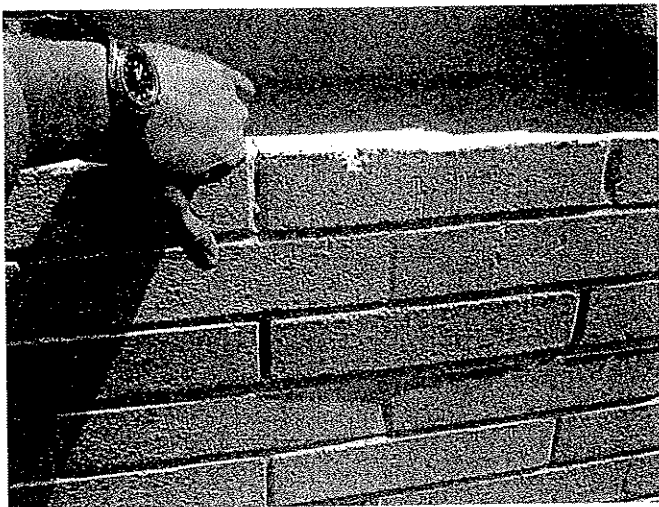
812 Mortar droppings filling cavity in the bottom three

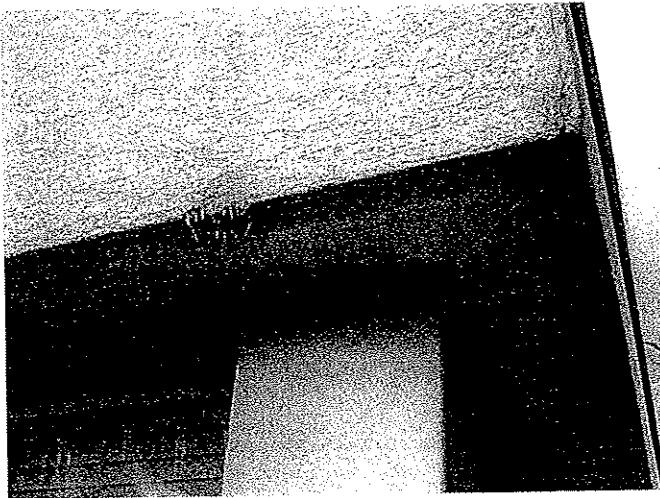
903 Localized damage at eifs band, upper roof deck

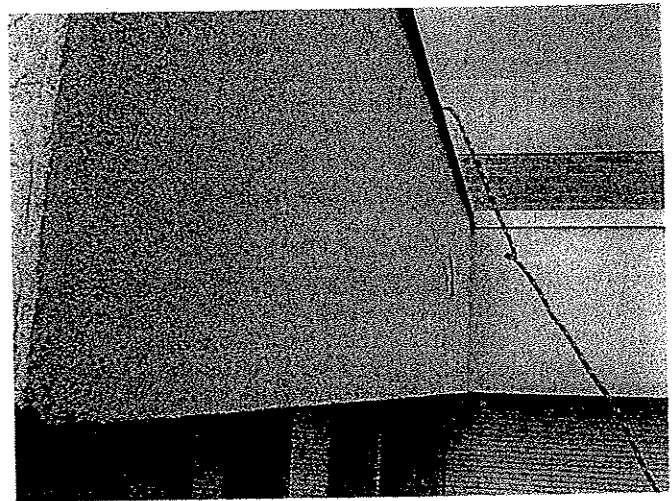
904 Delamination of EIFS band at upper roof deck

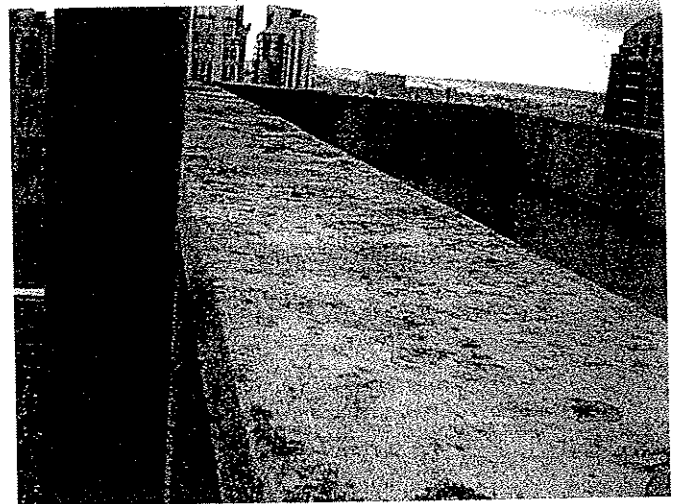
906 Concrete parapet atop concrete upstand wall

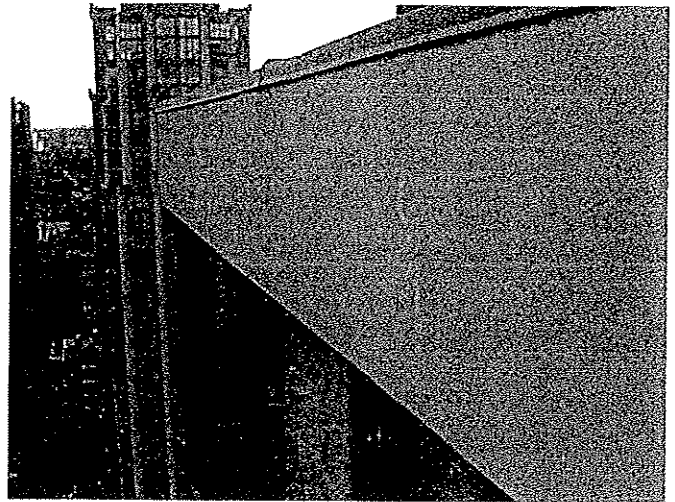
909 Concrete curb at lower roof section (over

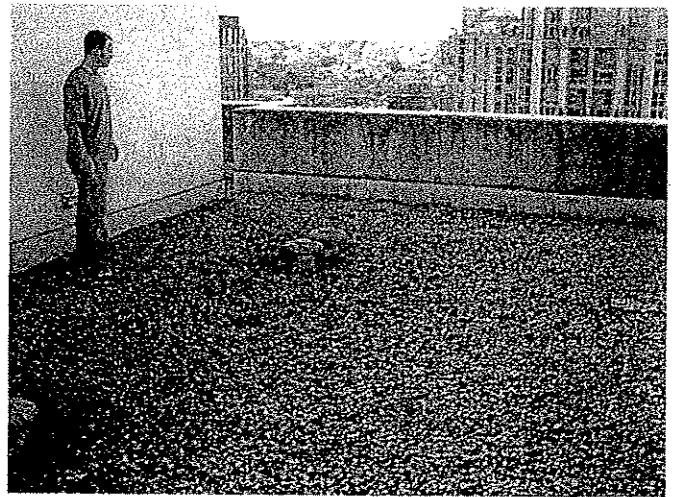
911 Main inverted roof assembly

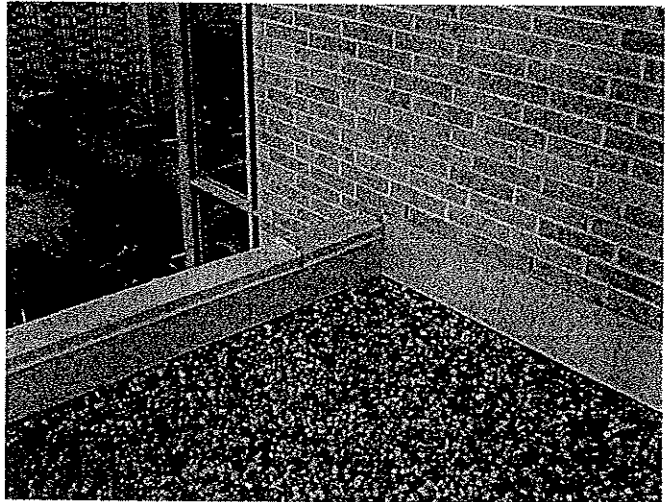
914 Typical curb detail at main roof

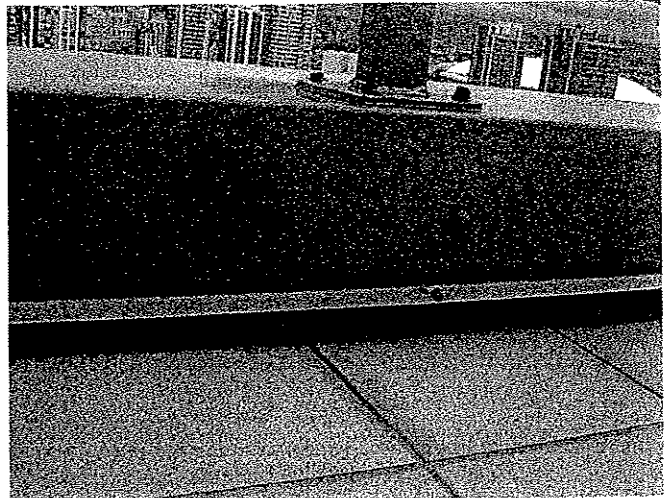
916 Corroded fasteners at tiled roof deck railing

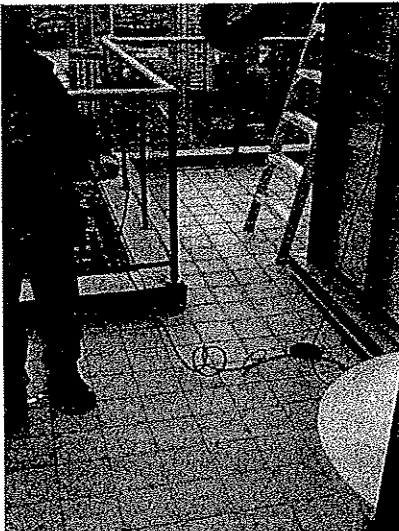
918 Tiled roof deck bonded over membrane

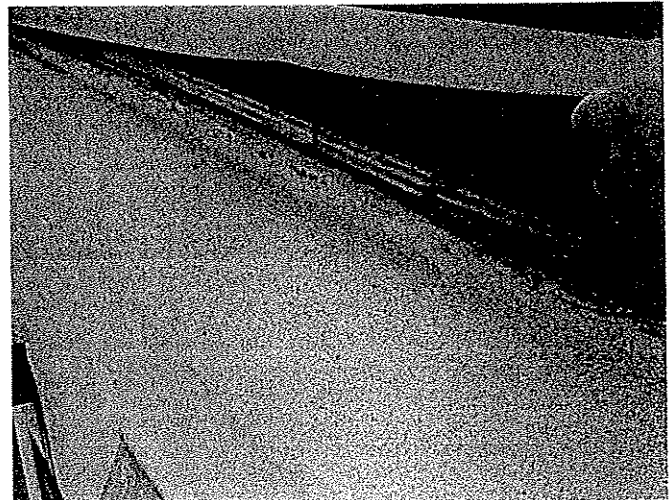
921 Wood blocking under cap flashing at garden

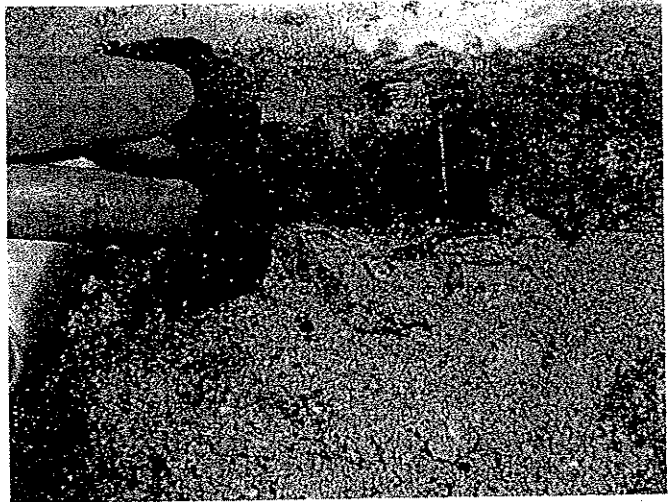
924 Liquid applied membrane under pavers up to

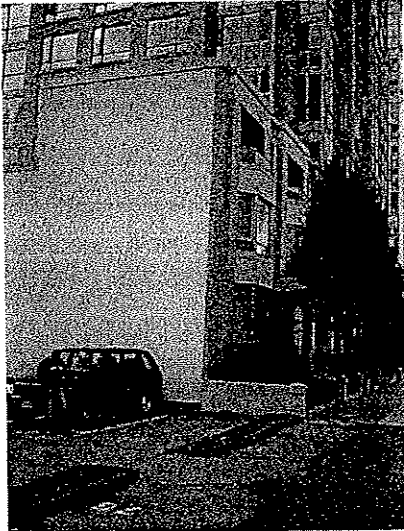
925 At grade condition at north west corner

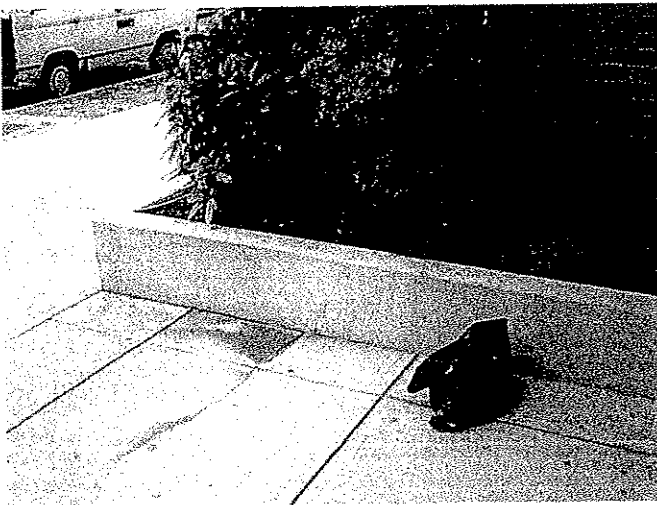
928 Staining at planter indicating drainage path

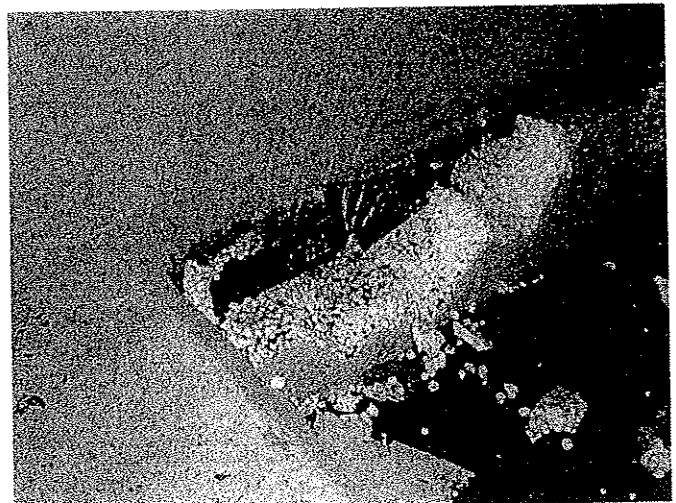
929 Hot, rubberized membrane and insulation

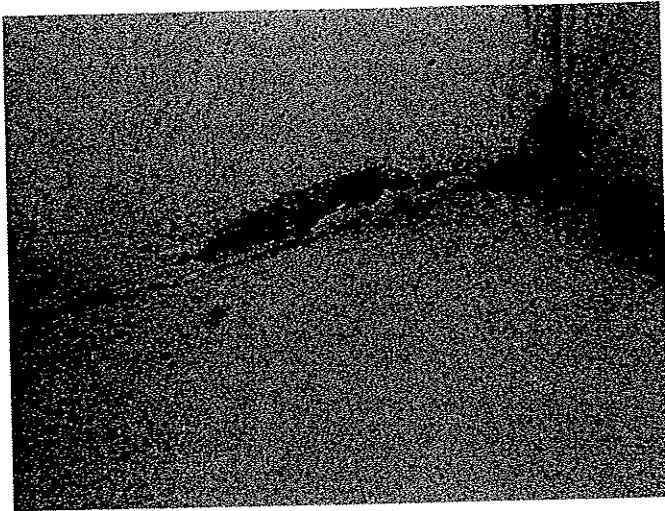
930 Membrane edge at main entrance

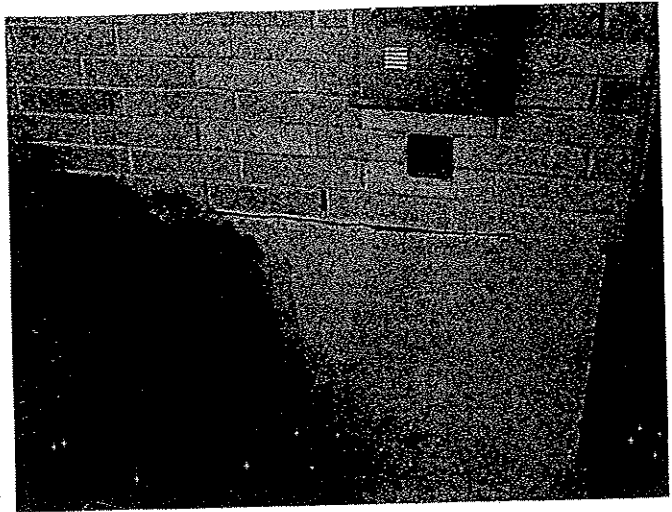
931 Self adhered membrane at base of masonry

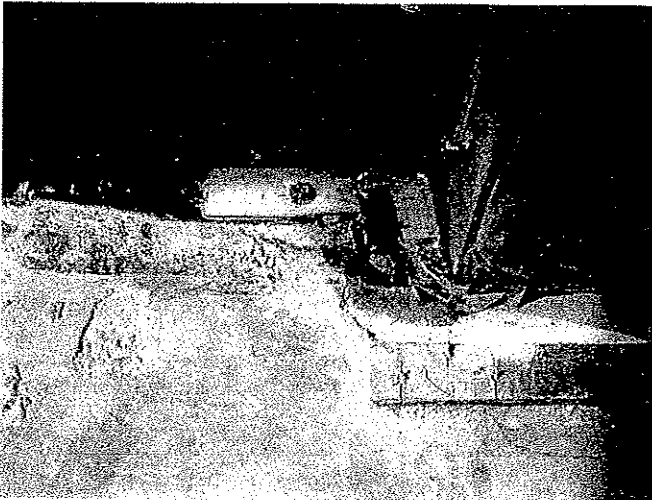
711 No water ingress at spandrel to brick transition

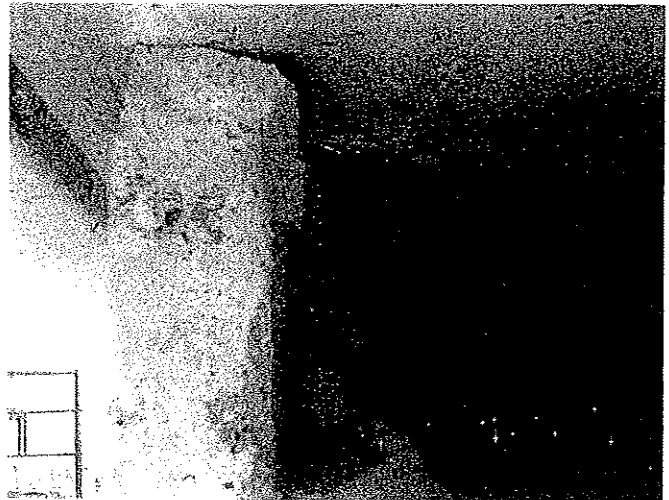
805 Pin connection of precast window sill into top

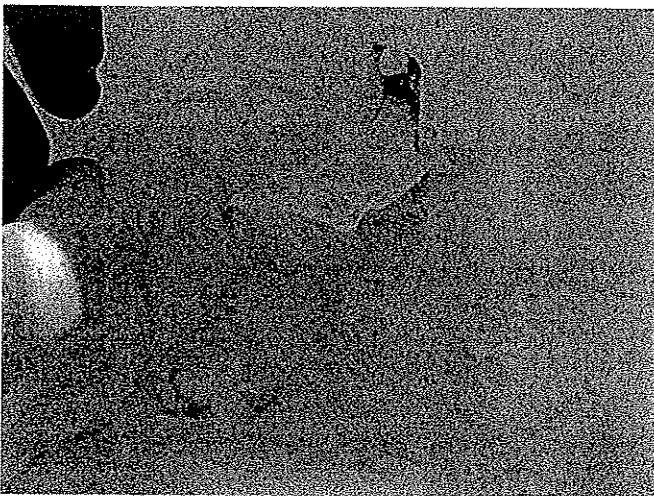
811 Condition of Dove Tail tie

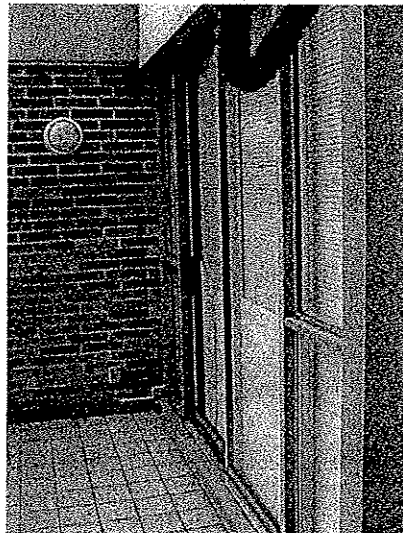
902 Exposed window wall and slider door at upper

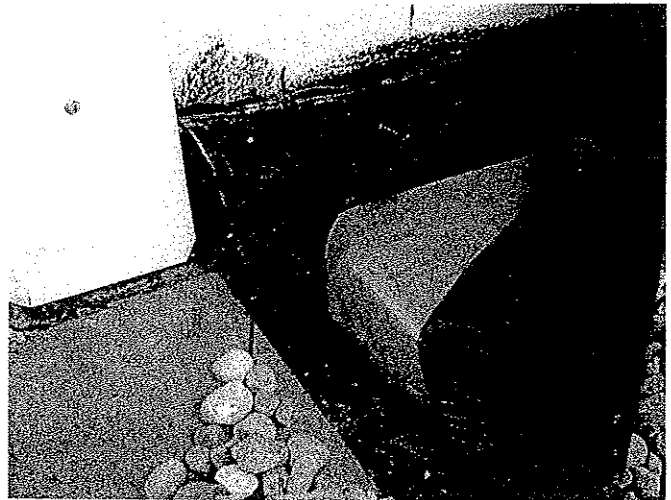
912 Hot applied rubberized asphalt roof system at  
20/21

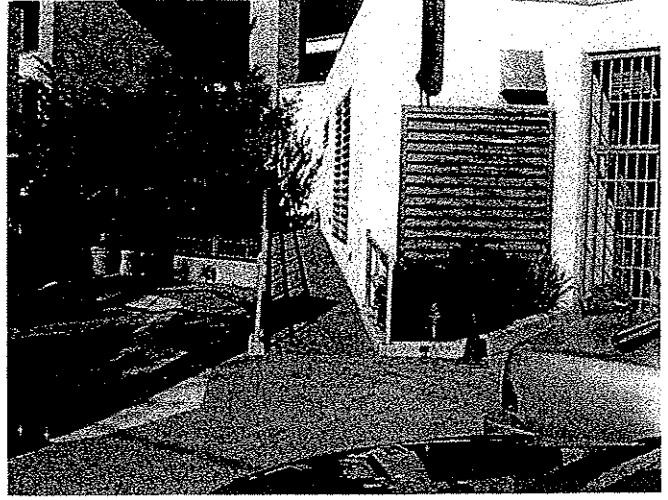
922 At grade detail at north east corner of structure
