BUILDING ENVELOPE ASSESSMENT

**AT
LEXINGTON NORTH
3709 PENDER STREET
BURNABY, BC**

File No. 071-03272

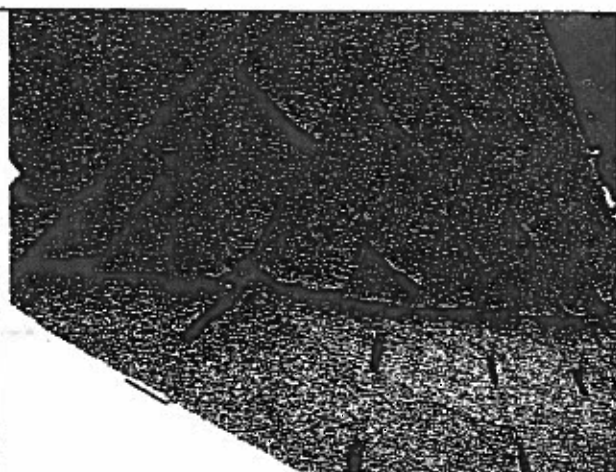
Photo 2: Deteriorated shingles at valley.

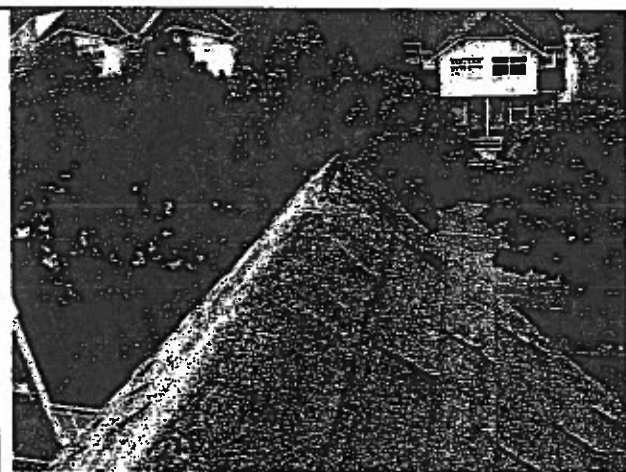
Photo 3: Deteriorated shingles at ridge.

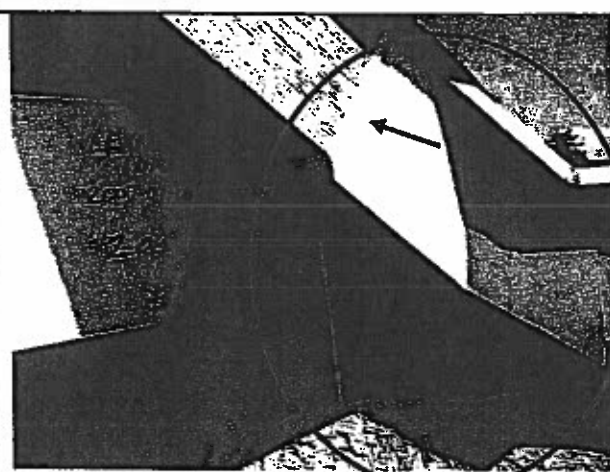
Photo 4: Unit #206 roof deck: note addition of metal flashing. Sealant will be a high priority maintenance item.

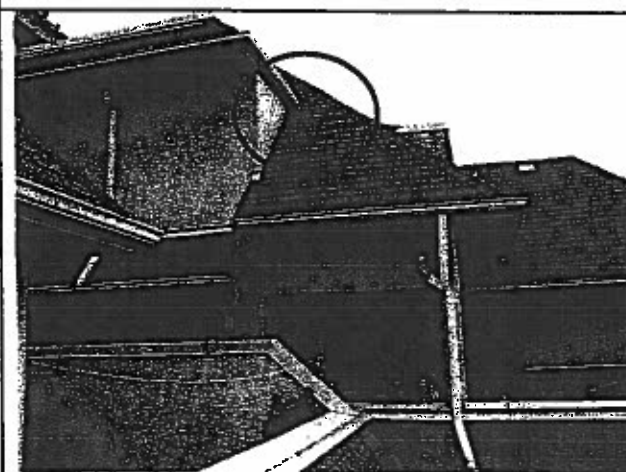
Photo 5: Note another area of shingle patching.

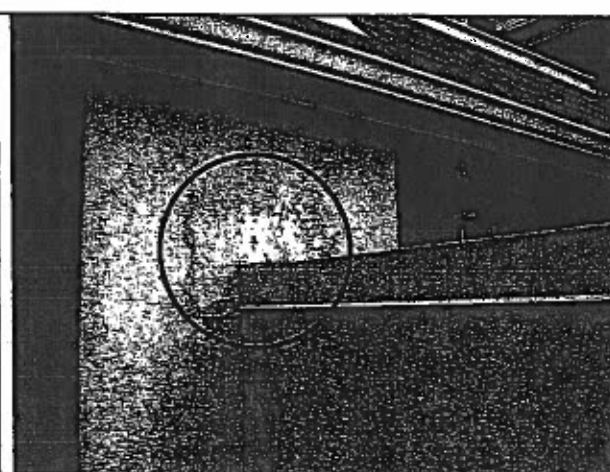
Photo 6: Cap flashing embedded into stucco. Evidence of past repair. Adequate shingling of saddle waterproofing with original building material might not be provided.

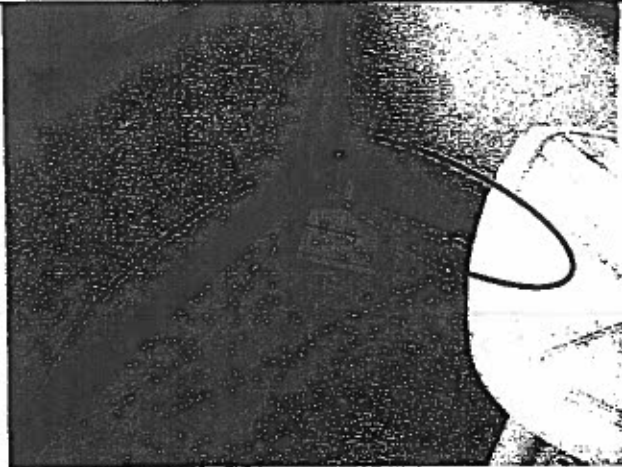
Photo 7: Evidence of past high water mark due to excessive cleaning (or flooding) of deck.

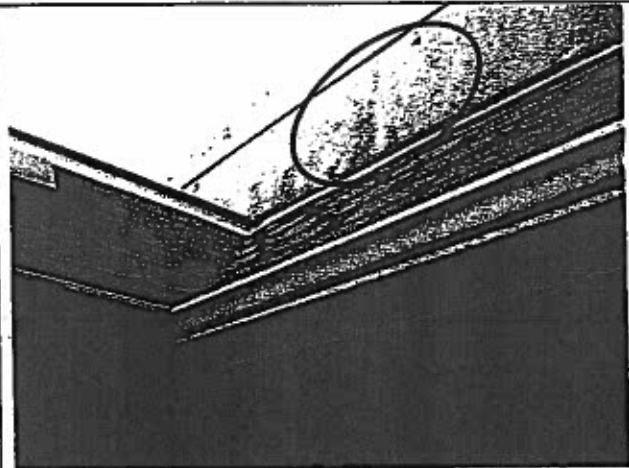
Photo 8: Heavy water staining on stucco. Stucco could be saturated and affect the wall structure behind.

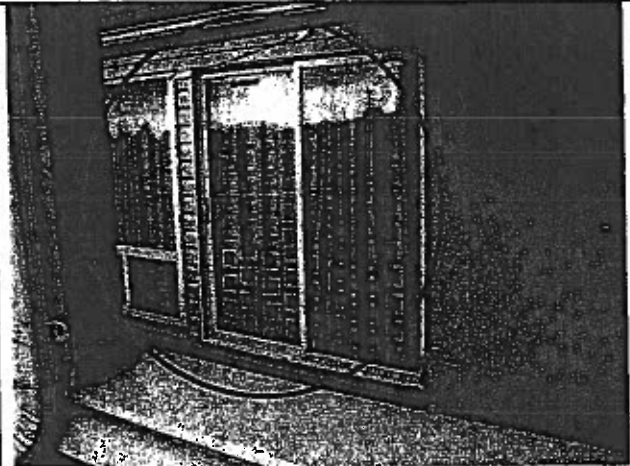
Photo 10: Unit #202 Level 4 roof deck has been enclosed by others. The enclosure construction may not be adequate and the increase of the interior space may not be allowed by the City of Burnaby.

- c) Regarding the Level 4 roof deck enclosure of Unit No. 202, check with the City of Burnaby if this interior space addition was adequately approved with necessary construction documents. If the addition was filed in the City of Burnaby, replace vinyl siding with non-combustible wall cladding. Review the wall construction (e.g. vapour retarder and insulation).

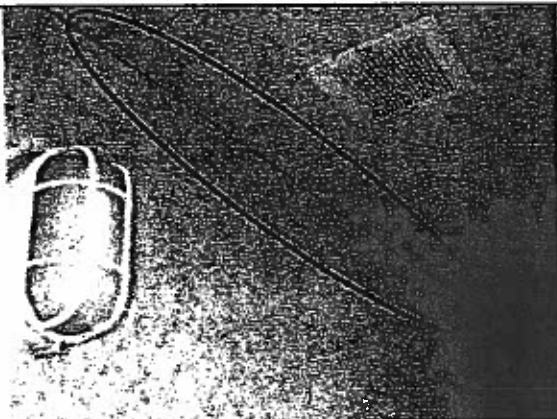
Photo 11: Level 4 exterior corridor: note crack in stucco between wall and soffit, which indicates building movement.

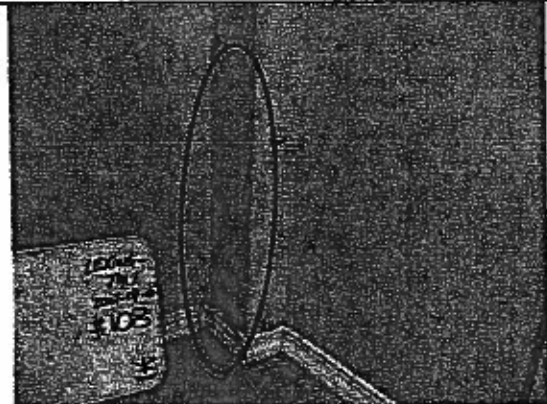
Photo 12: Unit #108 main floor SW corner: note mildew on the interior GWB surface.

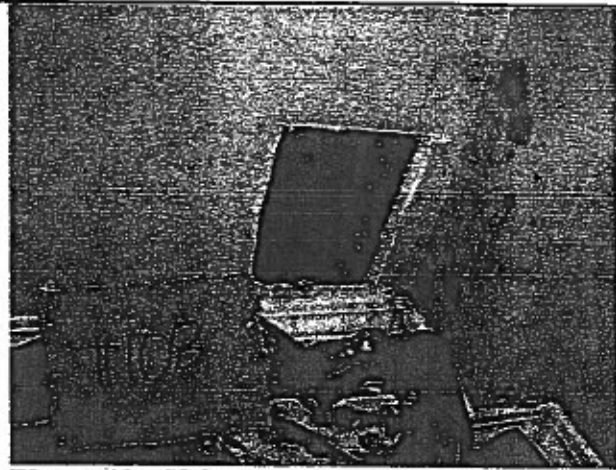
Photo 13: Unit #108 main floor SW corner. Exploratory Opening #1. Note lack of insulation and vapour retarder. This contributes to interior condensation.

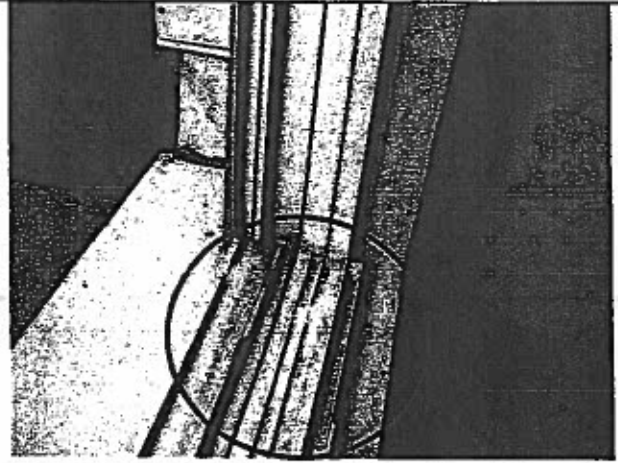
Photo 14: Unit #108 Level 1 patio sliding door showing heavy water staining and lack of drainage at sill track.

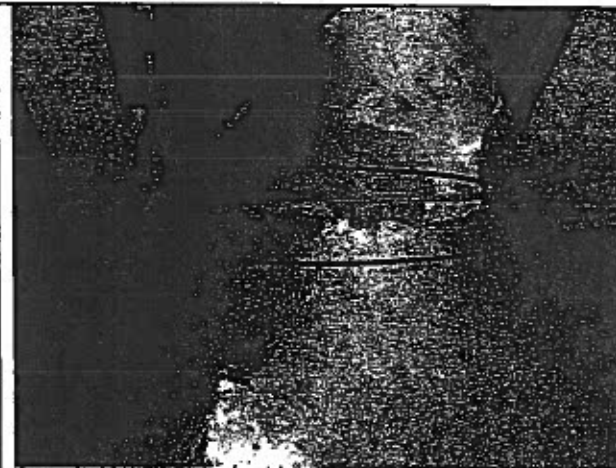
Photo 15: Unit #210 roof deck: note crack in concrete topping allowing water entry. Sufficient sub-waterproofing is required.

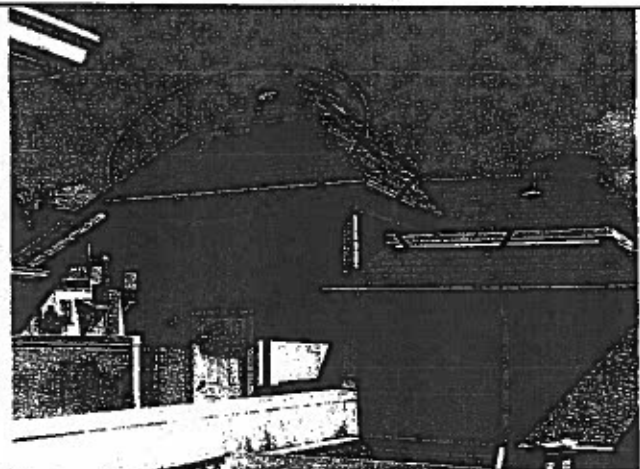
Photo 16: Unit #309 roof deck: note patches of shingles of differing ages.

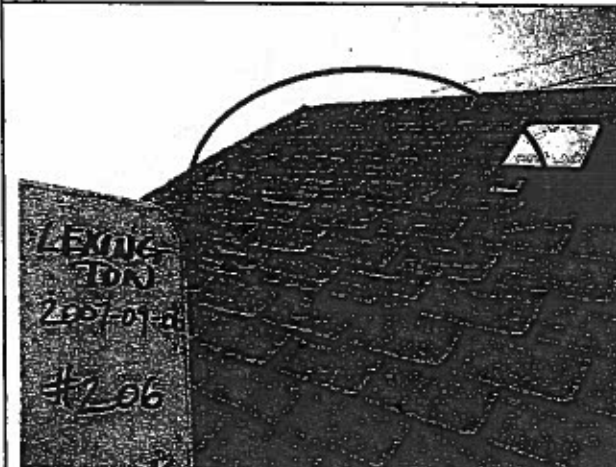
Photo 17: Unit #206: note deterioration of shingles.

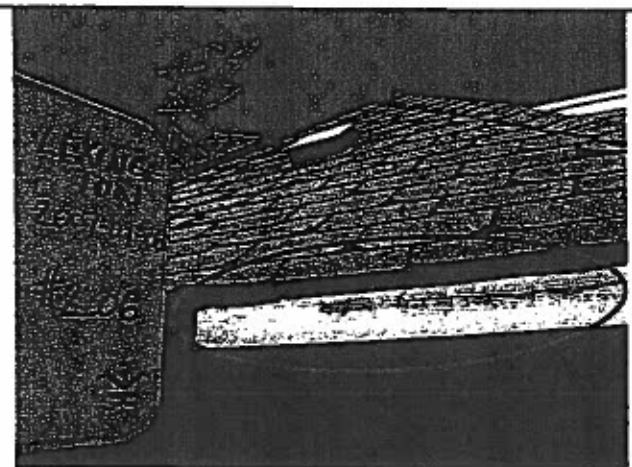
Photo 18: Unit #206: note deterioration of trim board.

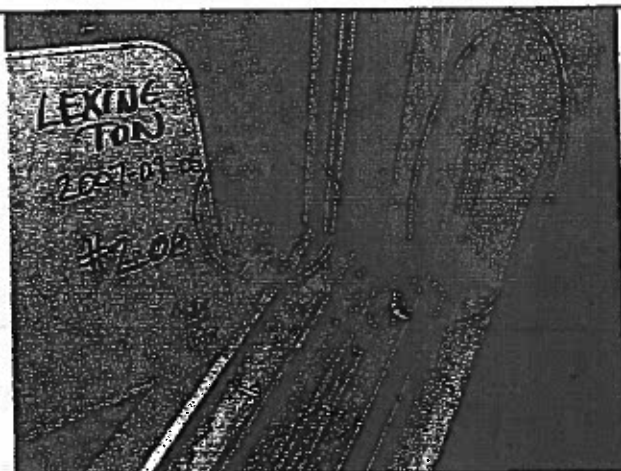
Photo 20: Unit #206 Level 4 balcony: showing heavy water staining and lack of drainage at sill track. Note crack in drywall and moss growth at bottom edge of stucco wall.

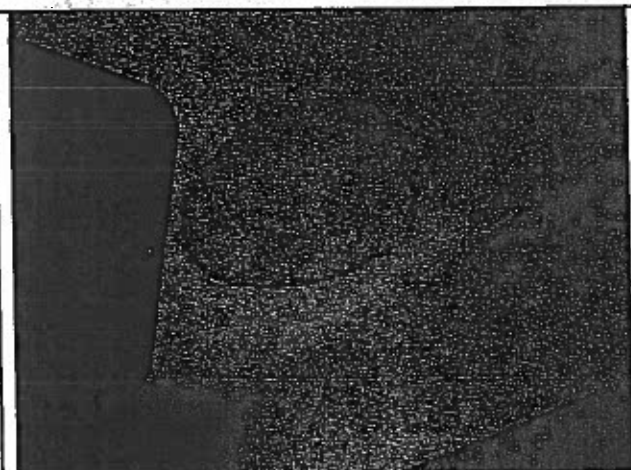
Photo 21: Unit #206: note water stains on ceiling. Evidence of water ingress from above.

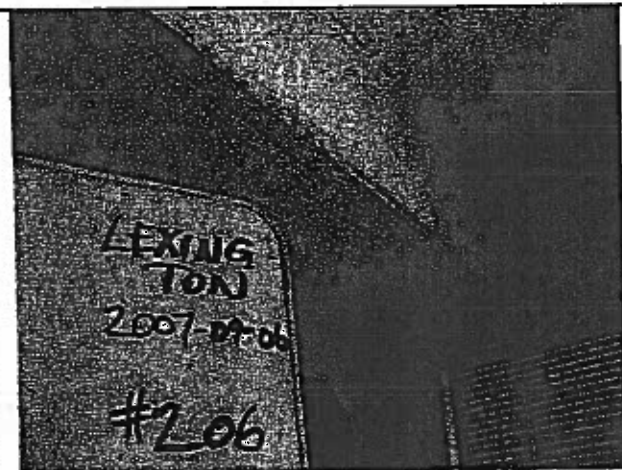
Photo 22: Unit #206: note water stains on ceiling. Evidence of water ingress from above.

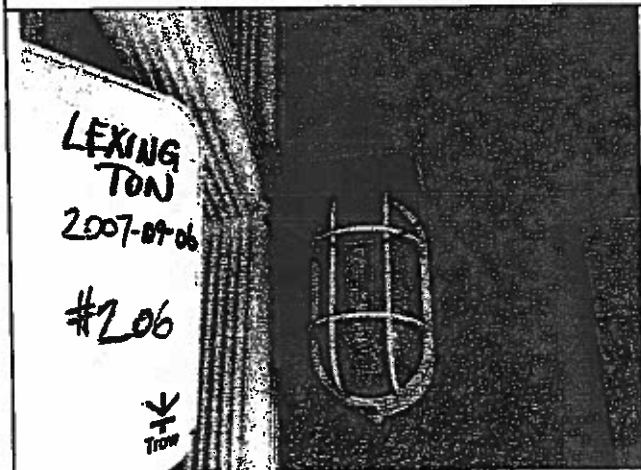
There were many locations of exhaust vents, B-vents, hose bibs, exterior lights and electrical outlets. Some exhaust vents are located close to a light fixture (Photo 23). Stucco cladding around the vent between Units No. 205 and 207 contains significant cracks (Photo 37).

Photo 23: Unit #206 Level 3 balcony: note proximity of vent to light fixture. Warm moist air will rust the light fixture.

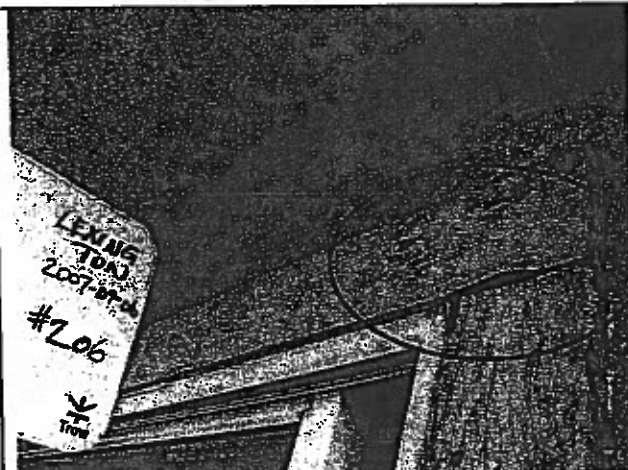
Photo 24: Unit #206 Level 3 balcony: deteriorated wood trim at sliding glass door.

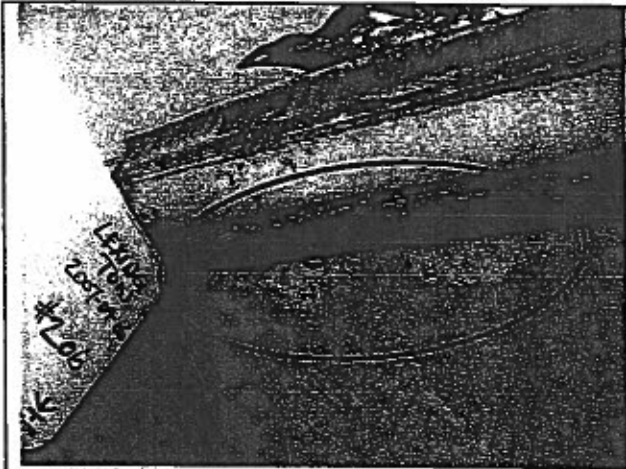
Photo 25: Unit #206 Level 3 balcony: note water staining on soffit behind trim board.

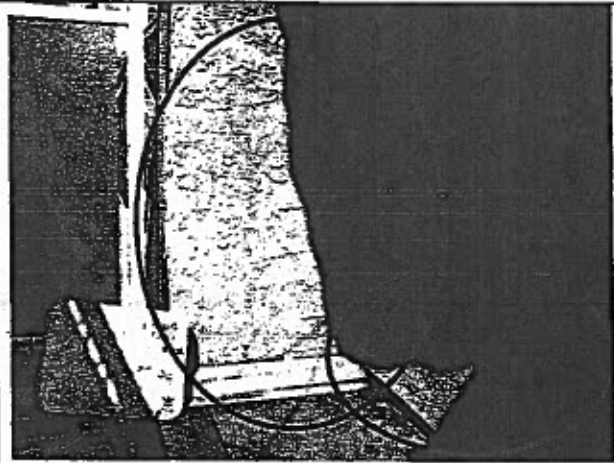
Photo 26: Unit #206 Level 3 balcony: note stucco patch to accommodate change to glass balcony railing. Note also stucco patch at bottom edge of wall.

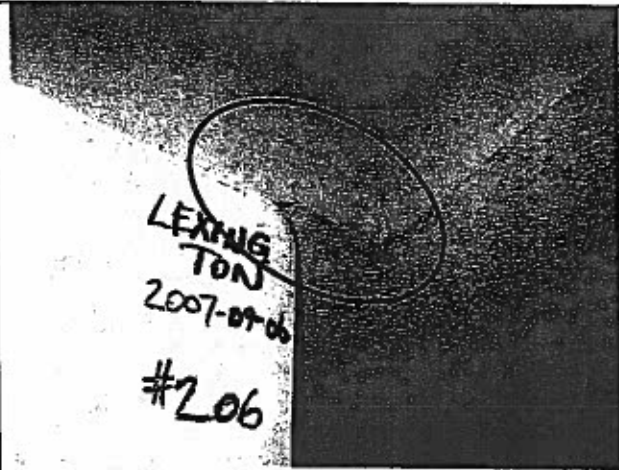
Photo 27: Unit #206 Level 4 at stairs below roof deck: note water staining at corner and at sprinkler head.

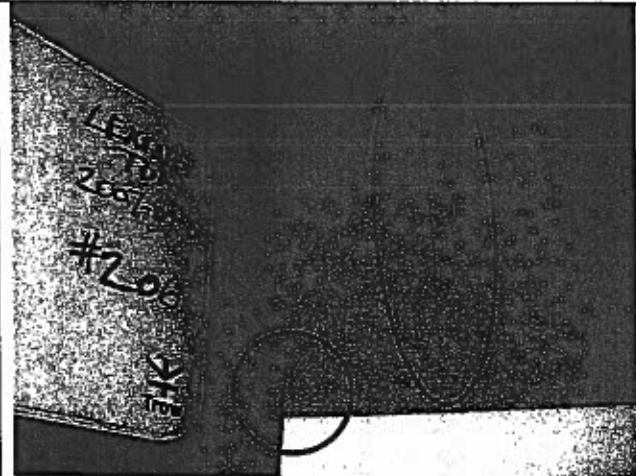
Photo 28: Unit #206 Level 3 living room: note cracks in bay window drywall. This indicates building structure movement.

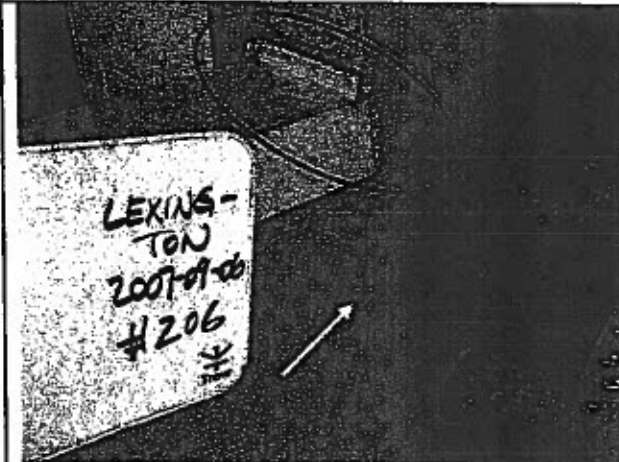
Photo 29: Unit #206 Level 2 entrance: note deterioration of sealant at cap flashing and vertical crack in stucco. Adequate saddle waterproofing and flashing upturn was not provided.

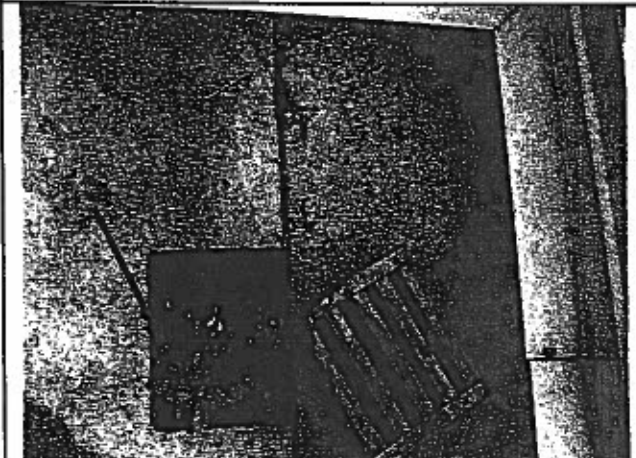
Photo 30: Floor drain at Level 2: note plant growth in drain which will impede water flow.

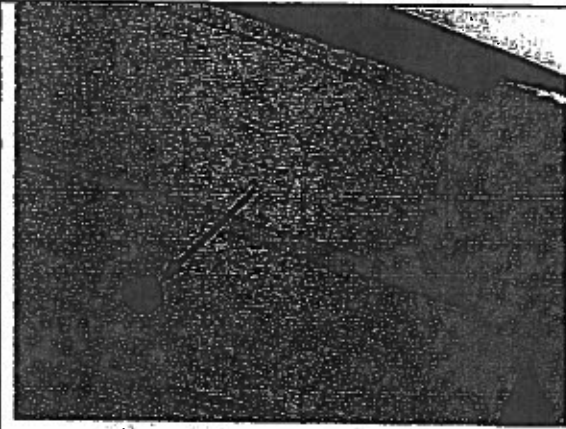
Photo 31: Unit #216 soffit: note unfinished drain through soffit from balcony above.

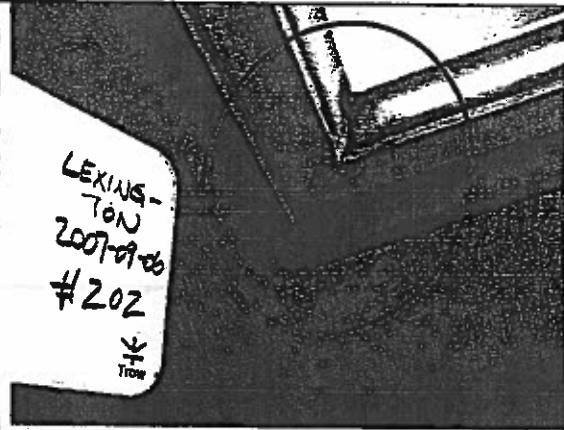
Photo 32: Unit #202 soffit: note water staining on soffit behind trim board indicating gutter joint waterproofing failure.

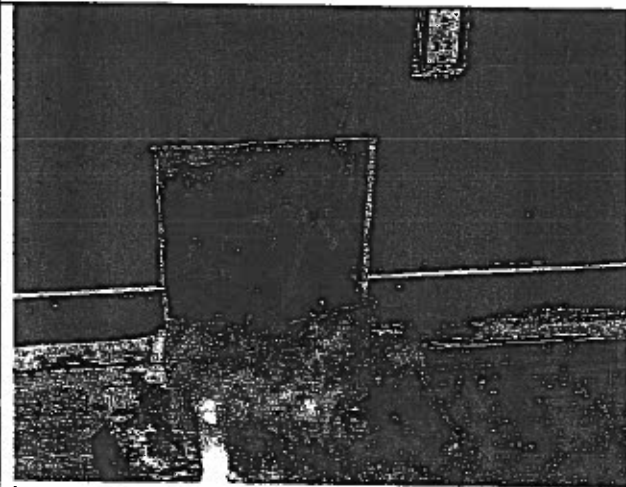
Photo 33: Unit #202 master bedroom: moisture content reading is over 40 indicating wood is saturated.

- b) It was confirmed water ingress at the east wall of the Level 3 master bedroom of Unit No. 202. We assume that the previous construction on the Level 4 deck of Unit No. 202 was not adequate and is causing active water ingress to construction below. Some interior and exterior walls below the Level 4 deck of Unit No. 202 must be reviewed and have structural repairs as necessary.

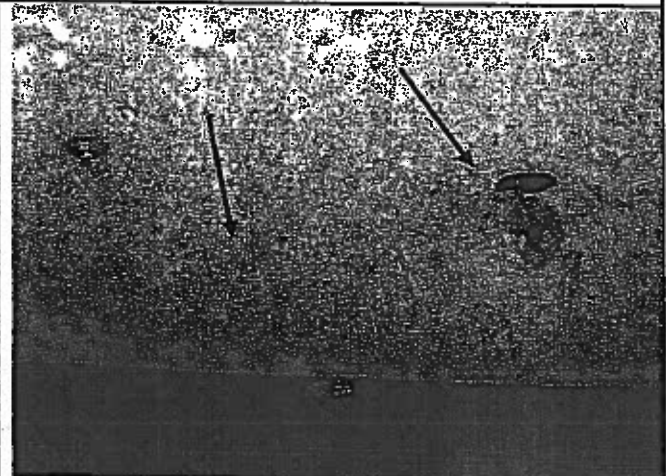
Photo 34: Unit #202 master bedroom: note water stains on ceiling.

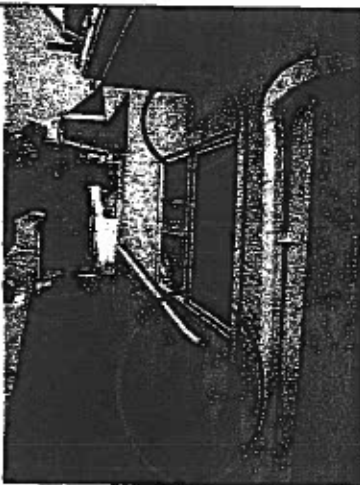
Photo 35: North elevation exterior walkway outside Unit #307: note water staining above and below window.

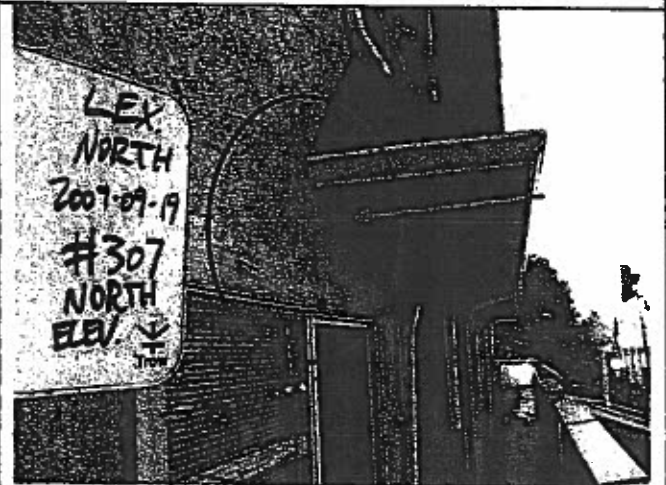
Photo 36: Close-up of Photo 35. Water leaks down the stucco from the end cap of roof gutter. Gutter is sloped towards the building.

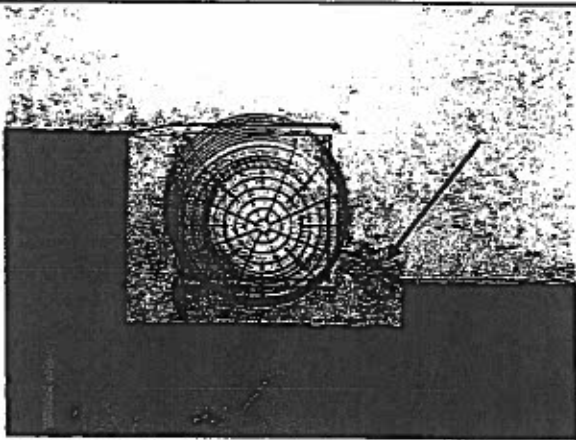
Photo 37: North elevation below exterior walkway between Units #205 and #207: note crack in stucco beside vent.

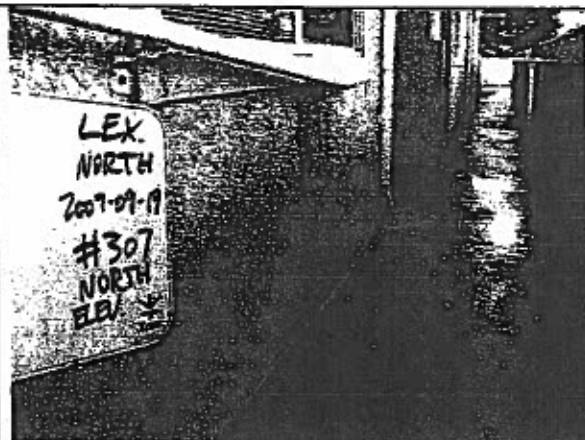
- Liquid-applied waterproofing membrane (not original construction) was applied on the top of concrete topping. Minor water ponding was observed along walkway (Photo 38). Sufficient slope to the walkway floor was not provided.
- If existing concrete topping was not removed during the previous walkway floor re-waterproofing work, original structural damage by past water ingress might not be repaired yet.

Photo 38: North elevation exterior walkway outside Unit #307: note water ponding along walkway.

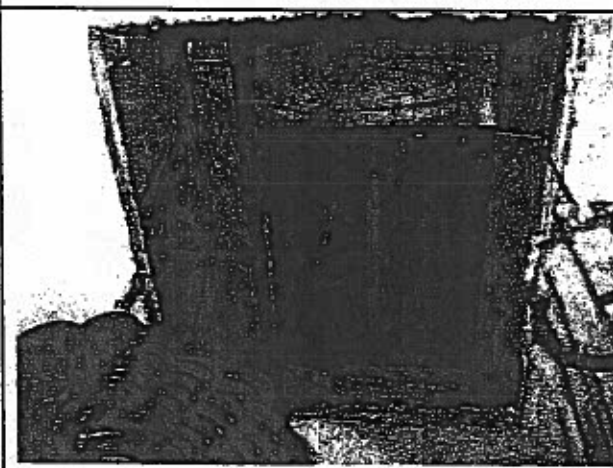
Photo 40: Close-up of Photo 39. Water staining is visible.

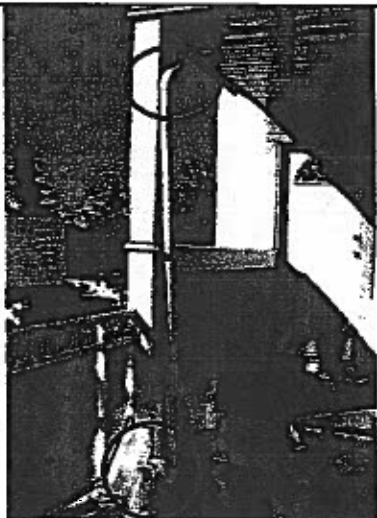
Photo 41: Unit #202 East elevation entrance: rain water leader is not connected at top and bottom.

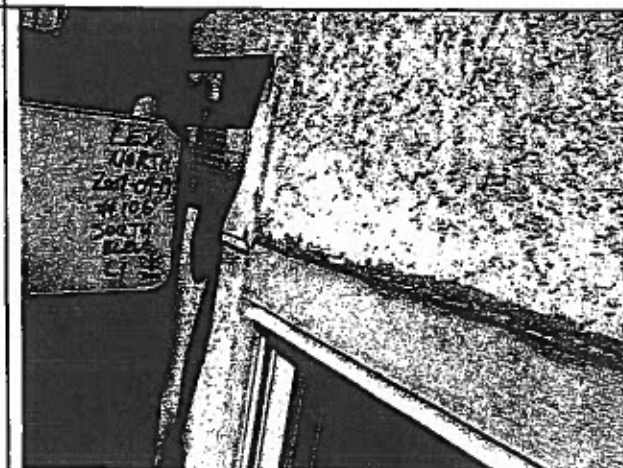
- Sealant was previously applied (not original construction) at the top of the wood trim at the head of windows and doors (Photo 42). This indicates that water ingress at the head of windows and doors has occurred.
- Sealant was previously applied (not original construction) at the exposed termination of some flashings (Photo 4). Sealant must be maintained.
- Sealant was not observed at wall penetrations, such as at hose bibs, exterior lights, electrical outlets and railing attachments.

Photo 42: Unit #106 South elevation at the patio sliding glass door: note deterioration of sealant bead between stucco and wood trim. Head flashing is not provided.

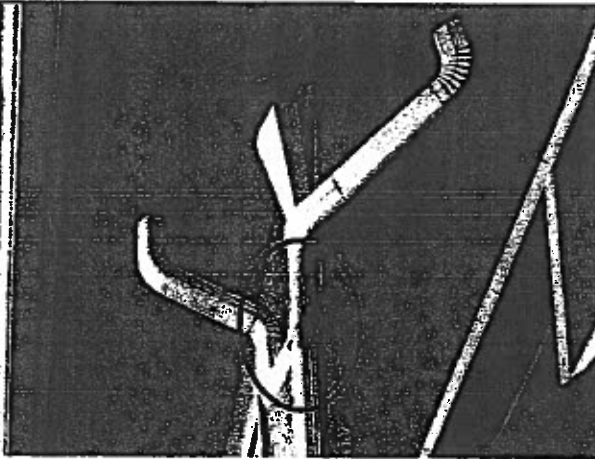
Photo 43: Unit #303 North elevation: note plant growth in convergence of downspouts.

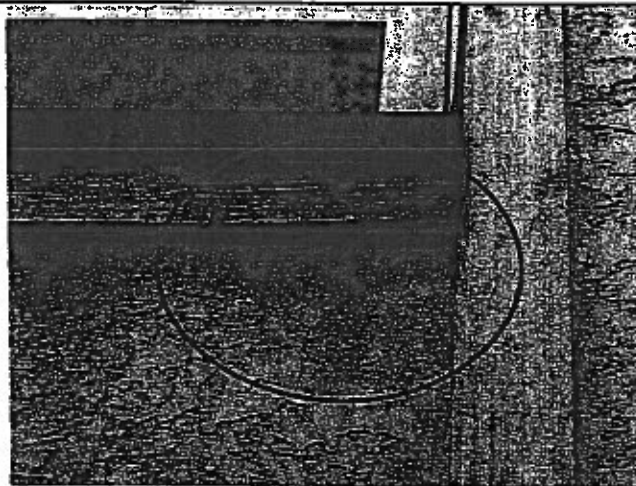
Photo 45: Note water staining and deterioration of wood trim. This indicates rainwater enters behind cladding and window. Window frame may not be water tight.

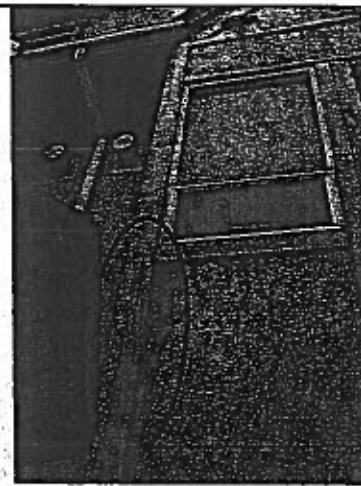
Photo 46: Unit #309 Level 3 East elevation: note water staining at corner of window trim. This indicates rainwater enters behind cladding and window. Window frame may not be water tight.

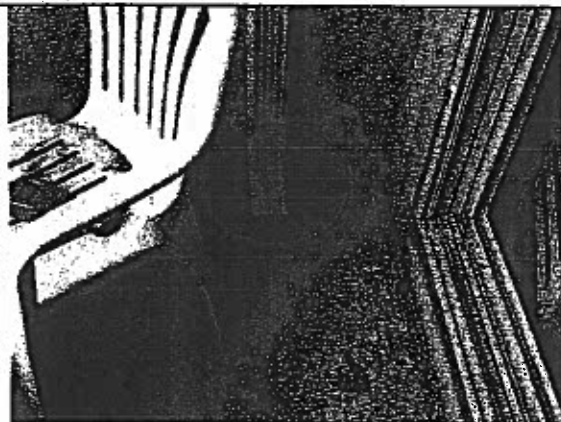
- A painted coating on the top of concrete topping was observed (Photos 7, 47, and 48). The coating appears not to be waterproofing material. The coating on many areas of balconies and decks is compromised.

Photo 47: Unit #208 South elevation balcony: note downspout discharging directly onto balcony surface. Note that existing balcony deck finish is paint, but not a waterproofing membrane.

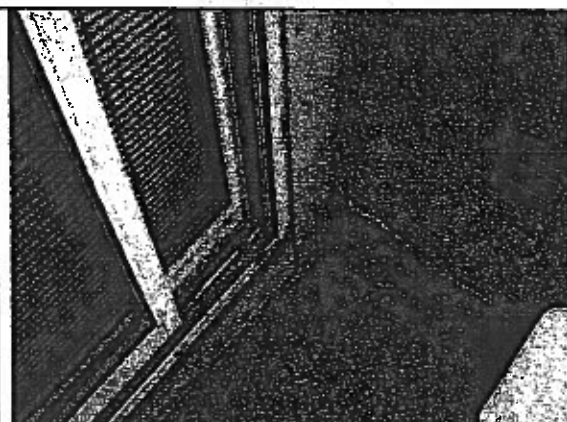
Photo 48: Unit #208 South elevation balcony: note high water mark on stucco wall. This indicates periodic water ponding and capillary saturation of adjoining stucco.

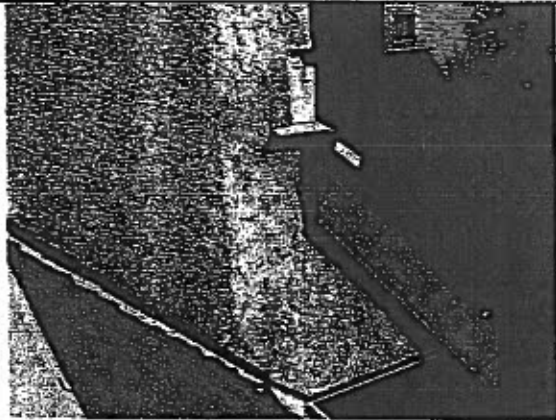
Photo 49: Note transition from new to old stucco. Metal flashing without end dams is embedded into stucco.

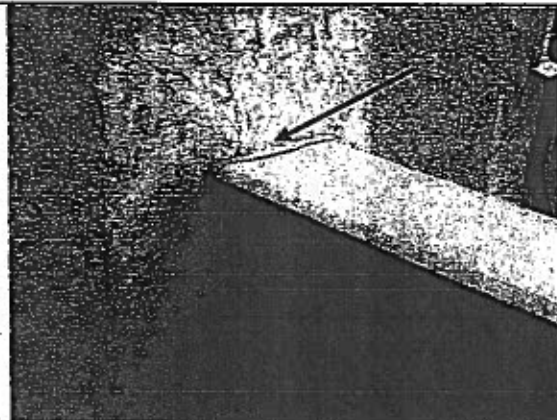
Photo 50: Note repair where metal cap flashing is embedded into stucco. Adequate shingling of saddle waterproofing with original building material might not be provided. Note also sealant bead will be a regular maintenance item.

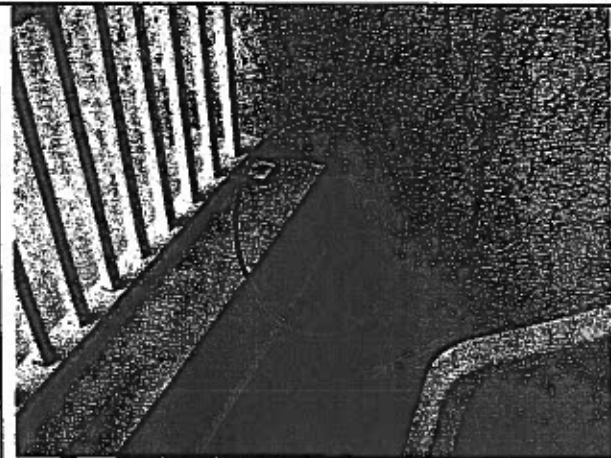
Photo 51: Unit #208 South facing balcony East wall: note lack of end dam on cap flashing and water staining.

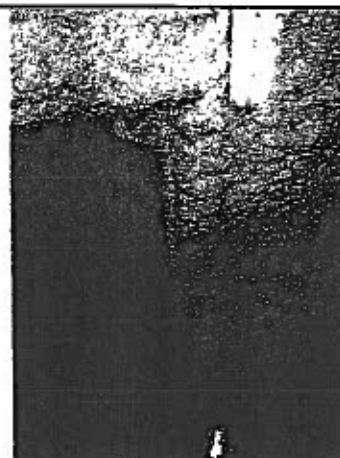
- Water stain in existing spray foam insulation was observed on the concrete ceiling above Stalls No. 23, 35, 36 and 38 (Photo 52). It is probable that the transition between the previous work and the original construction along the building perimeter exterior wall is not watertight at some areas.

Photo 52: Parking garage: Note evidence of water leaking through the spray foam insulation.

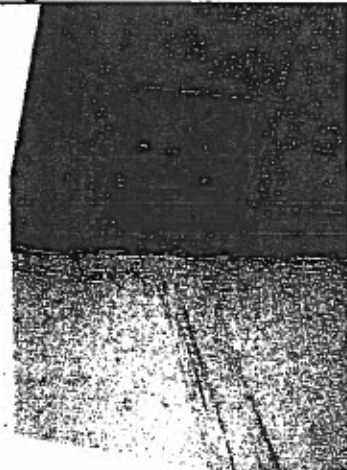
- Heavy water staining through exhaust fan penetration around Stall No. 9 was observed (Photo 53). The building manager advised that the exhaust fan penetration was protected by new cap flashing and water ingress has not re-occurred.
- Water staining was observed at the cold joint of the parking garage roof slab and wall above Stalls No. 17 to 20 (Photo 54). This indicates that the existing waterproofing membrane above does not as intended.

Photo 53: Parking garage: Note evidence of water having leaked through exhaust fan housing.

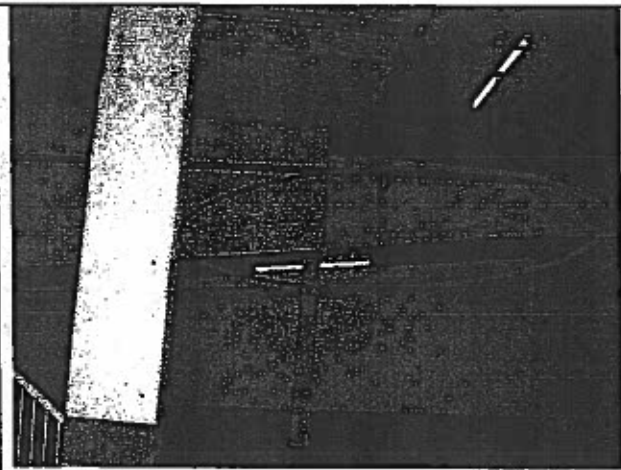
Photo 54: Parking garage: note evidence of water staining at concrete cold joint.

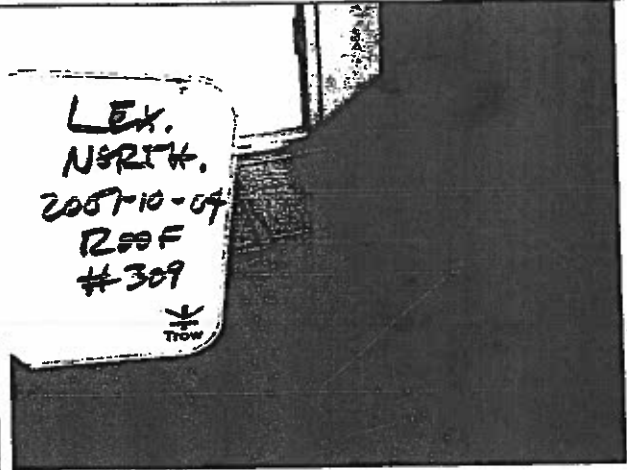
Photo 56: Unit #307 roof deck privacy wall has been cut off. Asphalt shingles have been applied to act as a weather shield. This is not adequate waterproofing.

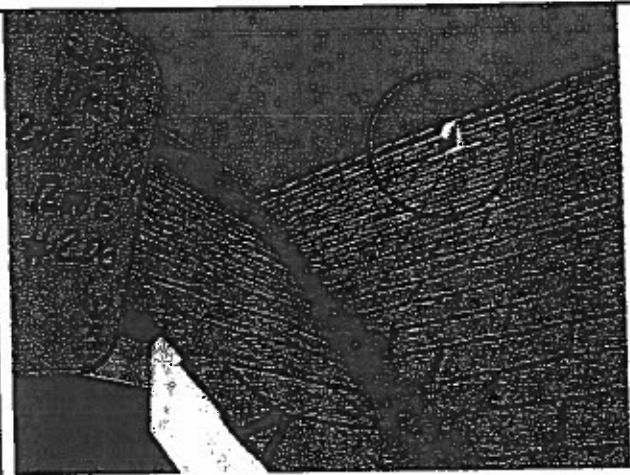
Photo 58: Unit #206 roof vent is folded over, severely restricting its function. Also note moss accumulation in valley of roof.

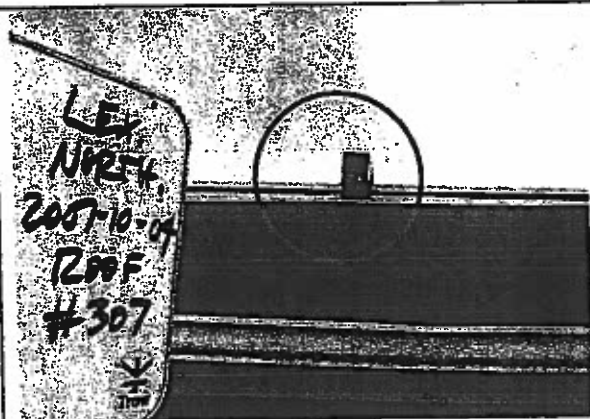
Photo 59: Unit #307 roof top stairwell: note missing rain water leader.

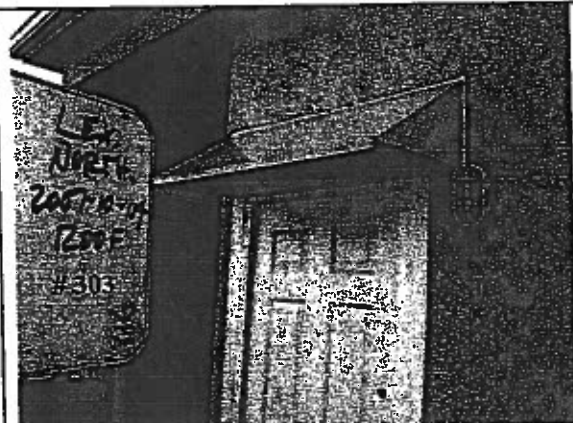
Photo 60: Unit #303 roof deck: metal awning added over roof deck door. Sealant will be a high maintenance item. Also occurs at #301 and #309.
