Depreciation Study Report for Sandborne Woods

Prepared for:
Strata Plan LMS 259
c/o Baywest Management Corporation
13468 – 77th Avenue
Surrey, BC
V5W 6Y3

Project Number:
VAN-00203248-01

Date Submitted:
2013.05.31

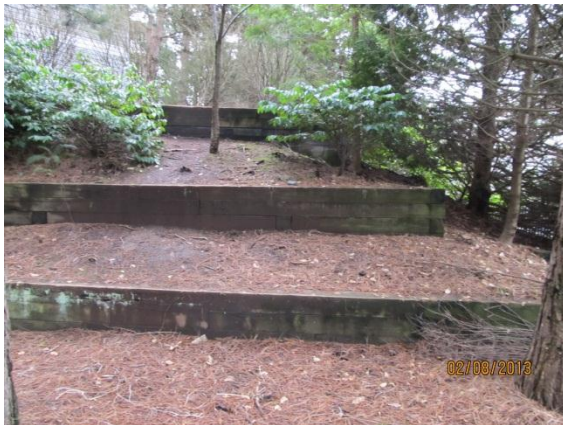
Wood timbers are used as landscape retaining walls, steps and edgings in the northwest and south west areas of the site. Typically, the service life of exposed wood retaining wall components is 15 years. Observed existing conditions of wood components demonstrates that service life has been exceeded.

Stepped timber retaining walls in northwest yard.

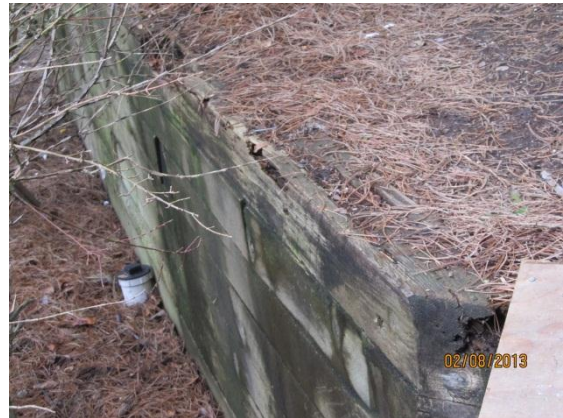
Existing wood deterioration was observed in several landscape timbers located in the northwest and southwest areas of the site. Immediate replacement of several components should be undertaken.

Observed existing wood deterioration in timber retaining wall.

We have provided a cost, as outlined in Table 1 - Cost Summary, for the periodic replacement of deteriorated landscape timber elements.

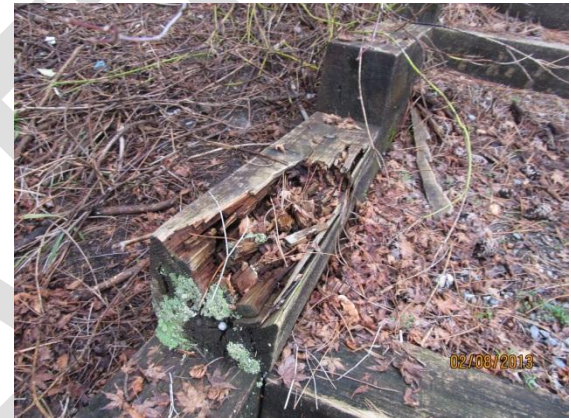
Observed existing wood deterioration in timber edging beside steps.

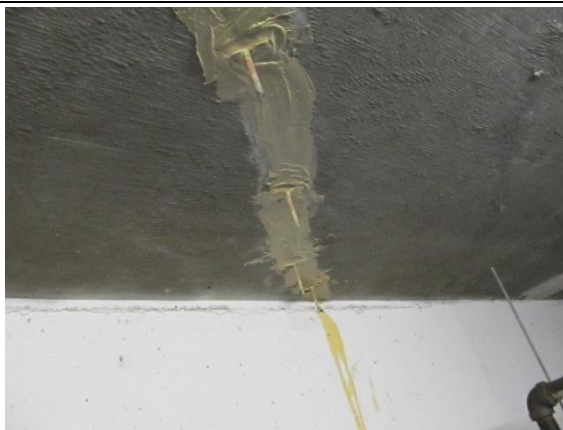
However, several active leaks were observed through the at-grade suspended concrete slab. Epoxy was observed to have been injected into cracks in several areas, some still leaking. Metal trays were observed hanging from the suspended concrete ceiling in some areas to divert some of the actively leaking water.

The existing waterproofing membrane on the at-grade concrete suspended slab was not visible for review due to installation of landscaping elements. According to observed existing leaks through the at-grade concrete suspended slab of the parking structure, waterproofing membrane replacement work should be considered soon.

Epoxy-filled cracks on underside of at-grade concrete suspended slab.

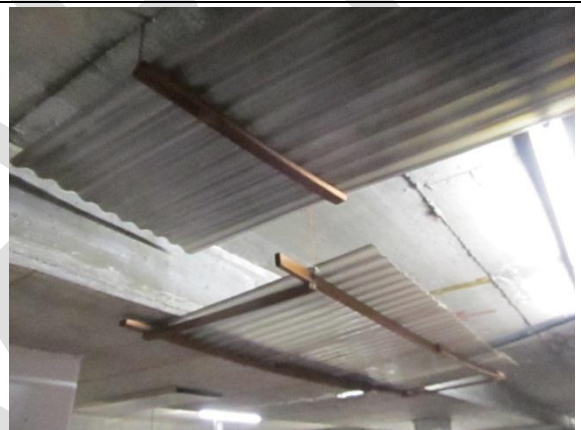
Water diverter trays suspended from concrete suspended slab ceiling.

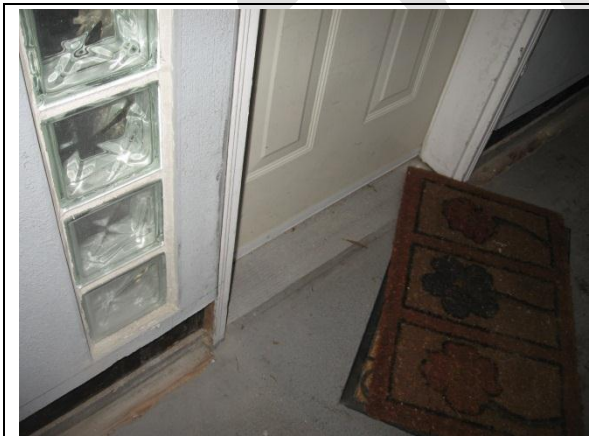
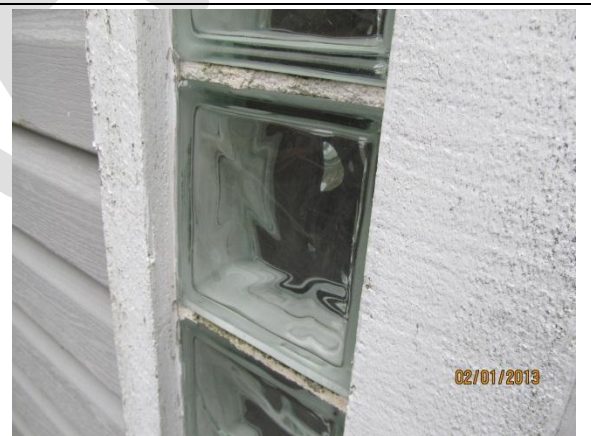
Glass block accents are featured adjacent to front entrance doors to suites. Mortar joints that were reviewed were observed to be in need of maintenance.

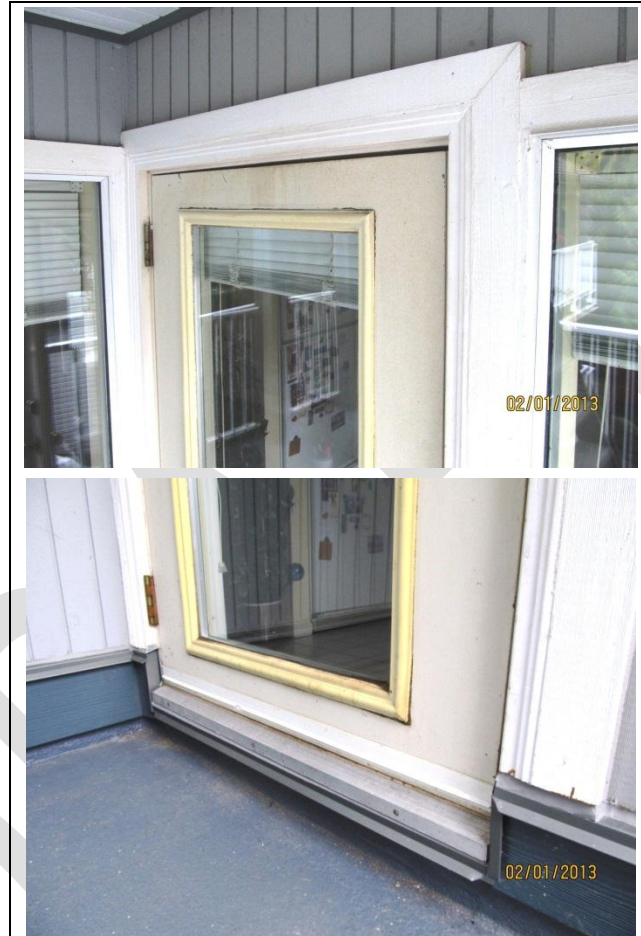
Typical patios/ balconies feature wood frame, metal-clad swing doors with a double-glazed panel. At the time of the review doors that were reviewed were generally observed to be in serviceable condition. The recent JRS BECA 2010 report indicated a couple of balcony swing doors that were observed to not fully seal around their perimeter.

We have provided a cost for replacement of metal-clad glazed swing doors at typical patio/ balcony locations, as outlined in Table 1 - Cost Summary.

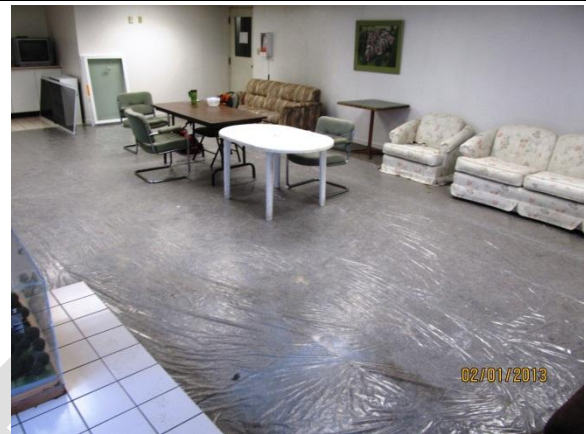
Protective plastic covered existing carpet in Community Room during room repairs.
