213vA006A

**Re: Place Fontaine Bleu, Coquitlam, BC  
2013 Depreciation Report**

## 2013 DEPRECIATION REPORT FOR

**Place Fontaine Bleu**  
Coquitlam, British Columbia

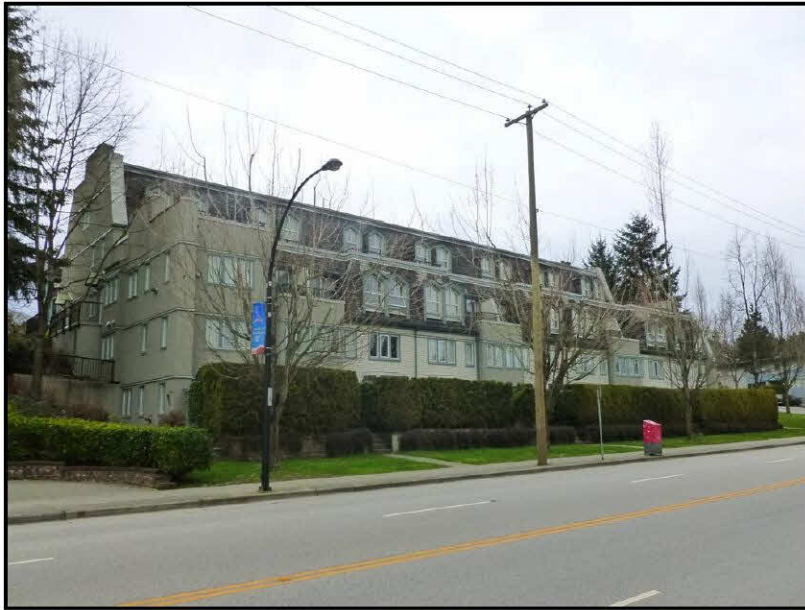
Photo No. 1: South elevation of Building F

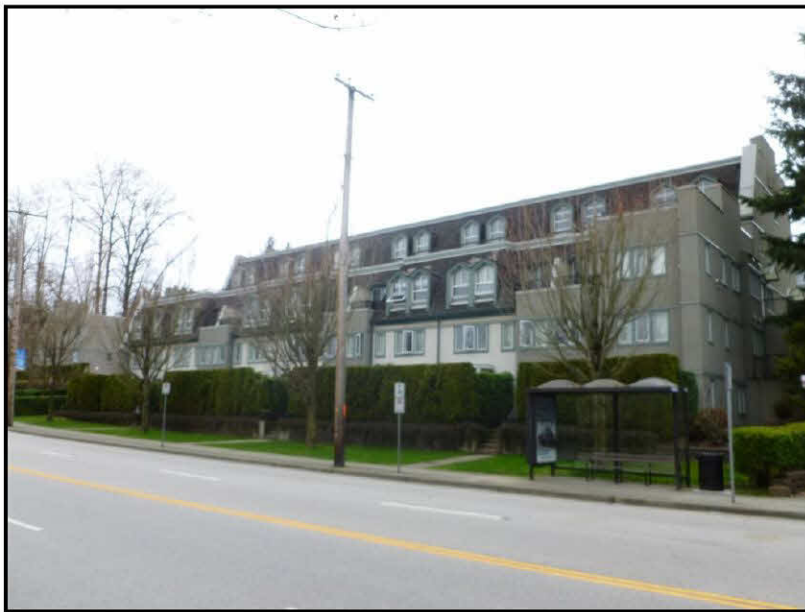
Photo No. 2: South elevation of Building E

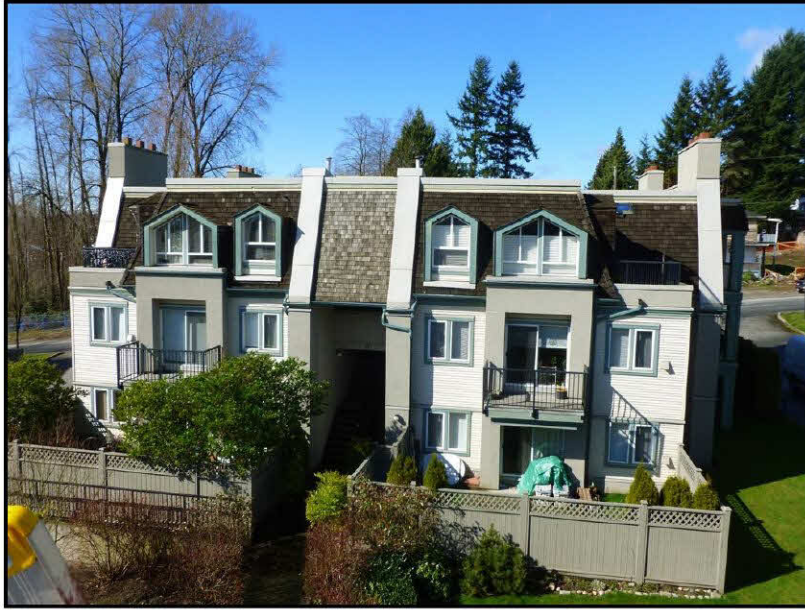
Photo No. 3: East elevation of Building C

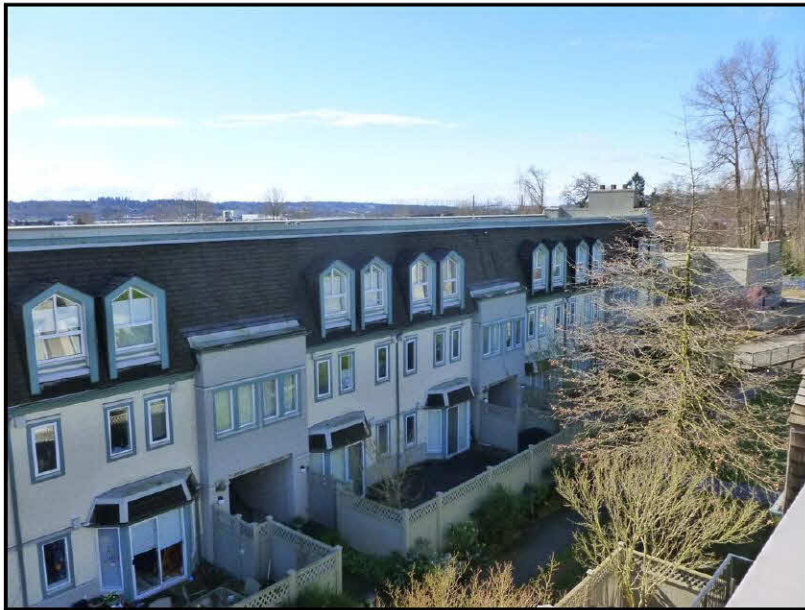
Photo No. 4: North elevation of Building E

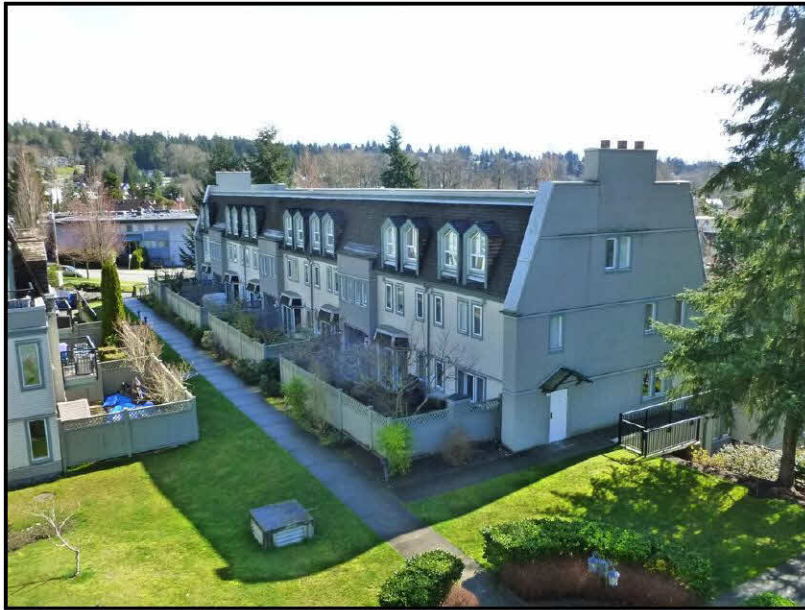
Photo No. 5: North elevation of Building F

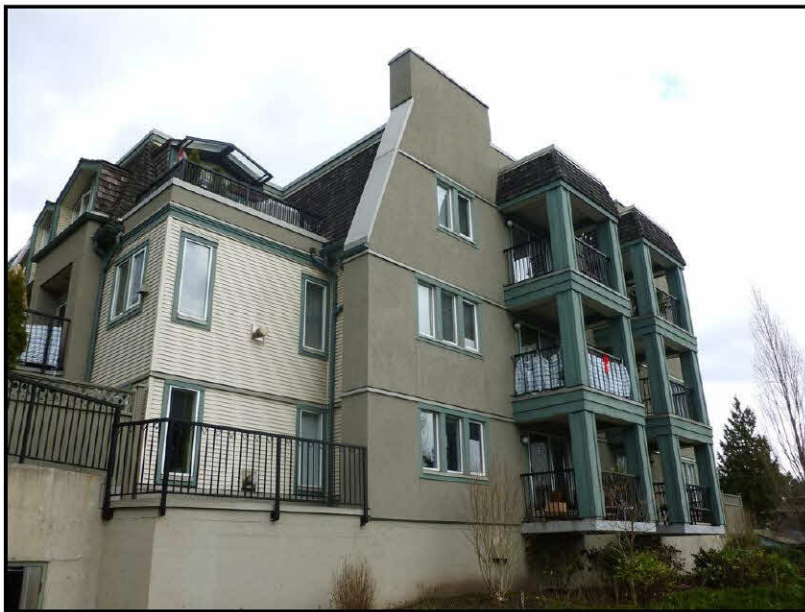
Photo No. 6: South elevation of Building H

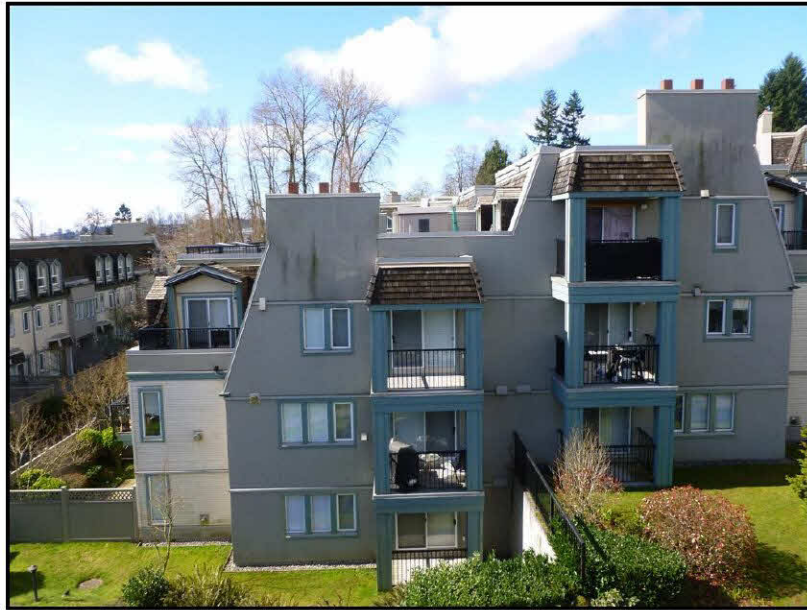
Photo No. 7: East elevation of Building D

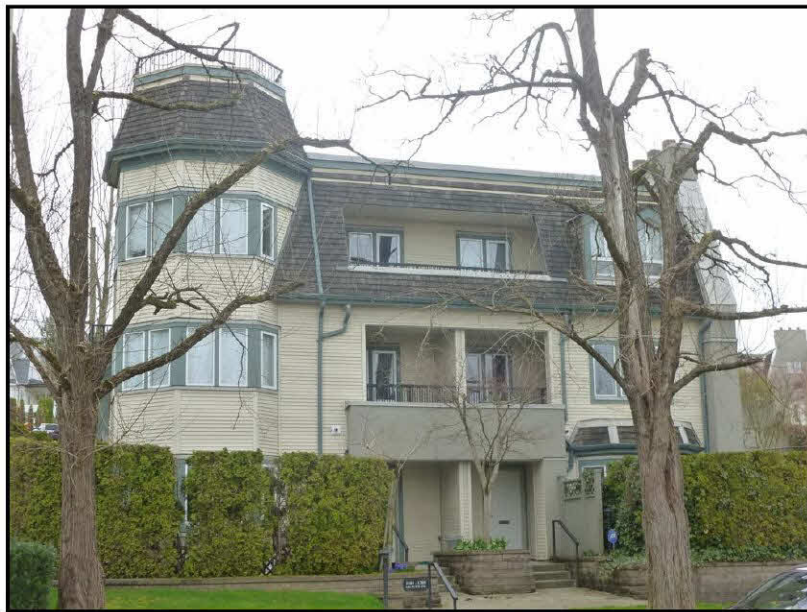
Photo No. 8: South elevation of The Gatehouse

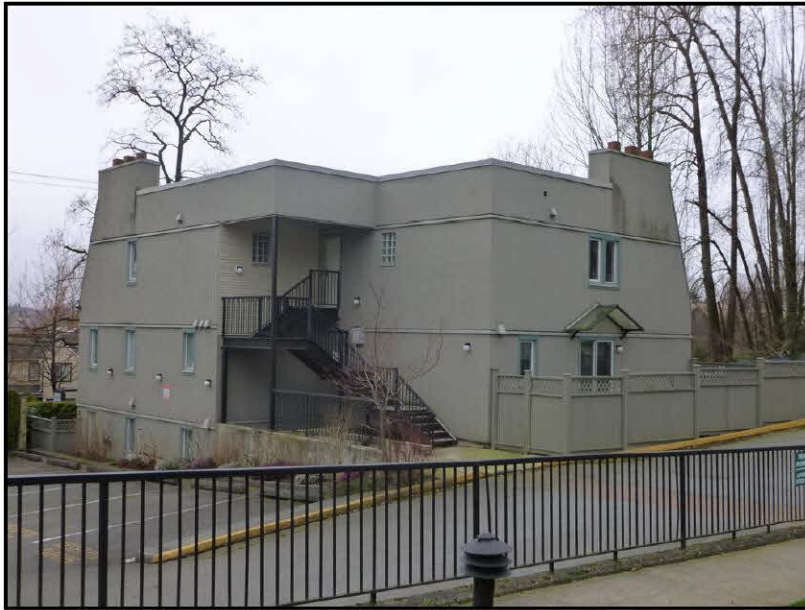
Photo No. 9: North elevation of The Gatehouse

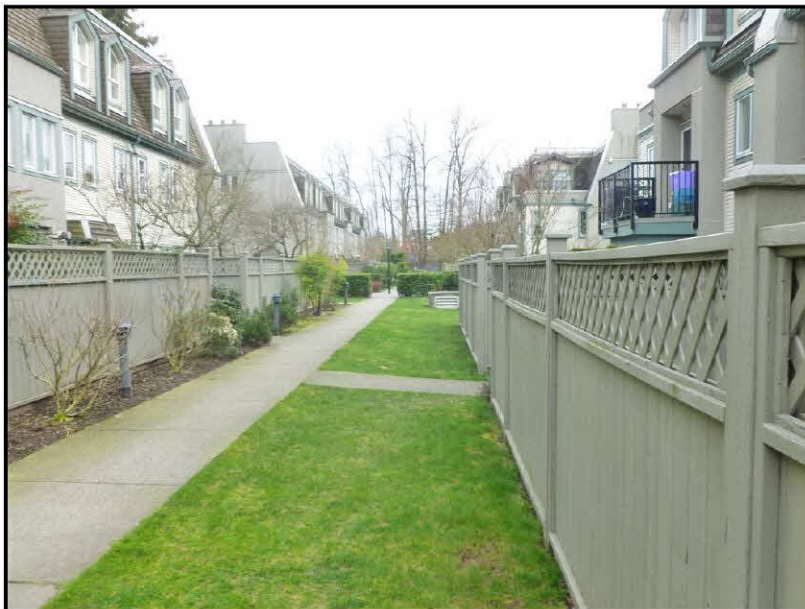
Photo No. 10: Typical path through the complex

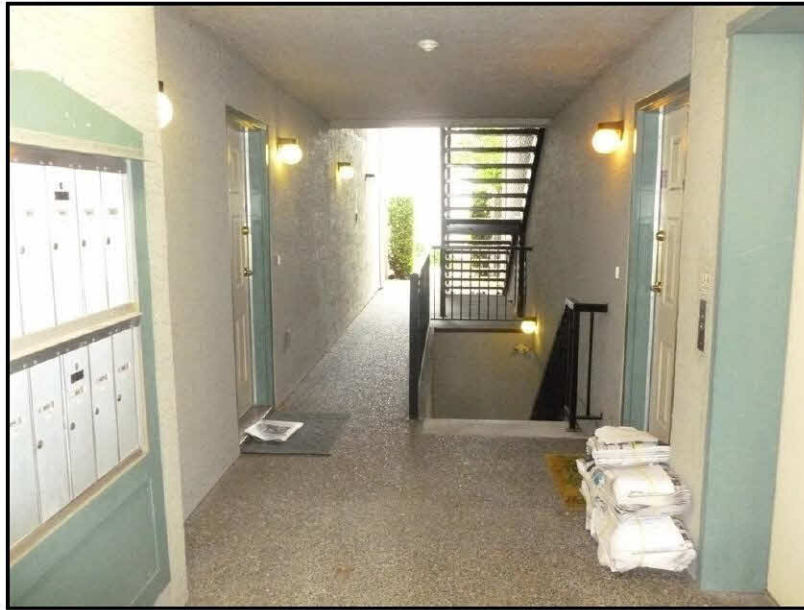
Photo No. 11: Typical covered exterior corridor

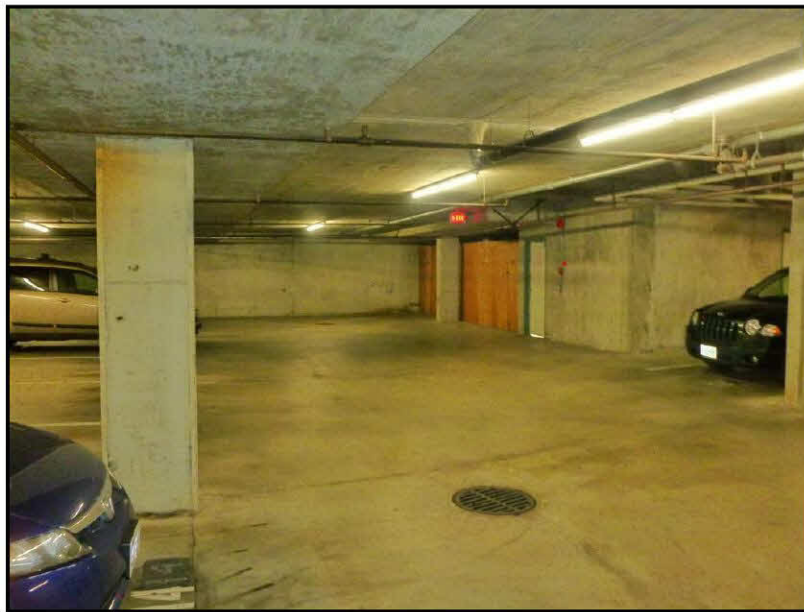
Photo No. 12: Typical garage condition

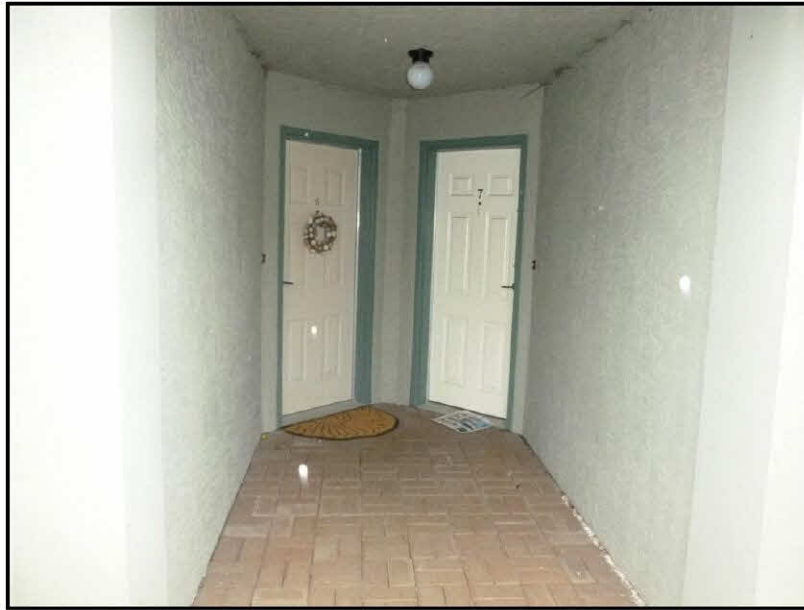
Photo No. 13: Typical unit front entrances

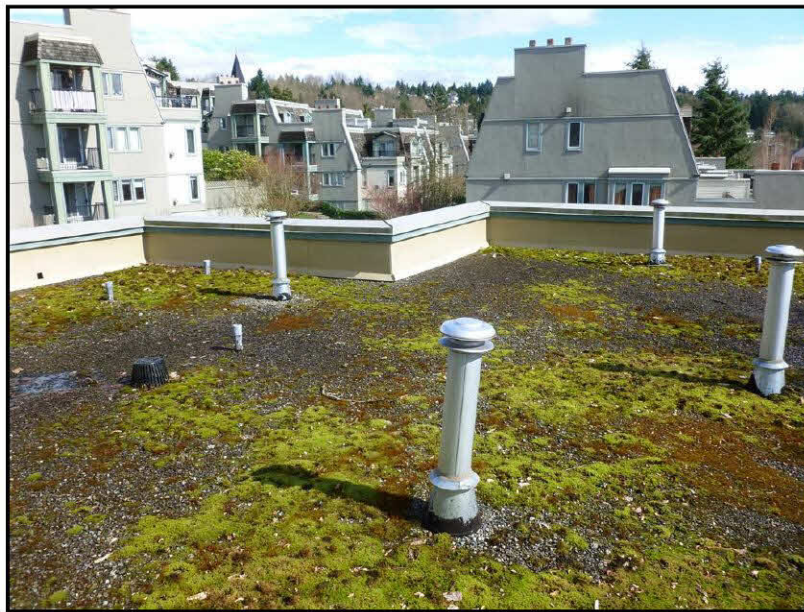
Photo No. 14: Built-up roof for The Gatehouse

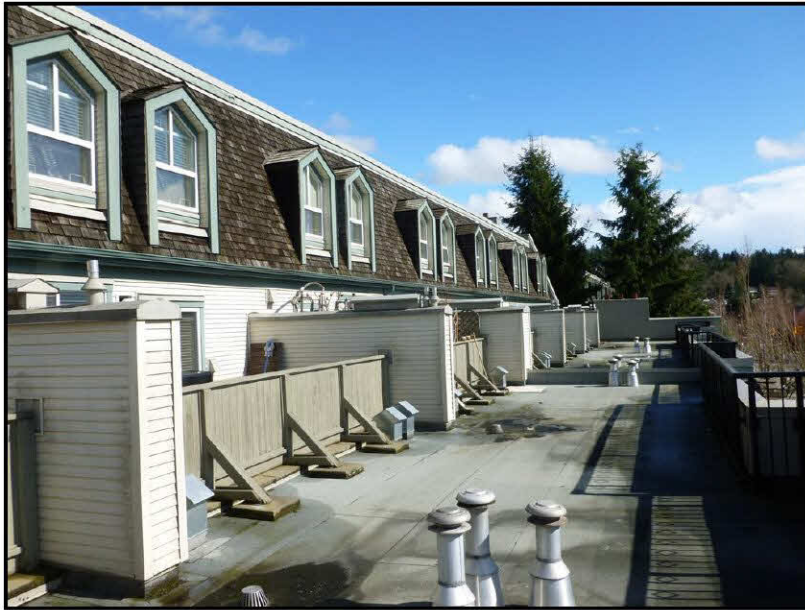
Photo No. 15: Large upper terrace for Building E

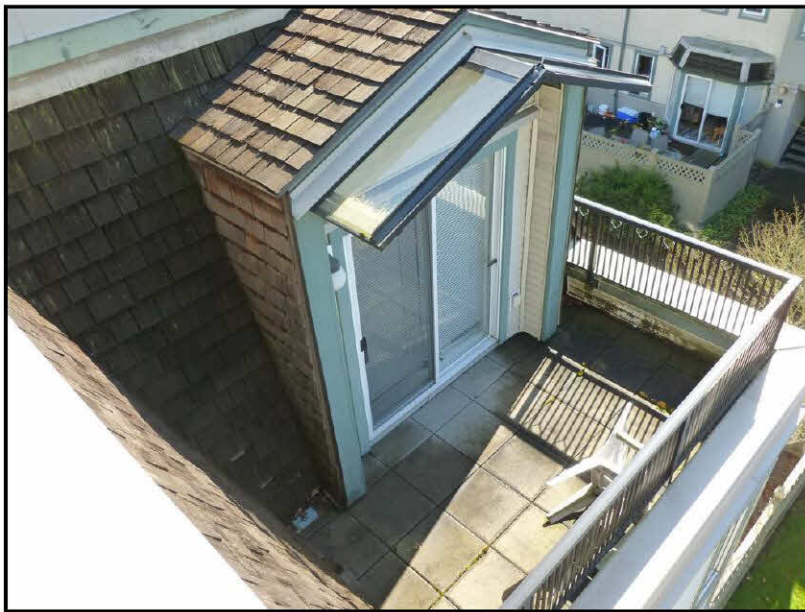
Photo No. 16: Typical third floor corner terrace

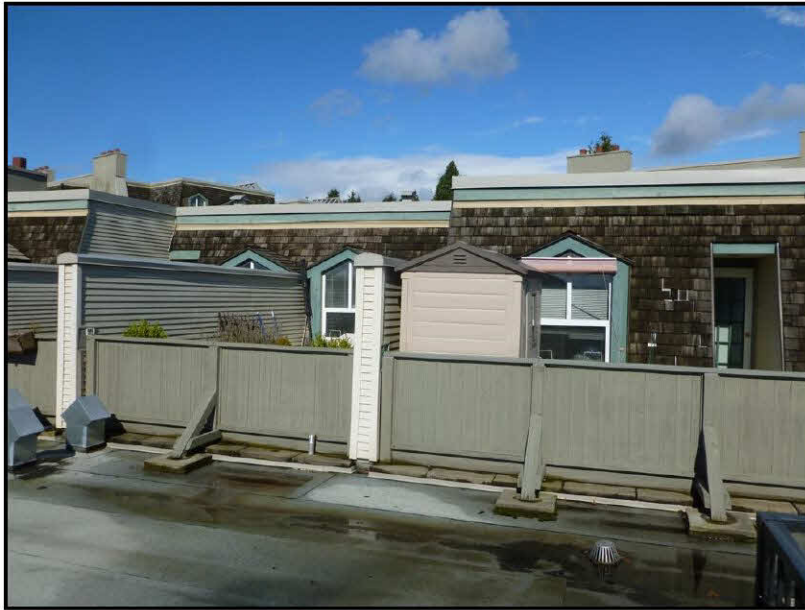
Photo No. 17: Typical third floor small terrace

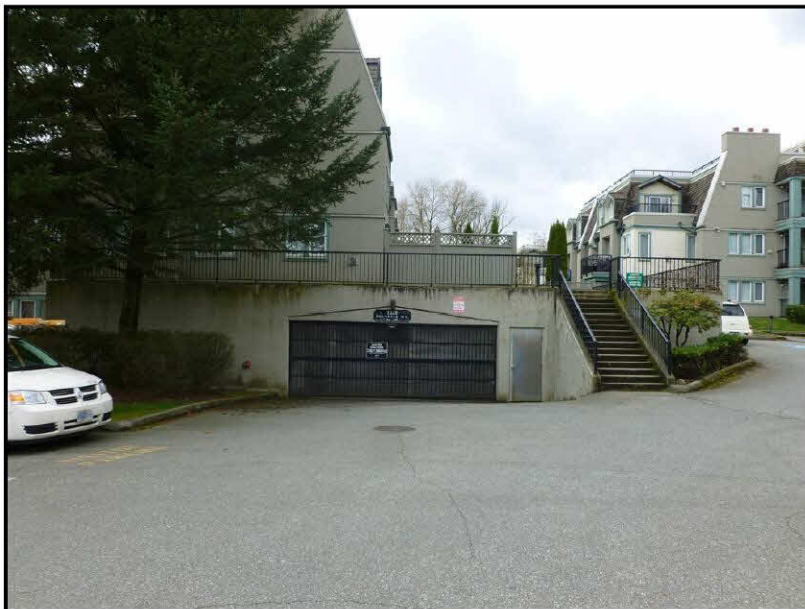
Photo No. 18: Entrance for Garage 5

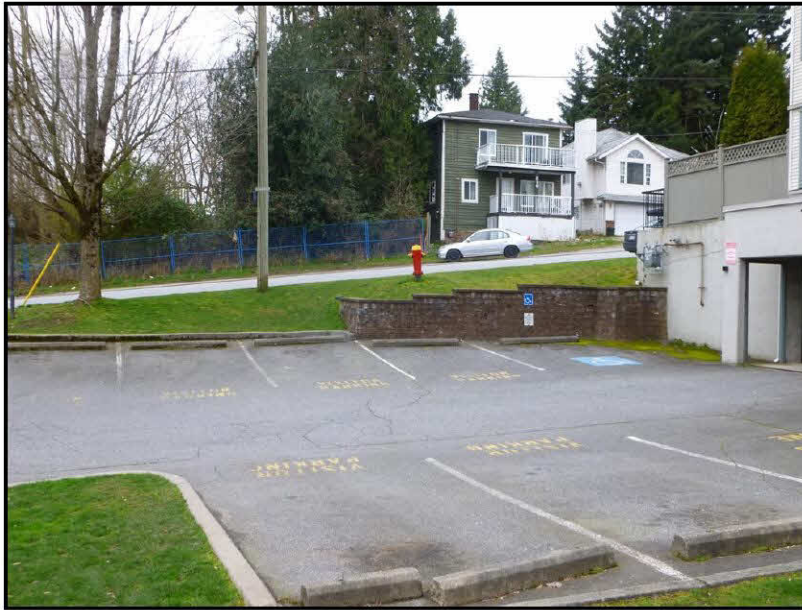
Photo No. 19: Parking lot 2

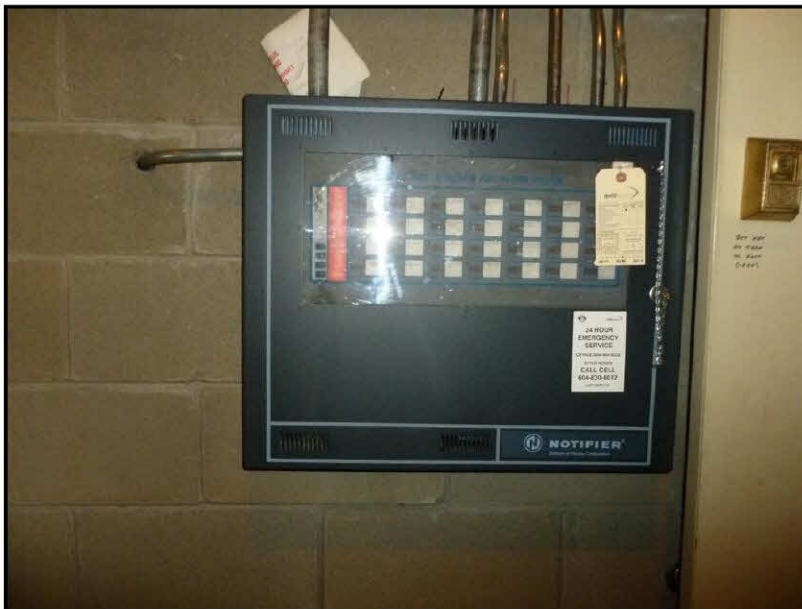
Photo No. 20: Typical fire alarm panel

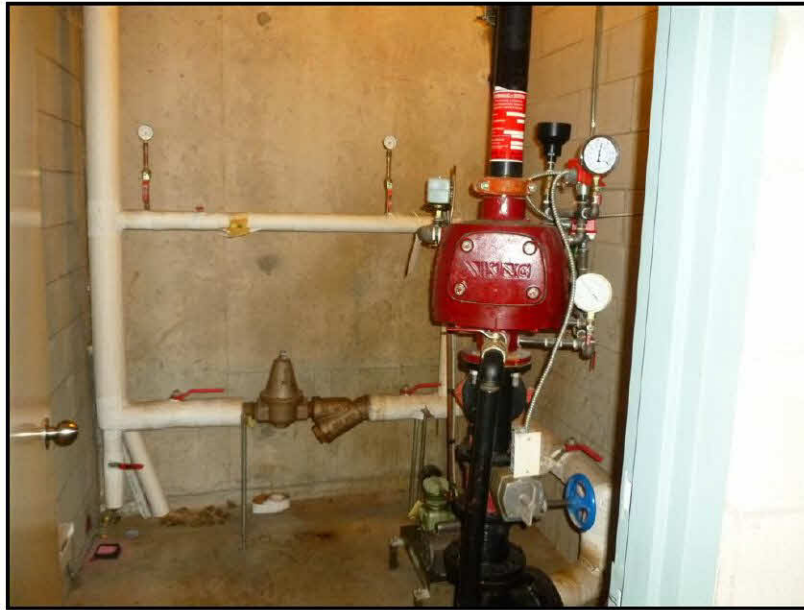
Photo No. 21: Typical incoming fire and domestic water lines
