BC Roof Inspections

July 31, 2019

Re: Residence at The Crystal
6028 & 2088 Willingdon Avenue,
Burnaby

As per your request we have completed a roof survey of the address noted above and offer the following recommendations.

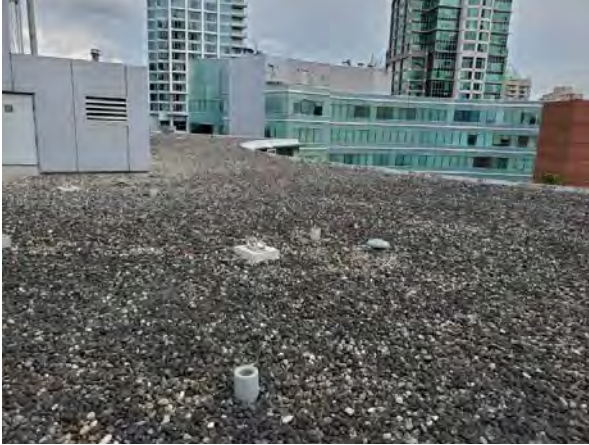
<p><u>Low Rise</u></p> <p>A view of the main flat roof on the low rise townhouse building. Access to the roof membrane in an inverted assembly is difficult as the gravel ballast needs to be removed, followed by the removal of the insulation.</p>
<p>3.</p>

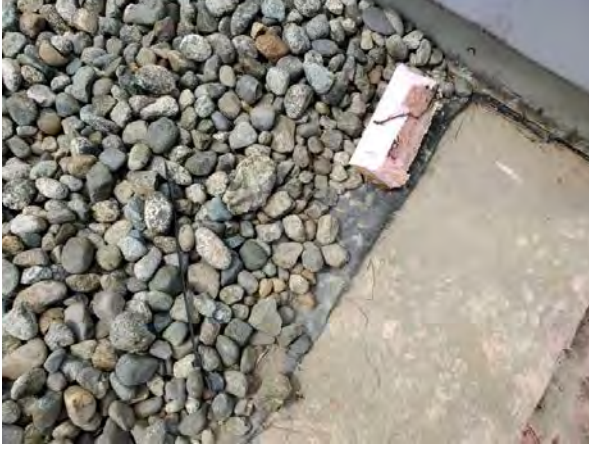
<p><u>Low Rise</u></p> <p>The gravel ballast and the filter fabric were pulled back in a few locations in order to review the roof system.</p>

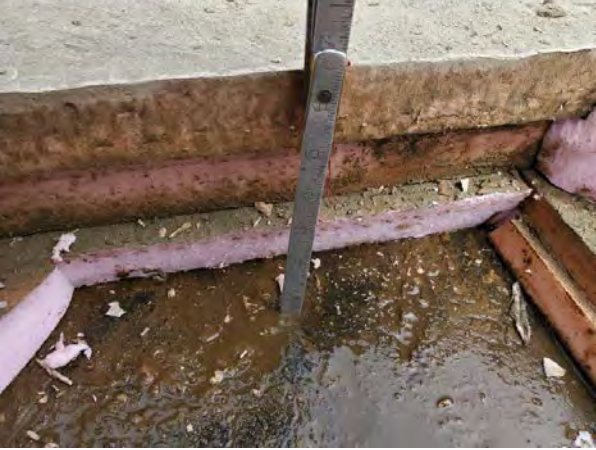
4.

<p><u>Low Rise</u></p> <p>The insulation consists of a base layer of 2” followed by a layer of 4” of Type 4 extruded polystyrene (XPS). This type of insulation is less hydroscopic than others and offers a better R value when compared to EPS insulation. XPS has an R-value of 5 per inch, though this will be reduced as the insulation absorbs water.</p> <p>Though less hydroscopic, it should be noted that the bottom layer is saturated with water.</p>

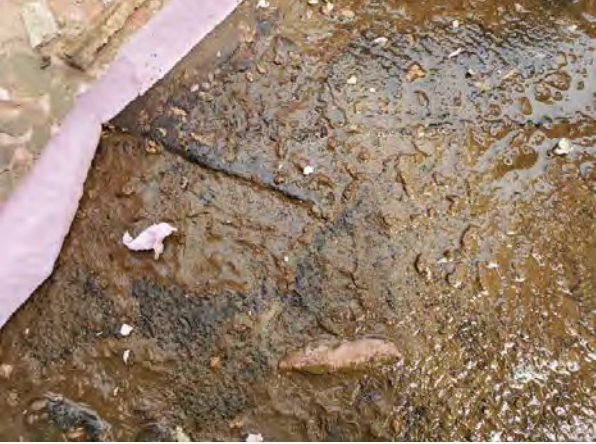
5.

<p><u>Low Rise</u></p> <p>The membrane exposed is an asphaltic based non-reinforced membrane.</p> <p>It should be noted that there is no protection sheet laid out over the rubberized asphalt. The insulation was set directly onto the roof membrane. This can cause issues as the insulation isn’t able to slip along the roof membrane, but will exert forces on the membrane as the insulation moves throughout the day.</p>

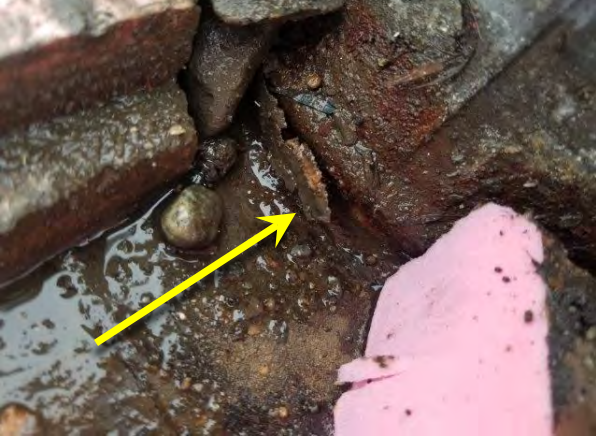
6.

<p><u>Low Rise</u></p> <p>The base of the galvanized flashings are heavily corroded. One drawback of an inverted roof assembly is that the roof stays wetter for longer. Today, vents are treated with a waterproofing coating that extends above the gravel to prevent this corrosion. When this roof was installed, no such action was ever taken.</p>

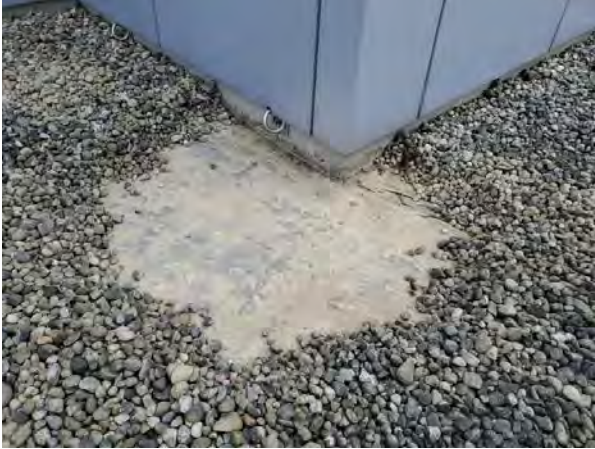
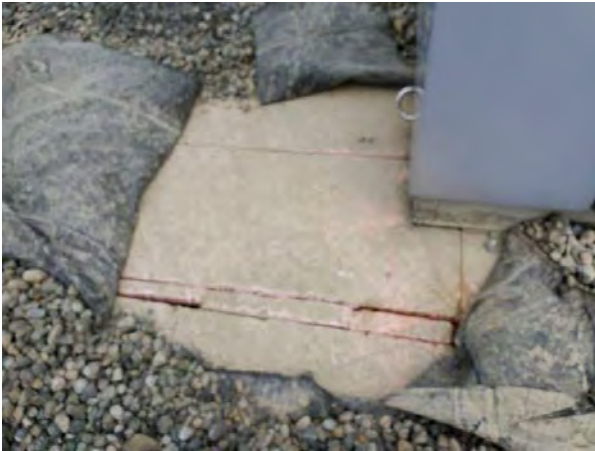
7.

Here is another location where the gravel was removed. In this area, the insulation was glued to the roof deck, which is not typical.

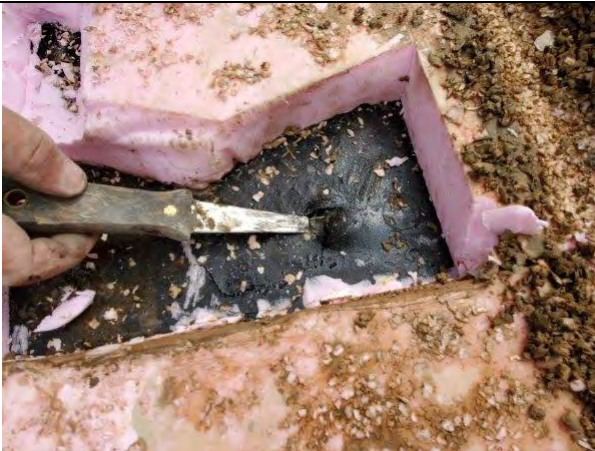
8.

Blisters were noted in the three locations where the membrane was inspected. The blistering is worse on the parapets. In all locations it was also observed that the membrane was applied unevenly; in some areas the membrane is 4mm thick while in others it is so thin that the rough concrete surface shows through. The membrane also appears to be deteriorating. When compressed, an oily fluid can be forced out from the membrane.

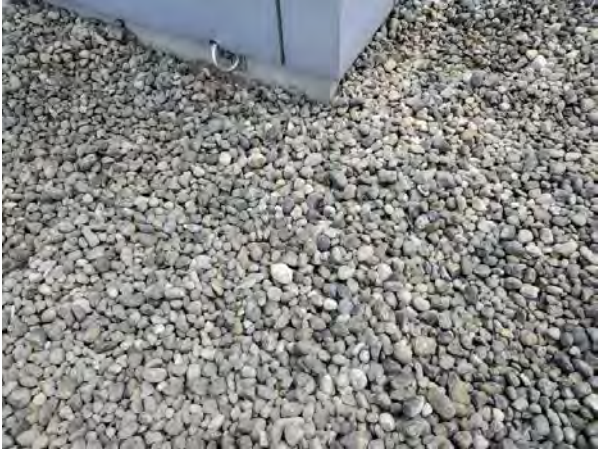
<p><u>Low Rise</u></p> <p>In all locations that were checked, the insulation was fit back into place and the filter cloth with ballast re-applied.</p>
<p>10.</p>

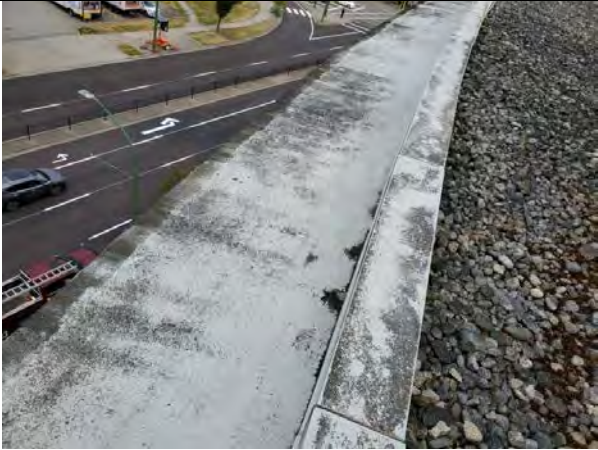
<p><u>Low Rise</u></p> <p>The outer eyebrow roof doesn't have a typical roof membrane installed. Instead, a thin liquid membrane was applied, known in the industry as a traffic coating. This coating is notorious for leaking.</p>
<p>11.</p>

Due to the poor condition of the rubberized asphalt roof membrane on the high rise roof, it is recommended to carry out a full membrane replacement in 2020. At this time, the traffic coating on the low rise eyebrow roof should be upgraded. The owners should plan on replacing the roof system on the low rise in 2021 or sooner if leaks develop.

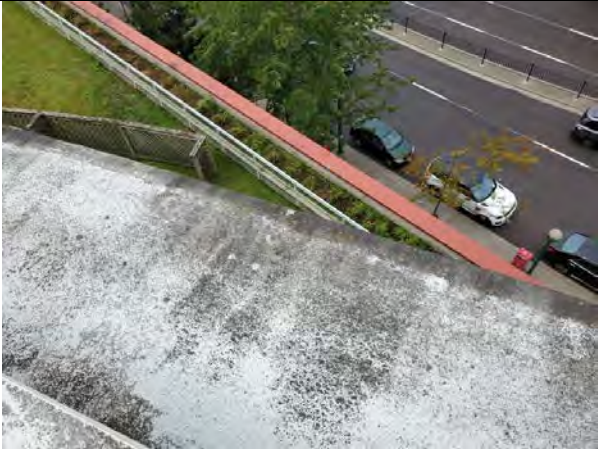
<p><u>Low Rise</u></p> <p>In all areas the traffic coating has deteriorated. Bare concrete is visible all along the perimeter. This coating has failed.</p>

The traffic coating on the low rise eyebrow roof has failed. The caretaker indicated that leaks have been reported in these areas. Cracks will develop in the concrete, and when the coating fails, water will leak into these cracks.

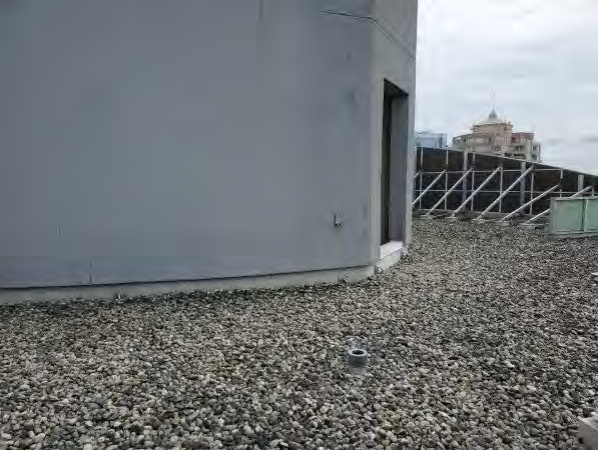
12.

<p><u>High Rise</u></p> <p>The roof system on the high rise is the same as what was found on the low rise roof.</p>
13.

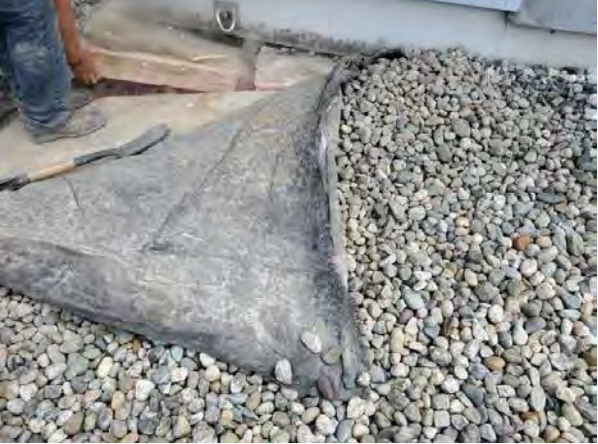
<p><u>High Rise</u></p> <p>The gravel and filter cloth were removed from select locations.</p>
14.

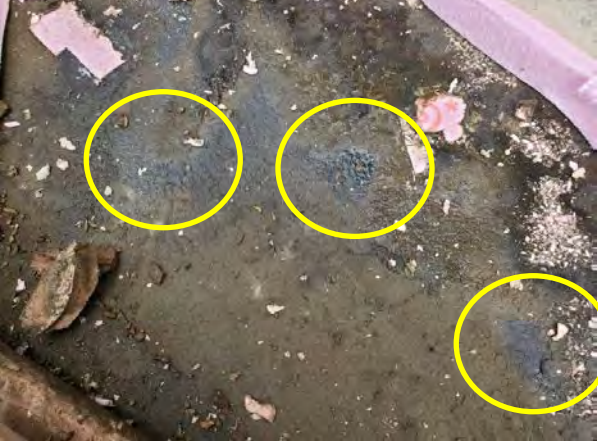
<p><u>High Rise</u></p> <p>The insulation consists of the 2" layer followed by a 4" layer, both of which are XPS.</p> <p>In this picture it is easier to see the uneven application of the roof membrane. The circled areas are very thin.</p>

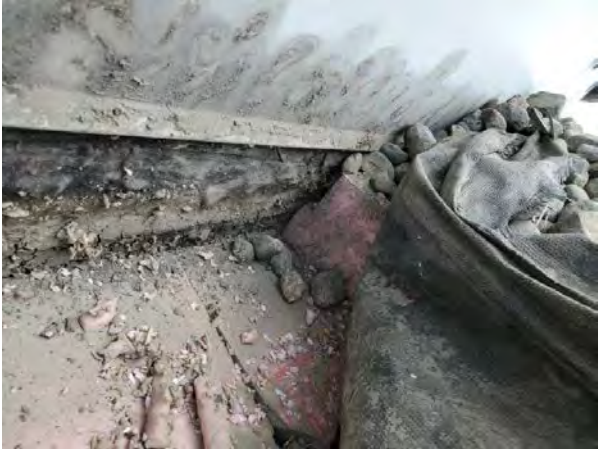
15.

<p><u>High Rise</u></p> <p>Blisters were noted along the walls at the first area investigated.</p>
16.

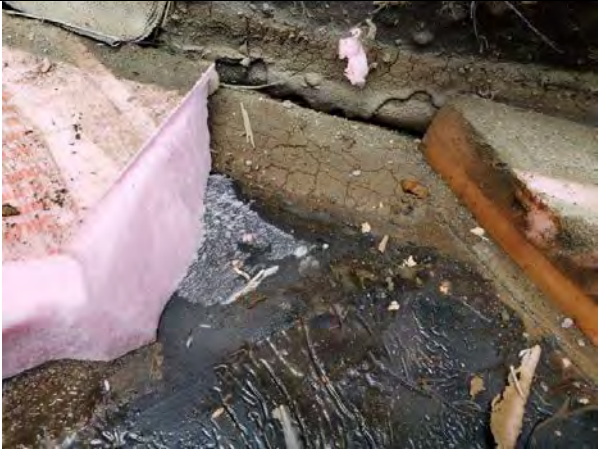
<p><u>High Rise</u></p> <p>A large water filled blister was discovered against the wall in the second location.</p>
17.

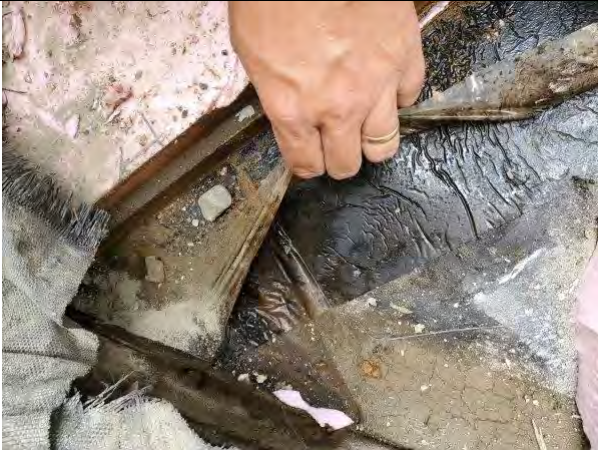
<p><u>High Rise</u></p> <p>Large water blisters were also discovered in the field at the second location as well. The thick concrete roof deck will usually keep water out until the water reaches a crack or a penetration, which is then when a roof leak will occur.</p>

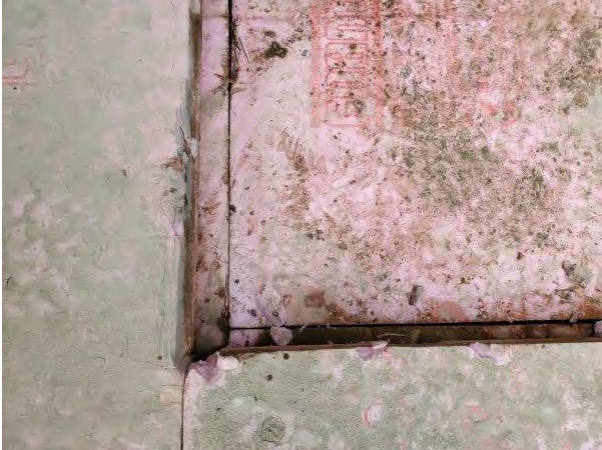
18.

<p><u>High Rise</u></p> <p>Insulation joints should be staggered to prevent thermal bridging. The joints were not offset in one location.</p>
19.

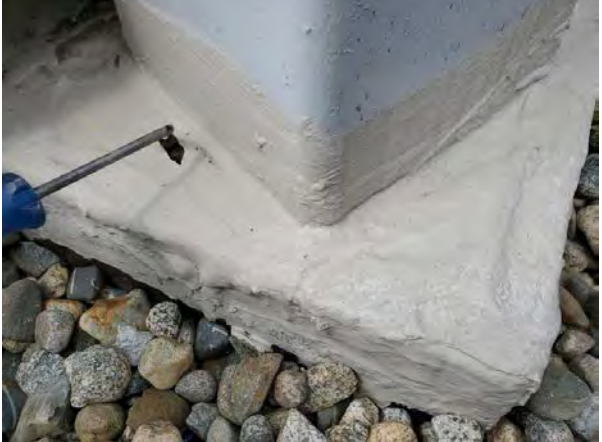
<p><u>High Rise</u></p> <p>Repairs have been made in areas of the high rise roof. Some of these repairs were not properly carried out; in this example the reinforcing scrim is missing in the liquid membrane.</p>
20.

Repairs have been noted in areas, and they have been carried out using a liquid membrane that is compatible with a rubberized asphalt roof system, though in some cases the repairs have not been made correctly.

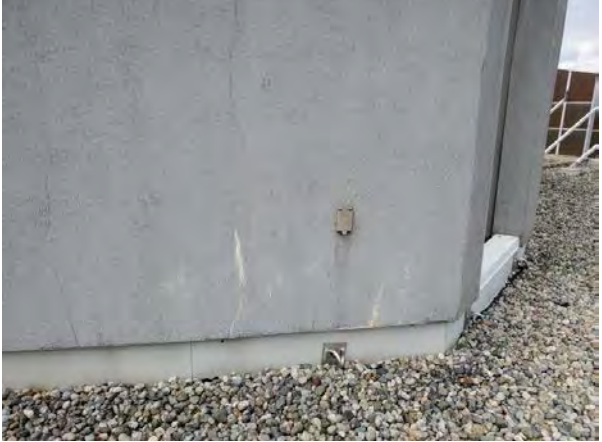
<p><u>High Rise</u></p> <p>Deep cracks in the stucco were noted. These cracks can allow water to leak in and onto the building wrap behind the stucco. Over time, this can deteriorate, allowing water to leak in behind the roof system if there are issues with the membrane at the wall.</p>

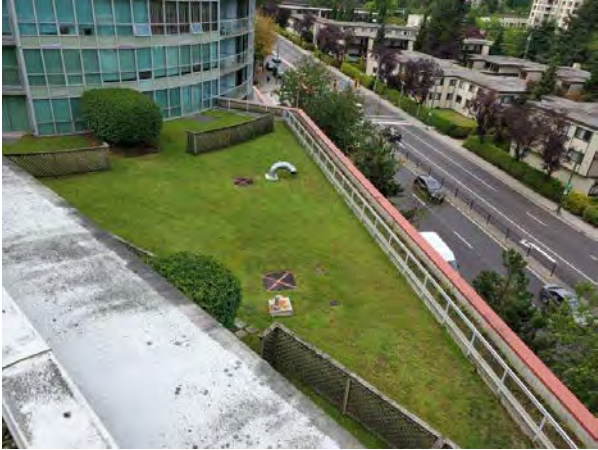
21.

<p><u>Garden roof</u></p> <p>Two leaks were reported on the garden roof. Due to the overburden, it is not possible to review the membrane as it was on the other roofs.</p>
22.

Due to the intense landscaping on the garden roof, a full review is not possible unless greater forces are mustered to carry out an investigation. Typically, heavily vegetated roofs are replaced when they start leaking as exploratory investigations can be quite costly. If leaks persist, or multiple leaks have occurred over a short period of time, the owners should consider replacing the membrane.

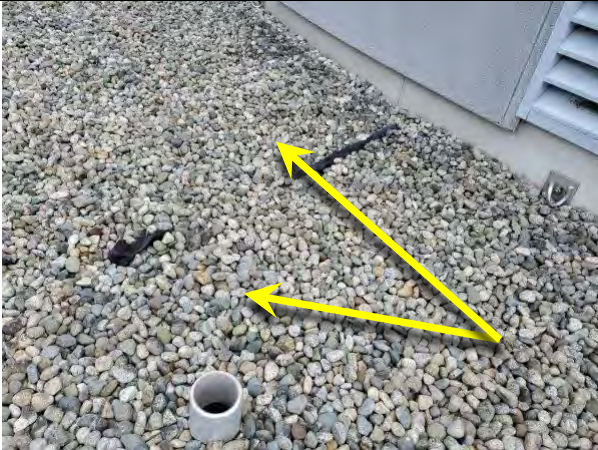
<p><u>The following are typical to all buildings</u></p> <p>The filter fabric must be completely buried to prevent it from fluttering in the wind, which would displace the ballast. If large enough areas become bare of the ballast, there is the possibility of the insulation blowing off the roof.</p>
23.

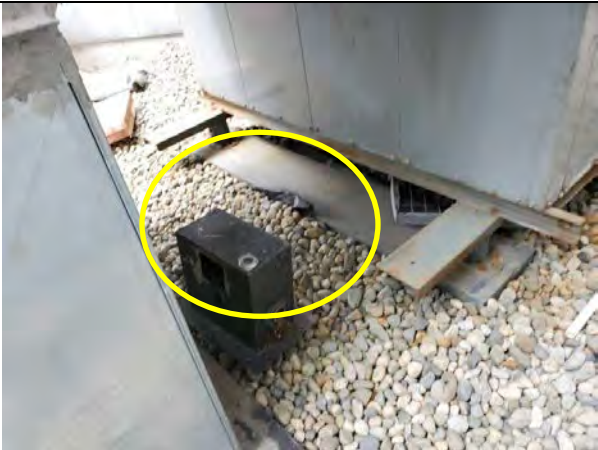
<p>Debris was noted on the roof and should be cleaned up. Old, broken equipment should not be left on the roof.</p>

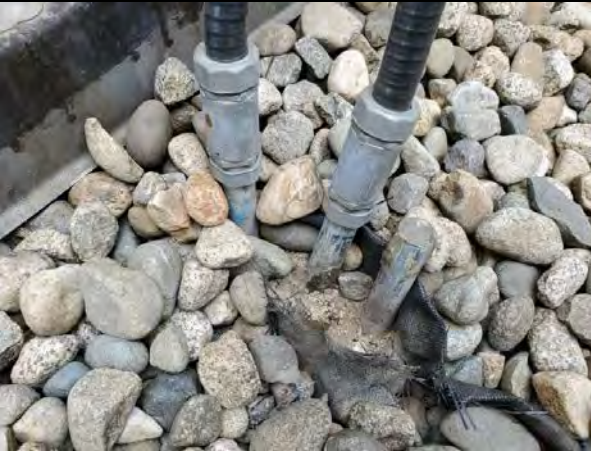
24.

Many of the penetrations in the roof deck do not exit through proper roof flashings. Instead they rely on a great deal of the roof membrane poured all around. Movement and vibrations can break this bond, leading to water leaking in under the roof membrane.

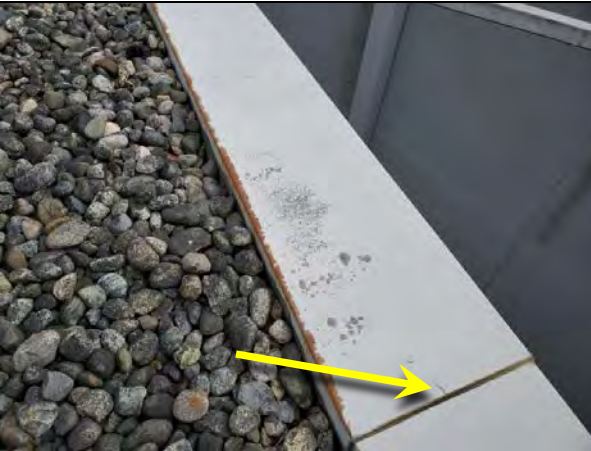
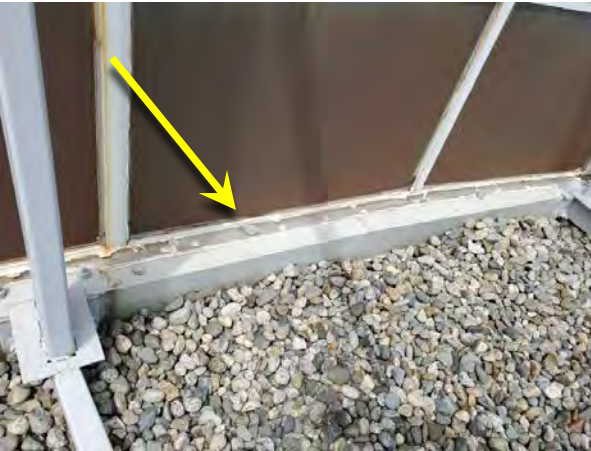
25.

The caulking at the flashing joints on the parapets has failed.

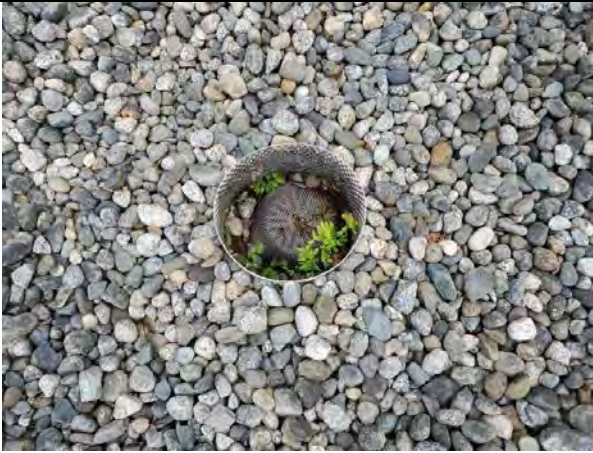
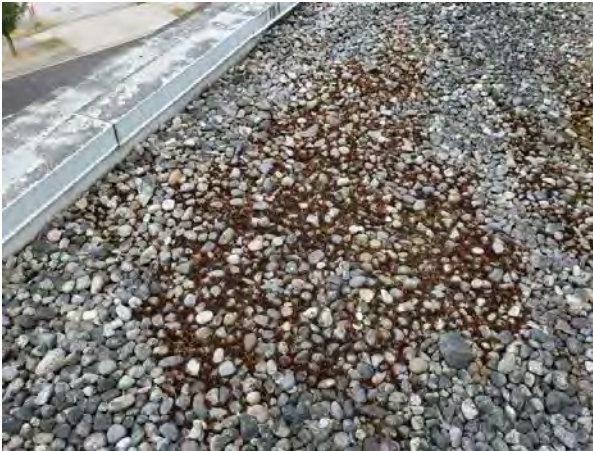
26.

Moss and other plants were noted to be growing on the roof. These plants can impede the flow of water towards the drains, and can cause the drains to plug up.
