DEPRECIATION REPORT

WESTHAMPTON COURT

**8511 WESTMINSTER HWY & 8500 ACKROYD
RICHMOND, BC**

JRS PROJECT: VR17061

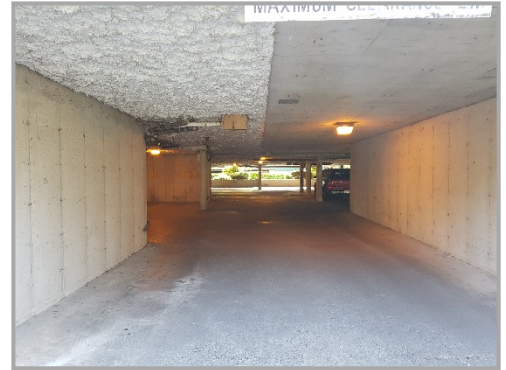
Description: This asset includes the exposed concrete parkade walls, stairs, slabs.

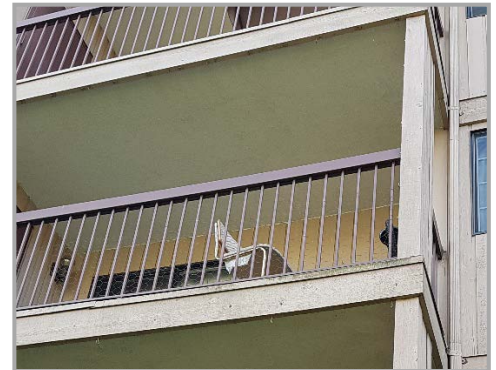
Description: The balcony metal railings are secured to the decks by surface mounting with screws.

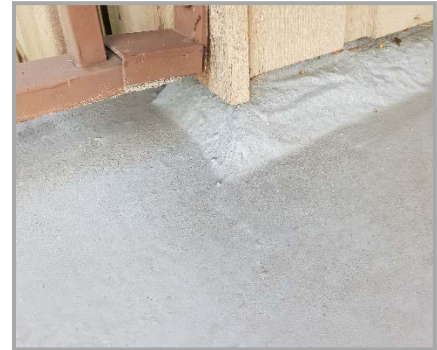
Description: The purpose of balcony membranes is to be the first line of defence against water penetration into the building's structural components and interior space. The balcony membranes are liquid applied on top of a wood framed deck. Water drains from the balcony by flowing off the edge of the deck. 16 balcony membranes and soffits were renewed in 2014.

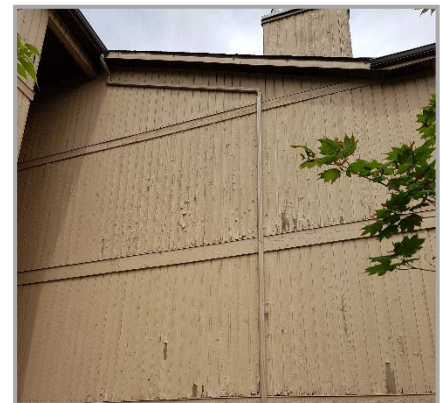
Description: The wood siding is part of the building's face-sealed design.

- ♦ Perform a Building Envelope Condition Assessment (BECA) in order to fine tune the service life predictions and replacement costs. Consider renewing the wood cladding and repointing the brickwork (item #4 & item #5).

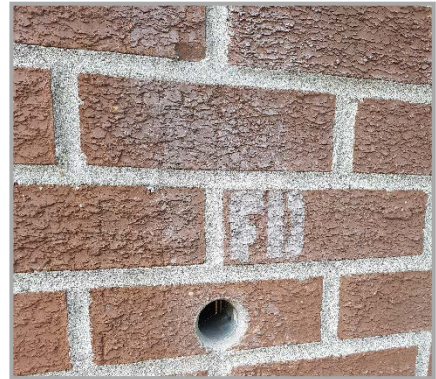
Description: The brick cladding incorporates a rainscreen design and is used in a small percentage of the building's overall cladding.

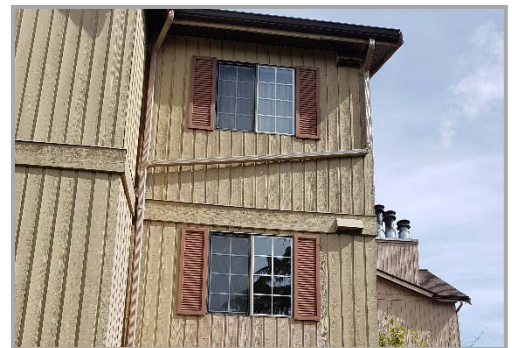
Description: The windows are aluminum framed, dual pane windows with aluminum spacers.

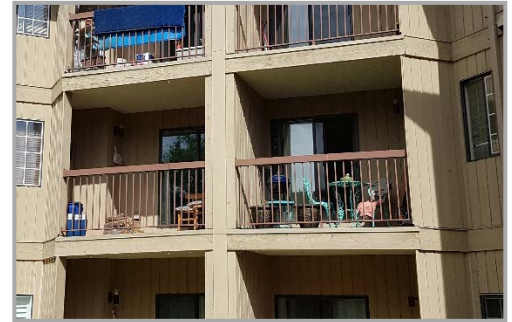
Description: The sliding doors provide access from the units to the balcony space. They consist of aluminum framed, dual paned insulated glass units (IGUs) with an aluminum spacer bar.

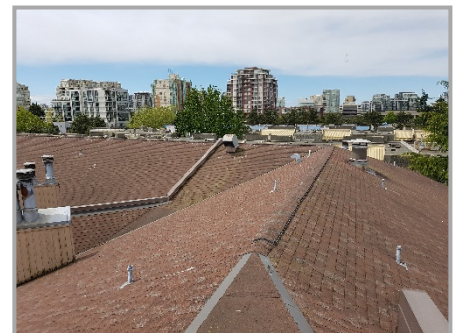
Description: The steep sloped roof is likely comprised of asphaltic shingles, underlayment and plywood sheathing. This type of roof is located on the top level and on the ground floor entrances.

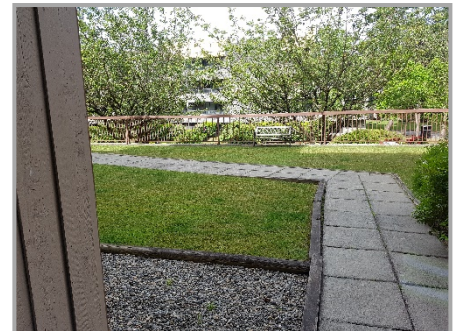
Description: The below grade membrane is from original construction and serves to prevent water ingress from the softscaping into parkade. The waterproofing membrane around the perimeter of the building was renewed in 2014.

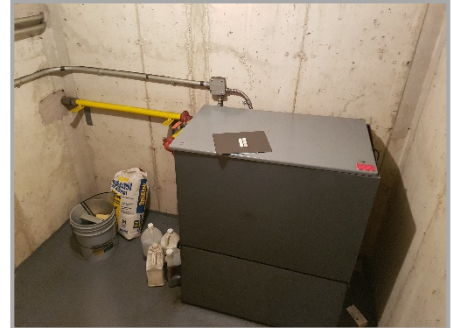
Description: There are three hydraulic elevators which services the building on all floors.

- ♦ Engage an elevator professional to inspect the existing elevator systems and provide a detailed modernization plan (item #20).
- ♦ Engage a mechanical engineer to assess the condition of the cold domestic water pipes and HVAC components and provide a detailed report on its condition (item #22 & item #29).

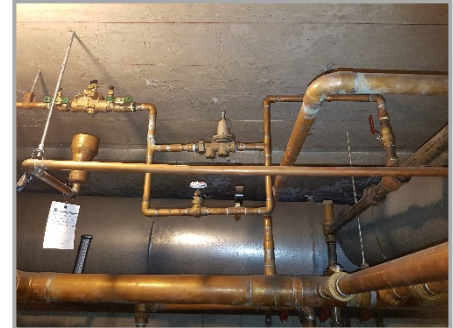
Description: The domestic water pipes are of copper material and provide cold water to units.

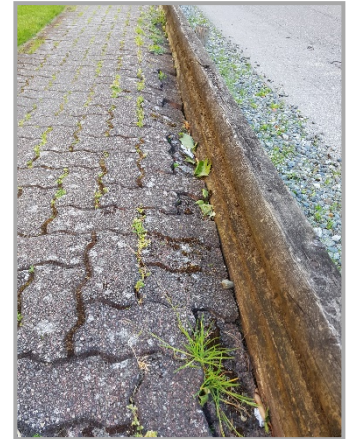
Description: This item includes the wooden and block retaining walls in the building's exterior.

- ♦ Consider repairing the retaining walls and landscaping (item #44).
