READ
JONES
CHRISTOFFERSEN
LTD.

February 13, 2003

**Re: Design Review, P/T Strand Extraction and CPE Testing
Westhampton Court
8511 Westminster Highway, Richmond, B.C.**

RJC No. 38294-03

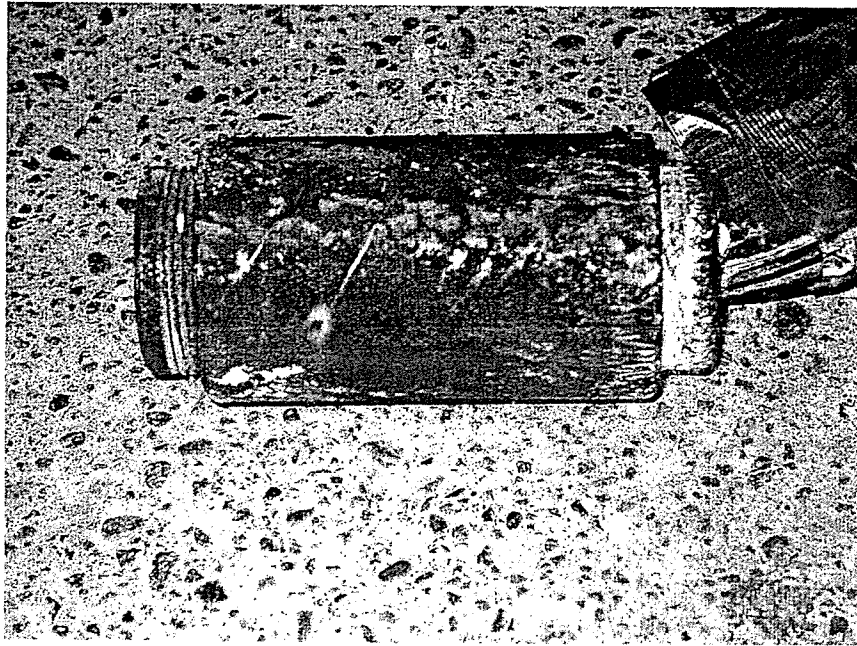
- General information: Strand forms part of banded group that runs along east column line in north and south parts of structure.
- Visual inspection of strand length:
 - Surface rusting noted at construction joint anchor (middle joint in structure). See Photo 1.
 - Strand failed as a result of corrosion at construction joint (see keyplan).

PHOTO NO. 1
CORRODED ANCHOR ALONG STRAND NO. 2

Existing P/T anchors were reused if considered in good condition. New anchors were used to replace rusty ones and at locations where access to the existing anchors was not possible.

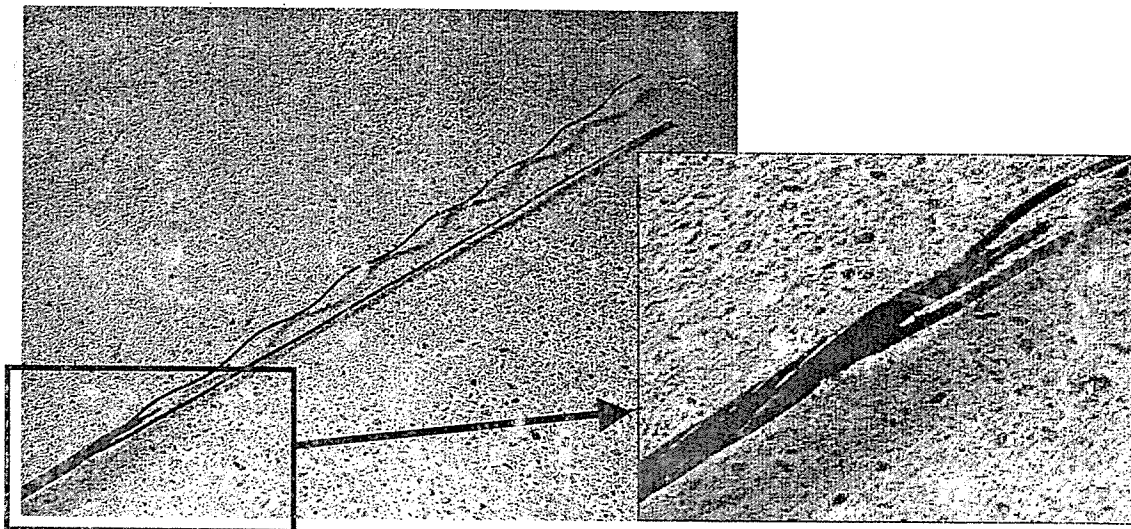
- Visual inspection of strand length:
 - Heavy pitting/corrosion noted at and adjacent to failure point. Failure location at construction joint (see key plan). See Photo 2.

PHOTO 2
CORROSION FAILURE OF P/T STRAND NO. 3

The other two strands had failed as a result of corrosion. Strand 3 exhibited wire failures in two locations. Both strands demonstrated significant corrosion and failure in the vicinity of a construction joint in the slab beneath interior, occupied living space. We suspect this location was left vulnerable during construction, likely permitting water to enter the P/T system at this location.

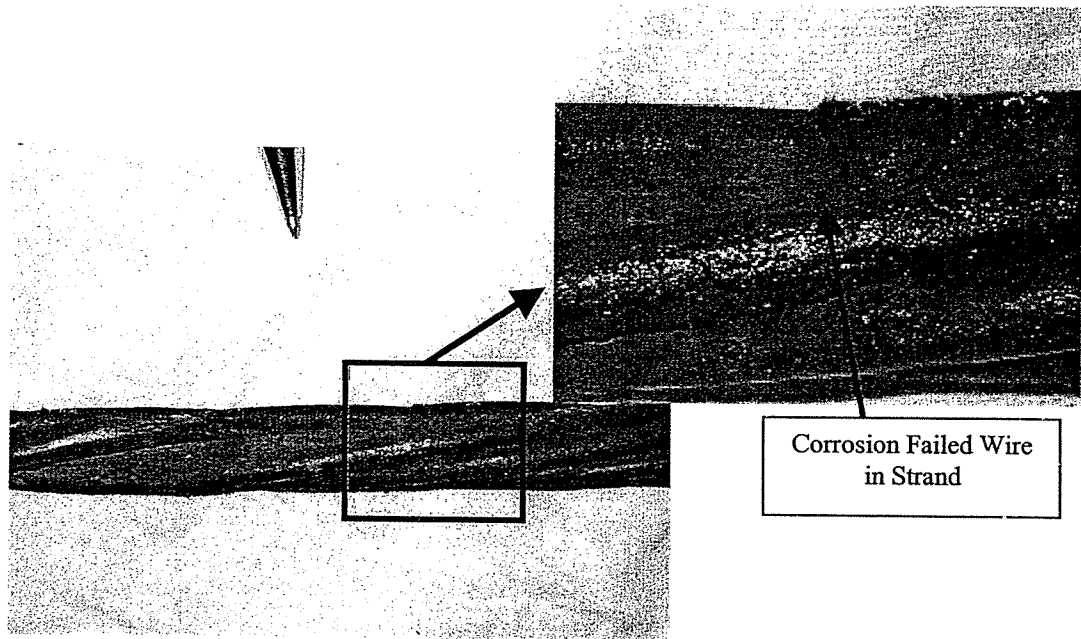
- Additional corroded region noted 16'-0" north of failure point. One wire detensioned as a result of corrosion. See Photo 3.
 - Remainder of strand exhibited little evidence of moisture contact.

PHOTO 3
SINGLE WIRE FAILURE AND CORROSION OF P/T STRAND NO. 3
(Location Approximately 16'-0" North of Failure Shown in Photo 2)

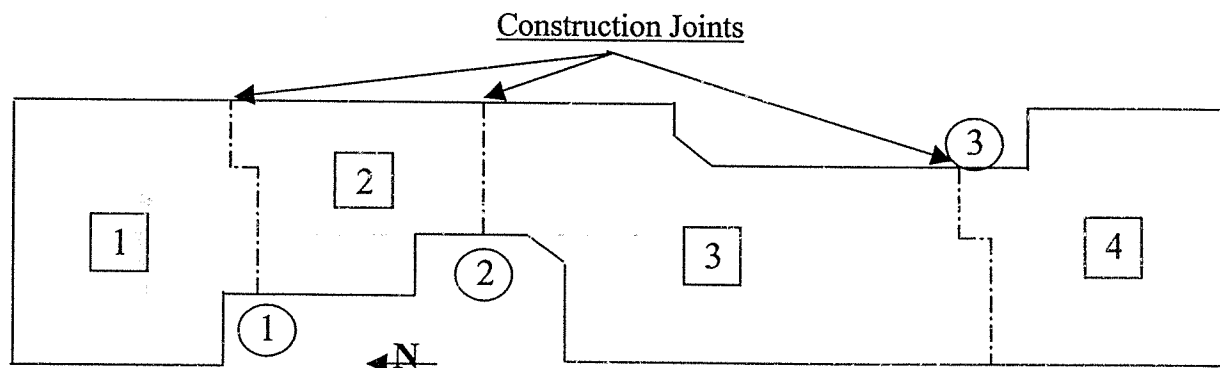
- The slab is segmented in four sections by three construction joints that traverse the slab from east to west. The keyplan reproduced below assigns numbers to each of the sections and joints to lend clarity. (Section numbers have been designated in boxes while circles designate construction joints.)

- Corrosion failure of two strands was noted at or near Construction Joint 2. We suspect water entry at this location likely occurred during construction. This vulnerability may have also been a source of moisture infiltration at the other two construction joints as well.
- The design review revealed little tolerance for strand failure before a reduction of structural capacity is realized. While a number of strands would likely have to fail before an unsafe condition is created, it is prudent to ensure failed strands are replaced in a timely fashion so as to preserve the capacity.
- **Section 1:** Five of 14 strands (or 36%) CPE tested contained sufficient moisture to be categorized WET. No evidence of moisture was detected when inspecting strands at inspection recesses.
