# Depreciation Report

BCS3495 – Grand Central

**RE: Depreciation Report for Strata Plan BCS3495  
File No. B3495DR17**

The subject of this depreciation report consists of “Grand Central” – Strata Corporation Section, a 642-unit apartment and commercial complex constructed in 2009/2012/2014 and located at 2968 – 2978 Glen Drive and 2975 Atlantic Avenue in Coquitlam, BC. We are pleased to present you with the enclosed depreciation report, which we believe will serve as the basis of your reserve planning to help better equip your members for future expenditures.

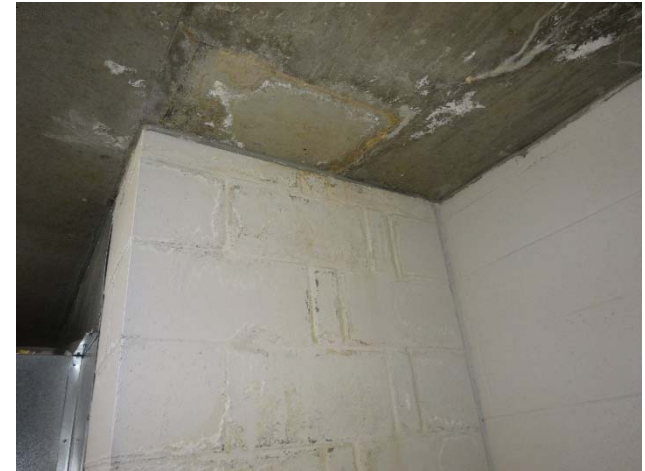
Cracks with efflorescence and water stains

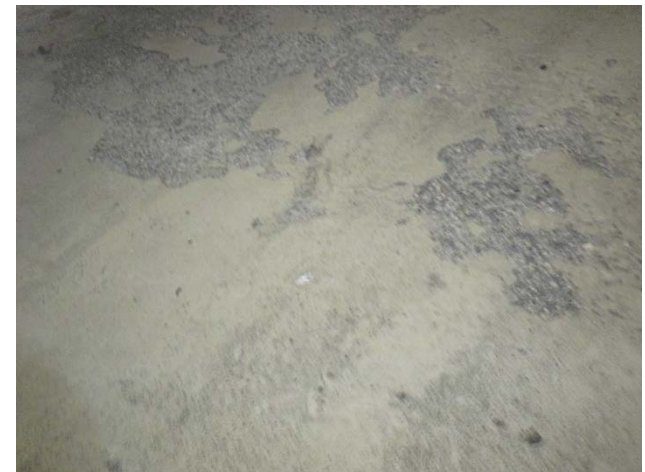
Scaled concrete surface with delaminated coating on parkade floor

<b>Cost Analysis</b>	<b>Current Cost</b>	<b>Starting Year</b>	<b>Funding Method</b>		
<b>Phase 1</b>	\$ 10,000	2018	Contingency every 5 years.		
<b>Phase 2</b>	\$ 10,000	2018	Contingency every 5 years.		
<b>Phase 3</b>	\$ 10,000	2018	Contingency every 5 years.		
<b>Preventative Maintenance</b>	Annual reviews for water ingress. Water ingress can be managed locally by sealing the leaking cracks. Repair and patch areas of delaminated or spalled concrete on floors and ceilings, seal joints and cracks, and apply and maintain a protective coating on floors.				
<b>Remarks</b>	None.

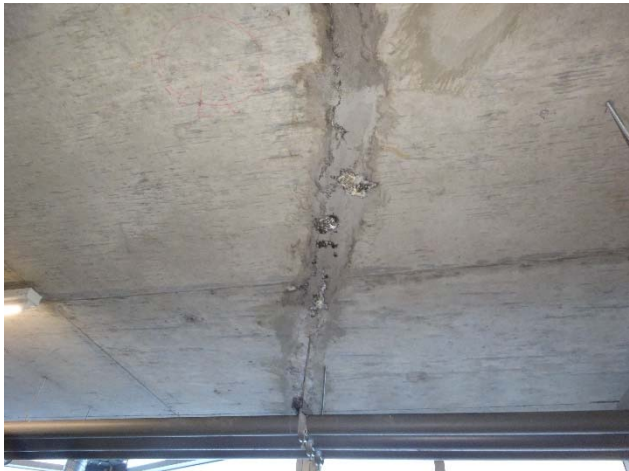
Repaired crack with water infiltration recurrence that denotes failure of the waterproofing membrane in the area

Phase 2	\$ 1,660,350	2047	Full replacement.		
Phase 3	\$ 1,395,975	2049	Full replacement.		
<b>Preventative Maintenance</b>	Sometimes discontinuities within the waterproofing membrane can be economically repaired from the exterior. If not, the water ingress can be managed by sealing the leaking cracks in the concrete from the interior.				
<b>Remarks</b>	None.

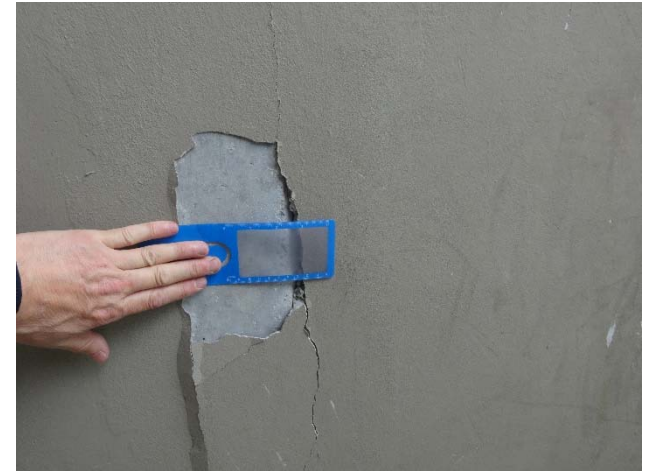
Crack and spalled coating

<b>Phase 2</b>	\$ 7,000	2018	Contingency every 5 years.		
<b>Phase 3</b>	\$ 5,000	2020	Contingency every 5 years.		
<b>Preventative Maintenance</b>	Repair and seal the cracks. Apply protective paint.				
<b>Remarks</b>	None.

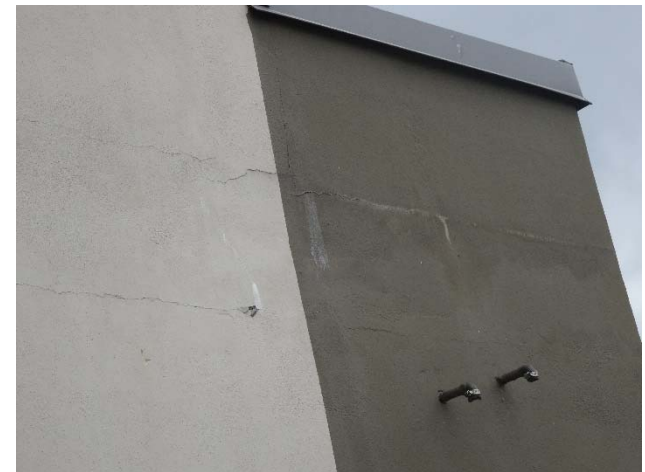
Crack and efflorescence at cold joint

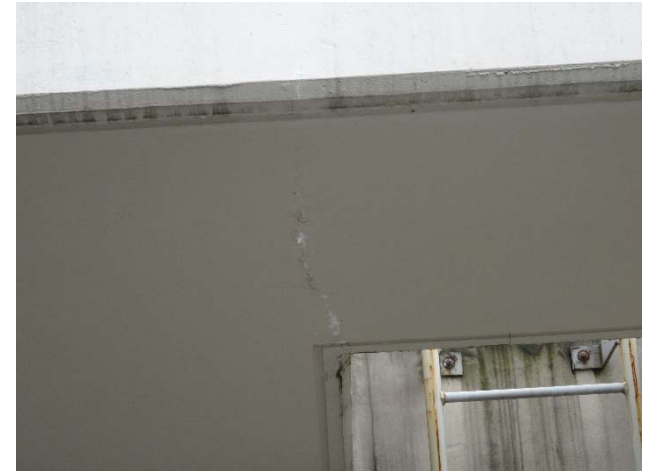
Crack extended through the entire thickness of the concrete canopy. Here view from underside.

<b>Cost Analysis</b>	<b>Current Cost</b>	<b>Starting Year</b>	<b>Funding Method</b>		
<b>Phase 1</b>	\$ 3,000	2019	Contingency every 5 years.		
<b>Phase 2</b>	\$ 3,000	2022	Contingency every 5 years.		
<b>Phase 3</b>	\$ 3,000	2024	Contingency every 5 years.		
<b>Preventative Maintenance</b>	Repair and patch areas of delaminated or spalled concrete, seal joints and cracks, and apply and maintain a protective coating.				
<b>Remarks</b>	None.

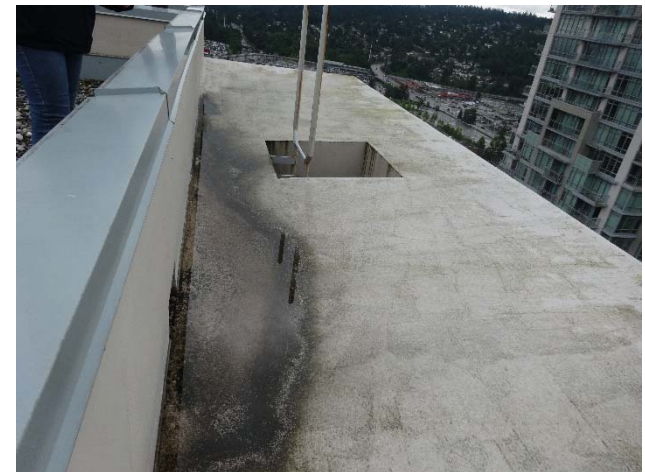
Water ponding due to missing storm drains at the lowest point.

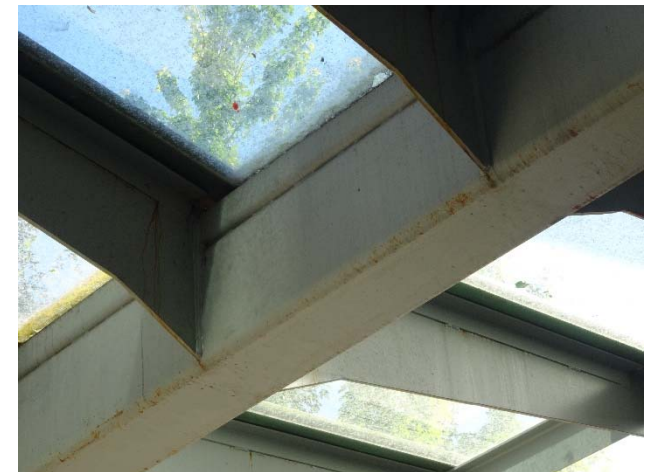
Corrosion spots on metal frame

<b>Phase 2</b>	\$ 3,000	2018	Contingency every 7 years.		
<b>Phase 3</b>	\$ 3,000	2018	Contingency every 7 years.		
<b>Preventative Maintenance</b>	Inspect every 2 years. Repair as needed. Repaint every 6-8 years.				
<b>Remarks</b>	None.

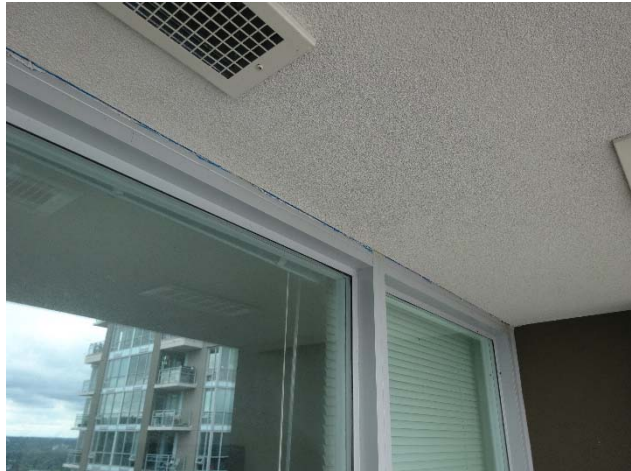
<b>Preventative Maintenance</b>	Inspect, clean and properly replace deteriorated sealant based on manufacturer's instructions.				
<b>Remarks</b>	Caulking was missing in unit #3208, phase 2.

Missing caulking at unit #3208

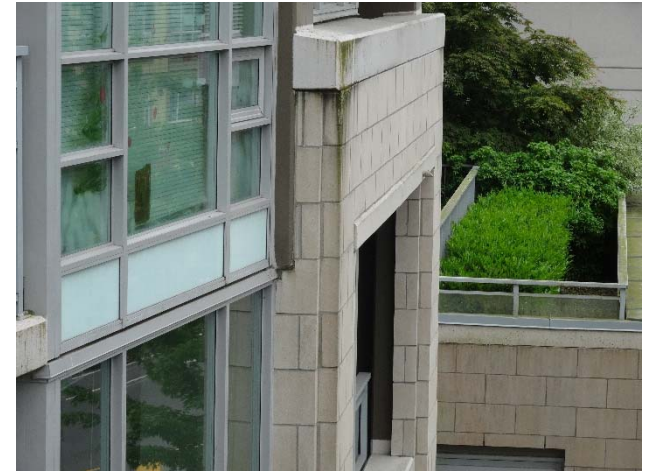
Algae growth

<b>Preventative Maintenance</b>	Once or twice a year inspect the stone veneer, and look for damaged stones, crack and loose mortar. Repoint if necessary. Clean with non-pressurized water every 3 years.				
<b>Remarks</b>	None.

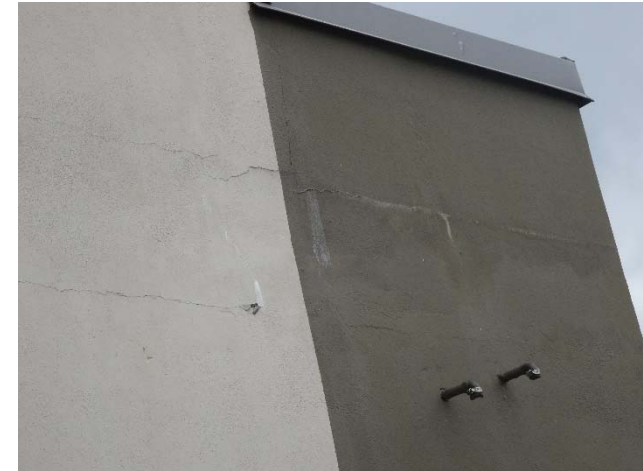
Cracks along cold joints

<b>Phase 2</b>	\$ 5,000	2022	Contingency every 7 years.		
<b>Phase 3</b>	\$ 6,000	2024	Contingency every 7 years.		
<b>Preventative Maintenance</b>	Power wash every 4-6 years. If a sealer or concrete coating has been used for aesthetics or to minimize moisture penetration, the sealer or coating will require reapplication (every 7 to 20 years).				
<b>Remarks</b>	None.

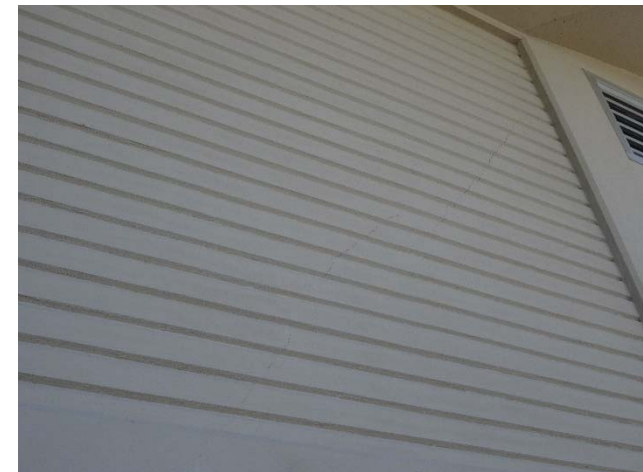
Diagonal crack

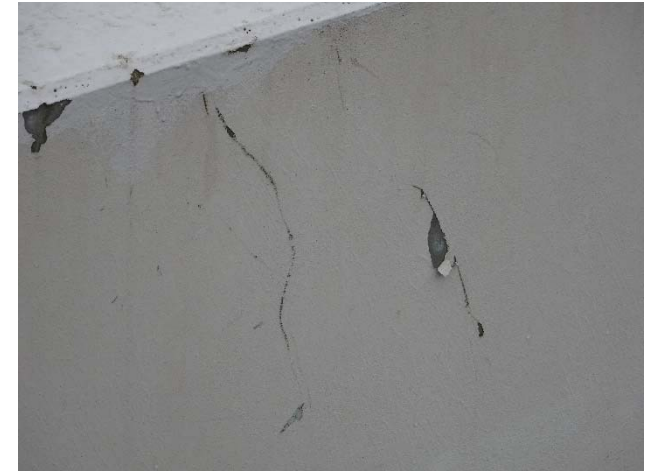
Scratched and peeling paint

<b>Preventative Maintenance</b>	Clean annually with mild detergent solution and natural bristle brush. Remove the deteriorated paint and re-paint locally.				
<b>Remarks</b>	None.

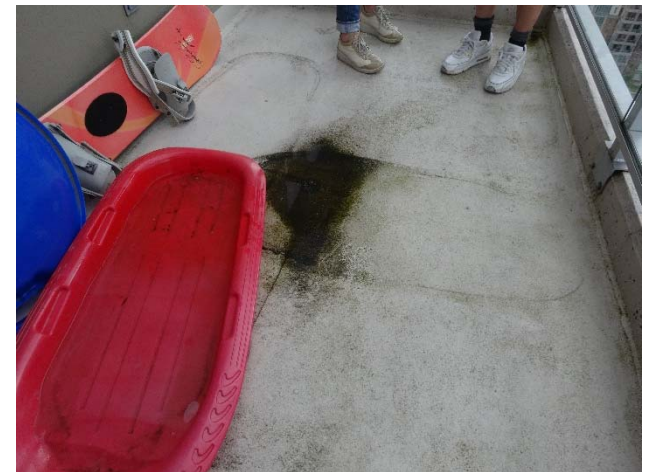
Weathering was observed where water is ponding

<b>Phase 3</b>	\$ 753,000	2038	Full replacement.		
<b>Preventative Maintenance</b>	Inspect every two years, patch locally.				
<b>Remarks</b>	None.
