10-YEAR STRUCTURAL WARRANTY REVIEW

Located at:
Grand Central One – 2978 Glen Drive, Coquitlam, BC

July 15th, 2019

File number: FSR-005-19-D
July 15th, 2019

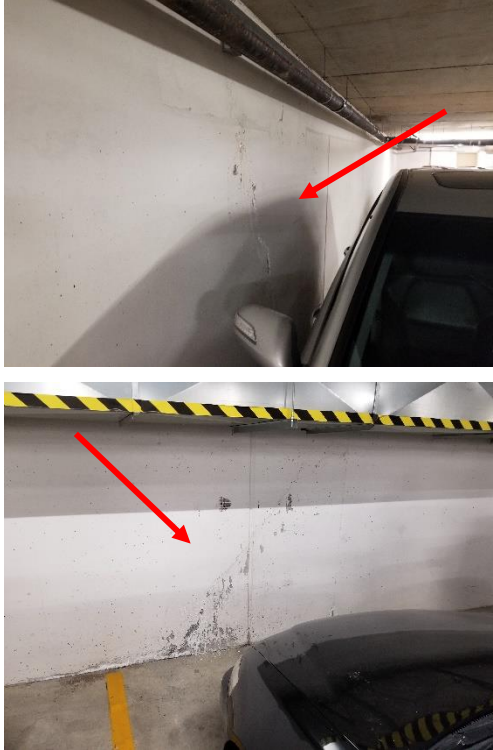
<p>These photos show possible shear cracks on the perimeter wall. These cracks may be the result of shear-stress concentration on the wall. However, since this is a singular hairline crack and no shear damage pattern was observed in any other area, we are the opinion that these particular cracks do not represent any structural concern at the time of this review.</p> <p>Nevertheless, we do recommend monitoring in order to detect any new cracks or a specific pattern that represent a hint of a structural deficiency as well as any water ingress into the parkade. In the case of water ingress, we recommend a polyurethane crack injection.</p> <p>Location: Parking 1 stall #70, 39, 36, 35, 9, 3 Type: NSD Importance: Low Action required: Monitor & Upkeep as needed</p>

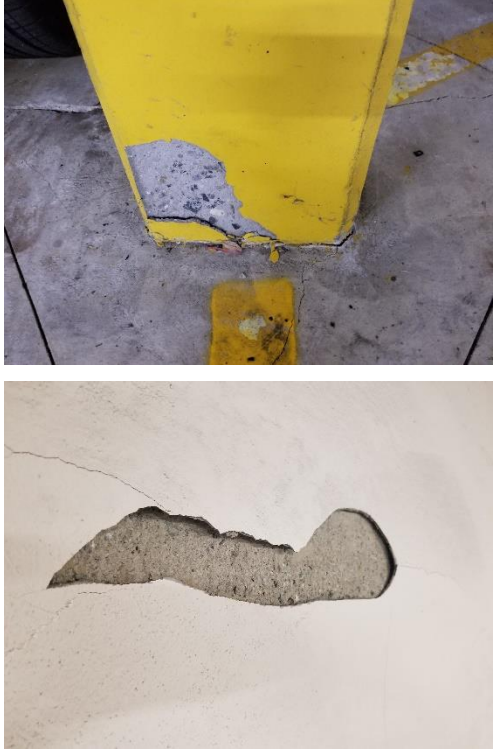
<p>4.4.1.7</p>

<p>These photos are intending to show failures by delamination in concrete elements. It appears that some concrete patches located on the column base and one of the walls of the parkade ramp towards P1 are popped-up.</p> <p>We recommend conducting further review and monitoring and/or upkeep as needed.</p> <p>Location: Column in P1 and southeast parkade ramp towards P1</p> <p>Type: SDE Importance: Medium Action required: Further Investigation and Upkeep as needed</p>
<p>4.4.1.8</p>

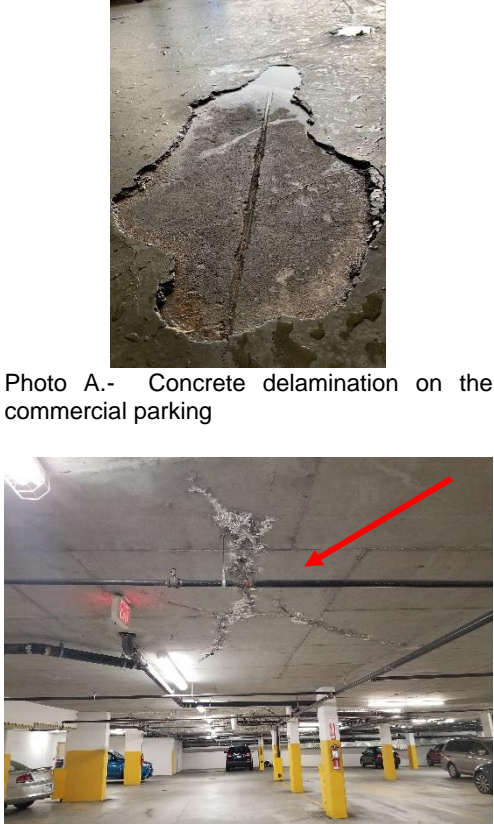
<p>Photo A.- Concrete delamination on the commercial parking</p> <p>Photo B.- Notorious water ingress from the commercial parking level towards P1 level</p>	<p>The following photos show a major deficiency in the commercial parking and its related ramp towards level 2 and the garbage loading bay.</p> <p>Photo A is showing a sample of some areas located on the commercial parking and the garbage loading bay. Concrete and membrane delaminations were documented prior to being repaired during 2019.</p> <p>As a part of the repair project undertaken in 2019 to repair this widespread deficiency at the commercial parking and numerous other locations of the parkade, some cracks/cold joints were discovered when the concrete delaminations started to show. This structural deficiency in the concrete slab entails other deficiencies related to water ingress. In the opinion of the writer, these water ingress into the parkade would not exist if the concrete delamination has never happened and hence the waterproof membrane have not been disintegrated/delaminated (Photos B and C).</p>

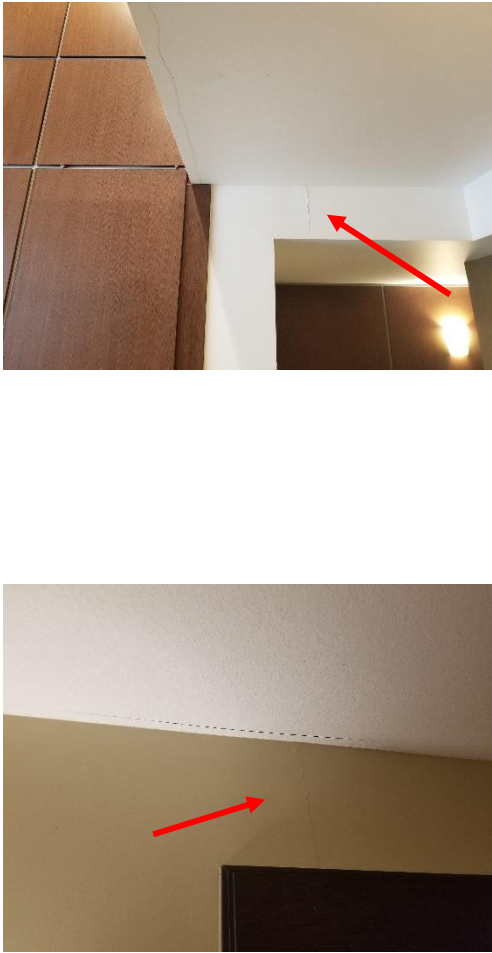
<p>Vertical hairline cracks were observed at numerous locations in drywall and they occur naturally along the seams between two boards. These isolated cracks usually do not represent a structural problem unless additional evidence of damage is observed.</p> <p>Location: Lobby of Grand Central Tower One. Level 22 (unit 2203, 2201), level 21 (units 2103, 2104), level 20 (units 2003, 2004), level 19 (unit 1901, 1903, 1904), level 18 (unit 1801, 1803, 1804), level 17 (unit 1703, 1704), level 11 (unit 1104), level 110 (unit 1001, 1007, 1004), level 9 (unit 901, 904), level 8 (unit 804), level 7 (unit 704, 701), level 6 (unit 604, 602, 601), level 3 (unit 301).</p> <p>Type: NSD Importance: Low Action required: Upkeep as needed</p>

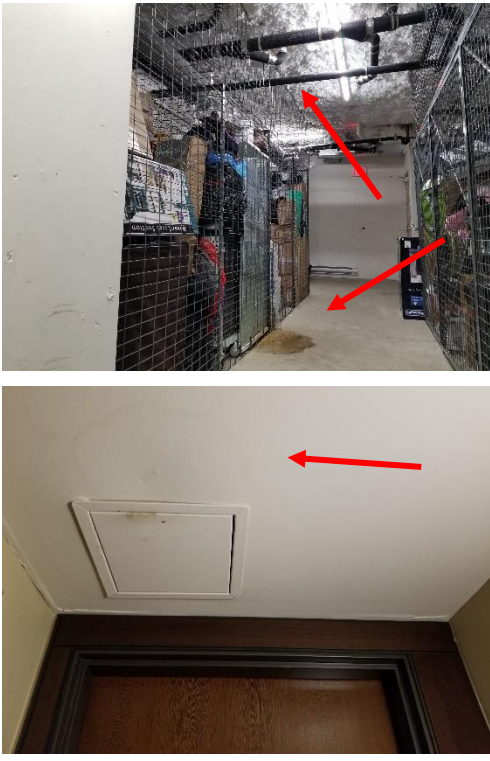
<p>Water ingress observed on the ceiling.</p> <ul style="list-style-type: none"> - It appears that the water ingress in the storage room is coming from the drainage system, however, further investigation is recommended in order to certainly know the source of the water ingress. - Unknown source of water ingress in the ceiling of the corridors. Further investigation is recommended. <p>Location:</p> <ul style="list-style-type: none"> - Corridor ceiling in front of the units 2307, 1501, 1506 - Media Center ceiling - Storage parking 1 at #91 and #53 <p>Type: ML Importance: Medium Action required: Further Investigation and Maintenance</p>
<p>4.4.2.6</p>

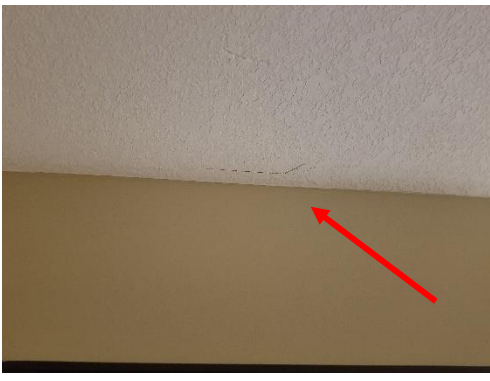
<p>Detached drywall tape was observed.</p> <p>Location: Level 31, Level 30 (all units), level 29 (unit 204, 2902, 2901, 2907), level 28 (unit 2804, 2801, 2802), level 27 (unit 2704, 2702, 2706), level 26 (unit 2604, 2605, 2603, 2601), level 22 (all units), level 19 (unit 1905), level 18 (unit 1805), level 8 (unit 805).</p> <p>Type: ML Importance: Low Action required: Upkeep as needed</p>

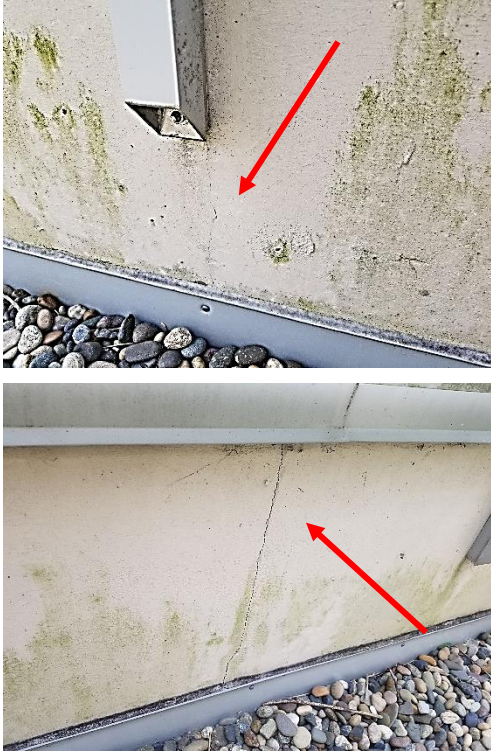
<p>These attached photos are showing examples of typical hairline cracks existing along the South perimeter wall of the building on level 5 (podium). This wall is facing Atlantic Ave.</p> <p>This kind of cracks are caused by shrinkage/thermal process of the concrete elements. These cracks are usually straight and even in width and commonly they do not represent a structural problem.</p> <p>However, since these cracks are exposed to direct rain may represent a building envelope concern because they may be a source of water ingress into the building or may contribute to deteriorating the paint coat of the walls facing outside the building.</p> <p>There is one particular crack that needs attention because it was observed to be approximately around 3 mm in width and has the potential to cause water ingress. Nevertheless, it is always recommended</p>

<p>to seal all these cracks with compatible sealant or even better by applying new paint coating after the sealant in order to stop, reduce or prevent water ingress.</p> <p>Location: 5th level in the south and southeast corner. Type: BE Importance: High Action required: Monitor & Upkeep as needed</p>
<p>4.4.3.4</p>

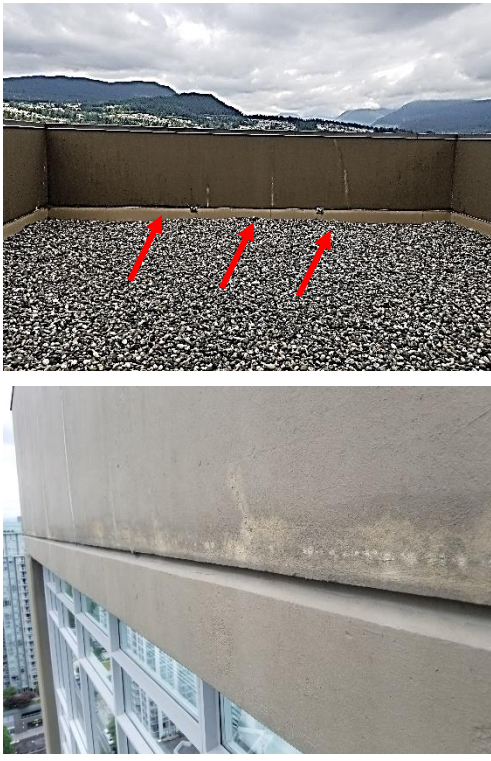
<p>These photos show the same deficiency mentioned in the previous point but in a different location. These photos were taken in the east of the perimeter wall of the rooftop.</p> <p>In the second photo, it can be observed how the paint was popped up from the concrete due to water ingress from the inside of the wall.</p> <p>The recommendation is the same as it was described for the point 4.4.3.3</p> <p>Location: Rooftop level in the east and west location. Type: BE Importance: High Action required: Upkeep as needed</p>
<p>4.4.3.5</p>

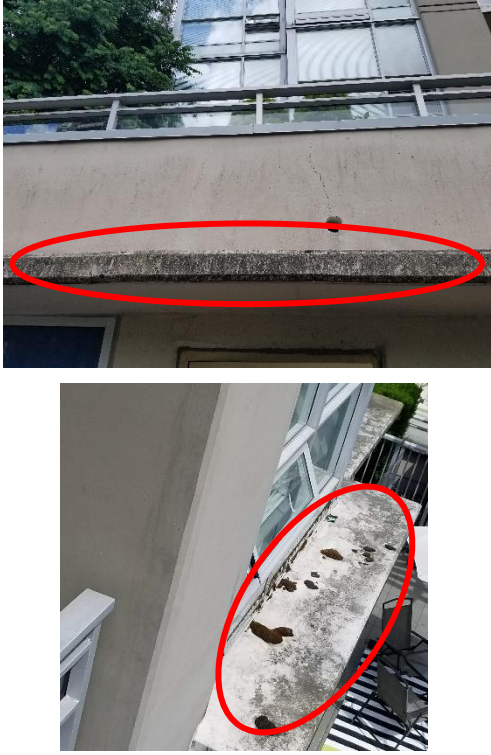
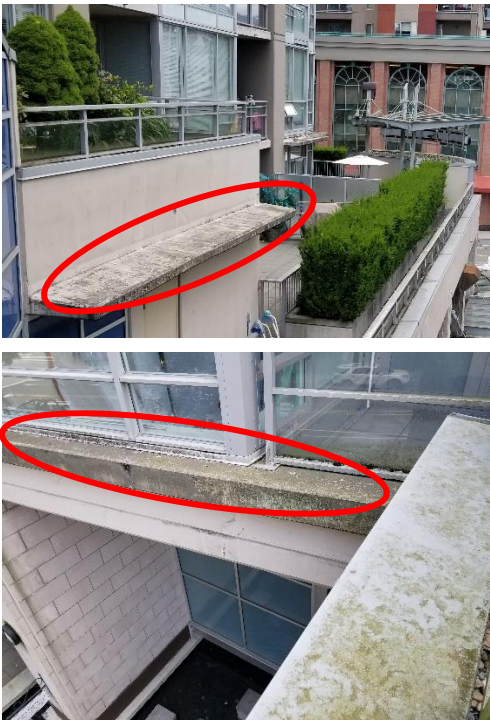
<p>The following photos show examples of typical deterioration in the waterproofing membrane at many locations of the building. This deficiency extends from areas where the membrane is deficient to areas where the membrane is disintegrated.</p> <p>We recommend addressing this envelope deficiency on ledges, overhangs and other building elements built with minimal slopes since the lack of waterproofing membrane helps water penetrate through the existing cracks on the surface of these elements.</p> <p>The water that penetrates the exposed concrete elements may ingress inside the units and it may contribute to increasing the humidity in the air inside the unit. High levels of humidity and a differential of the temperature from the outside to the inside may create or contribute to having condensation on the windows and concrete walls in the inside of the unit.</p> <p>The last photo of this deficiency was taken from the outside of unit 301. This unit is reported to experience water ingress from the</p>

<p>bottom of the window where the waterproofed membrane was disintegrated or washed. We also observed some cracks in the concrete ledge.</p> <p>Location: Exterior concrete elements around the complex.</p> <p>Type: BE Importance: High Action required: Maintenance</p>
<p>4.4.3.8</p>

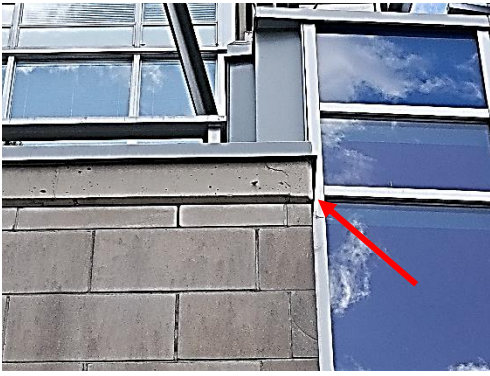
<p>This attached photo shows what appears to be a crack that needs attention to avoid water ingress into the cavity of the wall assembly.</p> <p>Location: On top of the stone cladding of unit 104 at 1168 The High St.</p> <p>Type: NSD Importance: Medium Action required: Maintenance</p>
<p>4.4.3.9</p>

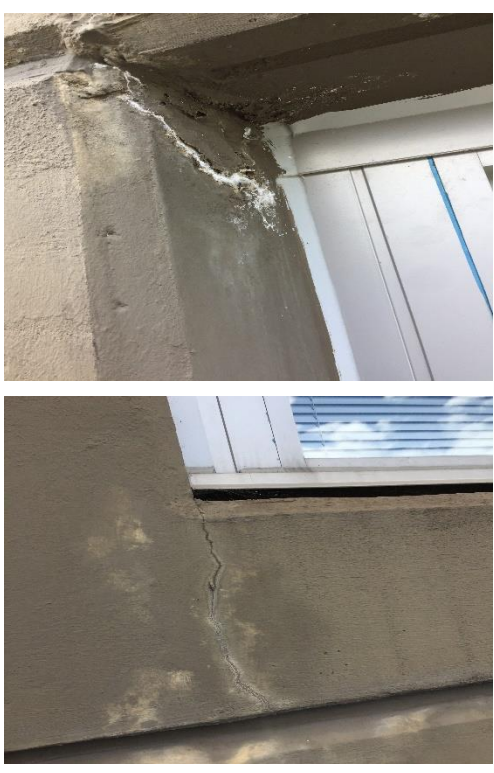
<p>These photos show examples of cracks commonly observed on the corners of windows. Even though some of these cracks appear after time, they always should be properly repaired to avoid water ingress into the units. We recommend attending these deficiencies with your maintenance plan or when the general repaint of the building is conducted.</p> <p>Location: Multiple locations around the four elevations. Type: BE Importance: Medium Action required: Maintenance</p>
------------------------	---	--

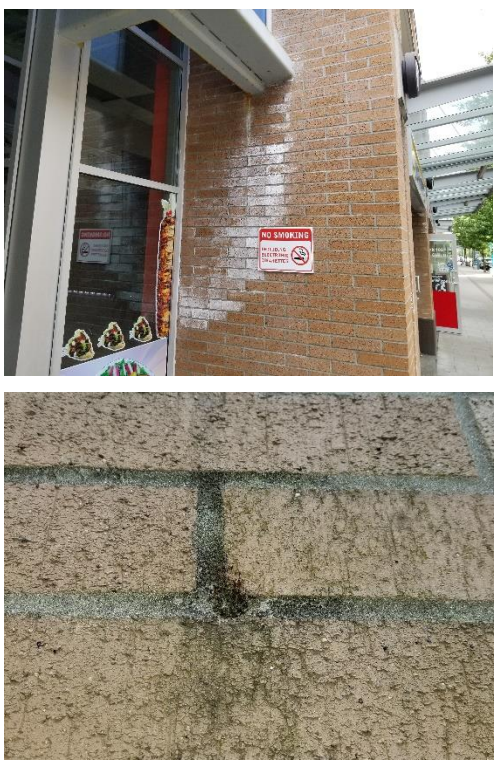
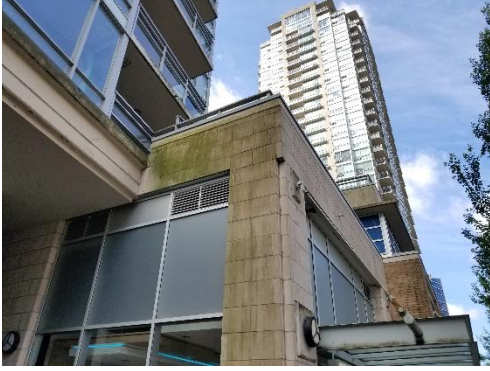
<p>The following photos are showing a repetitive deficiency on the brick and stone veneers. It appears that the cladding was not sealed with a penetrating waterproofing sealant (silane siloxane sealer) to protect against mould, algae, efflorescence and humidity as minimum protection.</p> <p>These signs may indicate water penetration from outside to the inside the veneer and/or water trying to escape from the inside cavity of the wall assembly. In any of the previously described situations, this deficiency needs to be attended in order to prevent further damages to the cladding or the units.</p>

<p>Location: Exterior cladding of the commercial units Type: BE Importance: High Action required: Maintenance</p>
<p>4.4.4.2</p>

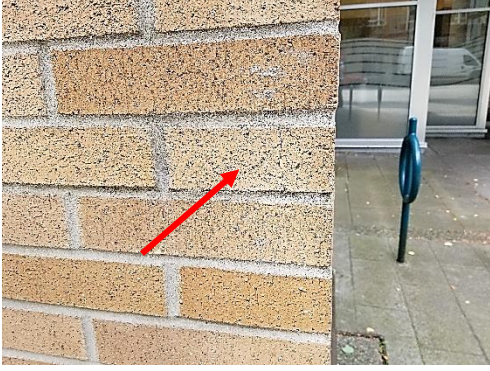
<p>Cracks in brick veneer and missed caulking may contribute to water ingress into the wall cavity. Even though in our opinion, these isolate deficiencies do not represent a structural concern for the cladding structure, they should be attended to and addressed in a maintenance program to prevent water ingress into the building.</p> <p>Location: Exterior cladding of the commercial units Type: BE Importance: High Action required: Maintenance</p>

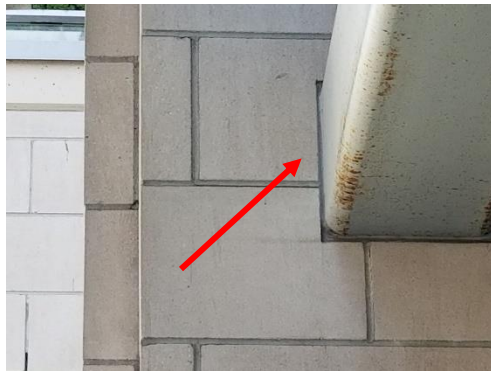
Cracks in stone veneer and missed caulking between the veneer and other elements may contribute to water ingress into the wall cavity. Even though in our opinion these isolate deficiencies do not represent a structural concern for the cladding structure, they should be attended and considered in a maintenance program to prevent water ingress into the building.

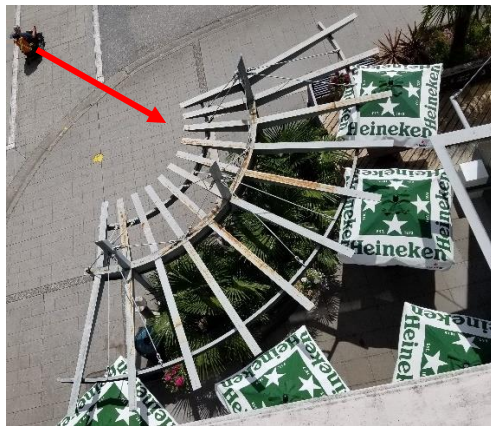
These attached photos show the deterioration of the attached pergolas. The pergolas are observed with serious deteriorations of their anti-corrosion coating. The coating is delaminated in several portions of the elements and the water has started to corrode many of them. This deficiency may ultimately lead to a reduction in the load-carrying capacity of the elements.

We recommend conducting an evaluation of the condition of the structure and prepare a maintenance

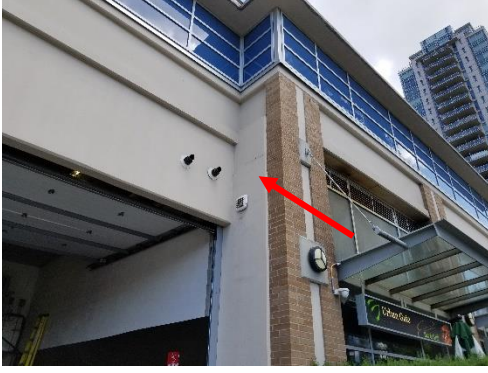
<p>This photo is showing the location of a cold joint where water has drained-out the paint and the concrete patch. Signs of water ingress are observed.</p> <p>Location: Garbage room on Atlantic Ave. Type: BE Importance: Low Action required: Maintenance</p>
<p>4.4.4.8</p>

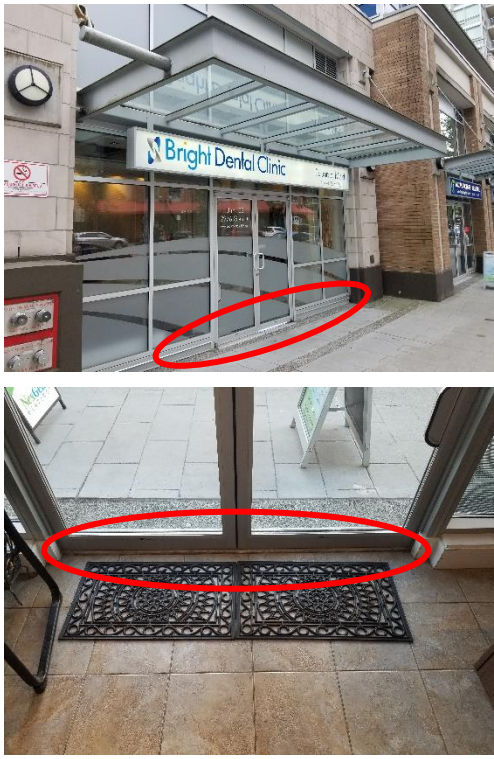
<p>All commercial units reported periodic and re-occurring water ingress at the ground floor, from exterior sources. This deficiency should be further investigated and attended since water ingress into the units and especially at entrance doors may become a risk for their occupants and belongings.</p> <p>We presume that attending the precede deficiency (gutters maintenance program) may aid to minimize this situation, but in the case this does not happen, further investigation should be conducted.</p> <p>Location: Commercial units Type: BE Importance: High Action required: Further Investigation, Monitor and Upkeep as needed</p>
<p>4.4.5.5</p>

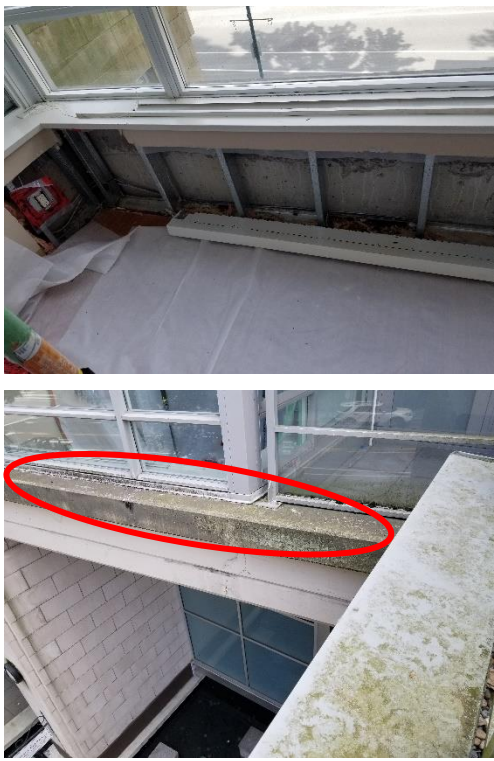
<p>Water ingress is reported in the unit. Further investigation is recommended to identify the source of the water ingress.</p> <p>The second photo shows the current state of the concrete ledge of the outside of the window. The horizontal surfaces or those ones with minimal slope must be always waterproofed to prevent water ingress into the building. This deficiency is widely explained in section 4.3 of this document.</p> <p>The third photo shows the location of widely open crack on the bottom of the window.</p> <p>Location: Unit 301 Type: BE Importance: High Action required: Further Investigation, Monitor and Upkeep as needed</p>

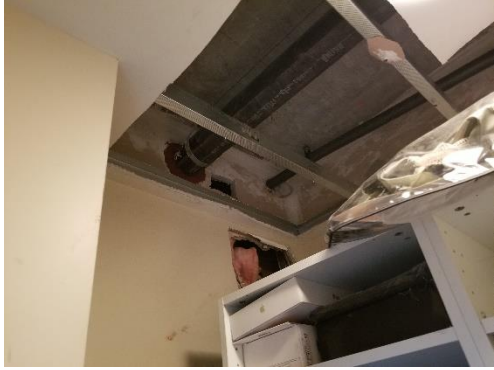
<p>Water ingress was reported into the unit. Based on the occupants' comments, water is constantly dripping/leaking from the cast-iron pipe. The occupants reported that this problem has happened several times in different locations of the unit. Further investigation is recommended in order to detect the source of the problem and if the system meets the British Columbia Building Code.</p> <p>Location: Unit 3203 Type: ML Importance: High Action required: Further Investigation, Monitor and Upkeep as needed</p>
<p>4.4.5.7</p>

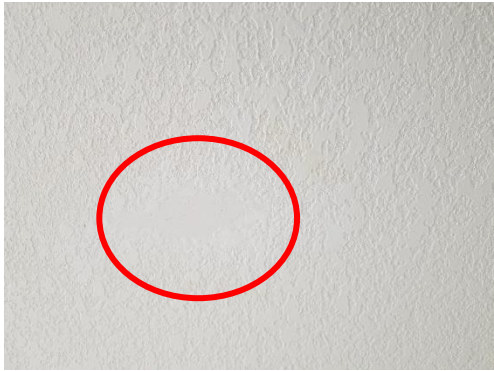
<p>Water ingress through the ceiling of the master bedroom was reported. It appears that water is dripping over the middle of the bed when the dryer machine is on. A leak investigation is recommended to detect the source of the problem which is suspected to be from the dryer vent.</p> <p>Location: Unit 2802 Type: ML Importance: High Action required: Further Investigation, Monitor and Upkeep as needed</p>

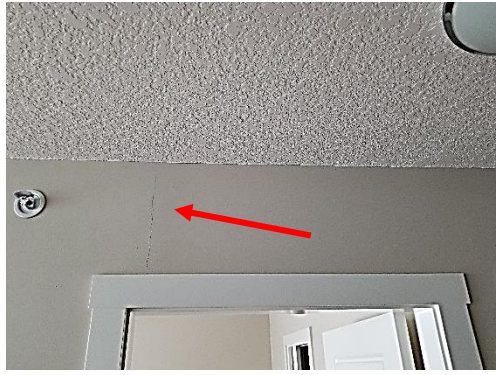
<p>Vertical hairline cracks in drywall were observed. These isolated cracks usually may not represent a structural problem unless in addition to other deficiencies show evidence of further damage.</p> <p>Location: Interior of the units Type: NSD Importance: Low Action required: Upkeep as needed</p>
<p>4.4.5.12</p>

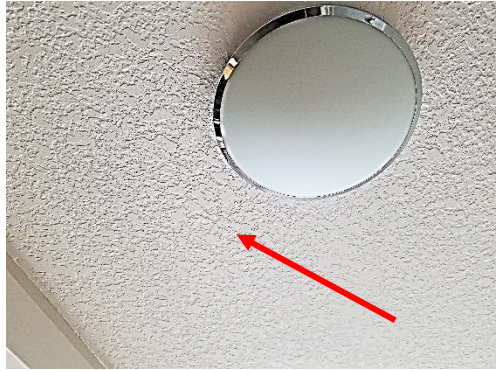
<p>The attached photo shows an example of the crack reported by the occupant. However, these hairline cracks are very common in concrete elements and usually are the result of shrinkage. Commonly, these hairline cracks do not represent a structural problem and no attention is required unless other deficiencies like water leaking are observed.</p> <p>Location: Interior of the units Type: NSD Importance: Low Action required: Upkeep as needed</p>
<p>4.4.5.13</p>

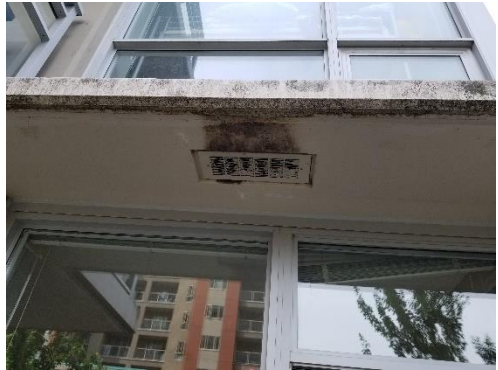
<p>Organic material like mould, mildew and moss is observed in several dryer vents, balcony edges, scuppers, etc. Even though these problems are not structural damage or concern, they should be attended and removed from the building envelope.</p> <p>This organic material commonly grows in almost any kind of surfaces when they experience long wet periods and shady conditions that do not allow the surfaces to dry out easily.</p> <p>We suggest including this deficiency as a part of the maintenance program.</p> <p>Location: All around the building envelope especially the north elevation Type: BE Importance: Medium to High Action required: Maintenance</p>

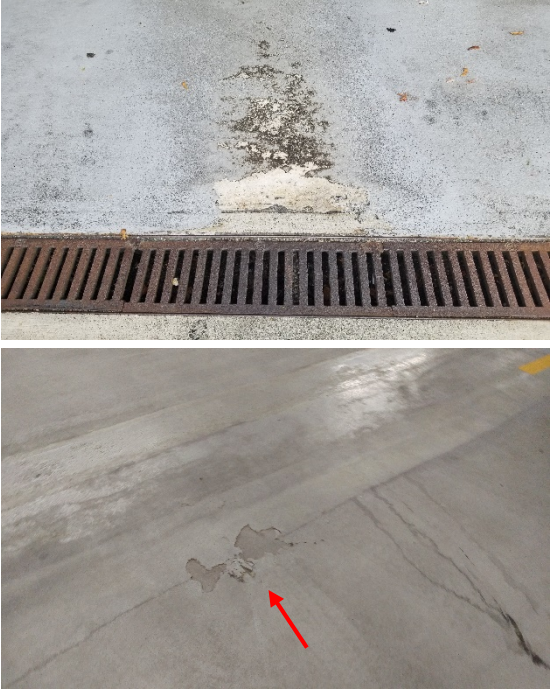
<p><u>OBSERVATION</u> Damaged and de-bonding waterproof traffic deck coating was observed at the entrance of the parkade.</p> <p><u>LOCATIONS</u> CG3 parkade main entrance and #2-49.</p> <p><u>RECOMMENDATION</u> Localized traffic deck coating repair work (patching) is recommended.</p> <p><u>CATEGORY</u> Maintenance.</p>
3.1.2

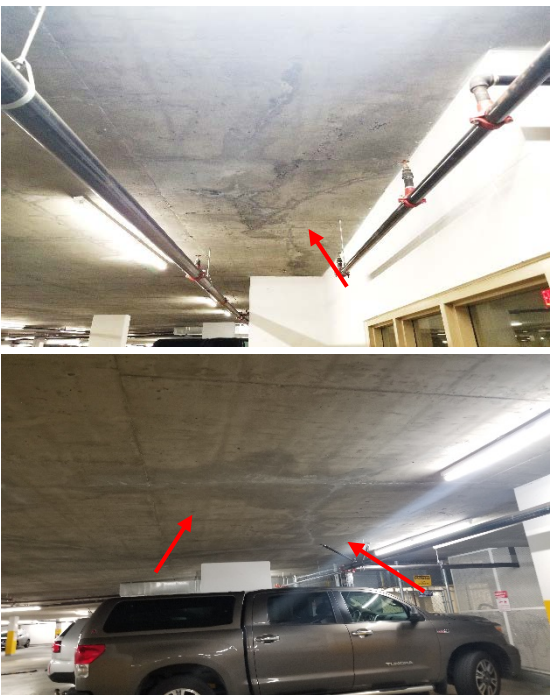
<p><u>OBSERVATION</u> Multiple cracks with efflorescence staining was observed on the ceiling of the suspended slab of the ground level of the parkade.</p> <p><u>LOCATIONS</u> Parkade Level 1; All around the parkade</p> <p><u>RECOMMENDATION</u> Remove efflorescence and monitor to show frequency and extent. Further investigation is recommended if the water ingress is still active.</p> <p><u>CATEGORY</u> Monitor.</p>

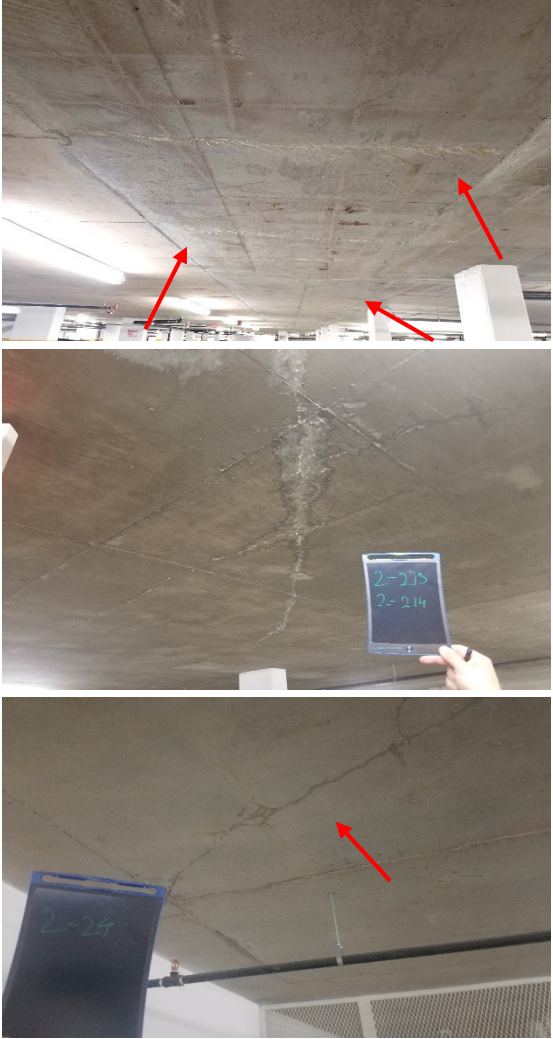
3.1.3

<p>OBSERVATION Typical to similar locations. Concrete cracking, water stains, and efflorescence were observed on the ceiling of the suspended slab of parkade level 2.</p> <p>LOCATIONS Parkade Level 2; Stall #: 2-09, 2-20, 2-24, 2-25, 2-26, 2-51, 2-52, 2-53, 2-54, 2-55, 2-93, 2-94, 2-95, 2-97, 2-98, 2-99, 2-100, 2-101, 2-102, 2-104, 2-106, 2-107, 2-110, 2-125, 2-213, 2-214, 2-119, 2-124, 2-125, 2-129, 2-128, 2-130, 2-131, 2-135, 2-137, 2-153, 2-156, 2-157, outside of bicycle room.</p> <p>RECOMMENDATION Remove efflorescence and monitor to show frequency and extent. Further investigation is recommended if the water ingress is still active.</p> <p>CATEGORY Monitor</p>

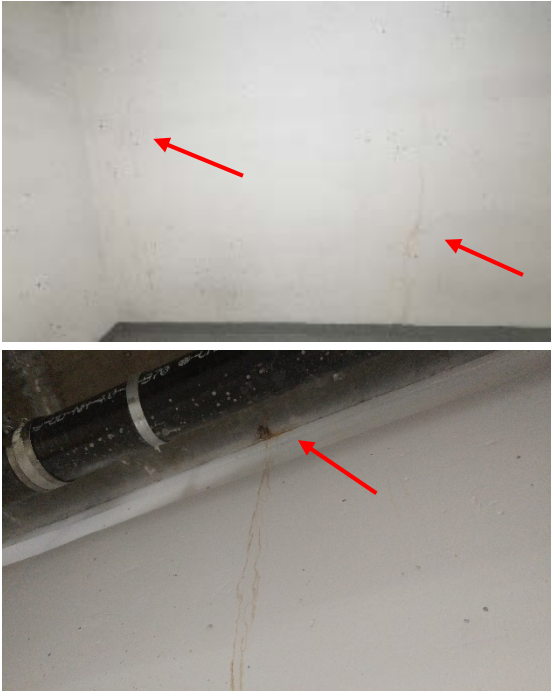
<p><u>OBSERVATION</u> Concrete cracking, water stains, and efflorescence were observed on the Perimeter wall of Level 3.</p> <p><u>LOCATIONS</u> Parkade level 3; Stall #: 3-199, 3-210,3-211,3-213 3-214, 3-215, 3-216, 3-217and 3-300.</p> <p><u>RECOMMENDATION</u> Remove efflorescence and monitor to show frequency and extent. Further investigation is recommended if the water ingress is still active.</p> <p><u>CATEGORY</u> Monitor</p>
<p>3.1.5</p>

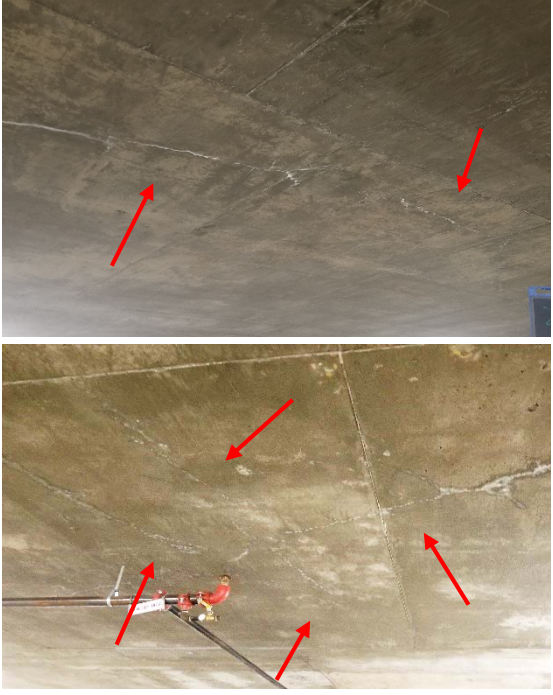
<p><u>OBSERVATION</u> Typical to similar locations. Concrete cracking, water stains, and efflorescence were observed on the ceiling of the suspended slab of parkade level 3.</p> <p><u>LOCATIONS</u> Parkade Level 3; Stall #: 3-109, 3-111, 3-113, 3-115, 3-140, 3-141, 3-142, 3-143, 3-144, 3-165, 3-166, 3-167, 3-170, 3-171, 3-172, 3-173, 3-174, 3-175, 3-177, 3-179, 3-180, 3-181, 3-182, 3-196, 3-197, 3-198, 3-200, 3-202, 3-203, 3-206, 3-208, 3-209, 3-211, 3-214, 3-215, 3-219, 3-223, 3-225, 3-226, 3-227, 3-228, 3-232, 3-233,</p> <p><u>RECOMMENDATION</u> Remove efflorescence and monitor to show frequency and extent. Further investigation is recommended if the water ingress is still active.</p> <p><u>CATEGORY</u> Monitor</p>

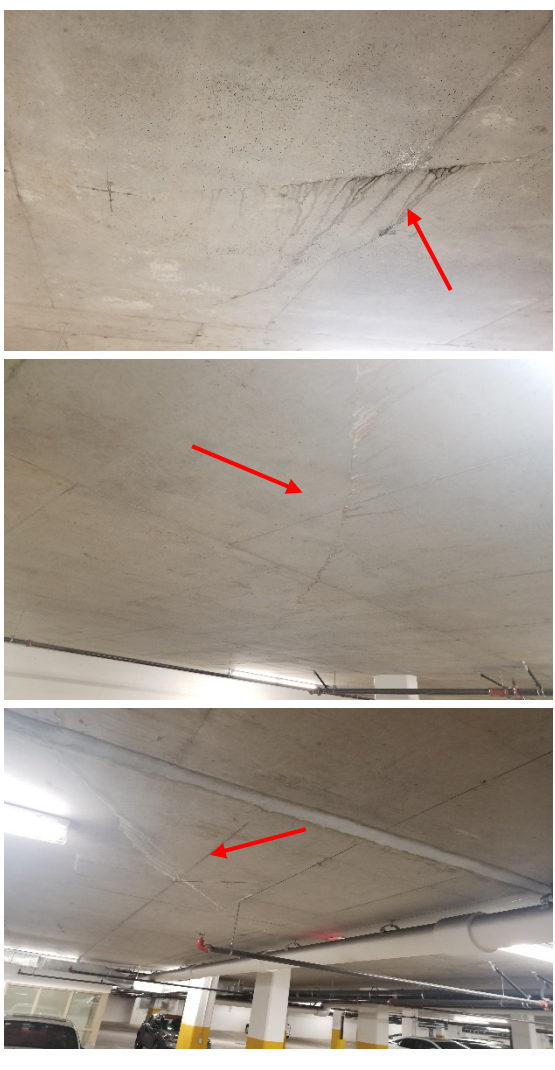
<p><u>OBSERVATION</u> Typical to similar locations. Concrete cracking, water stains, and efflorescence were observed on the ceiling of the suspended slab of Level P1.</p> <p><u>LOCATIONS</u> Parkade Level P1; Stall #: P174, P175, P176, P177, P178, P180 to P183, P189, P194, P195, P196 P219, P211, P214, P218, P219, P232, P233</p> <p><u>RECOMMENDATION</u> Remove efflorescence and monitor to show frequency and extent. Further investigation is recommended if the water ingress is still active.</p> <p><u>CATEGORY</u> Monitor</p>
<p>3.1.7</p>

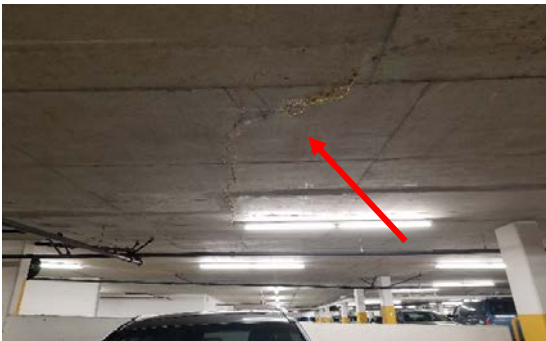
Photo D.- Crack possibly injected with polyurethane foam located beside the ramp which ends at P1

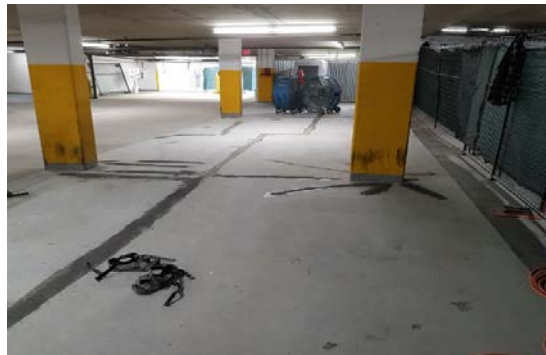
Photo E.- Concrete floor state after removing the topping from several areas and ready for re-coating with waterproof membrane.

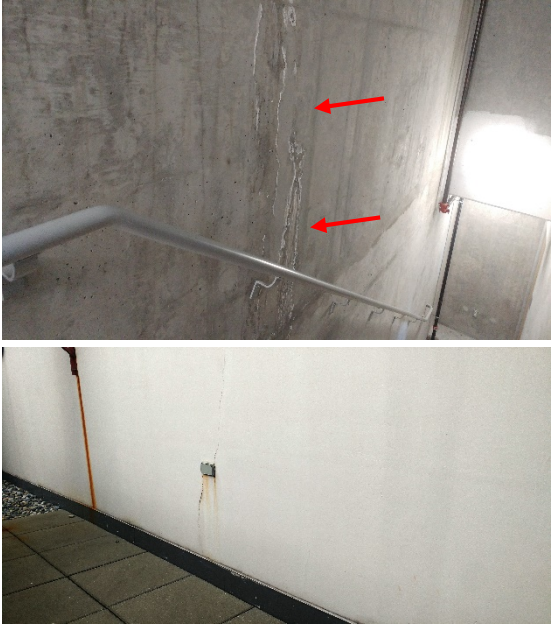
<p><u>OBSERVATION</u> Concrete cracking and efflorescence stain were observed. Bottom picture shows the crack on the exterior side of the wall where water ingress is occurring.</p> <p><u>LOCATIONS</u> North side wall of stair on the Level 39 (beside roof access door).</p> <p><u>RECOMMENDATION</u> The cracking should be routed out and sealed. However, a more comprehensive repair may require waterproofing from the exterior. Further investigation is recommended if the water ingress is still active.</p> <p><u>CATEGORY</u> Monitor.</p>

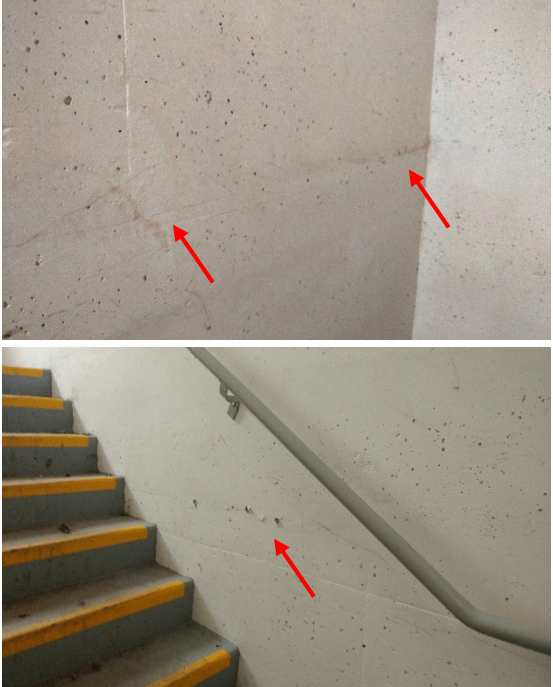
<p><u>OBSERVATION</u> Concrete cracking with efflorescence stain and peeling off paint were observed at the cold joint of stair wall and the suspended slab.</p> <p><u>LOCATIONS</u> Stair #6 Level 5.</p> <p><u>RECOMMENDATION</u> The cracking should be routed out and sealed. However, a more comprehensive repair may require waterproofing from the exterior. Further investigation is recommended if the water ingress is still active.</p> <p><u>CATEGORY</u> Monitor.</p>

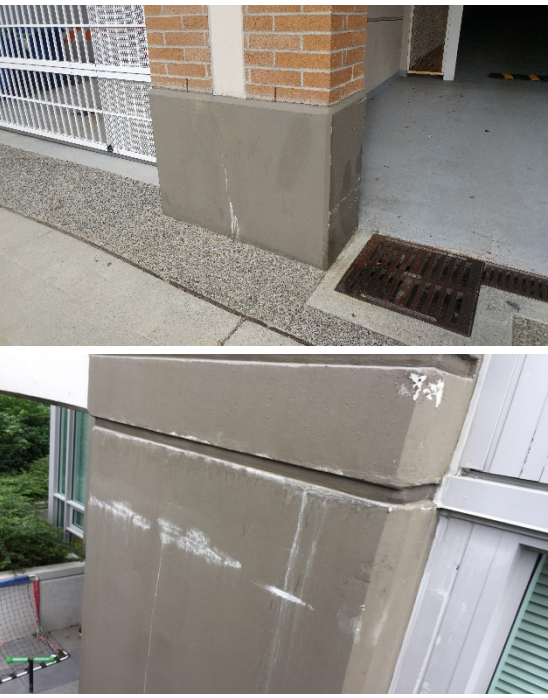
ITEM	PICTURE	DESCRIPTION
3.3.1

<p><u>OBSERVATION</u> Efflorescence staining and crack on the wall were observed.</p> <p><u>LOCATIONS</u></p> <ul style="list-style-type: none"> • Parkade entrance wall. • Roof parapet wall – Level 38 (W) and Level 38(N) • W1L5, S1L9 and S1L37 <p><u>RECOMMENDATION</u> Repair as needed during first upcoming maintenance program is recommended.</p> <p><u>CATEGORY</u> Maintenance.</p>

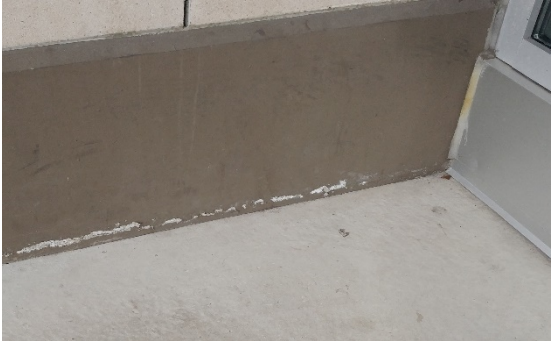
<p><u>OBSERVATION</u> Peeling of protective paint was observed on the bottom part of entrance wall.</p> <p><u>LOCATIONS</u> Ground Level (S)</p> <p><u>RECOMMENDATION</u> The peeling of paint will not create a problem in the foreseeable future. However, for aesthetic reasons, painting and protection of the concrete is recommended to prevent water ingress into the wall assemblies.</p> <p><u>CATEGORY</u> Maintenance.</p>
<p>3.3.3</p>

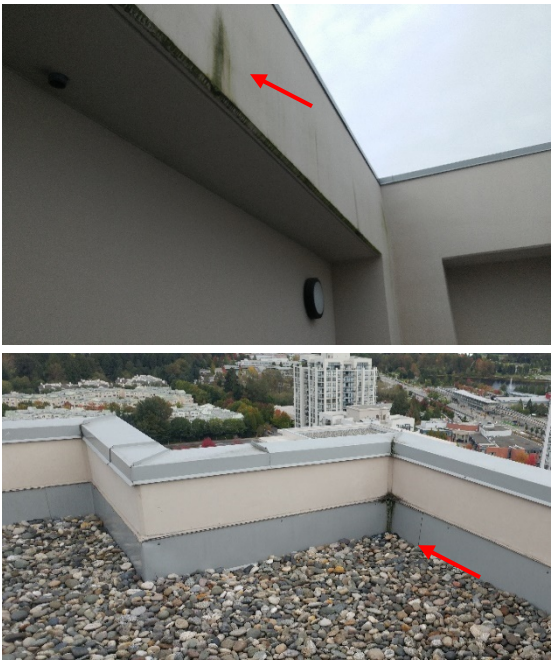
<p><u>OBSERVATION</u> Green/Black stain below on the exterior wall, flashing and balcony band was observed.</p> <p><u>LOCATIONS</u> Level 39 – Upper roof and balcony band (typical)</p> <p><u>RECOMMENDATION</u> Generally, the moss on this surface holds water. Depending on the condition of the concrete, it may also lead to spalling or frost damage of the concrete itself. Regular cleaning is recommended.</p> <p><u>CATEGORY</u> Maintenance.</p>

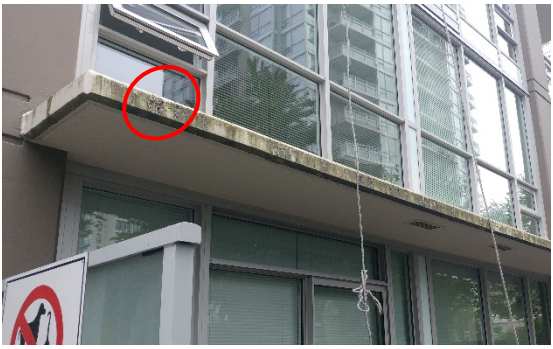
<p><u>OBSERVATION</u> Waterproofing membrane delaminated/ failure was noted on the exterior face of the balcony, on the balcony or overhang.</p> <p><u>LOCATIONS</u> N1L5 and typical to similar locations.</p> <p><u>RECOMMENDATION</u> Refinishing of the affected areas is required; matching the colour as close as possible.</p> <p><u>CATEGORY</u> Maintenance.</p>

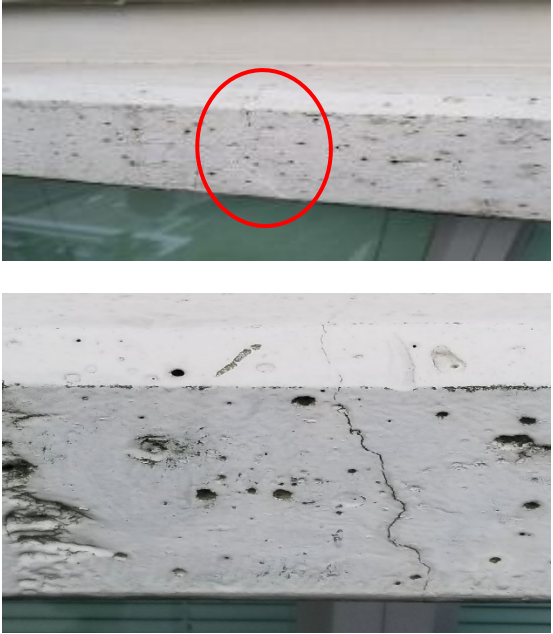
<p><u>OBSERVATION</u> Concrete cracking was observed at the ends of overhang, balcony band or exterior wall.</p> <p><u>LOCATIONS</u> Level - 6 to 37 (E), 5(W), 27(W), 35(W), 36(W), 16(N), 26(N), 29(N), 30(N), 31(N), 35(N), 15(S), 16(S), and 35(S).</p> <p><u>RECOMMENDATION</u> Such cracks should be sealed (with specialized sealant) and painted, during any future upcoming maintenance program. Left unrepaired, these types of cracks can and will cause water ingress into the wall assembly.</p> <p><u>CATEGORY</u> Investigate.</p>
<p>3.3.6</p>

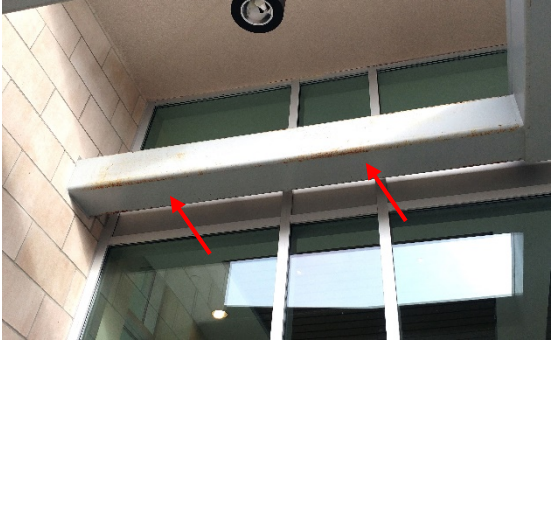
<p><u>OBSERVATION</u> Corrosion and staining was observed on steel structure.</p> <p><u>LOCATIONS</u> Main entrance canopy.</p> <p><u>RECOMMENDATION</u> Proper protection of the metallic surfaces is recommended to prevent future deterioration. Refinishing of the affected areas is required; matching the colour as close as possible.</p> <p><u>CATEGORY</u> Maintenance.</p>

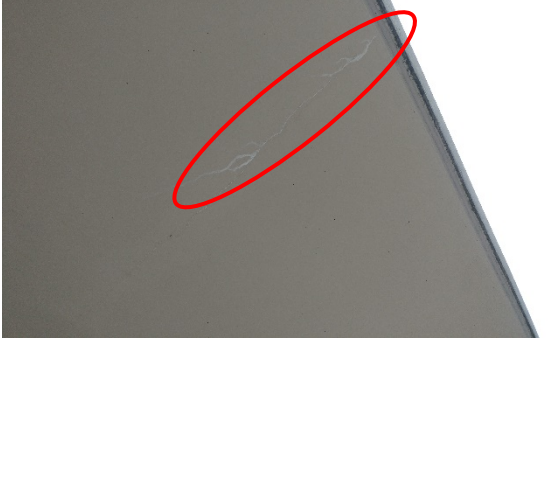
<p><u>OBSERVATION</u> A crack with efflorescence stain at the underside of the concrete overhang.</p> <p><u>LOCATIONS</u> Level 37(S)</p> <p><u>RECOMMENDATION</u> Such cracks should be sealed (with specialized sealant) and painted, during any future upcoming maintenance program. Left unrepaired, these types of cracks can and will cause water ingress into the wall assembly.</p> <p><u>CATEGORY</u> Maintenance.</p>

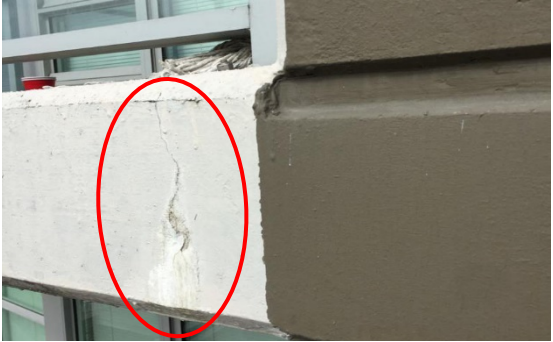
<p><u>OBSERVATION</u> The efflorescence staining and crack on the wall</p> <p><u>LOCATIONS</u> S1L15</p> <p><u>RECOMMENDATION</u> The efflorescence forming at the crack suggests water ingress and water path conditions due to the crack. Such cracks should be repaired during any upcoming maintenance program. These types of cracks can and will cause water ingress into the concrete slab.</p> <p><u>CATEGORY</u> Maintenance.</p>
<p>3.3.11</p>

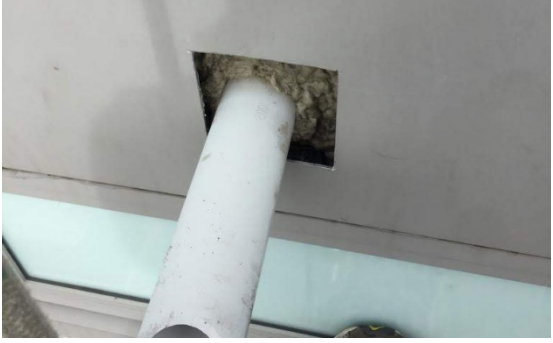
<p><u>OBSERVATION</u> Missing cover fixture for the scupper was observed.</p> <p><u>LOCATIONS</u> S1L38</p> <p><u>RECOMMENDATION</u> Cover should be properly installed to prevent water ingress to the wall assembly.</p> <p><u>CATEGORY</u> Maintenance.</p>
<p>3.3.12</p>

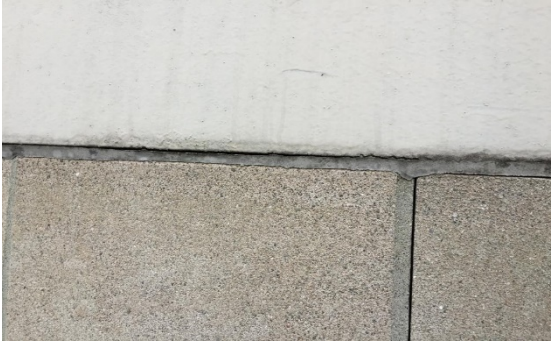
<p><u>OBSERVATION</u> Crack between concrete wall and the stone veneer.</p> <p><u>LOCATIONS</u> S1L5</p> <p><u>RECOMMENDATION</u> Regular maintenance and repair as needed are recommended.</p> <p><u>CATEGORY</u> Maintenance.</p>

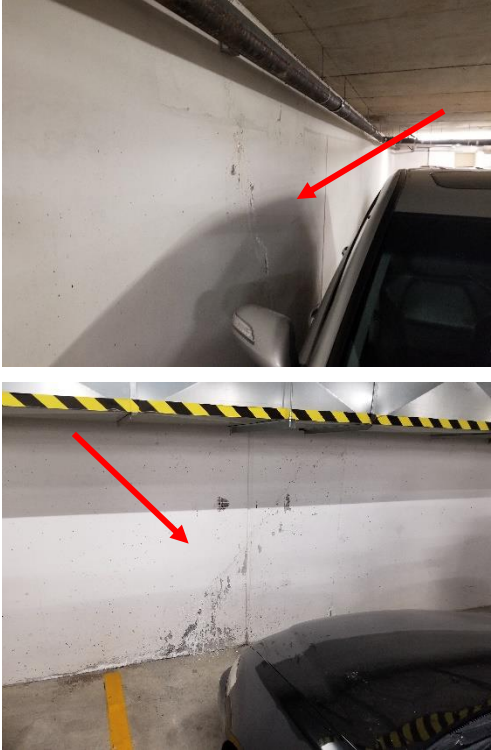
<p>These photos show possible shear cracks on the perimeter wall. These cracks may be the result of shear-stress concentration on the wall. However, since this is a singular hairline crack and no shear damage pattern was observed in any other area, we are the opinion that these particular cracks do not represent any structural concern at the time of this review.</p> <p>Nevertheless, we do recommend monitoring in order to detect any new cracks or a specific pattern that represent a hint of a structural deficiency as well as any water ingress into the parkade. In the case of water ingress, we recommend a polyurethane crack injection.</p> <p>Location: Parking 1 stall #70, 39, 36, 35, 9, 3 Type: NSD Importance: Low Action required: Monitor & Upkeep as needed</p>
