2021 DEPRECIATION REPORT
UPDATE
FOR
THE METROPOLITAN
5885 OLIVE AVENUE, BURNABY

PREPARED FOR:
The Owners, Strata Plan NW 3355
c/o FirstService Residential
700 – 200 Granville Street
Vancouver, BC V6C 1S4

PREPARED BY:
Sense Engineering Ltd.
104 – 788 Copping Street
North Vancouver, BC V7M 3G6

June 29, 2020

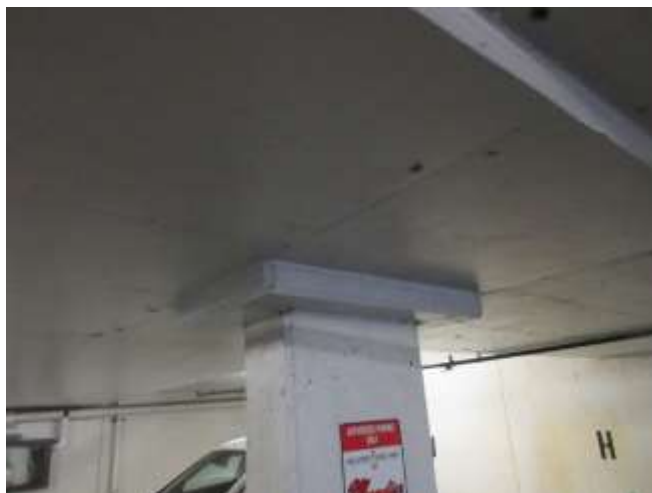
Photo 1: Typical structure in the parking garage.

Based on the structural drawings, we understand the PT system installed is a fully encapsulated/extruded system which means the cables are coated in protective grease and encapsulated in a tight-fitting plastic sheathing during the manufacturing process. However, this has not been confirmed. Extruded systems are more robust and resistant to deterioration than earlier stuffed systems, though early generations of extruded systems are sometimes susceptible to deterioration at anchorage locations.

Because the PT cables are under high tension, cable failure can be sudden and potentially result in significant loss of structural capacity. For this reason, and because we cannot confirm the type of system and the condition of the PT cables, the projected expenditures include for an initial evaluation and testing of the cables, including exposing the PT anchors and test openings to check the construction and condition of the cables. Pending the results of this, the projected expenditures do not include for any repairs. However, should problems become apparent, the evaluation scope may need to be expanded, repairs may be required, and/or additional evaluations may be required in the future. Future updates to the Depreciation Report should consider PT evaluation findings and additional project expenditures included for, if required.

| Description | Present Cost | Timing (Year) | Cycle (Years) |
|---|---|---|---|
| Evaluate Condition of the Post-Tensioning (PT) System | \$20,000 | 2022 2037 | 15 |

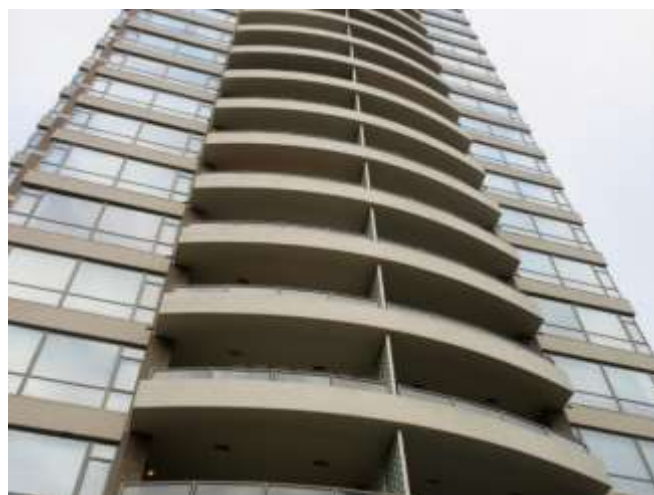
Photo 2: Typical balconies.

- Worn and failed membrane at balconies where the membrane is exposed.
- Some water leakage through balcony slabs; however, minimal amounts of visible concrete damage.
- Missing balcony drain covers resulting and a risk of blockage which can lead to water ponding or flooding on the balconies.
- Corrosion staining from the base of metal chairs (placed to support reinforcing steel and post-tensioning cables during construction) on some balcony soffits. Corrosion of the chairs is not a structural concern but may be an aesthetic issue for the residents.

The concrete balcony slabs require waterproofing to reduce the potential for leakage through the concrete and related deterioration. The waterproofing and paint materials will require periodic restoration in order to maintain protection of the concrete and embedded steel reinforcing and PT.

As per the recommendations provided in the Building Enclosure Evaluation Report, the projected expenditures include for re-waterproofing the top surface of the balconies, including local repairs to the concrete structure and re-painting of balcony soffits. Tile flooring, where installed by individual Owners, will require removal prior to re-waterproofing. The project cost shown includes an allowance to remove balcony tile flooring. The timing of balcony repairs matches the building envelope evaluation timing, which was deferred to allow other, more pressing, envelope repairs to occur first.

Subsequent to the initial repairs outlined above, a balcony evaluation is recommended prior to the next program of repairs to better determine the extent of repairs required, develop an appropriate scope, and to advise the Strata on more accurate projected expenditures, project timing, and potential phasing. Pending results from the balcony evaluation, the projected expenditures include for re-coating the top surface of the balconies, including local repairs to the concrete and re-painting of the balcony soffits. We assume that any local areas requiring repair in the interim will be carried out as part of maintenance out of operating budgets.

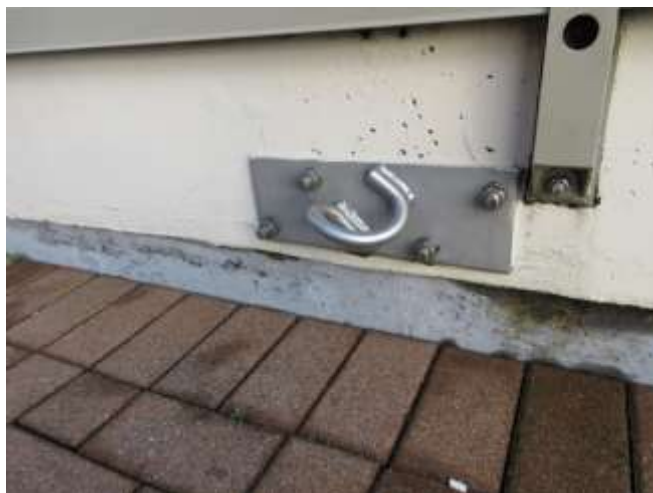
Based on the absence of major concerns to date, capital expenditures are not expected within the term of this report.

Photo 3: Typical adhesive wall anchor.

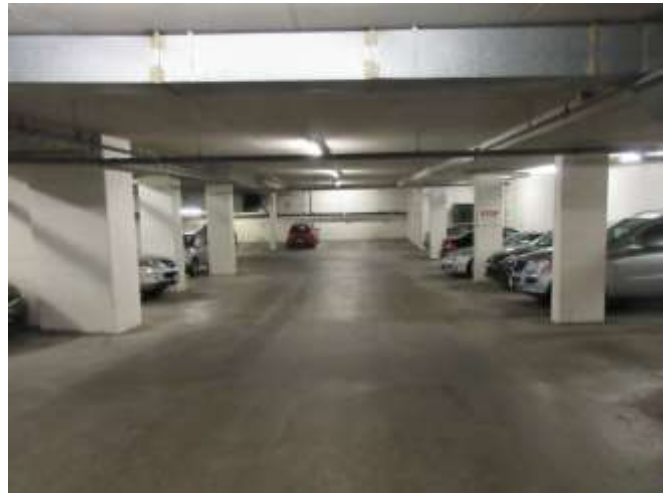
We noted evidence of past and active leakage on the underside of the suspended slabs at several locations. We also noted a few locations of locally deteriorated concrete at some slab topside areas.

Photo 4: Parking garage.

There is no waterproofing system installed on the top surface of the suspended slabs. The suspended slabs should be waterproofed to protect the concrete and mitigate further leakage into the parking areas below. Water leakage through the suspended slabs can induce corrosion of the reinforcing steel embedded within the concrete which can result in deterioration of the concrete (as starting to be seen in the garage) and associated costly repairs. We recommend completing an evaluation of the parking garage to determine the extent of required repairs, including the extent of corrosion of reinforcing steel embedded in the slabs, and to advise on repair strategies, potential phasing, and related costs. Pending the findings of the evaluation, the projected expenditures include for concrete repairs followed by waterproofing of the suspended slabs. The projected expenditures also include for future programs of re-waterproofing the suspended slabs to ensure the integrity of the waterproofing system.

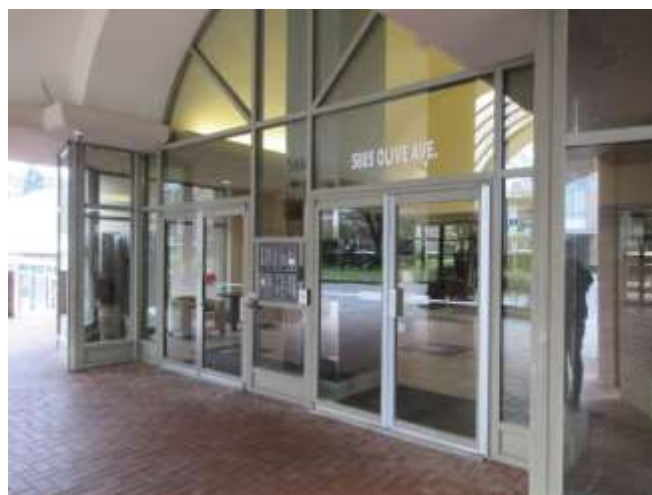
We were not made aware of any significant issues with the exterior doors. We noted condensation on the interior side of the single pane swing doors at the pool area. This condensation is formed as humid air from the pool area settles on the cold surface of the glass panes. Excess condensation on these doors will require regular cleaning in order to reduce the risk of mold growth. We assume that the door will be replaced, when required, as part of ongoing maintenance using funds from operating budgets.

Photo 7: Main building entrance doors.

The projected expenditures include for replacement of the overhead garage doors to and within the parking garage.

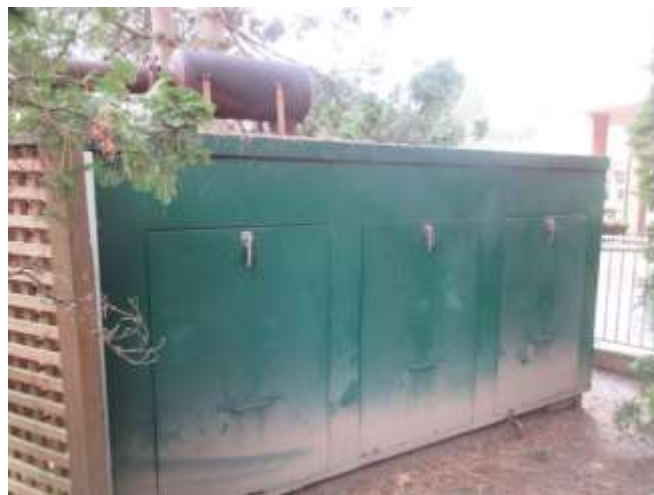
The generator is currently about 29 years old. With age, performance typically degrades to the point where it cannot meet the full load requirements and a major overhaul or replacement is required. Major manufacturers will typically not support older equipment, and we cannot predict how long replacement parts will remain available. Based on the age of the unit, the projected expenditures include to replace the generator, transfer switch, and diesel storage tank.

Photo 12: Emergency generator enclosure.

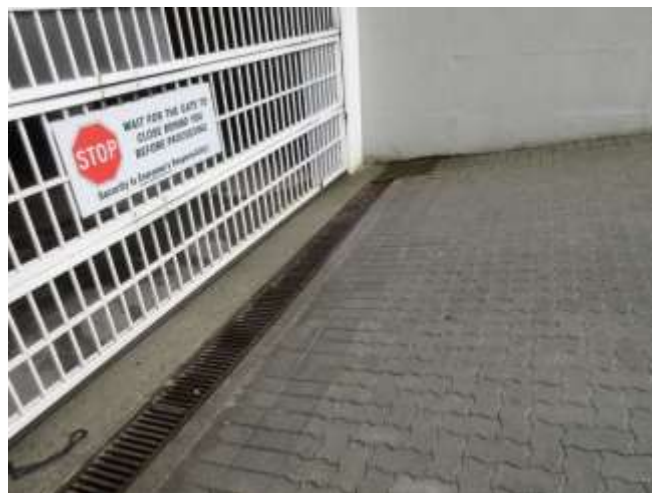
The condition of the buried and concealed piping cannot be evaluated visually. We recommend that drains be flushed and scoped routinely. This maximizes the service life of the piping and helps identify repair needs. We assume this will be done as part of ongoing maintenance funded from operating budgets.

Photo 21: Parking garage trench drain.

The projected expenditures include for periodic repairs that will inevitably be required. Actual repairs and related costs should be closely tracked, and budgets modified to suit, in future updates to the Depreciation Report.

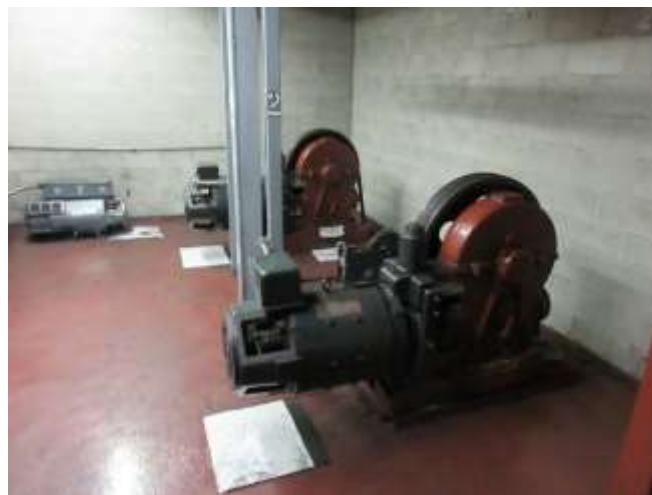
GUNN Consultants Inc. completed a third-party condition assessment of the elevators at the building in 2019, which assessed the present condition of equipment and the remaining service life and need for upgrades of various components. Based on the condition assessment report, we understand that the elevators are in acceptable condition for their age and use, and although components are generally well maintained, they are near the end of their reliable lifespans. The inspection report also noted several maintenance deficiencies, which we understand should be corrected by the service contractor at no cost to the Strata.

Photo 24: Elevator equipment.

Modernization of traction elevator controls is typically required after 25 to 30 years of service. Based on the recommendations provided in the condition assessment report, the projected expenditures include for complete modernization of the elevators. Modernization will include replacement of the present controller with a microprocessor-based controller, replacement of the drive system with a solid-state drive, fixture replacement and refurbishment or replacement of the geared machine and motor. Project budget and timing is based on the estimates provided in the condition assessment report and include a 15% contingency as recommended in the report.
