**Re: The Metropolitan – 5885 Olive Avenue, Burnaby
Garage Evaluation**

Sense's Project No. 18R085L

We are pleased to provide the following report summarizing the findings of our Garage Evaluation at The Metropolitan.

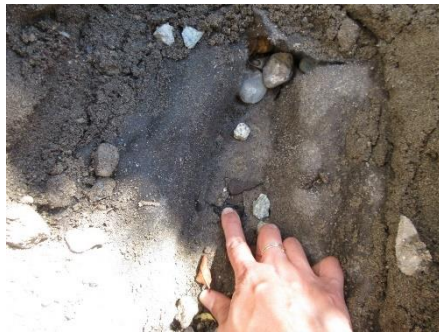
The original garage roof slab waterproofing is generally well bonded to the concrete slab and flexible; however, the concrete was wet below the waterproofing at Inspection Pit #3, but no signs of failure of the waterproofing was observed within the inspection pit area, suggesting water ingress is likely from localized failure of the membrane near the inspection pit, or water is bypassing the waterproofing by another means, such as a concrete crack or joint.

Photo 2: Moisture below garage roof waterproofing.

Based on the current age of the waterproofing membrane (32 years) it is nearing its expected service life of 35 to 40 years; however, given that widespread leakage is not occurring, re-waterproofing the garage roof slab could continue to be deferred until leakage becomes more problematic. We recommend re-evaluating the garage roof slab in about five years to better plan the timing of when the roof slab should be repaired or replaced. Meanwhile, localized leaking cracks can continue to be addressed by injection waterproofing repairs.

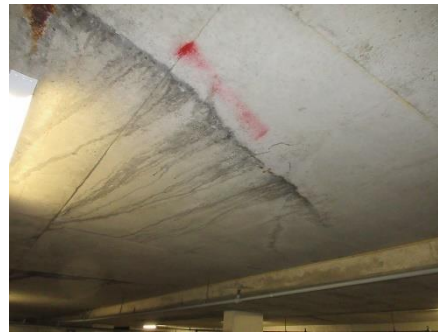
There are areas of localized leakage; however, the amount of leakage through the roof slab overall is minimal, suggesting that the waterproofing is still generally performing well. Crack injection repairs have been completed to address some of the leaking cracks and are still performing satisfactorily.

Photo 3: Cracks with evidence of leakage on garage soffit.

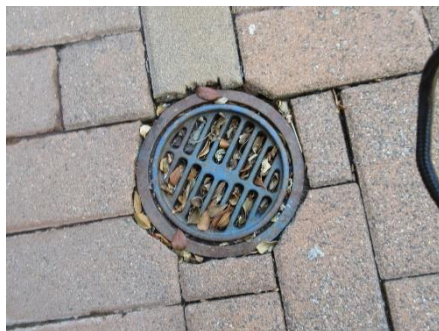
There is evidence of drainage issues due to plugged area drains at the walkway on the north-west side of the pool areas. The area drains are blocked with debris and the pavers have dirt build-up and efflorescence staining on the surface, indicating that water is sitting on the surface for long periods of time. We recommend clearing the drains in the area to promote drainage and reduce the risk of water leaking into the pool area from the walkway.

Photo 4: Plugged walk-way drain at north-west side, next to pool area.

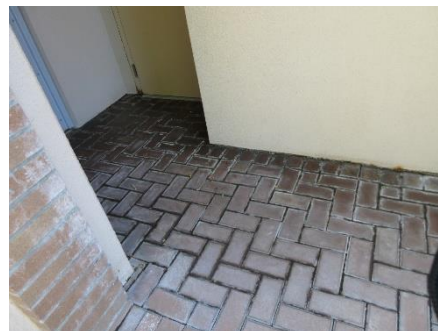
Photo 5: Staining on pavers near plugged drain indicating ponding water in the area.

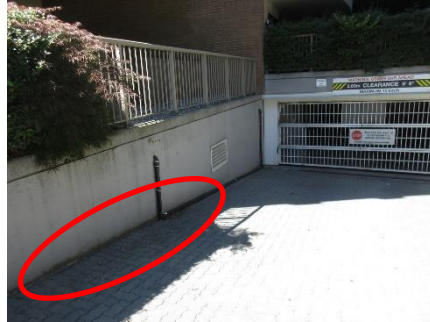
There is a large amount of leakage staining at the cold joint between the entrance ramp slab and ramp walls, suggesting that the waterproofing does not extend over this joint or that the waterproofing is damaged at this location. To address the leakage, we recommend lifting the pavers along the ramp walls and extending the waterproofing upturn 200 mm above the paver surface and covering the waterproofing with sheet metal flashings.

Photo 6: Entrance leaking entrance ramp to wall joint.

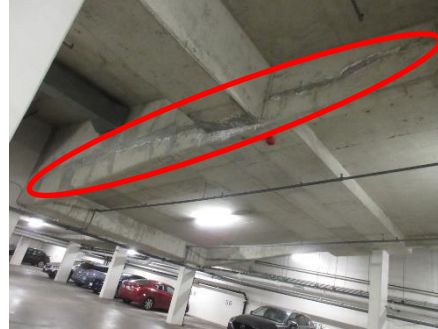
Photo 7: Entrance ramp staining along bottom of wall.

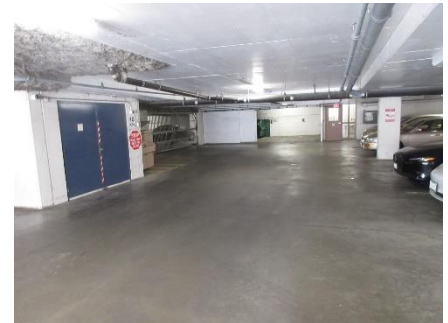
The lack of a waterproofing membrane on the parking garage suspended slabs has allowed water to leak through many surface cracks in the P1 and P2 slabs. The leaking water is generally brought into the garage by vehicles. When the water is combined with chlorides from road salts or pre-existing chlorides in the concrete, it causes corrosion of the reinforcing steel when in contact. The resulting rust that forms from steel corrosion pushes against the concrete, resulting in loose concrete at the slab, which could fall and injure pedestrians or damage property.

Photo 8: Typical unprotected P1 level drive aisle.

Installation of waterproofing on the topside of the suspended slab is recommended to mitigate ongoing leakage and concrete deterioration. Concrete repairs should be completed where the concrete is damaged and/or deteriorated, prior to installing the waterproofing. Concrete repairs include removing and repairing delaminated concrete, cleaning the steel of corrosion, and installing new concrete. We recommend these repairs be completed within the next 5 years.

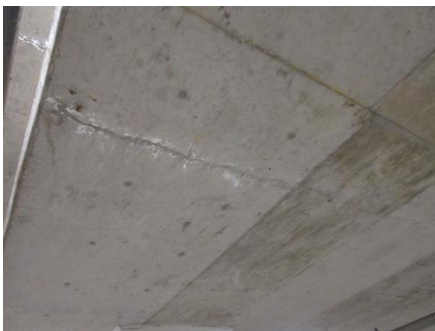
Concrete damage on the underside of the garage suspended slab of P1 and P2 is widespread with evidence of leakage. Also supported by the chloride testing results, chloride has penetrated past the reinforcement depth. Most of the concrete damage and leakage is concentrated along cracks that extend the width of the drive aisle and into the parking stalls. Based on our sounding survey, approximately 1% of the total suspended slab area has delaminated concrete.

Photo 10: Efflorescence on soffit of suspended slab.

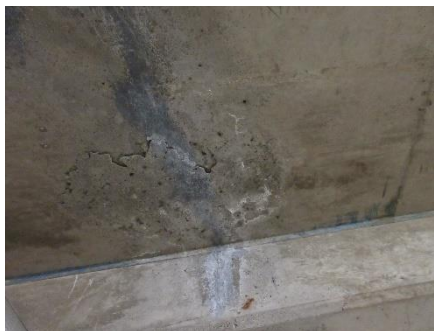
At several locations, the concrete damage has caused concrete to spall from the underside of the slab, exposing the reinforcing steel. There are several locations where the concrete has delaminated, appears loose, and could eventually fall. There is also concrete delamination on the topside of the slab.

Photo 11: Typical delaminated concrete on suspended slab soffit.

Should the Strata choose to phase and/or defer concrete repairs, the Strata should engage a contractor to locate and remove loose concrete from the underside of slabs, as there is a considerable amount, to reduce the risk of concrete falling on pedestrians and/or vehicles, until a repair project can be completed.

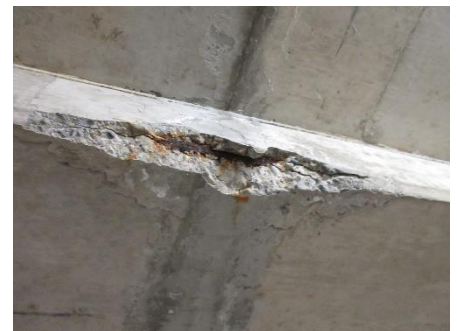
Photo 12: Loose concrete broken off when concrete sounding was completed during the garage evaluation.

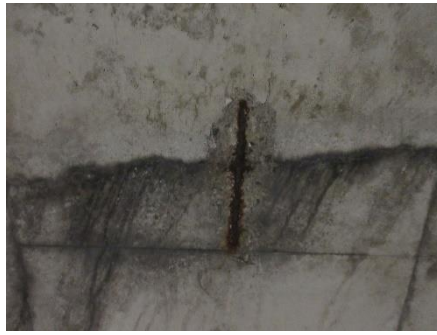
Photo 13: Typical exposed reinforcing at concrete spall location.

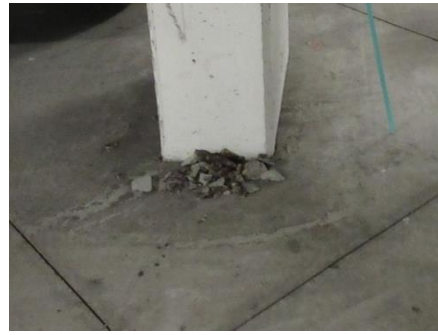
Photo 14: Loose concrete that has fallen from soffits during concrete sounding that was completed during the garage evaluation.

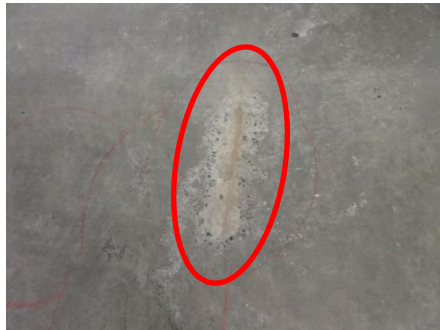
Photo 15: Typical topside delamination with exposed reinforcing steel.

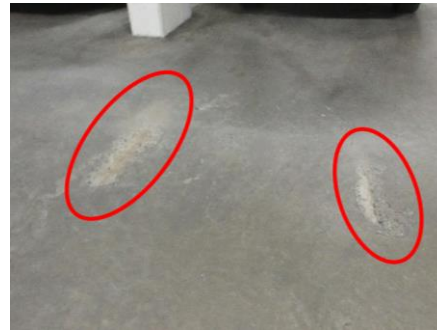
Photo 16: Typical topside delamination with exposed reinforcing steel.

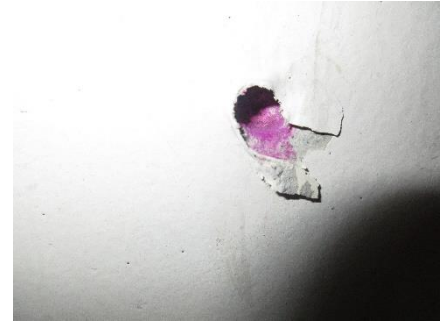
- Test Location 1: 5 mm
- Test Location 2: 10 mm
- Test Location 3: 5 mm

As carbonation has not reached the depth of the steel reinforcement, it is unlikely that carbonation is contributing to deterioration of the concrete in the garage currently.

Photo 17: Carbonation testing result.

Installing a coating on the concrete surface reduces the rate at which carbonation travels through the concrete and limits the risk of concrete deterioration where concrete is carbonated around steel by limiting the amount of water entering the structure. As such, installation of a waterproofing membrane on the suspended slab top surface is recommended.

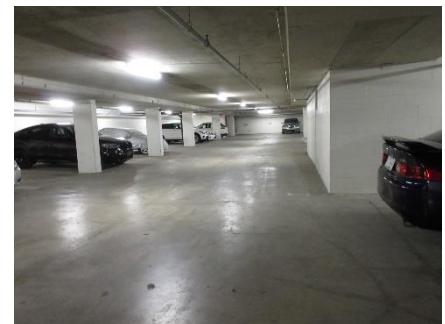
There are some cracks in the concrete slab-on-grade which is typical for most slab-on-grade construction over time. Some efflorescence staining was observed on the floor at base of wall nearby Stall 169 and 170. The efflorescence appears to be due to water seepage from groundwater below. However, there was no excessive cracking or significant differential settlement that would suggest there are sub-grade problems.

Photo 18: Typical condition of the Slab-on-grade at P3.

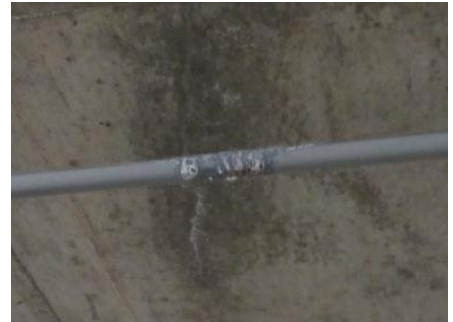
Cracks throughout the parking garage are showing signs of leakage. Leaks from these cracks are starting to corrode the sprinkler pipes below those cracks. Electrical conduits are also starting to corrode from the leaks at the cracks, which is another reason why the leakage through the suspended slab should be addressed by installing a traffic coating membrane. As part of the waterproofing work an allowance should be carried to address replacement of electrical conduits and sprinkler pipes if found to be required during the work.

Photo 19: Typical corrosion on sprinkler pipes.

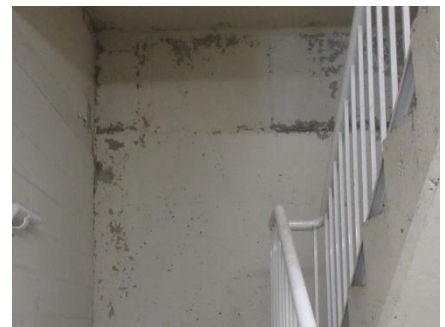
Peeling paint was observed on walls in some of the stairwells. This is an aesthetic item only and should not have any significant effect on the overall performance of the parking garage.

Photo 20: Typical peeling paint in the stairwells.

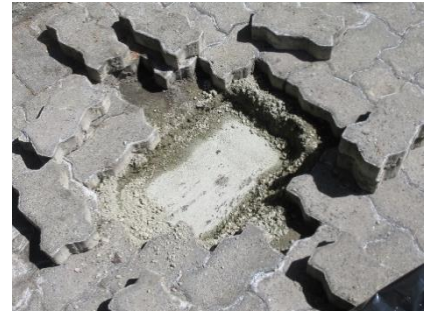
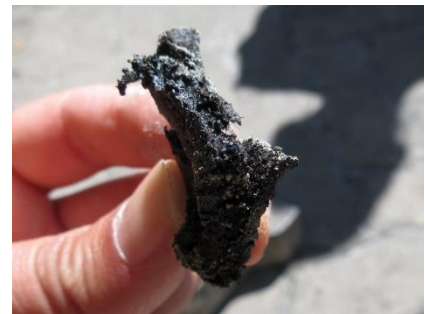
Opening No.	Opening Type	Date of Opening	Weather	
1	Inspection Pit	August 3, 2023	Sunny (25°C)	
Notes/Observations				
<p>Handicap visitor parking stall at the east side of the building. The assembly is as follows (top to bottom):</p> <ul style="list-style-type: none"> • 60 mm interlocking brick pavers; • 65 mm bedding sand; • Granulated modified bitumen protection sheet; • ~175mils hot applied rubberized asphalt waterproofing; and • Concrete slab. <p>The waterproofing is generally well bonded to the concrete slab and flexible. The concrete is dry below the waterproofing.</p>

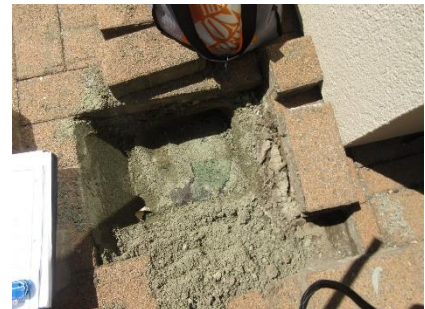
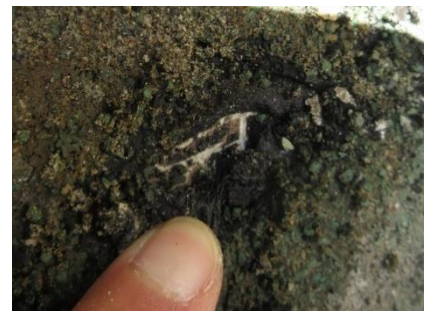
Opening No.	Opening Type	Date of Opening	Weather	
2	Inspection Pit	August 3, 2023	Sunny (25°C)	
Notes/Observations				
<p>East of the pool area, in the walkway. The assembly is as follows (top to bottom):</p> <ul style="list-style-type: none"> • 60 mm interlocking brick pavers; • 130 mm bedding sand; • Granulated modified bitumen protection sheet; • ~175mils hot applied rubberized asphalt waterproofing; and • Concrete slab. <p>The waterproofing is generally well bonded to the concrete slab and flexible. The concrete is dry below the waterproofing.</p>

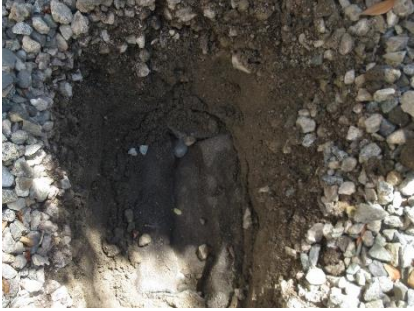
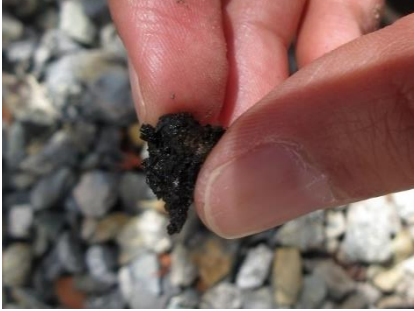
Opening No.	Opening Type	Date of Opening	Weather	
3	Inspection Pit	August 3, 2023	Sunny (25°C)	
Notes/Observations				
<p>West side of the building, in the gravel path next to the patio. The assembly is as follows (top to bottom):</p> <ul style="list-style-type: none"> • 100 mm gravel; • 170 mm bedding sand; • Filter fabric; • 70 mm drain rock; • Granulated modified bitumen protection sheet; • ~175mils hot applied rubberized asphalt waterproofing; and • Concrete slab. <p>The waterproofing is well bonded to the concrete slab and flexible. The concrete is wet below the waterproofing.</p>
