Re: The Metropolitan, 5885 Olive Avenue, Burnaby
Building Enclosure Evaluation

Sense's Project No. 18R085A

BUILDING ENCLOSURE EVALUATION FOR
THE METROPOLITAN
5885 OLIVE AVENUE, BURNABY

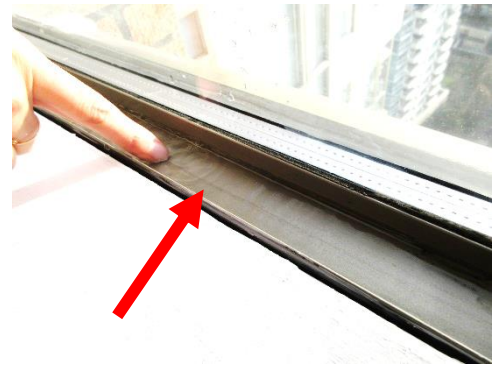
Many of the suites reviewed had evidence of water leakage through the window framing and/or at operable sashes. This is evident by the amount of pooling water sitting in the condensation tracks of the window frames, and staining and wetting on the interior finishes and window frames. Some Owners have reported that water runs down the interior side of the window framing and IGU's during rain events and they are able to collect large amounts of water in a large bowl in about an hour (reported at suite PH-03). Other Owners have indicated that they generally find large amounts of pooling water in the sill condensation tracks following rain events (reported at suite 2306, 2206, 2101, 1504 and 1404). Some suites had damaged, stained, and wet/moist drywall and flooring below windows (identified at suite 1903). The architectural drawings indicate that the window rough opening lacks a sub-sill membrane and water leakage through the window framing is likely traveling under the windows, through the wall cavity, to flooring finishes at some locations. There are also several locations where the concrete wall finish is blistering directly below windows on the exterior possibly as a result of window cracks.

Based on our review, it appears there are several items that may be contributing to water leakage into the windows and becoming trapped. These items include failed or shrunken exterior glazing gaskets, failed caulking at and around windows, unsealed window framing joints, blocked, poorly placed or lack of window drain holes, and operable sashes that do not close properly or tightly (refer to 3.1.2.2, 3.1.2.3, 3.1.2.4, and 3.1.2.5, for further discussion on these findings). Once water is inside the windows, there is an increased risk of water entering the building because of the lack of a sub-sill membrane as discussed above.

Photo 10: Pooling water in window track at PH-05.

In order to better isolate the causes of the water leakage and confirm what repairs are provided, systematic water testing should be completed at two sample windows with leakage issues. Window water testing would allow us to simulate wind driven rain, while focusing the water at specific locations such as vulnerable exterior window joints. Water testing would also allow us to observe how the windows manage water, and if the drain holes are effective in relieving the system of water. Once the causes of the window leakage are better defined, an appropriate repair strategy can be developed. Management strategies may include caulking replacement and additional window sealing, gasket replacement, drainage modifications, and operable window adjustment; however, these management strategies cannot be recommended until the mechanisms causing the window leakage area known. Testing may also revise that the windows can not be practically repaired to reasonably manage water ingress issues.

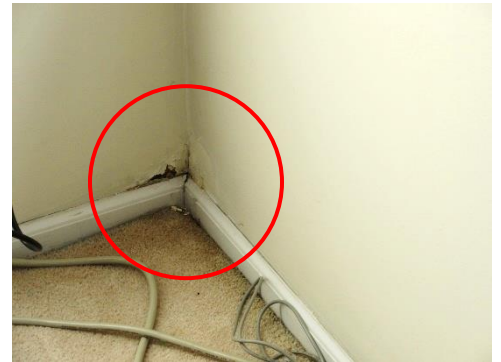
Photo 11: Damaged and moist drywall below window at Suite 1903.

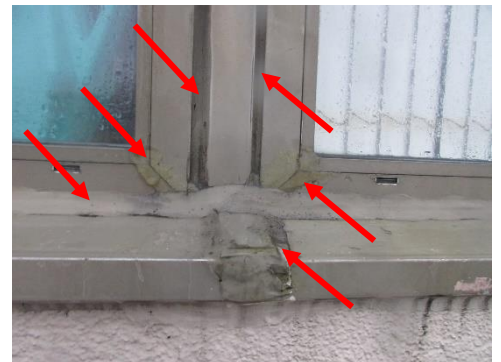
Photo 12: Typical window with varying caulking at exterior at North Elevation.

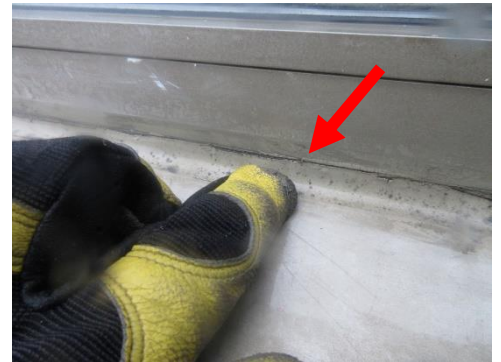
Caulking installed at the exterior of windows ranges in age, material type, and quality of installation. Some framing joints appear to be caulked in an effort to address leakage. The window sill and jamb caulking is beginning to de-bond at several locations, with the worst conditions typically at the west and south elevations. The caulking between the aluminum framing joints is generally cracked and crazed throughout. Water may be entering through the de-bonded joints at these locations, traveling through the window frame and leaking into the building. Further, the window sill to flashing joints, and the underside of the sill flashing is continuously caulked, so any water that gets under the window framing or flashing may not drain outwards, and as a result may be directed into the suites.

Photo 13: Debonding caulking at window sill.

Replacement of caulking at and around window is recommended if a window repair program is implemented. New caulking should include drain slots to allow water below framing to drain to the exterior. But this should be confirmed by water testing.

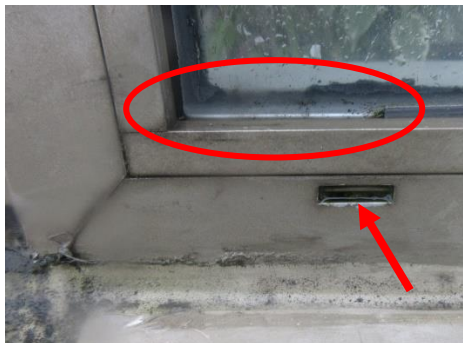
There are several locations where the exterior window frame to glass gaskets have shrunk, or are missing at corners, leaving open gaps. There are some locations where caulking has been applied at these corners to close off the gaps. There are other locations where exterior glazing stops are bent/damaged resulting in gaps between the glazing stops and window framing. These gaps may be a point of entry where water is making its way into the window framing. Gaskets and strips should be replaced where damaged or caulking installed at gaps.

Photo 14: Shrunk/missing exterior glazing gasket at window sill and drain hole with visible water sitting in framing (arrow).

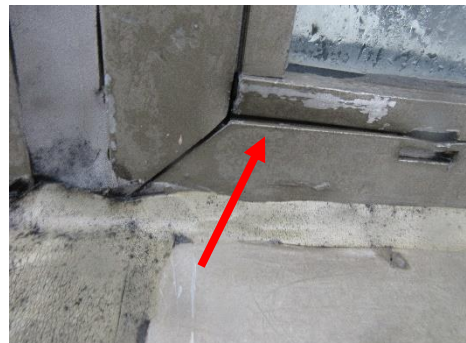
Photo 15: Gaps between window frame and exterior glazing stop.

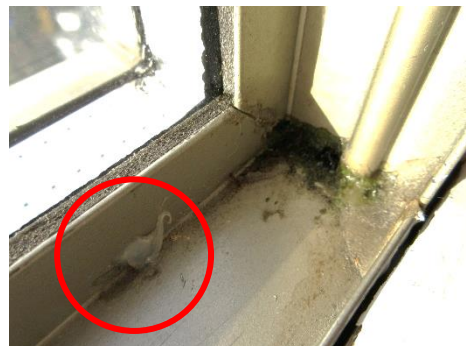
Photo 17: Interior drain hole filled with caulking.

In order to better understand how the windows, manage water and the effectiveness of the drain holes, we recommend completing window testing as discussed in 3.1.2.1 above, including removing some of the exterior window components to better review the intended drainage paths through the window assemblies.

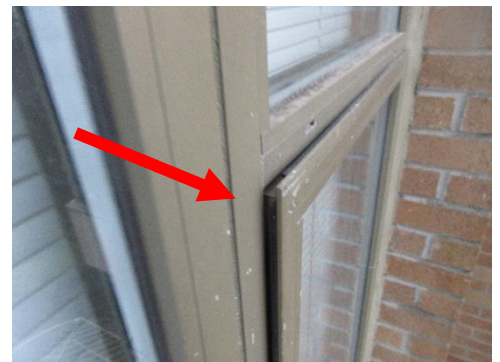
Several operable windows reviewed had damaged hardware, including bent hinges, broken guides, broken cam handles and worn compression gaskets, resulting in the operable windows not closing tightly. If the compression gasket on the operable window does not fully engage, water and air leakage is more likely to occur. In most cases, hardware damage appears to be the result of normal wear and tear. The window hinges, guides, cam handles, and gaskets should be replaced or repaired depending on the issues, to allow the compression gaskets to fully engage when the window is closed. This work can be incorporated into a window repair program, should window testing demonstrate that the window repair is practical.

Photo 18: Operable windows not closing tightly.

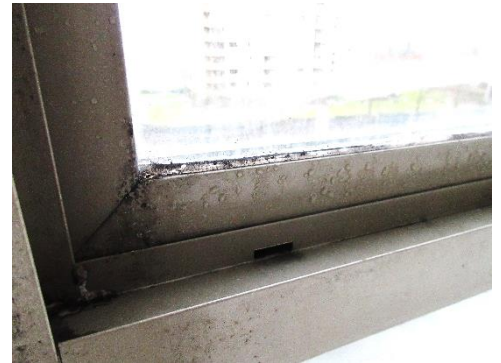
Fifteen suites reported in questionnaire that they have condensation on the interior side of the window framing and glazing. But we noticed condensation on almost all windows. So, it is likely that some residents are not noticing the condensation. This is evident by the visible moisture formation of the interior window frame and glass surfaces.

Condensation forms when humid air contacts a cold surface, causing the water vapour in the air to condense on the surface. Water vapour is generated from regular occupant activities, such as cooking, bathing, cleaning, etc. Most suites we reviewed with condensation issues had a high relative humidity (between 50% and 60%) with an average temperature of 20°C. The relative humidity can be reduced by increasing the ventilation and air circulation within the suite and, in particular, over window and door surfaces.

Photo 19: Condensation on window framing.

If not addressed, condensation can lead to mold/mildew growth and potential health hazards. To reduce the risk of condensation we recommend that residents carry out the following:

- Run bathroom exhaust fans (or allow the humidistat to operate where they have been installed) to maintain a relative humidity level between 25% and 40% (with the indoor temperature around 18°C to 24°C). The windows should be monitored for condensation and the humidistat setting adjusted, if needed. To prevent condensation from occurring during significantly cold outdoor temperatures, lower humidity levels may be required. Installation of a humidistat at all bathrooms could also be considered, to automatically regulate humidity levels at this area of the suite.

- Check that dryer lint traps are clean before each use.
- Run kitchen fans while cooking.
- Open windows to help ventilate air.
- Keep fans in good running condition.

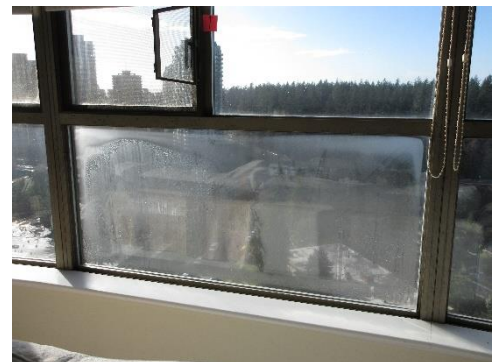
The majority of the suites reviewed had at least one or more failed IGU, where there is visible moisture or moisture staining trapped between the two panes of glass. Some suites had newer IGUs which were installed around 1999; however, the failed IGUs appeared to be limited to the original IGUs date stamped 1990.

Photo 20: Typical failed IGU.

IGU failure generally occurs when the glazing seals holding the glass to the spacer bar become compromised (i.e. if the seals become brittle/cracked over time, damaged from movement, or were poorly installed, etc.), allowing air and/or moisture to enter the space within the IGU. Failure can occur without any visible signs, as IGUs generally have desiccants placed in the spacer bar to absorb moisture within the air space. However, as the desiccants in the failed IGUs are expended over time, moisture can begin to build up and become trapped in the air space, forming condensation on the glass surfaces.

The air space in the IGUs provides the insulating properties for the IGUs. Once the sealed air space is compromised, the overall thermal performance of the IGUs is reduced. As such, the suites with failed IGUs may be experiencing increased heat loss and/or heat gain through failed IGUs, and are also more susceptible to condensation forming on the interior glass surface.

IGUs typically have a service life of around 25 years. As IGUs approach the 25-year mark, the glazing seals generally start to become brittle, resulting in failure of the IGUs. The original IGUs are currently around 28 years old. As such, the IGU failures are typical for the age of the units. IGUs without visible signs of failure may have already failed or are about to fail. As such, an IGU replacement program should be implemented if the windows are not going to be replaced in the near future.

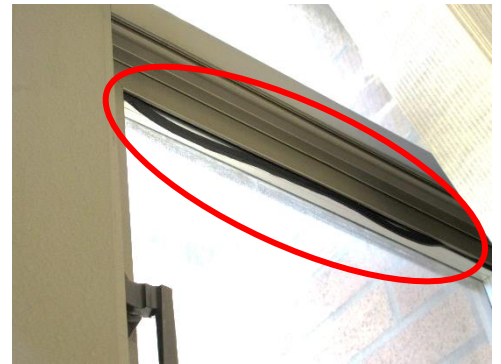
The interior glazing seals around the perimeter of the IGUs have shrunk or are seeping out of the window frames at several suites, compromising the window air and water seal at that location. Air leakage can also facilitate condensation within the window frame. The internal glazing seals should be cut back where they are beginning to seep out of the window framing, and where there is limited seal remaining, the interior glazing seals should be replaced or caulked.

Photo 21: Interior glazing sagging out of window frame.

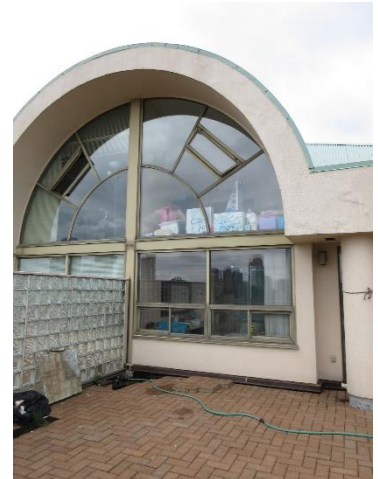
3.1.2.9 Failed caulking and open joints at the PH-3 upper roof deck arched window caused active leakage into the suite. A sealant repair project at the arched window was completed in 2020.

The arched window at the PH-3's upper roof deck had deteriorated caulking and open joints at the window frames. The majority of the exterior window frame joints was generally cracked, split, and failed throughout. The Suite Owners also had reported active leakage at and below the window during rain events. Previous water testing of the window also confirmed that the window was actively leaking at failed joints.

Photo 22: PH-3 upper roof deck arched window

To address the leakage, all existing sealant was replaced and unsealed joints were sealed. This work was completed throughout the entire arched window assembly and extended over to the adjacent suite, as the window assembly spans across the two suites.

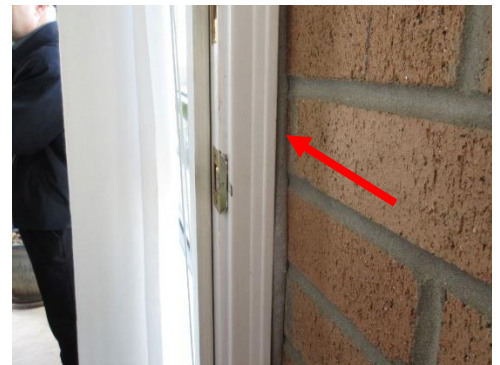
There are wood swing doors throughout the building to access roof decks and balconies. Wood doors are generally not durable enough for use on high-rise buildings, as they are not built to withstand the wind pressures that high buildings are typically exposed to. Further, the glazing stops on the exterior of the doors are plastic, and are discolored (yellowing), brittle and cracking at several locations, compromising the retention of the glazing in the doors. The door frames are also not caulked to the exterior cladding at most locations reviewed, which may be allowing drafts into the suites around the doors. Highrise buildings are also intended to be primarily constructed on non-combustible materials for fire-safety reasons, which the doors are not.

Photo 23: Wood door frame to brick cladding joint not caulked.

The door perimeters should be caulked to reduce the potential for water and air infiltration at these unprotected joints. Alternatively, the Strata may want to consider upgrading the swing doors with more durable assemblies, such as metal doors.

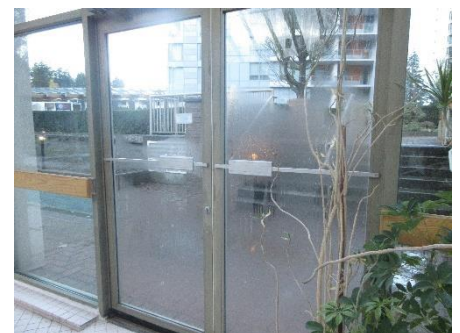
The pool room has a single pane double swing door, where condensation is forming on the interior side of the glass due to humid air in the space settling on the cold surface of the glass. Excess condensation forming on these doors will require regular cleaning in order to reduce the risk of mold growth on these surfaces. The single pane glass is also reducing the overall thermal performance of the pool area.

Photo 24: Single pane double swing door.

Consideration can be given to replacing the single pane glass with insulating glazing units in order to reduce the occurrence ongoing condensation and improve thermal performance of the doors.

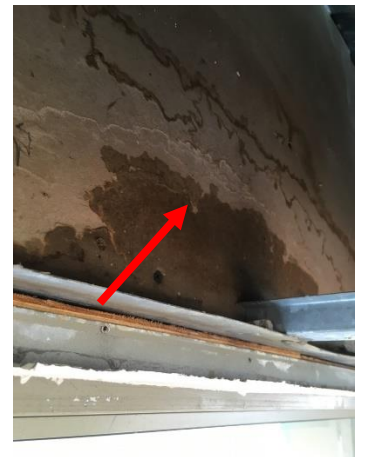
Photo 28: Water stain above PH-1 sliding door head, roof soffit space.

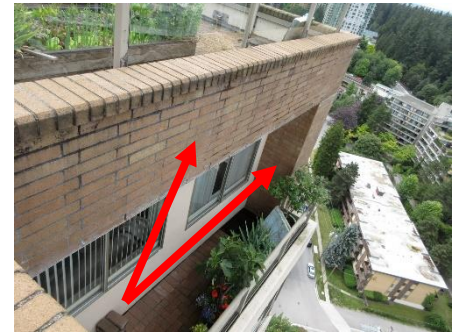
Photo 30: Brick cladding column and unprotected brick on a horizontal surface

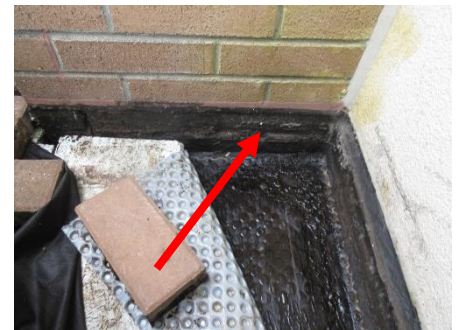
Photo 31: Waterproofing membrane upturns onto the outside surface of the brick cladding.

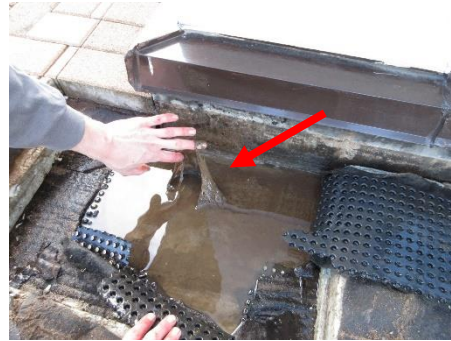
Photo 33: Ponding water and deteriorate membrane at roof opening at PH-1 upper roof deck

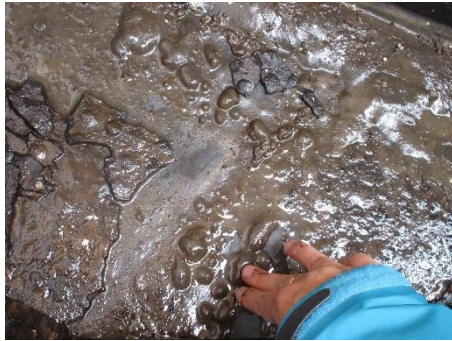
Photo 34: Waterproofing membrane with blisters at PH-6 roof deck.

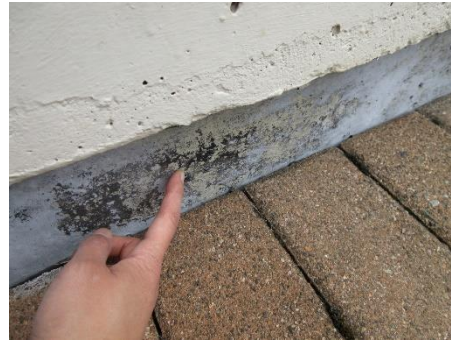
Photo 35: Flaked/peeled waterproofing membrane at PH-3 roof deck parapet wall

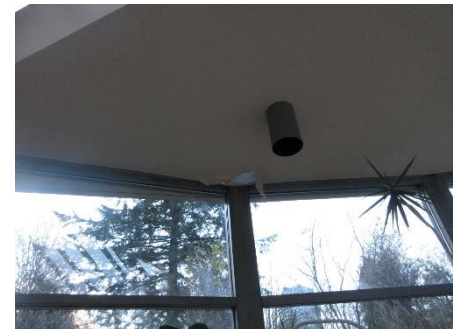
There is an active leak through the roof of the pool room at the south-west corner. The leakage is causing the ceiling finish to blister and peel, and the wood handrail below is beginning to deteriorate. It is likely that the EPDM roof gutter has a leak. The roof area above the leakage location should be investigated, and localized repairs completed in order to mitigate ongoing leakage.

Photo 36: Blistered and peeling ceiling paint in pool room below roof leak.

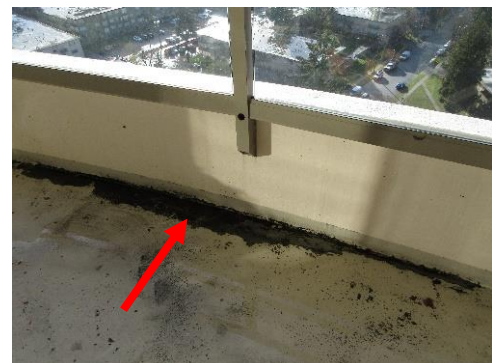
Photo 40: Failed balcony waterproofing membrane.

As it appears the slabs have been exposed for some time, due to failure of the membrane at many balcony locations, the Strata should have the post-tensioning reviewed to better understand the current condition of the building structure. Should the Strata have already had this work completed, a copy of the report should be forwarded to *Sense Engineering* to determine if further review of the post-tensioning system is required.

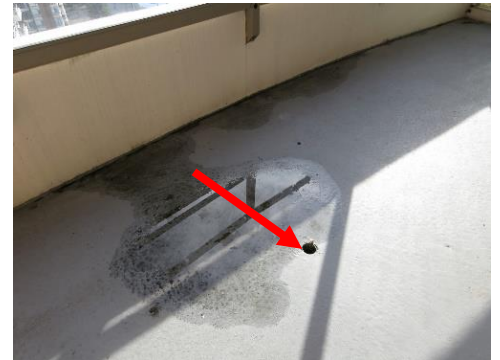
Many balconies were missing drain covers over their balcony area drains. Open area drains have a higher risk of becoming clogged, which can result in water ponding or flooding on the balconies, and cause damage to the drain piping. Balcony drains should be checked for clogging, and missing drain covers should be replaced, in order to reduce the risk of balcony drainage issues. We assume work would be completed as part of maintenance and have not included in cost for this work in section 5.

Photo 41: Missing balcony drain cover.

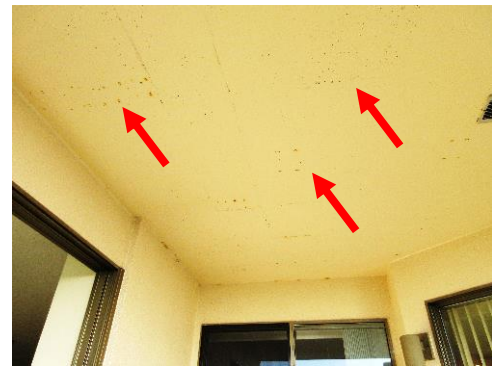
There is reinforcing steel/post tension cables chair staining on the soffits of the balconies, due to limited concrete cover over the reinforcing steel/post tension cables at the bottom of the concrete slab. The stains neither affect the structural or envelope performance and are generally more of an aesthetic issue. If the appearance of the rust staining is an issue to the Owner, the Strata could consider re-painting soffits every 5 to 7 years to conceal the rust staining.

Photo 42: Rebar staining on soffits.

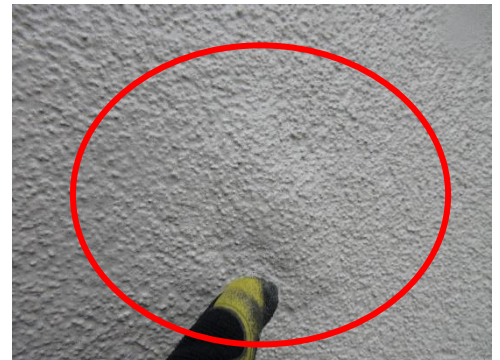
Photo 46: Blistered acrylic coating on concrete wall.

Localized repairs of the wall coating should be completed, in order to relieve the water build-up against the concrete and preventing further blistering or peeling of the coating and providing this risk of cracks into building.

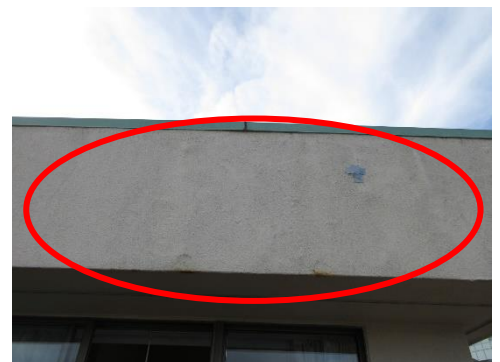
There are stucco blisters along the main roof parapet walls which are being caused by moisture finding its way behind the stucco cladding. A section of cap flashing between the gutter and parapet wall was removed above PH-1 where there was blistered stucco, which revealed that the gutter membrane does not extend over the top of the parapet wall. As such, if water is able to find its way past the metal flashing joints, or fill up in the gutter, the water can find its way behind the stucco at the top of the wall where it is not protected with waterproofing.

Photo 47: Blistered stucco at the main sloped roof parapet wall.

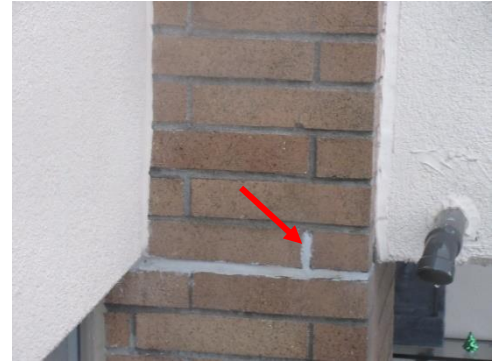
Photo 48: Caulked weep hole at brick veneer cladding.

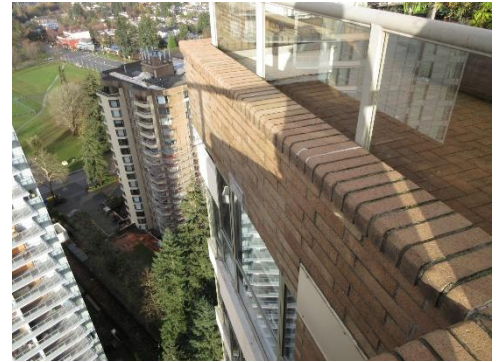
Photo 50: Brick clad parapet wall at penthouse roof deck.

Consideration should be given to installing a waterproofing membrane and sheet metal flashing over the brick caps in order to provide protection to the parapet wall.

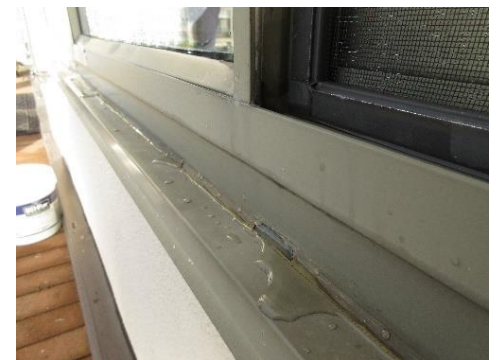
There are a few locations at the upper penthouse roof decks where the base of wall and sliding door sill flashings are back sloped and directing water back towards the building. The improperly directed water can find its way past the doors and walls at failed or improperly sealed joints. Repairs to these flashings is recommended in order to provide positive slope of the flashings, and direct water away from the building.

Photo 51: Back-sloped balcony flashings.
