## Depreciation Report

### Katsura & Sequoia Strata Plan BCS 1060

6233 Katsura Street & 9133 Hemlock Drive, Richmond BC.

Report No. 220357800

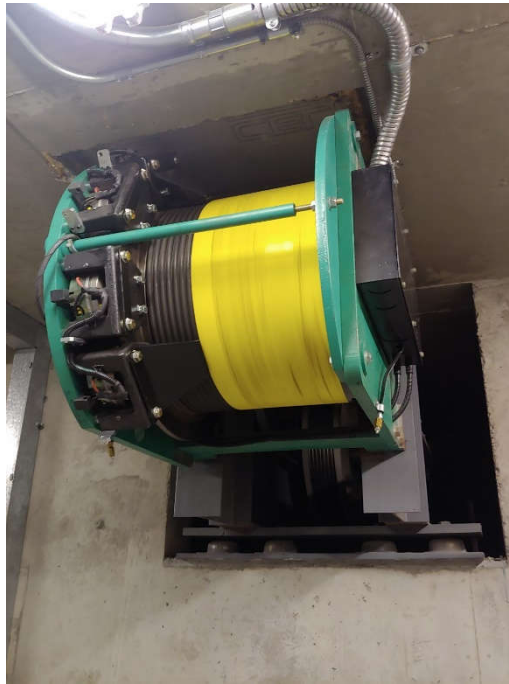
This particular line of gearless hoist machines by manufacturer Leroy Somers are known to have specific problems that warrant giving consideration to short term proactive replacement. There has been a concerning number of incidents involving these machines where the machine brakes were unable to hold the load required by code, the machine bearings failed prematurely, machine shafts failed outright, and/or due to extremely aggressive design rope replacements are required unusually frequently. Additional maintenance is also required for these machines as per revised manufacturer recommendations, especially relating to lubrication of the bearings. We have also frequently witnessed these machines installed in applications that exceed the manufacturer's published design thresholds of the machine (in terms of speeds and/or loads).

**Photo 1:** Elevator hoist machine

As a result of these concerns, we would recommend proactive replacement of these machines in the short term. Although costs for this work would vary considerably, we would recommend a conservative budget figure of \$150,000 per elevator to replace the machine, motor, drive unit and hoist ropes. The cost could be reduced if performed in conjunction with a major control modernization.

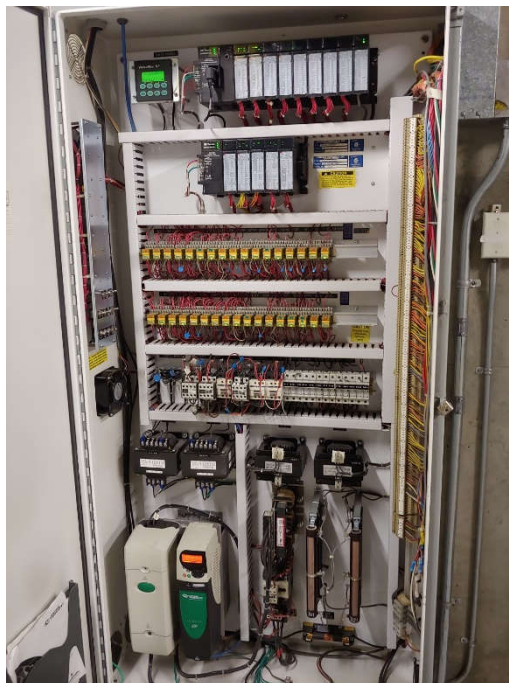
**Photo 2:** Elevator controller

Although major capital investment cycles for elevators can vary significantly depending on original equipment type, usage patterns, quality of maintenance, regulatory changes and technological advancements, major life cycle replacements are typically recommended every 25-30 years. Given existing the type of machines and the vintage of this equipment, we would recommend planning for a major life cycle upgrade of the elevator in 5 to 8 years.

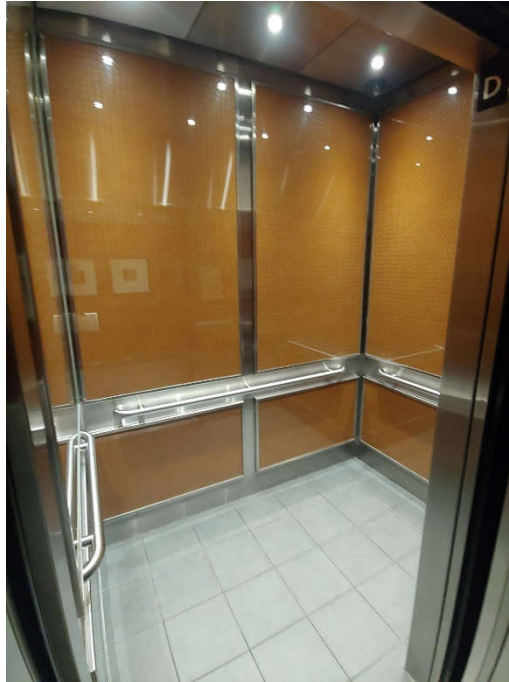
The existing cab finishes are in good condition. The cost to upgrade the cab finishes could range from \$15,000 to \$25,000 per elevator, depending on the finishes selected. We recommend using a figure of \$25,000 per elevator. We suggest the cab upgrades be performed in the next five to ten years with the modernization. The cost could be reduced if performed in conjunction with a major control modernization.

**Photo 5:** Elevator cab interior

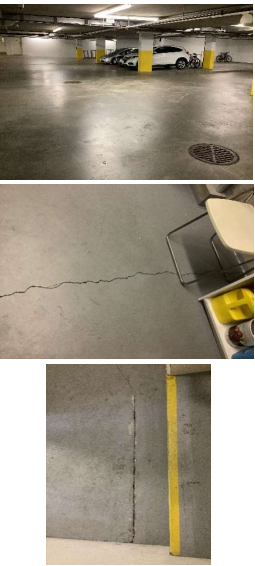
| PHOTOS | | COMPONENT | | CONDITION ASSESSMENT | | | RECOMMENDATION | | | LIFECYCLE DATA | | | | BUDGET | | |
|---|---|---|---|---|---|---|---|---|---|---|---|---|---|---|---|---|
| | BG01 | Concrete Structure | Parkade | The foundation walls are poured cast-in-place concrete supported on strip footings. The structural framing of the parkade consists of reinforced concrete slabs on reinforced concrete shear walls, foundation walls and columns. We noted various typical settlement cracking in isolated locations. | Fair | 2004 | A regular allowance has been included to address cracking as required. | Contingency | 2 | 19 | 5 | 5 | 1 | 100% | Y | \$6,000 |

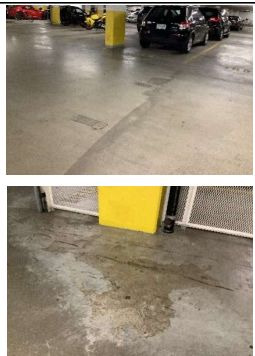
| PHOTOS | | COMPONENT | | CONDITION ASSESSMENT | | | RECOMMENDATION | | | LIFECYCLE DATA | | | | BUDGET | | |
|---|---|---|---|---|---|---|---|---|---|---|---|---|---|---|---|---|
| | BG03 | Suspended Slabs-Traffic Coating | Parkade Level P1 & P2 | The suspended slabs in the parking garage have been protected with a liquid-applied polyurethane waterproofing membrane system. Some repair patches were identified in different areas. | Fair | 2004 | Replacement of traffic coating, including repainting of stall and traffic lines at end of service life. Regular maintenance should include patch repair in high use areas (typically drive aisles). | Renewal | 3 | 19 | 20 | 3 | 3 | 100% | Y | \$898,000 |

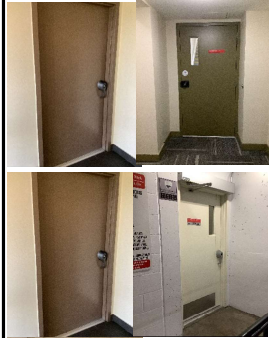
| PHOTOS | | COMPONENT | | CONDITION ASSESSMENT | | | RECOMMENDATION | | | LIFECYCLE DATA | | | | BUDGET | | |
|---|---|---|---|---|---|---|---|---|---|---|---|---|---|---|---|---|
| | BG06 | Man Doors | Parkade | There is one pedestrian exit door at grade. The door provide egress from the parking garage. The door is hollow metal with security glass in pressed steel frame and fire rated. Service room doors including mechanical, electrical and locker rooms, are typically hollow metal in pressed steel frames. | Good | 2004 | The man doors will likely last the life of the complex unless physically damaged. No capital replacements anticipated therefore individual replacements are assumed to completed as part of regular maintenance. | Renewal | Not Applicable | 19 | | | 1 | | N | |

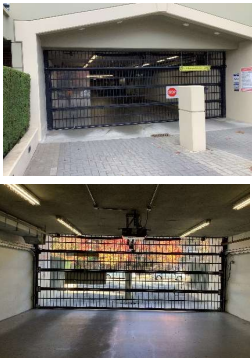
| PHOTOS | | COMPONENT | | CONDITION ASSESSMENT | | | RECOMMENDATION | | | LIFECYCLE DATA | | | | BUDGET | | |
|---|---|---|---|---|---|---|---|---|---|---|---|---|---|---|---|---|
| | BG07 | Overhead Doors - Metal | Parkade | There is an overhead door at the main parkade access to the below-grade levels. the main parkade access overhead door was painted in 2022. | Good | 2004 | Replacement of the overhead metal doors and operating system. | Renewal | 3 | 19 | 15 | 5 | 1 | 100% | Y | \$16,000 |

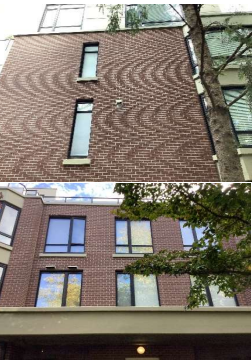
| PHOTOS | | COMPONENT | | CONDITION ASSESSMENT | | | RECOMMENDATION | | | LIFECYCLE DATA | | | | BUDGET | | |
|---|---|---|---|---|---|---|---|---|---|---|---|---|---|---|---|---|
| | EW02 | Brick Veneer Cladding | All Elevations Townhouses. | Drained cavity brick cladding is used at the townhouses. The assembly is brick, air space, moisture barrier applied to the concrete wall. | Good | 2004 | Brick is expected to last the life of the building, however, localized replacement and mortar joint repointing is required. | Repair Allowance | 3 | 19 | 20 | 5 | 1 | 100% | Y | \$90,000 |

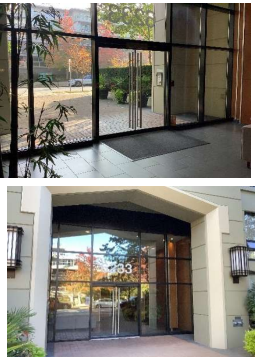
| PHOTOS | | COMPONENT | | CONDITION ASSESSMENT | | | RECOMMENDATION | | | LIFECYCLE DATA | | | | BUDGET | | |
|---|---|---|---|---|---|---|---|---|---|---|---|---|---|---|---|---|
| | GS09 | Lobby Doors | East and South Elevation of Towers | Main access to the front and rear lobbies on the East and South elevations are provided with glazed aluminum door assemblies in metal frames. | Good | 2004 | Replace the lobby door assemblies at the end of their service life. | Renewal | 3 | 19 | 40 | 21 | 1 | 100% | Y | \$21,000 |

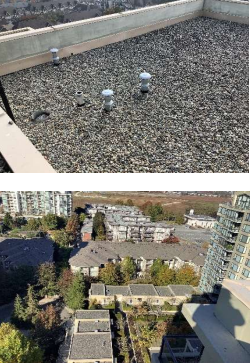
| PHOTOS | | COMPONENT | | CONDITION ASSESSMENT | | | RECOMMENDATION | | | LIFECYCLE DATA | | | | BUDGET | | |
|---|---|---|---|---|---|---|---|---|---|---|---|---|---|---|---|---|
| | RS01 | Flat roof | Tower & Townhouse Roofs | The tower roof system is a protected membrane roof (PMR) system, a system in which the membrane is located below insulation and ballast. The roof assembly consists of a waterproofing membrane directly applied to the concrete deck with drainage mat, insulation, filter fabric, finished with gravel ballast. This assembly is in place at rooftop level of the tower, over the rooftop mechanical rooms, and over stairwells at townhouses. We were unable to review the membrane due to the overburden material. | Good | 2004 | Replacement of the roof membranes at the end of the service life, including all associated work such as flashing replacement and joint sealing. Assumes the majority of ballast and insulation will be reused. Membranes can have a life expectancy from 15-30 years depending on the type. We assume SBS or better was installed during construction. No roof replacement, Repairs & maintenance of roof drains, scuppers, flashing, vents and anchors are included in the annual maintenance. | Renewal | 3 | 19 | 30 | 11 | 4 | 100% | Y | \$2,573,000 |

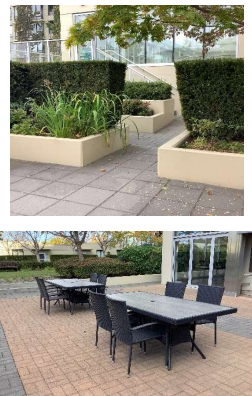
| PHOTOS | | COMPONENT | | CONDITION ASSESSMENT | | | RECOMMENDATION | | | LIFECYCLE DATA | | | | BUDGET | | |
|---|---|---|---|---|---|---|---|---|---|---|---|---|---|---|---|---|
| | RS04 | Podium Waterproofing System | Over Parkade | The landscaped areas of the podium, including the courtyard areas and at grade levels are comprised of a liquid applied waterproofing membrane, composite drainage layer and filter fabric on top of the parkade roof suspended slab. Overburden includes planters, grass, paved walkways and a pond area. We were unable to review the membrane due to the overburden material. | Good | 2004 | Replace waterproofing membrane at end of service life. Cost includes removal and replacement of all overburden. | Renewal | 3 | 19 | 30 | 11 | 2 | 100% | Y | \$2,693,000 |

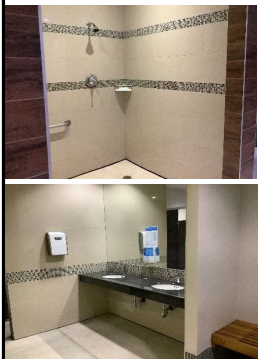
| PHOTOS | | COMPONENT | | CONDITION ASSESSMENT | | | RECOMMENDATION | | | LIFECYCLE DATA | | | | BUDGET | | |
|---|---|---|---|---|---|---|---|---|---|---|---|---|---|---|---|---|
| | IF09 | Washrooms | Ground Floor - Amenity Area | Amenity area include men and ladies changing and wash rooms. Finishes include tile flooring, painted drywall wall tiling, and various washroom related finishes. Renewal project was developed in 2013 including pool upgrades and lightinf replacement. | Good | 2013 | An allowance to renew finishes and equipment as needed. | Renewal | 3 | 10 | 15 | 5 | 1 | 100% | Y | \$15,000 |

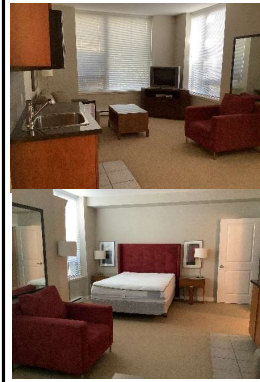
| PHOTOS | | COMPONENT | | CONDITION ASSESSMENT | | | RECOMMENDATION | | | LIFECYCLE DATA | | | | BUDGET | | |
|---|---|---|---|---|---|---|---|---|---|---|---|---|---|---|---|---|
| | IF10 | Amenity - Guest Suite | Ground Floor | There are two guest suite on ground floor of each tower. The rooms include carpeted flooring, painted gypsum walls and painted ceilings. Furnishes include a full bathroom. We understand various updates to the guest suite have been completed since construction. | Good | 2004 | An allowance to renew guest room finishes as needed. | Repair Allowance | 2 | 19 | 10 | 3 | 1 | 100% | Y | \$16,000 |

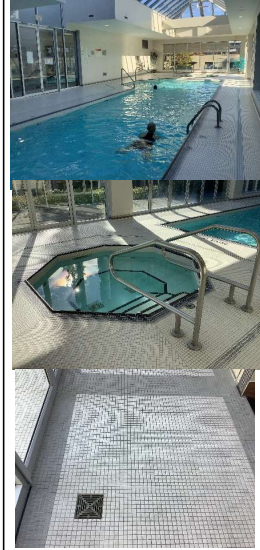
| PHOTOS | | COMPONENT | | CONDITION ASSESSMENT | | | RECOMMENDATION | | | LIFECYCLE DATA | | | | BUDGET | | |
|---|---|---|---|---|---|---|---|---|---|---|---|---|---|---|---|---|
| | IF13 | Pool Area | Ground Floor - Amenity Area | Pool area includes tile flooring, epoxy paint in walls, and jacuzzi area. Pool area was covered in a renovation project in 2013, including lighting replacement. | Good | 2013 | An allowance to renew finishes and equipment as needed. | Renewal | 3 | 10 | 15 | 5 | 1 | 100% | Y | \$50,000 |

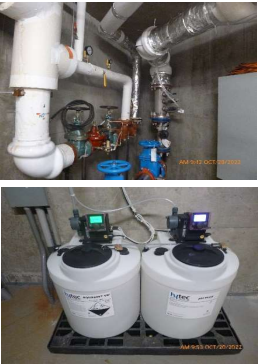
| PHOTOS | | COMPONENT | | CONDITION ASSESSMENT | | | RECOMMENDATION | | | LIFECYCLE DATA | | | | BUDGET | | |
|---|---|---|---|---|---|---|---|---|---|---|---|---|---|---|---|---|
| | MS03 | Domestic Water Distribution - Pipes | Throughout Building | DCW and domestic hot water (DHW) is distributed throughout the building with copper pipework. The 6" copper line going to the boiler room on the roof is split into two 4incopper pipes feeding the two boilers and the four HW tanks.<br><br>The domestic cold water is treated with Hytec water treatment system.<br><br>The condition of the interior of the pipes is unknown, and the insulation also renders the exterior of the pipe not visible. Given the age of the pipework, it is assumed to be in good condition. | Fair | 2019 | The life expectancy for copper pipework used for domestic water distribution ranges from 20-25 years . Re-piping a building requires demolition of wall finishings, removal of existing header and riser piping, replacement of all piping, and refinishing of demolished areas. Stainless steel piping is recommended as a replacement, as it is constructed with thicker walls, which extends service life significantly. Stainless steel re-piping typically has a cost of approximately \$8,150.00 per unit in the building. This cost estimate incorporates replacement of DCW, DHW and hot water recirculation piping risers and headers. | Renewal | 3 | 4 | 25 | 21 | 1 | 100% | Y | \$2,537,000 |
