Diamond Head Consulting Ltd. Arborist Report

13395 Amble Wood Drive
Surrey, BC V4A 6C6

November 13, 2015

To be submitted with Tree Protection Plan
Dated: Nov 17, 2015

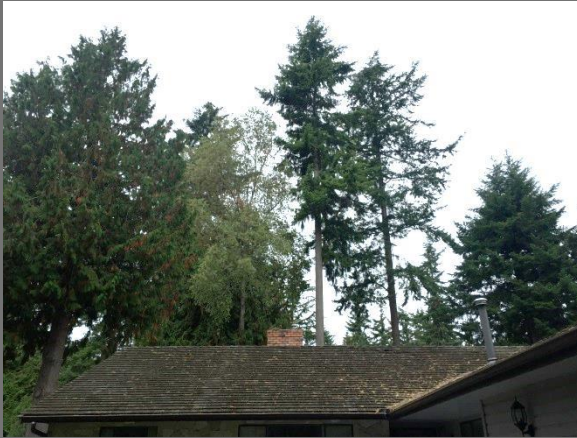
Photo 1. Looking south at the trees located in the backyard.

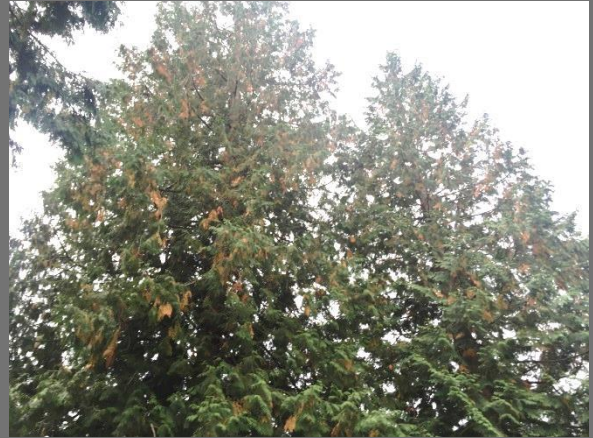
Photo 2. Looking west at the row of cedars along the western boundary.

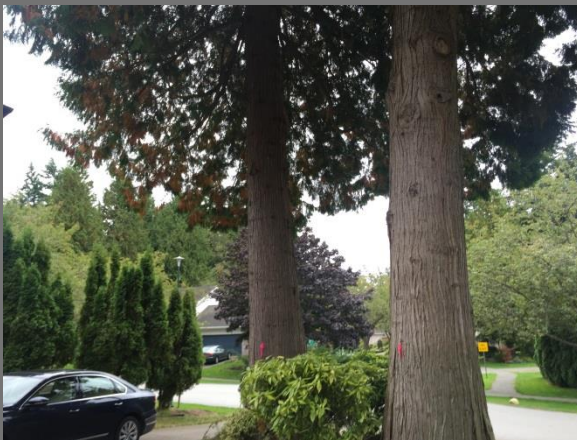
Photo 3. Looking at trees 362 and 363 at the front of the lot.

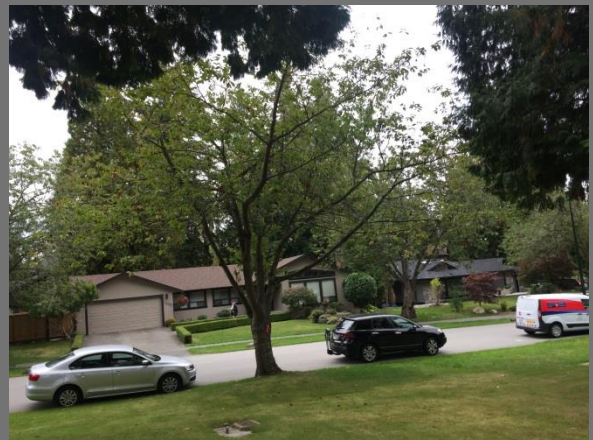
Photo 4. Looking at the City tree at the front of the lot.

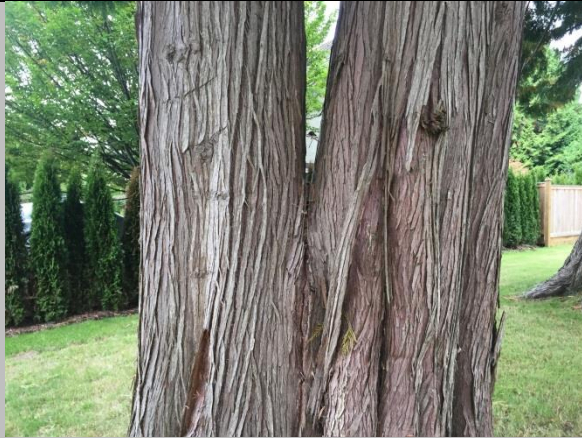
Photo 5. Looking at the inclusion on tree 360.

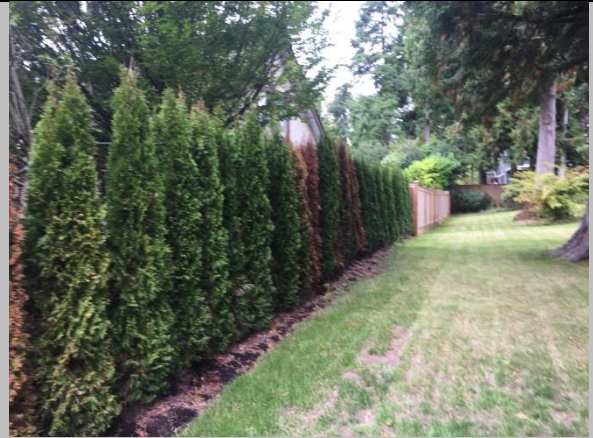
Photo 6. Looking at the hedging along the western edge.

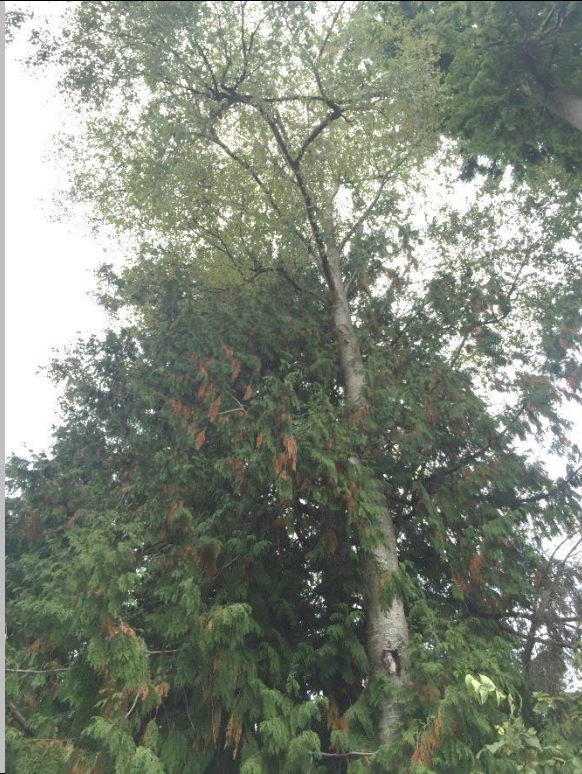
Photo 7. Looking at tree 394, the larger birch in the rear yard. There is dieback in the crown and a wound on the stem.

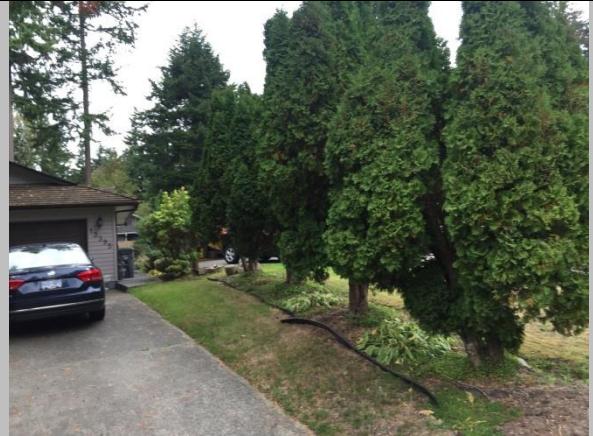
Photo 8. Looking at the neighbors hedging on the east side.

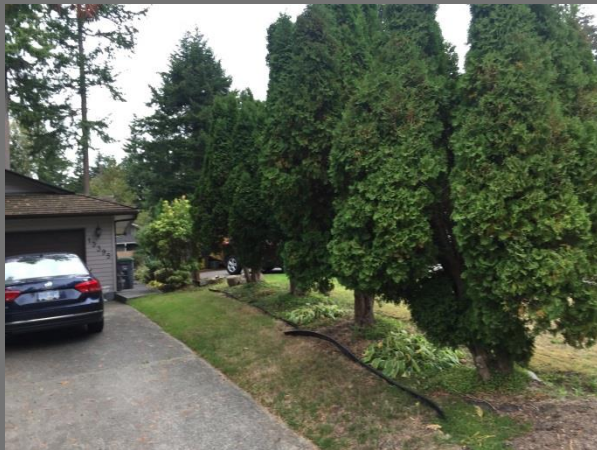
Photo 1. Offsite trees 2-5 – These trees are shared according to the survey.

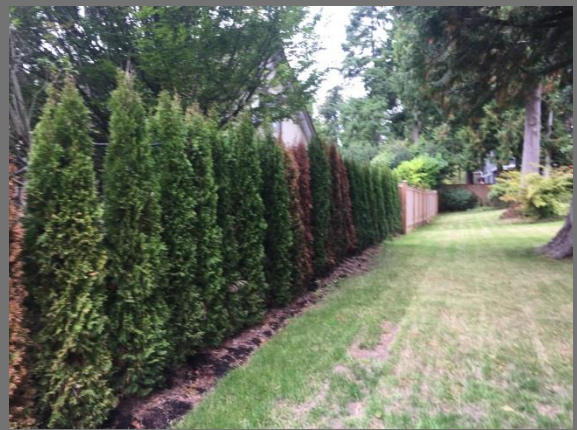
Photo 2. Offsite hedge 1.
