Inspection Report

Project Haro Glen – Strata Plan VR406 **Date** October 20, 2010
Site Address 1717 Haro Street **Temp.** _____
Vancouver, B.C. **Weather** _____
General Contractor _____
Site Supervisor Jason Kurtz (w_ford@hotmail.com)

Purpose: Request to review existing conditions of balcony posts and balcony deck vinyl membrane.
 Also to observe repairs to posts and vinyl decks.

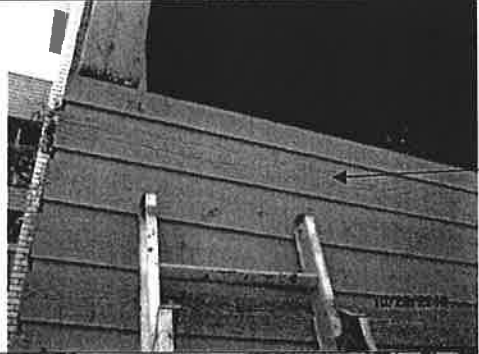
2.1

<p>North Elevation – 2nd Floor Balcony</p> <p>Balconies are enclosed on one side and covered with shiplap wood siding</p> <p>Enclosed walls are 2X4 stud walls with shiplap over the studs</p>
2.2

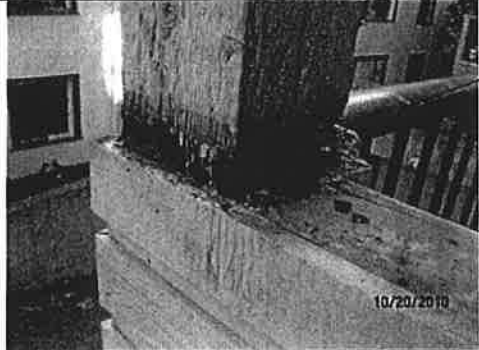
<p>North Elevation – 2nd Floor Balcony</p> <p>6X6 structural balcony posts are rotting at the top of the enclosed walls due to water getting trapped between the wood top and cap and the post</p>

The balcony posts are 6X6 fir structural posts designed to support the beams that carry the balcony assemblies. There is considerable deterioration in the balcony posts where the wood caps for the balcony ½ walls wrapped around the posts. Water trapped between the wood cap and the post has resulted in wood rot to the post in the area behind the wood caps. See Item 2.2

- 1) A structural engineer should be consulted to review the deterioration of the 6X6 balcony posts.
- 2) The peel and stick upgrade to the ½ walls and balcony posts will probably extend the life of the balcony walls and may protect the posts from further deterioration in the areas that are protected with peel and stick. However deterioration of the balcony posts may continue above the top cap and inside the balcony walls. Although the balcony walls are now protected at the top with peel and stick other areas on the balcony ½ walls will still allow water ingress. Eg. 45 degree corners, no building paper behind the wood siding. The above repairs would be considered temporary.

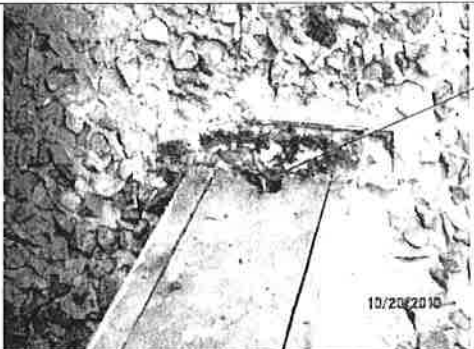
<p>North Elevation – 2nd Floor Balcony</p> <p>Some rotting of the 2X4 top plate on the enclosed balcony walls is evident</p> <p>This is due to water ingress at the joint between the stucco and the wood top plate</p>
2.4

Wood rot was also noted in the top plates in the balcony ½ walls. See Item 2.3

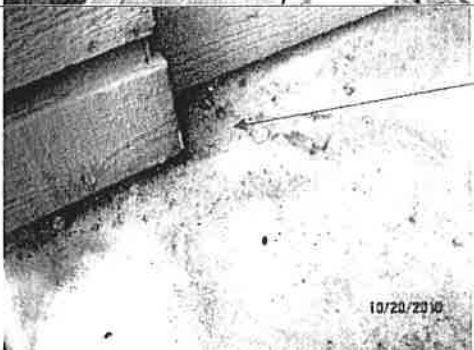
<p>West Elevation – Top Floor Balcony</p> <p>Tenting and voids in the vinyl deck membrane are evident</p> <p>Water is getting in behind the vinyl as there is no building paper to overlap the vinyl</p>
2.5

Balcony deck membranes are vinyl with felt backing. Tenting (voids under vinyl membrane) was noted on the 4th floor balcony membrane. This is the result of moisture ingress between the vinyl membrane and the substrate. See Item 2.4

- 3) The repairs to the vinyl deck membrane are acceptable. Nothing more can be done except to replace the deck membrane. The vinyl on some of the decks is lifting, some cuts in the membrane were evident and water ingress was noted. Damage to the balcony decks cannot be assessed without removing some deck vinyl and wood siding. If vinyl deck membranes are to be replaced, the vinyl should extend up the adjacent walls 8" and building paper should overlap the vinyl membrane.

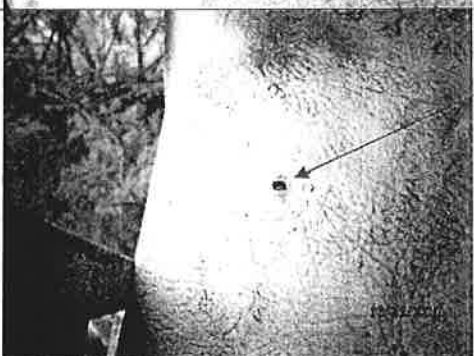
<p>West Elevation – Top Floor Balcony</p> <p>Surface mount railings have allowed water ingress at the screw holes</p> <p>Damage to plywood subfloor is probable</p>
2.6

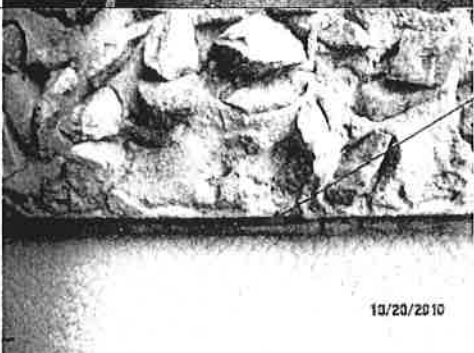
<p>West Elevation – Top Floor Balcony</p> <p>Vinyl deck membrane has been returned up the walls to the underside of the stucco and caulked along the bottom of the stucco</p> <p>Vinyl is loose and water is getting in behind the vinyl deck membrane</p>

It is possible that moisture is getting behind the vinyl membrane where it returns up the walls under the stucco and under the ½ walls. Vinyl deck membrane is loose in the areas where the balcony railings were secured through the top of the vinyl. See Item 2.6

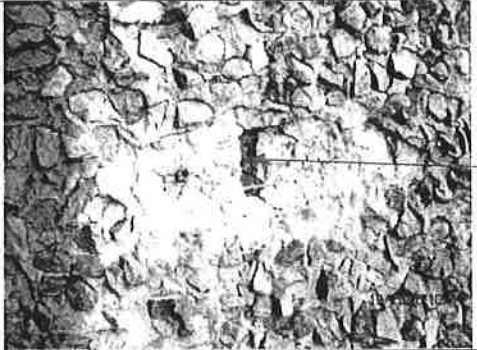
2.7

<p>West Elevation – Top Floor Balcony</p> <p>Stucco is damaged where railings have been attached through the stucco walls</p> <p>Penetrations in the stucco walls will allow moisture ingress behind the stucco</p>

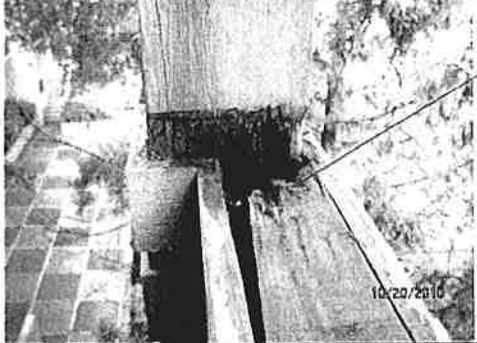
2.8

<p>West Elevation – Top Floor Balcony</p> <p>Significant rotting of the 2X4 top plate on the enclosed balcony walls is evident</p> <p>This is also due to water ingress at the joint between the post and the wood top plate</p>

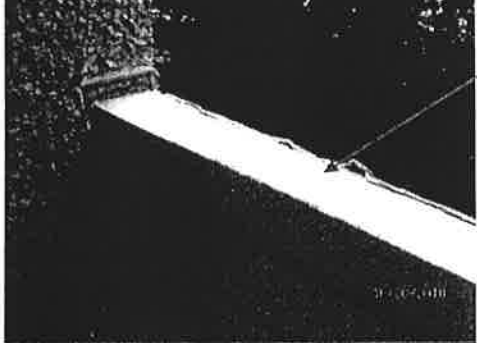
2.9

<p>Balconies</p> <p>Peel and stick and stick has been installed to the top of the enclosed balcony walls and returned over the edges of the wood siding</p>
