3010.10**Shawnoaks Targeted Condition Assessment****January 23, 2008****REGARDING Recreation Building Condition Assessment**

RDH Building Engineering Ltd. (RDH) was retained by Rancho Property Management to assess the condition of the building enclosure at the Shawnoaks Recreation Building and provide a brief letter report discussing our findings. This letter report has been written for an audience familiar with the Shawnoaks Recreation Building and the ongoing building enclosure concerns.

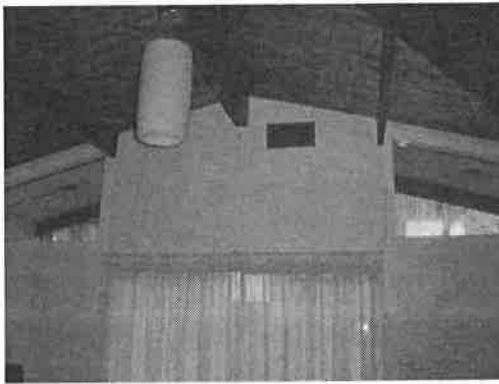
Fig. 1.2.1. Gable Vent In Common Area

There are vents on the east and west elevation of the common area (Fig. 1.2.1). The dressing room and shower area is vented through the low slope roof assembly above (Fig. 1.2.2).

The existing interior ventilation provisions should be further investigated at the time of exterior wall rehabilitation.

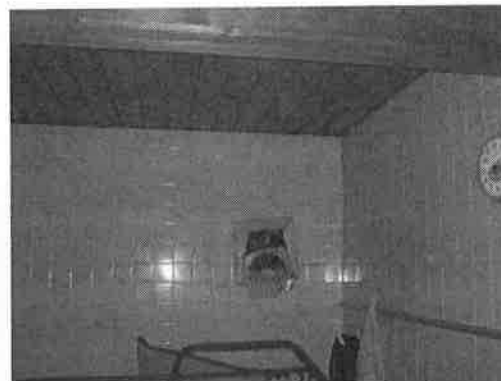
Fig. 1.2.4. Whirlpool Room

There is a broken exhaust fan within the whirlpool room which is mounted into the exterior wall assembly (Fig. 1.2.4). The interior walls of the whirlpool room are finished with ceramic wall tile. The whirlpool has been abandoned.

Prior to the rehabilitation the Owners should consider the function to be provided by this building. Considering that the whirl pool has been decommissioned it may be prudent to have it removed while the exterior walls are removed during the rehabilitation.

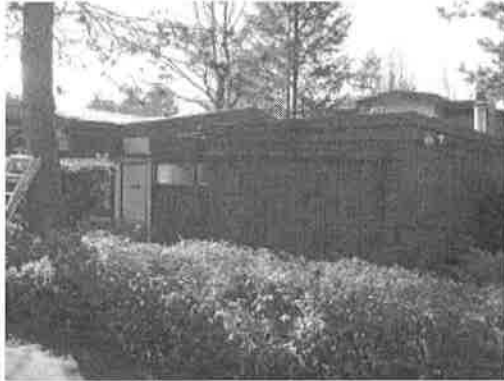
Fig. 1.3.1. Typical Wall Assembly Below Low Slope Roof Area (Northeast Corner)

The exterior wall assembly below the low slope roof area over the amenities area consists of vertical cedar cladding installed over building paper. The top of the wall is dressed with wooden fascia boards (Fig. 1.3.1). There is very little roof overhang to protect these walls.

Based on our observations the existing wall assemblies should be replaced with a new rainscreen wall assembly with improved interface detailing. The new wall assembly should include overhang protection for exposed swing door and window assemblies.

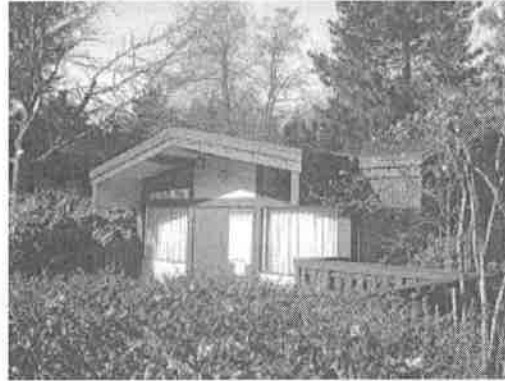
Fig. 1.3.2. Typical Wall Assembly Below Pyramid Type Sloped Roof Area (Southeast Corner)

The exterior cladding below the pyramid type sloped roof over the common area consists of painted dressed plywood infill panels installed over exterior sheathing and dressed with wood trim (Fig. 1.3.2).

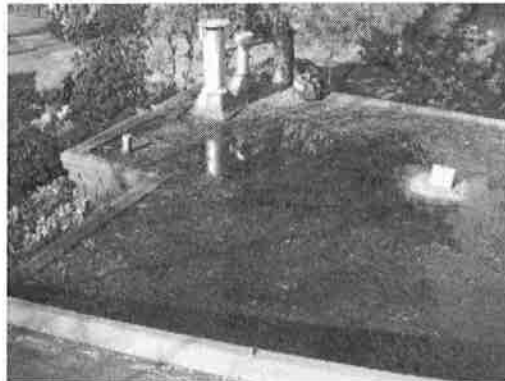
Fig. 1.4.2. Typical Flat Roof

The roof over the amenities area is a low slope built-up roof BUR assembly roof over structural wood planking and provides no overhang protection for the wall assemblies (Fig. 1.4.2).

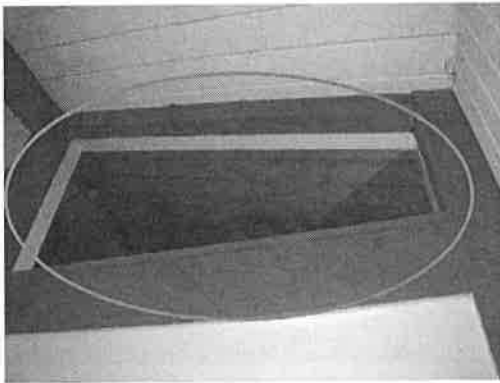
Fig. 1.5.1. Typical Field Glazed Single Pane Rake Window

The windows consist of field glazed single pane rake windows with wooden stops at the gable ends of the pyramid roof assembly with aluminum framed single glazed non-thermally broken windows at remaining areas around the building (Fig. 1.5.1). These types of window generally provide poor water penetration resistance and poor thermal performance. Most windows are protected by a significant overhang, however, the centrally located windows on the east and west elevations are located below the low slope roof and have no overhang protection (Fig. 1.5.2). There is no flashing or sealant present at these fully exposed window locations.

The existing windows provide poor thermal performance as well as poor condensation and water penetration resistance. We recommend the existing glazing assemblies be replaced with new double glazed, thermally broken window assemblies with improved interface detailing. This work should be performed in conjunction with the exterior wall rehabilitation.

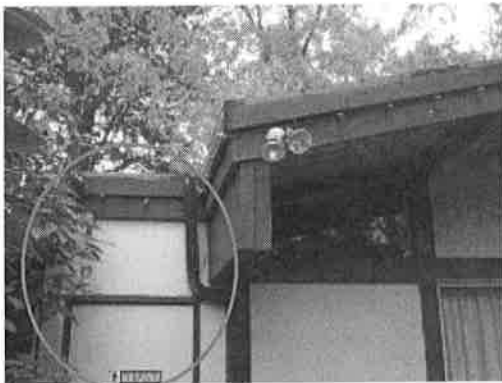
Fig. 1.6.1. Typical Exposed Swing Door

The entry doors are typical exterior wooden doors set into wooden casings with aluminum thresholds. This type of door assembly generally provides poor water penetration resistance.

The single swing entry doors on the east, west, and north elevation are situated in a high exposure location as there is no overhang protection. The head flashing over the exposed doors does not incorporate end dams and no sealant is present at the door casing to exterior cladding interface. There is a set of double swing entry doors on the south elevation adjacent to the outdoor pool area. These doors are situated in a low exposure location as they are protected by the roof overhang.

The exposed existing swing doors and casings are deteriorated to varying degrees at all high exposure locations. We recommend all existing door assemblies be replaced with new high performance door assemblies with improved interface detailing. Overhang protection should be provided over all existing exposed swing door assemblies.

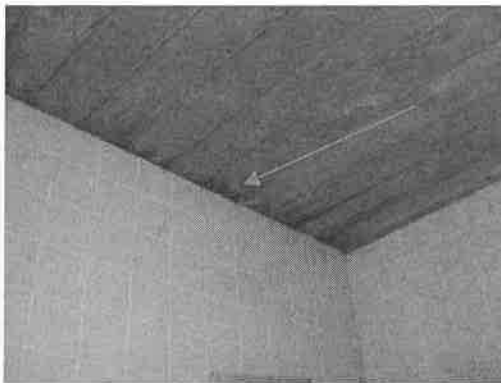
Fig. 2.1.1. Interior of East Wall in Whirlpool Room

- 1) Significant water staining at perimeter of roof planking likely as a result of water ingress through roof curb assembly above.

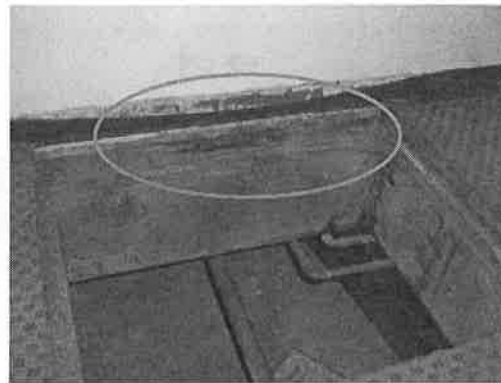
Fig. 2.1.2. Access Hatch to Crawl Space Below Common Area

- 1) Water is present at the base of the interior common area wall likely as a result of water ingress through the north facing gable end of the sloped pyramid type roof assembly

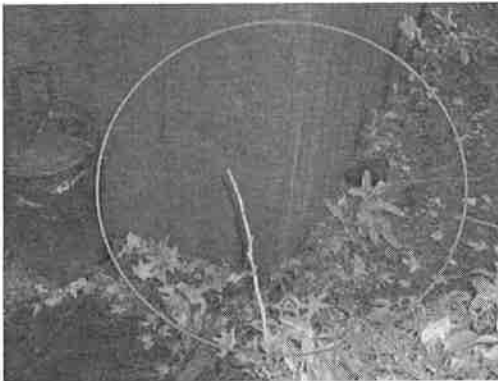
Fig. 2.2.1. Base of Wall on the East Elevation

- 1) There is no clearance between the exterior cladding and grade. This may result in extended wetting of moisture sensitive materials and deterioration. This does not conform to the British Columbia Building Code which requires 8" of separation between the exterior cladding and grade.

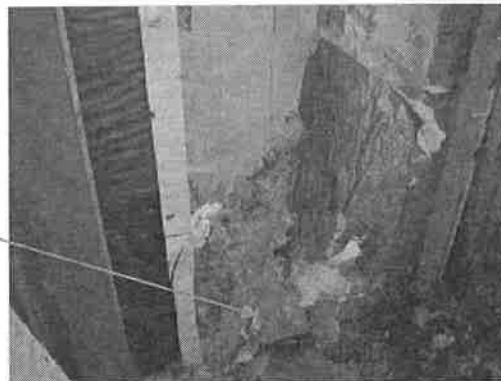
Fig. 2.2.2. Base of Wall on the East Elevation

- 1) There is significant deterioration of the underlying framing components and exterior cladding.
- 2) The insulation is wet and adhered to the back facer of the interior gypsum wall board which is also moisture damaged.

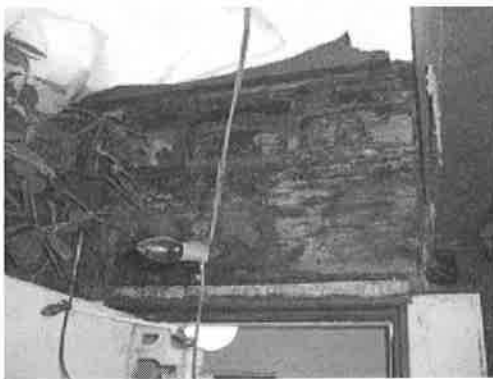
Fig. 2.2.3. Above West Elevation Entry Door

- 1) The structural lintel above the door and low slope roof parapet framing are significantly deteriorated.

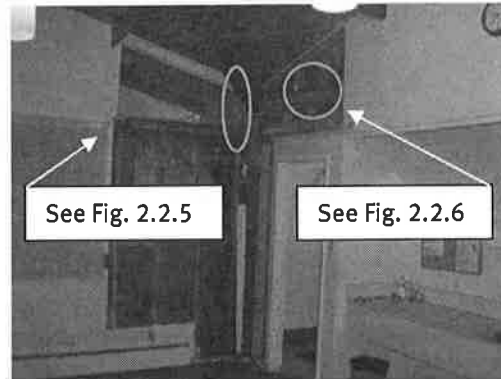
Fig. 2.2.4. View of Interior Exploratory Opening Below Northwest Corner of Sloped Roof

- 1) There is significant deterioration around the field glazed window and north-facing gable end wall.

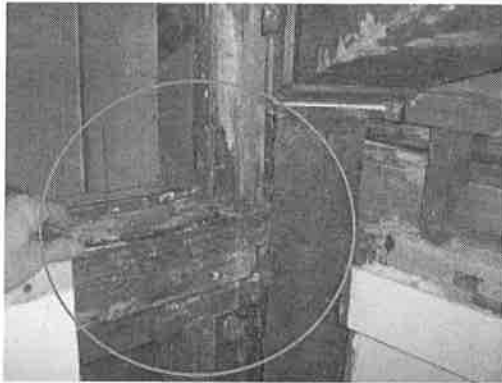
Fig. 2.2.5. Northwest Corner Common Area Window Sill

- 1) The framing adjacent to the structural steel column is significantly deteriorated.

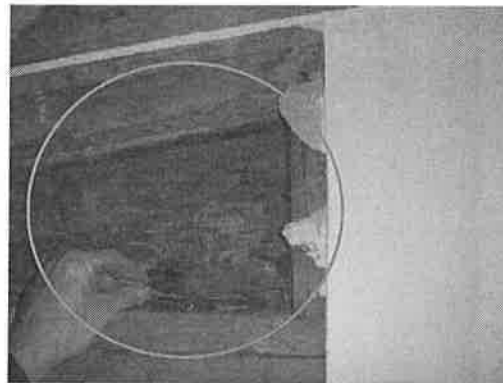
Fig. 2.2.6. Gable End Adjacent Northwest Corner in Common Area

- 1) There is significant deterioration of exterior sheathing at the north-facing gable end wall.

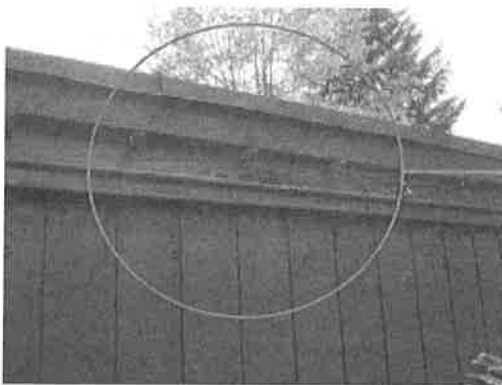
Fig. 2.2.7. Fascia at North Elevation Roof Curb

- 1) There is significant deterioration of roof curb fascia along the entire perimeter of the low slope roof area.

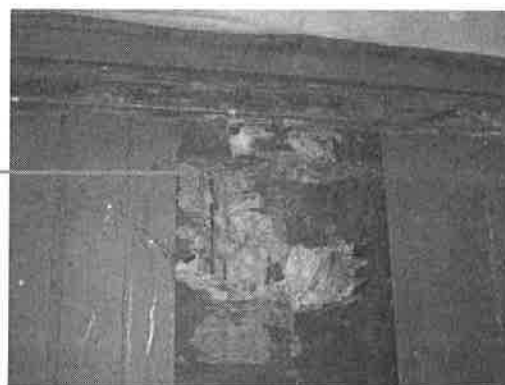
Fig. 2.2.8. Underlying Framing Below North Elevation Roof Curb Fascia

- 1) The underlying framing and sheathing are significantly deteriorated.

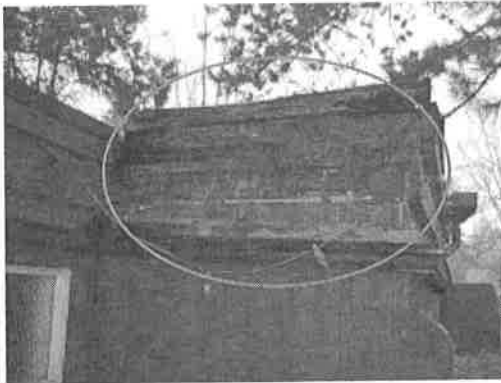
Fig. 2.2.9. South Face of the East Elevation Roof Curb and Wall Framing At The Low Slope Roof Area

- 1) There is significant deterioration of roof curb and wall framing.

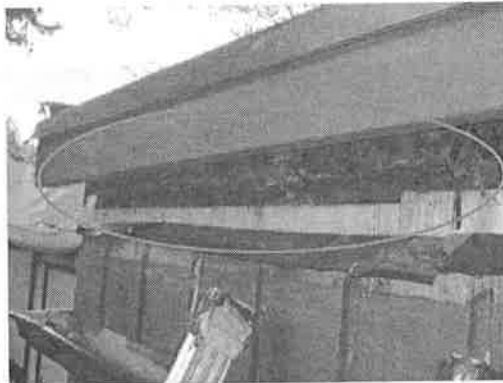
Fig. 2.2.10. East Elevation Roof Curb and Wall Framing Below Fascia At The Low Slope Roof Area

- 1) There is significant deterioration of roof curb and wall framing.

The exterior sheathing is in sound condition. The sheathing is date stamped 1999 suggesting it was replaced around that time. Based on the observed deterioration the underlying problems and deteriorated framing were not properly addressed.

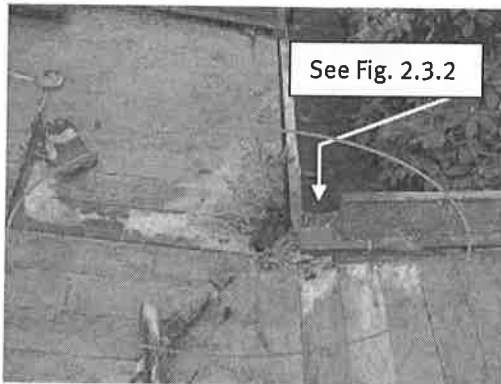
Fig. 2.3.1. Northwest Corner of Sloped Roof at Drain Location (Above Fig. 1.19)

- 1) The roof planking and lower wall framing are deteriorated. Note the white organic growth on the roof planking.

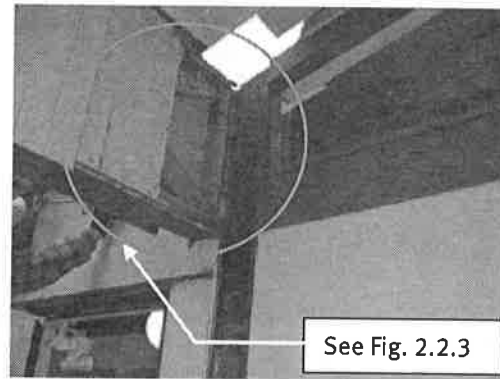
Fig. 2.3.2. Below Deterioration at Northwest Corner of Sloped Roof

- 1) The underlying wall sheathing and support framing are deteriorated.
- 2) The ellipse shows the existing roof overhang framing which consists of cross-braced pony wall framing attached to the wall framing. The wall framing is deteriorated and the overhang framing is structurally compromised.

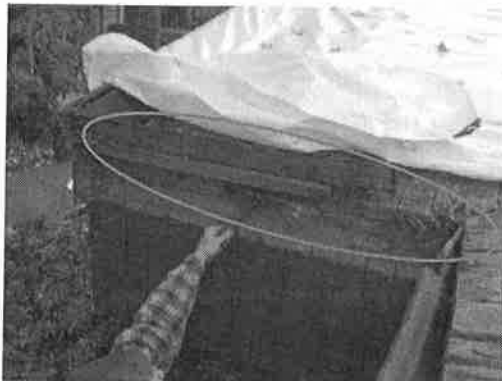
Fig. 2.3.3. Northeast Corner of Sloped Roof at Drain Location

- 1) The ends of the roof planking and underlying wall framing are deteriorated.

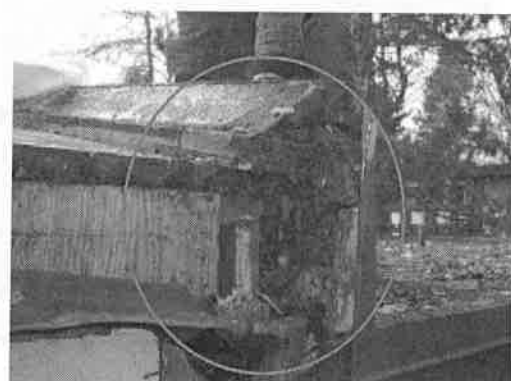
Fig. 2.3.4. Gable End at Southeast Corner of Low Slope Roof

- 1) There is significant deterioration of exterior sheathing at the north-facing gable end wall and roof curb.

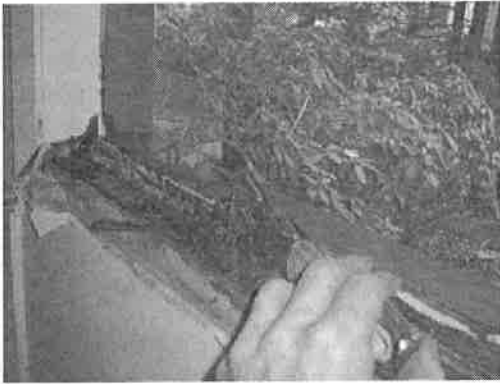
Fig. 2.4.1. West Elevation Single Pane Field Glazed Window Assembly

- 1) The window sill and underlying wood framing are extensively deteriorated.

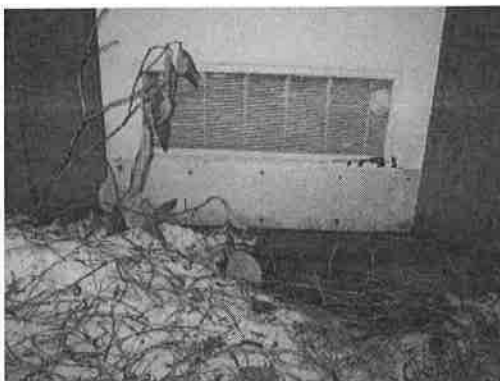
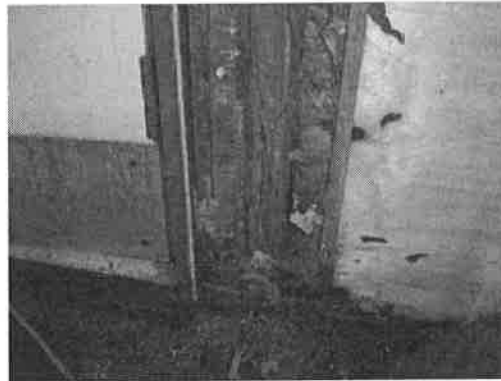
- 1) The door is deteriorated adjacent to the louver grill.
- 1) The wooden door casing and adjacent framing are deteriorated.
