# RDH Building Engineering Limited

**JOB NAME:** Pacific Point

No. of Copies	Item	Description
1	Building Envelope Condition Assessment Pacific Point – VR 2540	Additional colour copy of CA as requested.

**APPENDIX D – EXTERIOR OBSERVATIONS**

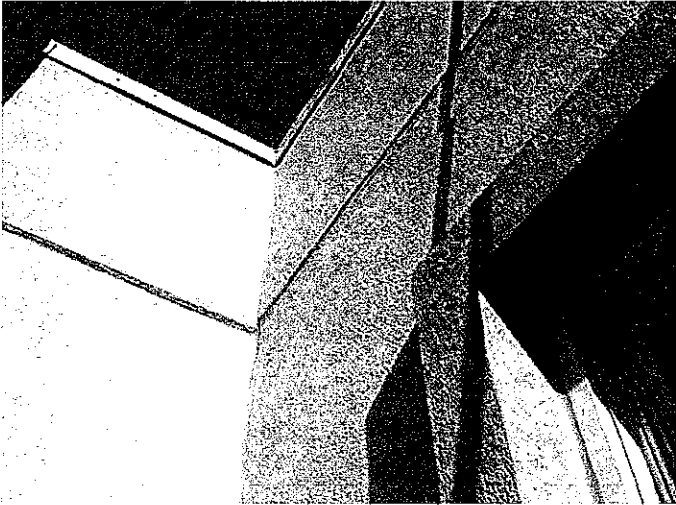
A03-01

- It appears that there is a coating over the EIFS panels. (Photo A03-01)
- The sealant at the window frame butt joints (mullions to frame) is discontinuous at several windows reviewed. (Photo A04-01)

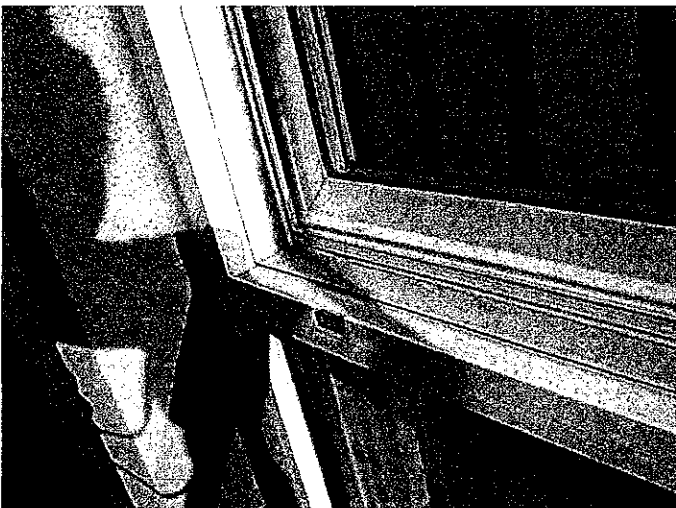
- The windows, accessible from drop #1, incorporate slider and awning style operable vents with moe-hair operable vent gaskets. (Photos A05-01 to A05-03).

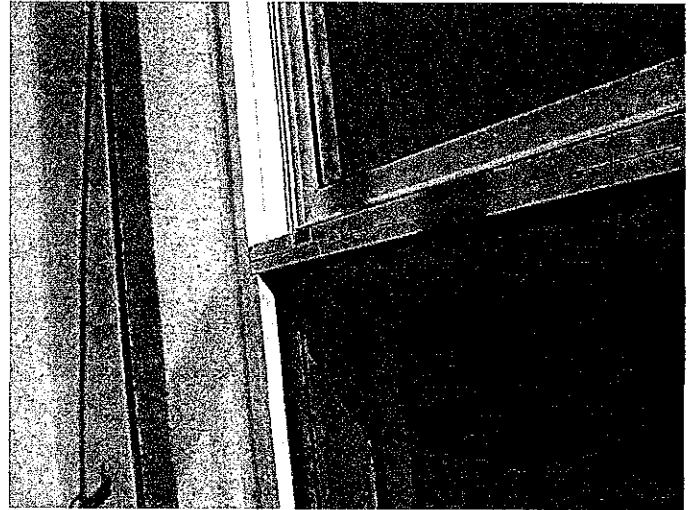
A06-01

- The window frame extrusions are typically "concealed barrier - improved" style. (Photo A06-01)
- Failed joint sealant was observed at several locations between the window frames and the adjacent EIFS. Some joints have failed cohesively and some joints have failed adhesively. (Photos A7-01 to A7-06)

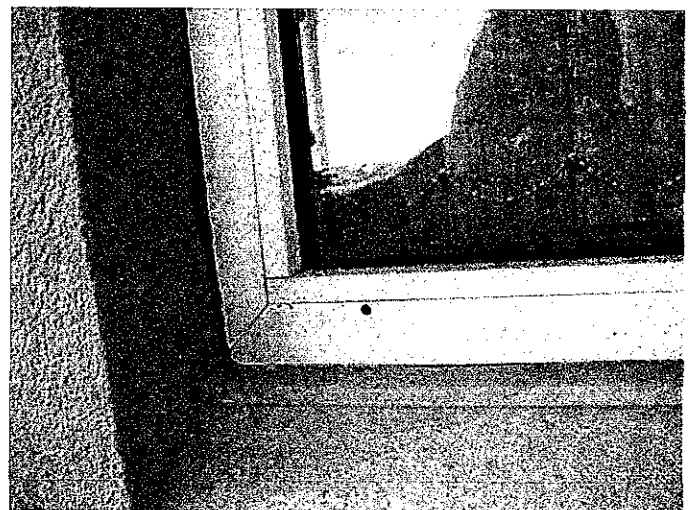
A11-01

- There are weepholes in the awning style windows. However, the weepholes are smaller than ¼ " in diameter. (Photo A11-01)
- The sealant between the EIFS cladding and the window frames does not have enough adhesive "bite" onto the window frames at numerous locations reviewed. Typically sealant should have a minimum of ¼" "bite". Typically, the sealant joints observed on drop #1 have less than 1/8" "bite" onto the frames. (Photos A12-01 to A12-02)

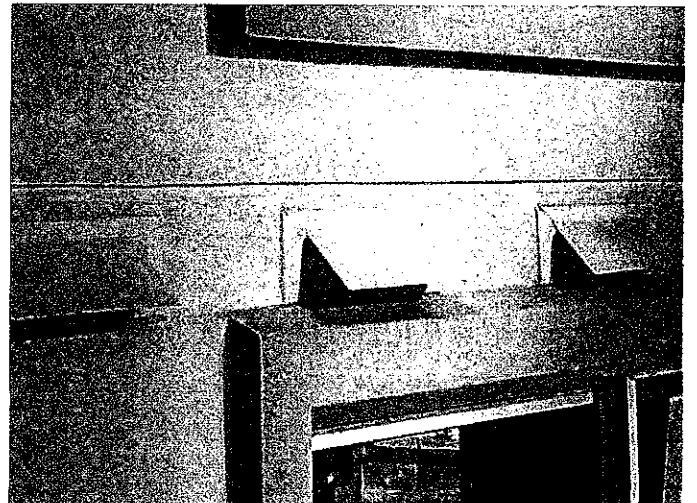
A13-01

- Exhaust vents are located directly above the EIFS window trim at various locations. Condensation was observed dripping from the EIFS trim at a few of these locations. (Photo A13-01)

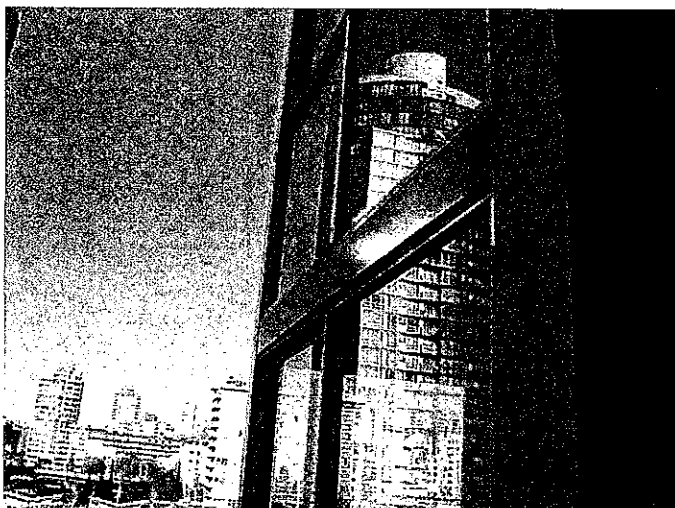
A14-01

- No weepholes were observed at the slab band panels at the enclosed balcony window wall assembly on the west side of drop #1. (Photo A14-01)
- One moisture reading was taken at the gypsum sheathing below a window corner. The moisture reading is 40 on the moisture meter reference scale. (Photo A15-01)

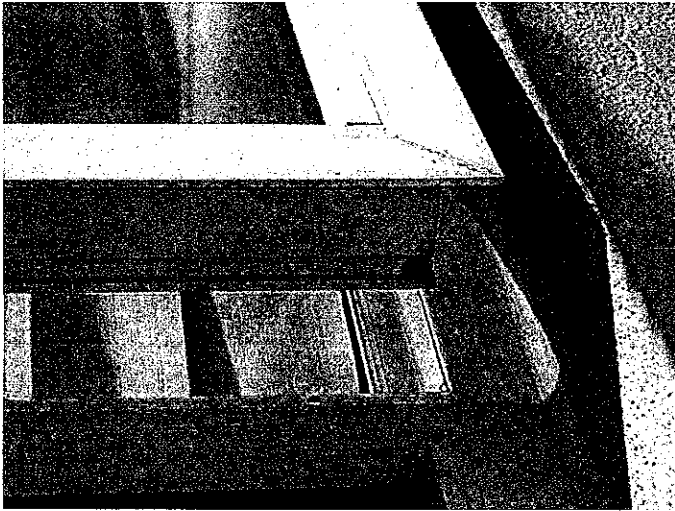
A16-01

- Various window frame fasteners are corroded at operable vents that are open. (Photo A16-01)
- The small roof area near the base of drop #1 was reviewed. The roofing membrane does not extend above the base of the EIFS cladding. The exterior gypsum is exposed. The exposed exterior gypsum appears to be deteriorated. (Photos A17-01 to A17-03)

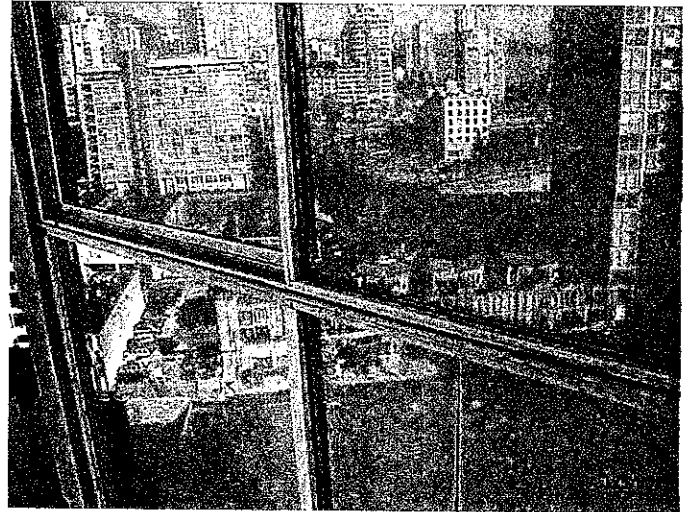
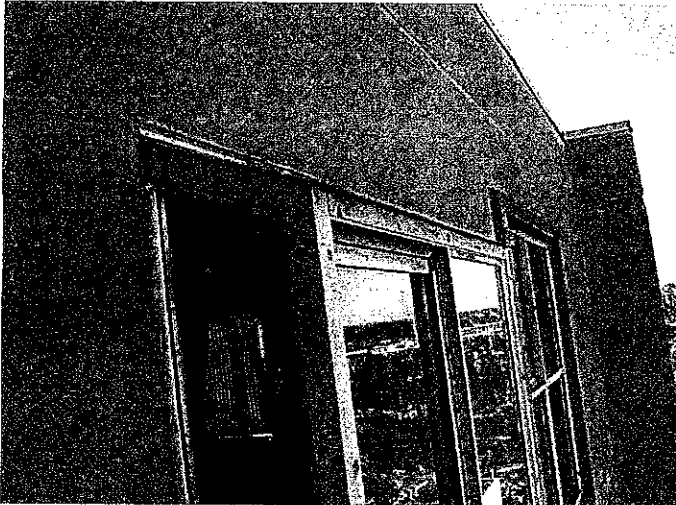
- The following window types are accessible from drop #2: "concealed barrier - improved" style windows with fixed lites and slider operable vents (moe-hair vent gaskets) and; "concealed barrier" style boxed-out windows with fixed lites and slider operable vents (moe-hair vent gaskets). The boxed-out windows have fixed lites on

the sides and are covered with "concealed barrier" style sloped glazing. The labels on the window extrusions and sealed units indicate that Wescraft manufactured the windows. (Photos B01-01, B01-02)

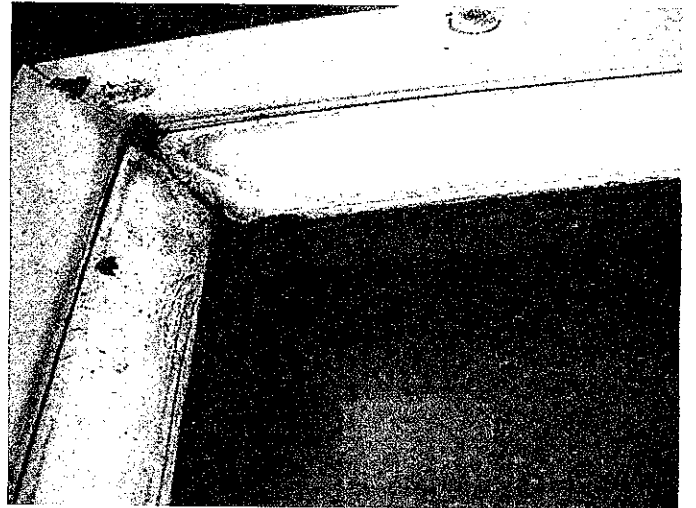
B02-01

- Some of the sloped glazed units have additional sealant applied along the metal glazing stops. Several have dirt and organic growth concentrated along the lower end of the glazing against the glazing stops. (Photo B02-01)

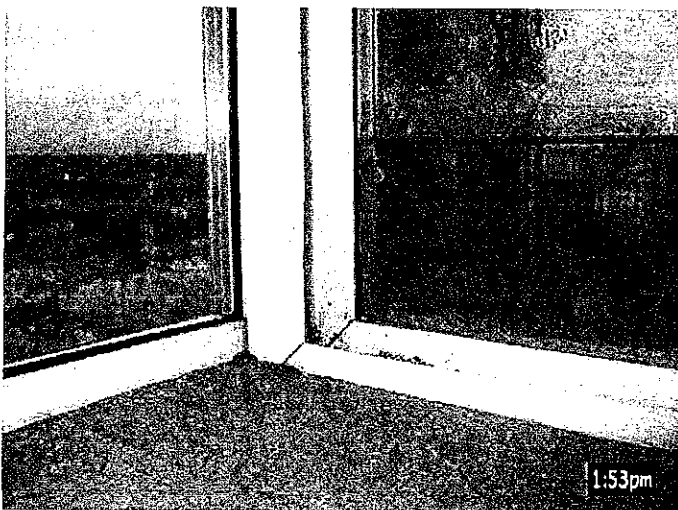
B03-01

- Several of the sealed units on the windows have visible moisture between the glass panes. A 2" depth of water and organic growth was observed within one of the sealed units (boxed out window). (Photo B03-01)

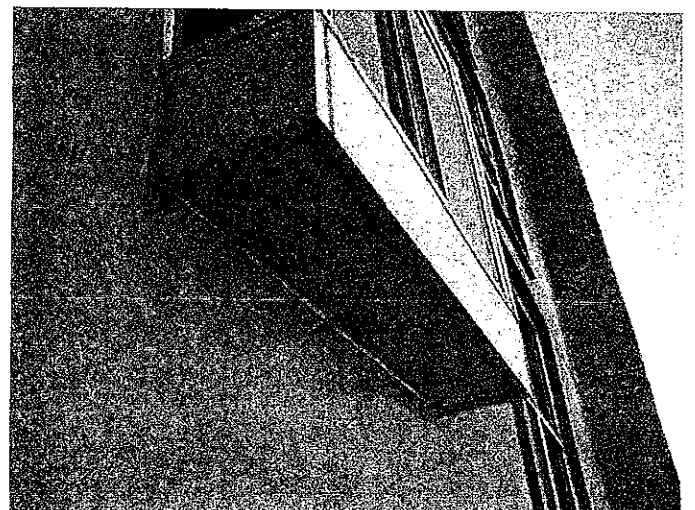
B04-01

- No weep holes were observed in the metal panels located at the base of the boxed out windows. The side panels typically terminated onto the EIFS cladding with sealant, some are sloped towards the building. Staining is typically noted along the bottom surface. (Photo B04-01)

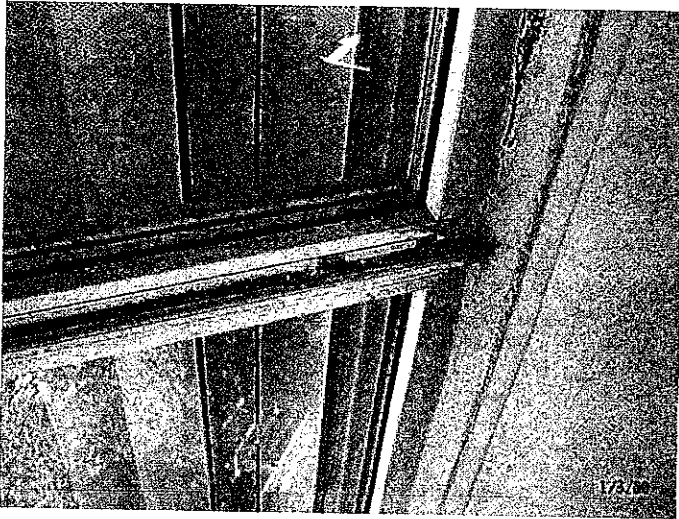
B05-01

- The external drainage track at the sliding vent terminates into the EIFS trim projection at the jamb. Failed sealant was noted at this termination. (Photo B05-01)

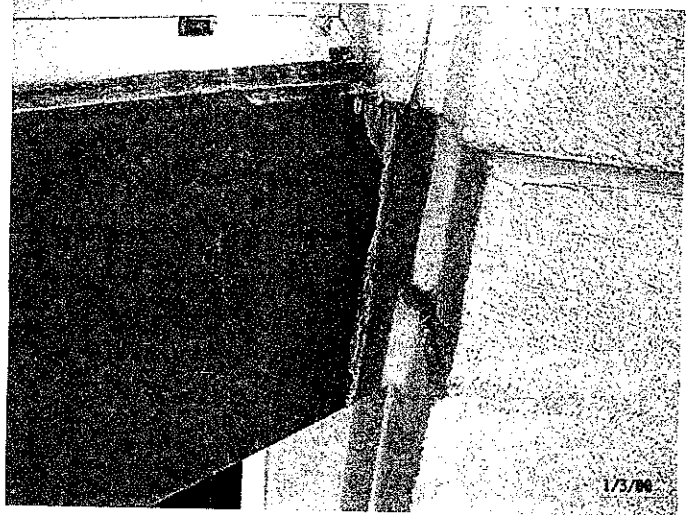
B06-01

- Cracked and failed sealant was observed along the bottom of the window frame at the interface with the metal panel that covered the slab. The exposed ledge at the top of the metal panel does not appear to have outward slope. (Photo B06-01)

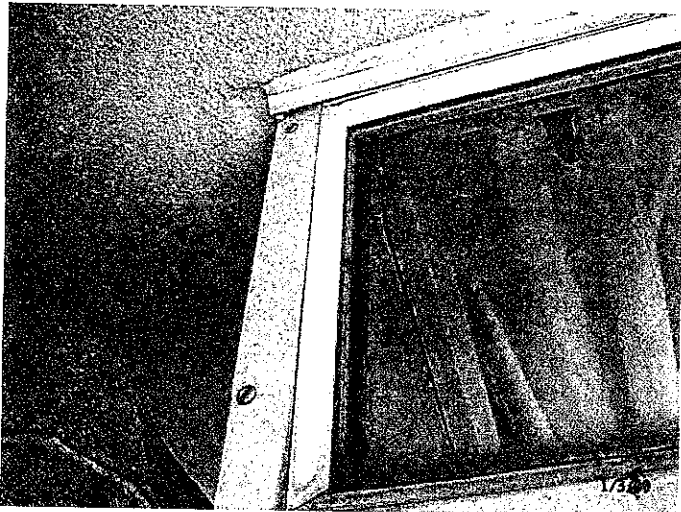
B07-01

- The windows on the balconies are not accessible for close review, however, it was noted that the sill flashings are terminated into the EIFS cladding. The interface is sealed with caulking. (Photo B07-01)

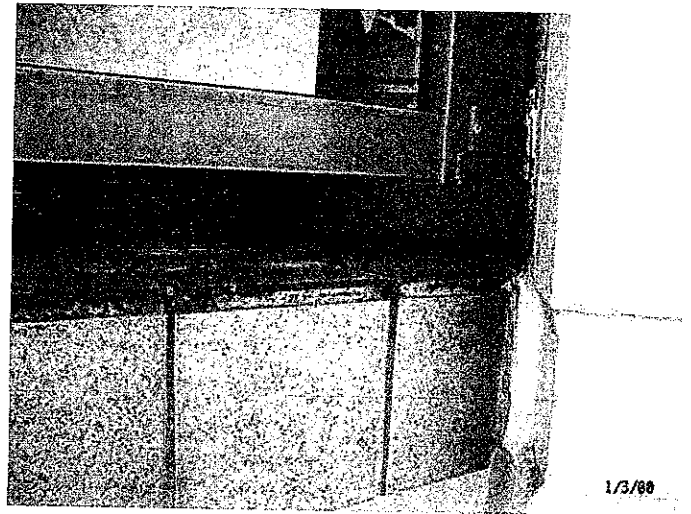
B08-01

- No sealant was observed around the attachment of the guardrail fastening plate to the exterior wall. A gap was common at this interface. (Photo B08-01)

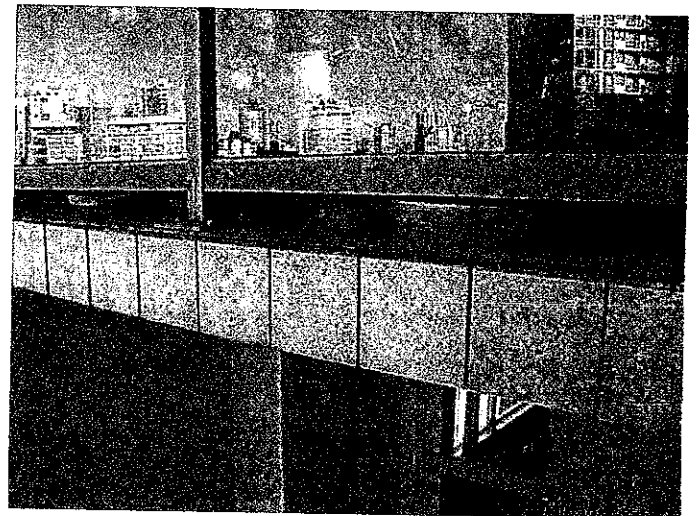
B10-01

- The central guardrail post is top mounted through the tiles that cover the balcony slab. No sealant was observed around the mounting plates or the fasteners. (Photo B10-01)

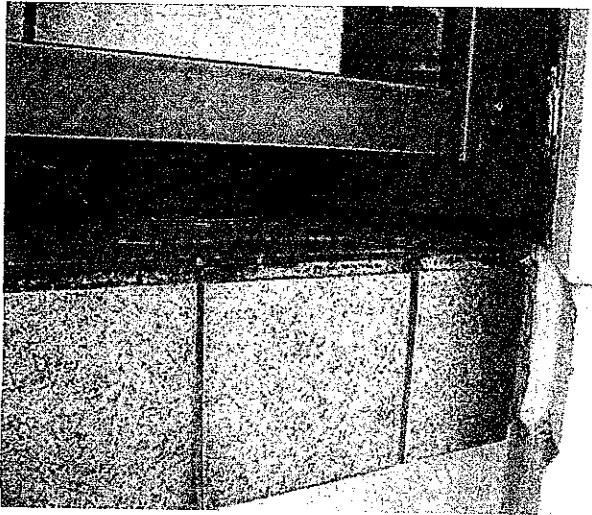
B11-01

- The EIFS cladding at the perimeter of the balconies is sealed to the tiles with caulking. Ponding water stains adjacent to the exterior walls were observed on several of the balconies. (B11-01)

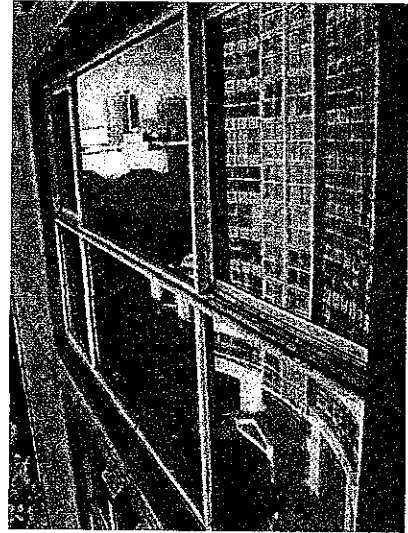
C01-01

- Several of the sealed units on the windows observed from drop #3 have visible moisture between the glass panes. (Photo C01-01)
- Paint is flaking off from the window frames at a few locations reviewed. (Photo C02-01)

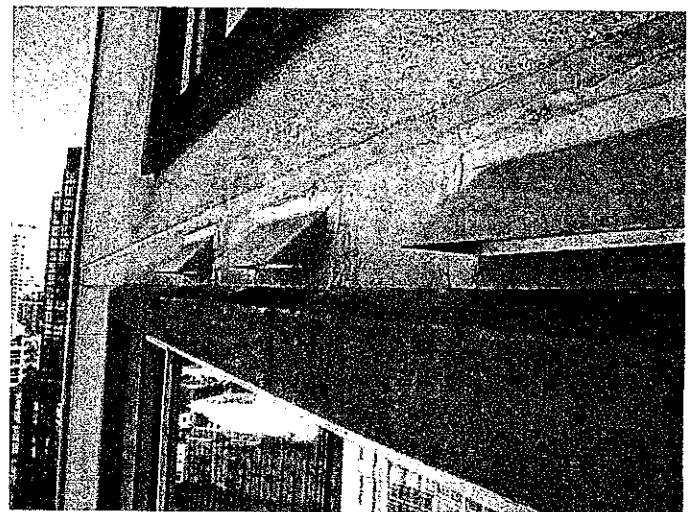
C04-02

- The windows accessible from drop #3 incorporate slider style operable vents with moe-hair operable vent gaskets. (Photo C03-01)
- Concentrated run-off is present at the EIFS trim around the windows at various locations. There is also increased staining at these locations directly below the exhaust vents (Photos C04-01 to C04-02)

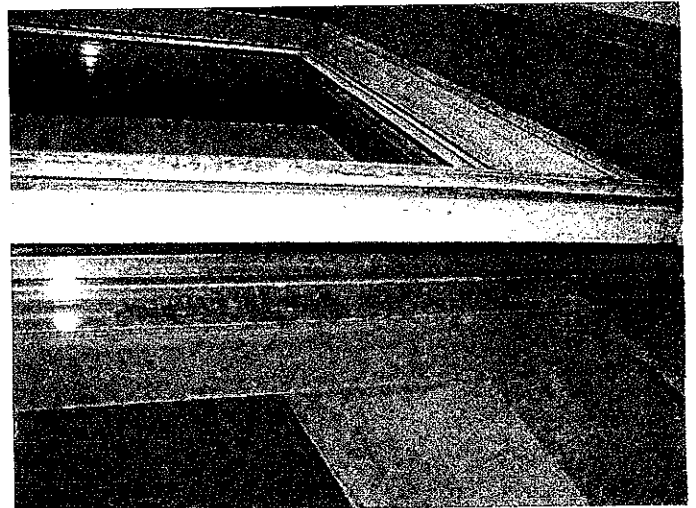
C07-02

- The sealant at the window frame butt joints (mullions to frame) is discontinuous at several windows reviewed.
- Severe condensation was observed dripping from the inside of the window frame at one window reviewed. Mould is present at various other window frames reviewed (Photos C07-01 & C07-02)

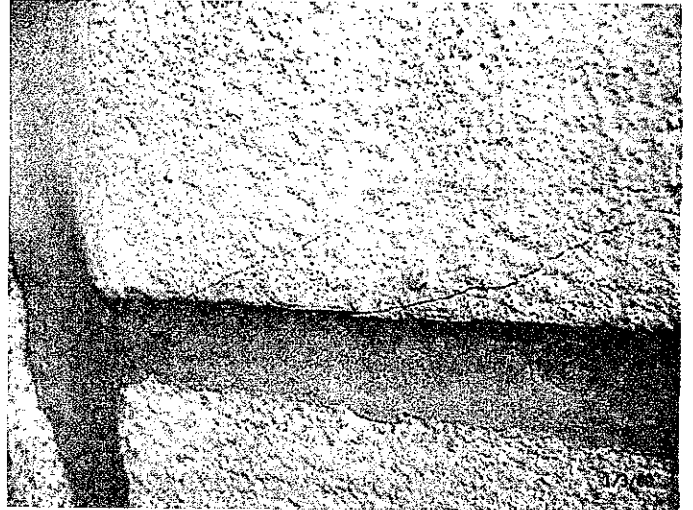
D01-01

- It appears that there is a paint over the EIFS panels.
- Cracking is commonly observed near the outer corners of the EIFS panels. (Photo D01-01)
- The windows are framed by an EIFS trim projection. The horizontal surfaces of the trim are sloped outwards. Cracking in the trim and in the adjacent EIFS cladding is typical. (Photos D02-01& D02-02)

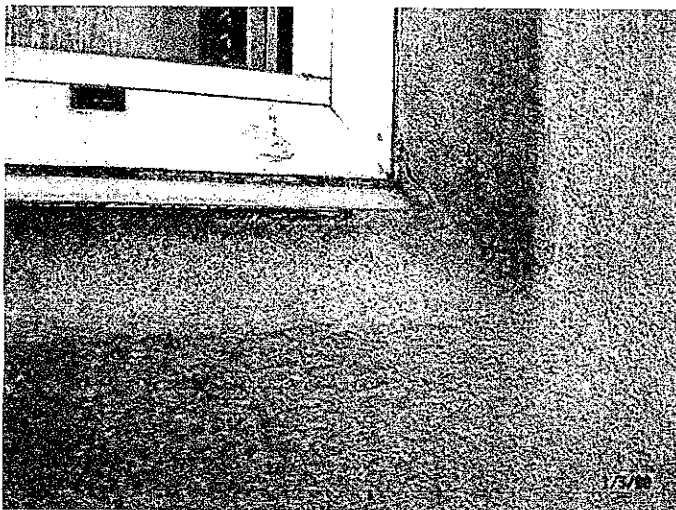
D03-01

- Several of the sealed units on the windows observed from drop #4 have visible moisture between the glass panes.
- The perimeter sealant at several of the windows is cracked and deteriorated. This common condition occurs in the sealant located both above and below the sill flashing. Some holes in the sealant were observed. (Photo D03-01)

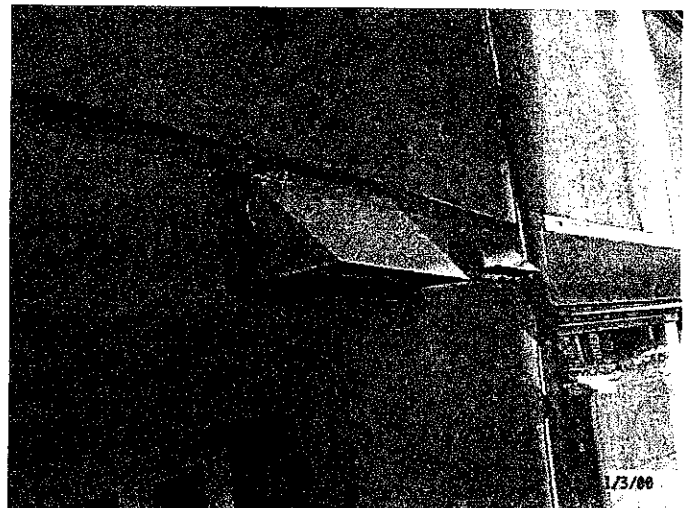
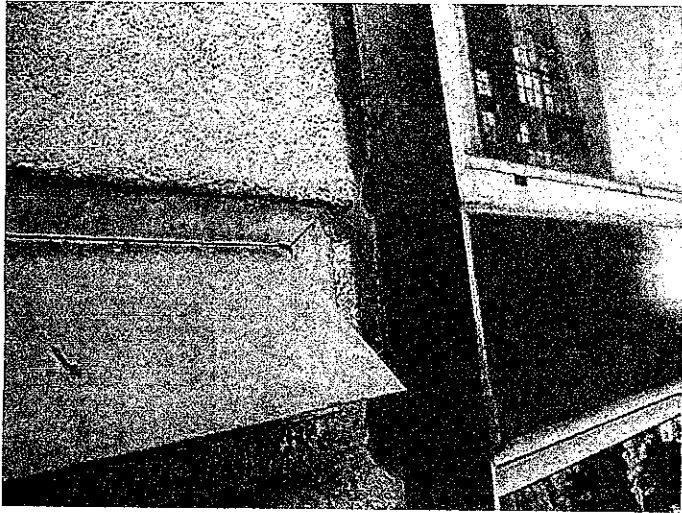
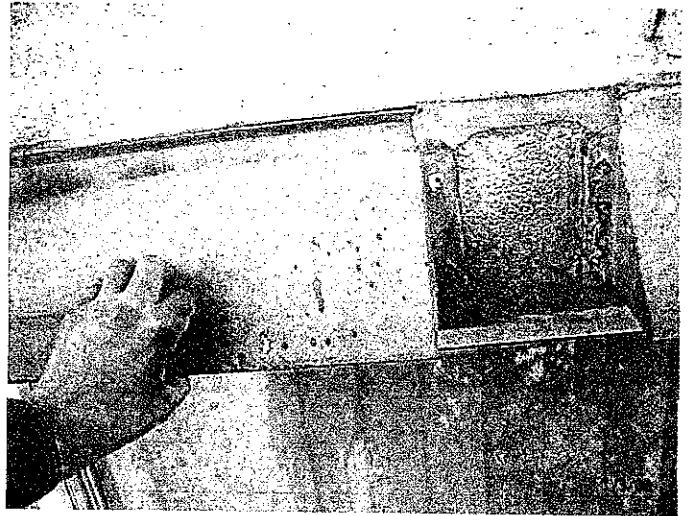
- Several types of face mounted exhaust vent hoods were accessible from this drop. Weathered and discontinuous sealant was noted at several vents. Some have secondary vent covers over top of the exhaust vent hoods. Some have large quantities of additional sealant applied in a trowel-like manner at the perimeter-fastening flange. (Photos D04-01, D04-01, D04-01)

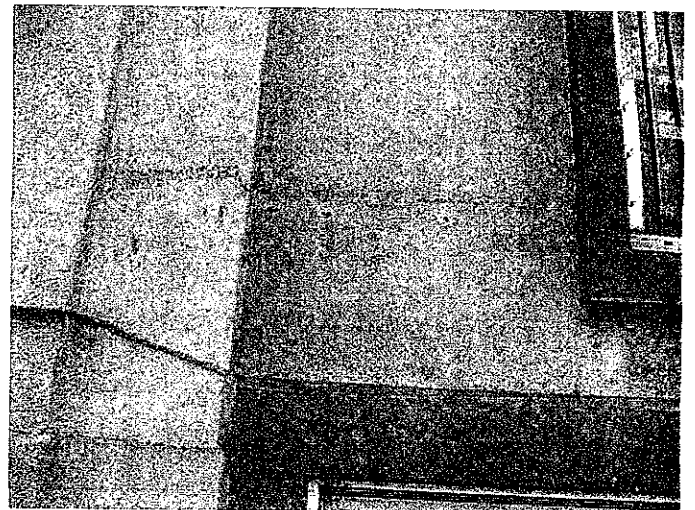
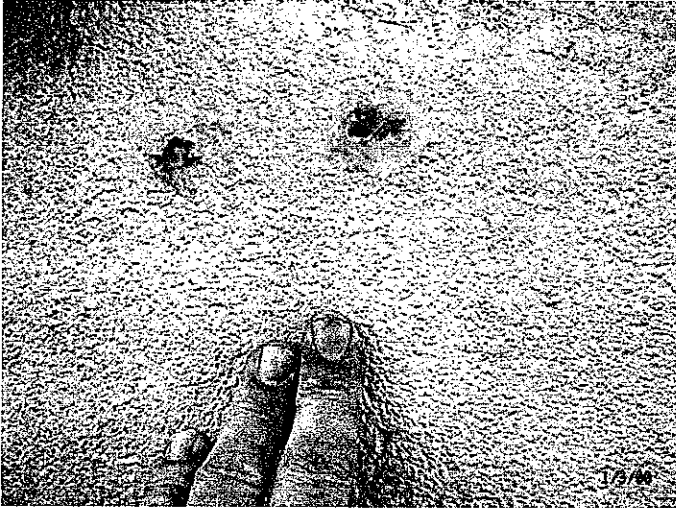
- Several small penetrations and tears in the EIFS cladding were noted above a lower level deck. An awning frame was previously installed at this location. The penetrations had been topically patched, however, holes through the patched areas were noted. (Photos D07-01, D07-02)
