Pacific Point

Exploratory Openings

Thirty-one interior exploratory openings were made into the exterior window, door, and wall assemblies to confirm conditions of concealed components and materials within the assemblies. The results of the exploratory openings are summarized in the following table. All interior exploratory openings are referenced as viewed from the interior.

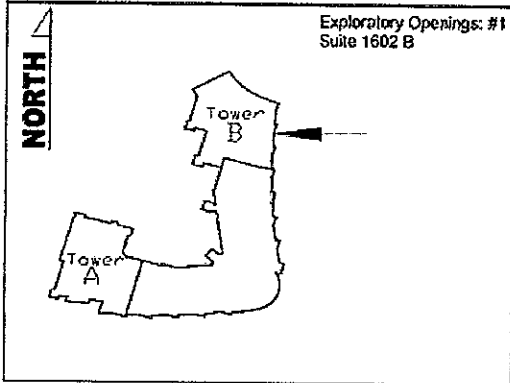
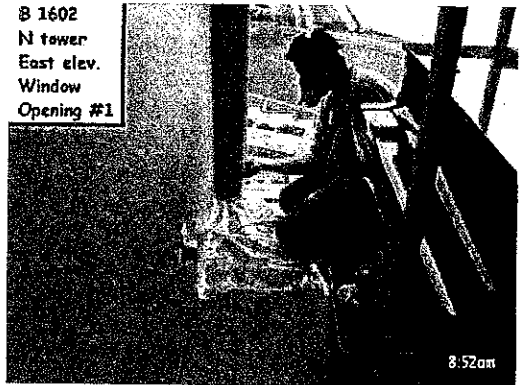
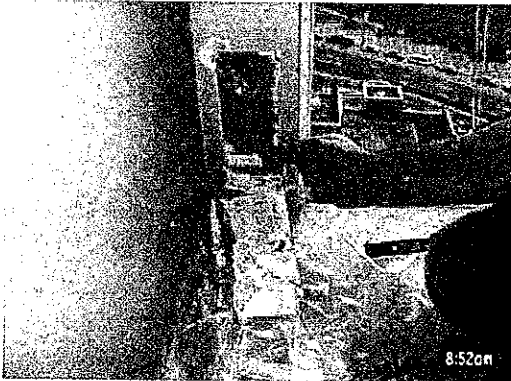
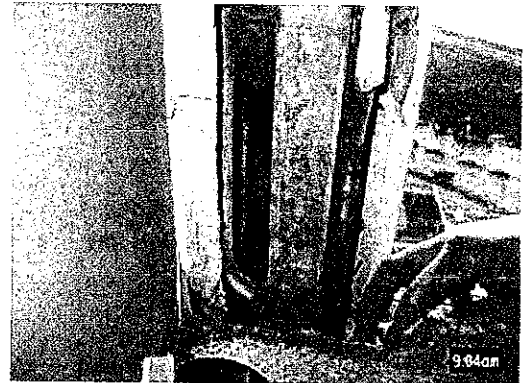
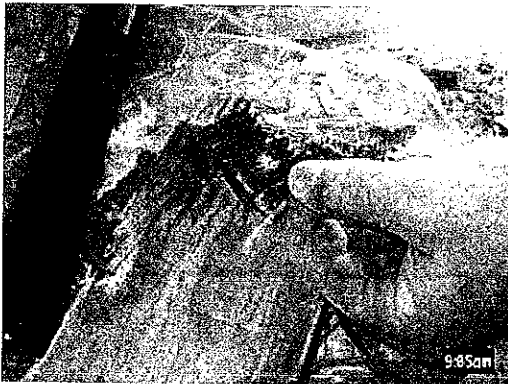
Exploratory Opening #1 1602

1	<p>Elevation & Location: 1602, east elevation, living room.</p> <p>The ext. cladding was the continuous metal panel at the window jamb.</p> <p>Observations:</p> <ul style="list-style-type: none"> • The exploratory opening was cut through the drywall adjacent to the full height window, at the slab level. • The interior drywall finish is peeling. • The edge of the carpet is stained along the interface with the windowsill and drywall. The carpet nail strip is stained and the fasteners are corroded, as are some of the window fasteners at the sill. • The drywall is stained behind the baseboard at the carpet level. • The drywall is very deteriorated. The backing paper is stained, affected with mould and delaminated from the gypsum core. • The metal corner bead is corroded. • The drywall is fastened to ½" plywood. A sheet of polyethylene is present between these components. Mould is on the plywood which is stained and deteriorated. • The batt insulation is stained. • The steel studs are corroded within the cavity. • The continuous metal panel (window trim) located at the window jamb is supported by a layer of plywood that has been fastened onto the exterior side of the studs. The plywood is stained and deteriorated. 	Photos

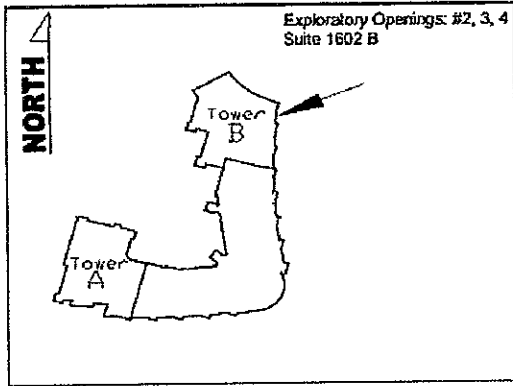
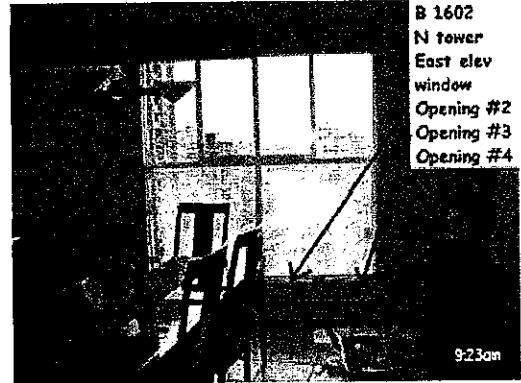
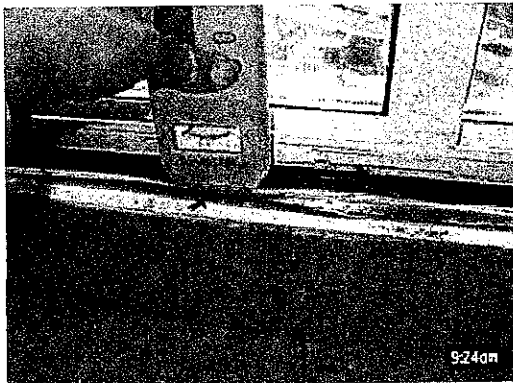
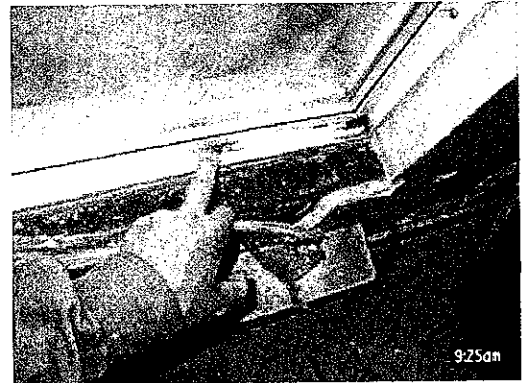
Exploratory Opening #2 1602

2	<p>Elevation & Location: 1602, east elevation, dining room</p> <p>Wood stool, punch window</p> <p>Observations :</p> <ul style="list-style-type: none"> • The exploratory opening consisted of removal of the wood stool at the bottom of the punch window. • The window is fastened through the drainage track at the sill with screw fasteners. The dabs of caulking over the penetrations in the drainage track are deteriorated. • The fasteners in the wood stool are all severely corroded. • There is no sub-sill drainage layer beneath the windowsill. • The intermittent wood shims beneath the window are wet and deteriorated. • The plywood liner beneath the window is wet and severely deteriorated. The exposed fasteners in the liner are significantly corroded. • The moisture content of the plywood liner is >40%. 	Photos
