Pacific Point

APPENDIX G – ROOF OBSERVATIONS

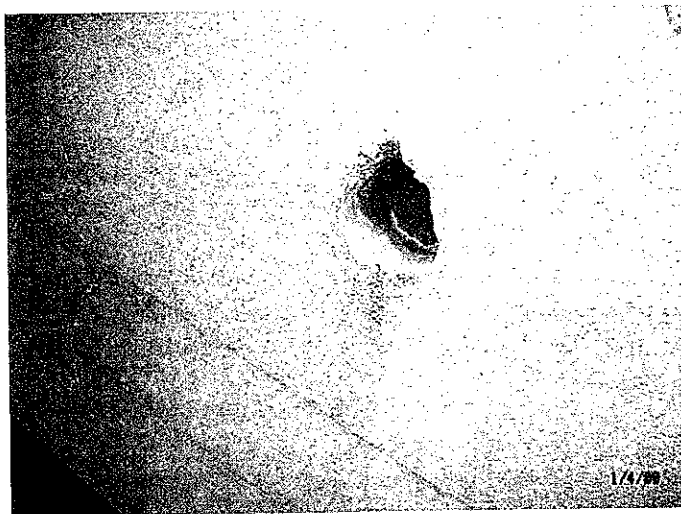
J-03

- Extension pipes are not incorporated into the roof deck overflow scuppers. (Photo J-03)
- RDH reviewed metal flashing debris and discarded fasteners that were found against the membrane by a resident handyman. (Photo J-04)
- Corroded clamp fasteners and tenting in the EPDM membrane around plumbing stack vents. (Photo J-05)
- Corrosion on the compression clamps and fasteners at various roof drains.
- Failed sealant was observed on the joints between cap flashing segments. (Photo J-06)
- Long-term bird infestation was observed beneath and around the sloped metal roof facades. (Photo J-07)
- The parapet terminates into the sloped metal roof over the northwest enclosed balcony. (Photo J-08)
- One of the roof decks has been upgraded to a modified bitumen SBS torch-on roof system.

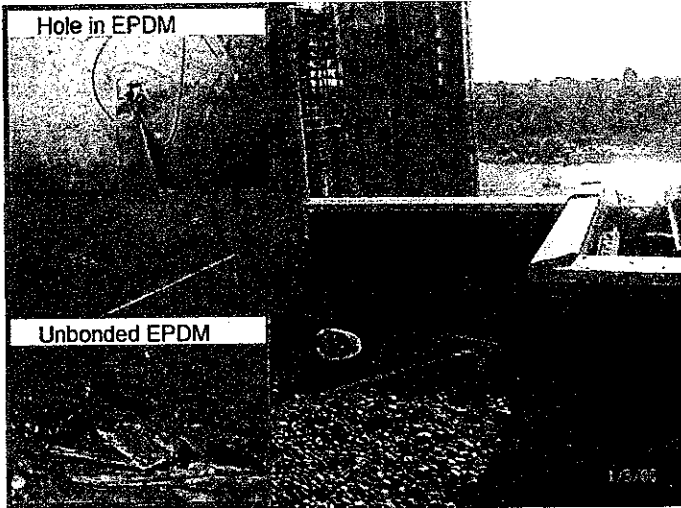
K-01

- The main roof assembly consists of the following: gravel ballast, filter cloth, rigid insulation, EPDM membrane.
- A parapet encloses the perimeter of the main roof. In some areas the EPDM membrane terminates at the inner sidewall of the parapet. A metal flashing covers this interface. In other areas, the EPDM membrane extends up the side and onto the top surface of the parapet. In this configuration the membrane on the inner side of the parapet is fully exposed. (Photo K-01)

- An EPDM patch at the deck interface with the parapet was exposed for review. The patch is not bonded. Water was observed beneath the patch. (Photo K-01)

- A ¼" diameter hole through the EPDM was noted on an exposed sidewall of the parapet. (Photo K-01)
- The parapet of a 16th floor roof deck is positioned in front of an enclosed balcony window. (Photo K-07)

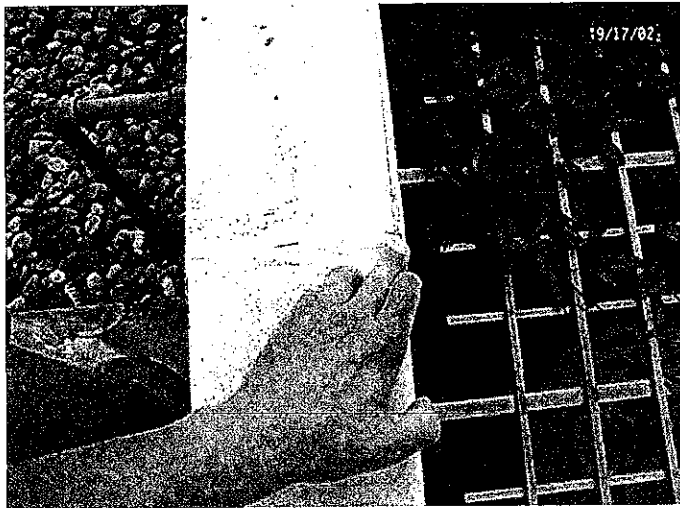
K-03

- Failed sealant was noted at various joints in the cap flashing. (Photo K-03)
- A self-adhered membrane was observed beneath the metal cap flashing at various locations. Deterioration of the membrane was observed at locations where the membrane application extends below the side flange of the metal cap flashing (exposure to sunlight). (Photo K-04)

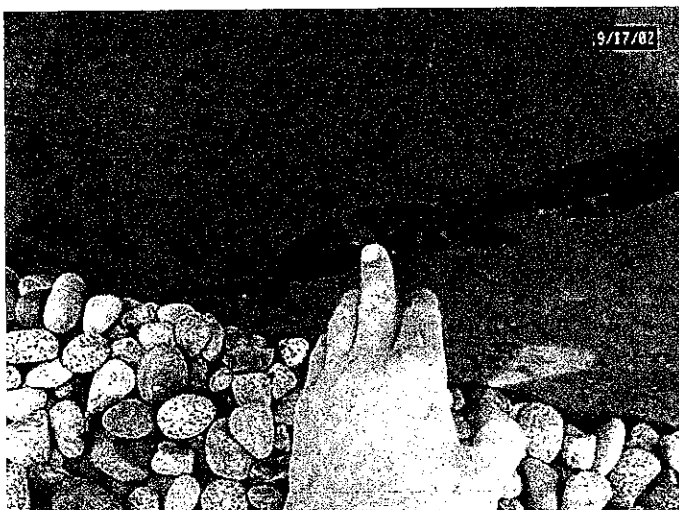
K-05

- Failed bond was observed at various EPDM seams on the inner face of the parapet. (Photo K-05)
- Tenting of the EPDM was observed at various exposed locations on the parapet. (Photo K-06)

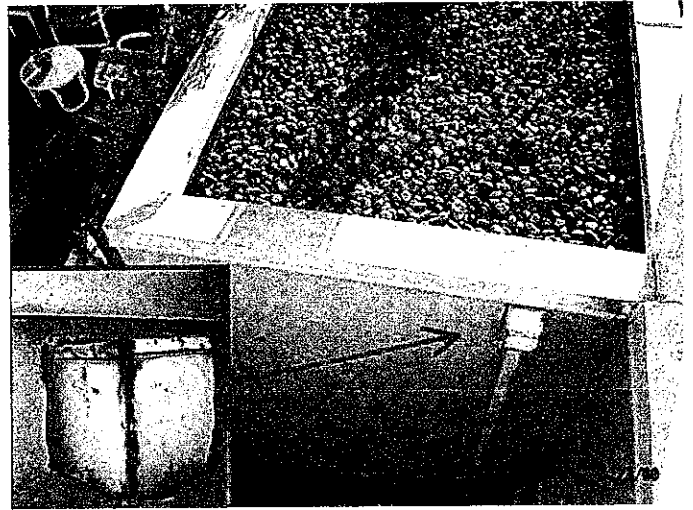
K-10

- Corrosion was observed on the metal cap flashing where the paint coating is discontinuous.
- The parapet drain scupper at a secondary roof was severely corroded. Additionally the penetration through the exterior EIFS cladding was not sealed with caulking. (Photo K-10)

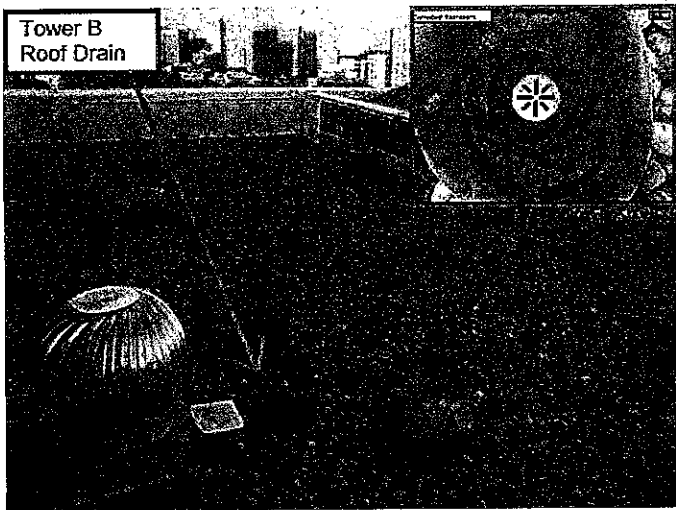
K-11

- Only one roof drain was observed on the main roof. A perforated metal shroud that retains the gravel ballast encloses the drain. Significant corrosion was observed on the fasteners that retain the compression clamp. Deteriorated sealant was observed at this interface. The location of the second drain was not confirmed. (As indicated on the drawings). (Photo K-11)

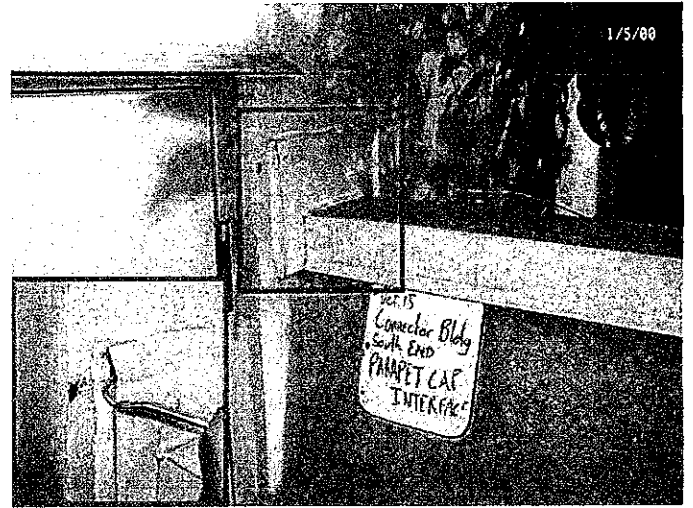
L-04

- Failed / discontinuous caulking was noted at several saddle flashings. (Photo L-04)
- At several locations the metal cap flashing is terminated into the EIFS cladding. A bead of caulking along the interface was noted at the locations reviewed; however the condition of the caulking often appears to be poor. (Photo L-05)

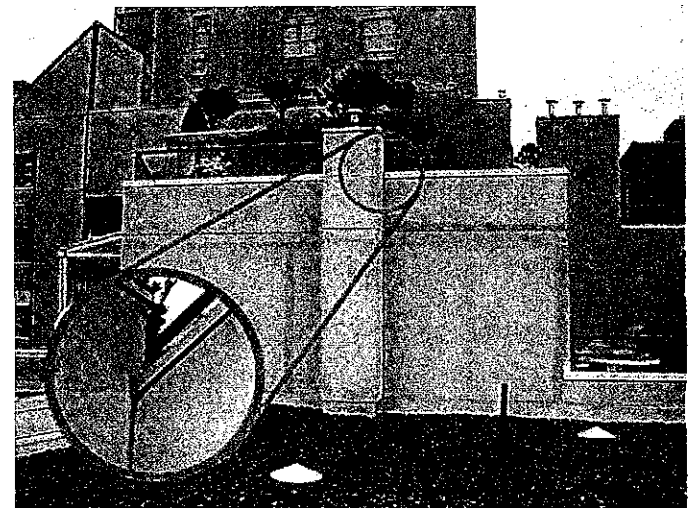
L-06

- At some locations concentrated run-off staining is present on the exterior walls below the parapets. (Photo L-06)
- At one location reviewed the parapet is terminated within 1.5 "of the window glazing. (Photo L-07).
