REGARDING 301 Kingsway (Uno) Warranty Review

1956.00
301 Kingsway - Uno
20 December 2007

REGARDING Warranty Review

Intracorp Projects Ltd. and the owners, Strata Plan BCS 1882 (Uno), jointly retained RDH Building Engineering Ltd. (RDH) to undertake a warranty review of the building enclosure. Specifically, our scope of work included:

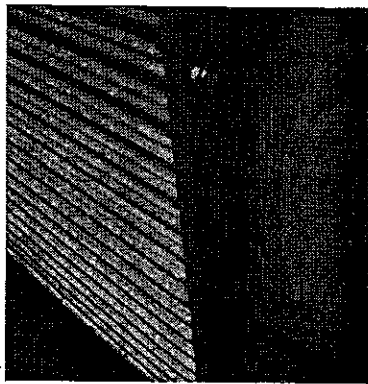
Photograph 1.1	Photograph 1.2

Observation (from main roof looking down): Sealant is missing from a window flashing end-dam on the high-rise tenth floor, west elevation.	Observation: Sealant is missing from the perimeter of the exterior doorframes at the high-rise mechanical penthouse.
Action Required: Install missing sealant at the flashing end-dam. Inspect other locations for missing sealant and end-dam installation.	Action Required: Install sealant around the doorframes.

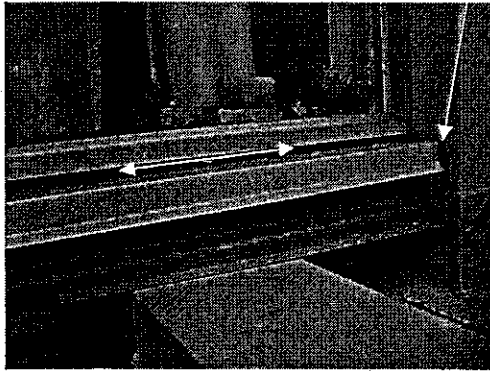
Photograph 1.3

Observation: The window sill flashing installation is incomplete at bedroom of Unit 607. Flashing end-dams and sealant are not installed, allowing for direct water penetration behind the cladding. The flashing also appears to be cut too short for the window opening.

Action Required: Complete window flashing and sealant installation.

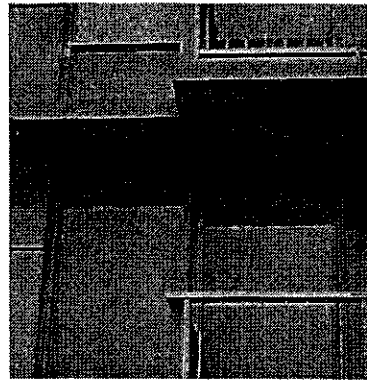
Photograph 1.4

Observation: Polyethylene window frame protection wrap has not been removed from unit on the sixth floor at south elevation of the high-rise.

Action Required: Remove polyethylene wrap from the window frame. Inspect all window frames for protection wrap and remove where necessary.

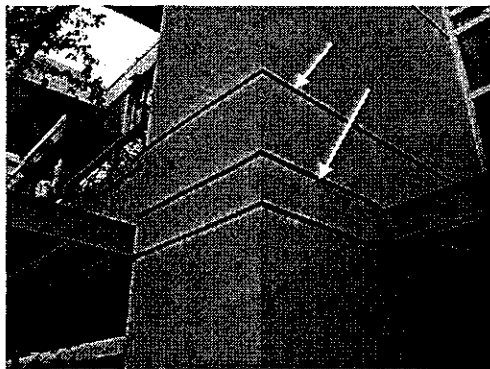
Photograph 1.5

Observation: Sealant is missing from the second level slab cold joint reveals at the southwest corner of the city-homes building.

Action Required: Install bond breaker tape and sealant at the cold joint reveals.

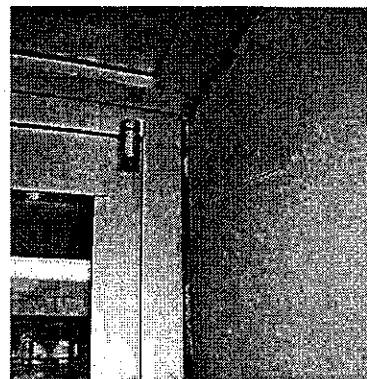
Photograph 1.6

Observation: Sealant is missing around the perimeter of a door at the southwest end of the commercial space on the ground floor. Foam backer-rod is already in place.

Action Required: Install sealant around doorframe.

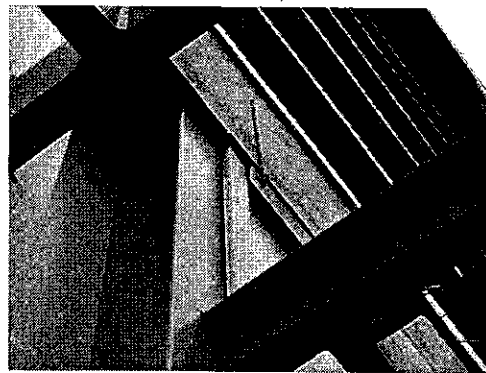
Photograph 1.8

Observation: The glazing pressure-plate cover is loose above the ground level canopy at the northwest corner of the high-rise.

Action Required: Snap-in pressure-plate cover.

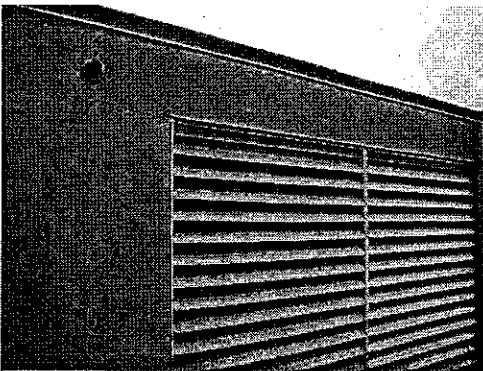
Photograph 1.9

Observation: Sealant is missing from perimeter of the mechanical louver at the south end of the city-homes building (fifth floor at stairwell).

Action Required: Install backer-rod and sealant around perimeter of louver.

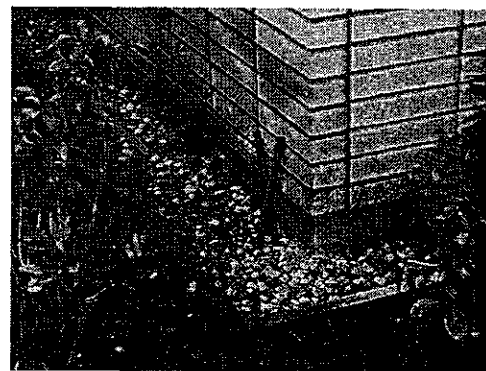
Photograph 1.10

Observation: The landscaping irrigation sprinklers at several locations at-grade and within planters around the complex are incorrectly adjusted and are spraying directly onto the exterior walls.

Action Required: Adjust sprinkler heads away from the walls and grade landscaping soil away from walls.

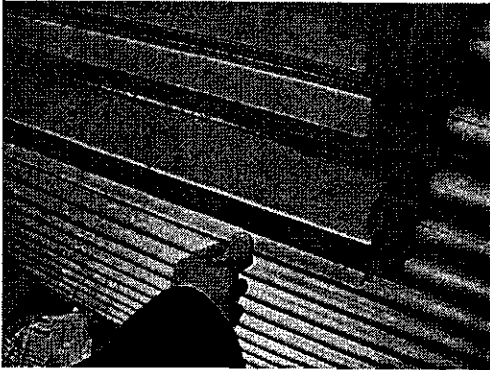
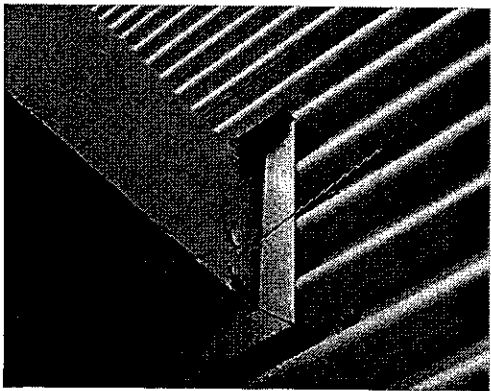
Photograph 1.11	Photograph 1.12

<p>Observation: A window sill flashing at the east side of the roof-deck at Townhouse 2713 is back-sloped towards the building. Ponding water on the window flashing was observed during the review.</p> <p>Action Required: Adjust flashing to provide positive slope away from building.</p>	<p>Observation: An exposed edge of self-adhered membrane is visible at the roof overhang at the southeast corner of Townhouse 2717 at the first level, near the courtyard entrance gate. Over time the exposed membrane will degrade, due to UV exposure, and should be cut-back.</p> <p>Action Required: Cut back self-adhered membrane and confirm membrane is adequately secured. Re-apply sealant and refinish concrete surface.</p>

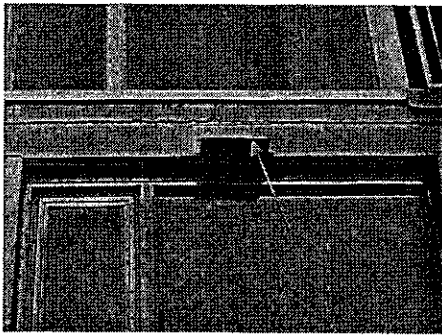
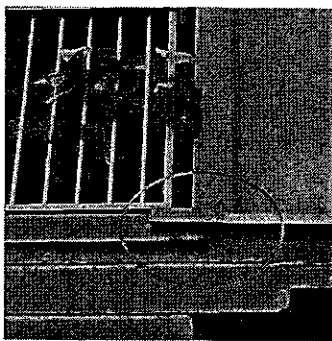
Photograph 1.13	Photograph 1.14

<p>Observation: Several dryer vent exhaust grilles throughout the building complex are clogged with lint.</p> <p>Action Required: Inspect and regularly clean dryer vent grilles as part of the ongoing maintenance program. In addition to having a reduced dryer performance, clogged dryer vents can potentially lead to moisture related problems and damage of adjacent interior finishes.</p>	<p>Observation: The flashing lap between the window sill and balcony is uneven at Unit 304 of the city-home building.</p> <p>Action Required: Flashing components should be properly evenly connected.</p>

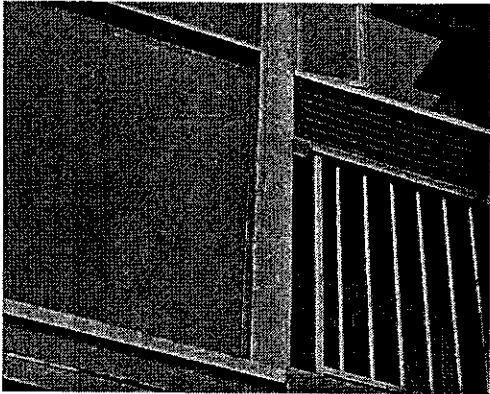
<p>Observation: The window frame at the east elevation above city-home Unit 2721 is damaged.</p>	<p>Observation: A concrete reveal (waterproofing reglet) is unsealed above the fifth floor stairwell entrance canopy at the south elevation of the city-home building.</p>
<p>Action Required: Repair damaged window frame.</p>	<p>Action Required: Provide sealant at concrete reveal.</p>

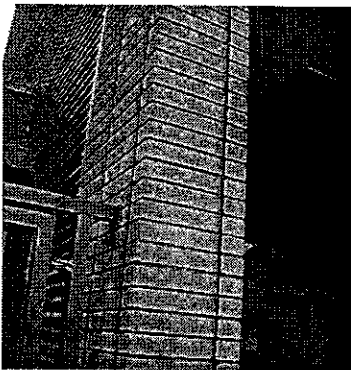
<p>Observation: Foil face membrane is exposed at the door thresholds at roof-deck level (fifth floor) of city-home units.</p>	<p>Observation: Efflorescence staining observed at two locations on the brick cladding at the southeast corner of the town-house building (adjacent to Townhouse 2717) at grade level.</p>
<p>Action Required: Install extruded aluminum thresholds, secured through the sides to avoid penetrating the waterproofing membrane. Seal any pilot holes with sealant compatible with SBS membrane (Flex Sealant by AC Industries Ltd.)</p>	<p>Action Required: Inspect waterproofing detail at the canopy-to-wall interface. Clean efflorescence staining from affected surfaces. Monitor location for re-occurrence of efflorescence staining.</p>

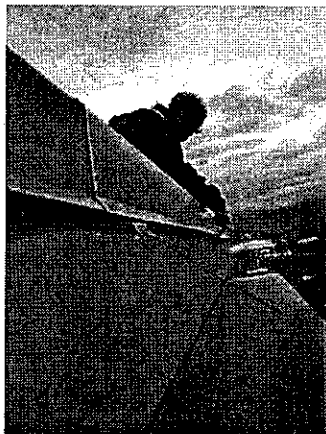
Photograph 2.1

Observation: The edge of the two-ply SBS roof membrane is exposed at the exterior side of the parapet cap flashing (main roof of high-rise building, at several locations).

Action Required: Trim back exposed edge of roof membrane where exposed to UV.

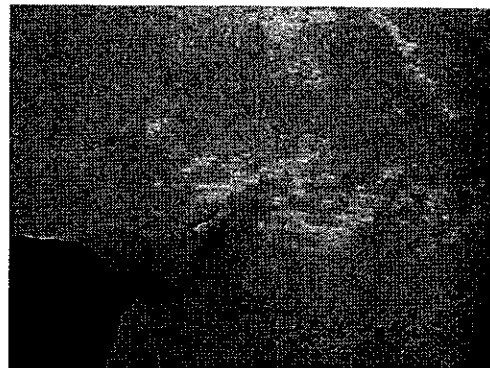
Photograph 2.2

Observation: Numerous defects and deficiencies are observed with the waterproofing membrane at the concrete overhangs and eyebrows. These include missing base coat and topcoat, missing or thinly applied topcoat, or small holes and application defects.

Action Required: Inspect waterproofing membrane at all locations and re-apply where top coat is missing, or membrane is too thin, and at defects.

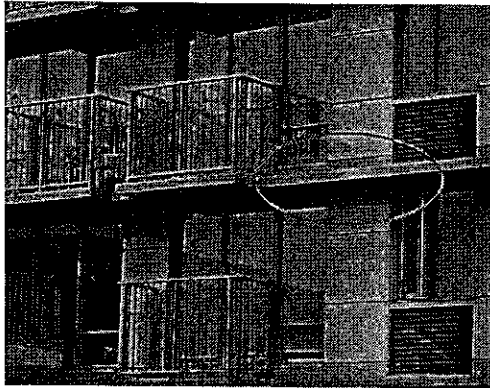
Photograph 2.3

Observation: The top-coat of the waterproofing membrane is missing at numerous floor-level eyebrows of the high-rise building

Action Required: Apply top coat of waterproofing membrane to missing areas, following product manufacturer's installation procedure. Installation should be reviewed by Sonneborn technical representative for recommendations for remedial work.

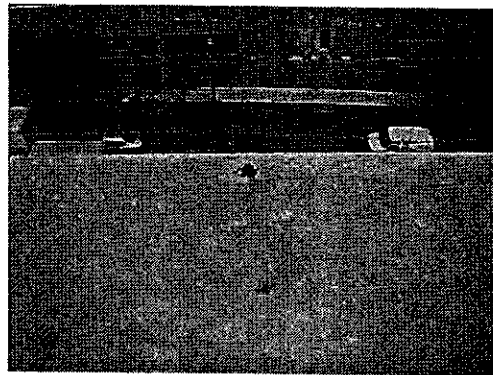
Photograph 2.4

Observation: Several localized voids are present in the concrete eyebrows/overhangs of the high-rise buildings along Kingsway.

Action Required: Fill localized voids for compatible product and re-coat surface with waterproofing membrane.

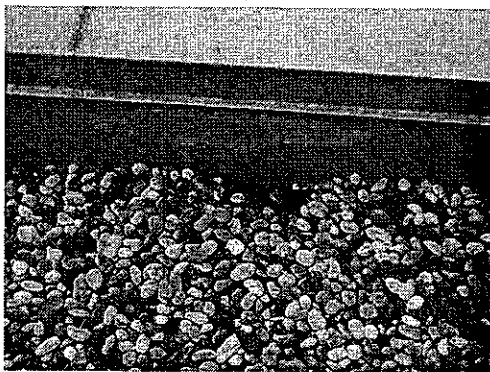
Photograph 2.5

Observation: Gaps in the filter fabric and insulation occur at the perimeter of the roof area in several locations at the main and upper mechanical roof of the high-rise building. This has allowed ballast to fall down to the roof membrane.

Action Required: Remove gravel ballast from contact with roof membrane and install additional insulation and filter fabric at the perimeter of the roof where required.

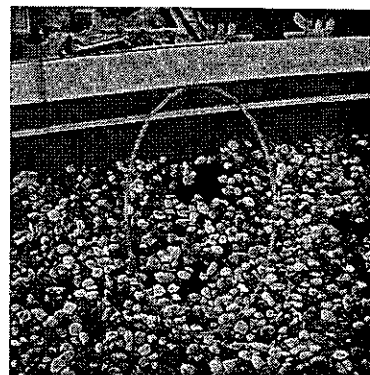
Photograph 2.6

Observation: The gravel ballast is uneven at isolated areas along the west side of the main roof of the high-rise building.

Action Required: Re-distribute and/or provide new ballast to achieve a minimum 2" thickness.

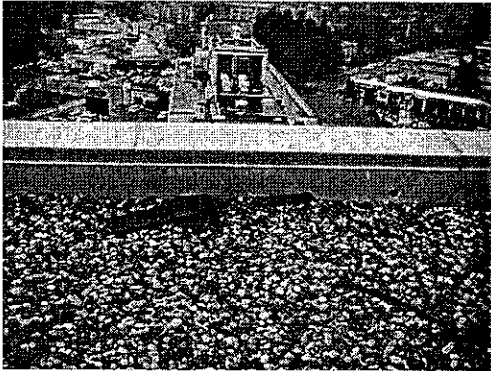
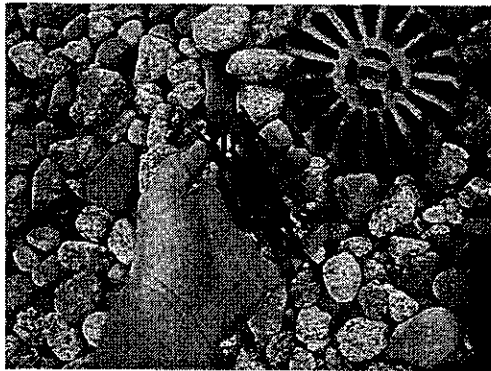
<p>Observation: Construction debris located on building roofs.</p>	<p>Observation: Construction debris including nails on the main building roof. Nails and other sharp objects may come into contact with the roof membrane and cause damage.</p>
<p>Action Required: Clean up construction debris.</p>	<p>Action Required: Inspect all roof surfaces and remove all debris to prevent possible damage to the membrane.</p>

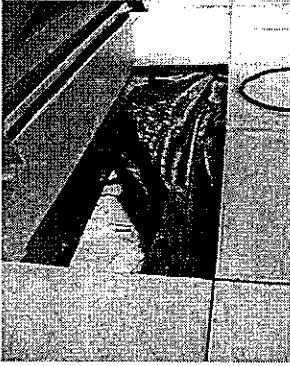
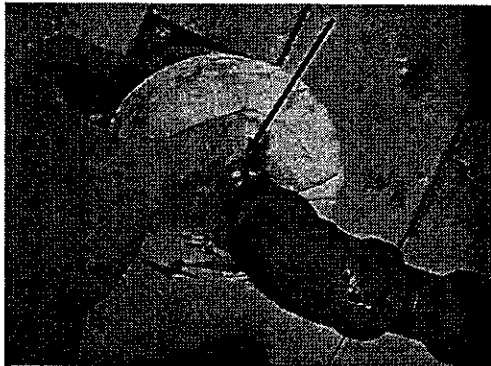
<p>Observation: Exposed insulation beneath mechanical unit at the main roof.</p>	<p>Observation: The sealant around the mechanical unit gas supply pipe has failed (main roof, to the west of the mechanical unit).</p>
<p>Action Required: Provide new concrete pavers where missing.</p>	<p>Action Required: Remove and re-apply sealant. Consider installing a metal flashing cover around penetration to protect sealant from degradation and moisture.</p>

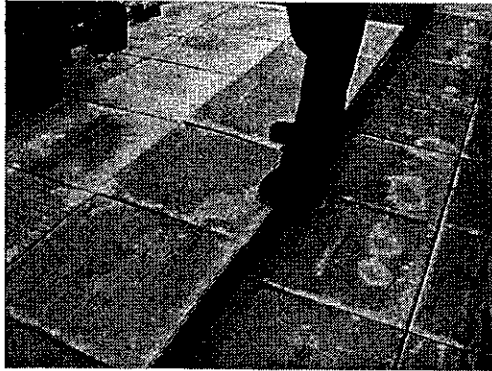
Photograph 2.11

Observation: Concrete pavers at penthouse Unit 1102 are not properly supported at one end and are loose when walked on.

Action Required: Shim concrete pavers along unsupported edge to prevent rocking.

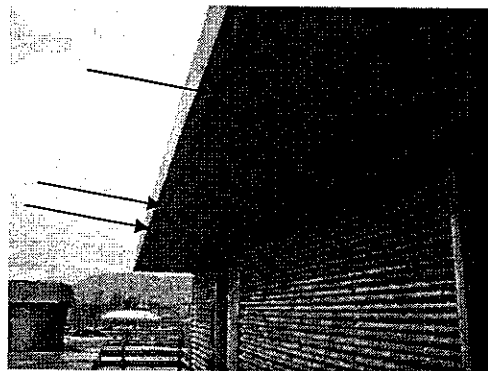
Photograph 2.12

Observation: Several cracks within the concrete overhang at the rooftop mechanical room are allowing water leakage through the waterproofing membrane. The cracks are reflected through the top of the overhang through to the soffit.

Action Required: Apply fabric-reinforced polyurethane traffic coat over all exposed cracks at this location.

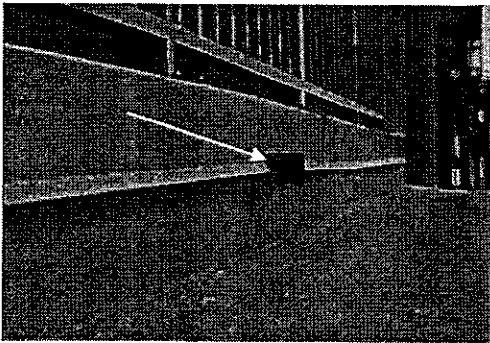
Photograph 2.13

Observation: Sealant is missing around the perimeter of the scupper drain, north elevation of the high-rise at the balcony of Unit 318.

Action Required: Inspect all scupper drain locations and provide sealant where missing around perimeter of scupper drains.

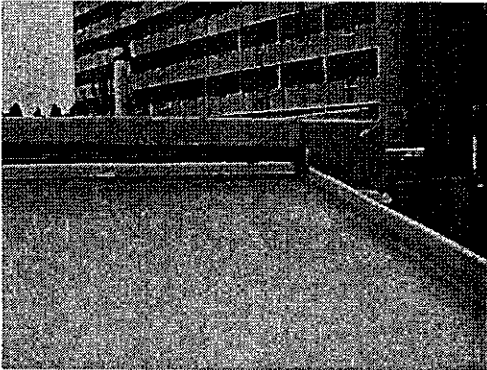
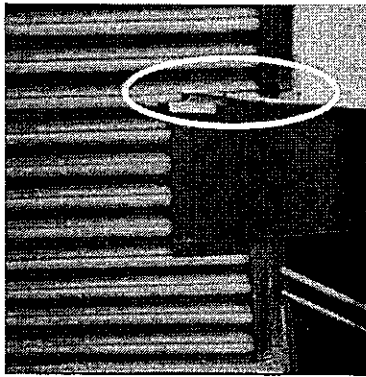
<p>Observation: The roof membrane does not adequately overlap the townhouse roof-terrace door canopies, leaving an exposed gap and potential for water penetration at this location. Townhouse 2717 is shown here; however, detail occurs at all townhouse unit canopies.</p> <p>Action Required: Install flashing drip over gap.</p>	<p>Observation: Sealant is missing at a wall to canopy joint interface at the east side of all of the townhouse roof-terrace entrance canopies.</p> <p>Action Required: Provide sealant at joint to prevent water penetration at all townhouse roof-terrace canopies.</p>

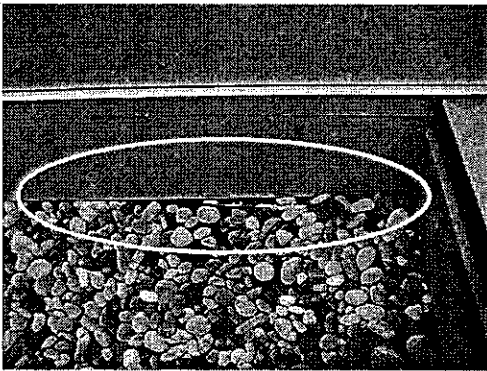
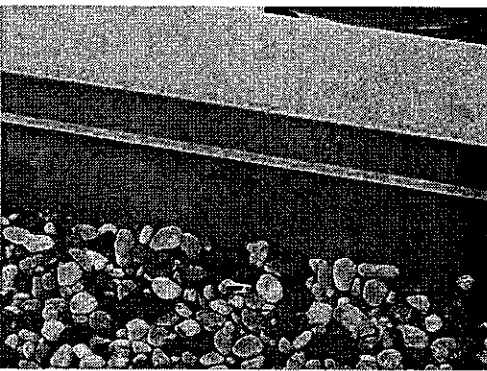
<p>Observation: Gap in the filter fabric and insulation at the northeast corner of the townhouse roof area. This has allowed ballast to fall down to the roof membrane.</p> <p>Action Required: Remove gravel ballast from contact with roof membrane and install insulation and filter fabric at the perimeter of the roof.</p>	<p>Observation: A small bracket is screwed into the parapet wall flashing at the northeast corner of Townhouse 390.</p> <p>Action Required: Remove unused bracket and seal membrane with compatible sealant. Seal flashing penetrations.</p>

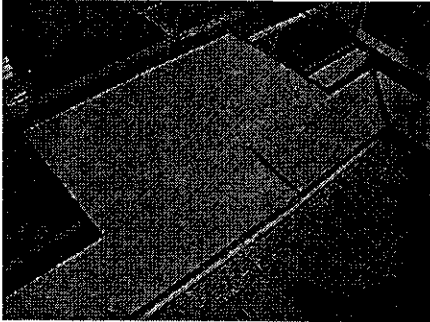
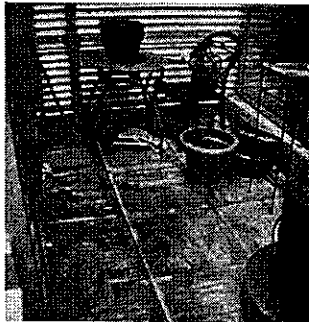
Photograph 2.19	Photograph 2.20

Observation: The parapet flashing and roof canopy at the roof terrace of city-home Unit 304 is damaged.	Observation: Red primer/paint on the concrete pavers at the roof terrace of city-home Unit 304.
Action Required: Replace damaged flashing and roof canopy.	Action Required: Remove paint where required or replace pavers. Confirm paint has not affected the membrane.

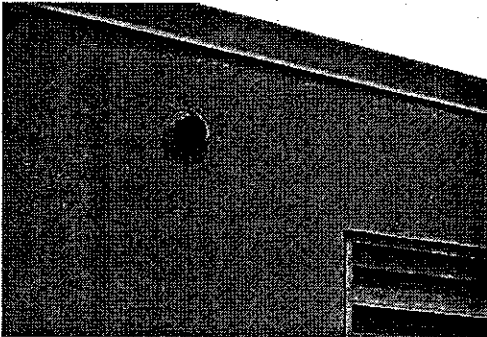
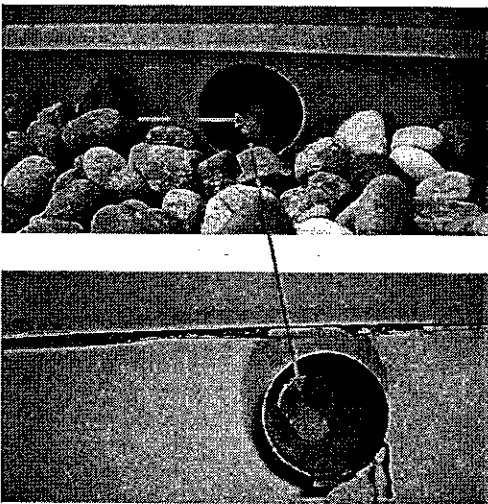
Photograph 2.21	Photograph 2.22

Observation: Rainwater leader is missing from the roof drain scupper at the Stair 24 roof at the south end of the city-homes building. Water is draining from scupper directly onto the wall below resulting in staining and excess wetting.	Observation: Gravel ballast is able to work its way into the overflow scuppers at the north side of the main high-rise roof.
Action Required: Install rain-water leader and splash-pad at this location to drain water directly onto roof-area below.	Action Required: Install screens/ballast guards at overflow scuppers to prevent gravel ballast from entering scupper pipes.

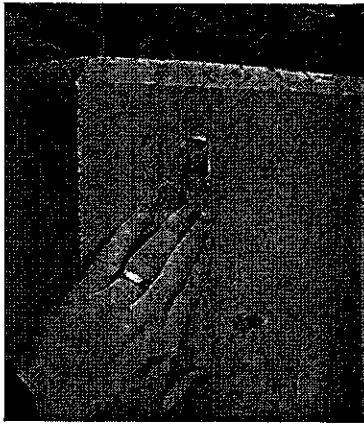
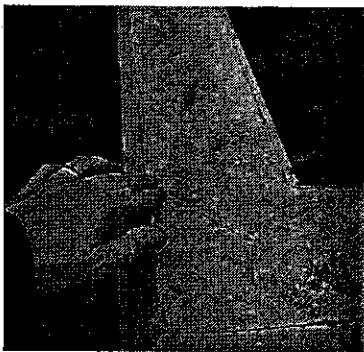
Photograph 3.1	Photograph 3.2

<p>Observation: The paint coating at the planter wall within the courtyard (outside of community room) has been damaged at several locations. The paint thickness was found to be thin in some areas.</p> <p>Action Required: Remove paint from affected areas and repaint.</p>	<p>Observation: The paint coating is damaged at the top of a few of planter walls.</p> <p>Action Required: Correct as required. Consider installing cap flashing on planter walls.</p>

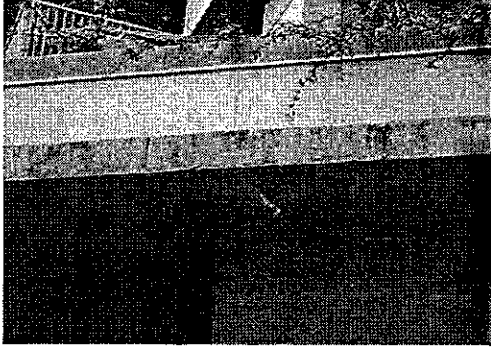
Photograph 3.3	Photograph 3.4

<p>Observation: Efflorescence and moisture was observed at a soffit, above the parkade entrance.</p> <p>Action Required: Further review the membrane above the crack and source of moisture.</p>	<p>Observation: Cracks and cold-joints within the concrete planter walls.</p> <p>Action Required: Further review and seal the cracks.</p>

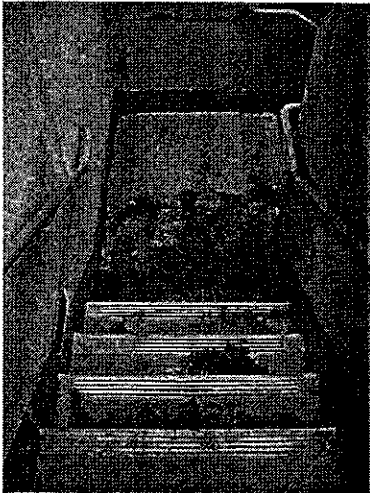
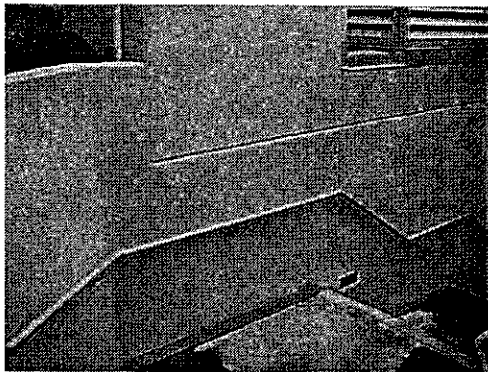
Photograph 3.5	Photograph 3.6

<p>Observation: Ponding water was observed during our visit at the parking garage stairwell in the courtyard.</p> <p>Action Required: Build up membrane to prevent ponding at this location.</p>	<p>Observation: Evidence of moisture at cold-joints within the concrete planter walls.</p> <p>Action Required: Seal cracks as required.</p>

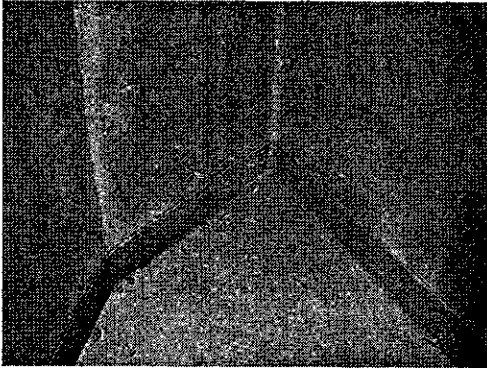
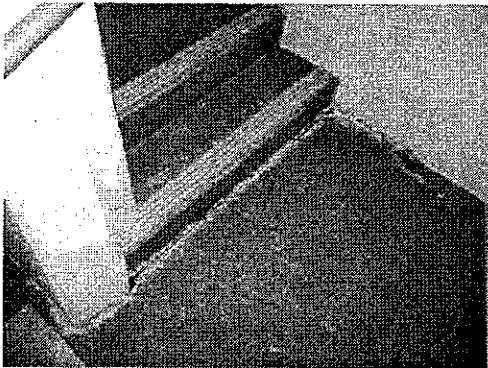
Photograph 3.7	Photograph 3.8

<p>Observation: Sealant is missing between traffic coat and concrete wall.</p> <p>Action Required: Provide sealant at joint.</p>	<p>Observation: Evidence of water migration was visible at the bottom of the stairwell within Stairwell 3 at parking level P2 below grade.</p> <p>Action Required: Rout and seal crack.</p>

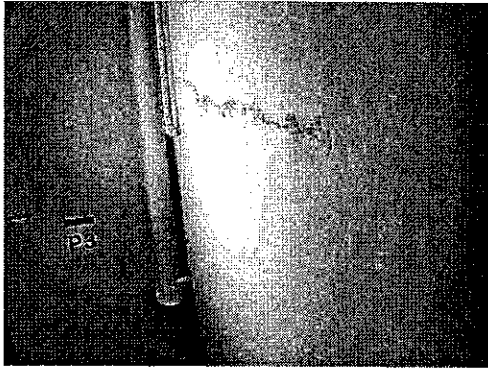
Photograph 3.9

Observation: Evidence of water migration (efflorescence) was visible at a cold-joint beneath the stair-case within Stairwell 3 at parking level P2 below grade.

Action Required: Rout and seal crack.

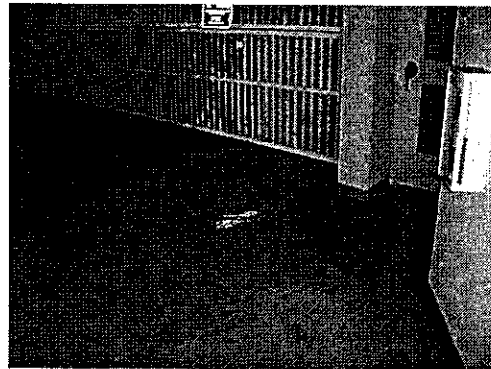
Photograph 3.10

Observation: Ponding water observed within the parking garage (level P1) at the corner of the resident parking area entrance gate.

Action Required: Re-slope affected area as required.

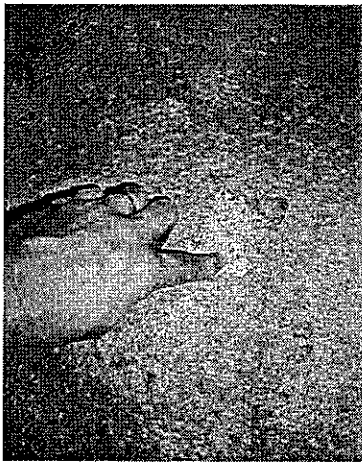
Photograph 3.11

Observation: The top coat of the waterproofing traffic membrane adjacent to the trench drain at the parking garage entrance has debonded at several locations.

Action Required: Remove and re-apply polyurethane traffic coat at debonded areas.

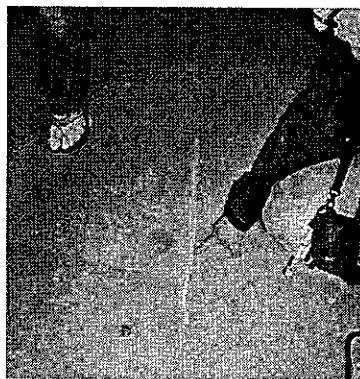
Photograph 3.12

Observation: The traffic coat waterproofing near the parking garage entrance is gouged at three isolated locations.

Action Required: Provide new waterproofing membrane at gouged and damaged locations as part of ongoing maintenance program.

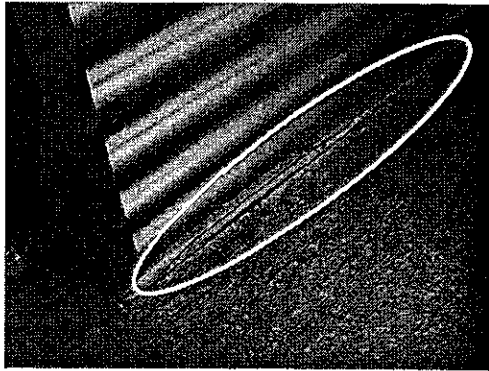
Photograph 3.13

Observation: The base of wall flashing at the main entrance to Townhouse 390 is corroding.

Action Required: Replace corroded flashing with new metal flashing. Flashing should be isolated from the concrete.

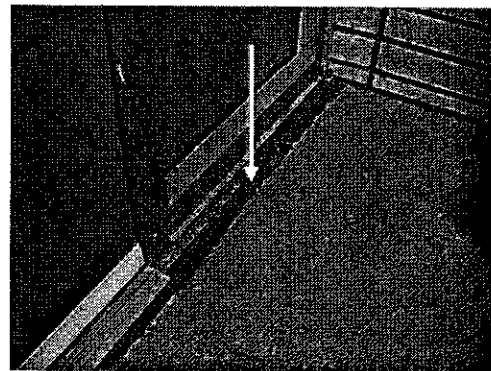
Photograph 3.14

Observation: A flashing is missing over the unprotected liquid applied waterproofing membrane at the main entrance to Townhouse 380.

Action Required: Install a cover flashing.

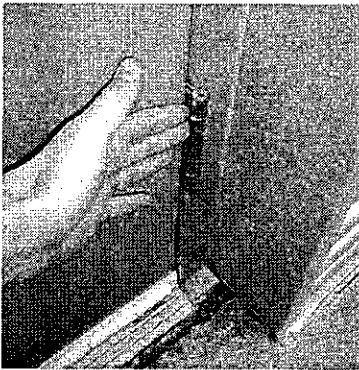
Photograph 3.15

Observation: The bottom door hinge at the main entrance to Townhouse 390 is corroded.

Action Required: Replace affected hinges.

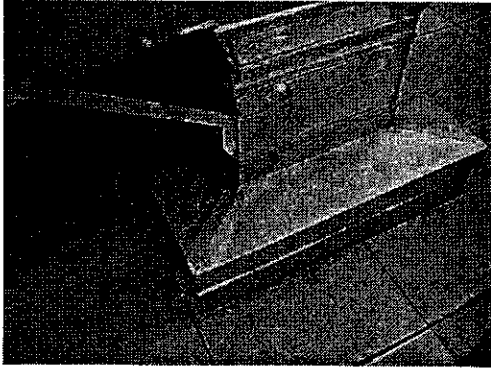
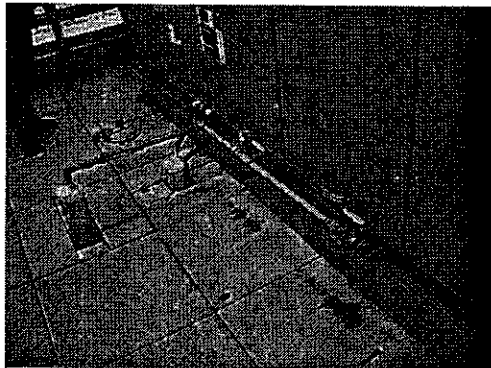
Photograph 4.1	Photograph 4.2

<p>Observation: The flashing around the mechanical unit roof penetration at the main roof of the high-rise building is corroded.</p> <p>Action Required: Re-paint flashing with corrosion-inhibiting paint.</p>	<p>Observation: Corrosion was observed on the gas pipelines at the rooftop mechanical unit.</p> <p>Action Required: Re-paint pipes with a corrosion inhibiting paint.</p>

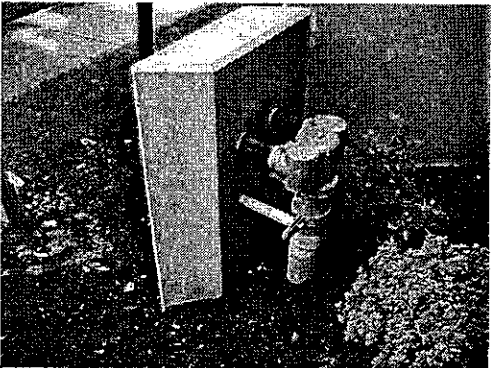
Photograph 4.3

<p>Observation: The siamese fire connection pipes are unpainted.</p> <p>Action Required: Paint unpainted components.</p>
