Park Place Estates
Strata Plan NW 2969
13725 – 72A Avenue,
Surrey, BC

Levelton Consultants Ltd.

The Owners, Strata Plan NW 2969, retained Levelton Consultants Ltd. (LCL) to prepare a Depreciation Report (DRP) for Park Place Estates, located at 13725 72A Avenue, Surrey, BC.

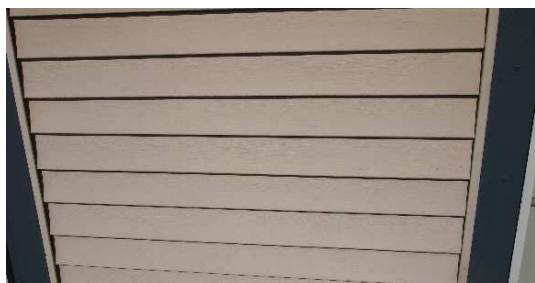
Vinyl Siding

- Vinyl siding is in generally good condition.

Regular cleaning of the vinyl siding surface is recommended to minimize staining and vegetation growth. The service life expectancy of vinyl siding varies depending on numerous factors and can reach 40 years or more. Localized repair and replacement may be required. Siding should be reviewed on a regular basis.

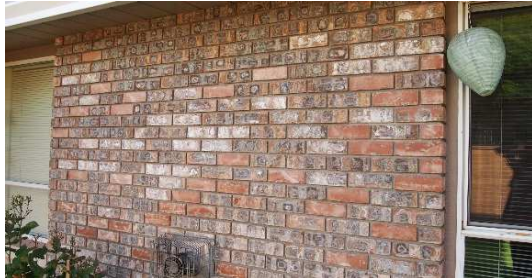
Brick Veneer

- The brick is currently in good condition.

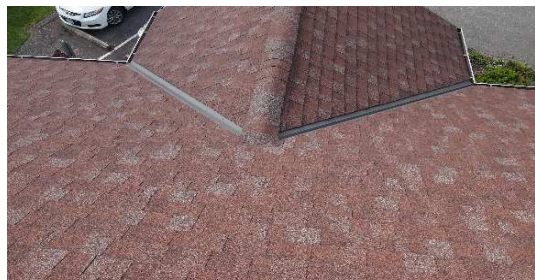
Asphalt Shingles

- The asphalt shingles are in generally good condition.

The review and maintenance of the asphalt shingles should be done regularly. The regular replacement of individual shingles should be done as required. Under normal conditions, the expected service life, with regular maintenance, of the asphalt shingles is approximately 20-25 years.

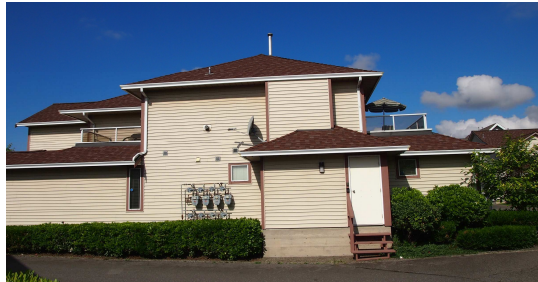
Decks

- The vinyl membranes are in generally good condition. The pony walls are repaired/maintained as required during the deck replacement projects.

The review and maintenance of the vinyl membranes should be done regularly. Any damage such as punctures, scrapes or cuts should be repaired immediately. The drains should be reviewed regularly and cleared as required. The following is the deck replacement history:

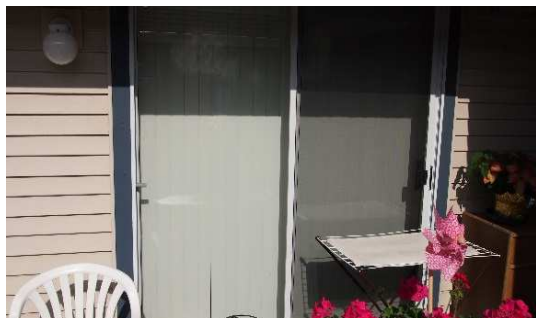
Aluminum Windows and Sliding Doors

- The aluminum windows and sliding doors are in generally acceptable condition. The replacement of the failed sealed units is included in the operating budget. The replacement cost shown in the table above is for a full scale replacement with vinyl windows.

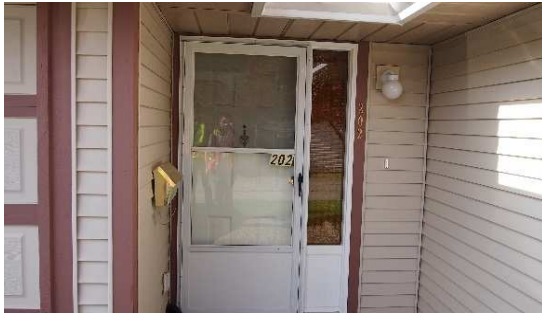
Entrance Doors

- Entrance doors and french doors are in acceptable condition.

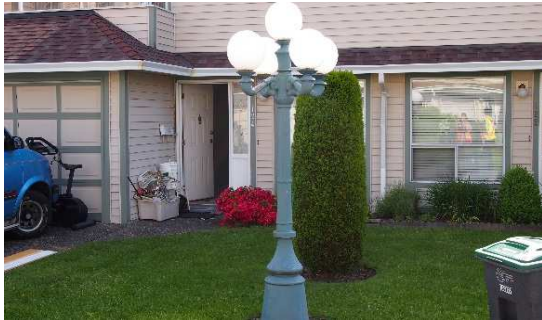
Garage Doors

- The garage doors are generally in good condition.

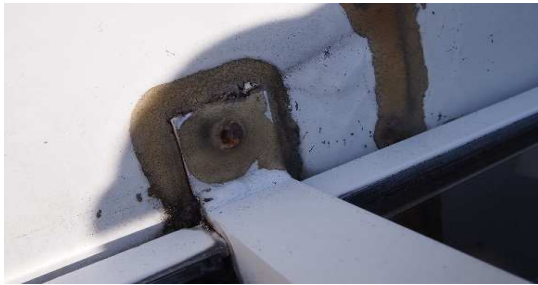
Sealants

Deterioration of the sealants or loss of adhesion can be caused by weathering, presence of coatings or contaminants, inappropriate joint design and deficient application. The service life expectancy of sealant varies and is dependent on numerous factors ranging from joint design to exposure levels. Under normal conditions, the expected service life of sealant is approximately 10 years, at which time a complete removal and replacement program of the sealant is recommended. The sealant should be reviewed annually. Localized failed sealant should be replaced as part of an on-going maintenance program.

- The age of existing sealant is unknown.
- Cracked and damaged sealant is observed at many location. Replacement is recommended.

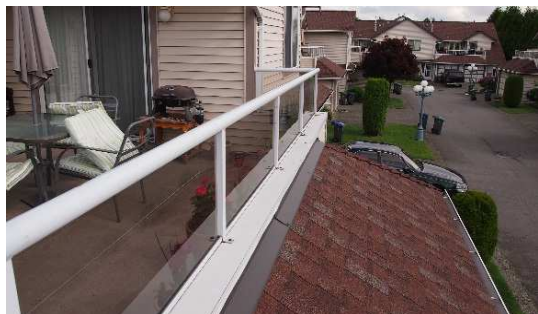
Aluminum Guardrail

- The guardrails are in generally good condition.

The review and maintenance of guardrails is an important part of any maintenance program and must be done on a regular basis. Any scratches or dents should be repaired to maintain continuity of the protective coating. Fasteners should also be reviewed on a regular basis. Any loose glass insert panels should be immediately corrected.

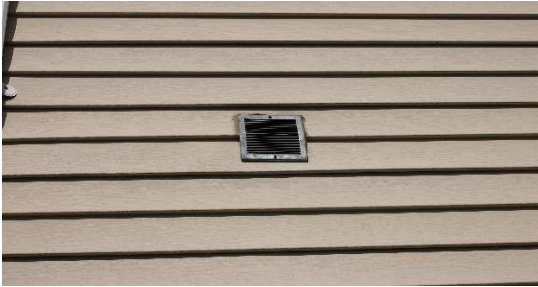
Exhaust Vents

- Regular maintenance is recommended.
- Exhaust vents are in good condition.

The exhaust vents can be cleaned with a combination of vacuums and compressed air lines. The vents can be replaced during roof/cladding replacements.

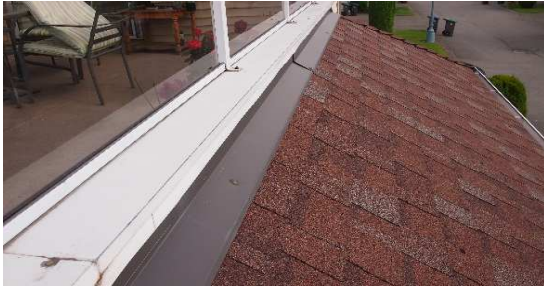
Flashings

- Metal flashings are in generally good condition.
- Replacement of metal flashing is recommended with related components.
