APPENDIX B: Photographs

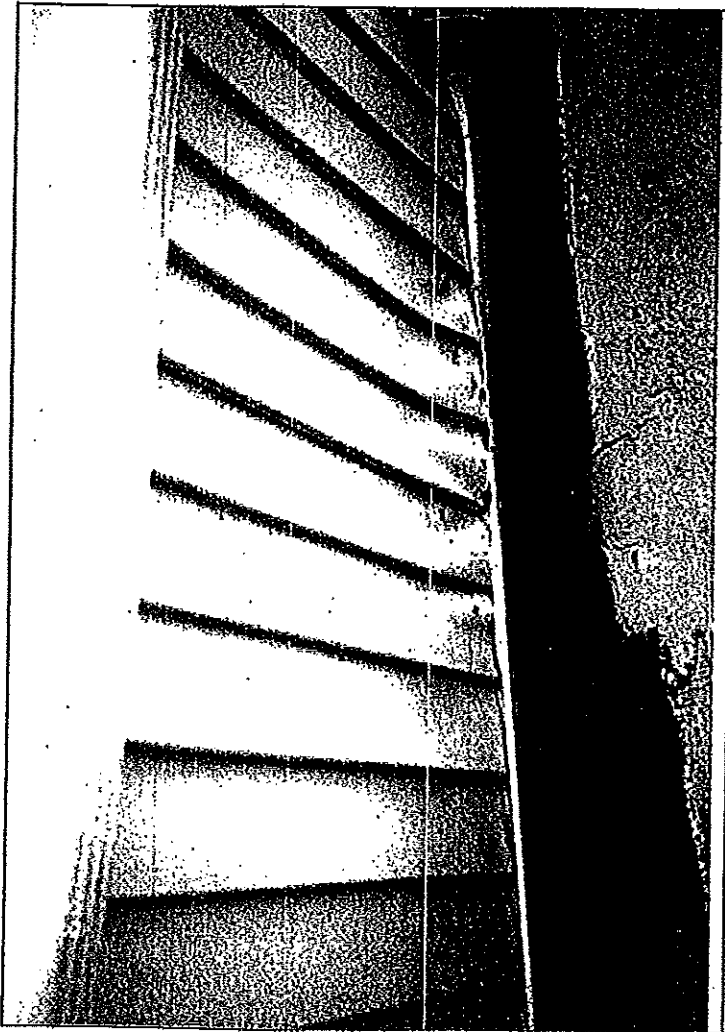
Photo No. 2 -
Location where the
vinyl siding has been
partially melted.

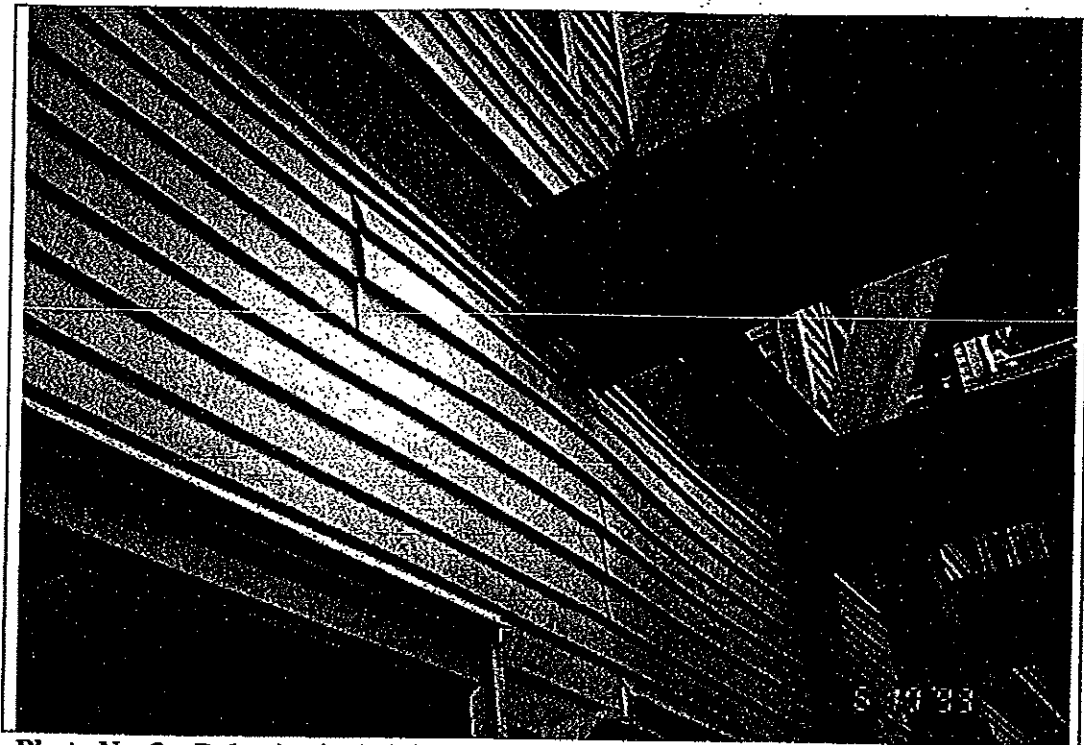
Photo No. 3 – Bulge in vinyl siding.

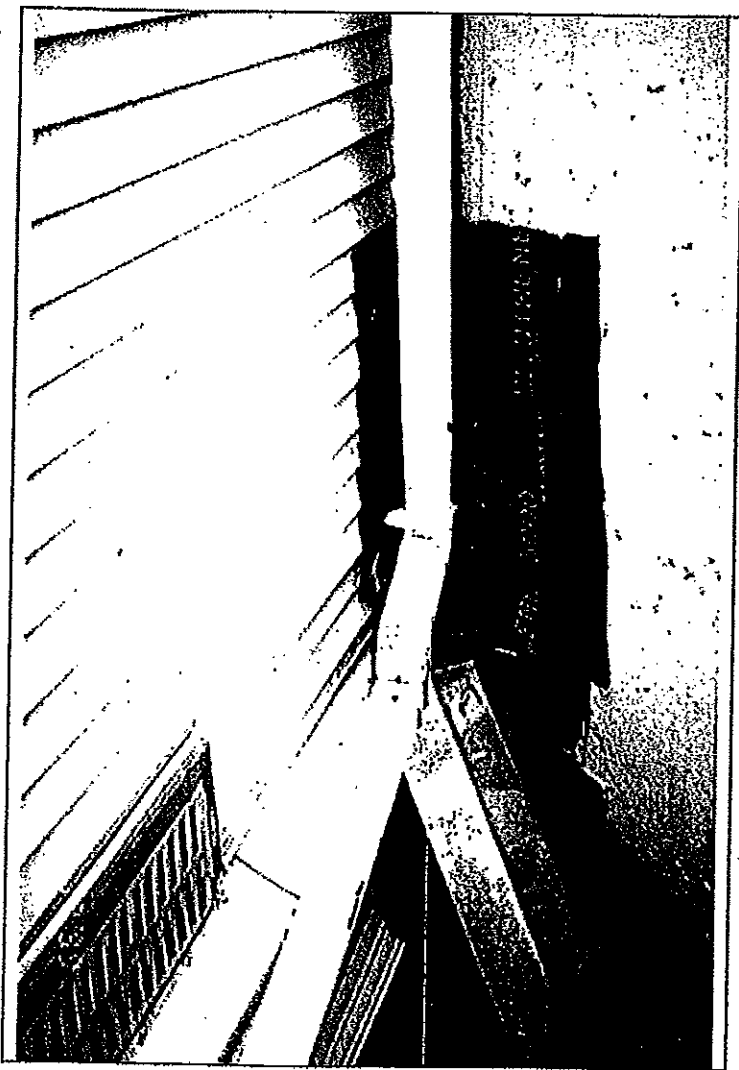
**Photo No. 4 –
Inappropriate use of
self-adhesive
membrane, which has
been installed over
the vinyl siding.**

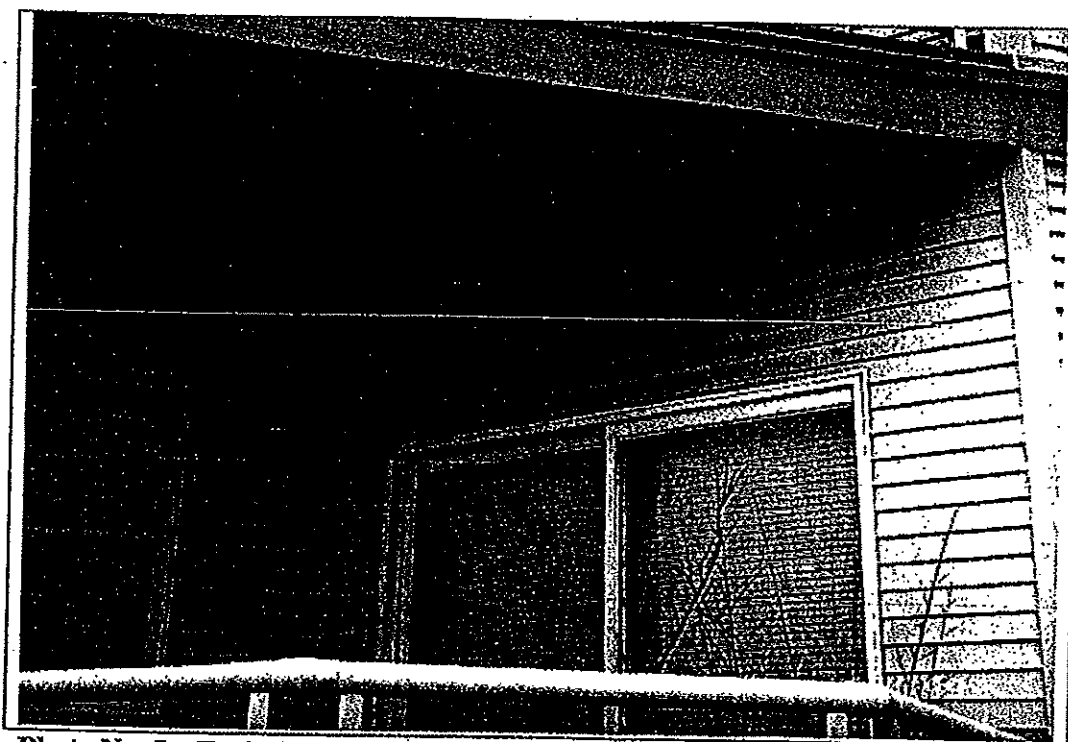
Photo No. 5 – Typical streaks on the vinyl siding on wall area sheltered by a balcony above. The streaks may indicate water penetrating the balcony water proofing membrane.

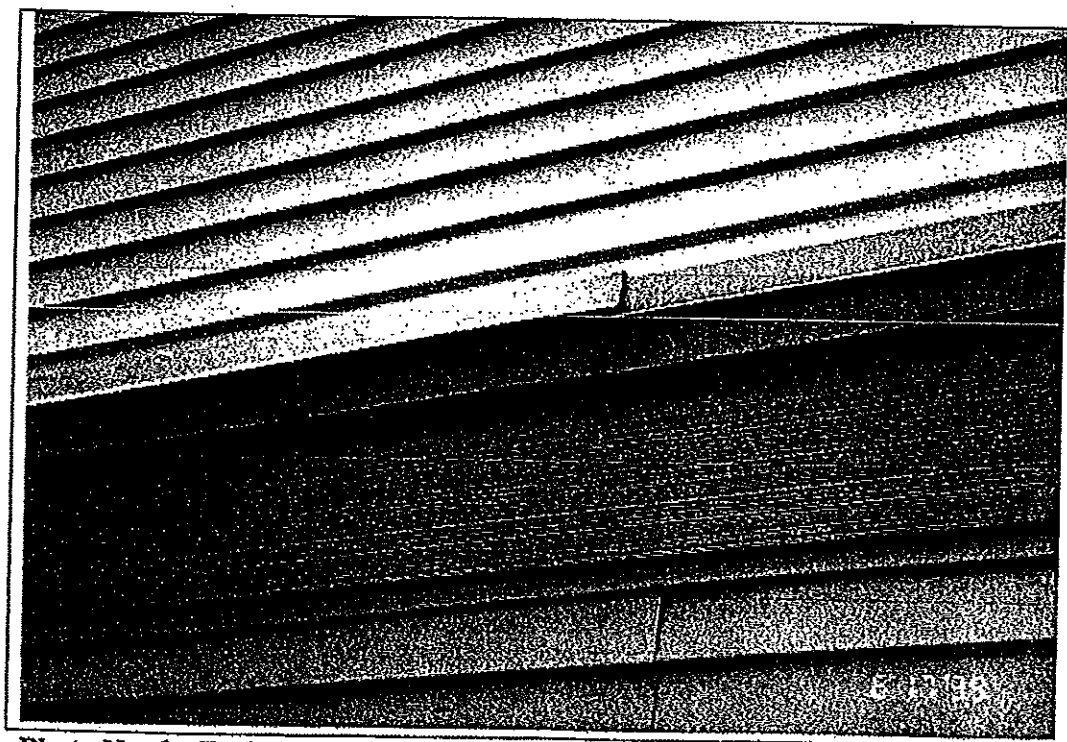
Photo No. 6 – Typical unsealed lap in the metal flashing over the wood bands at floor levels.

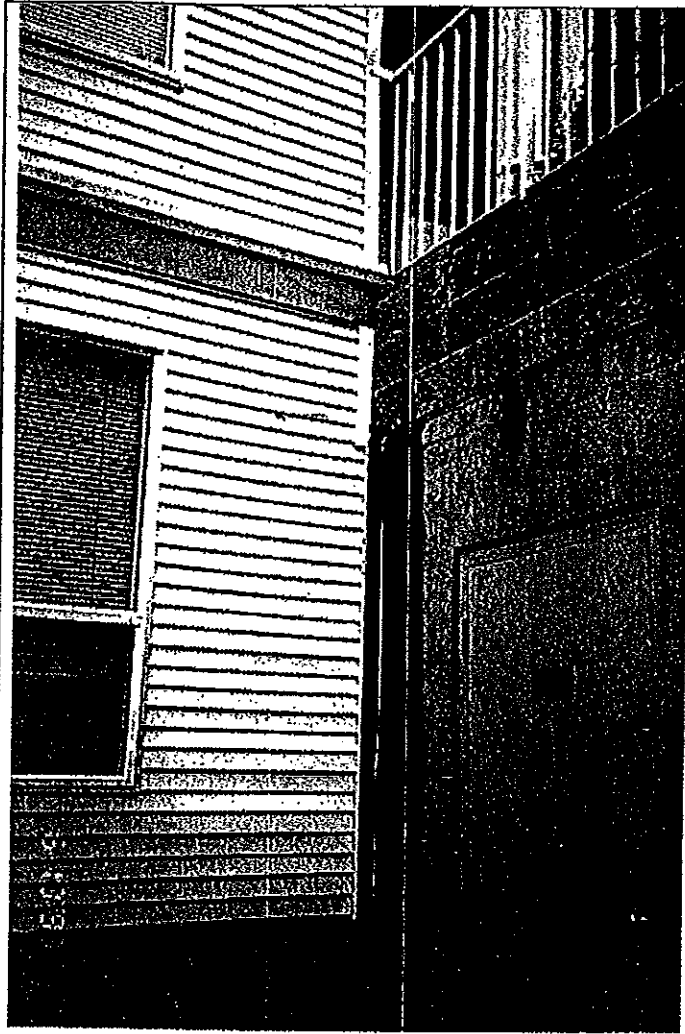
Photo No. 7 – Typical step in the foundation. MH understands remedial work had been performed at this location to address water ingress.

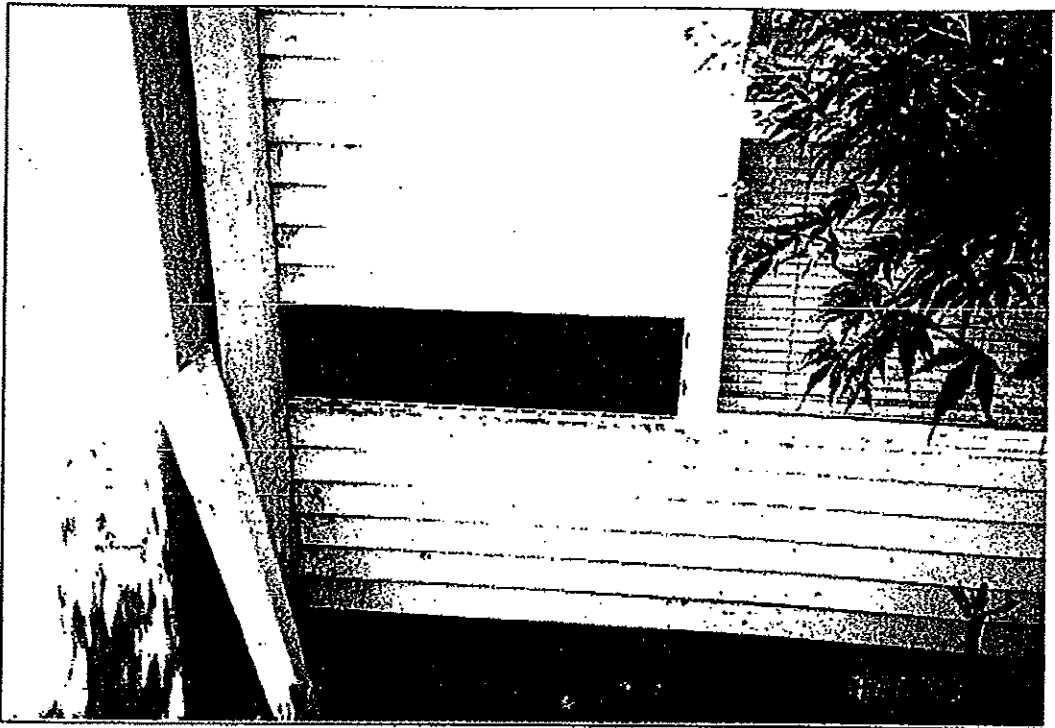
Photo No. 9 – Removal of vinyl siding during moisture probe survey. Note the moisture on the membrane near the concrete/wood framed wall intersection and the deterioration of the building paper adjacent to the window.

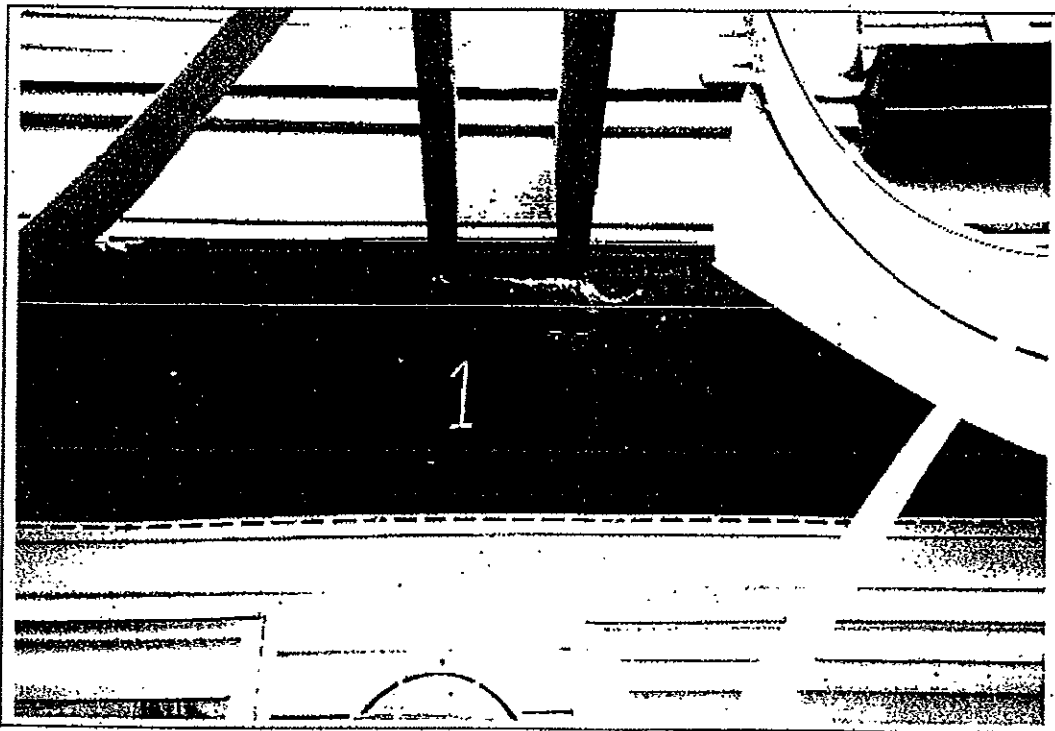
Photo No. 10 – Exploratory opening no. 1, at a location where a bulge in the siding was observed.

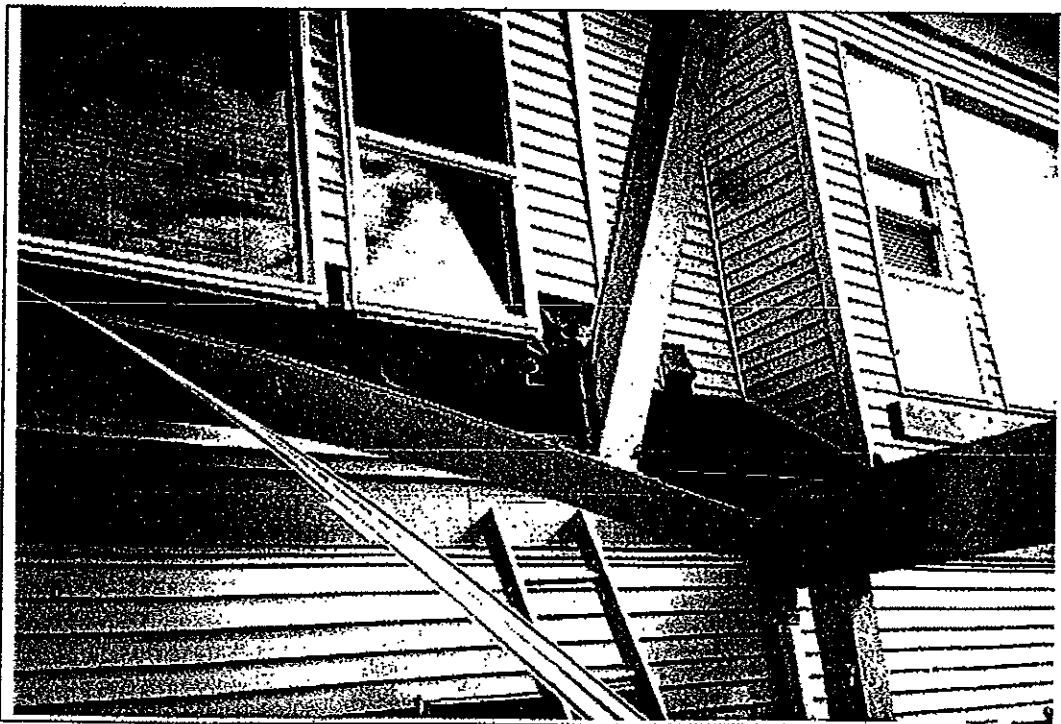
Photo No. 12 – Exploratory opening no. 2, which revealed the wall components to be in good condition.

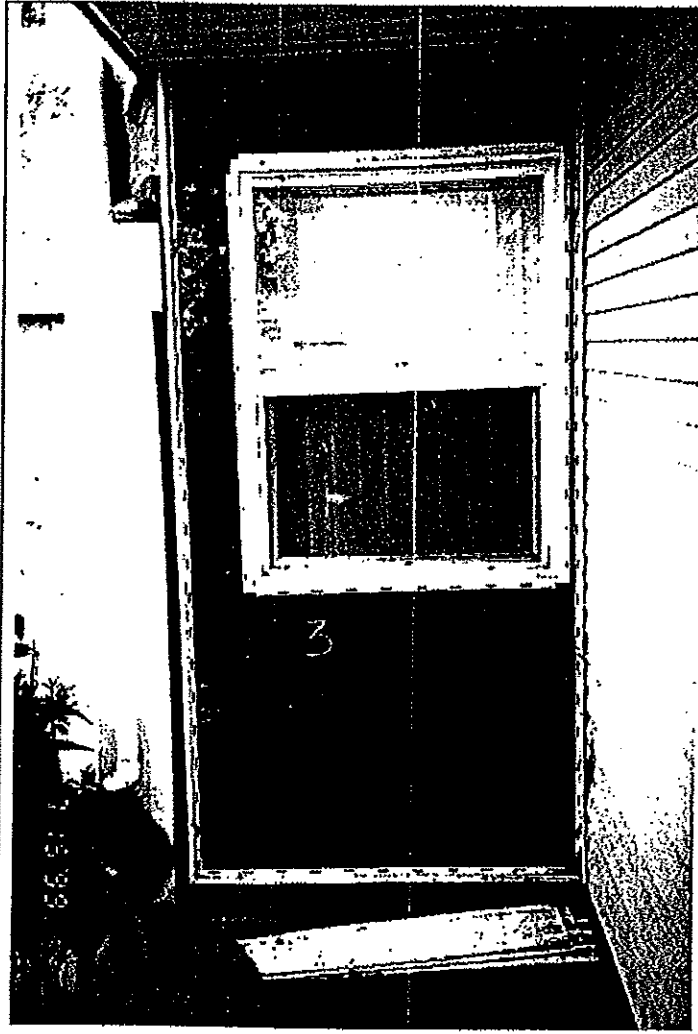
Photo No. 13 – Exploratory opening no. 3, at intersection of concrete foundation and wood framed building walls. Note the deterioration of the building paper and the gypsum sheathing.

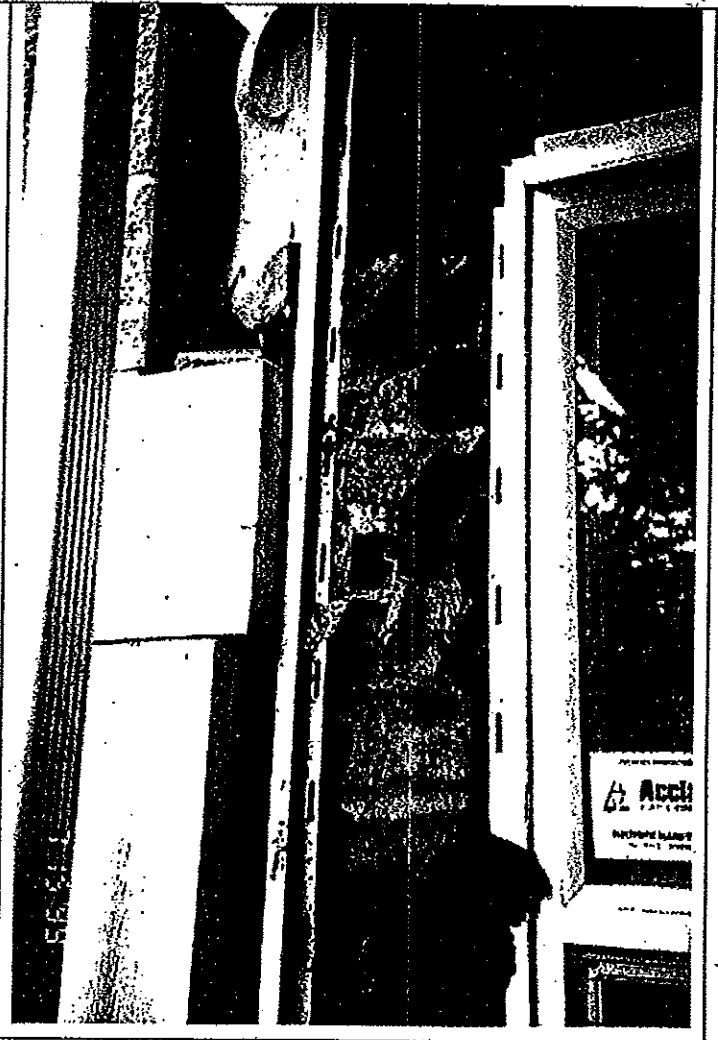
Photo No. 14 – Exploratory opening no. 3 (close-up), revealing the deterioration of the building paper and gypsum sheathing.

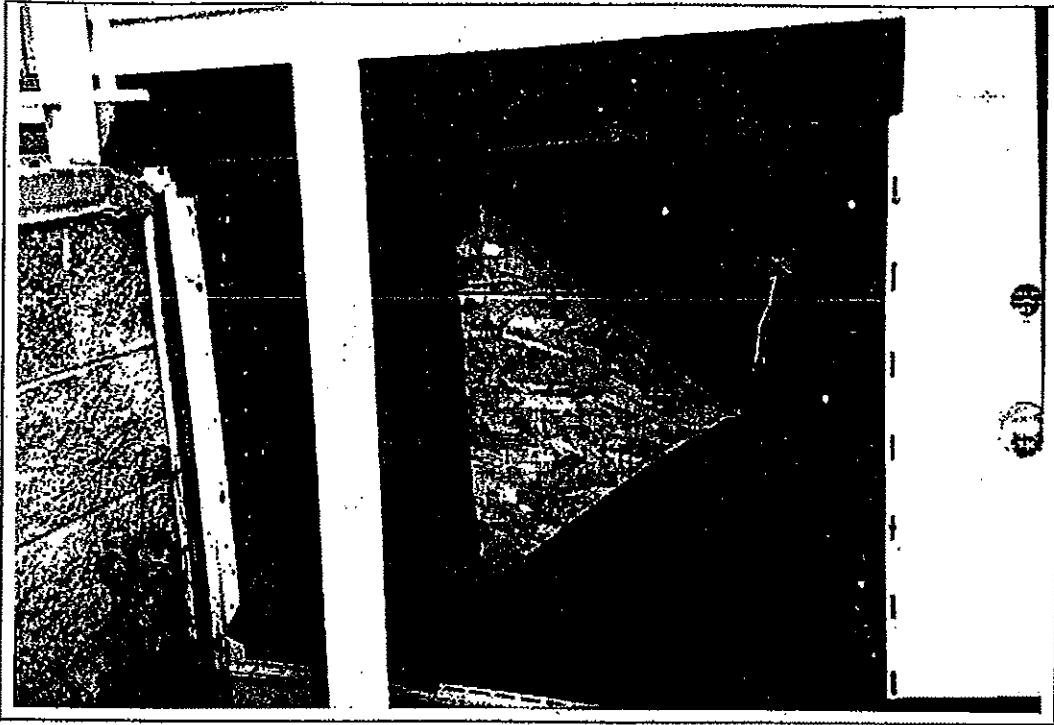
Photo No. 15 – Exploratory opening no. 4, revealing the OSB sheathing to be in good condition.

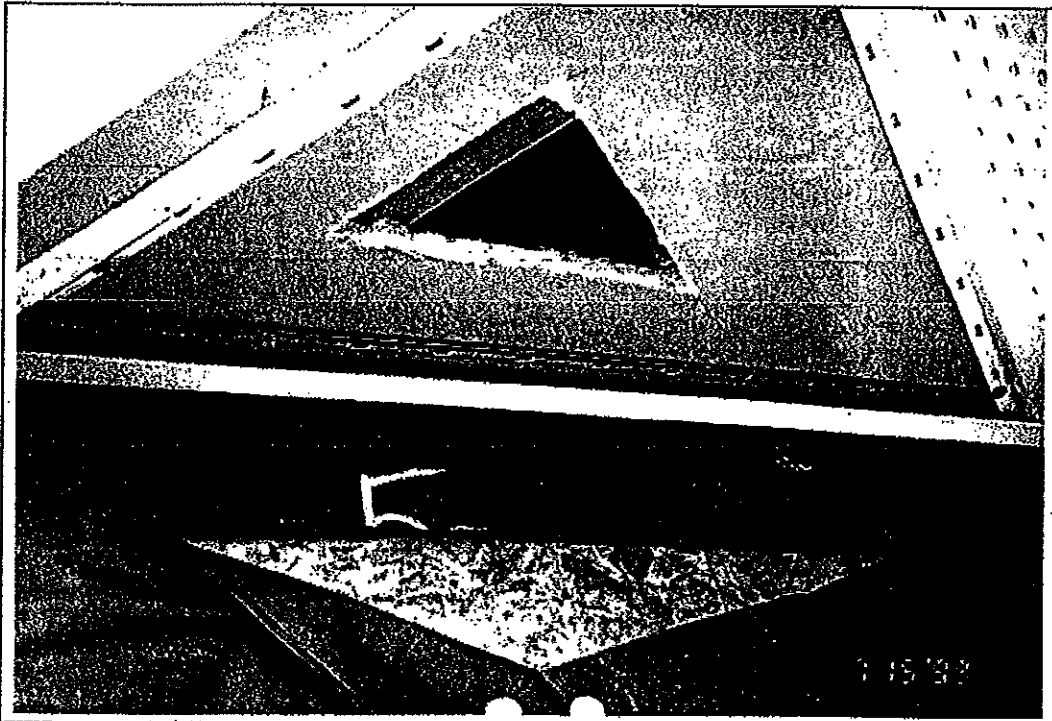
Photo No. 16 – Exploratory opening no. 5, revealing the OSB sheathing and balcony components to be in good condition.

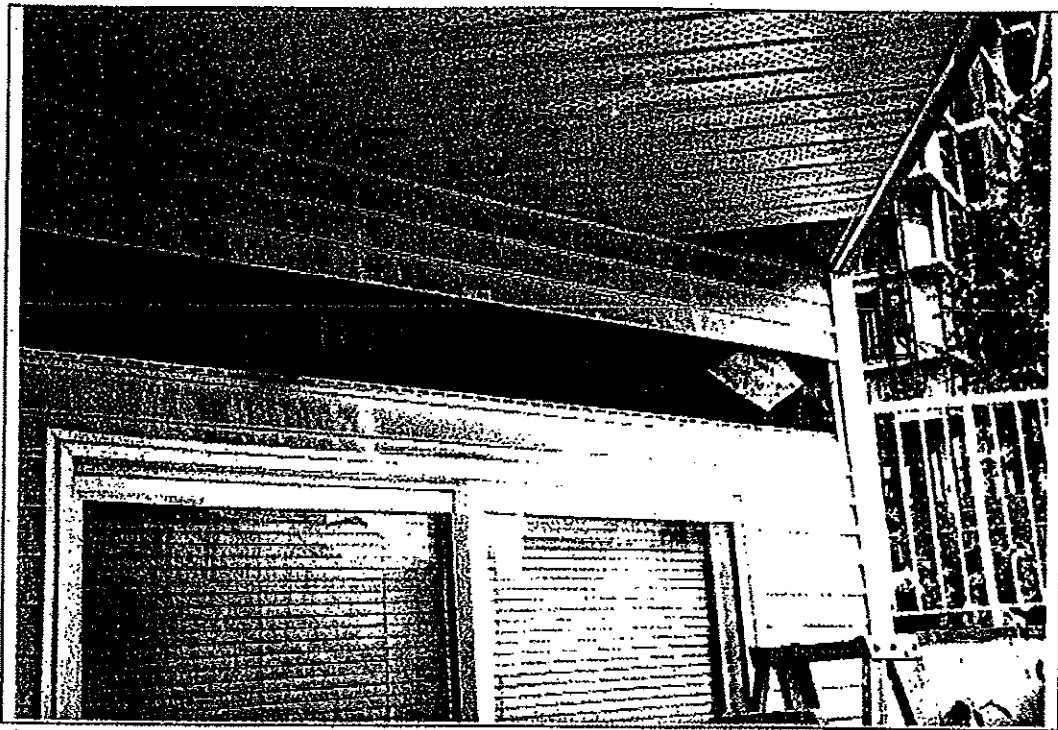
Photo No. 17 – Exploratory opening no. 6, revealing the OSB sheathing and gypsum soffit sheathing to be in reasonable condition.

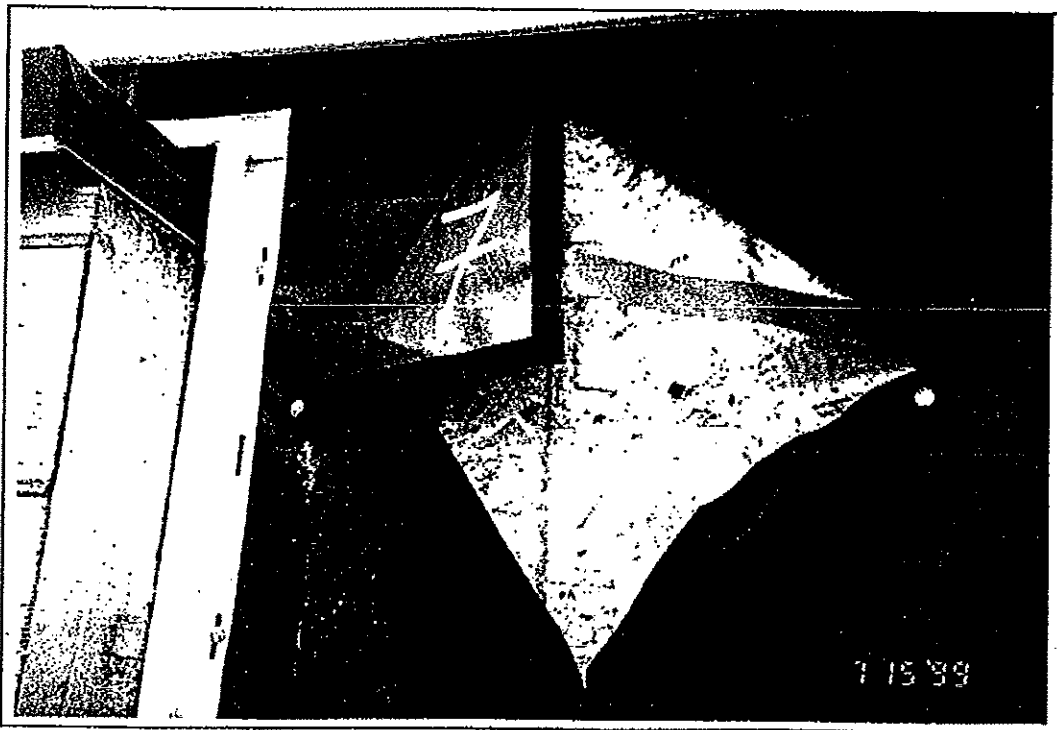
Photo No. 18 – Exploratory opening no. 7, revealing the OSB sheathing to be in good condition.

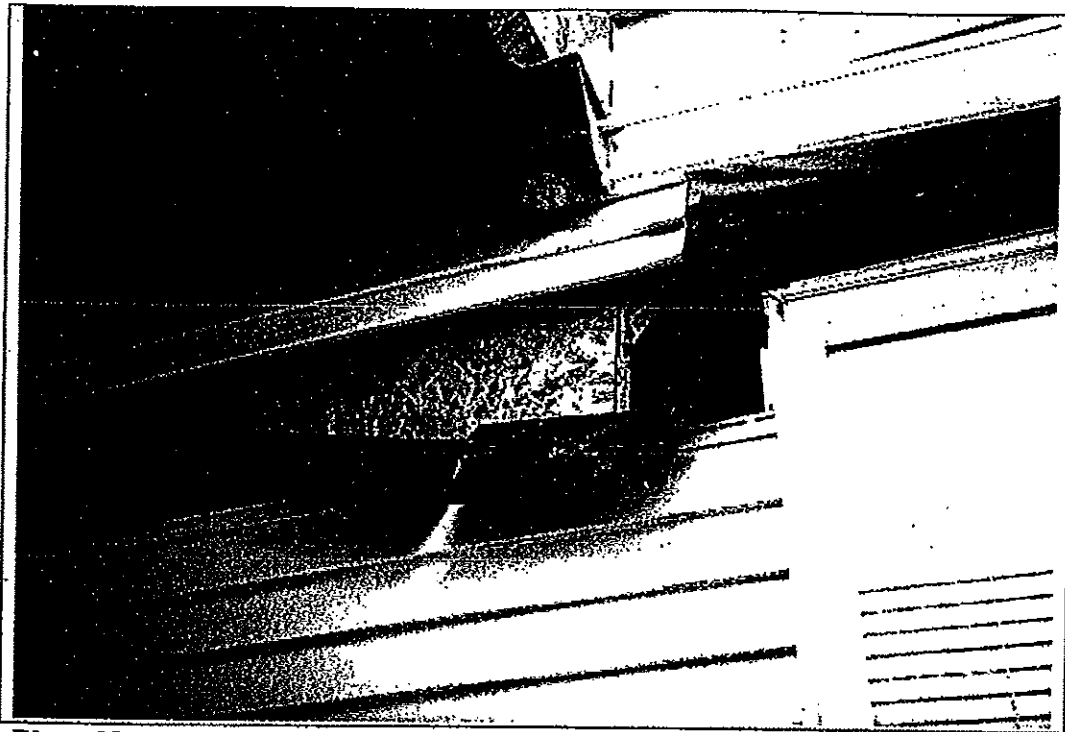
Photo No. 19 – Exploratory opening no. 8, revealing the OSB sheathing to be in reasonable condition.

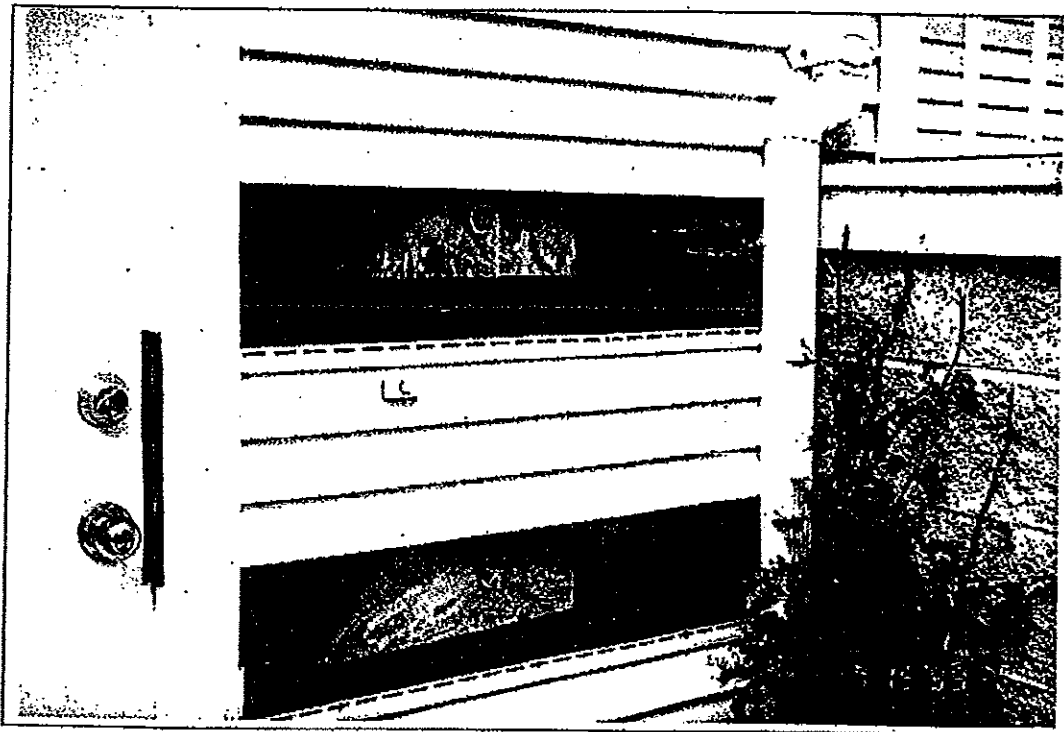
Photo No. 20 – Exploratory opening no. 9, revealing the OSB sheathing to be in good condition.

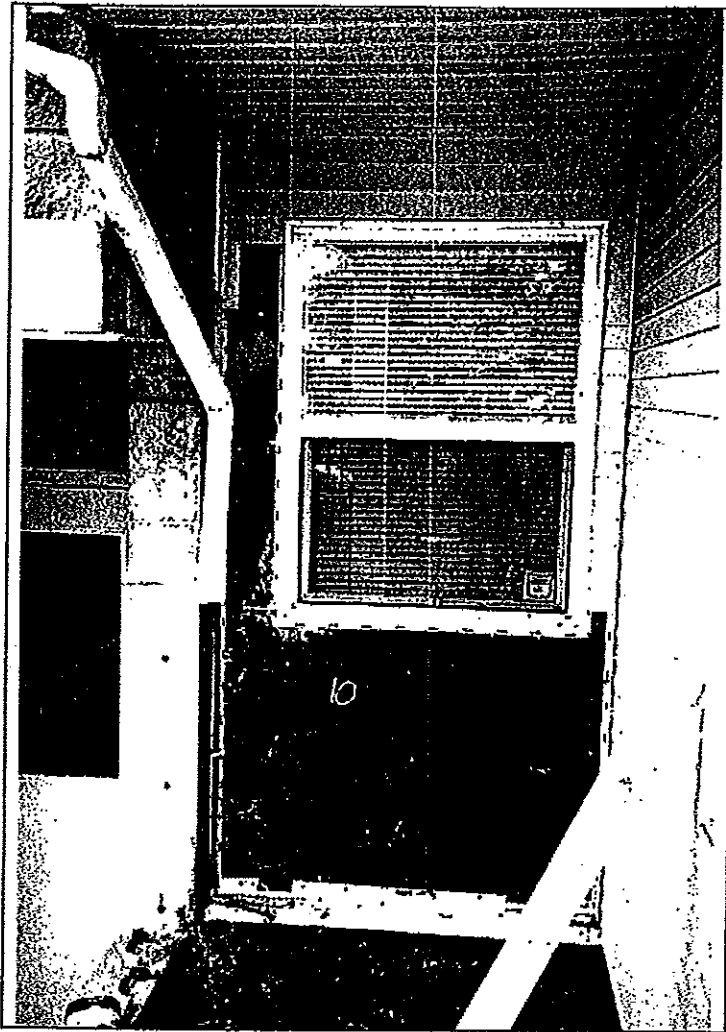
Photo No. 21 –
Exploratory opening
no. 10, revealing
deterioration of the
building paper and
gypsum sheathing.

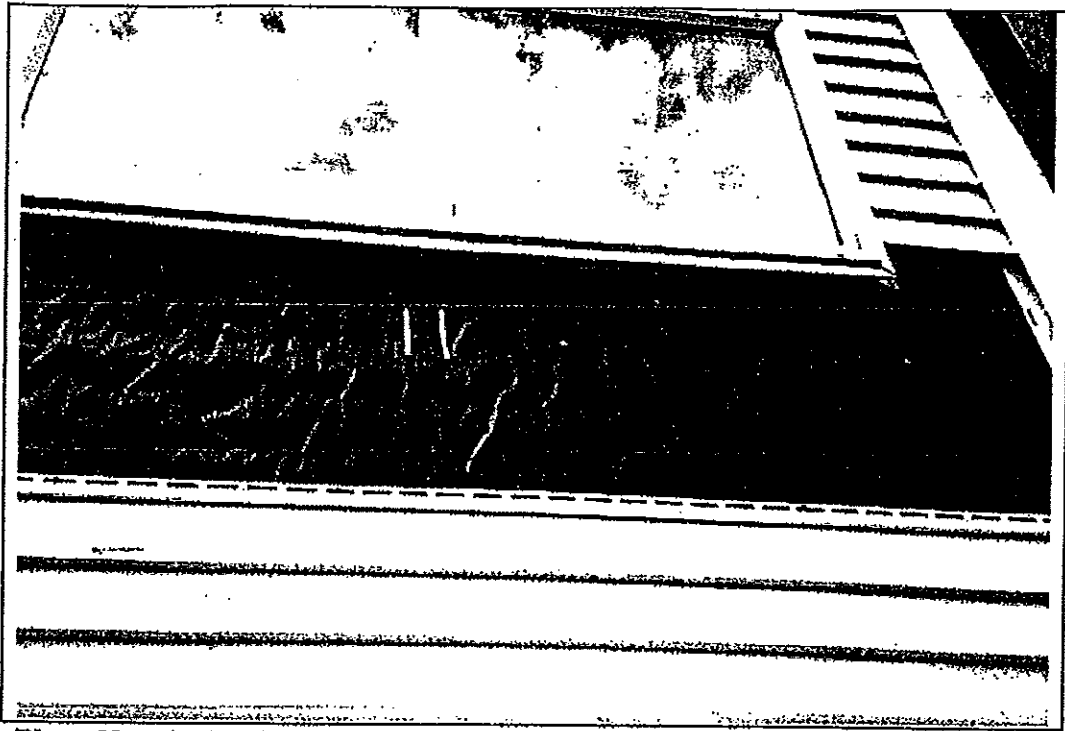
Photo No. 23 – Exploratory opening no. 11, which revealed the OSB to be in reasonable condition.

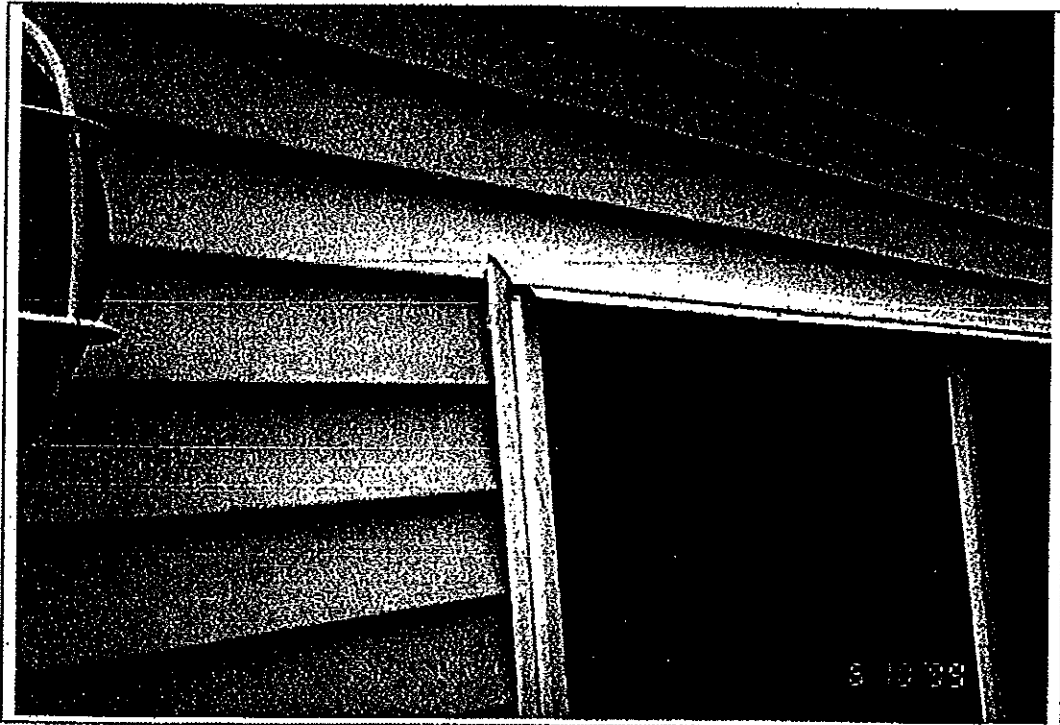
Photo No. 24 – Typical window head flashing. Note the limited slope to shed water to the exterior and the lack of end dams.

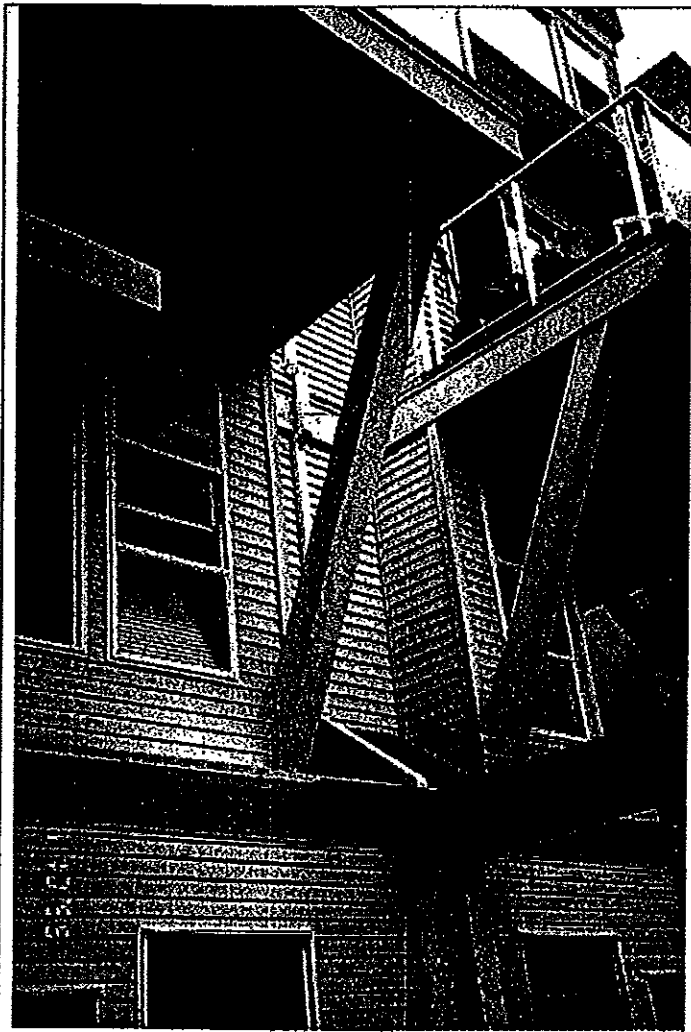
Photo No. 25 -- Building 1, south elevation. Typical location where balcony supports are anchored to the exterior walls.

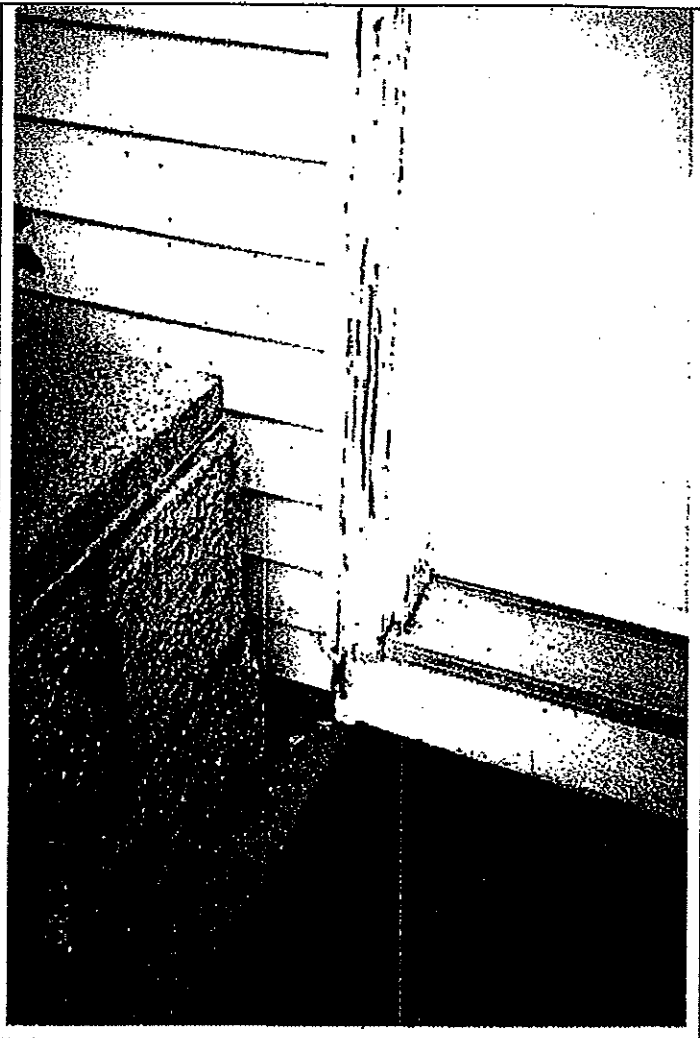
Photo No. 26 -- Typical peeling paint at the base of a door jamb.

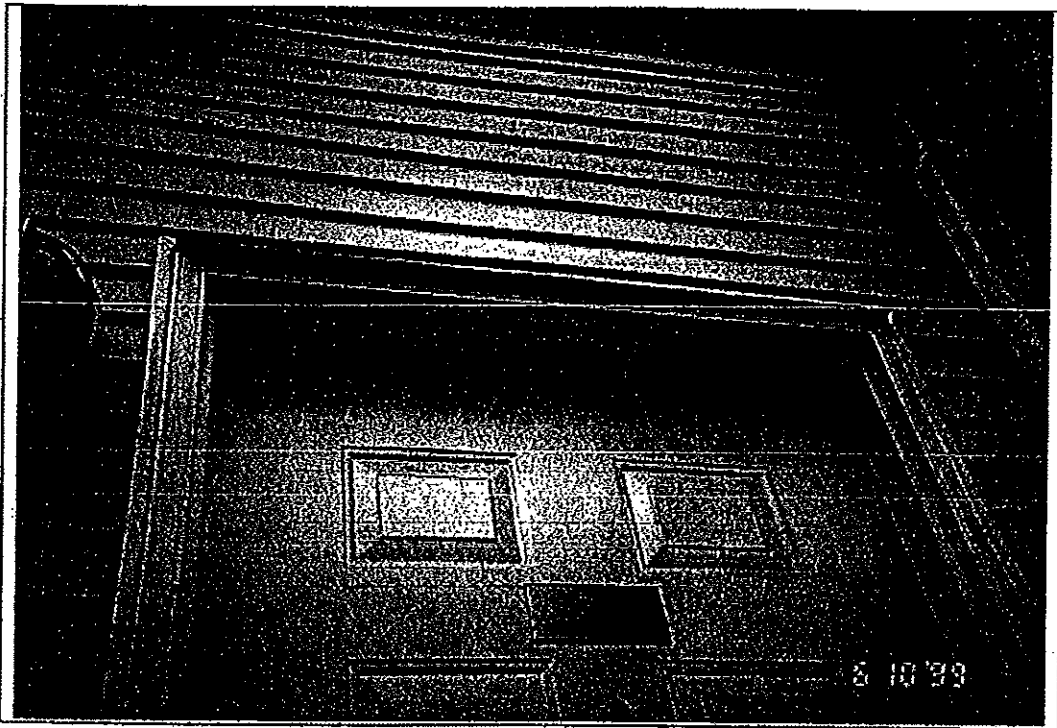
Photo No. 27 – Water stains at the door head framing above unit 24.

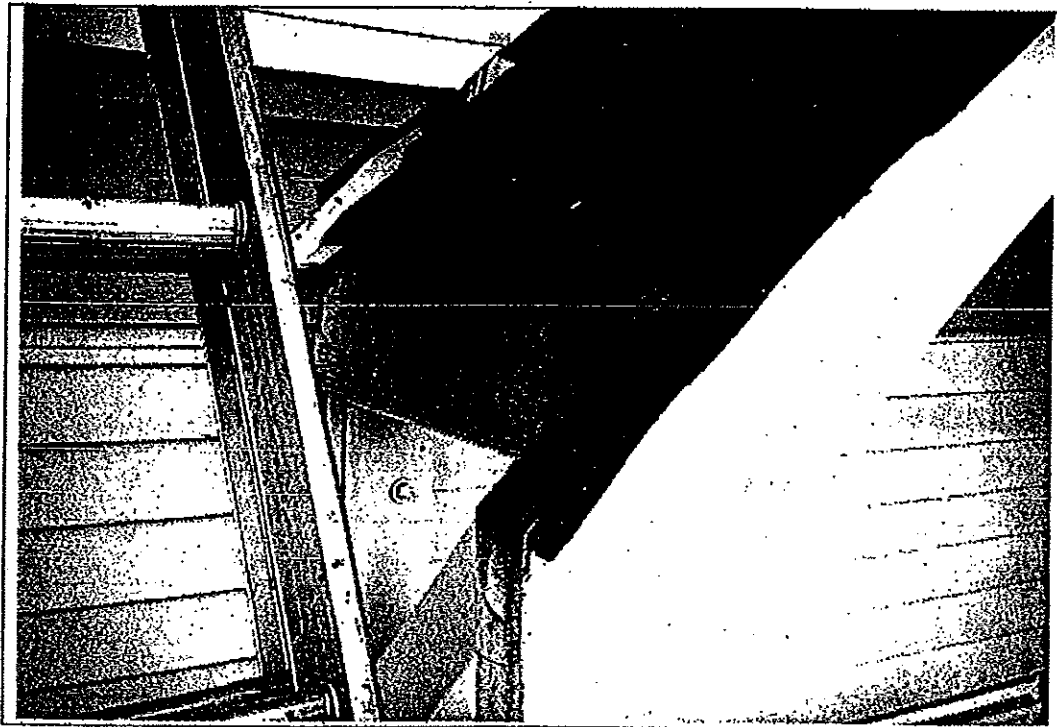
Photo No. 28 – Edge of gabled roof over an entrance. Note the staining of the wood fascia due to a lack of a gutter at this location.

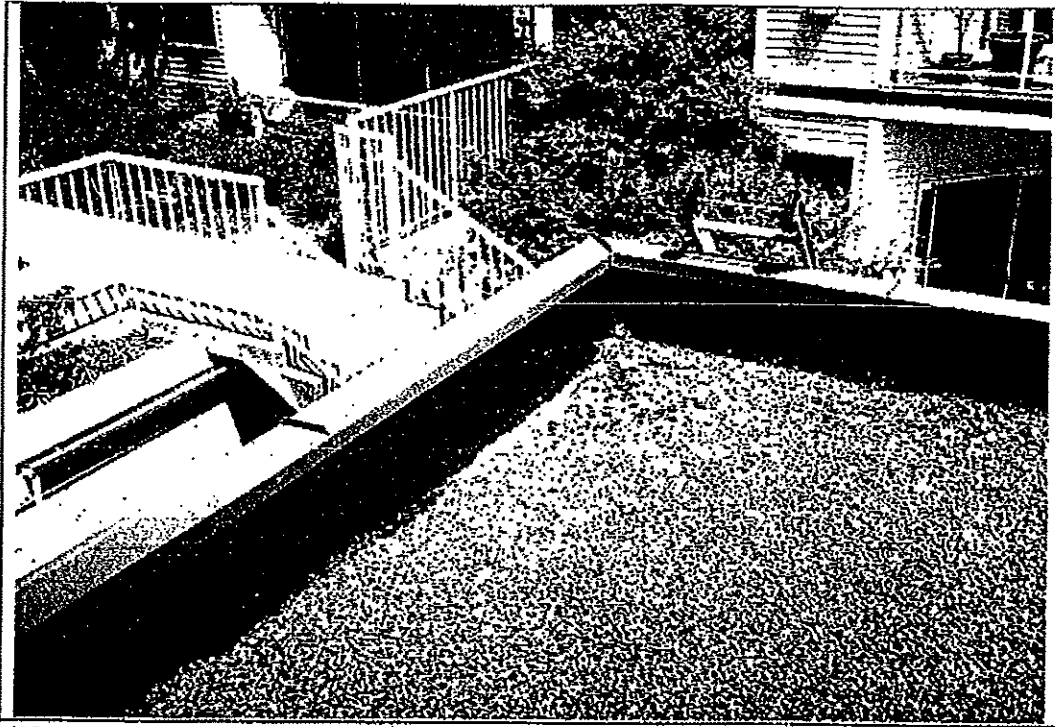
Photo No. 29 – Parapet wall along the perimeter of a flat roof.

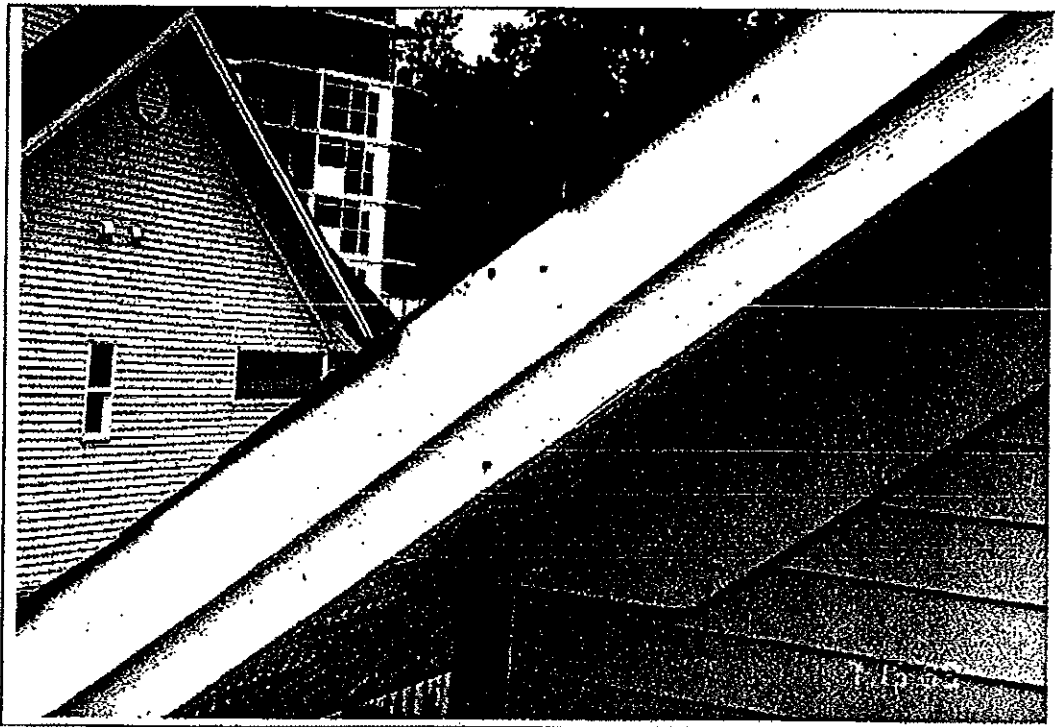
Photo No. 30 – Location where satellite dish had been secured to the roof fascia board above unit 65.

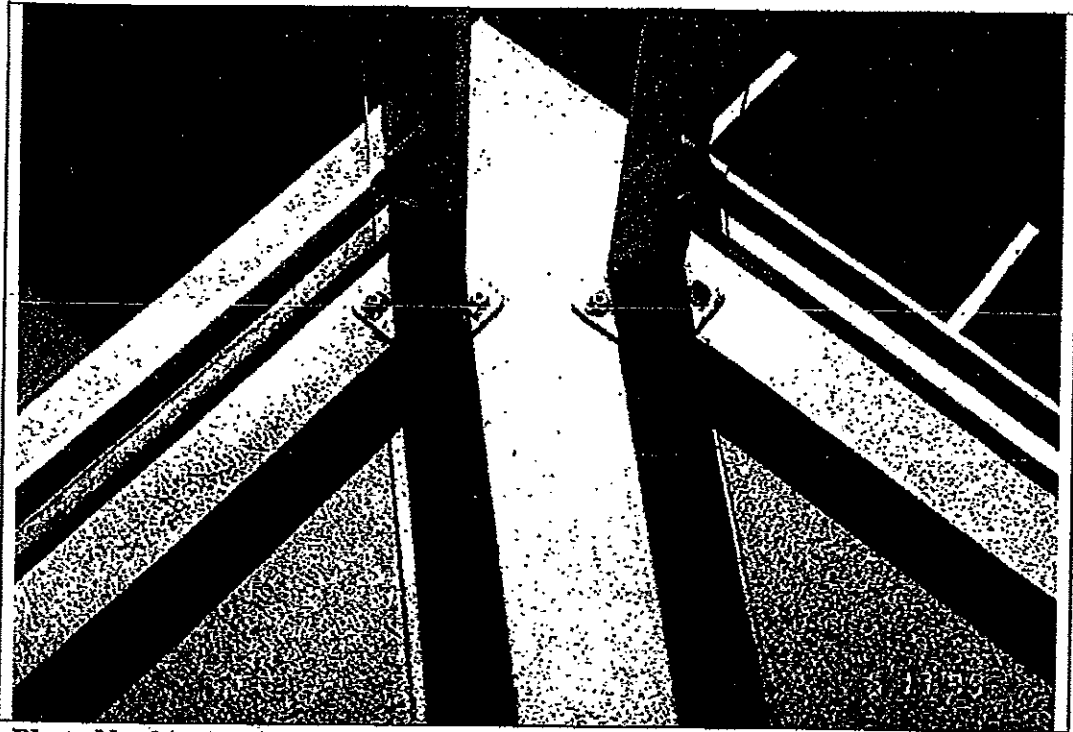
Photo No. 31 – Typical location where the balcony guardrails are secured through the vinyl membrane.

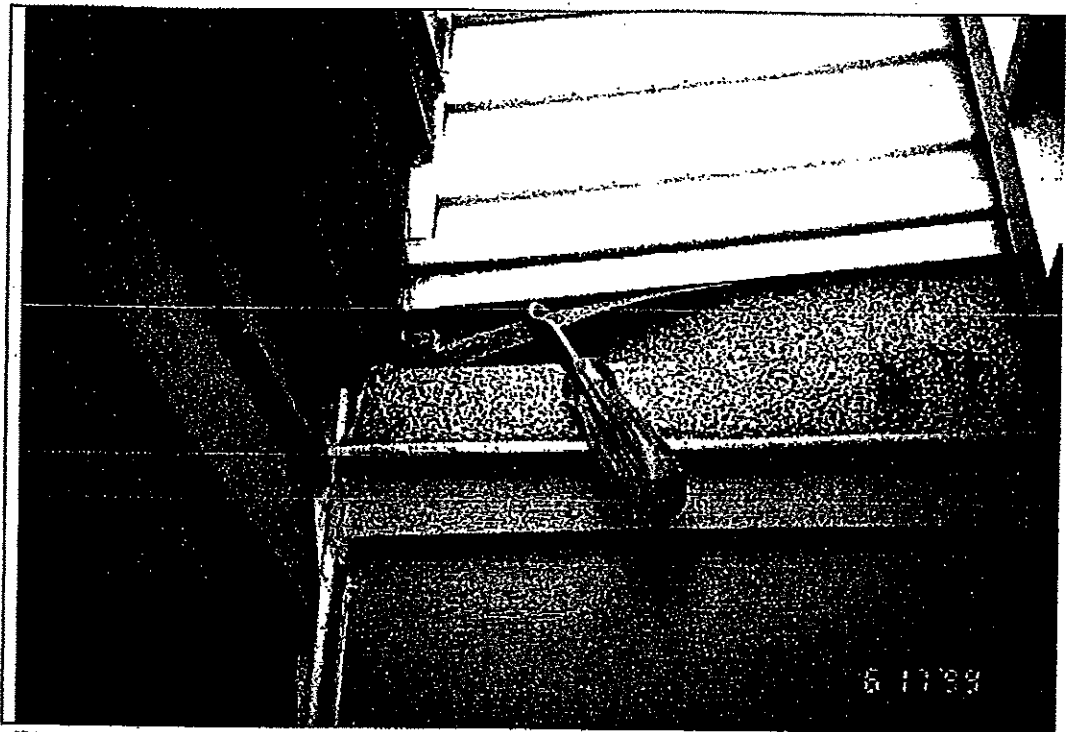
Photo No. 33 – Typical termination of the vinyl balcony membrane at an exterior wall. Note the lack of adhesion of the membrane to the sheathing.

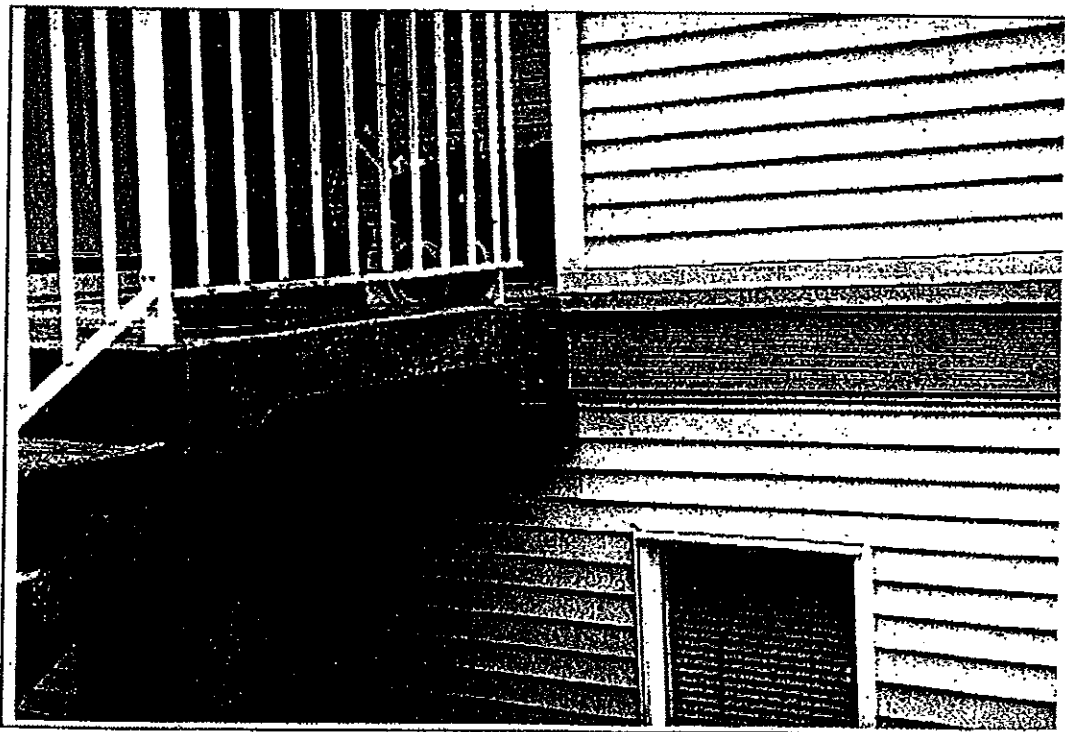
Photo No. 34 – Building 2, north elevation – gutter installed below entry landing stairwell.
