APPENDIX B: Photographs

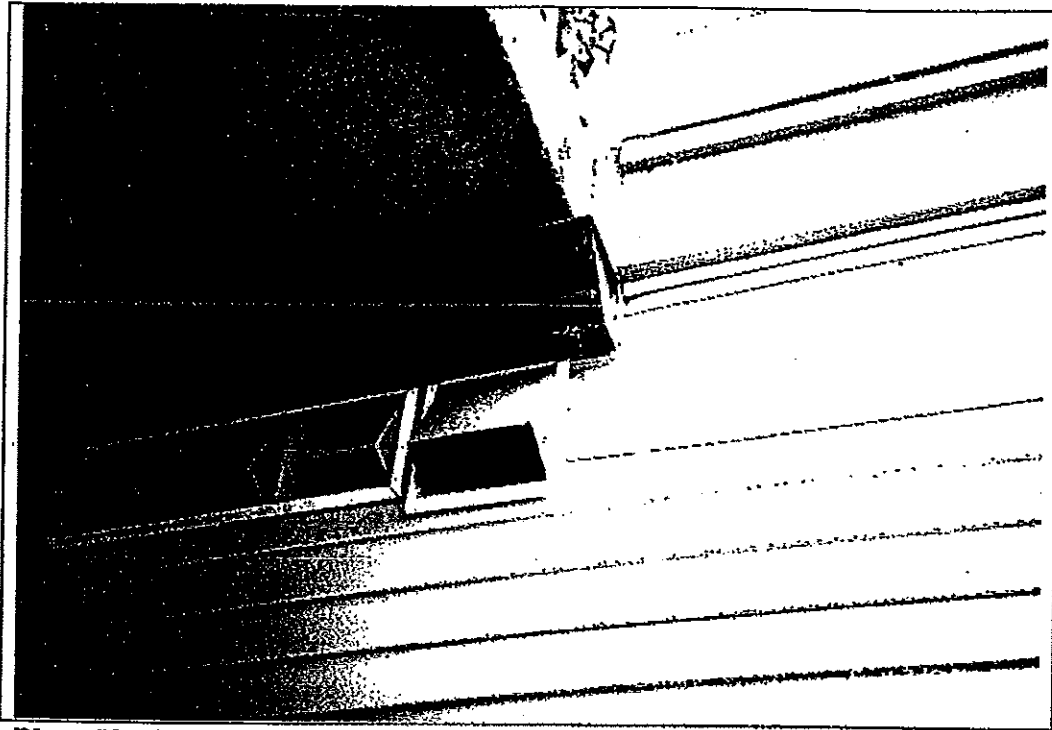
Photo No. 35 – Typical location, Building 2, north elevation, where no downspout has been installed at the gutter below an entry landing. Note that water draining from the gutter is directed onto a vent penetrating the vinyl siding.

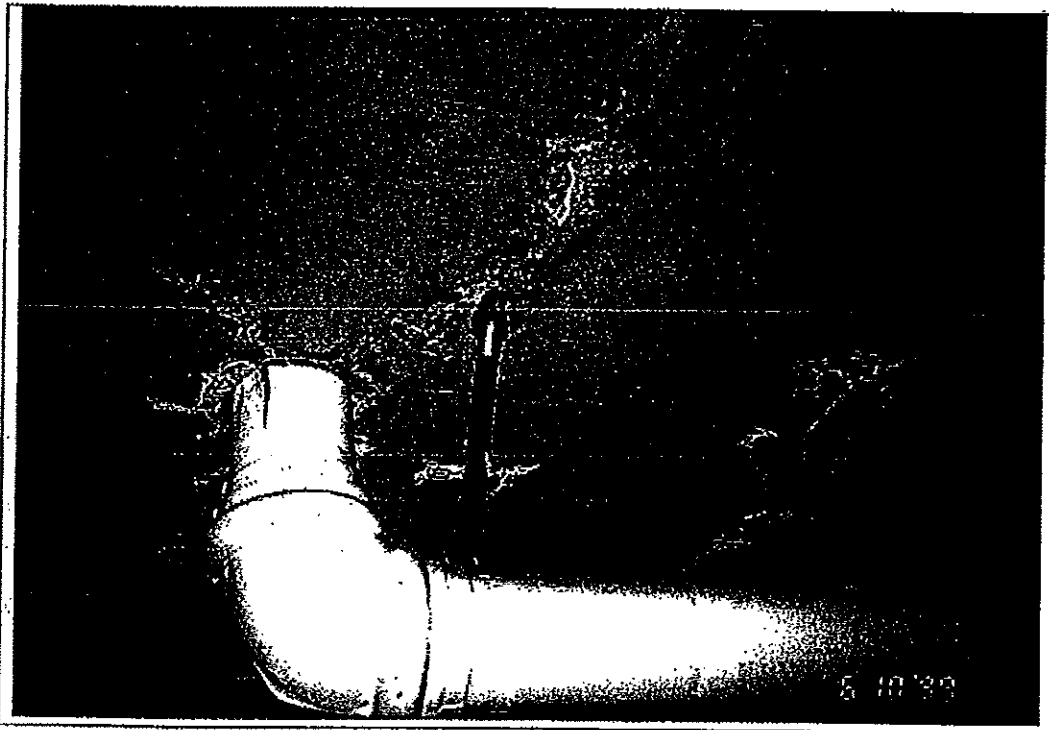
Photo No. 36 – Typical efflorescence on the concrete ceiling slab in the underground parking garage.

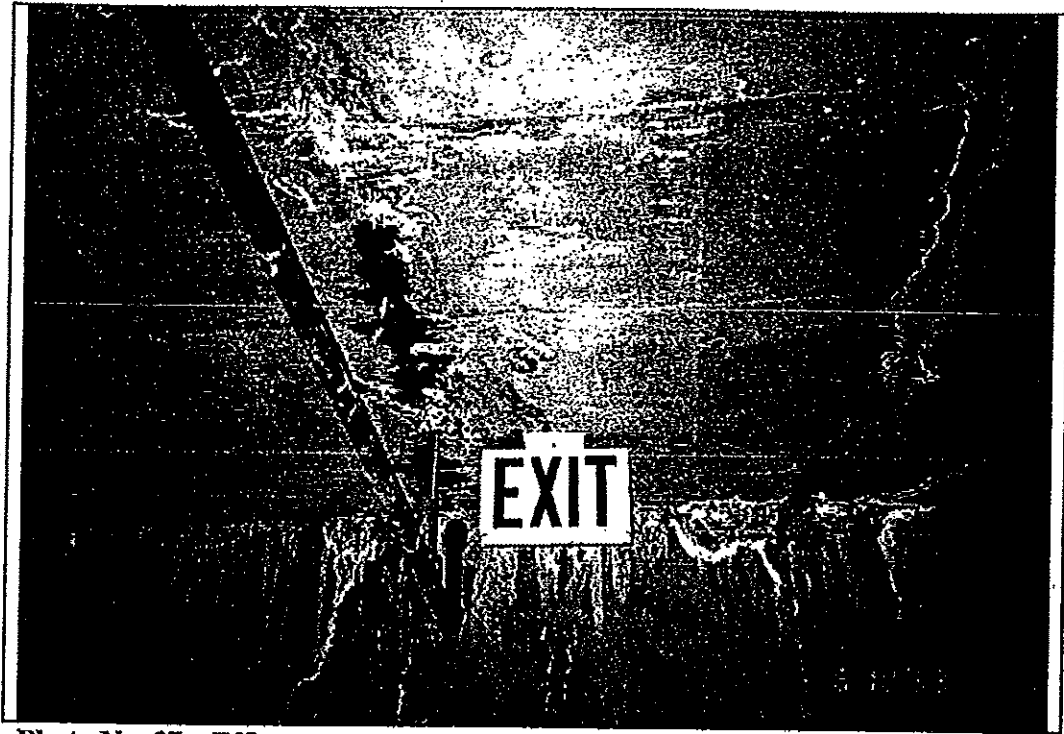
Photo No. 37 – Efflorescence on and water penetration through the concrete ceiling slab of the parking garage.
