FACILITY CONDITION REPORT

Strata Complex LMS 1978
2711 to 2733 East Kent
Vancouver, BC
V6G 2K5

File No.: P06-106

July 31st, 2006

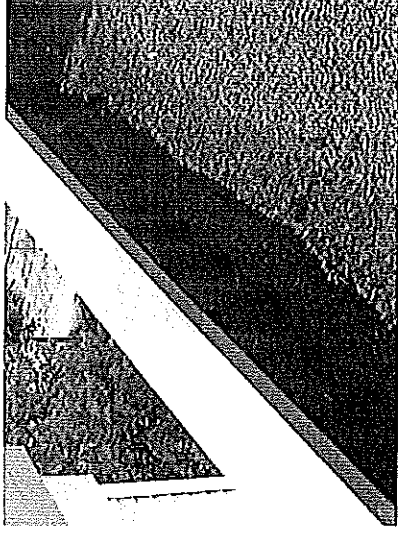
012

- Asphalt blocked scupper. (P.010,011)
- Ridging, tenting, and openings of perimeter membrane flashing. (P. 012,013,014,017,018,024)
- Deficient securment of centre venting hood. (P.015)
- Improper sized vent cap ; sealed at pipe with caulking . Cap should fit "IN" pipe. (P. 019,020,021)

Our overall recommendation is that perimeter membrane flashings deficiencies be repaired and that plumbing caps replacement be undertaken as they on a whole are sized incorrectly. This improper sizing has allowed water to ingress between the pipe and sleeve. Two areas where perimeter cap metal has been repaired with peel and stick membrane should be addressed correctly and put back to original condition.

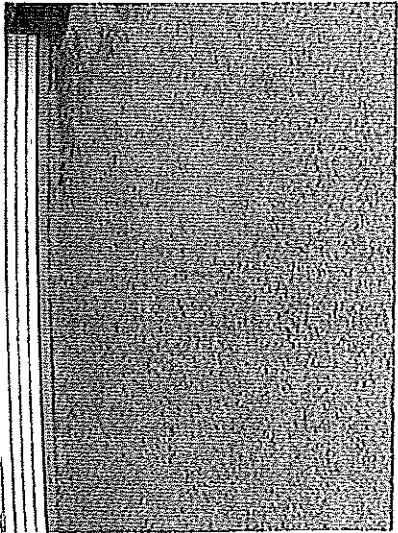
007

- Perimeter membrane openings. (P. 003,004,005,006)
- Ridging is observed. This should be monitored. (P. 007)

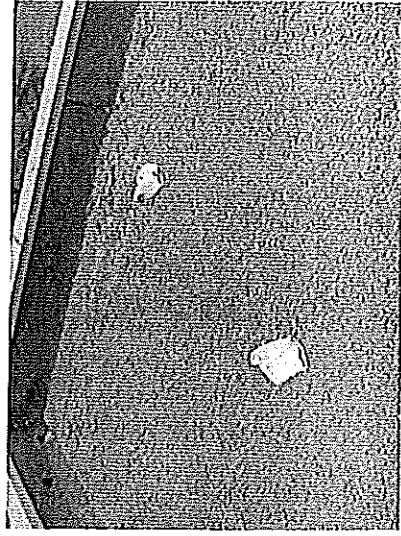
027

- Tenting and membrane openings at building perimeter. (P. 025,028,029,030)
- Improper sized vent caps. (P. 026)
- Blister at North/ East corner. Must be monitored. (P. 027)
- Wood Siding at cap flashing detail requires repair. (P. 031)

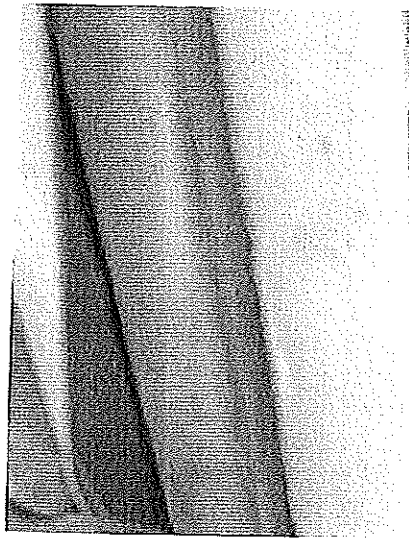
041

- Reasonable shingle condition. (P. 037,038,039,040)
- Membrane flashing paper should have been extended from horizontal plane down the outside vertical plane (2"), so as overlap siding. (P. 041)

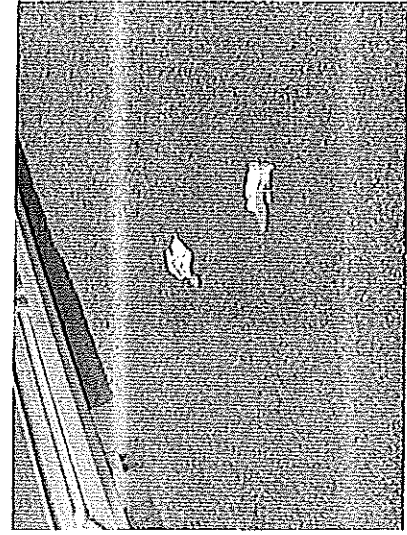
081

- Plywood substrate at shingle roof is observed to be buckling. (P. 074,075,076)
- Minor ponding on building 2727 and 2723. (P. 077)
- Repair to top of parapet flashing and membrane. This repair is incomplete. (P. 078)
- Membrane openings at perimeter scupper. (P. 080)
- Small blister on flat roof area. To be monitored. (P. 081)
- Improper sized vent caps. (P. 083)

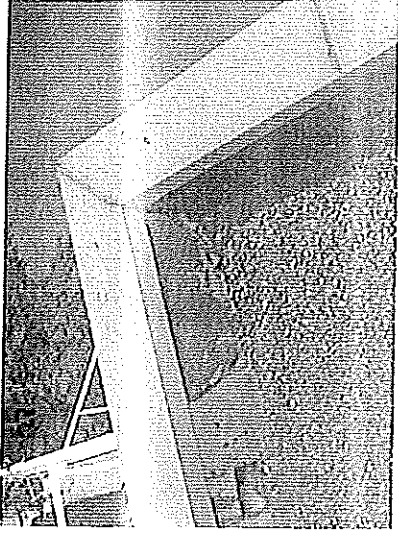
087

- Repair of perimeter membrane at scupper location. (P. 087,088)
- Shingles with minor curling at eaves. (P. 089,090)

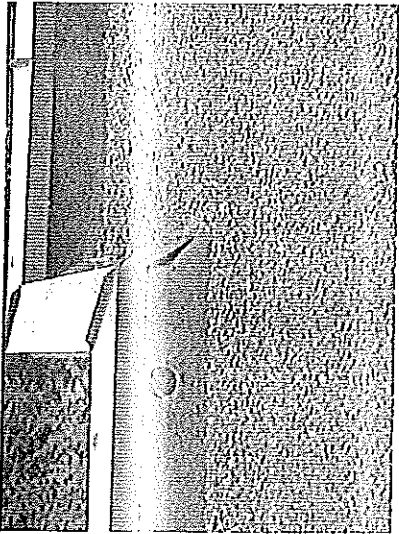
086

- Perimeter membrane openings. (P. 086)
- Improper repair on perimeter cap flashing and membrane. (P.085)

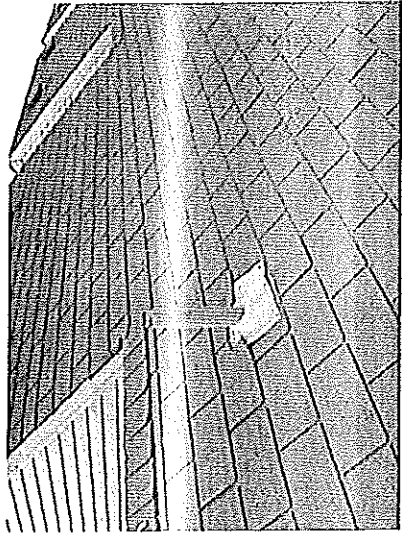
098

- Reasonable shingle condition. (P. 092,093,094,095)
- Buckling of plywood substrate on rear (north) section of building. Immediate repair is required. (P. 096,100)
- Problematic valley detail. Should be redesigned when re-roofing occurs. (P. 097)
- Missing plumbing caps on sloped sections, (P. 098)
- Improper application of shingles. (P. 104,105,106)

Our overall recommendations for the sloped section of the complex would be to repair all plywood substrate buckling, install deficient plumbing caps and repair with shingles or metal flashing, observed fascia boards where they overhang the building. Some painting will also be required at these locations.
