Our File No. GT-006-10-A
May 18, 2010

Re: Strata Plan BCS 2645 – Tapestry
750 West 12th Avenue and 2851 Heather Street, Vancouver, BC
- Building Envelope Maintenance Review Report

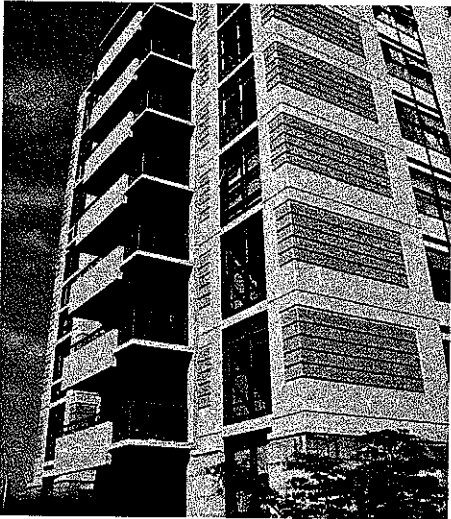
ITEM	DESCRIPTION	PHOTOGRAPH
3.1.1	<p>OBSERVATION Based on our random review of exterior walls they appear to be generally properly maintained. No major defects were observed or reported to us that require immediate attention. Deficiencies related to the maintenance are listed below under relevant sections of the report. Some of the deficiencies are not just a maintenance items but they may be related to the possible design and/or construction problems.</p> <p>RECOMMENDATION The deficiencies not related to the maintenance will require further investigation and review before the proper solution to rectify and/or eliminate them is implemented.</p>

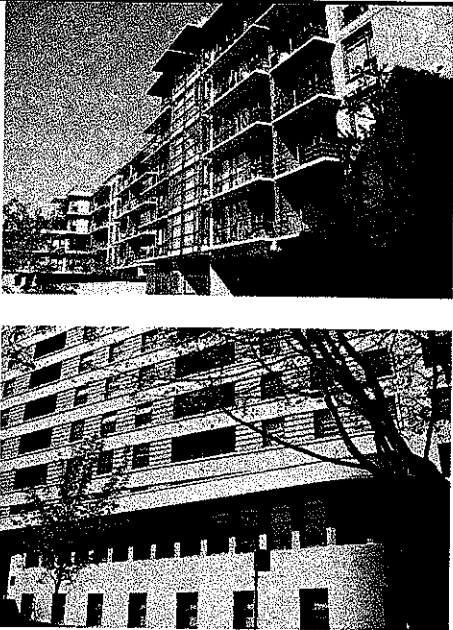
3.1.2	<p>OBSERVATION The above grade floors consist of reinforced concrete slabs, columns and walls. Horizontal and vertical reveal joints are used for architectural purposes and to control cracking. Concrete slab projections were used as a protective overhang at various wall areas and at the roof level. No major cracks in the concrete wall were observed or reported to us. Some cracks were observed in the underside of concrete slab projections.</p> <p>RECOMMENDATION Regular review of the concrete walls and other types of the exterior cladding including review of the window detail at the floor level and review of the connecting aluminum panels is recommended. (Review)</p>

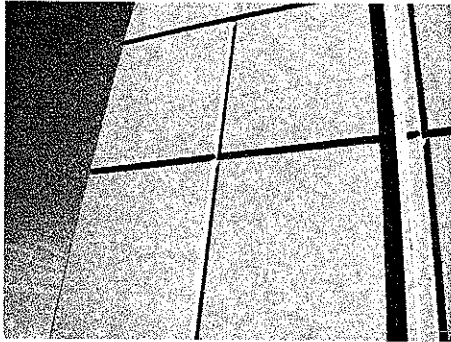
<p>3.1.3</p>	<p>OBSERVATION Several small cracks were observed at the elevator shaft walls at the mid-rise building at the roof level.</p> <p>RECOMMENDATION All cracks should be monitored. They should be repaired if they are 3mm wide or more to prevent water ingress into the wall assembly. Even small cracks can cause the water ingress which may not manifest itself inside the building for extended period of time.</p> <p>(Maintenance)</p>

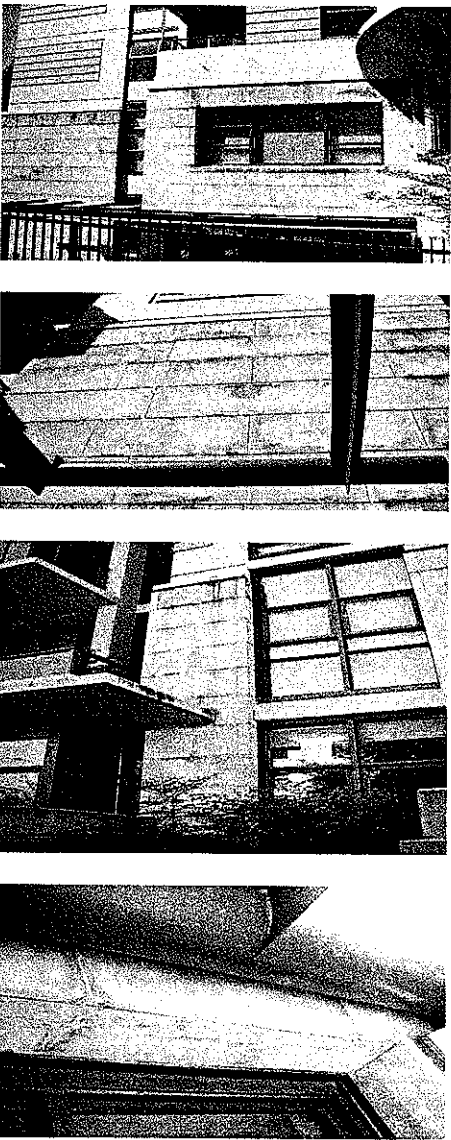
<p>3.1.4</p>	<p>OBSERVATION Various types of staining, algae and moss growth were observed on the stone cladding by the main entrance to 2851 Heather Street building. The types of staining and their severity is an indication of the moisture presence in and possibly behind the stone cladding. <u>Because of lack of the wall assemblies' descriptions and details we can not confirm if the stone cladding was installed as a rainscreen system.</u> We did not observe weep holes at the window head to allow for drainage of the accidental moisture that can enter past the cladding surface. It is quite possible that the stone tiles were applied directly over the concrete walls.</p> <p>It is not known to us if the sealer was applied over the stone cladding at the original construction.</p> <p>It was not confirmed if the protective ledge is properly sloped and sufficiently projected over the stone cladding to deflect the rain water away from the stone clad walls. It appears that there is a lot of staining present directly below the subject ledge which can be a part of the problem. Presence of the drip edge was also not confirmed.</p> <p>RECOMMENDATION Further investigation and review of the building envelope details specifically related to this location is required to identify the cause of the staining.</p>

- 4.2 The major and the most serious problems are related to the staining algae and moss growth on the stone cladding by the main entrance to 2851 Heather Street building. The types of staining and their severity is an indication of the moisture presence in and possibly behind the stone cladding. **Further investigation and review of the building envelope details specifically related to this location is required to identify the cause of the staining.**

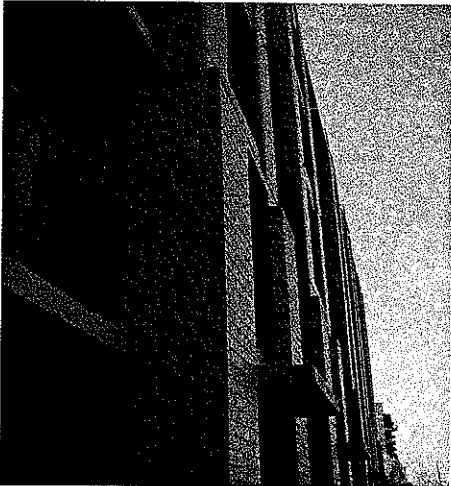
<p>3.1.5</p>	<p>OBSERVATION Moss growth and efflorescence staining was observed at the brick and the mortar joints at various wall areas clad with brick. The protective concrete ledge appears to be not sufficiently projecting over the brick to allow for diverting rain water from the brick cladding.</p> <p>RECOMMENDATION The building envelope detailing at the top of the parapet wall should be confirmed before any maintenance program is implemented. If there is no sufficient deflection provided at the top of the wall water ingress into the mortar joints, brick cladding and possibly behind will continue to occur. Once the proper deflection and detailing at the top of the wall is provided the moss and efflorescence should be cleaned and the brick, mortar joints and the concrete ledge should be protected with penetrating sealer to repel the water from the wall surface.</p> <p>(Warranty/Maintenance)</p>

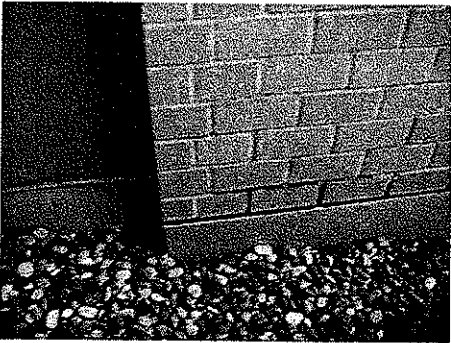
<p>3.1.6</p>	<p>OBSERVATION Moss growth was observed at the brick mortar joints at the wall base at various wall areas. The moss growth may be an indication of the moisture presence at the wall base and at the cavity behind the brick.</p> <p>RECOMMENDATION The proper spacing of the weep holes should be confirmed. All weep holes should be checked and cleaned if necessary. The moss should be removed and penetrating sealer applied at the brick and mortar joints (if it was not applied at the original construction).</p> <p>(Warranty/Maintenance)</p>

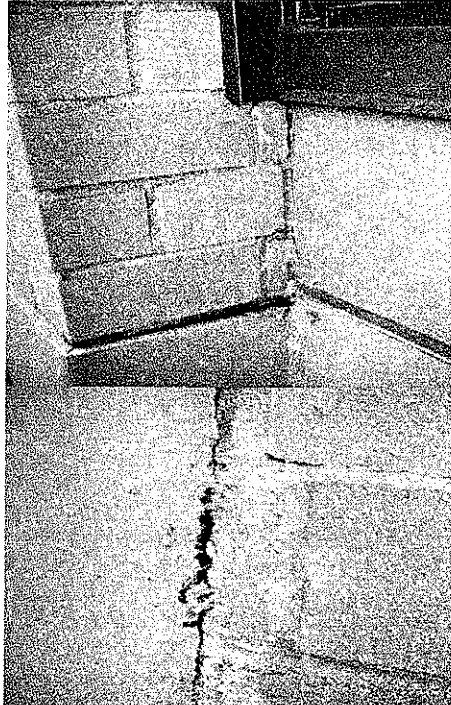
3.1.7	<p>OBSERVATION Sealant was not applied between brick and concrete wall at various location of the wall base at the building perimeter. The mortar joint was cracked and separated from the concrete wall. Water ingress behind the cladding can occur at those locations. Unsealed cracks were typically observed at those interfaces.</p> <p>RECOMMENDATION Sealant joint should be applied at the original construction at all joints and cladding interfaces to prevent water ingress behind the cladding. Proper sealant joint supported by backer rod should be provided at the interfaces between different types of cladding and their penetrations.</p> <p>(Warranty/Maintenance)</p>

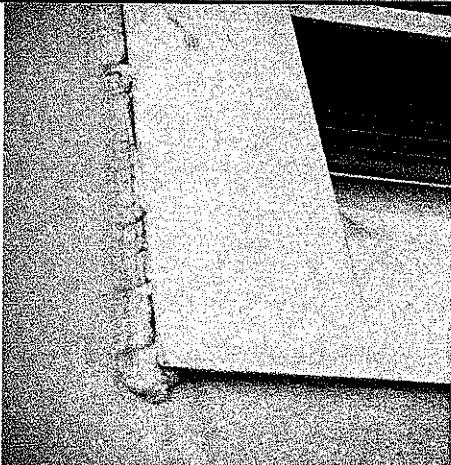
3.1.8	<p>OBSERVATION The sealant joint between the louver vent and concrete was deteriorated at elevator shaft wall at 750 W 12th Ave building.</p> <p>RECOMMENDATION New sealant joints must be applied at the locations where the sealant was missing and/or has failed.</p> <p>(Maintenance)</p>

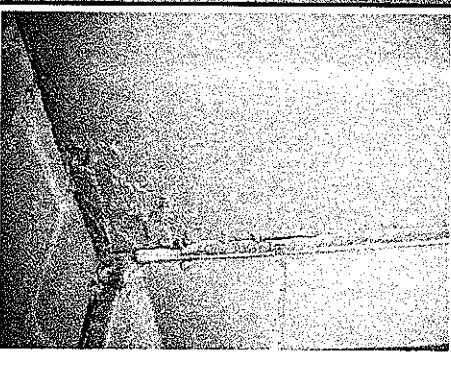
3.1.9	<p>OBSERVATION The sealant joint between at the gum lip detail between concrete wall and the base flashing at few locations.</p> <p>RECOMMENDATION New sealant joints must be applied at the locations where the sealant was has failed.</p> <p>(Maintenance)</p>

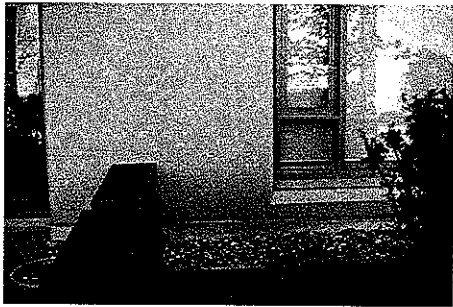
<p>3.1.10</p>	<p>OBSERVATION Staining and splashed dirt was observed on the base of the wall in a few locations.</p> <p>RECOMMENDATION All the causes of the splashing of the water from the upper wall decks or projecting eyebrows should be eliminated. The wall should be cleaned and repainted if necessary. (Maintenance)</p>

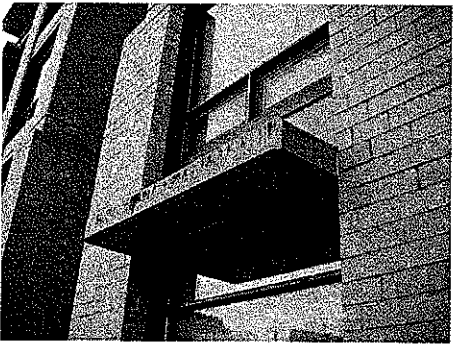
<p>3.1.11</p>	<p>OBSERVATION Staining on the face of the concrete eyebrows was observed in several locations throughout the project.</p> <p>RECOMMENDATION The stains should be cleaned and the face of the eyebrows re-painted if necessary to provide durable surface that will not allow for moisture ingress. (Warranty/Maintenance)</p>

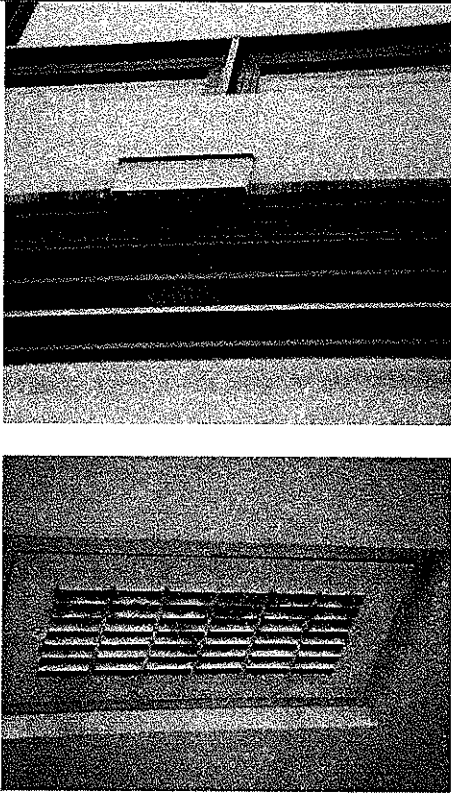
3.1.13	<p>OBSERVATION The dryer vents plugged with lint were observed in many locations. Those vents are typically located at the slab level or at the balcony underside.</p> <p>RECOMMENDATION The dryer screens inside the unit and vent screens on the outside must be cleaned regularly to allow for proper moisture removal. Accumulated lint is also a fire hazard. Review of the sealant applied at the vent hood and windows located below is highly recommended at the time of lint removal. (Maintenance)</p>

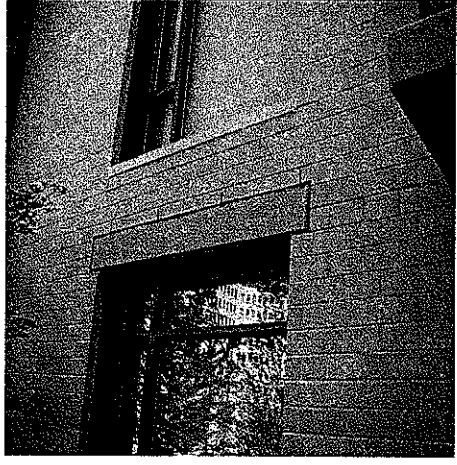
3.1.14	<p>OBSERVATION The staining at the base of the brick cladding above the concrete ledge installed at the window head was observed. The ledge was installed at the face of brick cladding</p> <p>RECOMMENDATION The weep holes should be regularly cleaned to allow for moisture drainage from the cavity behind the brick. The waterproofing detailing at this location must be confirmed. (Warranty/Maintenance)</p>

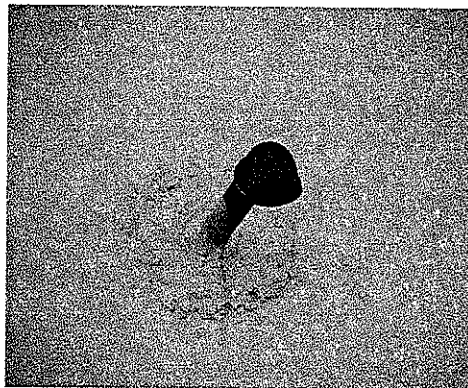
3.1.15	<p>OBSERVATION The rust staining on the concrete wall at the roof level was observed below the corroded pipe.</p> <p>RECOMMENDATION The pipe must be cleaned and protected with rust proof paint. (Maintenance)</p>

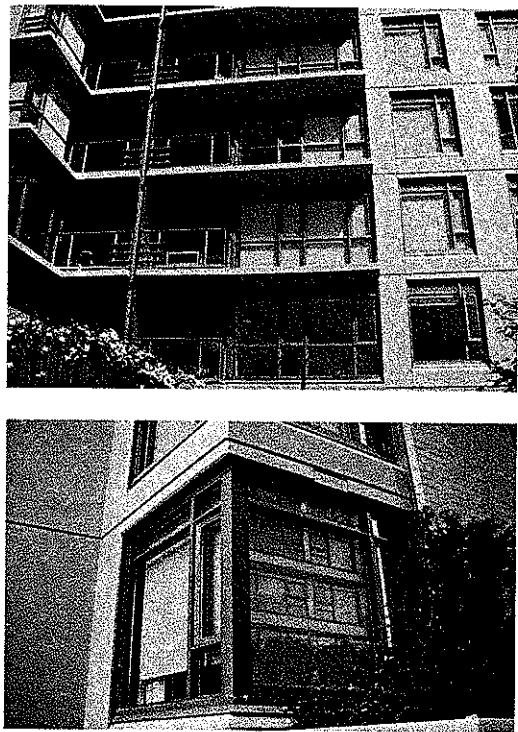
ITEM	DESCRIPTION	PHOTOGRAPH
3.2.1	<p>OBSERVATION The residential windows are aluminum frame, thermally broken punched windows with double glazed sealed units manufactured by Starline Windows. The window walls, windows and doors appear to be functioning as intended <u>with the exception of some windows and doors that have difficulties with opening and closing. This deficiency was reported by several Owners.</u></p> <p>RECOMMENDATION Further investigation and adjustment of the windows and doors which are difficult to open is required. (Maintenance)</p>

- Doors and/or windows not closing properly or hard to close were reported by many owners. **All doors and windows which don't function properly should be checked and adjusted by the window and door manufacturer/installer.**

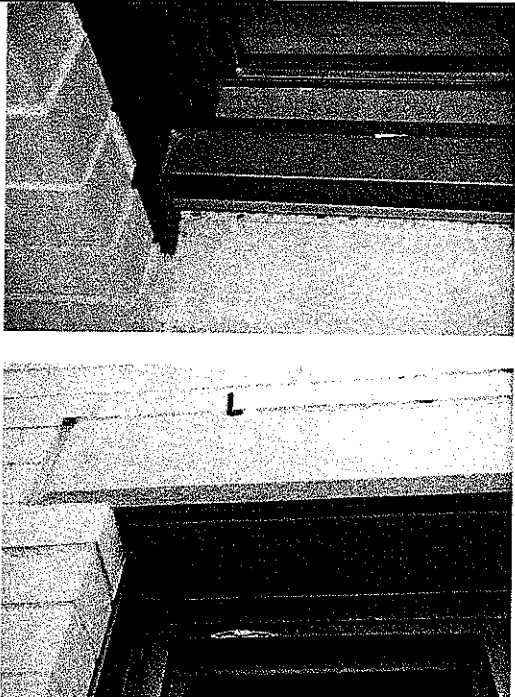
<p>3.2.2</p>	<p>OBSERVATION Prefabricated metal flashing was observed at the sill. At the head sealant joint was provided at the window and wall interface.</p> <p>RECOMMENDATION Regular review and renewal of the sealant joints is required as specified in the Building Maintenance Manual. (Maintenance)</p>

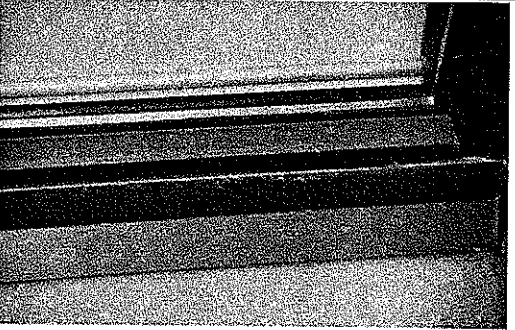
<p>3.2.3</p>	<p>OBSERVATION White staining was observed at the window and sill flashing interface. This is an indication of the water presence for an extended period of time.</p> <p>RECOMMENDATION The staining should be cleaned and those locations further investigated and monitored. (Maintenance)</p>

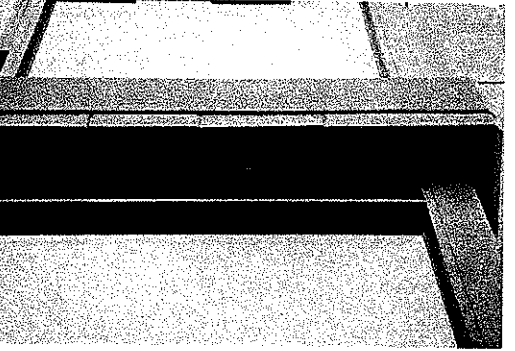
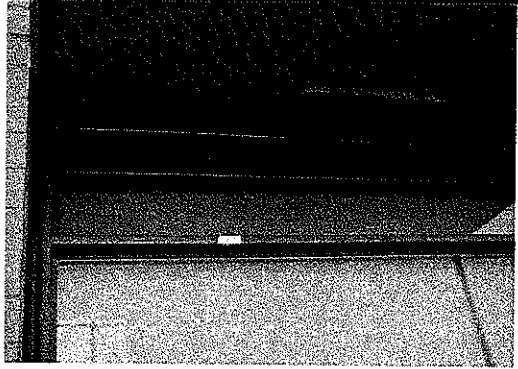
<p>3.2.4</p>	<p>OBSERVATION Staining and condensation on the exterior window glass surface below the dryer vent discharge was reported by some of the Owners. We observed more staining on the windows where the louver blades were directed towards the window. Some of the owners reported the staining and/or dust presence inside the sealed unit. The discharge of the moist air towards the window can cause the premature deterioration of the sealant and /or sealed glass units.</p> <p>RECOMMENDATION The regular review of the sealant joint</p>

<p>and clean-up of the vent screens is required to prevent moist air ingress into the wall and floor assemblies. The direction of the louver blades away from the window and building wall is recommended. (Warranty/Maintenance)</p>

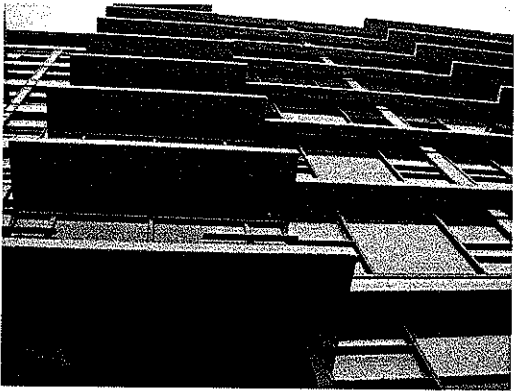
3.2.5	<p>OBSERVATION Misaligned, shrunken, or loose gaskets were observed at various spandrel panels during Two Year Post-Construction Audit prepared by Morrison Hershfield. During this review some other deficiencies were also observed, but all the deficiencies were rectified by the Developer according to the submitted report. RECOMMENDATION The detail review of the windows and window wall and spandrel panels is recommended from swing stage.</p>

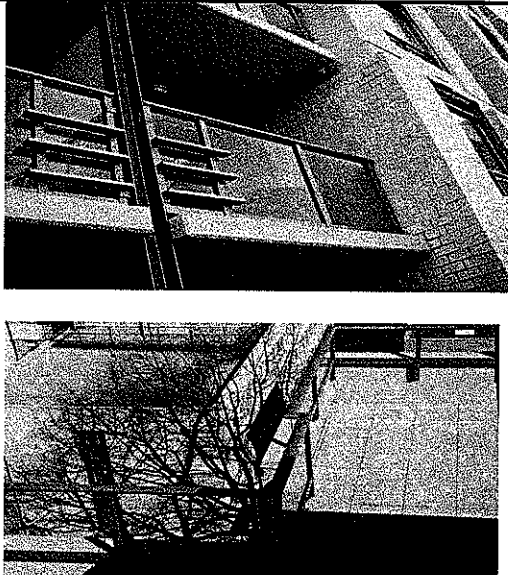
ITEM	DESCRIPTION	PHOTOGRAPH
3.3.1	<p>OBSERVATION The balcony railings are constructed out of aluminum frame with glass panels. They are typically top-mounted on the balcony/deck slab. Some of the railings are mounted to the interior face of the deck concrete curb.</p> <p>RECOMMENDATION Regular renewal of the sealant joint at the railing attachment bracket and on the top of the screws is recommended. (Maintenance)</p>

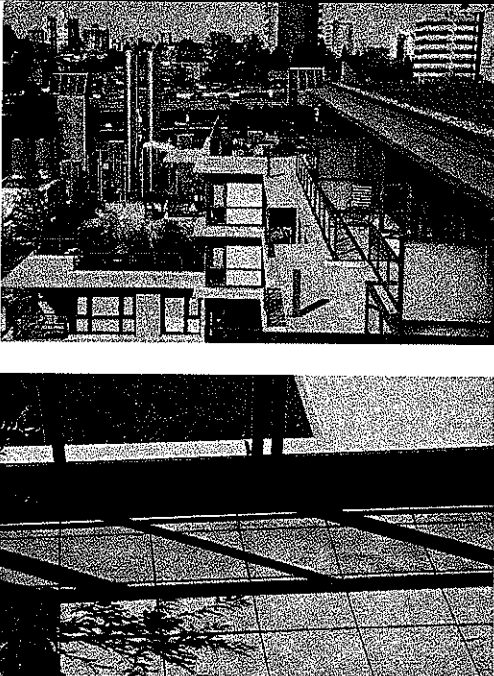
3.3.2	<p>OBSERVATION The lack of the gutter and downspout system at the perimeter of approximately 4' wide eyebrows at the roof level is resulted with direct water drainage from those surfaces and sometimes also overflow scuppers from the roof level on the balcony/deck below. This condition is causing the lack of enjoyment of the balcony/deck of the residents of the affected units. Water pooling on the eyebrows was observed in some locations, but this will be discussed under a roof section of this report.</p> <p>RECOMMENDATION The installation of the gutter and downspout system or implementation other solution is recommended to rectify the above listed problem. (Warranty/Maintenance)</p>

- Problems due to lack of the gutter and downspout system at the perimeter of approximately 4' wide eyebrows at the roof level is resulted with direct water drainage from those surfaces and sometimes also overflow scuppers from the roof level on the balcony/deck below. This condition is causing the lack of enjoyment of the balcony/deck of the residents of the affected units. **The installation of the gutter and downspout system or implementation other solution is recommended to rectify the above listed problem.**

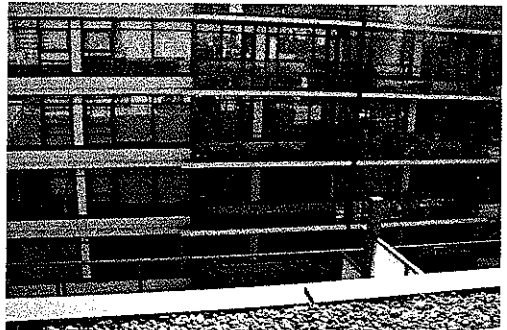
3.3.3	<p>OBSERVATION Staining on the balcony edges was observed in a few locations. Pooling of the water on the balcony/deck was only reported by few Owners.</p> <p>RECOMMENDATION The regular review and clean-up of the membranes is recommended in order to maximize their performance. (Maintenance)</p>

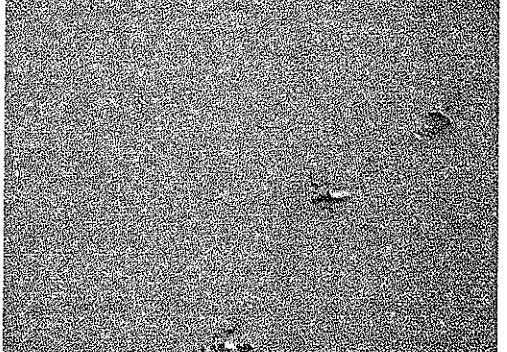
3.3.4	<p>OBSERVATION Paint peeling of from the underside of 750 W 12th Ave building.</p> <p>RECOMMENDATION The cause of peeling paint should be identified and rectified. (Warranty/Maintenance)</p>

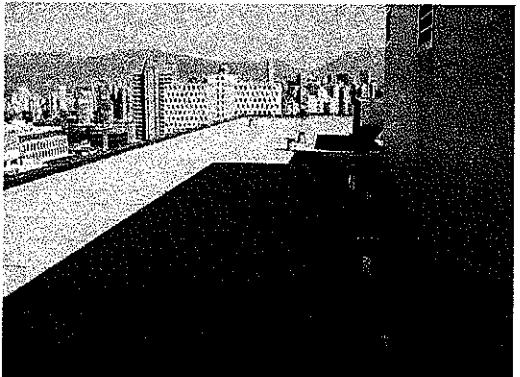
ITEM	DESCRIPTION	PHOTOGRAPH
3.4.1	<p>OBSERVATION The roof at 2851 Heather Street building is covered with a torch on membrane Various building vents are projecting above the roof surface. We did not observe any water pooling on the roof surface during our review.</p> <p>RECOMMENDATION The regular review and maintenance is recommended. (Maintenance)</p>

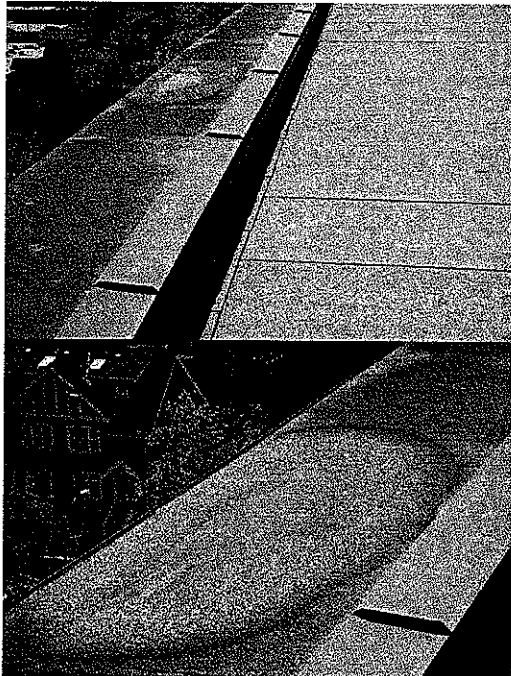
3.4.2	<p>OBSERVATION The water pooling on the eyebrows was observed at several locations. This is an indication that the eyebrows are not properly sloped. There was no drainage system (gutters and downspouts) provided at the eyebrows edges despite the large width of the eyebrows and the fact that the overflow scuppers from the roof surface were designed to discharge on the eyebrows level. The pooling water for extended period of time will cause premature deterioration of the membrane. The pooling water was present in the observed locations for more than 24 hours.</p> <p>RECOMMENDATION The above deficiency should be rectified. (Maintenance/Maintenance)</p>

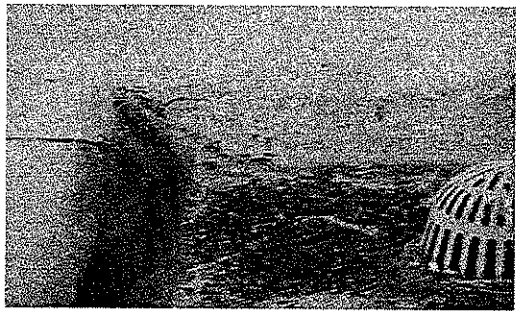
3.4.3	<p>OBSERVATION The small accumulation of the debris around the drain was observed.</p> <p>RECOMMENDATION The regular review and clean-up of the membranes is recommended in order to maximize their performance. (Maintenance)</p>

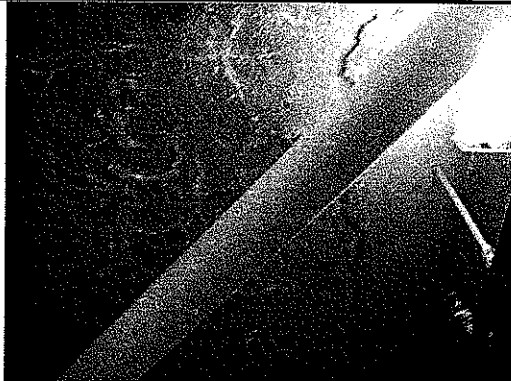
3.4.5	<p>OBSERVATION Staining on the underside of the mechanical room ceiling was observed. This staining appears to be a result of moisture presence. The caused of this staining was not identified.</p> <p>RECOMMENDATION The further investigation of the water ingress problem at this location is recommended.</p> <p>(Warranty)</p>

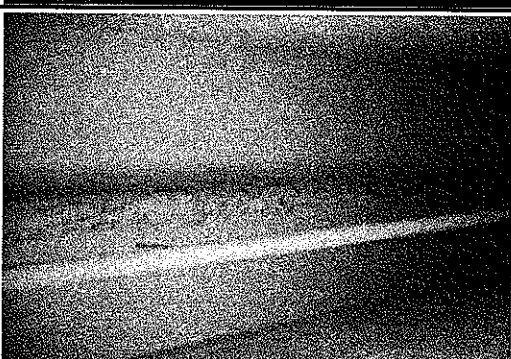
3.4.6	<p>OBSERVATION Staining and cracking of the plaster on the underside of the stairwell ceiling was observed. This staining can be a result of moisture presence. The caused of this staining was not identified.</p> <p>RECOMMENDATION The cause of the staining and cracking should be identified.</p> <p>(Warranty)</p>

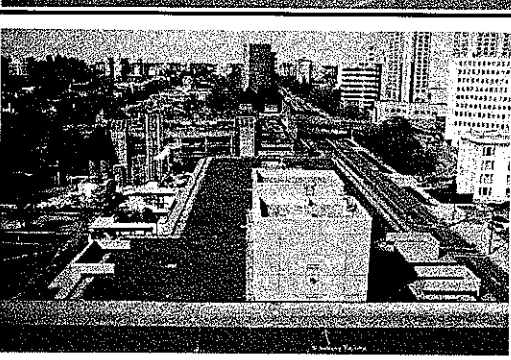
3.4.7	<p>OBSERVATION The roof at 750 W 12th Ave building is covered with a green roof. The type of roofing membrane was not confirmed.</p> <p>RECOMMENDATION The regular maintenance and review and early detection is very important on the green roofs since the membrane is not exposed for the review.</p> <p>(Maintenance)</p>

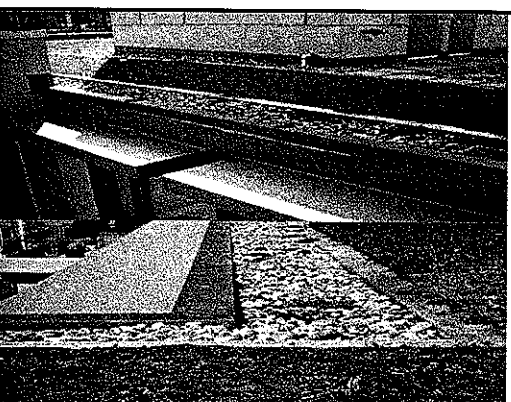
3.4.8	<p>OBSERVATION Vegetation growing at the perimeter drainage areas filed with drain rock was observed.</p> <p>RECOMMENDATION The vegetation should be removed regularly to allow designed roofing system to perform as intended.</p> <p>(Maintenance)</p>

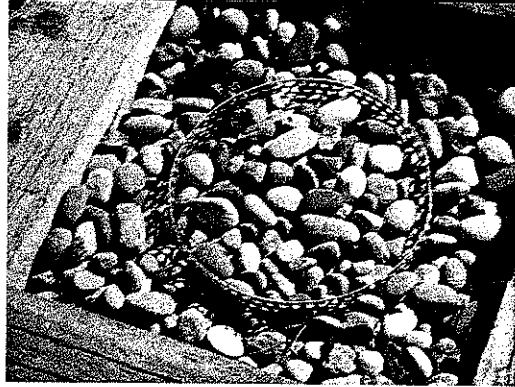
3.4.9	<p>OBSERVATION The drain pit areas appeared to be generally free from any debris.</p> <p>RECOMMENDATION The regular review and maintenance of the roof drains is required to allow designed roofing system to perform as intended.</p> <p>(Maintenance)</p>

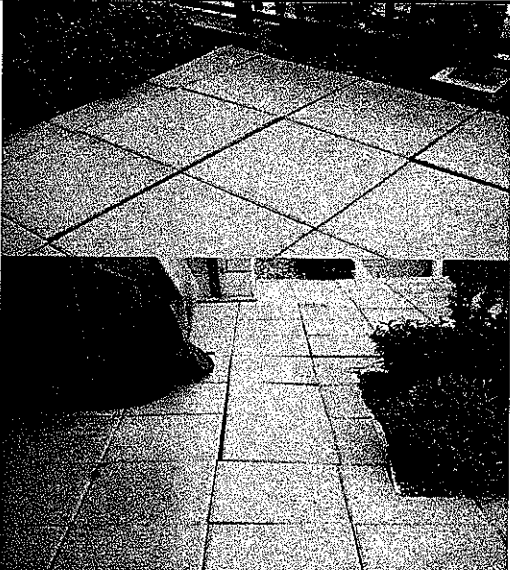
ITEM	DESCRIPTION	PHOTOGRAPH
3.5.1	<p>OBSERVATION Uneven surface of the pavers on the ground floor patios was observed at several locations. This condition is a tripping hazard.</p> <p>RECOMMENDATION The deficiencies related to the uneven surface of the patios should be eliminated.</p> <p>(Warranty/Maintenance)</p>

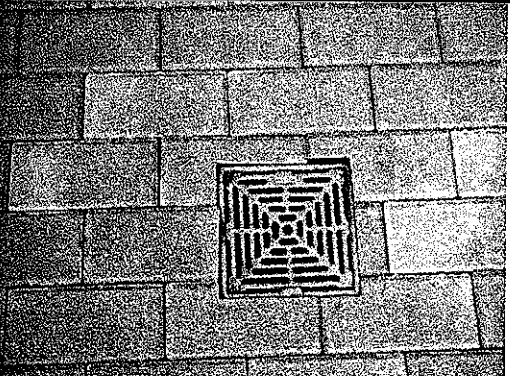
3.5.2	<p>OBSERVATION The rust on the metal cover by the main entrance and at some other locations was observed.</p> <p>RECOMMENDATION The metal cover should be protected with unty corrosive primer and paint.</p> <p>(Warranty/Maintenance)</p>
