VR61  
MRM  
Eng. Report.

**Re: Strata Plan VR 61 – The Sea Breeze**  
**2025 West 2<sup>nd</sup> Avenue, Vancouver, B.C.**  
**Condition Survey**

**Strata Plan VR 61 – The Sea Breeze**  
**2025 WEST 2<sup>ND</sup> AVENUE, VANCOUVER, B.C.**  
**PHOTOGRAPHS TAKEN BY LOUIS VAN BLANKENSTEIN, P.ENG., ON MARCH 14, 2005**

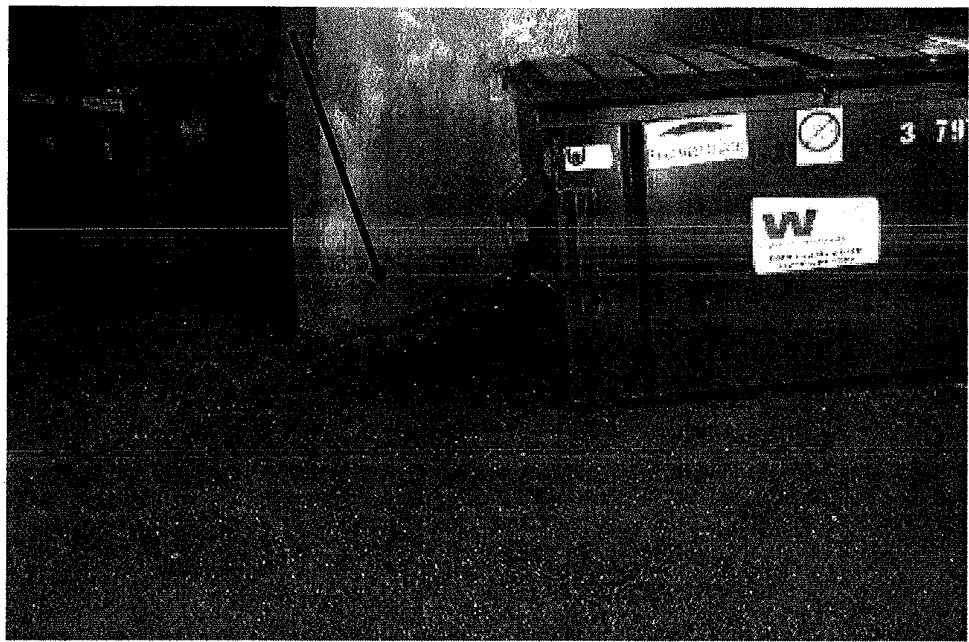
**Photos No. 1 & 2**

1. At the entrance to the parkade, there has been subsidence under the black top such that there is ponding on the west side of the entrance and breakup on the east side. (Photo No. 1)
2. This settlement is evident also at the adjacent exit threshold (Photo No. 2).
3. The privacy walls to patios are settling along the north side (Photos No. 3 & 4) as are patio slabs at the thresholds of the sliding doors (Photo No. 5).
4. The very densely planted screening trees are tilting indicating lack of an adequate root base. (Photo No. 6).
5. On the east face of the building, there are three brick features rising two storeys up the building (Photo No 7) and there is evidence of this feature separating from the stucco wall (Photo No. 8). This must be on-going as the lower portion of the most southerly of the three features has been caulked at sometime previously (Photo No. 9).

1. The conditions along the north side indicate a possible underground erosion of material. This should be investigated and, if necessary, perimeter drainage should

be restored in such a way that no more material can be removed. This may require a new line connected to the city storm system.
