Depreciation Report

LMS474 – City Gardens

**RE: Depreciation Report for Strata Plan LMS474
File No. 20130808-DR-LMS474**

The subject of this depreciation report consists of “City Gardens”, a 34-unit high rise apartment complex constructed in 1993 and located at 1268 W Broadway in Vancouver, BC. We are pleased to present you with the enclosed draft depreciation report, which we believe will serve as the basis of your reserve planning to help better equip your members for future expenditures.

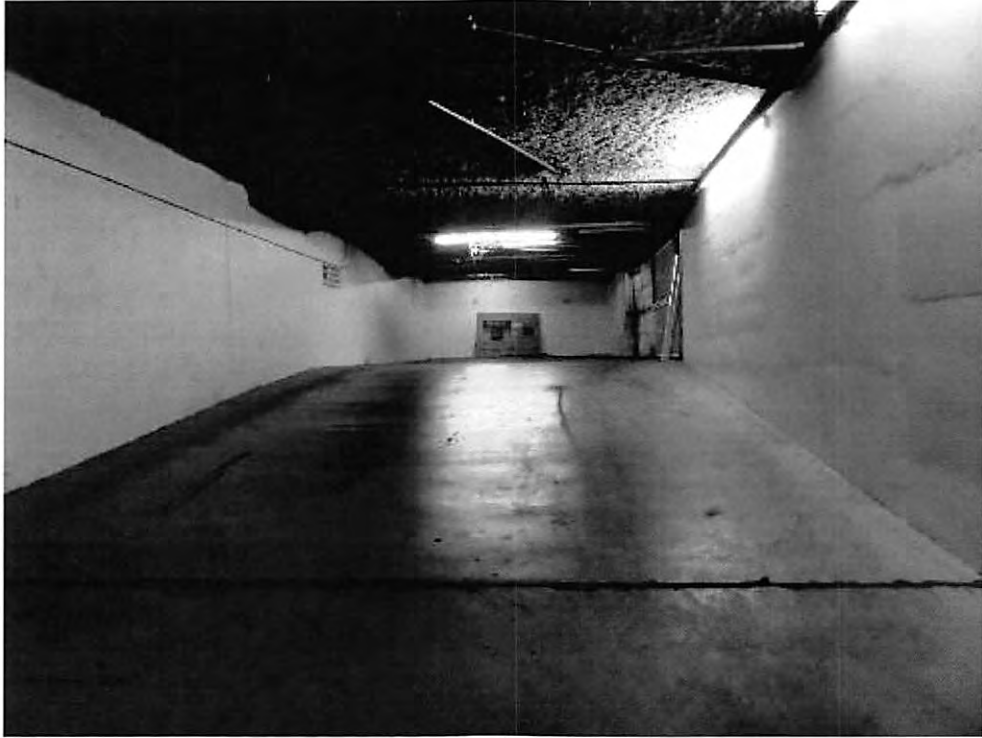
Reserve Component A103001	Underground parkade	
Properties	Concrete floor slab	
Potential Deterioration	Settlement over time due to grade changes can lead to cracks in the concrete floor. Prolonged load can also lead to extensive wear.	
Condition Analysis	<i>Deterioration</i>	Areas of abrasion on the floor slabs.
	<i>Repair/Replacement History</i>	N/A
	<i>Overall Condition</i>	Good
	<i>Date of Installation</i>	1993
Life Cycle Analysis	<i>Chronological Age</i>	20 years
	<i>Estimated Useful Life</i>	Building life
	<i>Effective Age</i>	20 years
	<i>Remaining Useful Life</i>	Building life
Replacement/Repair Estimates	<i>Current Repair/Replacement Cost Estimate</i>	\$ 20,000 (Repair costs approximated over 15 years)
	<i>Estimated Year of Repair/Replacement</i>	2015
Recommendations	None	
Preventive Maintenance	Sealant injections to repair minor cracks.

Concrete floor slab

Cracks in concrete floor slab

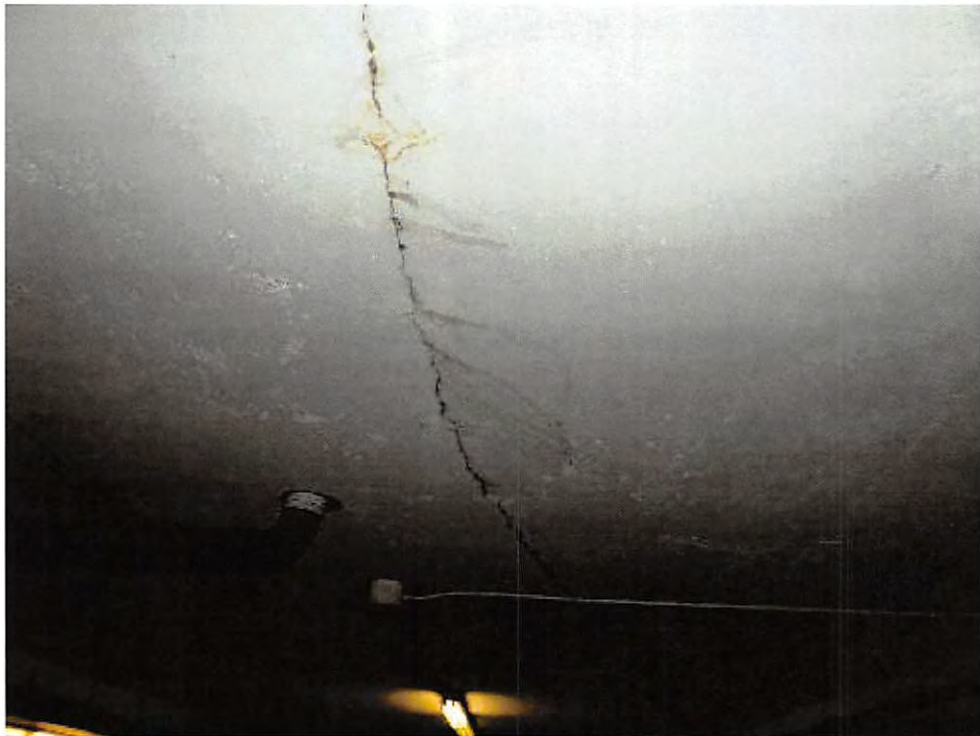
Reserve Component A103002	Underground parkade	
Properties	Concrete suspended slab	
Potential Deterioration	Settlement over time due to grade changes can lead to cracks in the roof slab.	
Condition Analysis	<i>Deterioration</i>	Water from planters may be leaking through cracks in P1 ceiling. Leaks were discovered under the electrical cable on P2.
	<i>Repair/Replacement History</i>	N/A
	<i>Overall Condition</i>	Good
	<i>Date of Installation</i>	1993
Life Cycle Analysis	<i>Chronological Age</i>	20 years
	<i>Estimated Useful Life</i>	Building life
	<i>Effective Age</i>	20 years
	<i>Remaining Useful Life</i>	Building life
Replacement/Repair Estimates	<i>Current Repair/Replacement Cost Estimate</i>	Repair cost included with the concrete floor slab repair estimate.
	<i>Estimated Year of Repair/Replacement</i>	N/A
Recommendations	Repair all leaky cracks, waterproof planters.	
Preventive Maintenance	Sealant injections to repair minor cracks.

Leaky cracks in ceiling

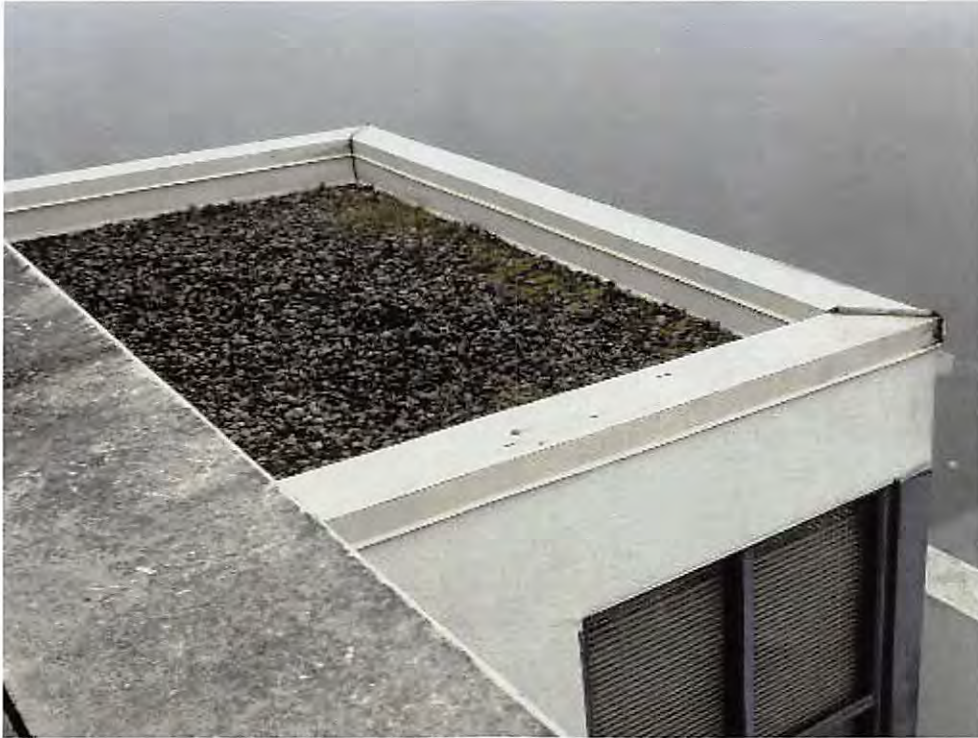
Reserve Component B10100102	Roof deck
Properties	Inverted roofing with gravel
Potential Deterioration	Uneven distribution of gravel will lead to an uneven load distribution on the inverted roof, affecting membrane exposure to the elements.
Condition Analysis	<i>Deterioration</i> None
	<i>Repair/Replacement</i> N/A
	<i>History</i>
	<i>Overall Condition</i>
Life Cycle Analysis	<i>Date of Installation</i> 1993
	<i>Chronological Age</i> 20 years
	<i>Estimated Useful Life</i> 30 years
	<i>Effective Age</i> 20 years
	<i>Remaining Useful Life</i> 10 years
Replacement/Repair Estimates	<i>Current Repair/ Replacement Cost Estimate</i>
	<i>Estimated Year of Repair/Replacement</i> 2023
Recommendations	None
Preventive Maintenance	Annual inspection.

Roof deck

Gravel on inverted roof

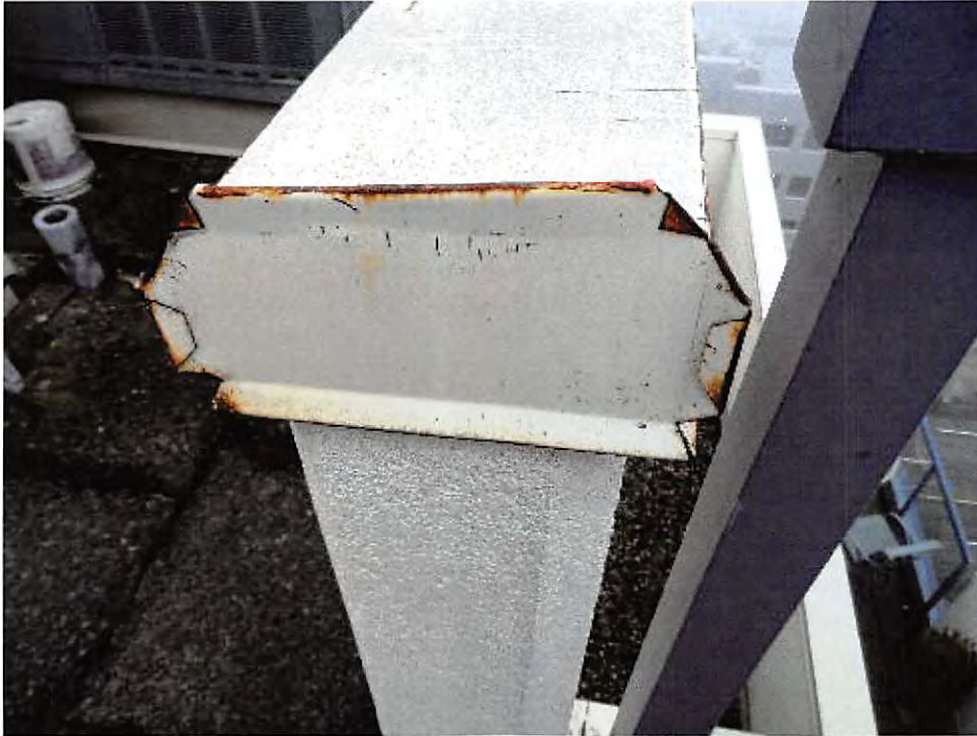
Concrete parapet wall with stucco

Preventive Maintenance	Annual inspection and repair as needed.

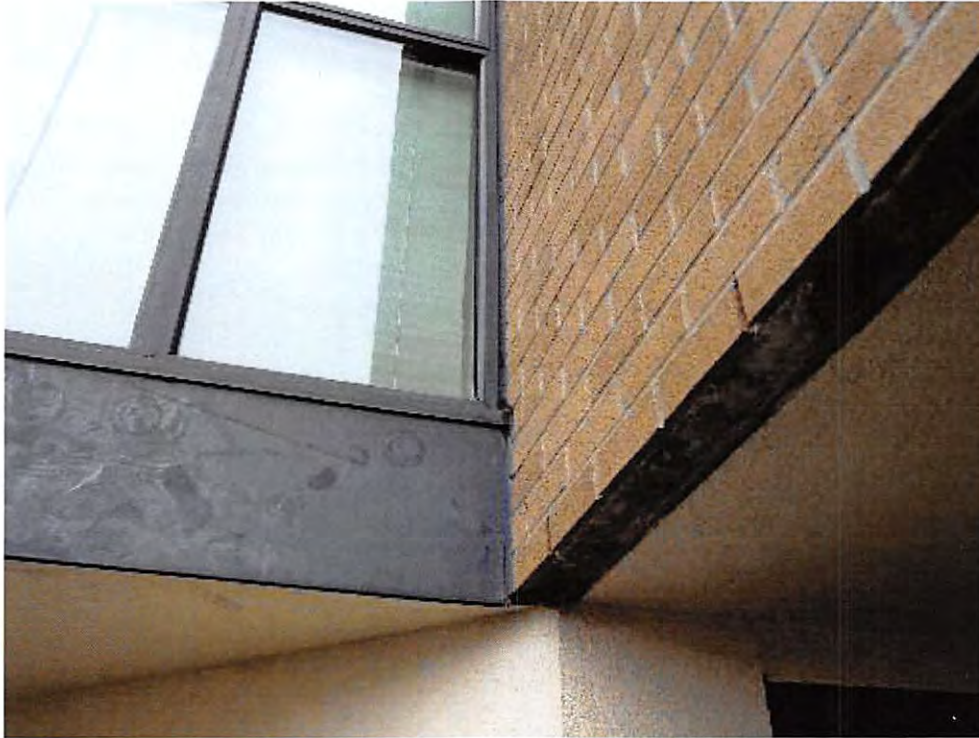
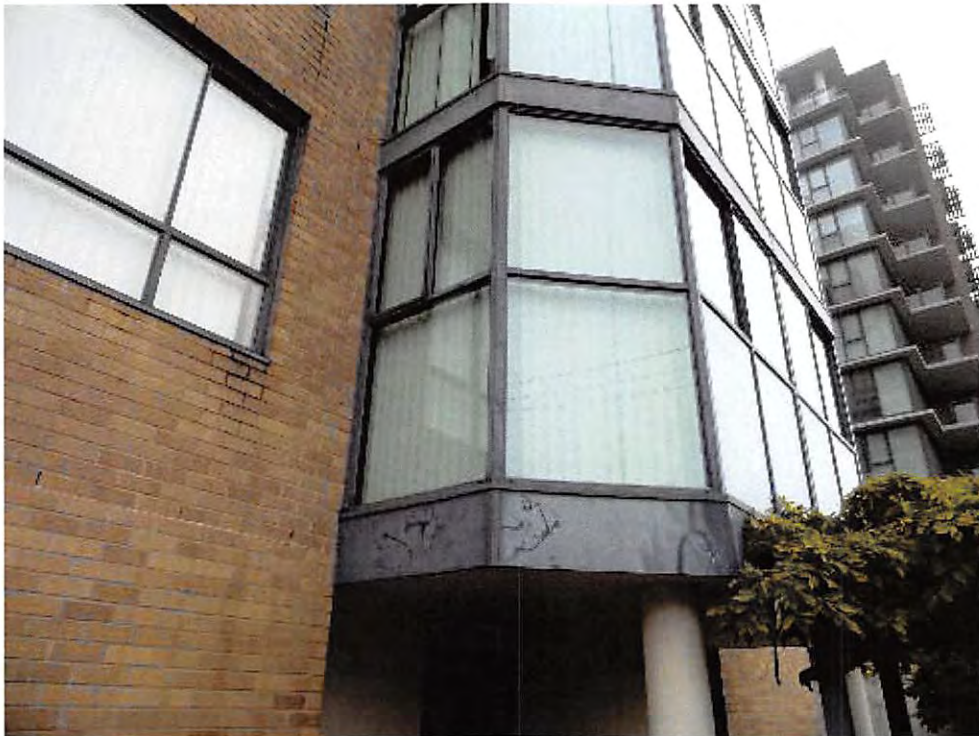
Reserve Component B20100101	Cladding
Properties	Brick veneer
Potential Deterioration	Expansion and contraction, wind erosion, settlement and other factors can lead to deterioration of brick masonry. Sometimes, brick mortar can also deteriorate after prolonged exposure to the elements. Cracking, bulging and spalling are often indicative of defective window installation and water ingress problems.
Condition Analysis	<i>Deterioration</i> None observed
	<i>Repair/Replacement</i> N/A
	<i>History</i>
Life Cycle Analysis	<i>Overall Condition</i> Good
	<i>Date of Installation</i> 1993
	<i>Chronological Age</i> 20 years
	<i>Estimated Useful Life</i> 40 years
	<i>Effective Age</i> 5 years
Replacement/Repair Estimates	<i>Remaining Useful Life</i> 35 years
	<i>Current Repair/ Replacement Cost Estimate</i> \$ 260,000
	<i>Estimated Year of Repair/Replacement</i> 2048
Recommendations	N/A
Preventive Maintenance	Clean with water every 5 years; apply masonry sealant every 6 years; repoint mortar every 15 years.

Brick veneer cladding

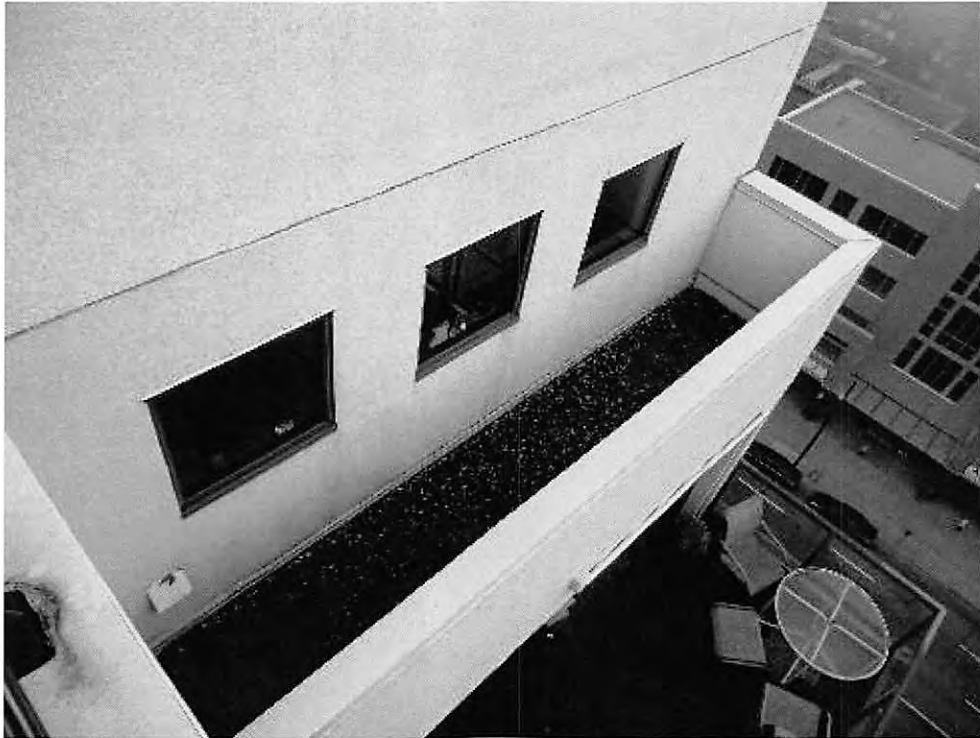
Stucco cladding

Cracks in stucco

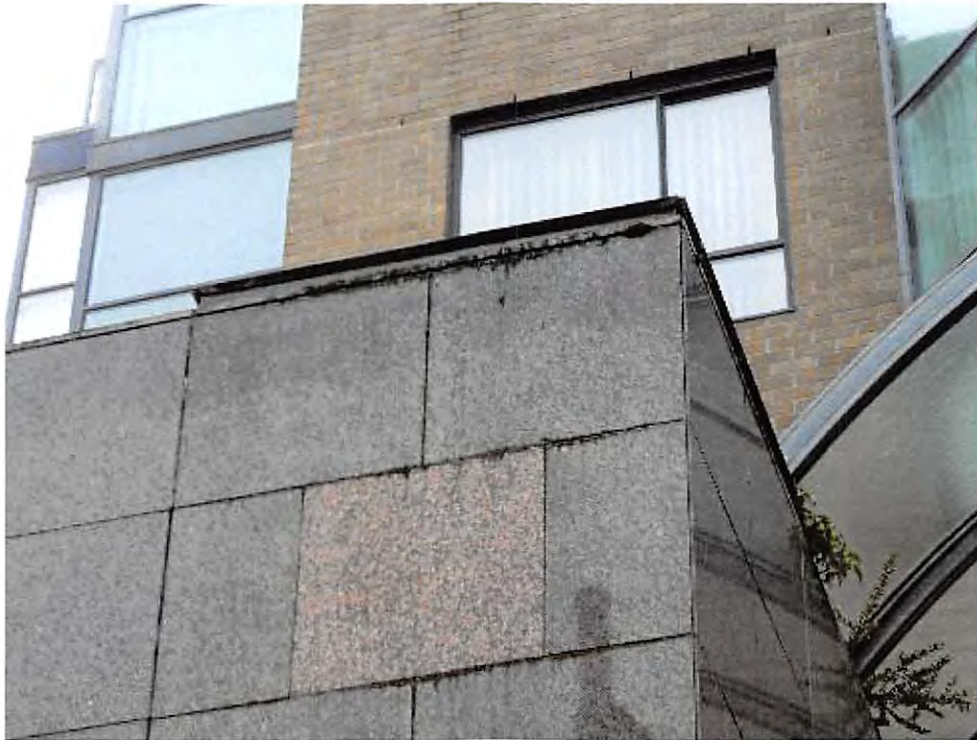
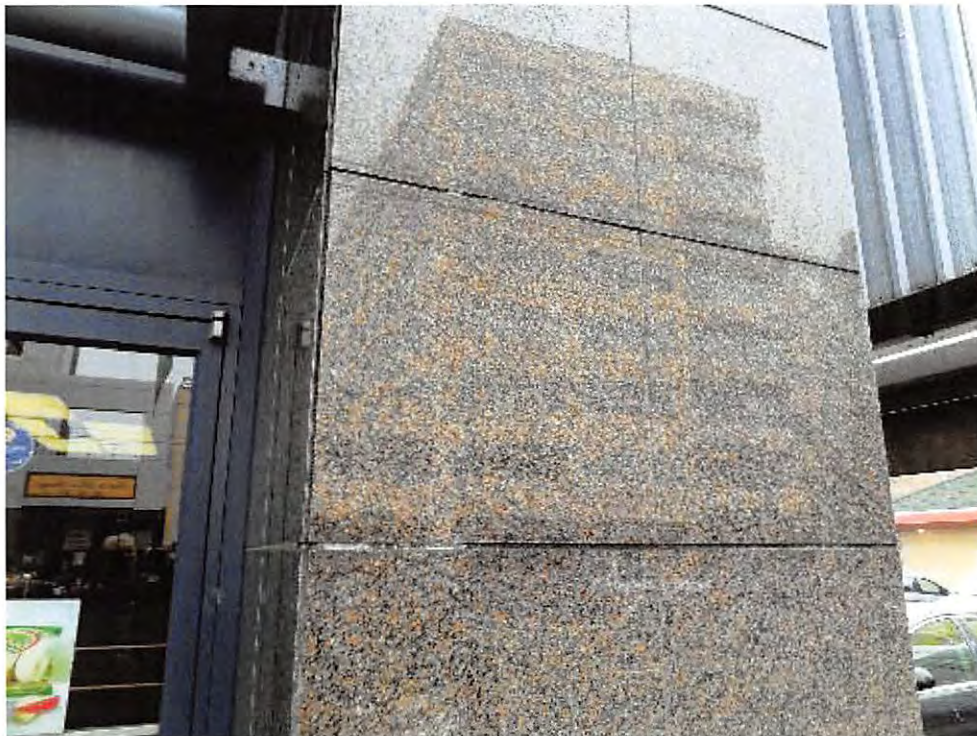
Reserve Component B20100102	Cladding
Properties	Granite tiles
Potential Deterioration	Internal or external stresses may cause cracks in the granite.
Condition Analysis	<i>Deterioration</i> None observed
	<i>Repair/Replacement History</i> N/A
	<i>Overall Condition</i> Good
	<i>Date of Installation</i> 1993
Life Cycle Analysis	<i>Chronological Age</i> 20 years
	<i>Estimated Useful Life</i> Building life
	<i>Effective Age</i> 20 years
	<i>Remaining Useful Life</i> Building life
	<i>Current Repair/Replacement Cost Estimate</i> \$ 10,000 (20% repair costs approximated over 10 years)
Replacement/Repair Estimates	<i>Estimated Year of Repair/Replacement</i> 2028
	<i>Recommendations</i> N/A
Preventive Maintenance	Clean regularly.

Granite tiles

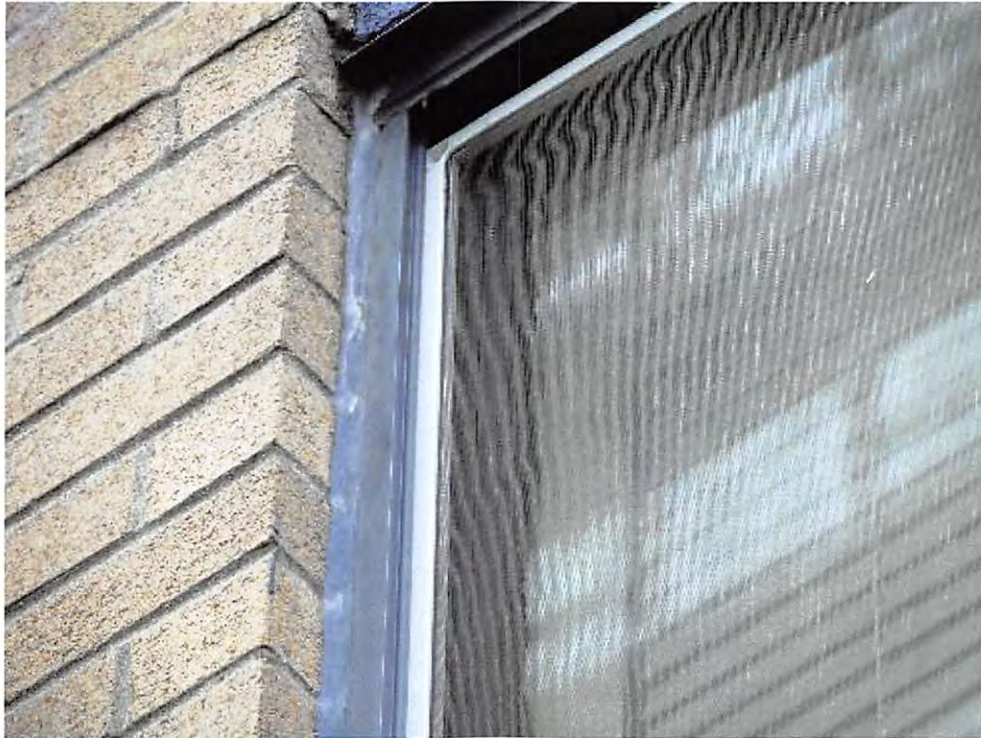
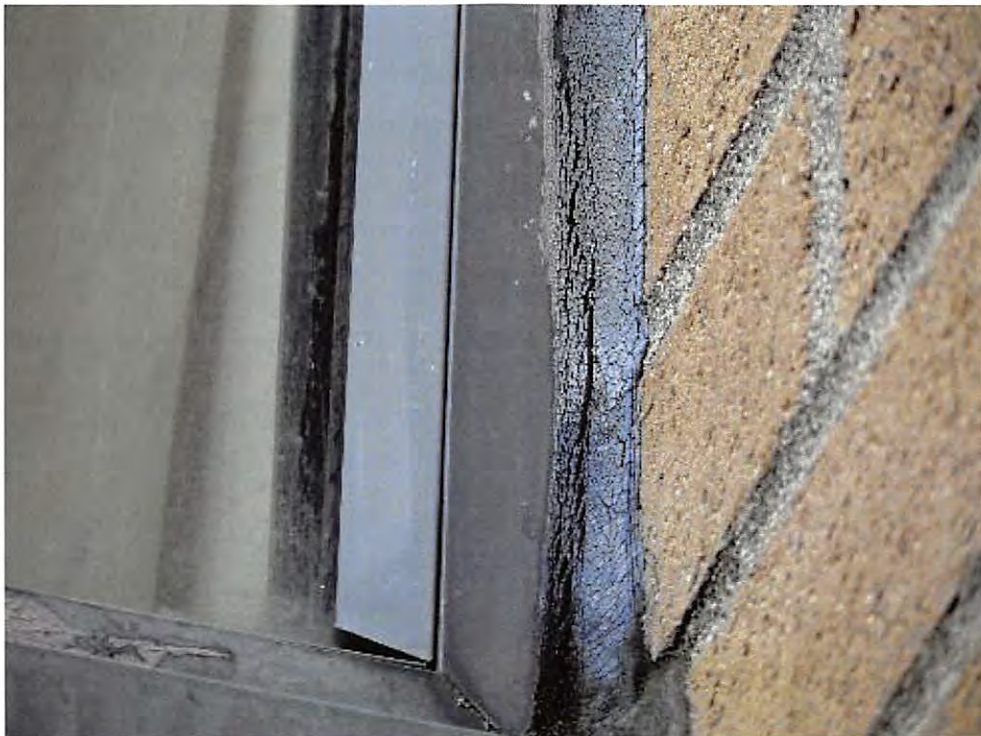
Caulking

Cracked caulking

Preventive Maintenance	Annual inspection.

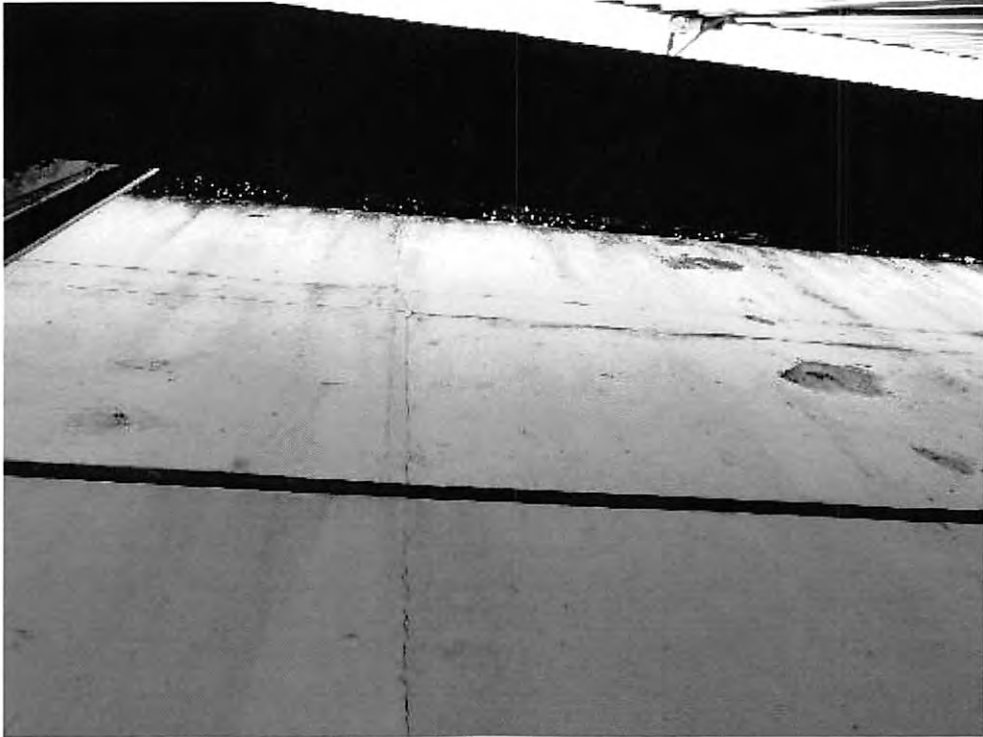
Reserve Component B201011	Exterior painting	
Properties	Acrylic paint	
Potential Deterioration	Over prolonged exposure to the elements, the stain may peel or fade. Rusting of metal components on surface may further deteriorate the finish.	
Condition Analysis	<i>Deterioration</i>	Paint peeling away from the concrete.
	<i>Repair/Replacement History</i>	Exteriors repainted in 2001.
	<i>Overall Condition</i>	Fair
Life Cycle Analysis	<i>Date of Installation</i>	1993
	<i>Chronological Age</i>	20 years
	<i>Estimated Useful Life</i>	8 years
	<i>Effective Age</i>	6 years
	<i>Remaining Useful Life</i>	2 years
Replacement/Repair Estimates	<i>Current Repair/Replacement Cost Estimate</i>	\$ 25,000
	<i>Estimated Year of Repair/Replacement</i>	2015
Recommendations	Exterior painting is required in 3 years.	
Preventive Maintenance	Clean annually.

Paint deterioration on building exterior

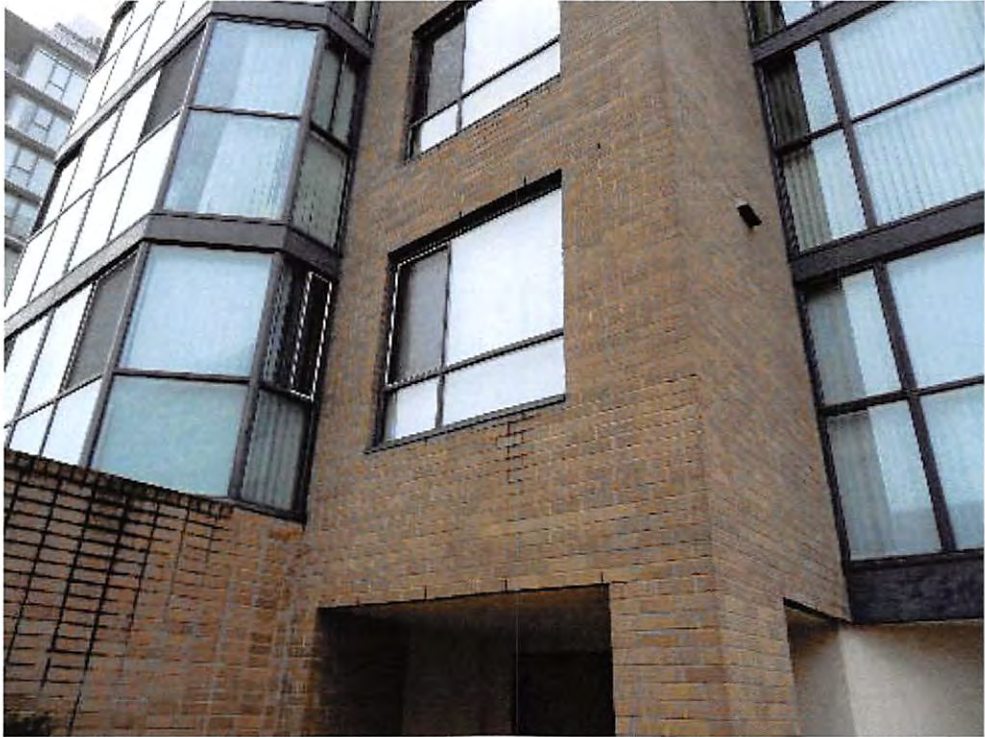
Reserve Component B20200101	Windows (frames)	
Properties	Aluminum-framed double glazed units	
Potential Deterioration	Building settlement may lead to the distortion of window frames, which may cause difficulties in opening and closing the windows.	
Condition Analysis	<i>Deterioration</i>	None observed
	<i>Repair/Replacement History</i>	N/A
	<i>Overall Condition</i>	Good
	<i>Date of Installation</i>	1993
Life Cycle Analysis	<i>Chronological Age</i>	20 years
	<i>Estimated Useful Life</i>	30 years
	<i>Effective Age</i>	21 years
	<i>Remaining Useful Life</i>	9 years
	Replacement/Repair Estimates	<i>Current Repair/Replacement Cost Estimate</i>
<i>Estimated Year of Repair/Replacement</i>		2022
Recommendations		N/A
Preventive Maintenance	Annual washing.

Exterior windows

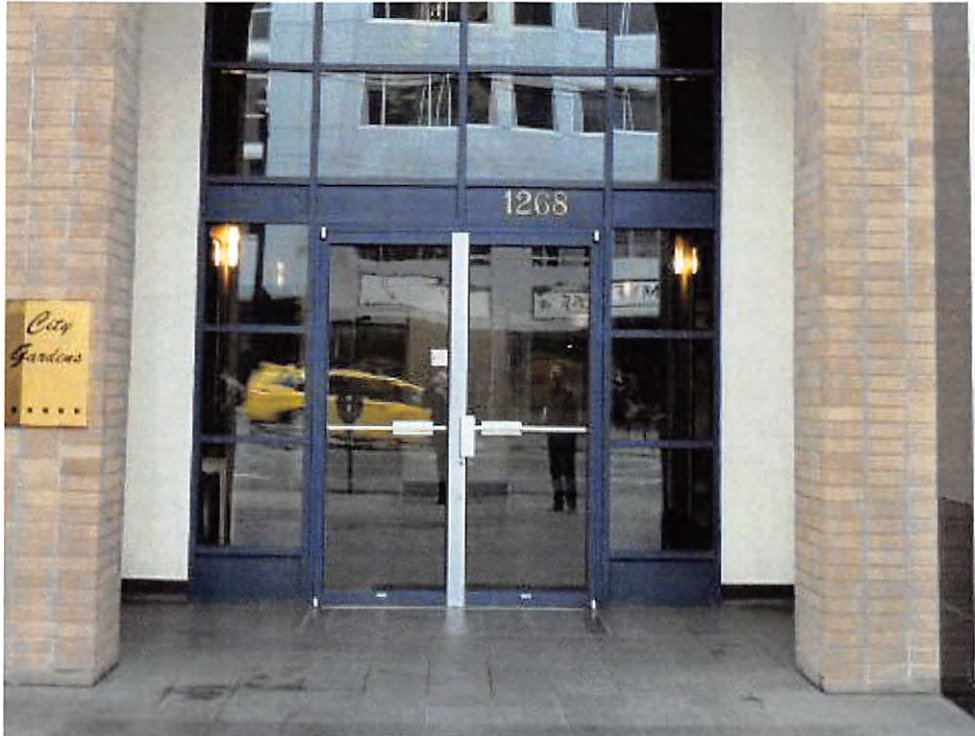
Reserve Component B20300101	Main doors	
Properties	Aluminum and glass	
Potential Deterioration	Deterioration of main entrance doors mainly concerns aesthetic appeal.	
Condition Analysis	<i>Deterioration</i>	None observed
	<i>Repair/Replacement History</i>	N/A
	<i>Overall Condition</i>	Good
	<i>Date of Installation</i>	1993
Life Cycle Analysis	<i>Chronological Age</i>	20 years
	<i>Estimated Useful Life</i>	50 years
	<i>Effective Age</i>	21 years
	<i>Remaining Useful Life</i>	29 years
	Replacement/Repair Estimates	<i>Current Repair/ Replacement Cost Estimate</i>
<i>Estimated Year of Repair/Replacement</i>		2042
Recommendations		N/A
Preventive Maintenance	Regular cleaning.

Main entrance doors

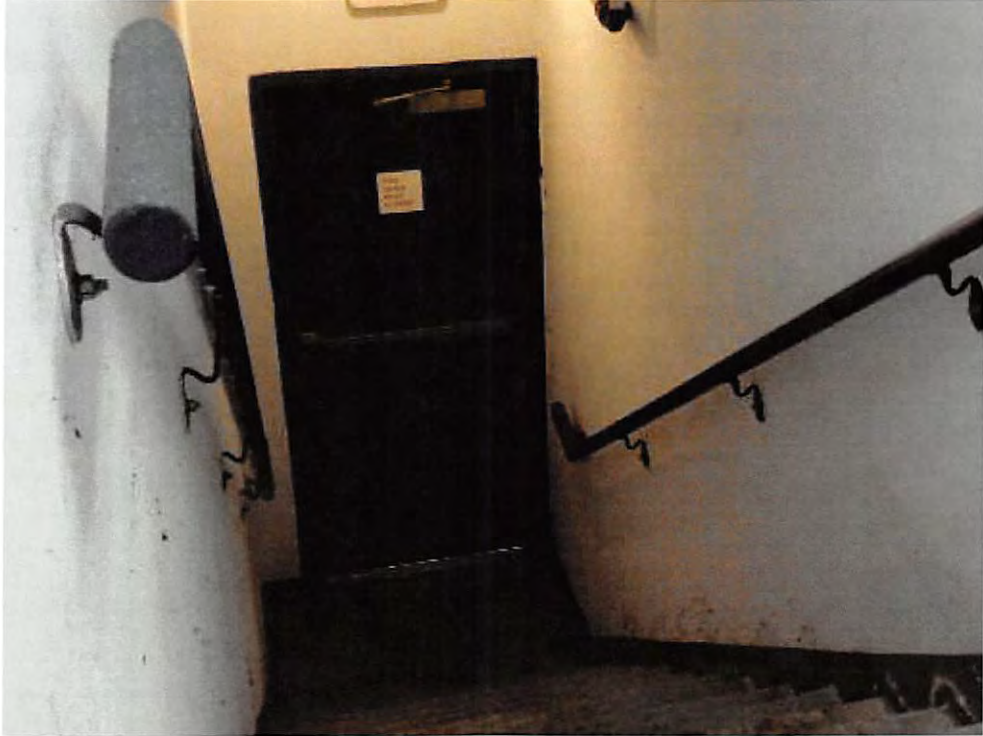
Reserve Component B20300102	Egress doors	
Properties	Metal fire doors	
Potential Deterioration	Egress doors are exposed to the elements and prone to rusting.	
Condition Analysis	<i>Deterioration</i>	None observed
	<i>Repair/Replacement History</i>	N/A
	<i>Overall Condition</i>	Good
	<i>Date of Installation</i>	1993
Life Cycle Analysis	<i>Chronological Age</i>	20 years
	<i>Estimated Useful Life</i>	50 years
	<i>Effective Age</i>	20 years
	<i>Remaining Useful Life</i>	30 years
	Replacement/Repair Estimates	<i>Current Repair/Replacement Cost Estimate</i>
<i>Estimated Year of Repair/Replacement</i>		2043
Recommendations		N/A
Preventive Maintenance	Annual inspection.

Egress door

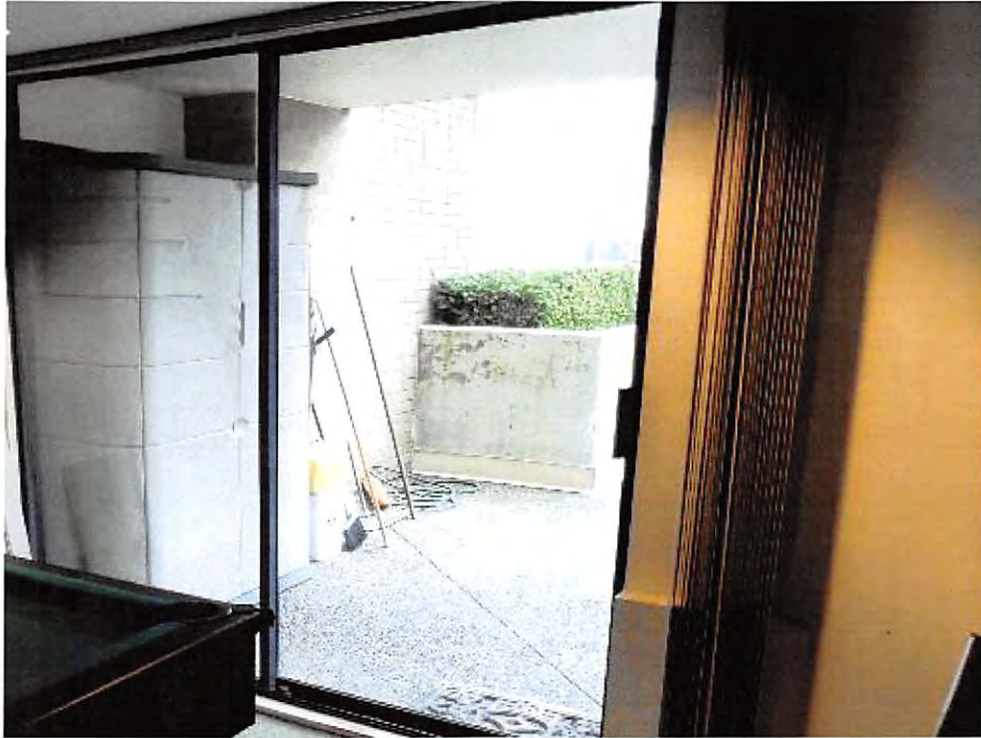
Sliding door

Recommendations	N/A	
Preventive Maintenance	Annual inspection and cleaning.

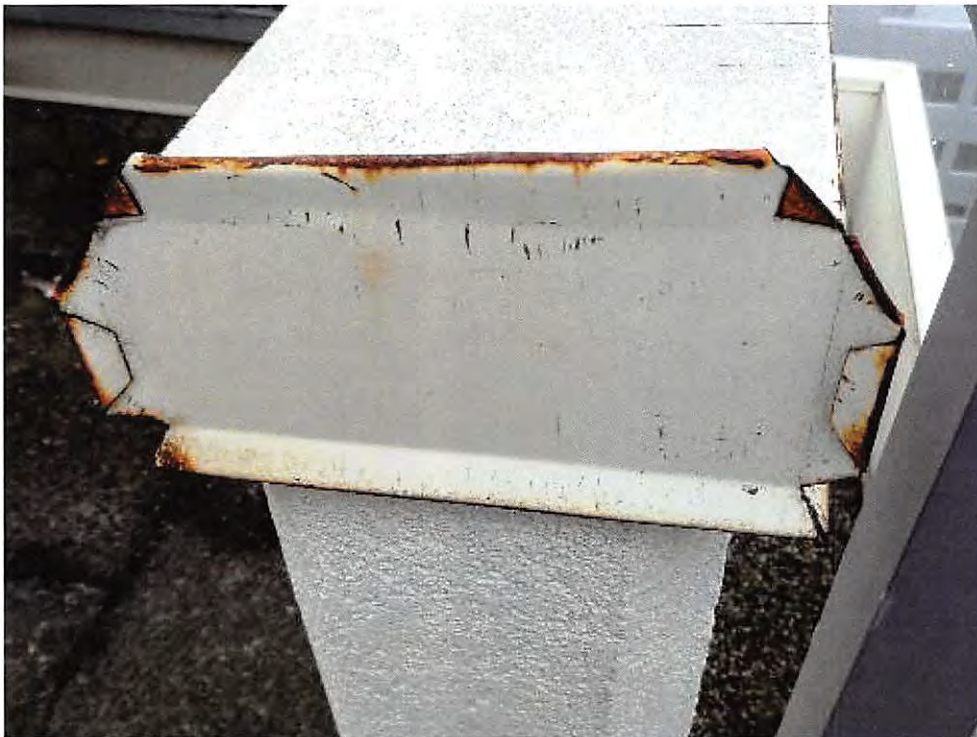
Reserve Component B301004	Flashings	
Properties	Metal flashing	
Potential Deterioration	Metal flashing may be affected by corrosion due to exposure to the elements. Furthermore, strong winds may dislodge flashing that is improperly secured.	
Condition Analysis	<i>Deterioration</i>	Flashings around first floor sloped negatively, directing water towards the building. Caulking in between flashing joints have deteriorated.
	<i>Repair/Replacement History</i>	N/A
	<i>Overall Condition</i>	Fair
Life Cycle Analysis	<i>Date of Installation</i>	1993
	<i>Chronological Age</i>	20 years
	<i>Estimated Useful Life</i>	30 years
	<i>Effective Age</i>	21 years
	<i>Remaining Useful Life</i>	9 years
Replacement/Repair Estimates	<i>Current Repair/Replacement Cost Estimate</i>	\$ 9,040
	<i>Estimated Year of Repair/Replacement</i>	2022
Recommendations	Roof parapet flashings are rusty and should be painted or replaced.	
Preventive Maintenance	Inspect twice a year (spring and fall) and repair/replace any damage.

Roof flashing

Rusty flashing on parapet wall

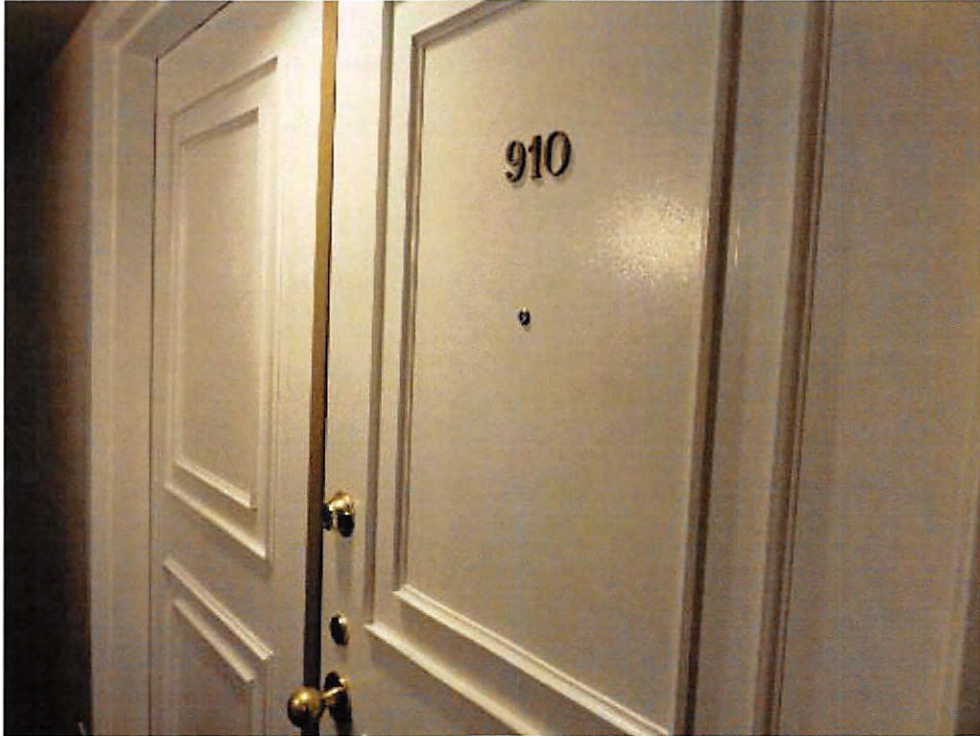
Reserve Component C102001	Interior unit doors	
Properties	Hollow wood doors	
Potential Deterioration	Deterioration mostly concerns loss of aesthetic appeal.	
Condition Analysis	<i>Deterioration</i>	None observed
	<i>Repair/Replacement History</i>	N/A
	<i>Overall Condition</i>	Good
	<i>Date of Installation</i>	1993
Life Cycle Analysis	<i>Chronological Age</i>	20 years
	<i>Estimated Useful Life</i>	50 years
	<i>Effective Age</i>	20 years
	<i>Remaining Useful Life</i>	30 years
	<i>Current Repair/Replacement Cost Estimate</i>	\$ 8,500
Replacement/Repair Estimates	<i>Estimated Year of Repair/Replacement</i>	2043
	<i>Recommendations</i>	N/A
Preventive Maintenance	Wipe down once a month; inspect every 6 months.

Interior unit door

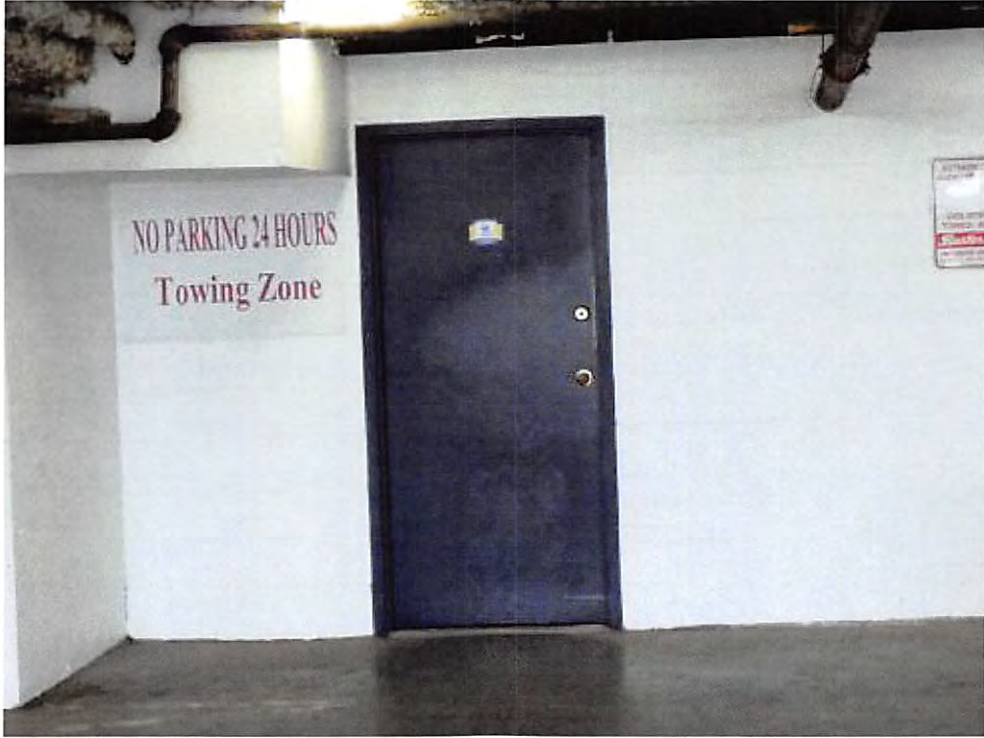
Reserve Component C102006	Service doors	
Properties	Metal fire doors	
Potential Deterioration	Deterioration mostly concerns loss of aesthetic appeal.	
Condition Analysis	<i>Deterioration</i>	None observed
	<i>Repair/Replacement History</i>	N/A
	<i>Overall Condition</i>	Good
	<i>Date of Installation</i>	1993
Life Cycle Analysis	<i>Chronological Age</i>	20 years
	<i>Estimated Useful Life</i>	50 years
	<i>Effective Age</i>	21 years
	<i>Remaining Useful Life</i>	29 years
	<i>Current Repair/Replacement Cost Estimate</i>	\$ 9,000
Replacement/Repair Estimates	<i>Estimated Year of Repair/Replacement</i>	2042
	<i>Recommendations</i>	N/A
Preventive Maintenance	Regular cleaning.

Service door

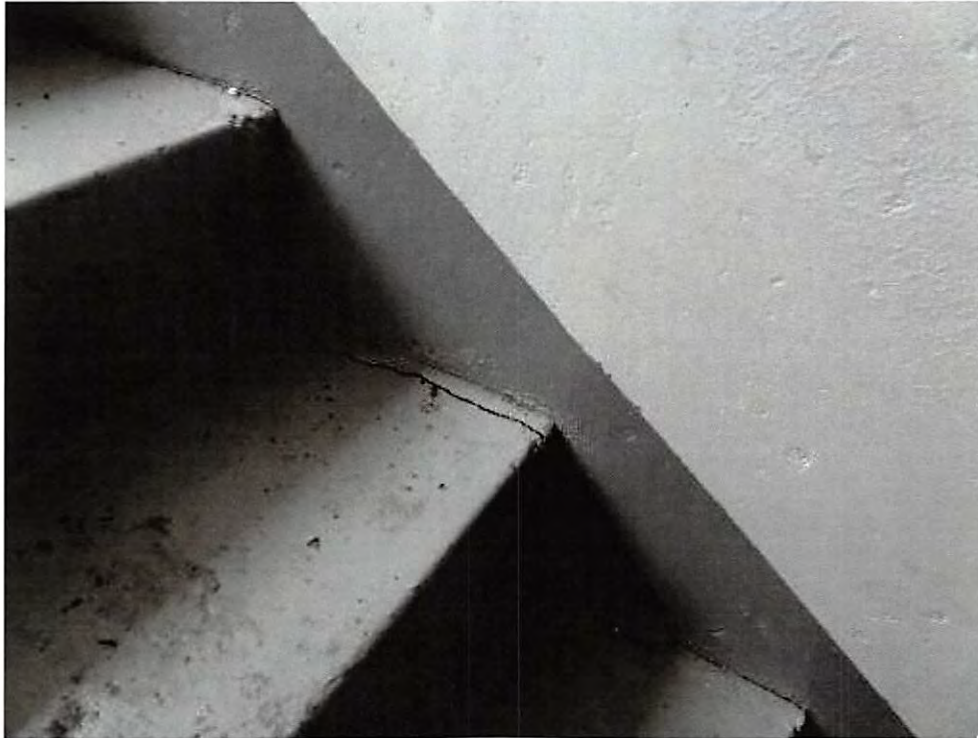
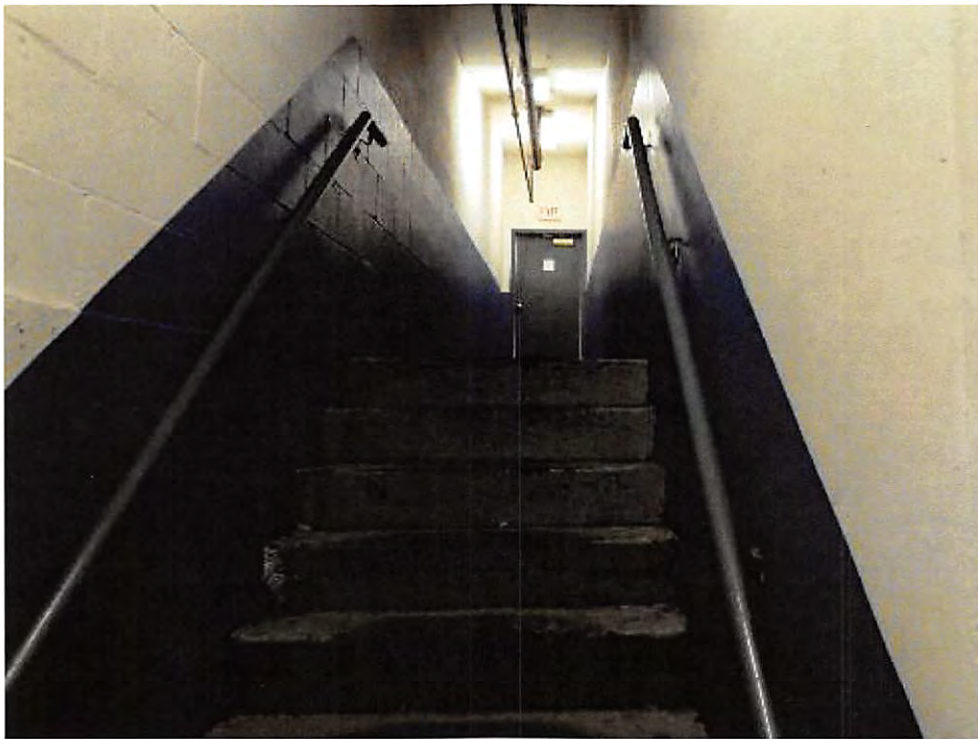
Reserve Component C201001	Interior stairs	
Properties	Concrete	
Potential Deterioration	Settlement may cause cracks in the concrete.	
Condition Analysis	<i>Deterioration</i>	Settlement has led to cracks within stairs.
	<i>Repair/Replacement History</i>	N/A
	<i>Overall Condition</i>	Good
	<i>Date of Installation</i>	1993
Life Cycle Analysis	<i>Chronological Age</i>	20 years
	<i>Estimated Useful Life</i>	Building life
	<i>Effective Age</i>	20 years
	<i>Remaining Useful Life</i>	Building life
	Replacement/Repair Estimates	<i>Current Repair/Replacement Cost Estimate</i>
<i>Estimated Year of Repair/Replacement</i>		2018
Recommendations		Repair cracks.
Preventive Maintenance	Clean regularly. Repair as needed.

Cracks in stairs

Cracking in stairs

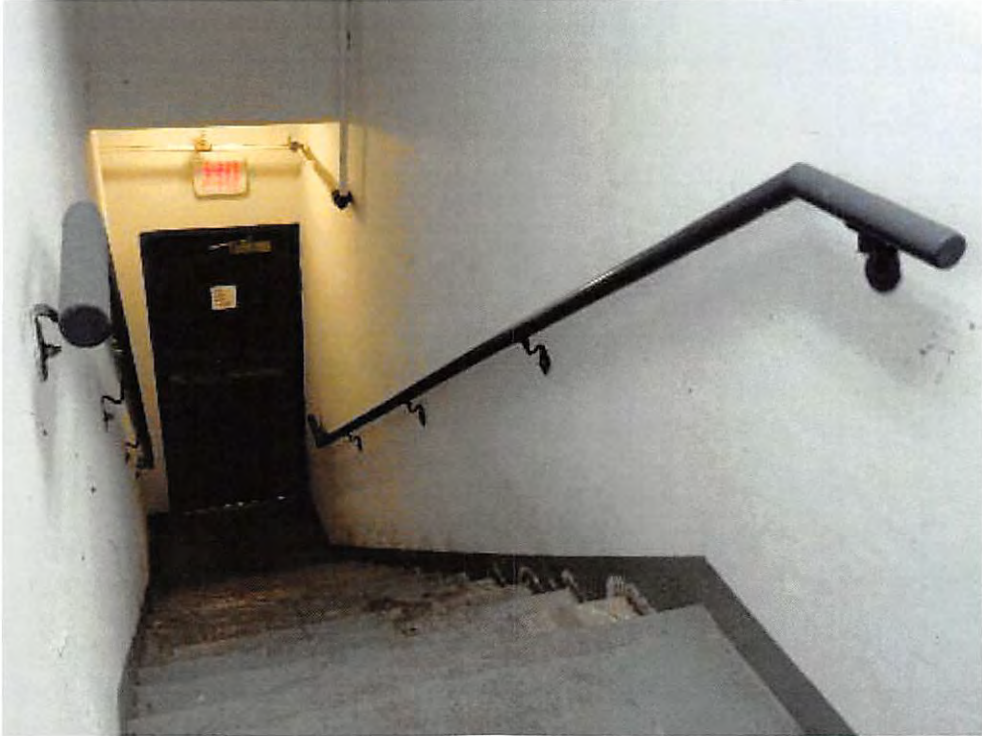
Reserve Component C202001	Stair railings	
Properties	Metal railings	
Potential Deterioration	Deterioration mostly concerns the decrease in aesthetic appeal over time.	
Condition Analysis	<i>Deterioration</i>	Railings damaged in concrete stairwell leading to pizza shop.
	<i>Repair/Replacement History</i>	N/A
	<i>Overall Condition</i>	Fair
Life Cycle Analysis	<i>Date of Installation</i>	1993
	<i>Chronological Age</i>	20 years
	<i>Estimated Useful Life</i>	Building life
	<i>Effective Age</i>	20 years
	<i>Remaining Useful Life</i>	Building life
Replacement/Repair Estimates	<i>Current Repair/Replacement Cost Estimate</i>	\$ 9,870
	<i>Estimated Year of Repair/Replacement</i>	2015
Recommendations	Repairs are recommended.	
Preventive Maintenance	Inspect every two years.

Stair railings

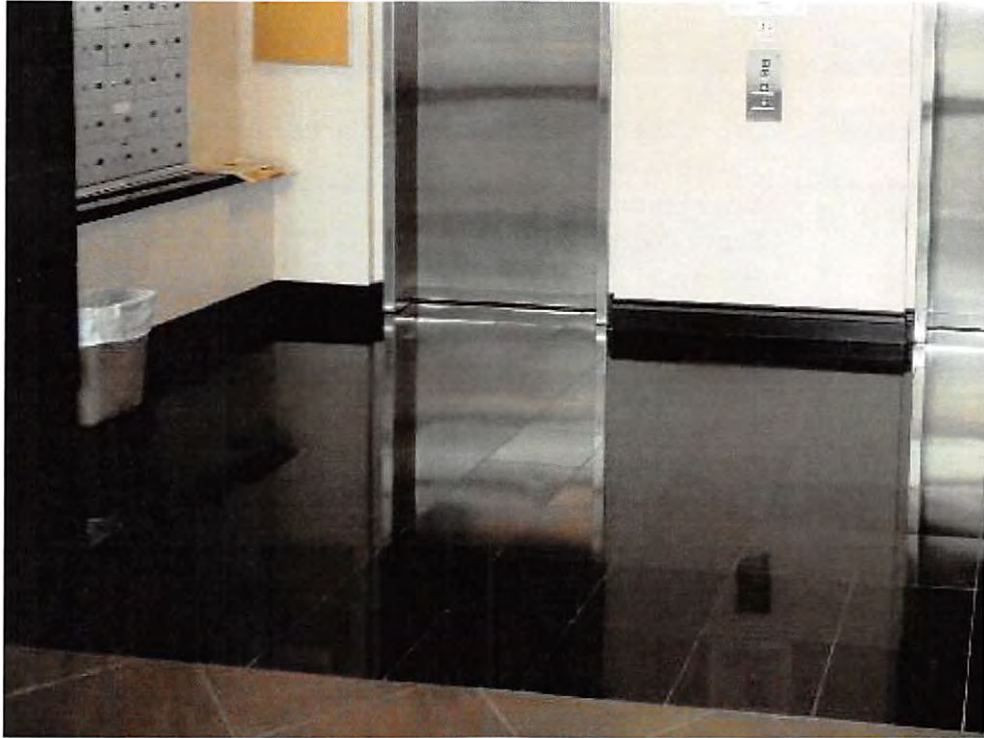
Reserve Component C302004	Floor finishes	
Properties	Tile	
Potential Deterioration	Prolonged wear and tear deteriorates the tiles and grouting. Extensive deterioration may lead to water penetration and damage.	
Condition Analysis	<i>Deterioration</i>	None observed
	<i>Repair/Replacement History</i>	N/A
	<i>Overall Condition</i>	Good
	<i>Date of Installation</i>	2010
Life Cycle Analysis	<i>Chronological Age</i>	3 years
	<i>Estimated Useful Life</i>	30 years
	<i>Effective Age</i>	3 years
	<i>Remaining Useful Life</i>	27 years
	Replacement/Repair Estimates	<i>Current Repair/Replacement Cost Estimate</i>
<i>Estimated Year of Repair/Replacement</i>		2040
<i>Recommendations</i>		N/A
Preventive Maintenance	Regular cleaning.

Tile flooring

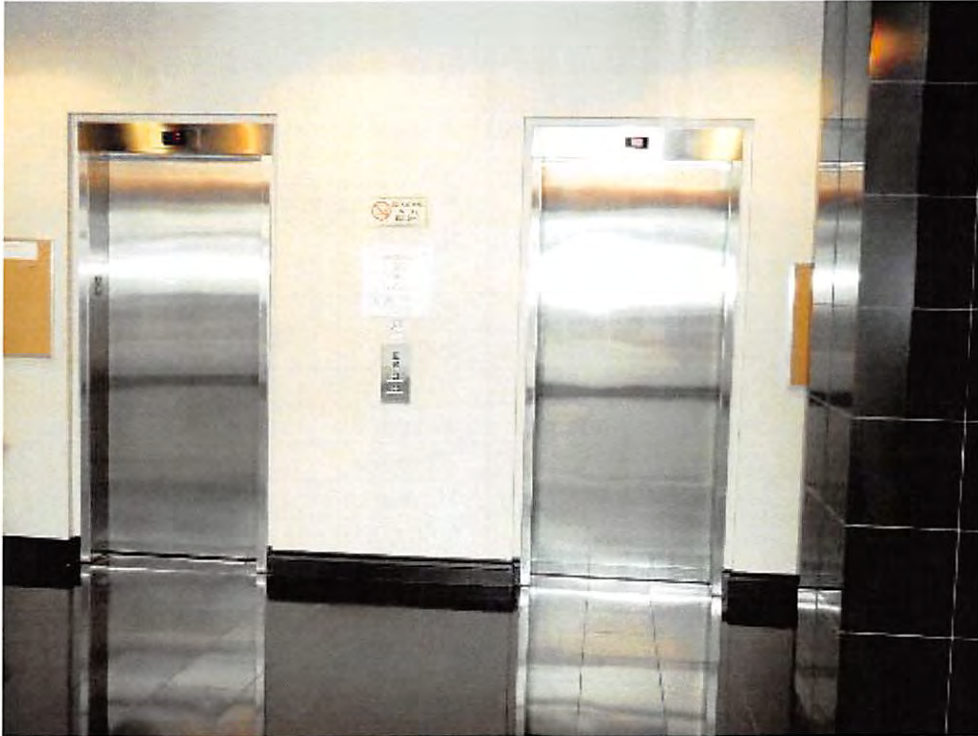
Reserve Component D10100101	Elevator
Properties	Cab
Potential Deterioration	Elevator cab may be damaged by moving large objects in and out. Vandalism and wear and tear are the main causes for deterioration for the elevator cab.
Condition Analysis	<i>Deterioration</i> None observed
	<i>Repair/Replacement History</i> N/A
	<i>Overall Condition</i> Good
Life Cycle Analysis	<i>Date of Installation</i> 1993
	<i>Chronological Age</i> 20 years
	<i>Estimated Useful Life</i> 30 years
	<i>Effective Age</i> 21 years
	<i>Remaining Useful Life</i> 9 years
Replacement/Repair Estimates	<i>Current Repair/Replacement Cost Estimate</i> \$ 20,000
	<i>Estimated Year of Repair/Replacement</i> 2022
Recommendations	N/A
Preventive Maintenance	Regular cleaning.

Elevators

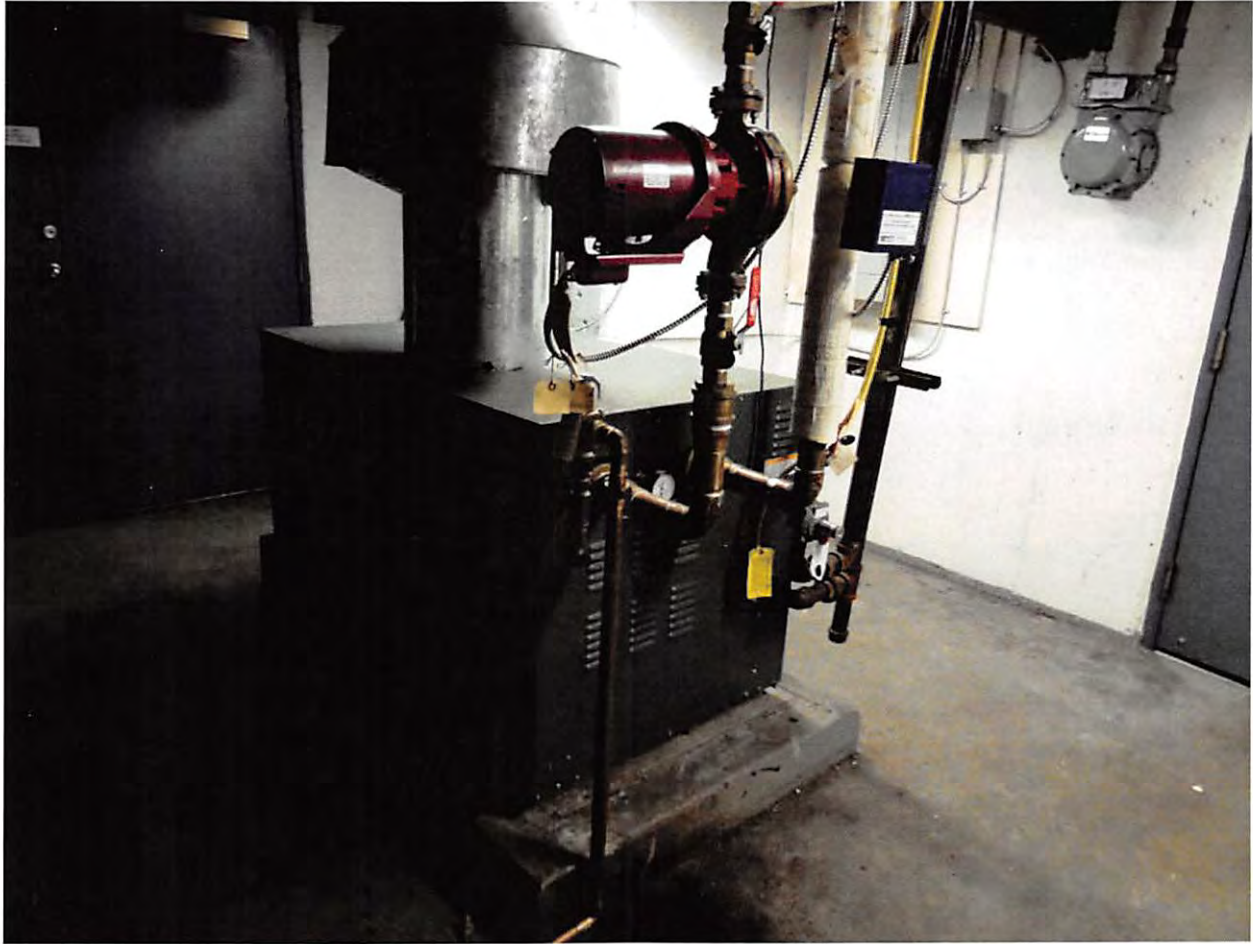
Boiler

Recommendations	N/A	
Preventive Maintenance	Annual inspection.
