Depreciation Report

LMS474 – City Gardens

**RE: Depreciation Report for Strata Plan LMS474
File No. 20130808-DR-LMS474**

The subject of this depreciation report consists of “City Gardens”, a 34-unit high rise apartment complex constructed in 1993 and located at 1268 W Broadway in Vancouver, BC. We are pleased to present you with the enclosed draft depreciation report, which we believe will serve as the basis of your reserve planning to help better equip your members for future expenditures.

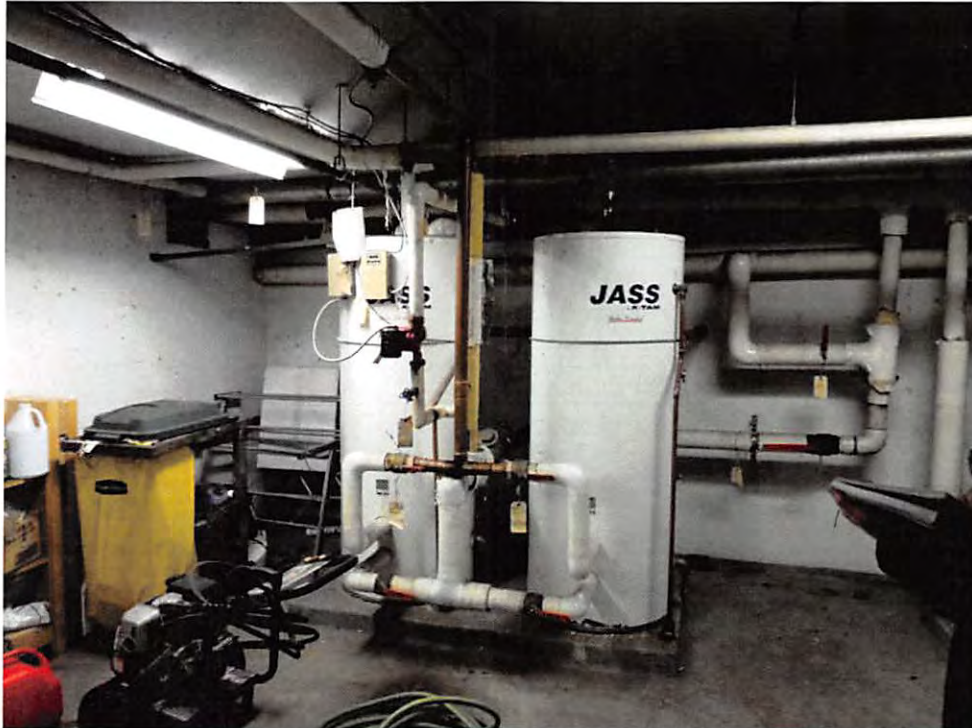
Reserve Component D302001	Hot water tanks	
Properties	Indirectly fired hot water tanks	
Potential Deterioration	Interior components are prone to corrosion and other forms of deterioration due to the high temperatures and impurities in the water.	
Condition Analysis	<i>Deterioration</i>	None observed
	<i>Repair/Replacement History</i>	N/A
	<i>Overall Condition</i>	Good
Life Cycle Analysis	<i>Date of Installation</i>	1998
	<i>Chronological Age</i>	15 years
	<i>Estimated Useful Life</i>	15 years
	<i>Effective Age</i>	12 years
	<i>Remaining Useful Life</i>	3 years
Replacement/Repair Estimates	<i>Current Repair/Replacement Cost Estimate</i>	\$ 12,000
	<i>Estimated Year of Repair/Replacement</i>	2016
Recommendations	N/A	
Preventive Maintenance	Annual inspection.

Hot water tanks

Hot water tank detail

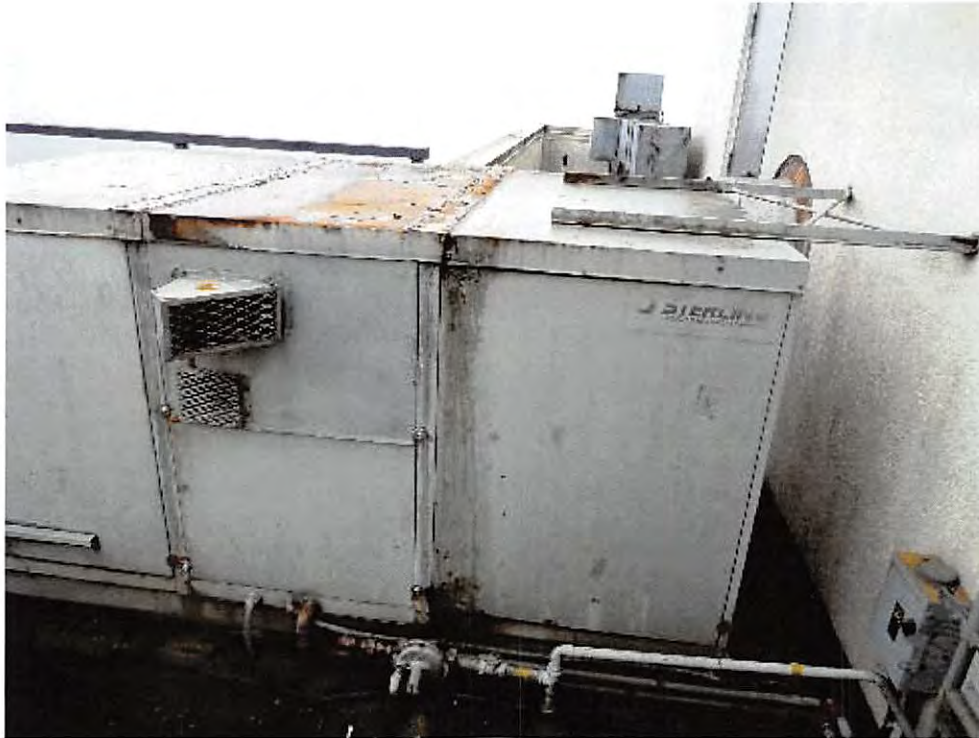
Reserve Component D309007	HVAC	
Properties	Make up air unit	
Potential Deterioration	Dust particles accumulated over time may affect the efficiency of the fan. Over time, mechanical components of the fan may be prone to failure.	
Condition Analysis	<i>Deterioration</i>	None observed
	<i>Repair/Replacement History</i>	N/A
	<i>Overall Condition</i>	Good
	<i>Date of Installation</i>	1993
Life Cycle Analysis	<i>Chronological Age</i>	20 years
	<i>Estimated Useful Life</i>	20 years
	<i>Effective Age</i>	10 years
	<i>Remaining Useful Life</i>	10 years
	<i>Current Repair/Replacement Cost Estimate</i>	\$ 9,151
Replacement/Repair Estimates	<i>Estimated Year of Repair/Replacement</i>	2023
	Recommendations N/A	
Preventive Maintenance	Annual inspection; repair/replace, lubricate, re-align components as necessary.

Make-up air unit

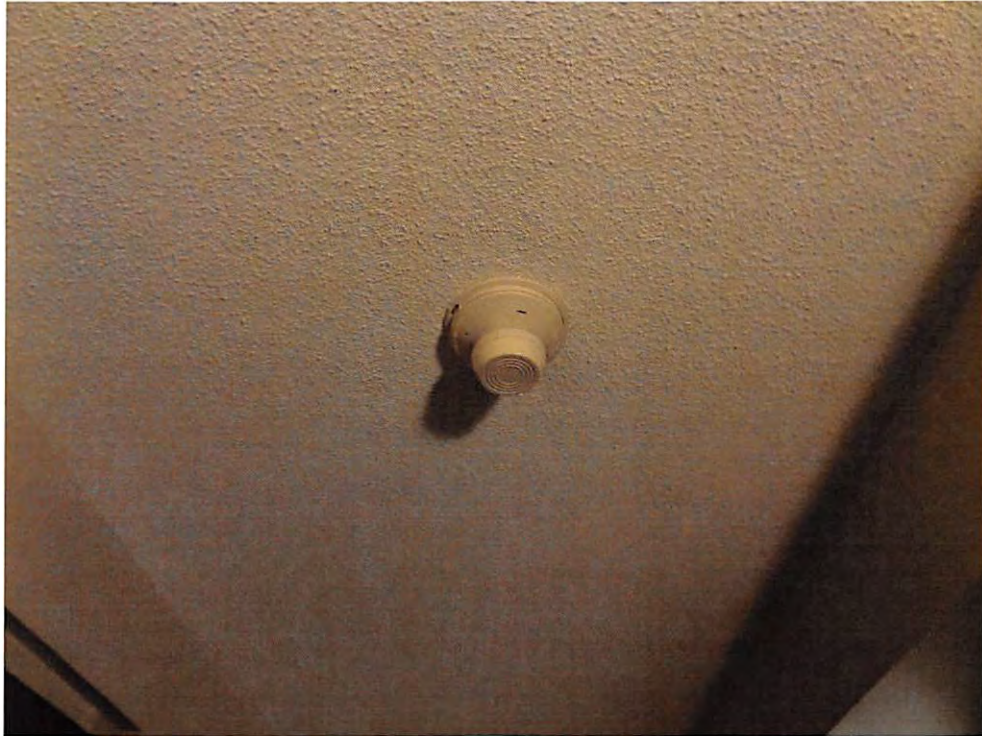
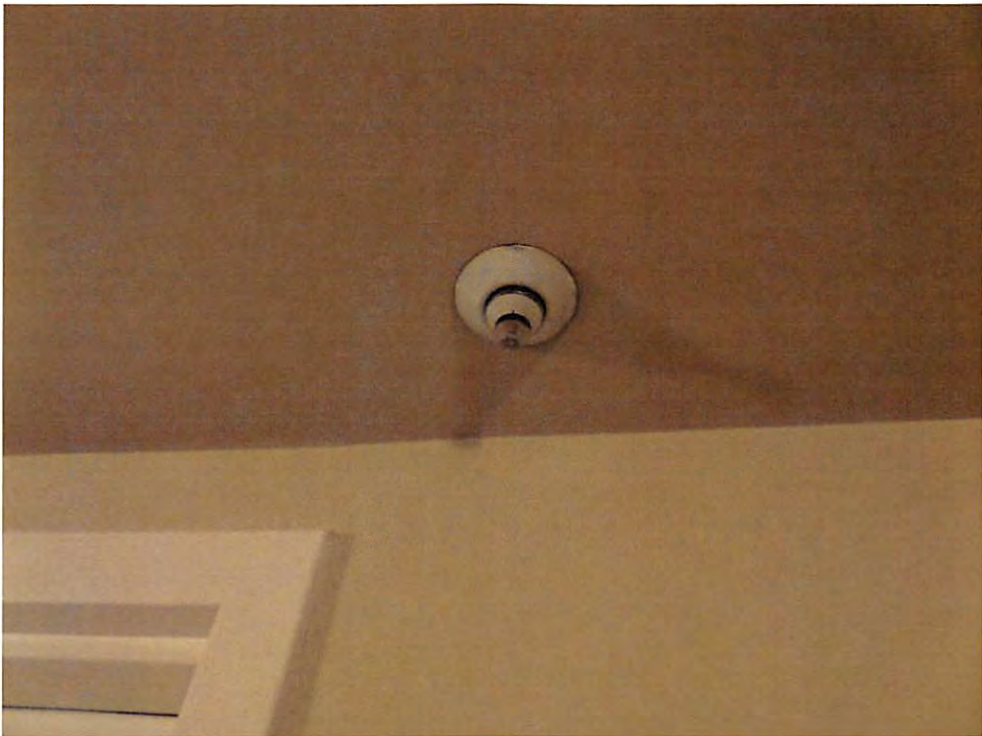
Reserve Component D503007	Smoke & Fire Detection System	
Properties	Central Panel	
Potential Deterioration	N/A	
Condition Analysis	<i>Deterioration</i>	None observed
	<i>Repair/Replacement History</i>	10-20 heat detectors changed yearly.
	<i>Overall Condition</i>	Fair
	<i>Date of Installation</i>	1993
Life Cycle Analysis	<i>Chronological Age</i>	20 years
	<i>Estimated Useful Life</i>	Building life
	<i>Effective Age</i>	N/A
	<i>Remaining Useful Life</i>	Building life
	<i>Current Repair/Replacement Cost Estimate</i>	\$ 5,000 (Repair costs approximated over 10 years)
Replacement/Repair Estimates	<i>Estimated Year of Repair/Replacement</i>	2021
Recommendations	N/A	
Preventive Maintenance	Annual inspection.

Fire alarm

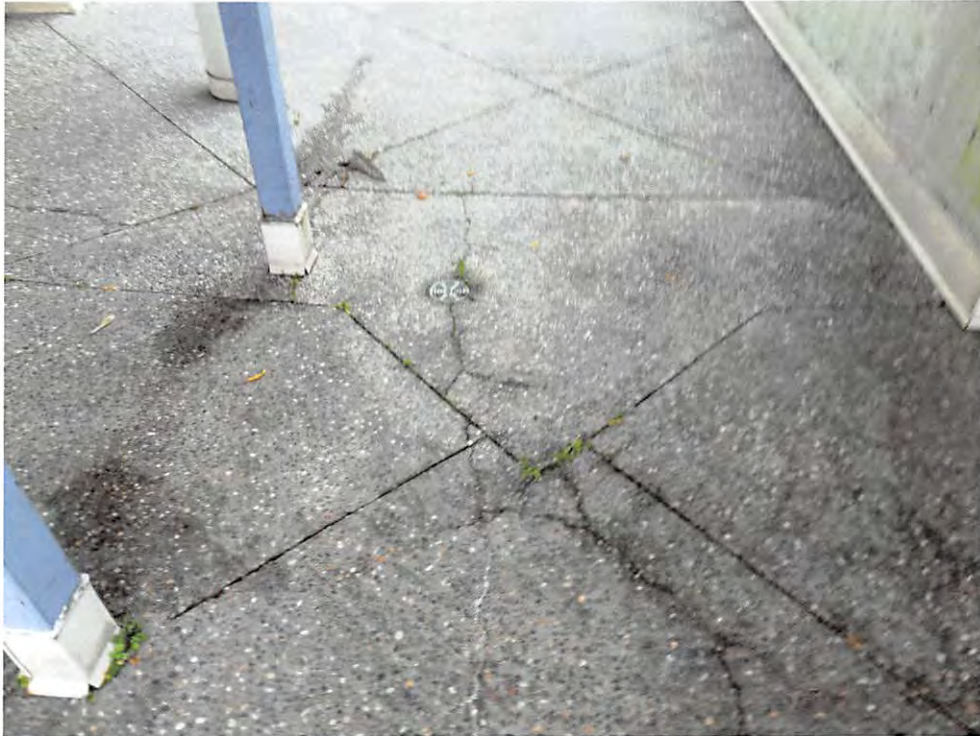
Reserve Component G203001	Exterior paving
Properties	Concrete pavers with aggregate finish
Potential Deterioration	Long-term use and exposure to the elements and freeze-thaw effects may lead to cracks. Minor cracks may decrease aesthetic appeal while major cracks may present a tripping hazard.
Condition Analysis	<i>Deterioration</i> Cracks are present in 4'x4' pavers.
	<i>Repair/Replacement History</i> N/A
	<i>Overall Condition</i> Good
	<i>Date of Installation</i> 1993
Life Cycle Analysis	<i>Chronological Age</i> 20 years
	<i>Estimated Useful Life</i> 30 years
	<i>Effective Age</i> 20 years
	<i>Remaining Useful Life</i> 10 years
	<i>Current Repair/Replacement Cost Estimate</i> \$ 10,000 (Repair costs approximated over 10 years)
Replacement/Repair Estimates	<i>Estimated Year of Repair/Replacement</i> 2023
Recommendations	Repairs or partial replacement is recommended.
Preventive Maintenance	Repair as needed.

Cracks in concrete pavers

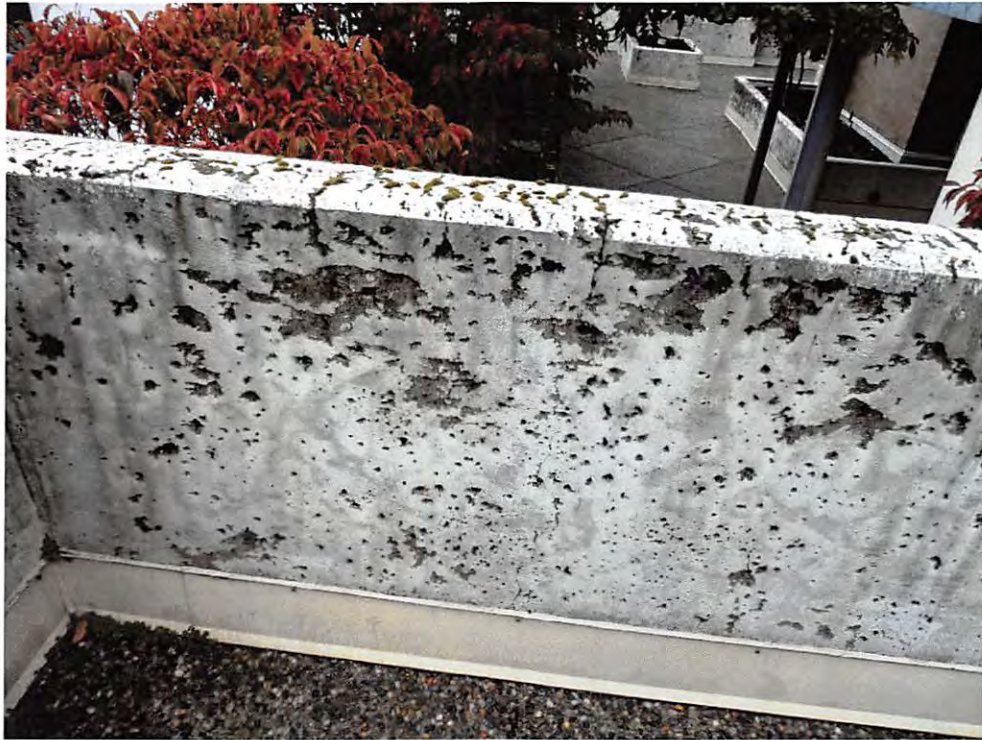
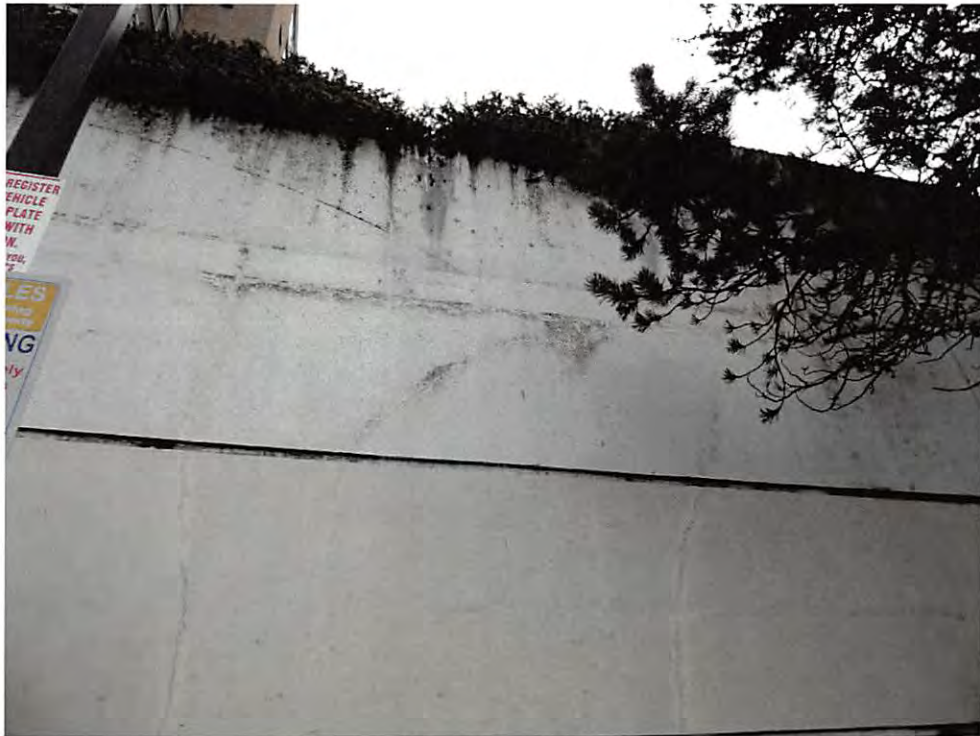
Reserve Component G204002	Concrete exterior walls	
Properties	Concrete	
Potential Deterioration	Long-term use and exposure to the elements and freeze-thaw effects may lead to cracks.	
Condition Analysis	<i>Deterioration</i>	Efflorescence and water damage of concrete observed.
	<i>Repair/Replacement History</i>	N/A
	<i>Overall Condition</i>	Fair
Life Cycle Analysis	<i>Date of Installation</i>	1993
	<i>Chronological Age</i>	20 years
	<i>Estimated Useful Life</i>	Building life
	<i>Effective Age</i>	20 years
	<i>Remaining Useful Life</i>	Building life
Replacement/Repair Estimates	<i>Current Repair/Replacement Cost Estimate</i>	\$ 15,000 (Repair costs approximated over 15 years)
	<i>Estimated Year of Repair/Replacement</i>	2015
Recommendations	Cracks needs to be repaired in the courtyard concrete walls. Also, the walls need painting.	
Preventive Maintenance	Sealant injections to repair minor cracks.

Concrete walls

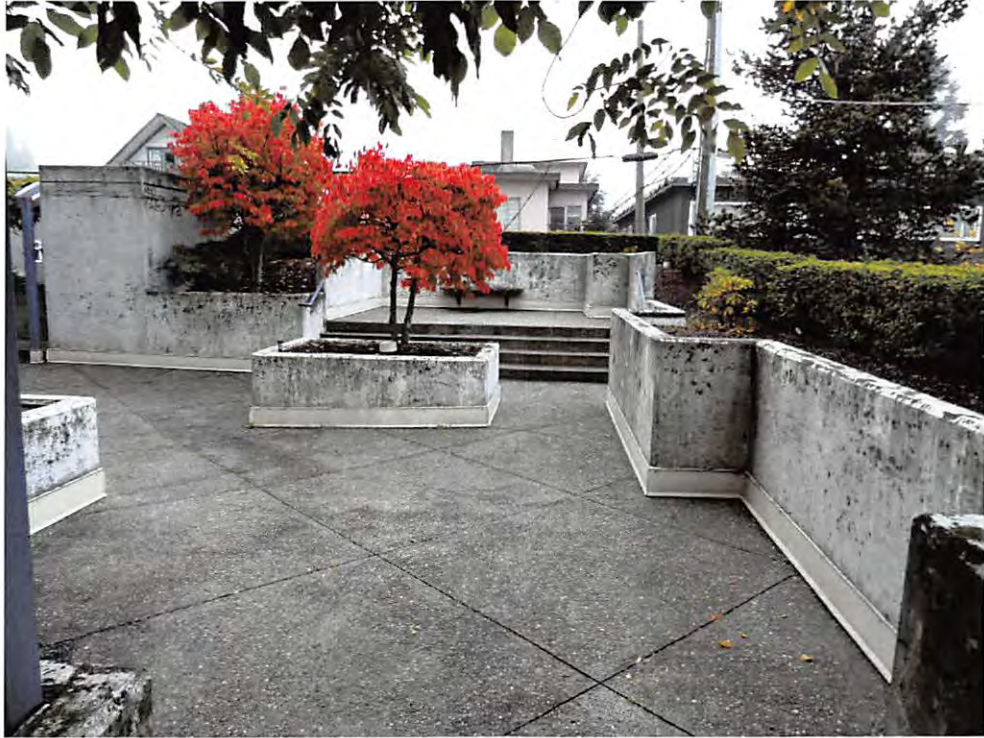
Reserve Component G205005	Landscaping	
Properties	Planting	
Potential Deterioration	N/A	
Condition Analysis	<i>Deterioration</i>	None observed
	<i>Repair/Replacement History</i>	N/A
	<i>Overall Condition</i>	Good
	<i>Date of Installation</i>	1993
Life Cycle Analysis	<i>Chronological Age</i>	20 years
	<i>Estimated Useful Life</i>	Building life
	<i>Effective Age</i>	20 years
	<i>Remaining Useful Life</i>	Building life
	<i>Current Repair/Replacement Cost Estimate</i>	\$ 10,000 (Repair costs approximated over 15 years)
Replacement/Repair Estimates	<i>Estimated Year of Repair/Replacement</i>	2022
	<i>Recommendations</i>	N/A
Preventive Maintenance	Regular maintenance.
