To The Owners, Strata Plan NW2502 Site Vi c/o Mr. Robert Gillan, Strata Council Submi Strata Plan NW2502 RDH B

12901 - 12981 17th Avenue Surrey BC V4A 8T3 Site Visit: October 13th, 2016 Submitted: December 23rd, 2016 by RDH Building Science Inc. 224 West 8th Avenue Vancouver BC V5Y 1N5

This Report is an update to the Depreciation Report issued on November 12, 2013. A site visit was completed on October 13, 2016, and the financial data is based on the 2016 fiscal year. The final Report was distributed to the Strata Council on December 23, 2016.

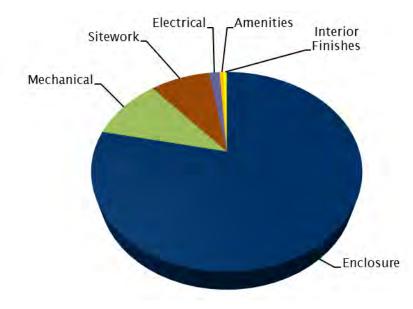
Approximately 10% to 15% of the Strata Corporation's capital expenditures will likely occur in the next 10 years. The distribution of estimated capital expenditures over the next 10 years is shown in Figure 4.1 below.

*Figure 4.1 Distribution of estimated capital expenditures over 10 years by system.*

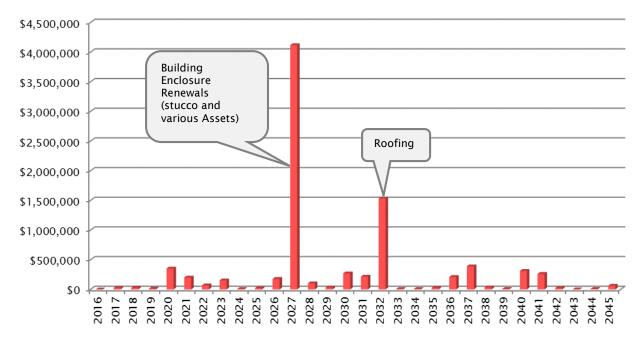
Estimated major maintenance and renewal costs over the next 30 years are shown on the graph below (Figure 5.1). The red bars represent the estimated value of capital costs.

*Figure 5.1* Strategic Forecast (30 Years), showing the approximate timing and value of some key capital expenditures.

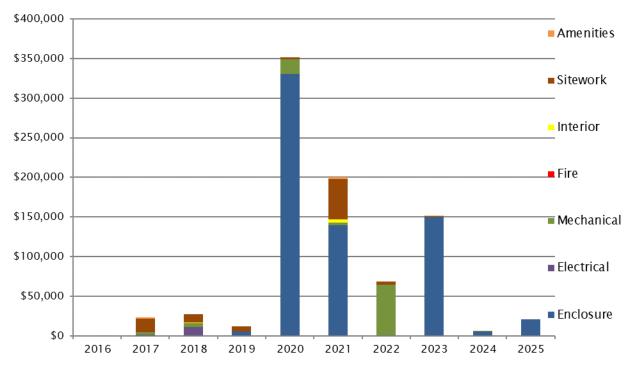
The bars indicate the years in which an event (or bundle of events) is most likely to occur as well as the total magnitude of major maintenance and renewal costs for that year, and the costs broken down by system. Labels summarize renewals and major maintenance activities forecast for that year. The soft costs associated with project implementation, such as site access, design, and contract administration, are not included.

*Figure 5.2* Tactical Forecast (10 years), showing the approximate timing and value of some key capital expenditures.

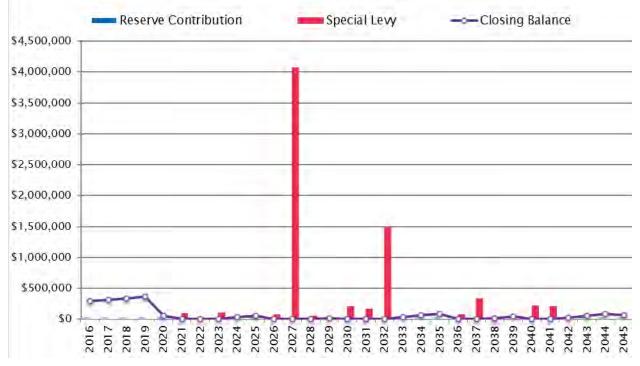
The graph below shows the annual contribution to the CRF, the closing balance of the CRF, and the size of the special levies forecast for the next 30 years.

Figure 6.1 CRF balance, contribution and special levies based on the current funding.

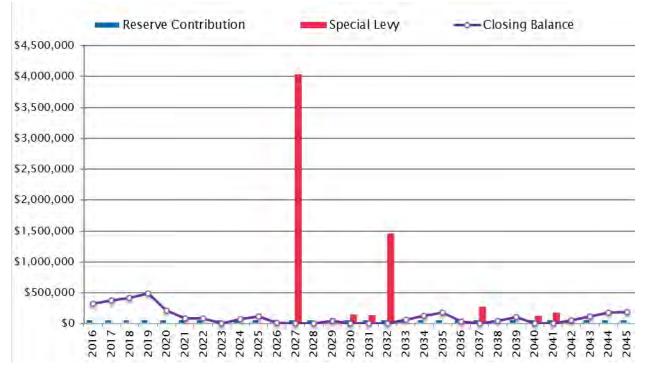
Alternative Funding Scenario eliminates some of the smaller levies, but it is not adequate to offset all the special levies over the 30-year planning horizon. The graph below shows the annual contribution to the CRF, the closing balance of the CRF, and the size of the special levies forecast for the next 30 years.

Figure 6.2 CRF balance, contribution and special levies based on Alternative.

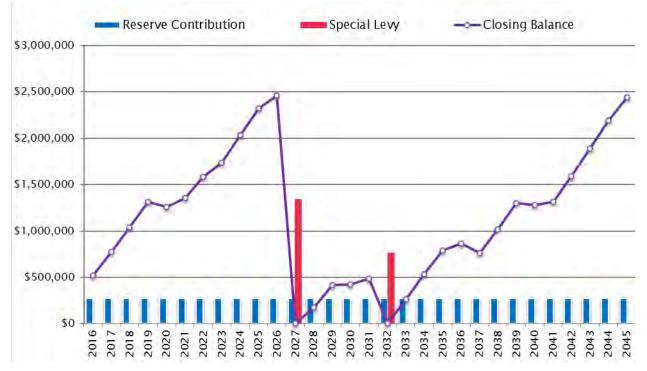
The Progressive Reserve would offset smaller special levies. However, because of the timing of anticipated renewals projects, a fixed annual contribution will not eliminate all special levies over the 30-year planning horizon. The graph below shows the annual contribution to the CRF, the closing balance of the CRF, and the size of the special levies forecast for the next 30 years.

*Figure 6.3 CRF balance, contribution, and special levies based on a Progressive Reserve calculation.*
