Building Envelope Condition Assessment

VAS2131 - The Emperor
c/o Associa British Columbia Inc.

i3 Building Science and Consulting Inc. (i3BSC) was retained by the Strata Corporation of VAS2131 - The Emperor to conduct a Building Envelope Condition Assessment (BECA) at the property located at 925 West 15th Avenue Vancouver, BC, herein referred to as the subject property. The condition assessment was conducted by Claude Boldut and Tinu Oros.

Strata Plan VAS2131 "The Emperor" is located at 925 W 15th Avenue, Vancouver BC. The Emperor is a low-rise wood-frame strata building of 3 stories built in 1988.

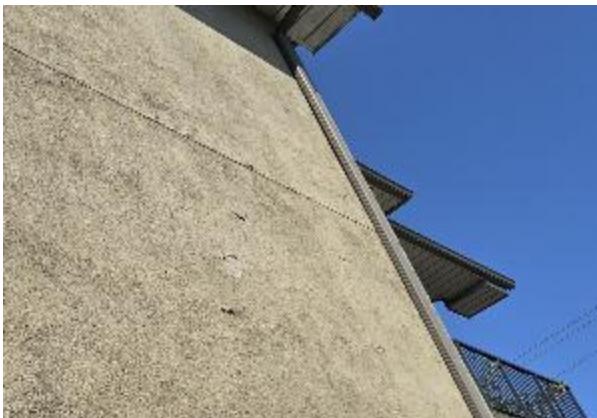
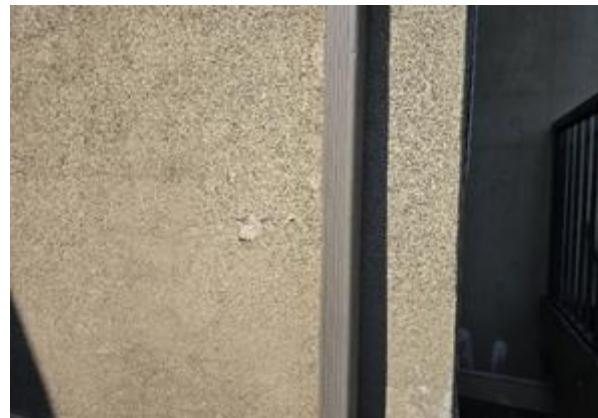
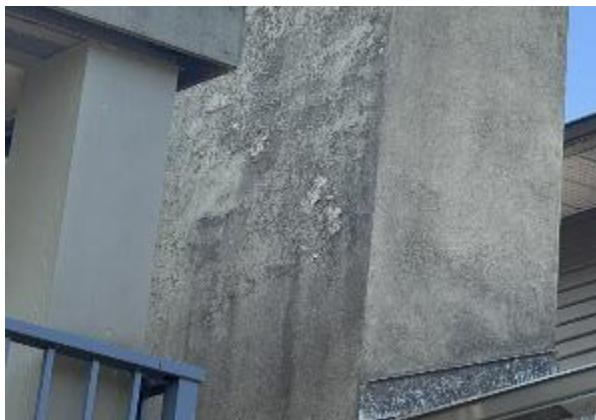
No	Observation/Comment and Photos
1.	<p>Description: The photos below document typical failures observed in the stucco system at the walls and chimney elevations of the building. These conditions highlight recurring issues that are consistent across multiple areas and demonstrate the need for comprehensive repair.</p> <p>Photos 1.1 through 1.3 illustrate failures of the stucco topcoat. In these areas, the outer protective layer of the stucco has begun to peel away from the substrate, exposing the underlying material. This type of failure is commonly caused by prolonged exposure to weather conditions, moisture intrusion behind the stucco surface, or insufficient bonding during the original application. Left unaddressed, peeling of the topcoat can accelerate deterioration by allowing additional water penetration and reducing the overall weather resistance of the system.</p> <p>Photo 1.4 shows damage at the stucco end cap and transition points. These locations are particularly vulnerable because they represent changes in plane or termination details, which are often stress points in the building envelope. Improper sealing, thermal expansion and contraction, or mechanical impact can lead to separation, chipping, or cracking at these junctions. Damage in these areas increases the likelihood of water infiltration and compromises the durability of adjacent finishes.</p>

Photo 1.1: Damaged stucco at the wall elevation

Photo 1.2: Damaged stucco at the wall elevation.

Photo 1.3: Damaged stucco at the wall elevation

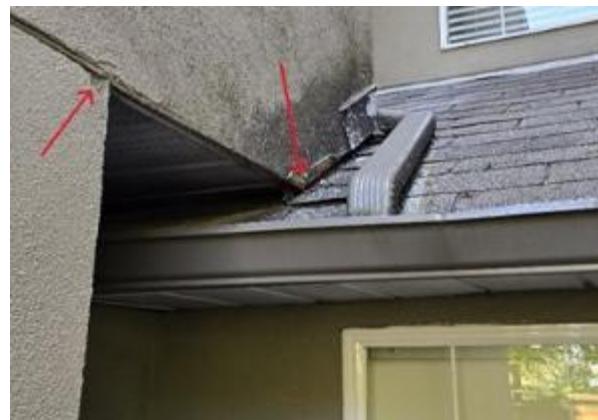
Photo 1.4: Damaged stucco at the end cap and transition strip

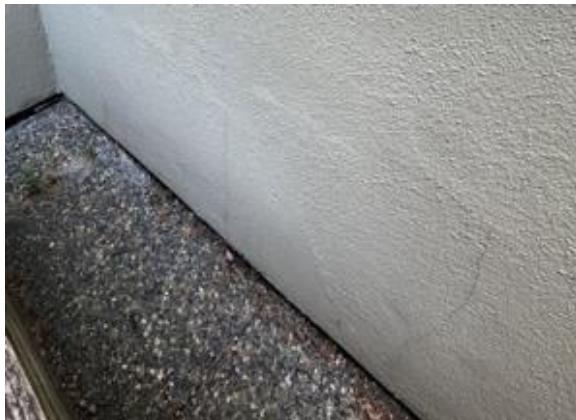
Photo 1.5 highlights typical cracking observed on the wall elevations. Cracks in stucco can develop due to a number of factors, including settlement of the building structure, thermal movement, or insufficient control joints in the original design. Depending on their size and depth, cracks may function as direct pathways for moisture intrusion, which can cause further delamination, efflorescence, or corrosion of embedded components such as lath and fasteners.

Photo 1.5: Crack stucco at the wall elevation

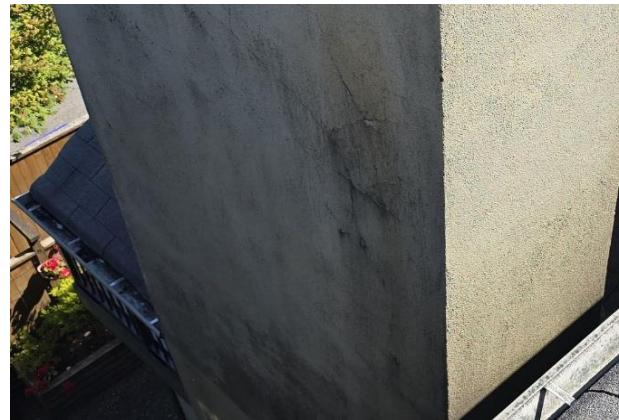
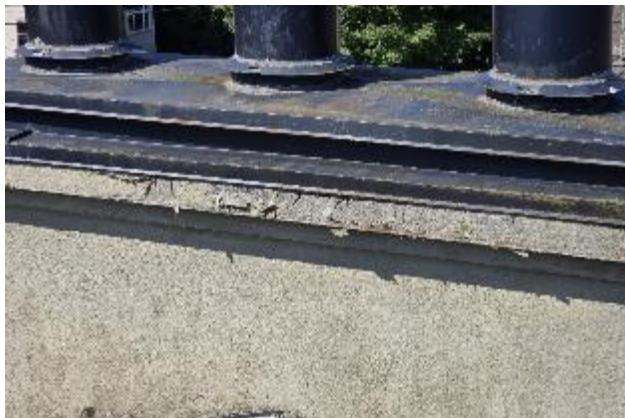
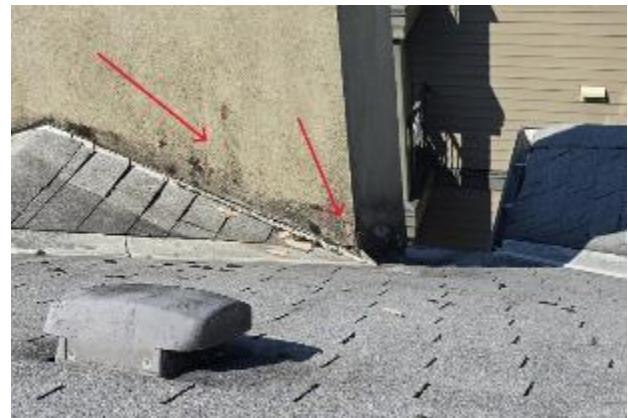
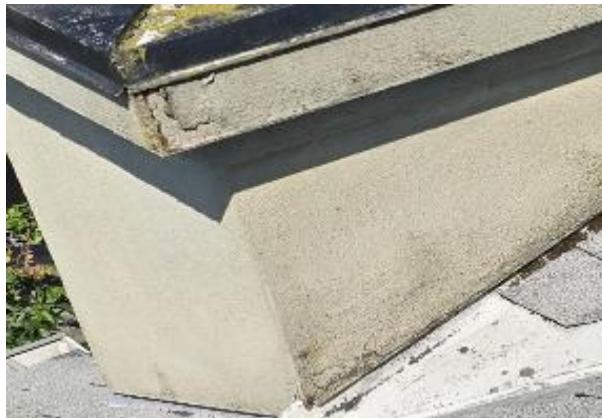
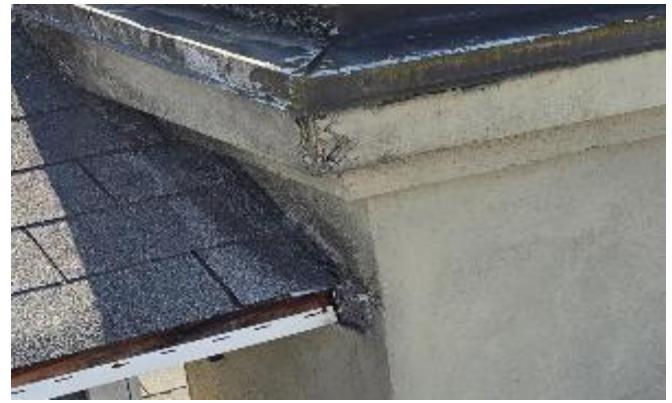
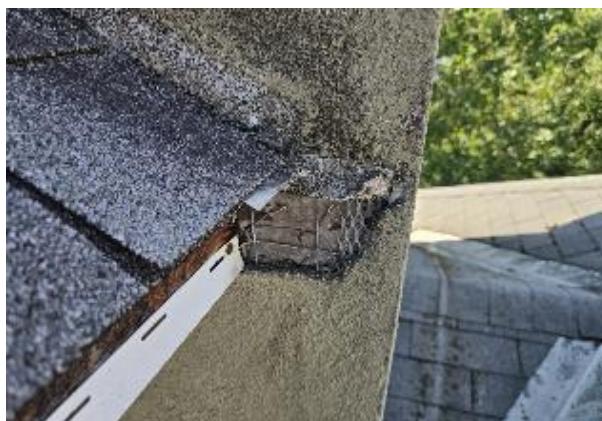
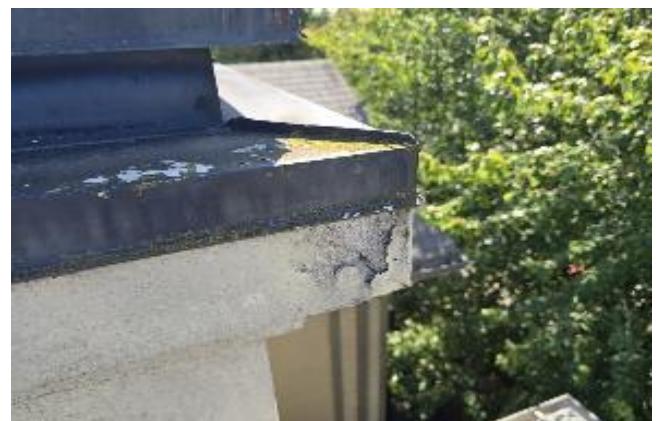
Photos 1.6 and 1.12 depict damaged stucco at the chimney levels. Chimneys are exposed components that endure greater weather exposure compared to other elevations, including wind-driven rain, freeze-thaw cycles, and thermal stress from heating operations. The observed damage around the chimney is not isolated but occurs frequently around the building, indicating a widespread vulnerability. Deterioration in these areas may include spalling, loss of material adhesion, or surface cracking, all of which reduce the chimney's ability to function as a weatherproof barrier.

Photo 1.6: Stucco damaged at the chimney level

Photo 1.7: Stucco damaged at the chimney level

Photo 1.8: Stucco damaged at the chimney level

Photo 1.9: Stucco damaged at the chimney level

Photo 1.10: Stucco damaged at the chimney level

Photo 1.11: Stucco damaged at the chimney level

Photo 1.12: Stucco damaged at the chimney level.

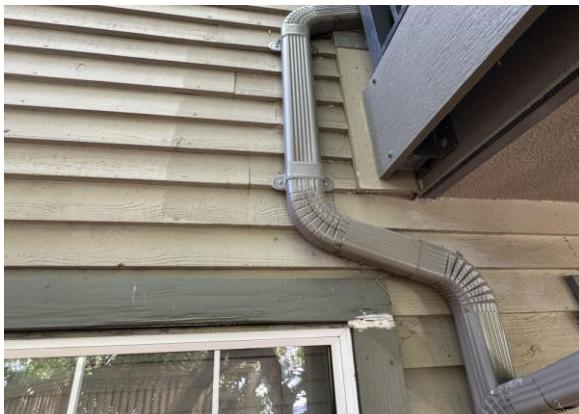
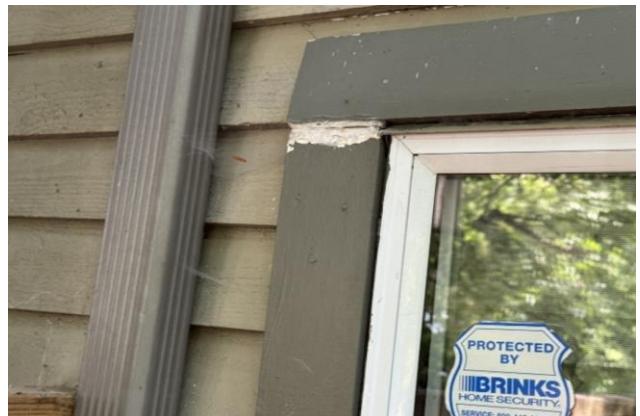
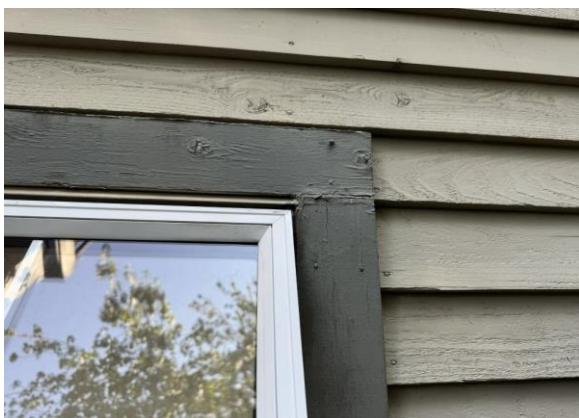
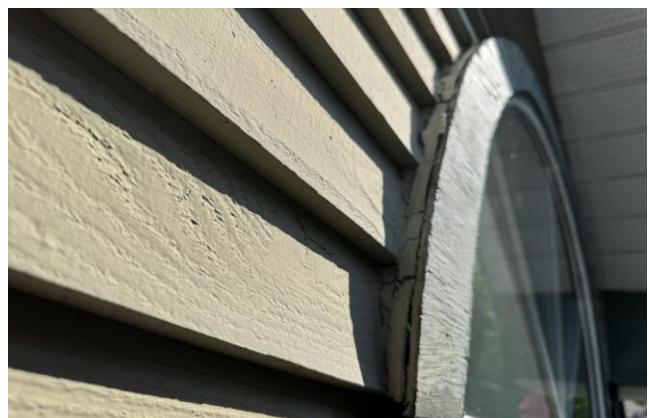
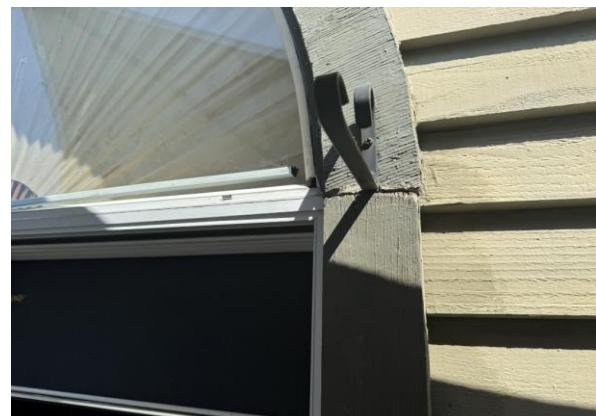
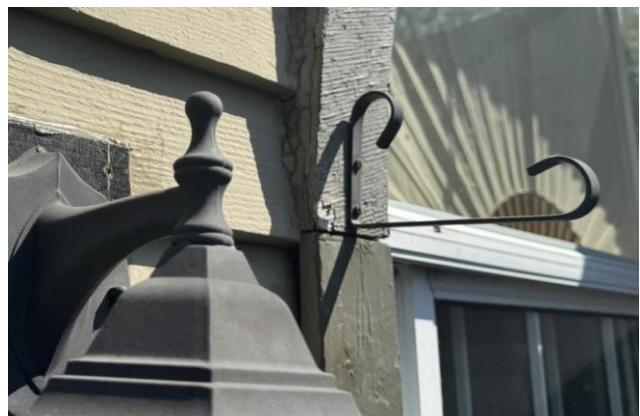
Photos 1.13 through 1.18 document deficiencies observed at the window trim levels. The most common issues include missing or deteriorated sealant, as well as areas where the window trims have rotted. Sealant failures are particularly concerning because they compromise the building envelope's ability to resist water intrusion. Missing or damaged sealant leaves gaps around the trim, which allow moisture to penetrate behind the assemblies, leading to further deterioration of both the wood components and the surrounding stucco. The presence of rotten trims indicates that moisture ingress has already occurred, causing the wood to decay and lose structural integrity. If left unrepaired, this condition can expand to adjacent materials and accelerate the degradation of finishes around the windows.

Photo 1.13: Rotten window trim

Photo 1.14: Rotten window trim

Photo 1.15: Rotten window trim

Photo 1.16: Rotten window trim

Photo 1.17: Rotten window trim

Photo 1.18: Rotten window trim

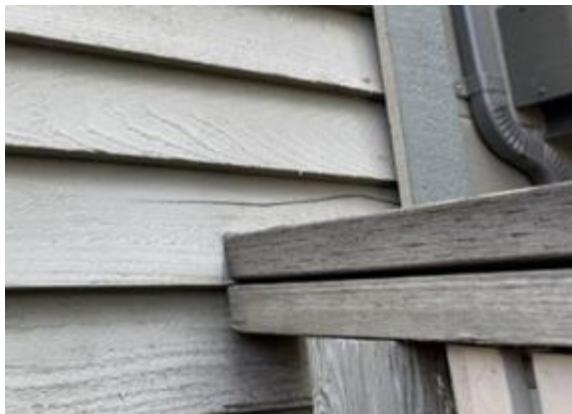
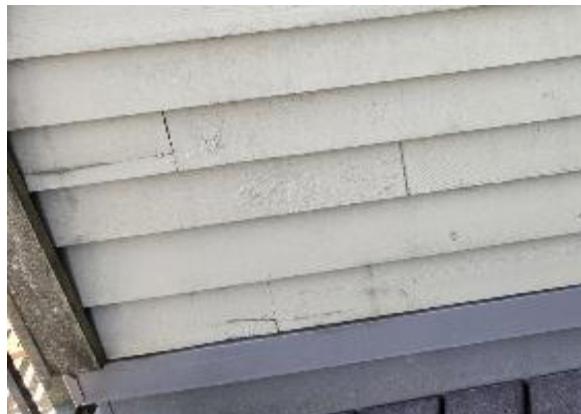
Photos 1.21 and 1.22 show examples of damaged wood siding with visible cracks. Cracks in wood siding often develop due to prolonged weather exposure, thermal expansion and contraction, or insufficient maintenance of protective coatings such as paint or stain. These cracks create direct pathways for water to infiltrate the siding, which can result in swelling, further splitting, and eventual rot of the boards. Damaged siding not only affects the aesthetics of the exterior but also compromises the protective function of the cladding system, increasing the risk of damage to the underlying building structure.

Photo 1.21: Cracked wood siding

Photo 1.22: Cracked wood siding

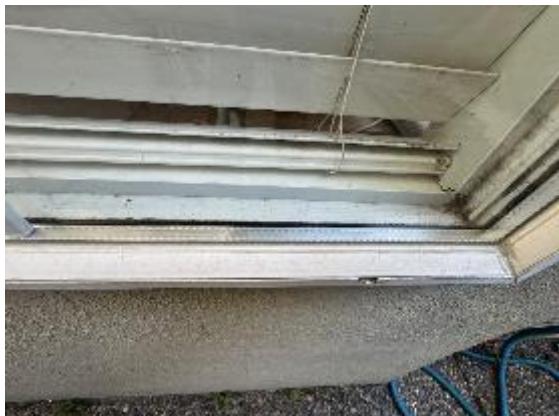
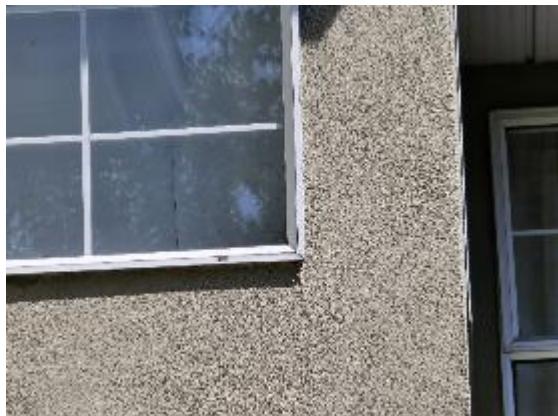
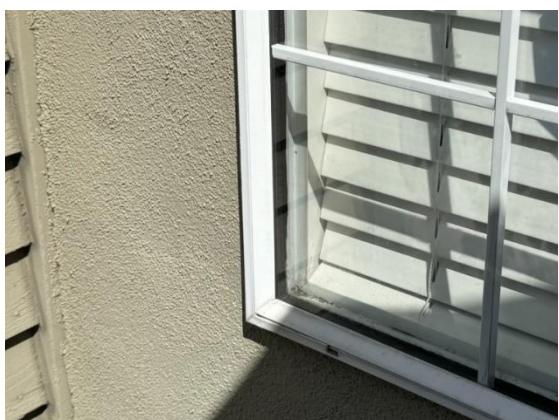
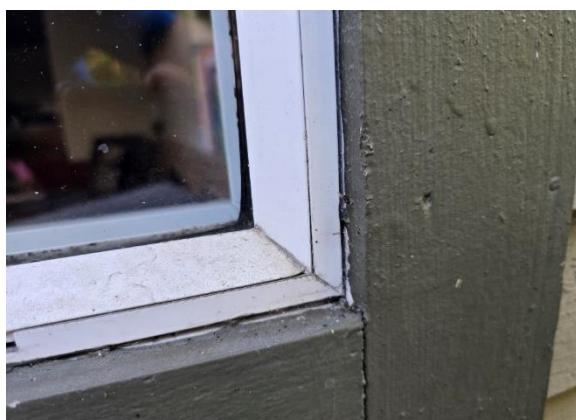
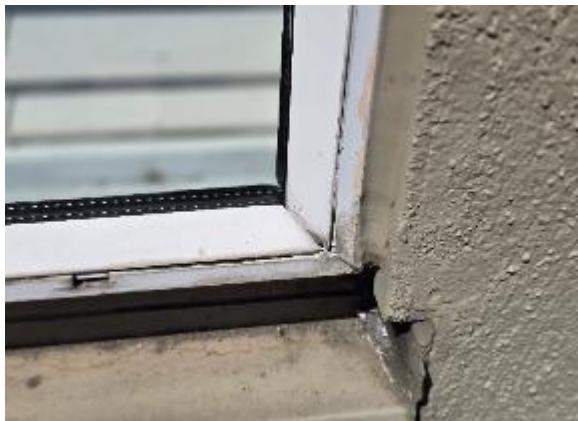
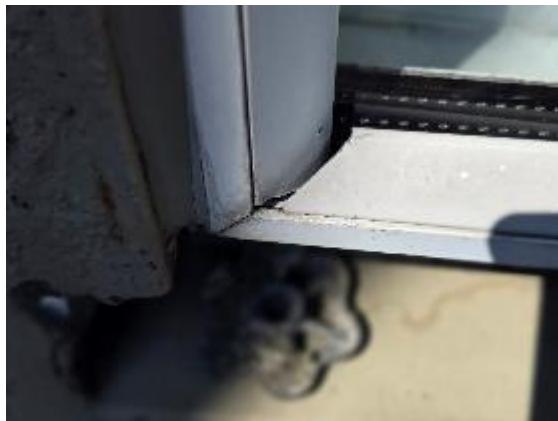
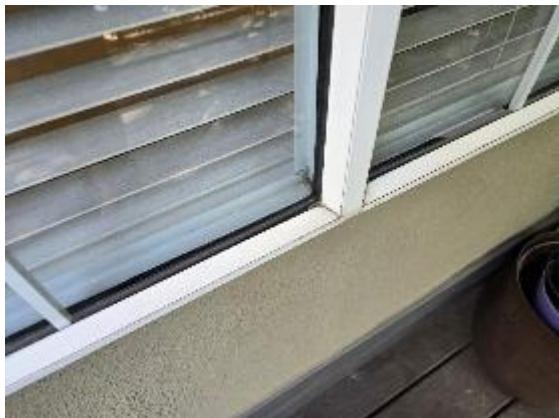
Photos 2.1 through 2.7 illustrate representative examples of the window assemblies. Overall, the windows appear to be in fair condition considering their age, and most units seem to be functioning as intended in terms of operation and basic performance. However, closer inspection reveals that the miters at the window frame corners are open. Open miters are often indicative of aging materials, sealant shrinkage, or movement within the frame over time. This condition can create small gaps that allow moisture infiltration, air leakage, or loss of energy efficiency if not addressed.

Although the current condition does not suggest widespread failure, the open miters highlight the gradual wear of the assemblies. Over time, these deficiencies could worsen, leading to water intrusion around the frames, deterioration of adjacent trims, and potential damage to the surrounding finishes.

Photo 2.1: Window frame miter not sealed

Photo 2.2: Window frame miter not sealed

Photo 2.3: Window frame miter not sealed

Photo 2.4: Window frame miter not sealed

Photo 2.5: Window frame miter not sealed

Photo 2.6: Window frame miter not sealed

Photo 2.7: Window frame miter not sealed

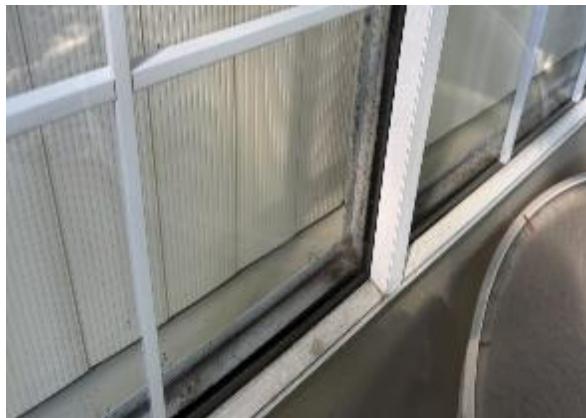
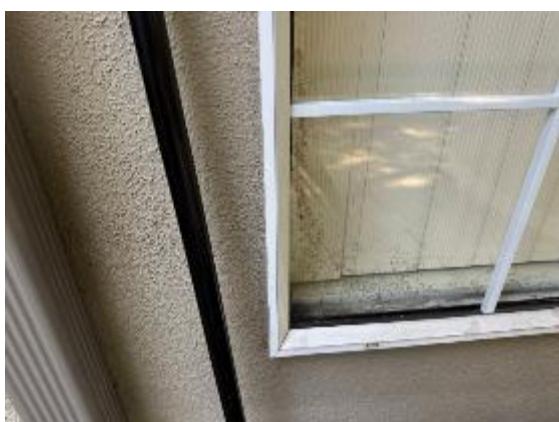
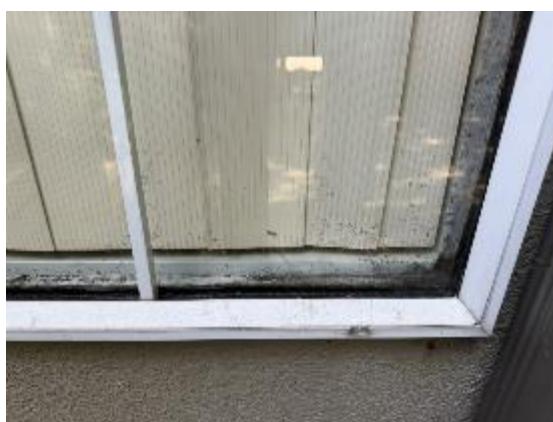
Photos 2.8 and 2.9 show the presence of mold growth at the window level. The mold appears to be concentrated around areas where moisture intrusion is likely occurring, such as along the frame edges and adjoining finishes. This condition suggests that water is entering the assembly either through failed sealant joints, condensation buildup due to inadequate insulation or ventilation, or minor leaks at the interface between the window and surrounding wall system.

The presence of mold is a clear indicator of prolonged moisture exposure. If left unaddressed, mold growth can deteriorate surrounding building materials, including wood trims, drywall, and sealants, while also contributing to poor indoor air quality. Over time, the structural integrity of the window assembly and adjacent finishes may be compromised, requiring more extensive repair or replacement.

Photo 2.8: Mold at window level

Photo 2.9: Mold at window level

Photo 2.10: Mold at window level

To mitigate this issue, it will be necessary to identify and eliminate the source of moisture, thoroughly clean and treat the affected areas, and repair or replace any damaged materials. Ensuring proper sealing at the window perimeter and improving ventilation in the affected spaces will be essential steps to prevent future recurrence.

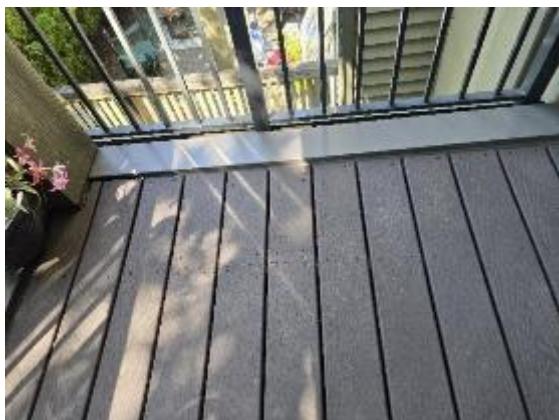
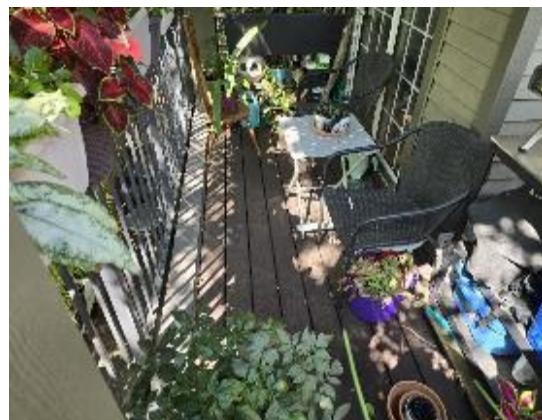
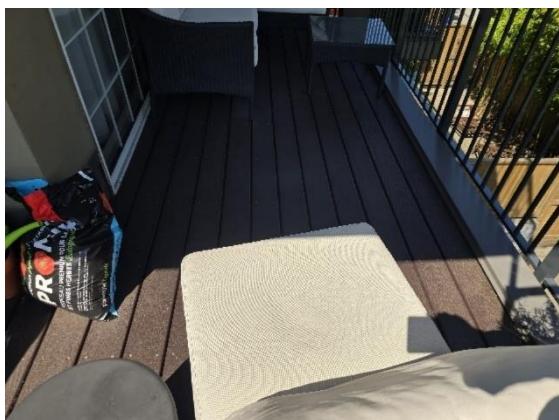
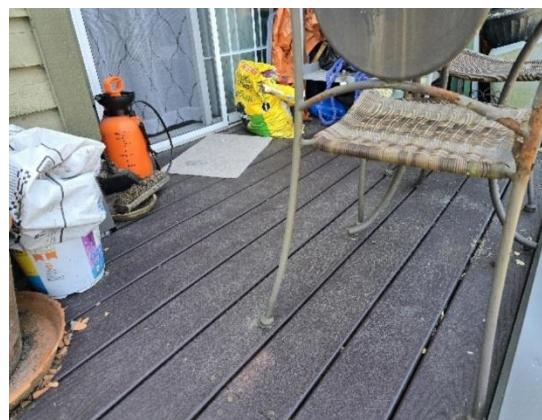
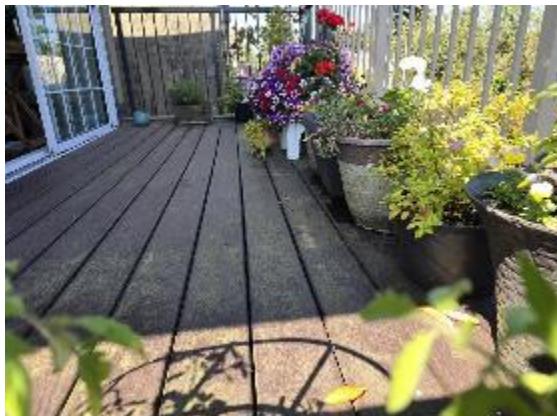
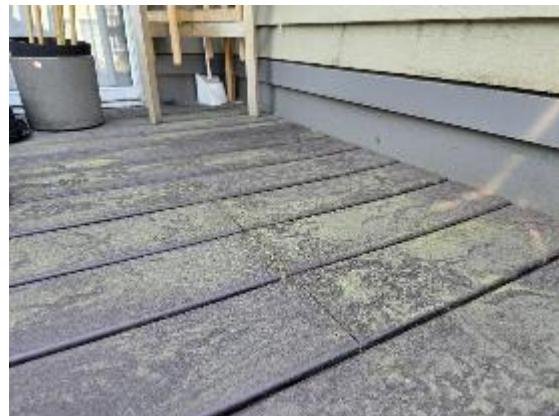
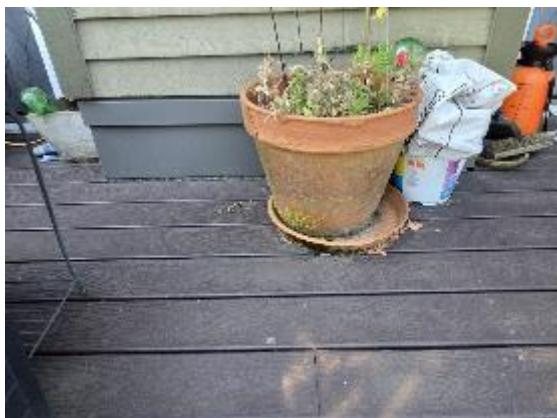
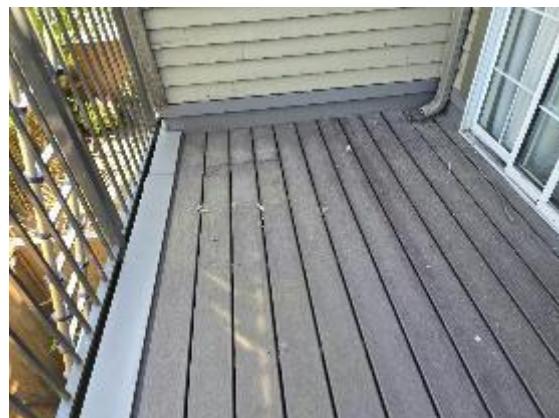
Photos 3.1 through 3.8 provide typical views of the balconies with the composite decking installed, illustrating the uniform appearance and consistent installation of the surface covering. Photos 3.9 and 3.10 shows a section of the SBS membrane captured through a gap in the composite decking, offering a rare view of the underlying waterproofing layer.

Photo 3.1: Overview of the balcony

Photo 3.2: Overview of the balcony

Photo 3.3: Overview of the balcony

Photo 3.4: Overview of the balcony

Photo 3.5: Overview of the balcony

Photo 3.6: Overview of the balcony

Photo 3.7: Overview of the balcony.

Photo 3.8: Overview of the balcony.

While the visible portion of the membrane appears serviceable, the limited access makes it difficult to fully assess potential concealed issues such as trapped moisture, punctures, or localized deterioration. To confirm the overall condition, a more intrusive inspection—such as temporarily lifting sections of the decking—would be recommended if concerns about water infiltration arise. Regular monitoring of drainage performance and surface conditions will also be important to ensure long-term durability of the balcony assemblies.

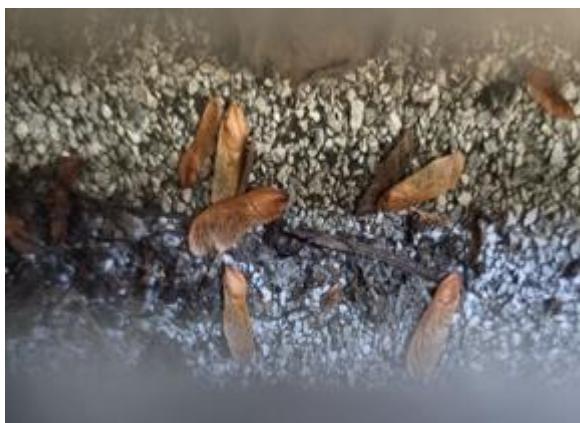
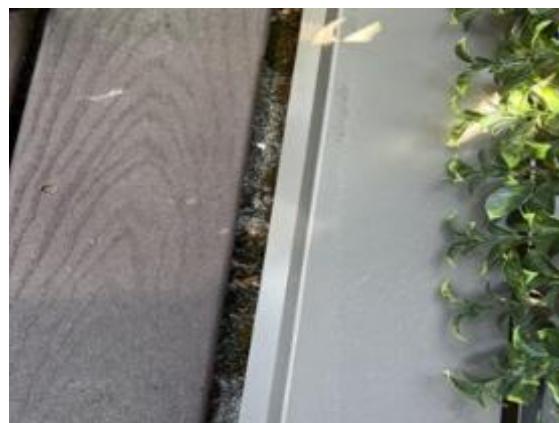
Access to the membrane was significantly restricted due to the installation of the composite decking, which covers most of the waterproofed surface. As a result, only partial observations could be made, limiting the ability to perform a full evaluation of the system's current performance. Where visible, the membrane did not show evidence of significant deterioration, suggesting that it continues to function as intended.

Photo 3.9: Overview of the SBS torch-on from the balcony

Photo 3.10: Overview of the SBS torch-on from the balcony

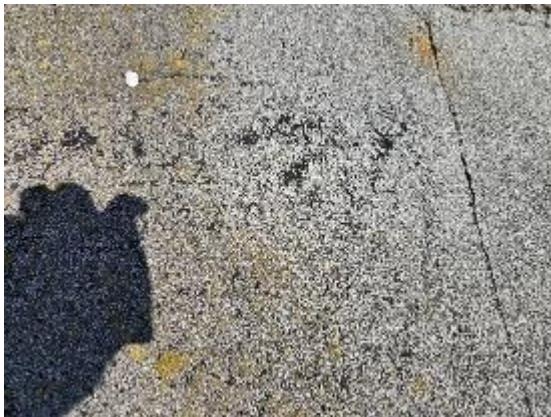
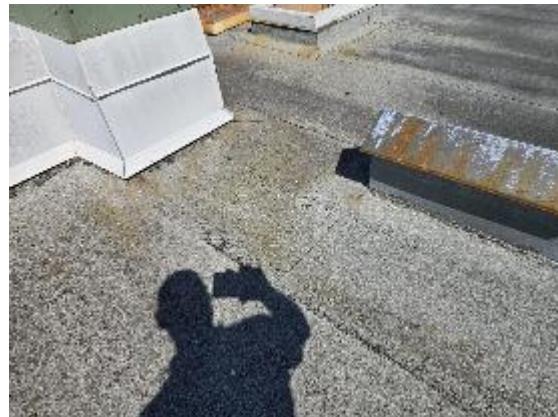
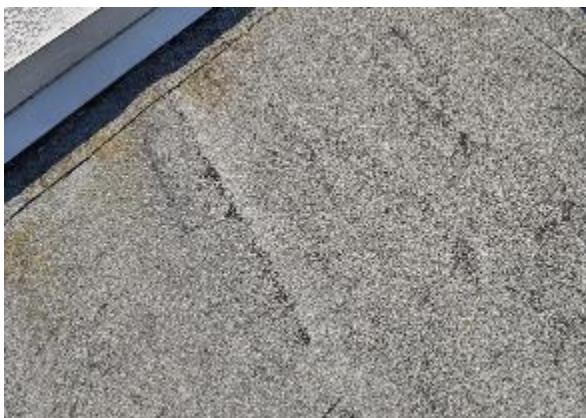
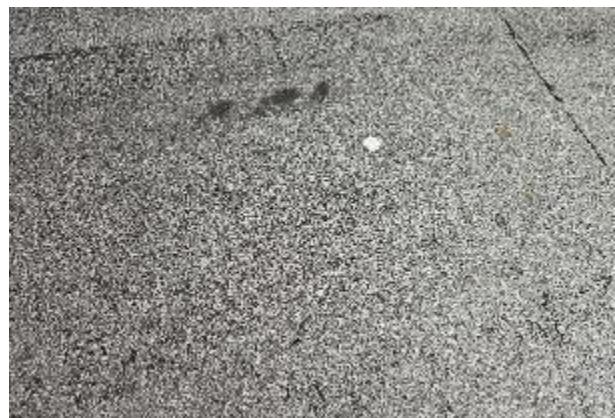
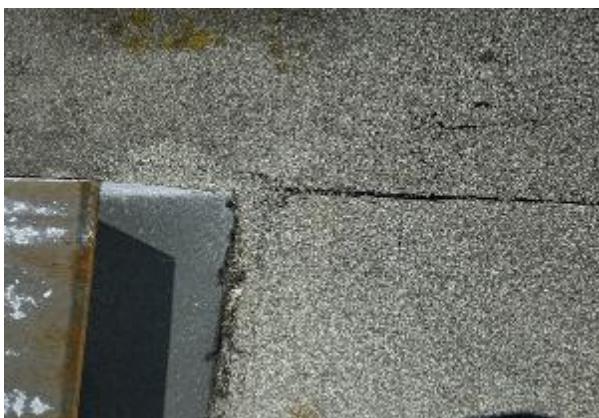
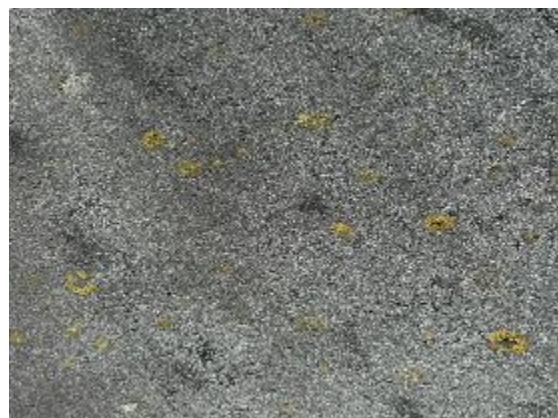
for this type of roofing system is generally between 25 and 30 years under normal conditions. As membranes age, they typically show signs of surface wear, loss of flexibility, and increased vulnerability to cracking or splitting, all of which reduce their ability to function as an effective waterproofing barrier. Based on the observed condition, the flat roof appears to be nearing the end of its functional lifespan, with an estimated 2 to 3 years remaining.

Photo 4.1: View of flat roof membrane

Photo 4.2: . View of flat roof membrane

Photo 4.3: View of flat roof membrane.

Photo 4.4: View of flat roof membrane.

Photo 4.5: View of flat roof membrane

Photo 4.6: View of flat roof membrane

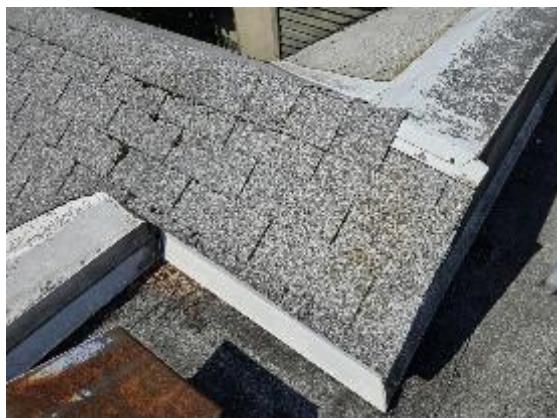
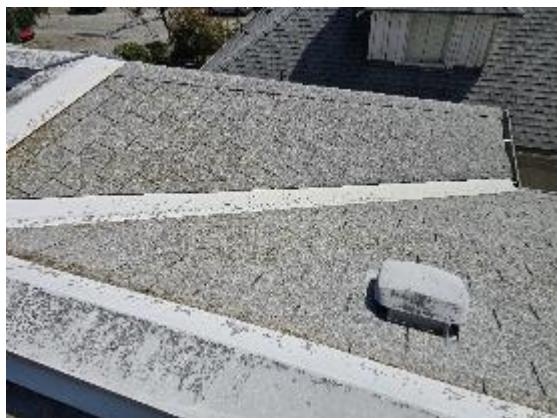
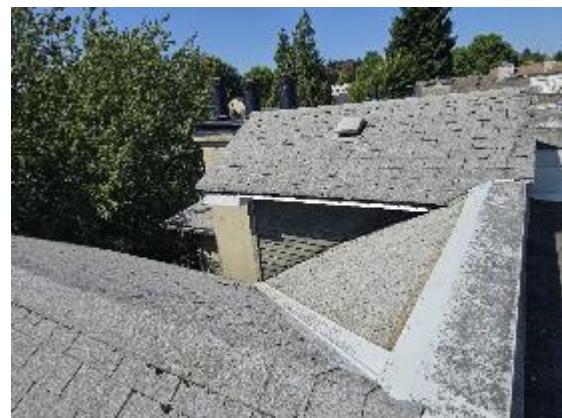
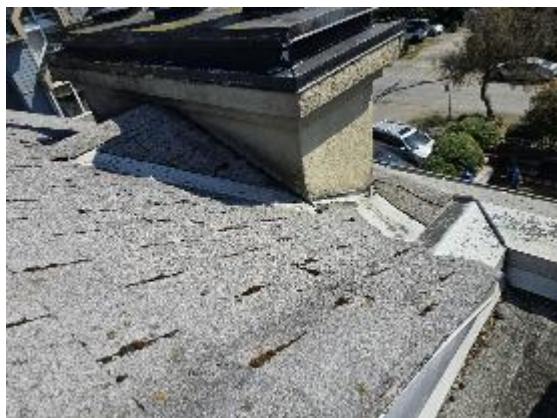
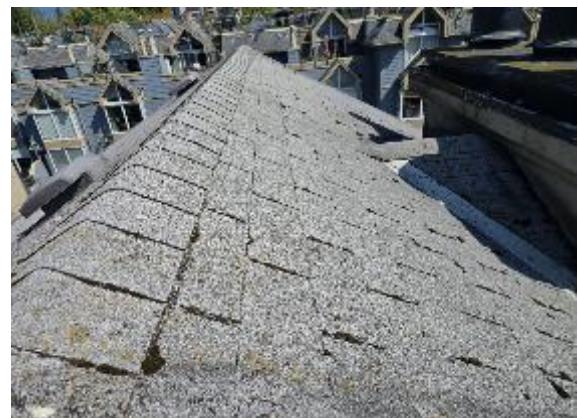
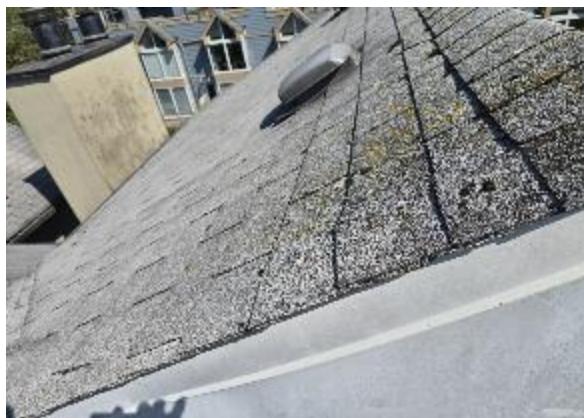
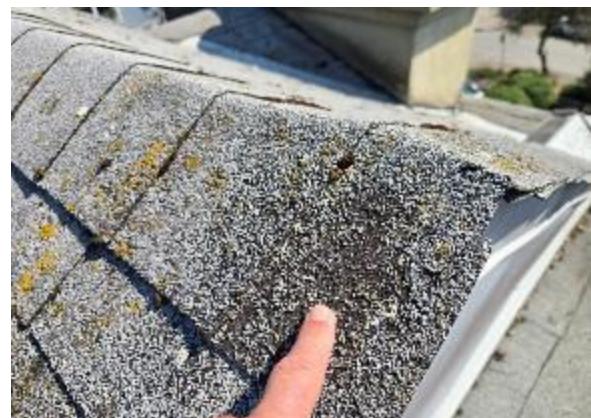
No	Observation/Comment and Photos
4.	<p><u>Description:</u> The roof is composed of two distinct sections: a flat roof with an SBS torch-on membrane system and a pitched roof finished with asphalt shingles.</p> <p>Photos 4.1 through 4.10 document the condition of the flat roof. The SBS torch-on membrane, which was installed as the waterproofing layer, shows visible signs of deterioration. Common issues observed with aging SBS membranes include surface cracking, blistering, and loss of granule protection, all of which can compromise the system's ability to shed water effectively. These deficiencies increase the risk of leaks, moisture ingress into the roof assembly, and potential damage to underlying structural components if not addressed in a timely manner.</p> <p>The typical life expectancy for this type of membrane roofing is approximately 25 to 30 years under normal maintenance conditions. As the membrane approaches or exceeds this service life, it is expected that wear and deterioration will become more apparent. Environmental factors such as UV exposure, temperature fluctuations, ponding water, and limited upkeep can accelerate the rate of decline.</p> <p>Based on the observed condition, the flat roof appears to be approaching the latter stages of its functional lifespan, with an estimated 2 to 3 years remaining. Proactive measures such as localized repairs may provide temporary protection, but long-term planning for full replacement of the membrane system should be considered to maintain the integrity of the building envelope and prevent costly water damage. Regular inspections and maintenance will also be essential until replacement can be scheduled.</p> <p>Photos 4.7 through 4.13 show the pitched roof sections finished with asphalt shingles. The overall condition of the shingles appears to be poor, with several deficiencies clearly visible.</p> <p>Moss and algae growth are evident across multiple areas of the roof surface. The presence of moss indicates prolonged moisture retention, which can accelerate the deterioration of shingles by lifting their edges, preventing proper water shedding, and creating pathways for water infiltration. Algae staining, while more cosmetic in nature, also indicates moisture-related concerns and can contribute to surface degradation over time.</p>

In addition, widespread degranulation of the shingles is visible. Granule loss is a common sign of aging in asphalt shingles, as the protective surface layer wears away due to prolonged UV exposure, weathering, and natural aging. Without sufficient granule coverage, shingles become more susceptible to cracking, curling, and further deterioration, all of which reduce their ability to effectively protect the building against water ingress.

Photo 4.7: Overview of the roof with asphalt shingles

Photo 4.8: Overview of the roof with asphalt shingles

Photo 4.9: Overview of the roof with asphalt shingles

Photo 4.10: Overview of the roof with asphalt shingles

Photo 4.11: Overview of the roof with asphalt shingles

Photo 4.12: Overview of the roof with asphalt shingles

Photo 4.13: Overview of the roof with asphalt shingles

Photo 4.14: View of the roof where the degranulation is visible

The combined presence of moss, algae, and significant degranulation indicates that the roof has reached an advanced stage of wear. While targeted cleaning or maintenance may provide temporary improvement in appearance and performance, the extent of deterioration suggests that the roof is nearing the end of its service life. Planning for a full replacement of the asphalt shingle system should be considered to restore the integrity of the roof and ensure long-term protection of the building. Regular maintenance in the interim, including removal of moss and debris, will help limit further accelerated damage.

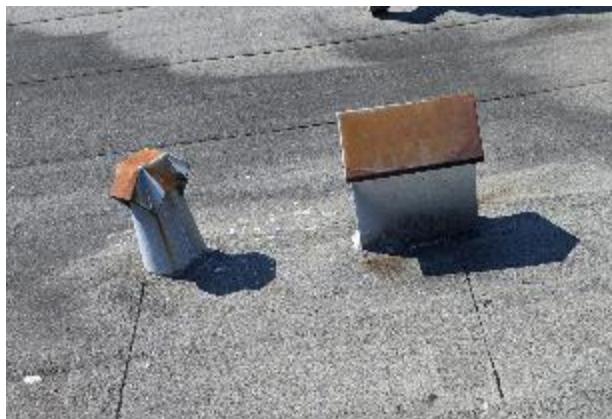
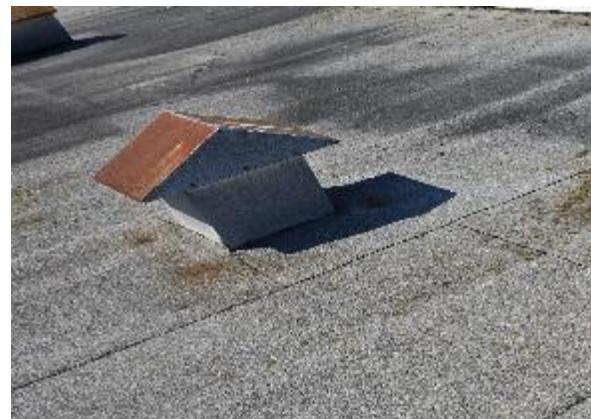
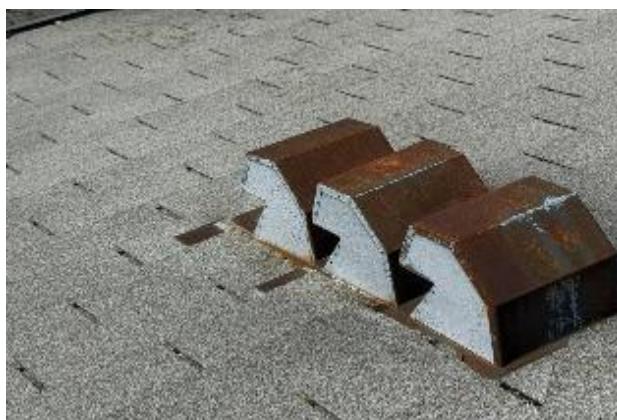
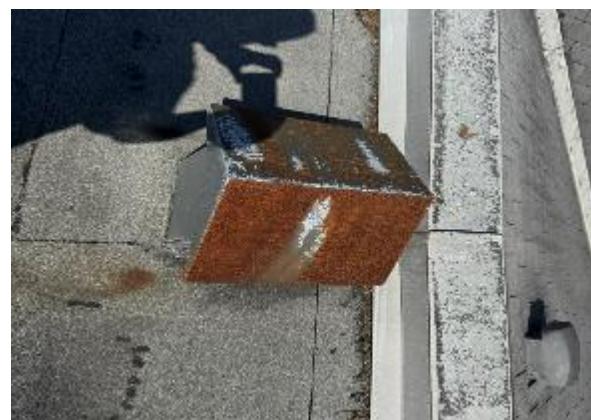
Photos 4.15 through 4.18 show the condition of the metal vents located on the roof. The vent caps are exhibiting visible signs of corrosion, which is likely the result of prolonged exposure to moisture, temperature fluctuations, and UV degradation over time. Corrosion on metal components not only affects the appearance of the vents but can also compromise their durability and weather resistance.

If left untreated, corrosion may continue to progress, eventually weakening the metal and reducing the effectiveness of the vent caps in preventing water ingress. This can also lead to staining on surrounding roof surfaces and potential damage to the underlying roof assembly.

Photo 4.15: Vent caps at the roof elevation

Photo 4.16: Vent caps at the roof elevation

Photo 4.17: Vent caps at the roof elevation

Photo 4.18: Vent caps at the roof elevation

To address this issue, maintenance is recommended in the form of either repainting or replacing the vent caps. Repainting with a suitable rust-inhibiting primer and weather-resistant coating can extend the life of the existing vents if the corrosion is only superficial. However, if the caps are significantly deteriorated or structurally weakened, replacement with new corrosion-resistant units would provide a longer-term solution and improve the overall performance of the roof system.

Acting at this stage will help restore protection at the vent locations and prevent further deterioration of both the vents and the adjacent roofing materials.

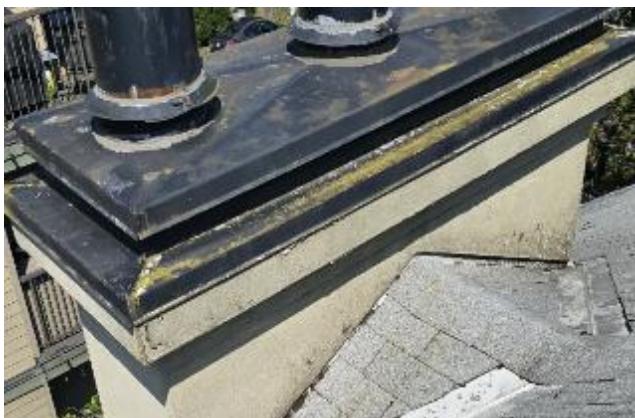
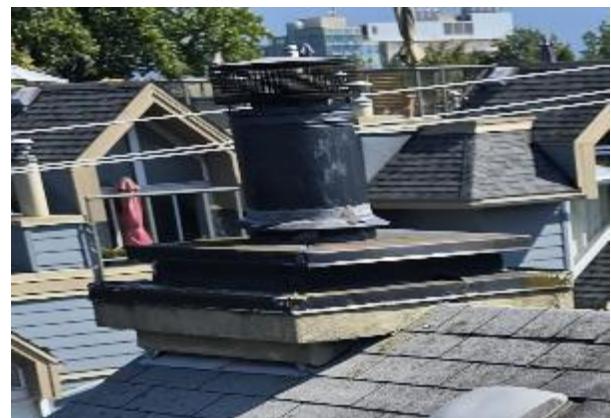
Photos 4.19 and 4.20 show the chimney caps and flue assemblies. The metal components in these areas are exhibiting visible corrosion, a condition commonly caused by continuous exposure to moisture, temperature fluctuations, and long-term weathering.

Corrosion on chimney caps and flue elements is a concern because these components play an essential role in protecting the chimney system from water intrusion and ensuring proper ventilation. As the metal continues to deteriorate, the caps may lose structural integrity, allowing rainwater or debris to enter the flue. This can lead to additional damage, including interior moisture penetration, staining on surrounding finishes, and reduced performance of the chimney system as a whole.

Photo 4.19: Overview of the corroded chimney caps and flue

Photo 4.20: Overview of the corroded chimney caps and flue

If corrosion is still at a superficial stage, maintenance through cleaning and application of a rust-inhibiting primer and protective coating may extend the service life of the metal. However, if the corrosion has progressed to the point of pitting, thinning, or structural weakness, replacement of the affected components will be necessary to restore proper functionality and protection.

Given the critical role of chimney caps and flue assemblies in maintaining the building envelope, timely remediation is strongly recommended to prevent further deterioration and to ensure ongoing weather resistance and safe operation.

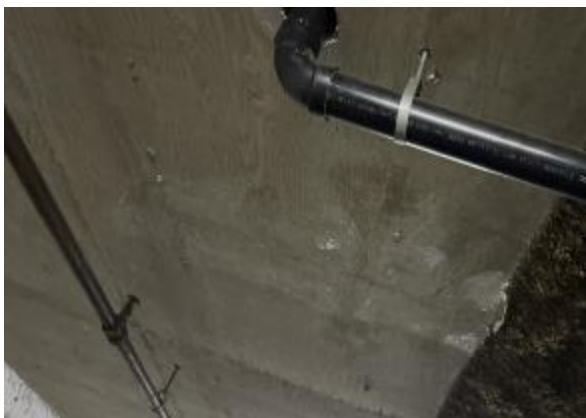
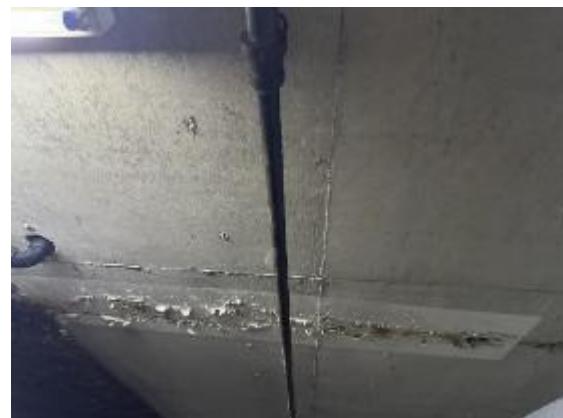
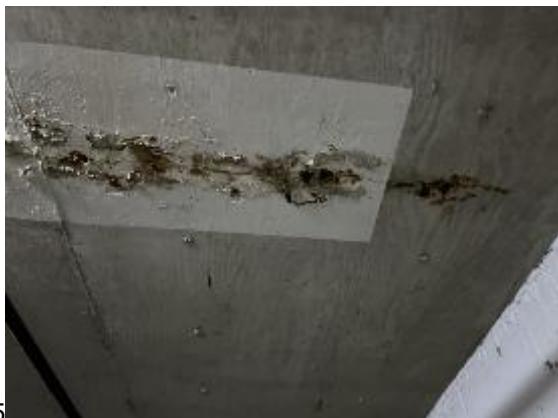
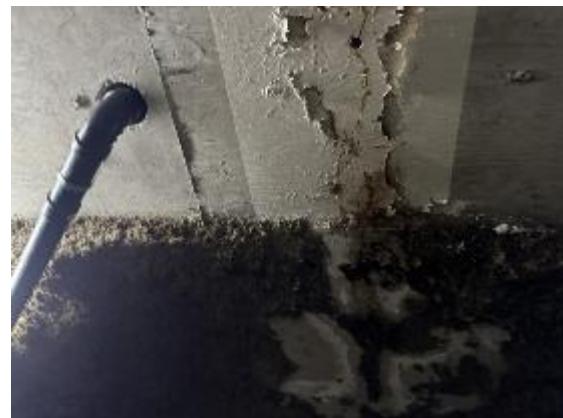
No	Observation/Comment and Photos
5.	<p><u>Description:</u> The photos below illustrate typical deficiencies observed within the parkade. Two primary concerns were noted during the review: evidence of water ingress at the ceiling level and cracking of the concrete at the access ramp.</p> <p>Photos 5.1 through 5.4 show areas where water ingress is present at the parkade ceiling. Moisture staining and efflorescence are visible, indicating that water has been penetrating through the slab above over a prolonged period. Such conditions can lead to progressive deterioration of the concrete and reinforcement, including spalling and corrosion of embedded steel, if not addressed. Persistent water infiltration also poses ongoing maintenance challenges and can reduce the overall durability of the parkade structure.</p> <p>Photos 5.5 and 5.6 highlight cracks observed at the access ramp. These cracks may be the result of heavy vehicular traffic, freeze-thaw cycles, or natural settlement of the structure over time. If not repaired, cracks can widen and allow additional water to infiltrate, accelerating deterioration and creating unsafe surface conditions for both vehicles and pedestrians.</p> <p>Overall, the deficiencies observed in the parkade point to active moisture-related issues and structural wear that should be addressed promptly. Recommended actions include investigating the source of water ingress, repairing, or resealing the affected areas, and applying appropriate crack-repair methods at the access ramp. Proactive maintenance will be essential to prevent further deterioration and ensure the long-term serviceability and safety of the parkade.</p>

Photo 5.1: Water ingress evidence

Photo 5.2: Water ingress evidence

Photo 5.3: Water ingress staining at parking

Photo 5.4: Water ingress

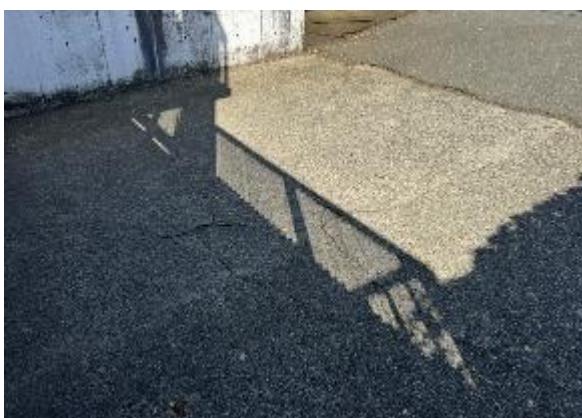
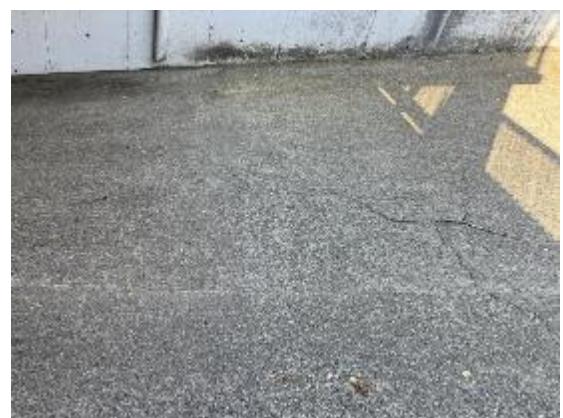
Photo 5.5: Typical cracks on the access ramp

Photo 5.6: Typical cracks on the access ramp
