DEPRECIATION REPORT

VR 2131—“The Emperor”

925 West 15th Avenue

July 19, 2023

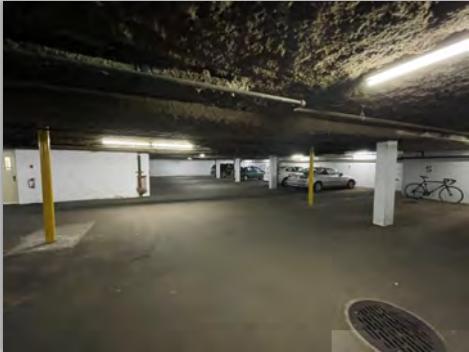
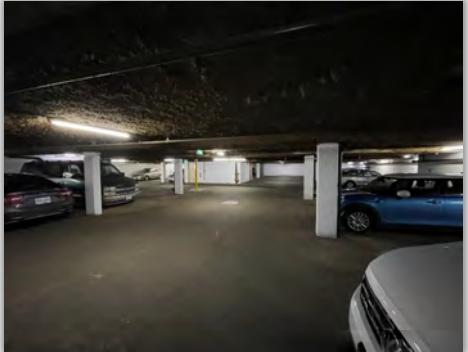
Component 1		Substructure and Underground Garage

Description		<p>This component accounts for major repairs to the below-grade portions of the property. This includes the foundation walls and parkade: the footings, basement floors, walls, parkade ceilings, columns, and courtyard membrane.</p>
	Quantity	1 Allowance
	Current Job Cost	\$58,685
Condition Analysis	<p>Based on a partial visual inspection, this component appears to be in average condition for its age. No major deficiencies were noted or reported at the time of inspection.</p>	
Reserve History	Year of Acquisition	1988
	Work Completed	Strata reports additional support columns were installed in 1999.
	Dollars Spent	\$77,000
Life Cycle Analysis	Expected Lifespan	50 years (Budget Provision)
	Effective Age	35 years
	Remaining Lifespan	15 years
Funding Analysis	Work	<p>Non-structural cracks can sometimes be injected with a sealant. We have budgeted for periodic structural stabilization work, spot replacement of damaged concrete, underdrain repairs, waterproofing, and membrane replacement. This includes excavation and compacted backfilling.</p>

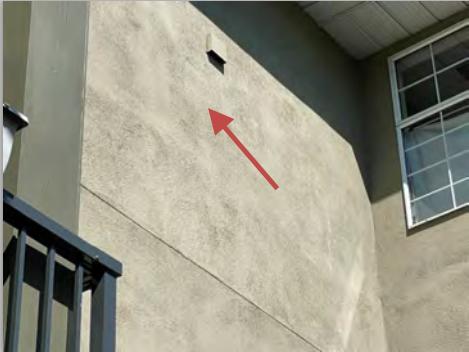
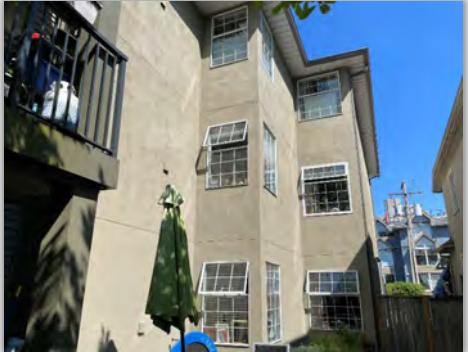
Description		<p>This component accounts for the stucco siding envelope system. This system includes the building frame, sheathing, building paper, insulation, and stucco siding.</p>
Condition Analysis		<p>Based on a partial visual inspection, this component appears to be in average condition for its age. No major deficiencies were noted or reported at the time of inspection.</p>
Reserve History		<p>Year of Acquisition 1988</p> <p>Work Completed The East side of the building was reclad in 1999 with a rainscreen solution.</p> <p>Dollars Spent N/A</p>
Life Cycle Analysis		<p>Expected Lifespan 40 years (Budget Provision)</p> <p>Effective Age 35 years</p> <p>Remaining Lifespan 5 years</p>
Funding Analysis		<p>Work Remove and dispose of all or damaged stucco. Repair damaged building frame and sheathing. Replace building paper and insulation as needed. Install new stucco system, work-site clean up, and any special safety preparation and precautions as required.</p> <p>Budget A budget equal to 50% of the estimated total cost is provided for significant expenditures every 40 years.</p>

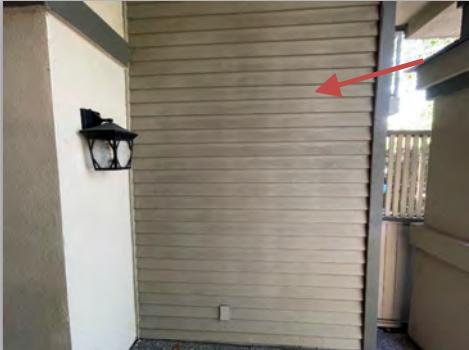
Description		<p>This component accounts for the composite siding system. This system includes the building frame, sheathing, building paper, insulation, and the composite siding.</p>						
Condition Analysis		<p>Based on a partial visual inspection, this component appears to be in average condition for its age. No major deficiencies were noted or reported at the time of inspection.</p>						
Reserve History		<table border="1"> <tr> <td>Year of Acquisition</td><td>1988</td></tr> <tr> <td>Work Completed</td><td>None noted or reported</td></tr> <tr> <td>Dollars Spent</td><td>N/A</td></tr> </table>	Year of Acquisition	1988	Work Completed	None noted or reported	Dollars Spent	N/A
Year of Acquisition	1988							
Work Completed	None noted or reported							
Dollars Spent	N/A							
Life Cycle Analysis		<table border="1"> <tr> <td>Expected Lifespan</td><td>50 years (Budget Provision)</td></tr> <tr> <td>Effective Age</td><td>35 years</td></tr> <tr> <td>Remaining Lifespan</td><td>15 years</td></tr> </table>	Expected Lifespan	50 years (Budget Provision)	Effective Age	35 years	Remaining Lifespan	15 years

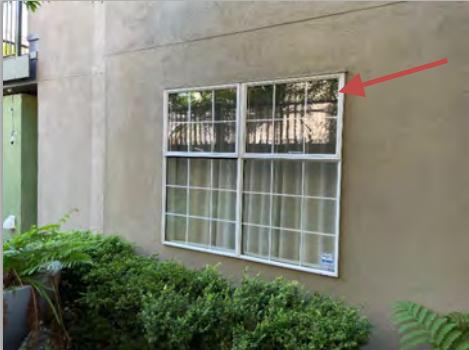
Description		<p>This component accounts for the exterior aluminum-frame windows. This includes the frame, hardware, casing, and aluminum windows.</p>
Condition Analysis		<p>Based on a partial visual inspection, this component appears to be in average condition for its age. No major deficiencies were noted or reported at the time of inspection.</p>
Reserve History		<p>Year of Acquisition 1988</p> <p>Work Completed A number of window flashings were replaced and repair in 2015/2016 and 2017.</p> <p>Dollars Spent N/A</p>
Life Cycle Analysis		<p>Expected Lifespan 35 years (Budget Provision)</p> <p>Effective Age 30 years</p> <p>Remaining Lifespan 5 years</p>
Funding Analysis		<p>Work Remove and dispose of damaged window assemblies, repairs to or replacement of the frame, casing, and hardware as required, and installation of new windows. Appropriate safety preparation and precautions as required.</p> <p>Budget A budget equal to 50% of the estimated total cost is provided for significant expenditures every 35 years.</p>

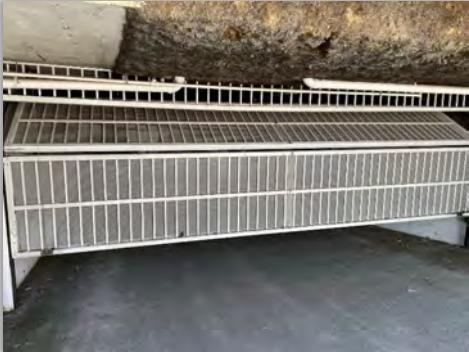
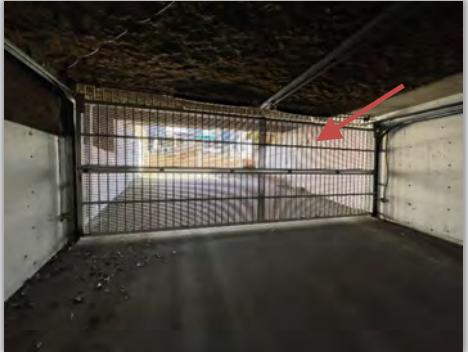
Description		<p>This component accounts for the parkade's entrance gate. This excludes the remote openers but includes the gate, operating mechanism, tracks, rollers, and associated hardware.</p>						
Condition Analysis		<p>Based on a partial visual inspection, this component appears to be in average condition for its age. No major deficiencies were noted or reported at the time of inspection.</p>						
Reserve History		<table border="1"> <tr> <td>Year of Acquisition</td><td>2016</td></tr> <tr> <td>Work Completed</td><td>None noted or reported</td></tr> <tr> <td>Dollars Spent</td><td>N/A</td></tr> </table>	Year of Acquisition	2016	Work Completed	None noted or reported	Dollars Spent	N/A
Year of Acquisition	2016							
Work Completed	None noted or reported							
Dollars Spent	N/A							
Life Cycle Analysis		<table border="1"> <tr> <td>Expected Lifespan</td><td>22 years</td></tr> <tr> <td>Effective Age</td><td>7 years</td></tr> <tr> <td>Remaining Lifespan</td><td>15 years</td></tr> </table>	Expected Lifespan	22 years	Effective Age	7 years	Remaining Lifespan	15 years

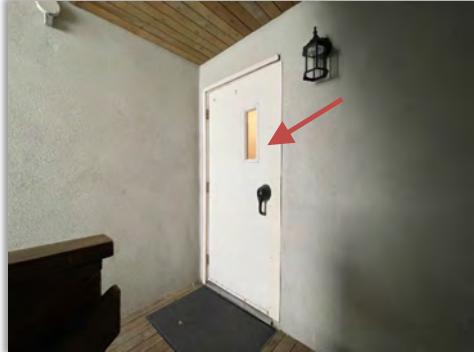
Description This component accounts for the common-element exterior metal doors. This includes the doors and all associated hardware.								
Quantity 1 Allowance								
Current Job Cost \$2,735								
Condition Analysis Based on a partial visual inspection, this component appears to be in average condition for its age. No major deficiencies were noted or reported at the time of inspection.								
Reserve History <table border="1"> <tr> <td>Year of Acquisition</td><td>1988</td></tr> <tr> <td>Work Completed</td><td>None noted or reported</td></tr> <tr> <td>Dollars Spent</td><td>N/A</td></tr> </table>		Year of Acquisition	1988	Work Completed	None noted or reported	Dollars Spent	N/A	
Year of Acquisition	1988							
Work Completed	None noted or reported							
Dollars Spent	N/A							
Life Cycle Analysis <table border="1"> <tr> <td>Expected Lifespan</td><td>40 years (Budget Provision)</td></tr> <tr> <td>Effective Age</td><td>25 years</td></tr> <tr> <td>Remaining Lifespan</td><td>15 years</td></tr> </table>		Expected Lifespan	40 years (Budget Provision)	Effective Age	25 years	Remaining Lifespan	15 years

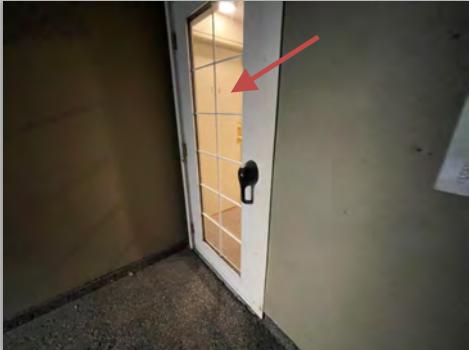
Description		<p>This component accounts for the common-element exterior metal-and-glass doors. This includes the doors, glass lites, frames, and all associated hardware.</p>			
	Quantity	1 Allowance			
	Current Job Cost	\$3,191			
Condition Analysis		<p>Based on a partial visual inspection, this component appears to be in average condition for its age. No major deficiencies were noted or reported at the time of inspection.</p>			
Reserve History	Year of Acquisition	1988			
	Work Completed	None noted or reported			
	Dollars Spent	N/A			
Life Cycle Analysis	Expected Lifespan	30 years			
	Effective Age	25 years			
	Remaining Lifespan	5 years			
Funding Analysis	Work	<p>Remove and replace damaged door system components as required or desired.</p>			
	Budget	<p>We have allowed for a full replacement of this component every 30 years.</p>

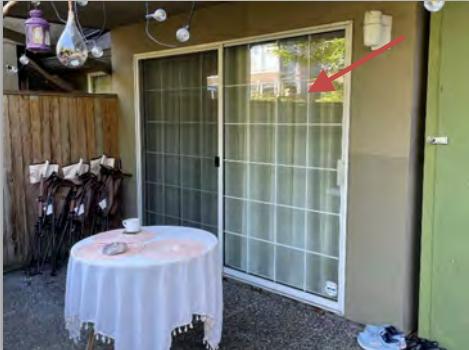
Description		<p>This component accounts for the common-element sliding glass doors. This includes the doors, glass, and all associated hardware. Each sliding door system is counted as one opening for the purposes of this report.</p>						
Condition Analysis		<p>Based on a partial visual inspection, this component appears to be in average condition for its age. No major deficiencies were noted or reported at the time of inspection.</p>						
Reserve History		<table border="1"> <tr> <td>Year of Acquisition</td><td>1988</td></tr> <tr> <td>Work Completed</td><td>None noted or reported</td></tr> <tr> <td>Dollars Spent</td><td>N/A</td></tr> </table>	Year of Acquisition	1988	Work Completed	None noted or reported	Dollars Spent	N/A
Year of Acquisition	1988							
Work Completed	None noted or reported							
Dollars Spent	N/A							
Life Cycle Analysis		<table border="1"> <tr> <td>Expected Lifespan</td><td>30 years</td></tr> <tr> <td>Effective Age</td><td>25 years</td></tr> <tr> <td>Remaining Lifespan</td><td>5 years</td></tr> </table>	Expected Lifespan	30 years	Effective Age	25 years	Remaining Lifespan	5 years

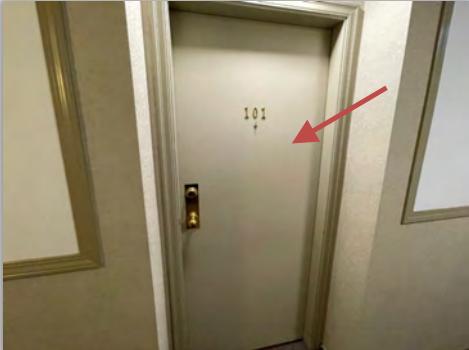
Description		<p>This component accounts for the common-element interior wooden doors. This includes the doors, frames, and all associated hardware.</p>
	Quantity	1 Allowance
	Current Job Cost	\$5,164
Condition Analysis	<p>Based on a partial visual inspection, this component appears to be in average condition for its age. No major deficiencies were noted or reported at the time of inspection.</p>	
Reserve History	Year of Acquisition	1988
	Work Completed	None noted or reported
	Dollars Spent	N/A
Life Cycle Analysis	Expected Lifespan	35 years (Budget Provision)
	Effective Age	25 years
	Remaining Lifespan	10 years
Funding Analysis	Work	Remove and replace damaged door system components as required or desired.
	Budget	A budget equal to 25% of the estimated total cost is provided for significant expenditures every 35 years.
Potential Deterioration	<p>Includes impact damage, misalignment, failure to latch, and aesthetic degradation. Contributing factors include wear-and-tear, physical damage, excessive force, and subsurface shifting.</p>

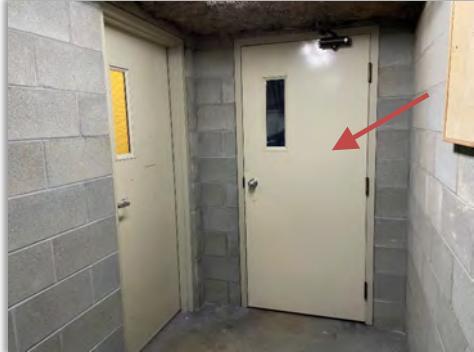
Description		<p>This component accounts for the common-element interior metal doors. This includes the doors, frames, and all associated hardware.</p>
Quantity		1 Allowance
Current Job Cost		\$1,849
Condition Analysis	<p>Based on a partial visual inspection, this component appears to be in average condition for its age. No major deficiencies were noted or reported at the time of inspection.</p>	
Reserve History	Year of Acquisition	1988
	Work Completed	None noted or reported
	Dollars Spent	N/A
Life Cycle Analysis	Expected Lifespan	40 years (Budget Provision)
	Effective Age	25 years
	Remaining Lifespan	15 years
Funding Analysis	Work	Remove and replace damaged door system components as required or desired.
	Budget	A budget equal to 25% of the estimated total cost is provided for significant expenditures every 40 years.
Potential Deterioration	<p>Includes impact damage, misalignment, failure to latch, and aesthetic degradation. Contributing factors include wear-and-tear, physical damage, excessive force, and subsurface shifting.</p>

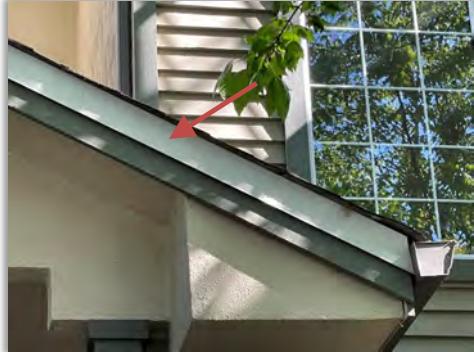
Description	<p>This component accounts for the common-element wooden fascia board and trim.</p> <table border="1"> <tr> <td>Quantity</td><td>1 Allowance</td></tr> <tr> <td>Current Job Cost</td><td>\$14,618</td></tr> </table>		Quantity	1 Allowance	Current Job Cost	\$14,618
Quantity	1 Allowance					
Current Job Cost	\$14,618					
Condition Analysis	<p>Based on a partial visual inspection, this component appears to be in average condition for its age. No major deficiencies were noted or reported at the time of inspection.</p>					
Reserve History	Year of Acquisition	1988				
	Work Completed	None noted or reported				
	Dollars Spent	N/A				
Life Cycle Analysis	Expected Lifespan	25 years (Budget Provision)				
	Effective Age	20 years				
	Remaining Lifespan	5 years				
Funding Analysis	Work	Remove and replace damaged elements as required or desired. Appropriate safety preparation and precautions as required.				
	Budget	A budget equal to 50% of the estimated total cost is provided for significant expenditures every 25 years.				
Potential Deterioration	<p>Includes impact damage, water damage, and deterioration. Contributing factors include physical damage, insufficient paint and caulking, and environmental factors such as extreme temperature changes, rain, snow, wind, and sun exposure.</p>					
Suggested Maintenance	<p>Regular visual inspection. Clean, paint, and caulk as required.</p>

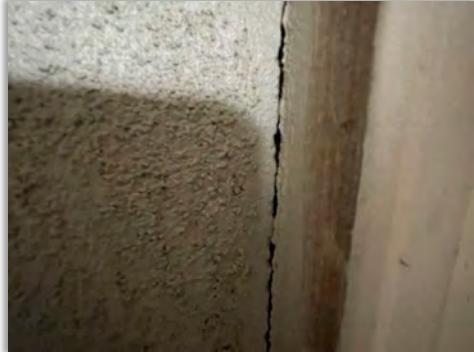
Description		<p>This component accounts for the common-element caulking found around the windows, exterior doors, and some trim.</p>
Condition Analysis	Quantity	1 Allowance
	Current Job Cost	\$6,928
Condition Analysis	<p>Based on a partial visual inspection, this component appears to be in average condition for its age. No major deficiencies were noted or reported at the time of inspection.</p>	
Reserve History	Year of Acquisition	2006
	Work Completed	Caulking undertaken as part of the remedial siding work in 2006.
	Dollars Spent	\$46,500 including painting
Life Cycle Analysis	Expected Lifespan	18 years (Budget Provision)
	Effective Age	17 years
	Remaining Lifespan	1 year
Funding Analysis	Work	Remove and replace failed caulking as required. Appropriate safety preparation and precautions as required.
	Budget	A budget equal to 50% of the estimated total cost is provided for significant expenditures every 18 years.

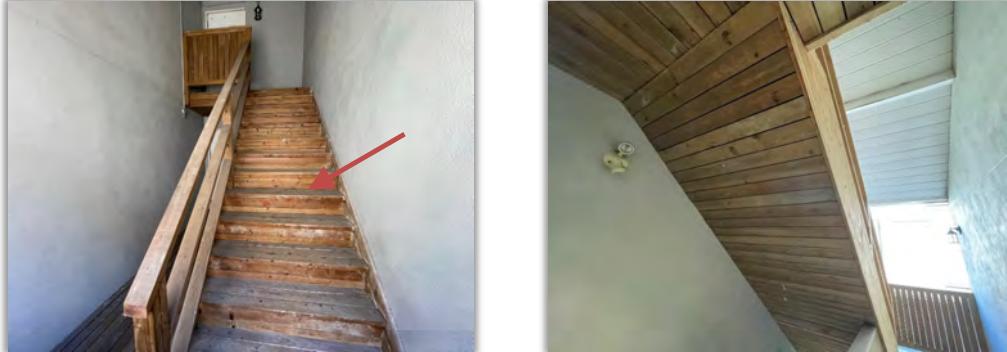
Description		<p>This component accounts for the exterior stair system. This includes the support posts, stringers, tread, landings, railing system, and associated hardware.</p>
Condition Analysis	Quantity	1 Allowance
	Current Job Cost	\$7,153
Condition Analysis	<p>Based on a partial visual inspection, this component appears to be in average condition for its age. No major deficiencies were noted or reported at the time of inspection.</p>	
Reserve History	Year of Acquisition	1988
	Work Completed	None noted or reported
	Dollars Spent	N/A
Life Cycle Analysis	Expected Lifespan	35 years (Budget Provision)
	Effective Age	10 years
	Remaining Lifespan	25 years
Funding Analysis	Work	Replace or repair damaged stair components as required.
	Budget	A budget equal to 40% of the estimated total cost is provided for significant expenditures every 35 years.
Potential Deterioration	<p>Includes impact damage, cracking, splitting, warping, water damage, infestation, and wear-and-tear. Contributing factors include physical damage, subsurface shifting, debris accumulation, and environmental factors such as extreme temperature changes, rain, snow, wind, and sun exposure.</p>

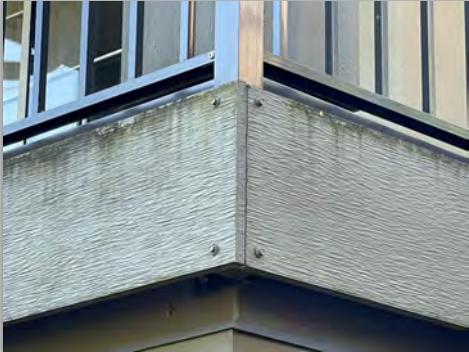
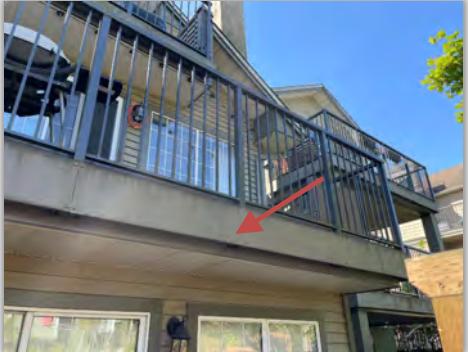
Description		<p>This component accounts for typical repairs to the common-element balcony structure. This includes repairs to the beams and girders, framing joists, beam-to-girder saddles, subfloor, and associated hardware.</p>
	Quantity	1 Allowance
	Current Job Cost	\$100,670
Condition Analysis	<p>Based on a partial visual inspection, this component appears to be in average condition for its age. No major deficiencies were noted or reported at the time of inspection.</p>	
Reserve History	Year of Acquisition	2015
	Work Completed	Council reports the balconies were remediated in 2015 at a cost of \$396,000.
	Dollars Spent	N/A
Life Cycle Analysis	Expected Lifespan	30 years
	Effective Age	8 years
	Remaining Lifespan	22 years
Funding Analysis	Work	Remove and replace failed structural elements as required. Appropriate safety preparation and precautions as required.

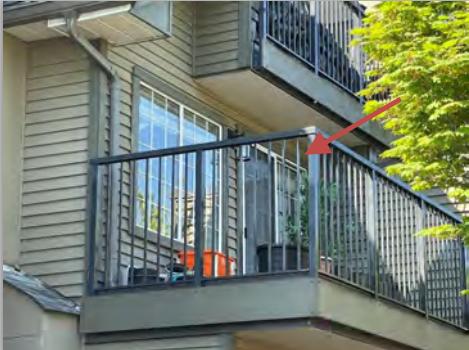
Description		<p>This component accounts for the common-element balcony railing systems, including all associated fasteners and hardware.</p>
Quantity		1 Allowance
Current Job Cost		\$33,800
Condition Analysis		<p>Based on a partial visual inspection, this component appears to be in average condition for its age. No major deficiencies were noted or reported at the time of inspection.</p>
Reserve History		<p>Year of Acquisition 2015</p> <p>Work Completed None noted or reported</p> <p>Dollars Spent N/A</p>
Life Cycle Analysis		<p>Expected Lifespan 35 years (Budget Provision)</p> <p>Effective Age 8 years</p> <p>Remaining Lifespan 27 years</p>
Funding Analysis		<p>Work Remove and replace failed balcony railings. Appropriate safety preparation and precautions as required.</p> <p>Budget A budget equal to 50% of the estimated total cost is provided for significant expenditures every 35 years.</p>

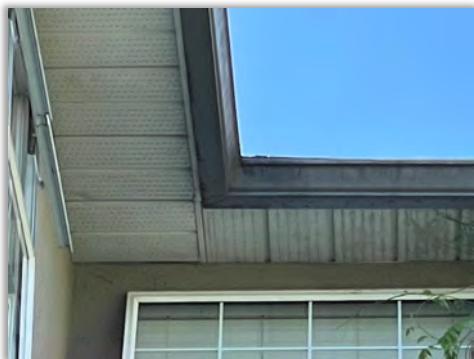
Description	This component accounts for the soffits, also known as the eaves.	
	Quantity	1 Allowance
	Current Job Cost	\$1,357
Condition Analysis	Based on a partial visual inspection, this component appears to be in average condition for its age. No major deficiencies were noted or reported at the time of inspection.	
Reserve History	Year of Acquisition	1988
	Work Completed	None noted or reported
	Dollars Spent	N/A
Life Cycle Analysis	Expected Lifespan	40 years (Budget Provision)
	Effective Age	20 years
	Remaining Lifespan	20 years
Funding Analysis	Work	Remove and replace damaged soffits. Appropriate safety preparation and precautions as required.
	Budget	A budget equal to 15% of the estimated total cost is provided for significant expenditures every 40 years.
Potential Deterioration	Includes impact damage, heat damage, water damage, fading, warping, and cracking. Contributing factors include physical damage and environmental factors such as extreme temperature changes, rain, snow, and wind exposure.

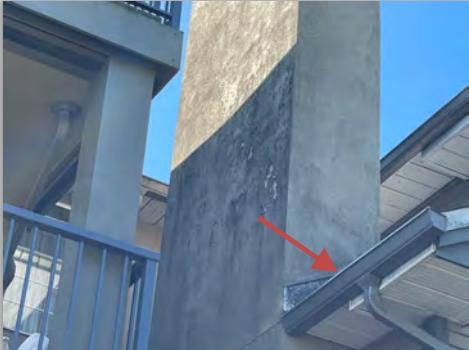
Description		This component accounts for the gutters (also referred to as "eavestroughs") and the downspouts.
	Quantity	1 Allowance
	Current Job Cost	\$7,609
Condition Analysis	Based on a partial visual inspection, this component appears to be in average condition for its age. No major deficiencies were noted or reported at the time of inspection.	
Reserve History	Year of Acquisition	1988
	Work Completed	None noted or reported
	Dollars Spent	N/A
Life Cycle Analysis	Expected Lifespan	35 years
	Effective Age	20 years
	Remaining Lifespan	15 years
Funding Analysis	Work	Remove and replace damaged gutters and downspouts as required. Appropriate safety preparation and precautions as required.
	Budget	We have allowed for a full replacement of this component every 35 years.
Potential Deterioration	Includes impact damage, seal failure, warping, and deterioration. Contributing factors include physical damage and environmental factors such as extreme temperature changes, rain, snow, wind, and sun exposure.

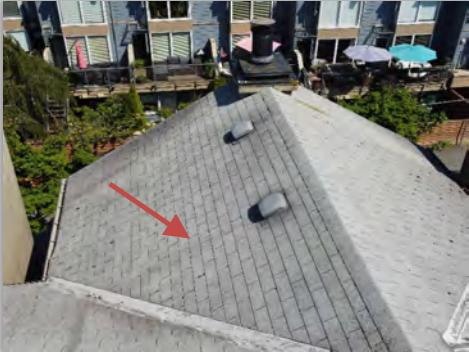
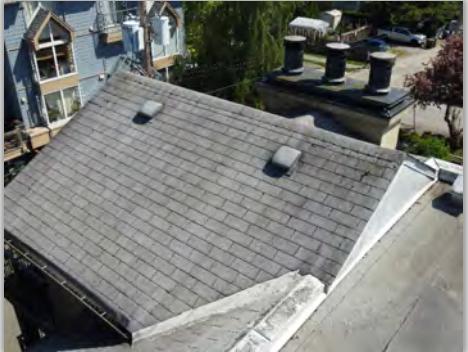
Description		<p>This component accounts for the asphalt/fiberglass shingle roofing system. This includes the shingles, underlayment, flashing, and an allowance for replacement of damaged sheathing and roof-openings such as vents.</p>			
Condition Analysis	Quantity	1 Allowance			
	Current Job Cost	\$106,681			
Condition Analysis	<p>Based on a partial visual inspection, this component appears to be in average condition for its age. No major deficiencies were noted or reported at the time of inspection.</p>				
Reserve History	Year of Acquisition	2002			
	Work Completed	None noted or reported			
	Dollars Spent	N/A			
Life Cycle Analysis	Expected Lifespan	22 years			
	Effective Age	21 years			
	Remaining Lifespan	1 year			
Funding Analysis	Work	<p>Remove and replace existing roofing assembly. Appropriate safety preparation and precautions as required.</p>

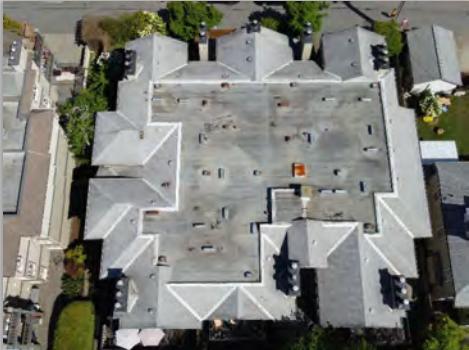
Description This component accounts for the two-ply membrane roofing system. This includes the membrane, insulation, flashing, and an allowance for replacement of roof-openings such as vents.									
Condition Analysis Based on a partial visual inspection, this component appears to be in average condition for its age. No major deficiencies were noted or reported at the time of inspection.									
Reserve History <table border="1"> <tr> <td>Year of Acquisition</td><td>1988</td></tr> <tr> <td>Work Completed</td><td>None noted or reported</td></tr> <tr> <td>Dollars Spent</td><td>N/A</td></tr> </table>		Year of Acquisition	1988	Work Completed	None noted or reported	Dollars Spent	N/A		
Year of Acquisition	1988								
Work Completed	None noted or reported								
Dollars Spent	N/A								
Life Cycle Analysis <table border="1"> <tr> <td>Expected Lifespan</td><td>22 years</td></tr> <tr> <td>Effective Age</td><td>20 years</td></tr> <tr> <td>Remaining Lifespan</td><td>2 years</td></tr> </table>		Expected Lifespan	22 years	Effective Age	20 years	Remaining Lifespan	2 years

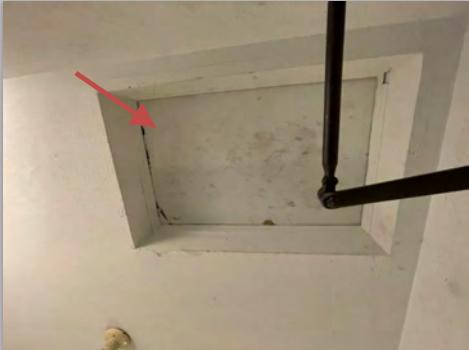
Description		This component accounts for the roof access hatch. This includes the cover, hatch, curb, and insulation.
	Quantity	1 Allowance
	Current Job Cost	\$2,960
Condition Analysis	Based on a partial visual inspection, this component appears to be in average condition for its age. No major deficiencies were noted or reported at the time of inspection.	
Reserve History	Year of Acquisition	1988
	Work Completed	None noted or reported
	Dollars Spent	N/A
Life Cycle Analysis	Expected Lifespan	35 years
	Effective Age	35 years
	Remaining Lifespan	0 years
Funding Analysis	Work	Remove and replace existing hatch assembly. Appropriate safety preparation and precautions as required.
	Budget	We have allowed for a full replacement of this component every 35 years.
Potential Deterioration	Includes impact damage, corrosion, seal/curb deterioration, hinge/spring deterioration, opening-mechanism failure, and water damage. Contributing factors include physical damage, wear-and-tear, and environmental factors such as extreme temperature changes, rain, snow, wind, and sun exposure.

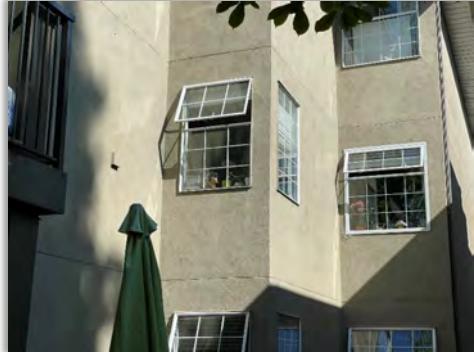
Description		<p>This component accounts for the exterior paint finish. No caulking is accounted for in this component.</p>
	Quantity	1 Allowance
	Current Job Cost	\$25,634
Condition Analysis	<p>Based on a visual inspection, this component appears to be in average condition for its age. No major deficiencies were noted or reported at the time of inspection.</p>	
Reserve History	Year of Acquisition	2006
	Work Completed	Painting undertaken as part of the remedial siding work in 2006.
	Dollars Spent	\$46,500 including caulking
Life Cycle Analysis	Expected Lifespan	18 years
	Effective Age	17 years
	Remaining Lifespan	1 year
Funding Analysis	Work	Surface preparation, painting, and clean-up.
	Budget	We have allowed for a full replacement of this component every 18 years.
Potential Deterioration	<p>Includes impact damage, fading, peeling, chipping, and water damage. Contributing factors include physical damage, debris accumulation, and environmental factors such as extreme temperature changes, rain, snow, wind, and sun exposure. Painting may also be done for aesthetic reasons.</p>

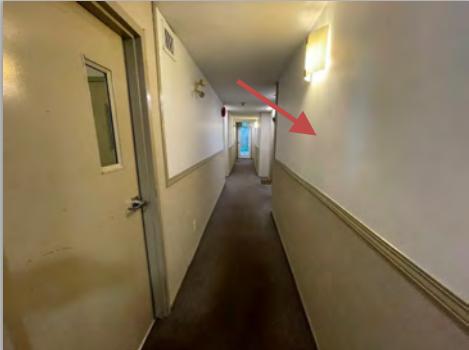
Description This component accounts for the interior paint finish in common areas.		
Quantity 1 Allowance Current Job Cost \$10,820		
Condition Analysis Based on a visual inspection, this component appears to be in average condition for its age. No major deficiencies were noted or reported at the time of inspection.		
Reserve History	Year of Acquisition 2020	
	Work Completed None noted or reported	
	Dollars Spent N/A	
Life Cycle Analysis	Expected Lifespan 20 years	
	Effective Age 3 years	
	Remaining Lifespan 17 years	
Funding Analysis	Work Surface preparation, painting, and clean-up.	
	Budget We have allowed for a full replacement of this component every 20 years.	
Potential Deterioration	Includes impact damage, stains, markings, fading, and water damage. Contributing factors include physical damage, wear-and-tear, and environmental factors such as temperature changes, humidity, and sun exposure. Painting may also be done for aesthetic reasons.

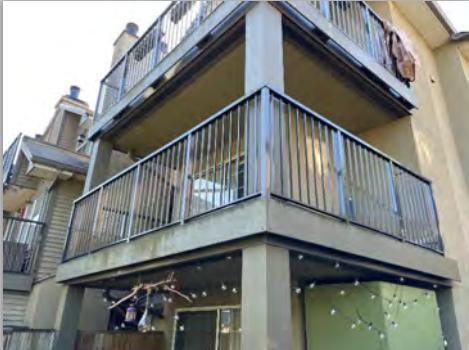
Description		This component accounts for the balcony waterproofing membrane.
	Quantity	1 Allowance
	Current Job Cost	\$13,598
Condition Analysis	Based on a partial visual inspection, this component appears to be in average condition for its age. No major deficiencies were noted or reported at the time of inspection.	
Reserve History	Year of Acquisition	2015
	Work Completed	None noted or reported
	Dollars Spent	N/A
Life Cycle Analysis	Expected Lifespan	18 years
	Effective Age	8 years
	Remaining Lifespan	10 years
Funding Analysis	Work	Remove old membrane. Prepare balcony surface. Re-install metal flashing. Install vinyl membrane with liquid adhesive and hot-air welding.
	Budget	We have allowed for a full replacement of this component every 18 years.
Potential Deterioration	Includes impact damage, delamination, fading, cracking, bubbling, wear-and-tear, and water damage. Contributing factors include physical damage, debris accumulation, and environmental factors such as extreme temperature changes, rain, snow, wind, and sun exposure.

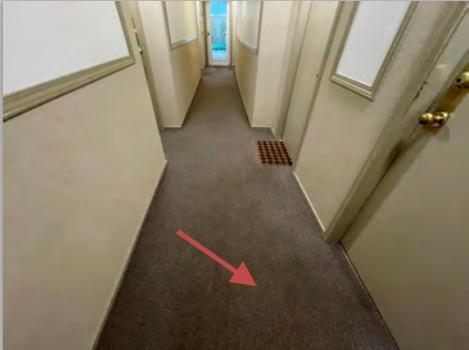
Description		<p>This component accounts for the interior common-area carpet flooring.</p>
	Quantity	1 Allowance
	Current Job Cost	\$10,970
Condition Analysis	<p>Based on a visual inspection, this component appears to be in average condition for its age. No major deficiencies were noted or reported at the time of inspection.</p>	
Reserve History	Year of Acquisition	1988
	Work Completed	None noted or reported
	Dollars Spent	N/A
Life Cycle Analysis	Expected Lifespan	20 years
	Effective Age	18 years
	Remaining Lifespan	2 years
Funding Analysis	Work	Remove and replace the damaged carpet or the entire carpet, including the carpet pad, depending on the extent and cause of the damage.
	Budget	We have allowed for a full replacement of this component every 20 years.
Potential Deterioration	<p>Includes fading, matting, colour-loss, wear-and-tear, wrinkles, ripples, stains, burns, strong odors, and lack of padding support. Contributing factors include physical damage, water damage, spills, debris accumulation, and damage from environmental factors such as temperature changes, humidity, and sun exposure. Carpet may also be replaced for aesthetic reasons.</p>

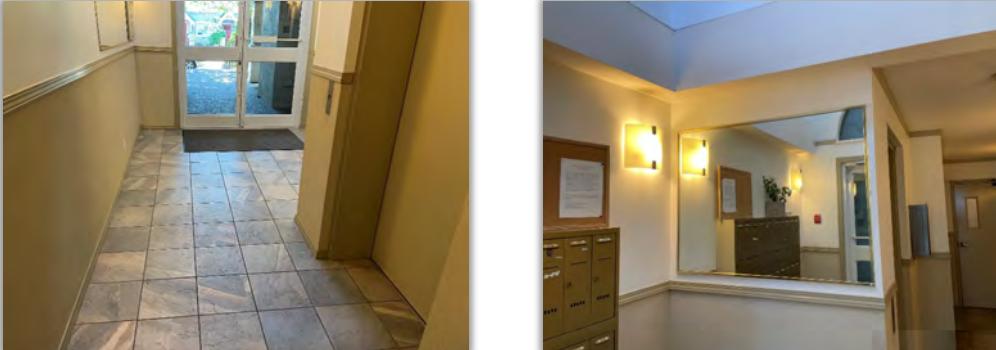
Description		<p>This component accounts for periodic renovations to the common-area lobby. This includes the flooring, lighting, finish, furniture, and décor.</p>
	Quantity	1 Allowance
	Current Job Cost	\$4,427
Condition Analysis	<p>Based on a visual inspection, this component appears to be in average condition for its age. No major deficiencies were noted or reported at the time of inspection.</p>	
Reserve History	Year of Acquisition	2017
	Work Completed	None noted or reported
	Dollars Spent	N/A
Life Cycle Analysis	Expected Lifespan	25 years (Budget Provision)
	Effective Age	6 years
	Remaining Lifespan	19 years
Funding Analysis	Work	Renovate the lobby components as desired.
	Budget	A budget equal to 75% of the estimated total cost is provided for significant expenditures every 25 years.
Potential Deterioration	<p>Includes impact damage, water damage, wear-and-tear, aesthetic degradation, discoloration, stains, and fading. Contributing factors include physical damage, debris accumulation, changing preferences, and damage from environmental factors such as temperature changes, humidity, and sun exposure.</p>

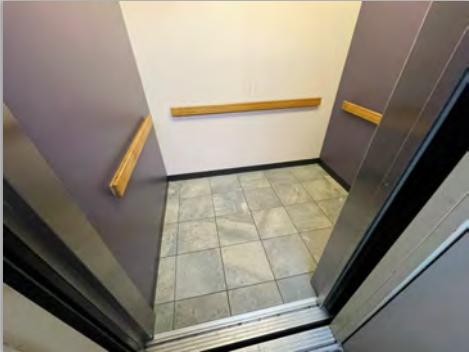
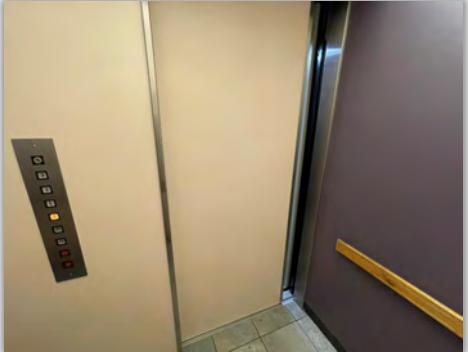
Description		<p>This component accounts for periodic renovations to the interior of the elevator cabs. This includes the flooring, wall panels, ceiling, lighting, and railings. This component does not include safety features or mechanical/electrical components within the elevator enclosure.</p>	
	Quantity	1 Cab	
	Current Job Cost	\$9,421	
Condition Analysis		<p>Based on a visual inspection, this component appears to be in average condition for its age. No major deficiencies were noted or reported at the time of inspection.</p>	
Reserve History	Year of Acquisition	2017	
	Work Completed	None noted or reported	
	Dollars Spent	N/A	
Life Cycle Analysis	Expected Lifespan	22 years	
	Effective Age	6 years	
	Remaining Lifespan	16 years	
Funding Analysis	Work	Renovate the elevator cab components as desired.	
	Budget	We have allowed for a full replacement of this component every 22 years.

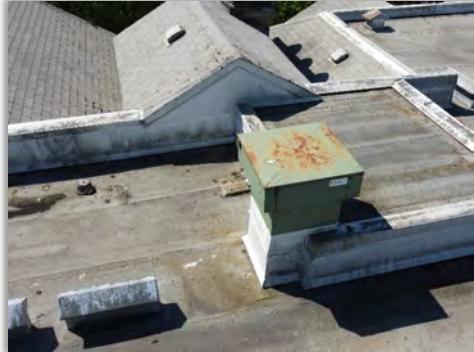
Description		<p>This component accounts for the Rooftop Unit (RTU). This includes ventilation system all contained in the same rooftop cabinet. This does not include the ductwork system, which is accounted for in the HVAC distribution component.</p>
Condition Analysis	Quantity	1 Unit
	Current Job Cost	\$7,875
Condition Analysis	<p>Based on a partial visual inspection, this component appears to be in average condition for its age. No major deficiencies were noted or reported at the time of inspection.</p>	
Reserve History	Year of Acquisition	1988
	Work Completed	None noted or reported
	Dollars Spent	N/A
Life Cycle Analysis	Expected Lifespan	30 years (Budget Provision)
	Effective Age	20 years
	Remaining Lifespan	10 years
Funding Analysis	Work	<p>Remove and replace the failing components as required. Increasing repairs are expected towards the end of the unit's life; replacement parts can sometimes become obsolete and repairs can become so frequent and costly that a full replacement becomes necessary.</p>

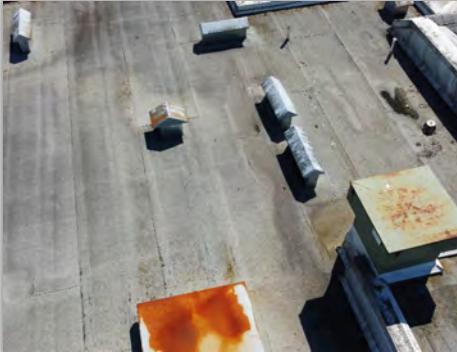
Component 27		HVAC - Rooftop Unit

Budget	<p>A budget equal to 50% of the estimated total cost is provided for significant expenditures every 30 years.</p>
Potential Deterioration	<p>Includes rising energy costs, corrosion, compressor failure, piping failure, and controls failure. Contributing factors include wear-and-tear, impact damage, debris accumulation, scale accumulation, leaks, overheating, insufficient maintenance, insufficient efficiency, and environmental factors such as temperature changes, humidity, rain, snow, wind, and sun exposure.</p>	
Suggested Maintenance	<p>Regular inspection by a certified contractor. Be alert to falling efficiency, unusual temperatures, unusual humidity, unpleasant odors, excessive moisture, poor airflow, increasing outages, increasing oil consumption, and increasing system noise. Inspect, test, clean, and repair as required.</p>

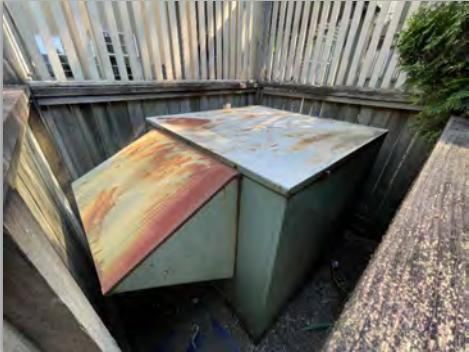
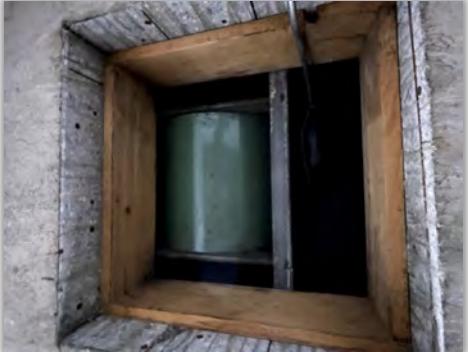
Description This component accounts for the parkade exhaust fans.					
	Quantity	1 System			
	Current Job Cost	\$1,249			
Condition Analysis	Based on a partial visual inspection, this component appears to be in average condition for its age. No major deficiencies were noted or reported at the time of inspection.				
Reserve History	Year of Acquisition	1988			
	Work Completed	None noted or reported			
	Dollars Spent	N/A			
Life Cycle Analysis	Expected Lifespan	35 years (Budget Provision)			
	Effective Age	30 years			
	Remaining Lifespan	5 years			
Funding Analysis	Work	Remove and replace the failed fan parts as required.			
	Budget	A budget equal to 50% of the estimated total cost is provided for significant expenditures every 35 years.			
Potential Deterioration	Includes corrosion, high operating costs, air leakage, motor failure, fan failure, and controls failure. Contributing factors include wear-and-tear, physical damage, frequent start-ups, overheating, debris accumulation, and environmental factors such as extreme temperatures and humidity.

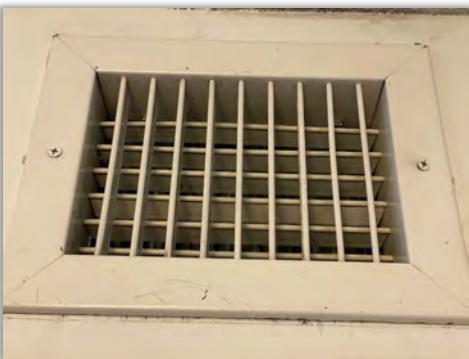
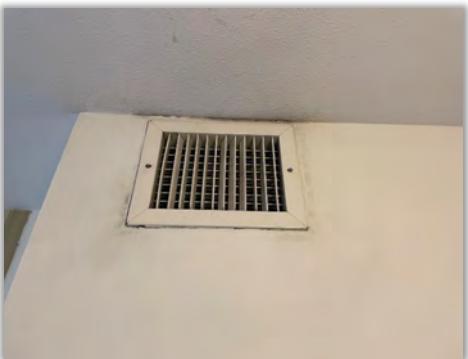
Description		<p>This component accounts for the HVAC distribution system. This includes the plenum, ductwork, duct connections, GRDs (grilles, registers, and diffusers), and thermostats.</p>			
Condition Analysis	Quantity	1 System			
	Current Job Cost	\$3,221			
Condition Analysis	<p>We were not able to visually inspect this component. No major deficiencies were reported at the time of inspection, so we assume it to be in average condition for its age.</p>				
Reserve History	Year of Acquisition	1988			
	Work Completed	None noted or reported			
	Dollars Spent	N/A			
Life Cycle Analysis	Expected Lifespan	50 years (Budget Provision)			
	Effective Age	30 years			
	Remaining Lifespan	20 years			
Funding Analysis	Work	<p>Remove and replace ductwork, GRDs, and thermostats as required.</p>			
	Budget	<p>A budget equal to 20% of the estimated total cost is provided for significant expenditures every 50 years.</p>

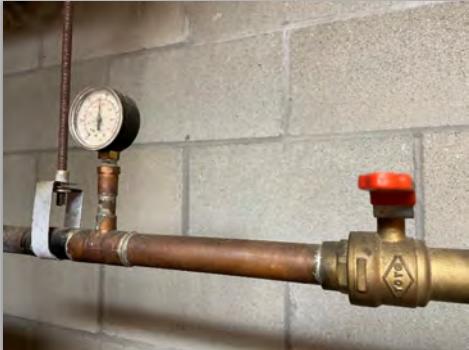
Description		<p>This component accounts for the interior common-element domestic water distribution system. This includes risers, pumps, branch lines, valves, and backflow preventers for both the supply and removal of hot and cold water.</p>	
Condition Analysis		<p>We were not able to visually inspect this component. No major deficiencies were reported at the time of inspection, so we assume it to be in average condition for its age.</p>	
Reserve History		Year of Acquisition	1988
Life Cycle Analysis		Work Completed	None noted or reported
Funding Analysis		Dollars Spent	N/A
Potential Deterioration		Expected Lifespan	35 years (Budget Provision)
Suggested Maintenance		Effective Age	32 years
Remaining Lifespan		Budget	3 years
Work		<p>Notify residents of work scope, disruption, and timeline. Access relevant areas while causing minimal damage. Replace damaged water supply components (usually with PEX) or, if water damage is frequent and severe, repipe most or all of the property to prevent further damage from occurring. Test system. Repair any damage and clean work areas.</p>

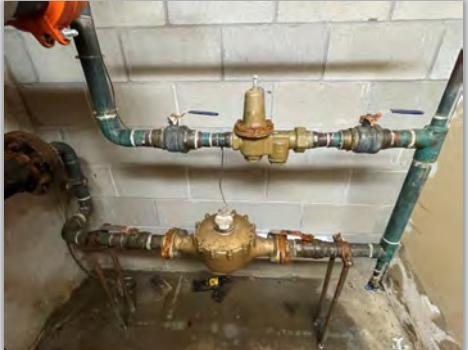
Component 30		Domestic Water Distribution - Building

Budget		<p>A budget equal to 25% of the estimated total cost is provided for significant expenditures every 35 years.</p>	
Potential Deterioration		<p>Includes pipe leaks and bursts, connection failure, pump failure, and valve failure. Contributing factors include impact damage, turbulence, the chemical makeup of supplied water (acidic water, hard water, highly chlorinated water, and chemical drain cleaners can sometimes cause deterioration), vibration and stress, and environmental factors such as extreme temperatures.</p>	
Suggested Maintenance		<p>Regular inspection for leaks (unusually high water bill, drips, pools, damp spots, discolouration, stains, dimpling, or flaking), unusual sounds (banging or knocking), water colour (brown or yellow is often a sign of decaying pipes, especially if the pipe has not been used for some time), low or inconsistent water pressure, and odors. Test and repair as required.</p>

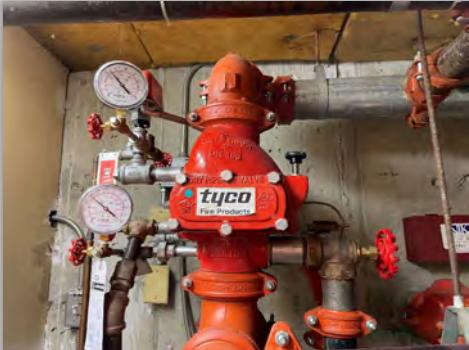
Description This component accounts for the dry sprinkler system. This includes piping, pipe tees, valves, alarms, sprinkler heads, connections, air compression, and associated components.					
Quantity 1 System Current Job Cost \$22,412					
Condition Analysis	Based on a partial visual inspection, this component appears to be in average condition for its age. No major deficiencies were noted or reported at the time of inspection.				
Reserve History	Year of Acquisition	1988			
	Work Completed	None noted or reported			
	Dollars Spent	N/A			
Life Cycle Analysis	Expected Lifespan	35 years (Budget Provision)			
	Effective Age	32 years			
	Remaining Lifespan	3 years			
Funding Analysis	Work	Inspect and test system regularly to comply with local regulations. Do all work as required or recommended by the inspector. Remove and replace failing components.

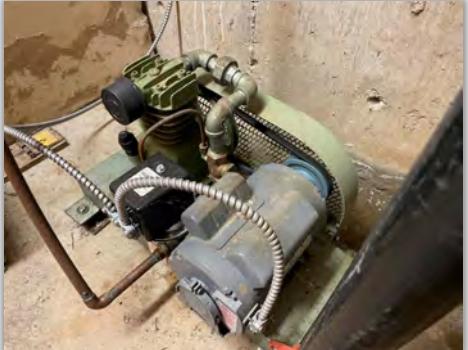
Component 32		Sprinkler System - Dry

Budget	A budget equal to 25% of the estimated total cost is provided for significant expenditures every 35 years.			
Potential Deterioration	Includes corrosion, pipe leaks and bursts, connection failure, and mechanical failure. Contributing factors include impact damage, wear-and-tear, the presence of oxygen and water in the pipes, and environmental factors such as extreme temperatures.				
Suggested Maintenance	Regular inspection as required or recommended by the inspector. Test, purge water from the lines, monitor corrosion, and repair as required. In some cases, filling the system with nitrogen instead of oxygen can increase the life expectancy of the pipes threefold.

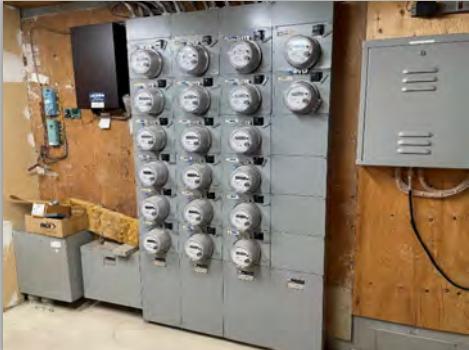
Description		<p>This component accounts for the common-element electrical service and distribution system. This includes wiring, service panels, breakers, switches, receptacles, and various electrical accessories.</p>		
		Quantity	1 System	
		Current Job Cost	\$13,531	
Condition Analysis		<p>Based on a partial visual inspection, this component appears to be in average condition for its age. No major deficiencies were noted or reported at the time of inspection.</p>		
Reserve History		Year of Acquisition	1988	
		Work Completed	None noted or reported	
		Dollars Spent	N/A	
Life Cycle Analysis		Expected Lifespan	35 years (Budget Provision)	
		Effective Age	25 years	
		Remaining Lifespan	10 years	
Funding Analysis	Work	<p>Remove and replace the various electrical components as required or desired.</p>		
		Budget	A budget equal to 15% of the estimated total cost is provided for significant expenditures every 35 years.

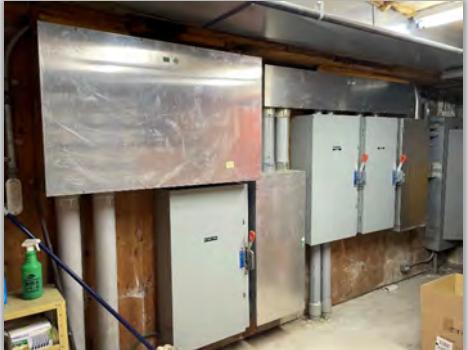
Component 34		Electrical Service and Distribution

Potential Deterioration		<p>Includes component failure, wire degradation, wire insulation failure, loosening of connections, and insufficient power. Contributing factors include wear-and-tear, usage, load demand, debris accumulation, corrosion, increased power demands, and environmental factors such as extreme temperatures, humidity, and ventilation.</p>		
Suggested Maintenance		<p>Regular inspection of electrical equipment and systems to determine maintenance requirements and priorities. Inspect, test, service, and repair as required.</p>

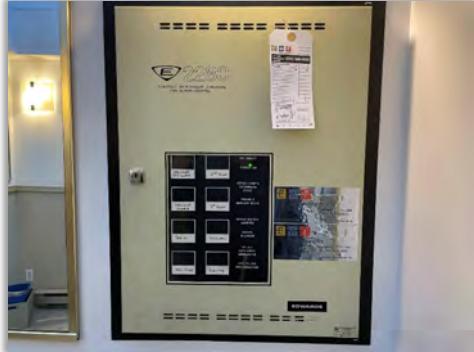
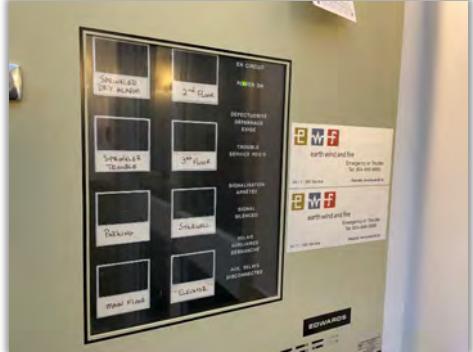
Description <p>This component accounts for the fire detection and notification system. This includes initiating devices, relays, conduits, wiring, panels, and fire equipment.</p>		
Quantity 1 System Current Job Cost \$24,080		
Condition Analysis <p>Based on a partial visual inspection, this component appears to be in average condition for its age. No major deficiencies were noted or reported at the time of inspection.</p>		
Reserve History	Year of Acquisition 1988	
	Work Completed None noted or reported	
	Dollars Spent N/A	
Life Cycle Analysis	Expected Lifespan 15 years	
	Effective Age 14 years	
	Remaining Lifespan 1 year	
Funding Analysis	Work Repair or replace the various components as required or recommended by qualified fire inspectors.	
	Budget We have allowed for a full replacement of this component every 15 years.	
Potential Deterioration	Includes component failure, wire degradation, electrical failure, impact damage, and functional obsolescence. Contributing factors include wear-and-tear, usage, debris accumulation, corrosion, physical damage, technological improvements, building code changes, and environmental factors such as extreme temperatures, humidity, and ventilation.

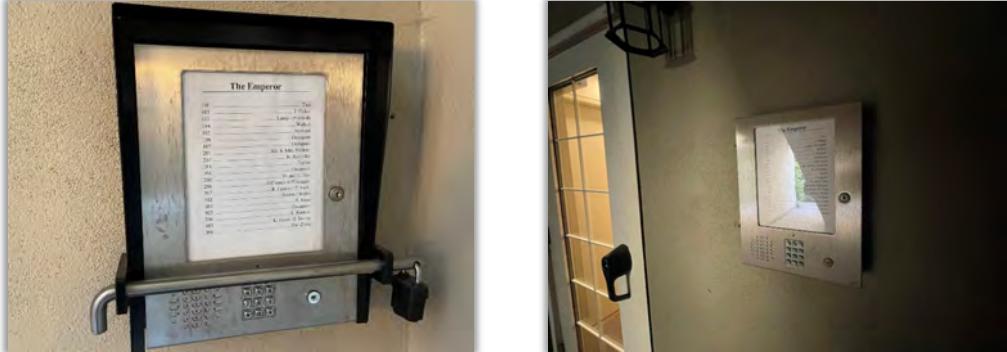
Description		<p>This component accounts for the common-element access entry system. This includes the intercom terminal and door-release system.</p>
	Quantity	1 Allowance
	Current Job Cost	\$16,144
Condition Analysis	<p>Based on a partial visual inspection, this component appears to be in average condition for its age. No major deficiencies were noted or reported at the time of inspection.</p>	
Reserve History	Year of Acquisition	1988
	Work Completed	None noted or reported
	Dollars Spent	N/A
Life Cycle Analysis	Expected Lifespan	15 years
	Effective Age	14 years
	Remaining Lifespan	1 year
Funding Analysis	Work	Remove and replace failing access control systems as required or replace as desired for upgraded security. Integrate the new system with the connected components where possible.
	Budget	We have allowed for a full replacement of this component every 15 years.

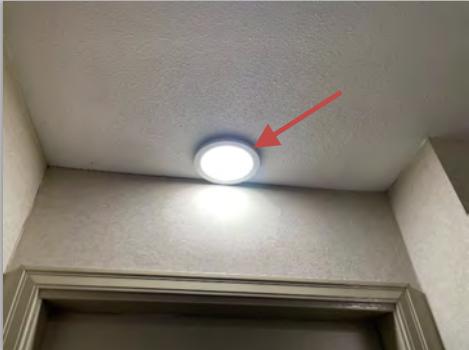
Description		<p>This component accounts for the interior common-area lighting. This includes the fixtures and a small allowance for box and wiring costs.</p>
	Quantity	1 Allowance
	Current Job Cost	\$11,715
Condition Analysis	<p>Based on a visual inspection, this component appears to be in average condition for its age. No major deficiencies were noted or reported at the time of inspection.</p>	
Reserve History	Year of Acquisition	2014
	Work Completed	The fixtures are of newer design and installation.
	Dollars Spent	N/A
Life Cycle Analysis	Expected Lifespan	25 years (Budget Provision)
	Effective Age	9 years
	Remaining Lifespan	16 years
Funding Analysis	Work	Remove and replace failed lighting components as required or desired.
	Budget	A budget equal to 60% of the estimated total cost is provided for significant expenditures every 25 years.
Potential Deterioration	<p>Includes impact damage, electrical component failure, and water damage. Contributing factors include physical damage, power surges, usage, and damage from environmental factors such as temperature changes and humidity. Fixtures may also be replaced due to functional obsolescence or for aesthetic reasons.</p>

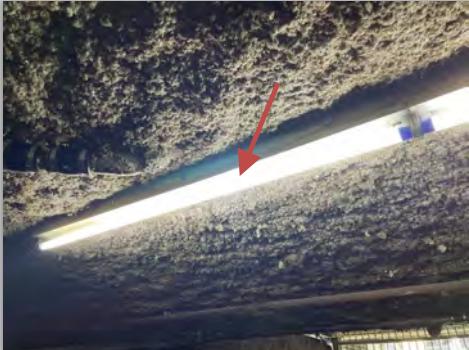
Description		<p>This component accounts for the lighting in the underground parking area. This includes the fixtures and a small allowance for box and wiring costs.</p>
	Quantity	1 Allowance
	Current Job Cost	\$6,276
Condition Analysis	<p>Based on a visual inspection, this component appears to be in average condition for its age. No major deficiencies were noted or reported at the time of inspection.</p>	
Reserve History	Year of Acquisition	1988
	Work Completed	None noted or reported
	Dollars Spent	N/A
Life Cycle Analysis	Expected Lifespan	20 years (Budget Provision)
	Effective Age	15 years
	Remaining Lifespan	5 years
Funding Analysis	Work	Remove and replace failed lighting components as required or desired.
	Budget	A budget equal to 50% of the estimated total cost is provided for significant expenditures every 20 years.
Potential Deterioration	<p>Includes impact damage, electrical component failure, and water damage. Contributing factors include physical damage, power surges, usage, and damage from environmental factors such as temperature changes and humidity. Fixtures may also be replaced due to functional obsolescence or for aesthetic reasons.</p>

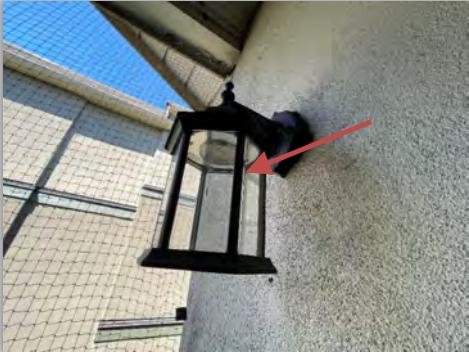
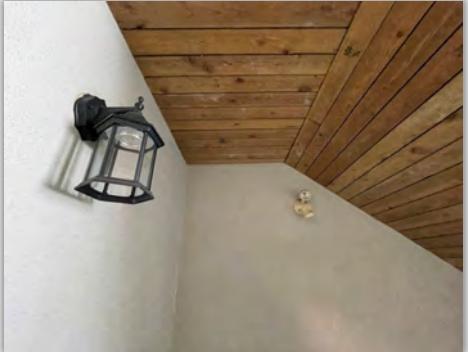
Description This component accounts for the common-element exterior lighting. This includes the fixtures and a small allowance for box and wiring costs.		
	Quantity	1 Allowance
	Current Job Cost	\$943
Condition Analysis	Based on a visual inspection, this component appears to be in average condition for its age. No major deficiencies were noted or reported at the time of inspection.	
Reserve History	Year of Acquisition	2019
	Work Completed	None noted or reported
	Dollars Spent	N/A
Life Cycle Analysis	Expected Lifespan	20 years (Budget Provision)
	Effective Age	4 years
	Remaining Lifespan	16 years
Funding Analysis	Work	Remove and replace failed lighting components as required or desired.
	Budget	A budget equal to 15% of the estimated total cost is provided for significant expenditures every 20 years.
Potential Deterioration	Includes impact damage, electrical component failure, and water damage. Contributing factors include physical damage, power surges, usage, and damage from environmental factors such as extreme temperature changes, rain, snow, wind, and sun exposure. Fixtures may also be replaced due to functional obsolescence or for aesthetic reasons.

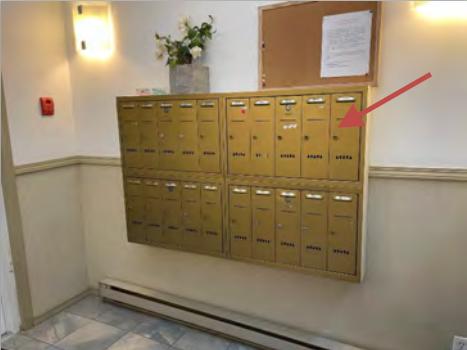
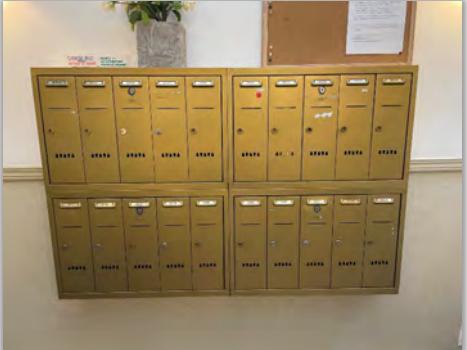
Component 40		Mailboxes

Description This component accounts for the mailboxes.		
Quantity 1 Allowance		
Current Job Cost \$4,729		
Condition Analysis Based on a partial visual inspection, this component appears to be in average condition for its age. No major deficiencies were noted or reported at the time of inspection.		
Reserve History	Year of Acquisition 1988	
	Work Completed None noted or reported	
	Dollars Spent N/A	
Life Cycle Analysis	Expected Lifespan 45 years	
	Effective Age 20 years	
	Remaining Lifespan 25 years	
Funding Analysis	Work Remove and replace the failed mailboxes.	
	Budget We have allowed for a full replacement of this component every 45 years.	
Potential Deterioration	Includes impact damage and corrosion. Contributing factors include physical damage, wear-and-tear, and environmental factors such as temperature changes and humidity.	
Suggested Maintenance	Regular inspection of the mailboxes for deterioration and vandalism. Clean and repair as required.

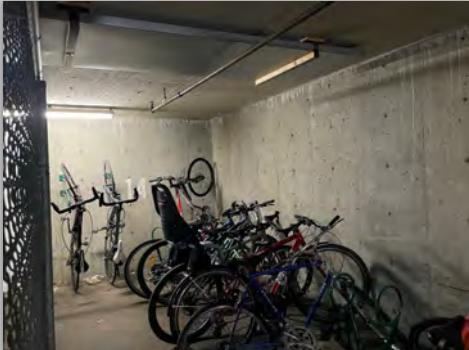
Description		<p>This component accounts for the bicycle racks.</p>
	Quantity	1 Allowance
	Current Job Cost	\$2,583
Condition Analysis	<p>Based on a visual inspection, this component appears to be in average condition for its age. No major deficiencies were noted or reported at the time of inspection.</p>	
Reserve History	Year of Acquisition	1988
	Work Completed	None noted or reported
	Dollars Spent	N/A
Life Cycle Analysis	Expected Lifespan	40 years (Budget Provision)
	Effective Age	10 years
	Remaining Lifespan	30 years
Funding Analysis	Work	Remove and replace the failing bicycle racks.
	Budget	A budget equal to 50% of the estimated total cost is provided for significant expenditures every 40 years.
Potential Deterioration	<p>Includes impact damage, loosening of fasteners, and corrosion. Contributing factors include physical damage, wear-and-tear, and environmental factors such as temperature changes and humidity.</p>
