DEPRECIATION REPORT

VR 2131—“The Emperor”

925 West 15th Avenue

July 19, 2023

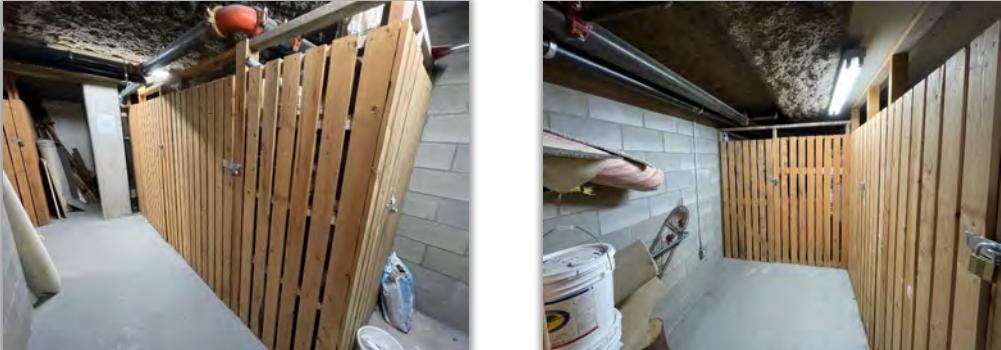
Description		<p>This component accounts for the wooden storage lockers.</p>
	Quantity	1 Allowance
	Current Job Cost	\$2,583
Condition Analysis	<p>Based on a visual inspection, this component appears to be in average condition for its age. No major deficiencies were noted or reported at the time of inspection.</p>	
Reserve History	Year of Acquisition	1988
	Work Completed	None noted or reported
	Dollars Spent	N/A
Life Cycle Analysis	Expected Lifespan	40 years (Budget Provision)
	Effective Age	30 years
	Remaining Lifespan	10 years
Funding Analysis	Work	Remove and replace the failing locker system.
	Budget	A budget equal to 25% of the estimated total cost is provided for significant expenditures every 40 years.
Potential Deterioration	<p>Includes impact damage, loosening of fasteners, and corrosion. Contributing factors include physical damage, wear-and-tear, and environmental factors such as temperature changes and humidity.</p>

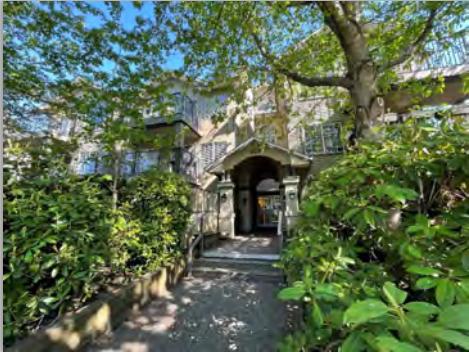
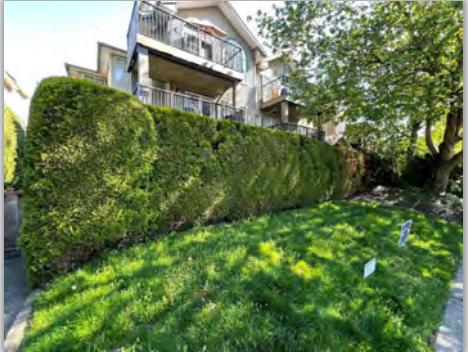
Description		<p>This component accounts for the common-element landscaping. This excludes any routine maintenance that is covered by the operating fund.</p>
Quantity		1 Allowance
Current Job Cost		\$2,825
Condition Analysis	<p>Based on a partial visual inspection, this component appears to be in good condition. No major deficiencies were noted or reported at the time of inspection.</p>	
Reserve History	Year of Acquisition	1988
	Work Completed	None noted or reported
	Dollars Spent	N/A
Life Cycle Analysis	Expected Lifespan	25 years (Budget Provision)
	Effective Age	15 years
	Remaining Lifespan	10 years
Funding Analysis	Work	Regrade as necessary. Replace or repair dead and damaged vegetation. Top up beds. Change landscaping for aesthetic purposes.
	Budget	A budget equal to 10% of the estimated total cost is provided for significant expenditures every 25 years.
Potential Deterioration	<p>Includes poor grading, impact damage, and wear-and-tear. Contributing factors include physical damage, subsurface shifting, debris accumulation, lack of maintenance, and environmental factors such as extreme temperature changes, rain, snow, wind, and sun exposure.</p>

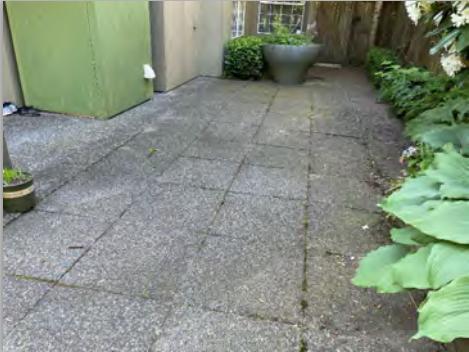
Description		This component accounts for the common-element paving stones.
	Quantity	1 Allowance
	Current Job Cost	\$22,439
Condition Analysis	Based on a visual inspection, this component appears to be in average condition for its age. No major deficiencies were noted or reported at the time of inspection.	
Reserve History	Year of Acquisition	1988
	Work Completed	None noted or reported
	Dollars Spent	N/A
Life Cycle Analysis	Expected Lifespan	35 years (Budget Provision)
	Effective Age	20 years
	Remaining Lifespan	15 years
Funding Analysis	Work	Remove failing sections and store paving stones nearby. Repair the subgrade and base course as required. Replace pavers: use old pavers where possible.
	Budget	A budget equal to 25% of the estimated total cost is provided for significant expenditures every 35 years.
Potential Deterioration	Includes cracking, crumbling, impact damage, and poor grading. Contributing factors include physical damage, wear-and-tear, debris accumulation, chemical damage (particularly from de-icing chemicals), subsurface shifting, and environmental factors such as temperature changes, rain, snow, and wind.

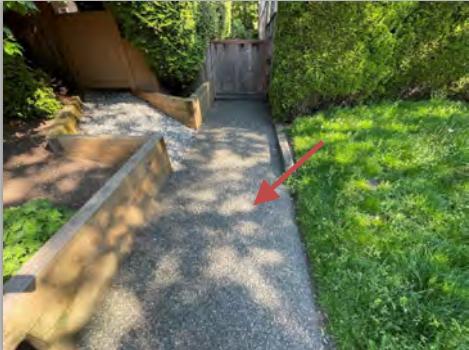
Description		<p>This component accounts for the concrete walkways.</p>
	Quantity	1 Allowance
	Current Job Cost	\$3,320
Condition Analysis	<p>Based on a visual inspection, this component appears to be in average condition for its age. No major deficiencies were noted or reported at the time of inspection.</p>	
Reserve History	Year of Acquisition	1988
	Work Completed	None noted or reported
	Dollars Spent	N/A
Life Cycle Analysis	Expected Lifespan	35 years (Budget Provision)
	Effective Age	20 years
	Remaining Lifespan	15 years
Funding Analysis	Work	Break and remove concrete slabs. Repair the subgrade and base course as required. Form and pour concrete with relief joints.
	Budget	A budget equal to 25% of the estimated total cost is provided for significant expenditures every 35 years.
Potential Deterioration	<p>Includes holes, cracking, spalling, delamination, poor grading, ponding water, and expansion joint failure. Contributing factors include impact damage, wear-and-tear, debris accumulation, subsurface shifting, and environmental factors such as temperature changes, rain, snow, wind, and sun exposure.</p>

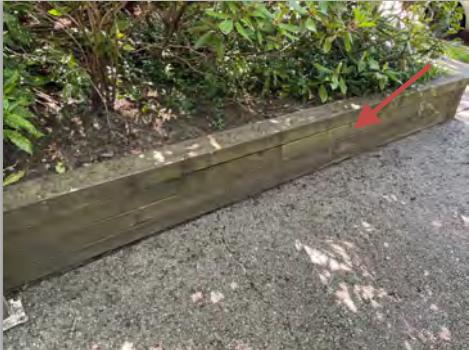
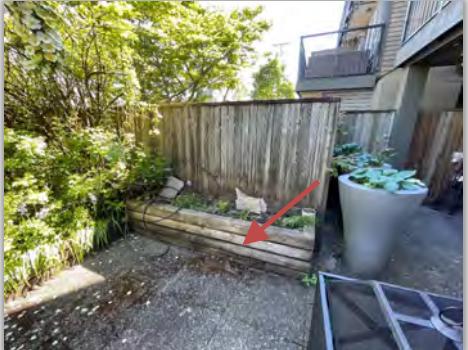
Component 47		Retaining Walls - Wood

Description This component accounts for the common-element wooden retaining wall system.		
	Quantity	1 Allowance
	Current Job Cost	\$20,713
Condition Analysis	Based on a visual inspection, this component appears to be in average condition for its age. No major deficiencies were noted or reported at the time of inspection.	
Reserve History	Year of Acquisition	2020
	Work Completed	None noted or reported
	Dollars Spent	N/A
Life Cycle Analysis	Expected Lifespan	30 years
	Effective Age	3 years
	Remaining Lifespan	27 years
Funding Analysis	Work	Remove damaged sections. Install new retaining wall system with proper drainage.
	Budget	We have allowed for a full replacement of this component every 30 years.
Potential Deterioration	Includes impact damage, cracking, splitting, buckling, leaning, water damage, and infestation. Contributing factors include physical damage, subsurface shifting, debris accumulation, improper installation, poor drainage, and environmental factors such as extreme temperature changes, rain, snow, wind, and sun exposure.

Suggested Maintenance	Regular visual inspection of the retaining wall for wall movement and wood deterioration. Inspect, slope the ground around the retaining wall for drainage, and repair as required.

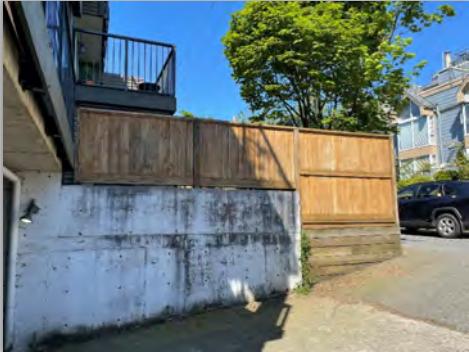
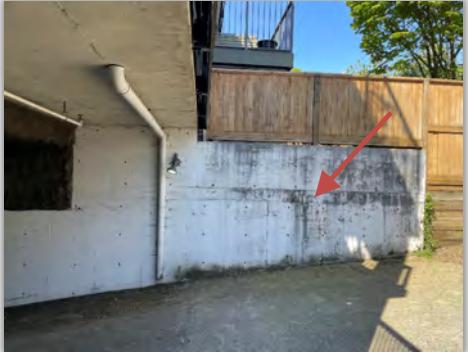
Description	<p>This component accounts for the common-element concrete retaining wall system.</p> <table border="1"> <tr> <td>Quantity</td><td>1 Allowance</td></tr> <tr> <td>Current Job Cost</td><td>\$29,453</td></tr> </table>		Quantity	1 Allowance	Current Job Cost	\$29,453
Quantity	1 Allowance					
Current Job Cost	\$29,453					
Condition Analysis	<p>Based on a visual inspection, this component appears to be in average condition for its age. No major deficiencies were noted or reported at the time of inspection.</p>					
Reserve History	Year of Acquisition	1988				
	Work Completed	None noted or reported				
	Dollars Spent	N/A				
Life Cycle Analysis	Expected Lifespan	40 years (Budget Provision)				
	Effective Age	20 years				
	Remaining Lifespan	20 years				
Funding Analysis	Work	Remove damaged sections. Install new retaining wall system with proper drainage.				
	Budget	A budget equal to 30% of the estimated total cost is provided for significant expenditures every 40 years.				
Potential Deterioration	<p>Includes impact damage, cracking, spalling, water damage, buckling, and leaning. Contributing factors include physical damage, subsurface shifting, debris accumulation, improper installation, poor drainage, and environmental factors such as temperature changes, rain, snow, wind, and sun exposure.</p>					
Suggested Maintenance	<p>Regular visual inspection of the retaining wall for wall movement and concrete deterioration. Inspect, slope the ground around the retaining wall for drainage, and repair as required.</p>

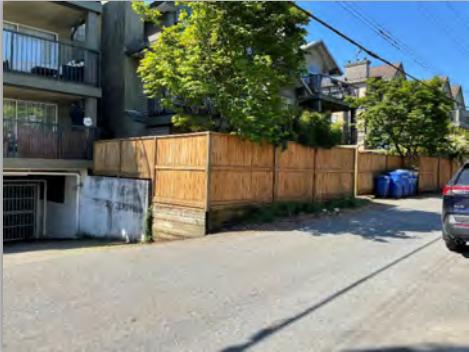
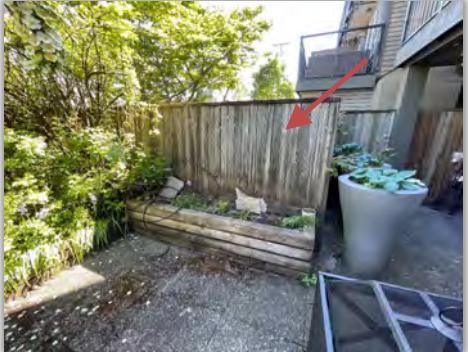
Description		<p>This component accounts for the common-element wood fencing.</p>
	Quantity	1 Allowance
	Current Job Cost	\$33,004
Condition Analysis	<p>Based on a partial visual inspection, this component appears to be in average condition for its age. No major deficiencies were noted or reported at the time of inspection.</p>	
Reserve History	Year of Acquisition	2019
	Work Completed	Some fencing has been replaced, other sections appear to be older.
	Dollars Spent	N/A
Life Cycle Analysis	Expected Lifespan	25 years
	Effective Age	4 years
	Remaining Lifespan	21 years
Funding Analysis	Work	Remove and replace fencing as required or desired.
	Budget	We have allowed for a full replacement of this component every 25 years.
Potential Deterioration	<p>Includes impact damage, cracking, splitting, warping, water damage, infestation, wear-and-tear, and leaning. Contributing factors include physical damage, subsurface shifting, debris accumulation, lack of maintenance, proximity to organic material, and environmental factors such as extreme temperature changes, rain, snow, wind, and sun exposure.</p>
