Design Development Report

Villa Jardin, 6833 Station Hill Drive, Burnaby, B.C.

REPORT 3437.10

DATE July 24, 2009

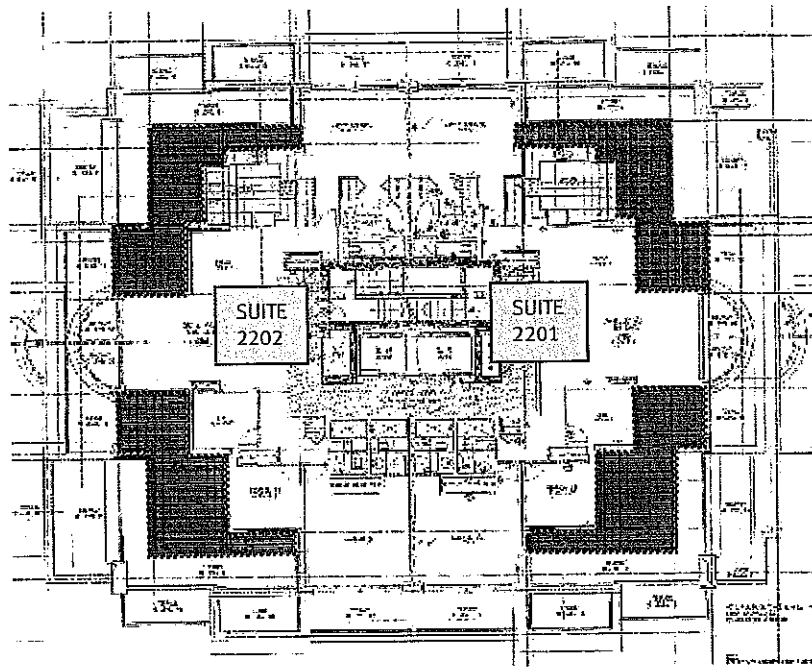
Fig. 3.5. Red shading shows fully exposed deck membrane assembly at level 22.

The red shaded areas in Fig. 3.5 show the location of a fully exposed deck membrane assembly location at level 22. The decks at levels 2, 9, 16, and 21 are partially exposed (Fig. 3.6, Fig. 3.7, Fig. 3.8, and Fig. 3.9).

We randomly removed the pavers at one location on the fully exposed level 22 deck adjacent to suite 2201 (Fig. 3.1) and observed water beneath the modified asphalt deck membrane. We recommend the deck membrane at level 22 be replaced. We removed the pavers at the partially exposed deck at suites 1602 (Fig. 3.2) and 201 (Fig. 3.3) and observed no damage to the underlying deck membrane. However, we observed two small blisters at the suite 901 partially exposed deck membrane assembly (Fig. 3.4). These observations of more significant damage at fully exposed locations and random areas of minor damage at partially exposed locations are consistent with our findings at similar buildings with this deck membrane type.

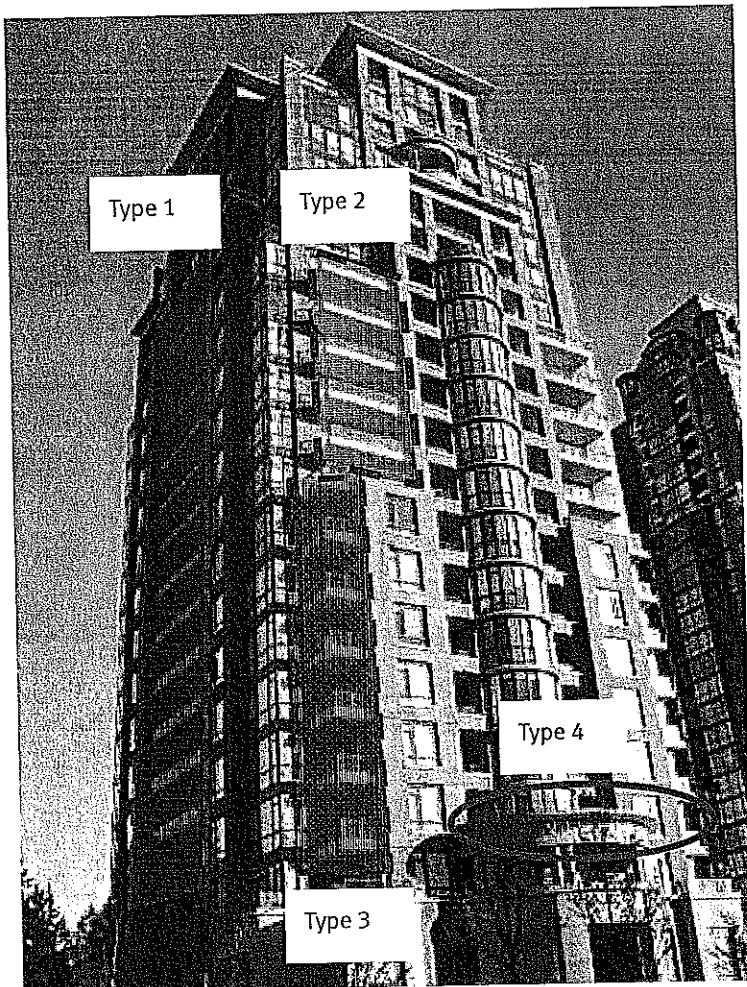
Fig. 4.7. Southeast Elevation View of Balcony Layout.

There are four balcony assembly types currently experiencing water penetration through the balcony assembly (refer to Fig. 4.7 for representative locations of balcony types). The concerns with each of these balcony types are discussed below.

The second balcony type is located at the northeast, northwest, southeast, and southwest corners at levels 10 through 15 (Fig. 4.7, yellow section). The conditions observed at these locations are similar to those at the side by side balconies on levels 3 through 17. Therefore, the same remedial work should be implemented.

The third balcony type is located at the southeast and northeast corners at levels 3 through 8 (Fig. 4.7, green section). There is water staining at the concrete cold joint at the base of the concrete balcony curb suggesting failure of the balcony membrane. The cold joint at the concrete perimeter curb to concrete slab interface should be routed and sealed. The remaining conditions observed at these locations and the recommendations provided are similar to those described for the side by side balconies on levels 3 through 17.

The fourth balcony type experiencing water ingress is the radial balcony at level 3 on the east elevation (Fig. 4.7, blue ellipse). This leakage is associated with drain detailing (Fig. 4.3). The existing balcony membrane is significantly stained. Performing localized urethane repairs on an older, heavily stained balcony membrane is generally unsuccessful over the long-term. We recommend the comprehensive urethane balcony membrane renewal at this location. The new urethane balcony membrane should extend up and over the concrete parapets.

installed to extend the existing balcony membrane up and over the concrete curbs down to the drip edge beneath the structural concrete slab. The existing drain pipe extensions at most locations are too short and allow water to track to the underside of the structural balcony slab. The existing drain pipe should be extended to improve rainwater management (Fig. 4.7, dotted red line).

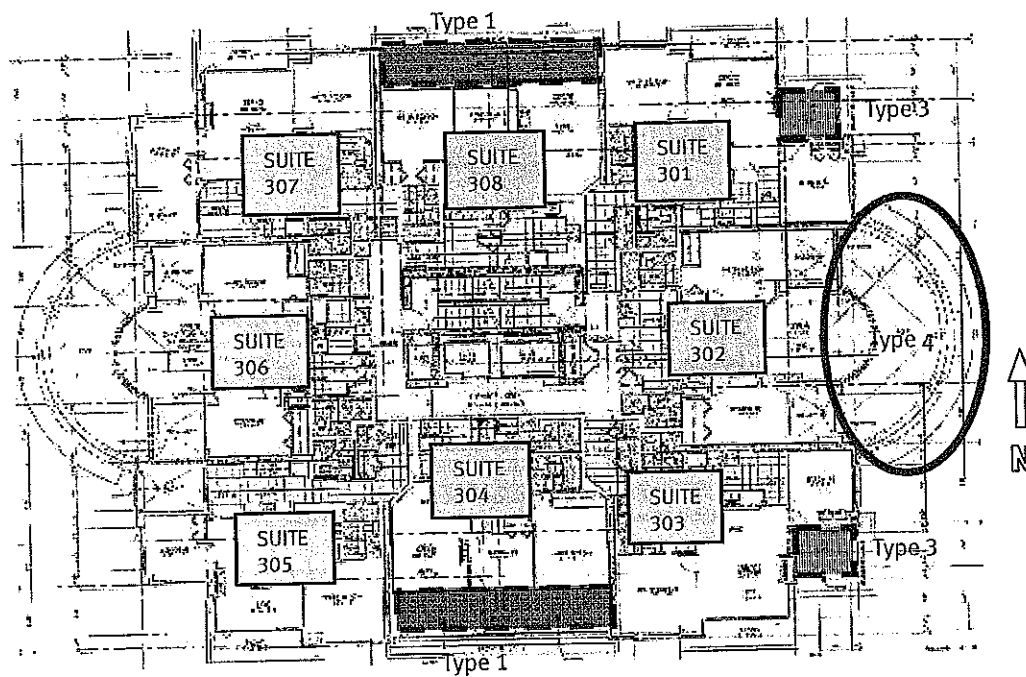
Fig. 4.8. Level 3 Floor Plan.

Fig. 4.8 to Fig. 4.12 illustrate plan views of various balcony areas from levels 3 to 17 at Villa Jardin. (Refer to Fig. 4.7 for colour referencing)
