March 11, 2007

PROJECT: Mayfair Place
7368 & 7388 Sandborne Avenue, New Westminster, BC

SUBJECT: Follow-up End-of-Warranty-Period Review

**END OF WARRANTY REVIEW
MAYFAIR PLACE
7368 & 7388 SANDBORNE AVENUE,
BURNABY, B.C.**

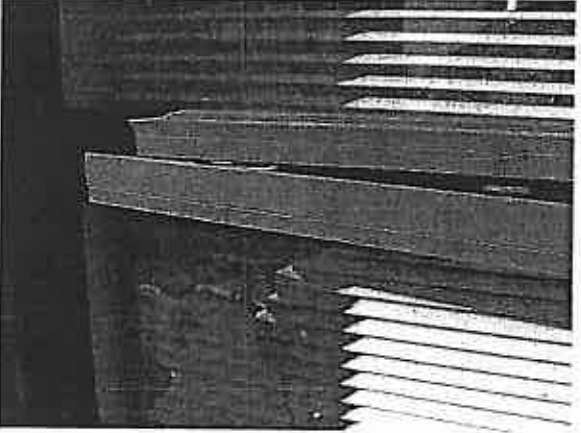
Operable sash does not close properly.
12

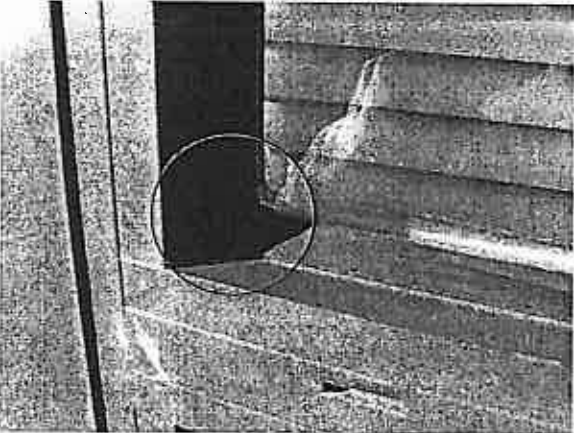
Gasket not extending into the corner of the of the window glazing.
15

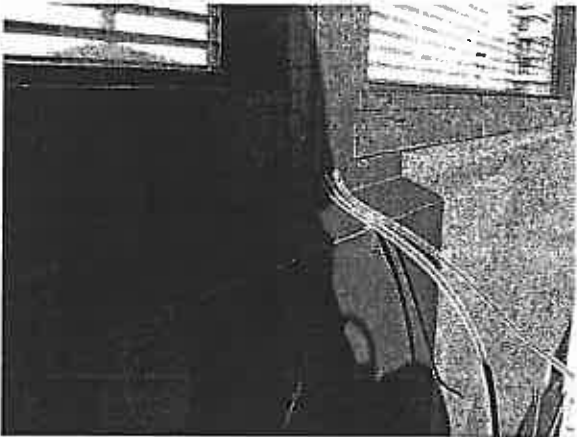
- Corrosion of brick shelf angles visible on painted surface. Shelf angle ends protruding from the wall. [Photograph 16]
- Mohair gaskets slipping out from the window frames, which decreases the air tightness of the windows. A large number of windows are affected. [Photograph 17]

Mohair gaskets slipping out of the operable sashes.
18

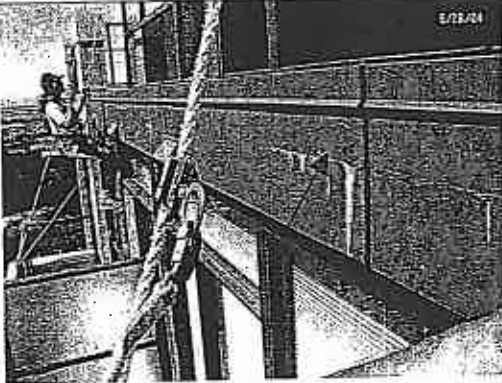
<p>Drop #1 – Tower I East Elevation, 21st Floor</p> <p>View of slab band.</p> <p>Note: Efflorescent leaching from the cold joint.</p>
4

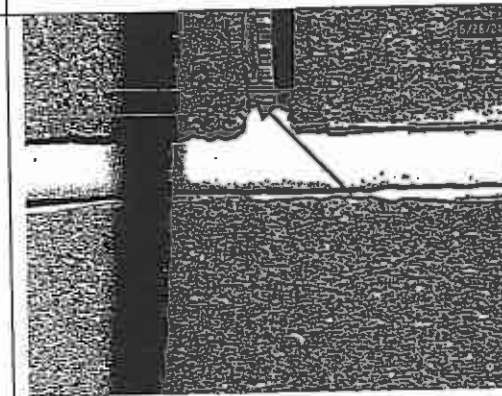
<p>Drop #2 – Tower I East Elevation, 13th Floor</p> <p>Close-up of the weep hole.</p> <p>Note: Exposed Blueskin at weep hole.</p>

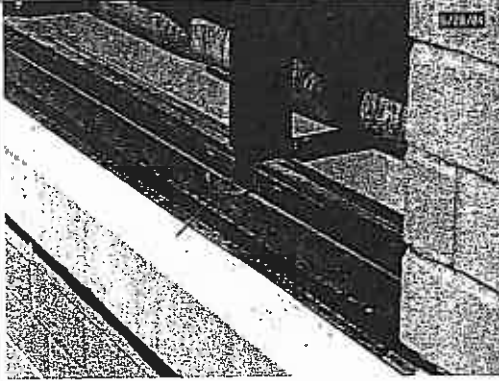
<p>Drop #2 – Tower I East Elevation, 11th Floor</p> <p>Note: Mohair gasket sticking out from the window frame.</p>
9

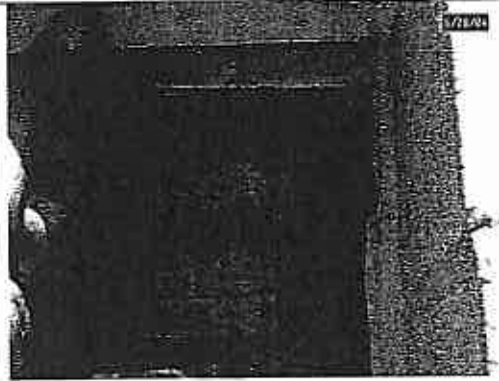
<p>Drop #2 – Tower I East Elevation</p> <p>Close-up at the head of the window.</p> <p>Note: Flashing installed above deflection header to eliminate the gap between deflection header and shelf angle.</p>
10

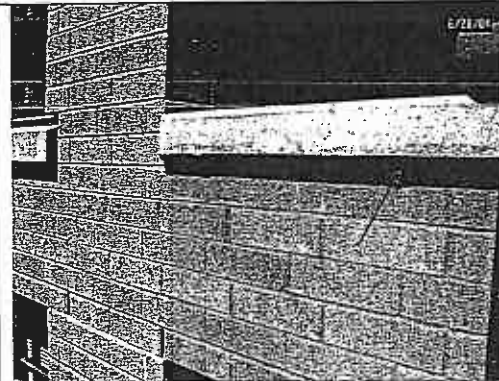
- Brick mortar was projecting past the shelf angle in several locations throughout the project (especially at drop 1, 2, 3 and 4- Photo 7).
- Unprotected 1 ½" gap between the concrete sill and brick cladding was observed at Drop # 2 – Tower 1 East Elevation (Photo 10).

<p>Drop #2 – Tower I East Elevation, 10th Floor</p> <p>Note: Unprotected 1-1/2 inch gap between the concrete sill and the brick cladding.</p>

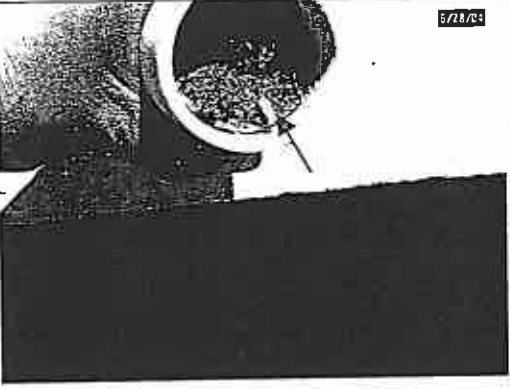
<p>Drop #2 – Tower I East Elevation, 6th floor.</p> <p>Close-up of the scupper.</p> <p>Note: Vegetation growing in the scupper due to the negative slope of the scupper. The detail drawing requires the in-slab scupper drain to have a positive slope to allow for proper drainage.</p>
12

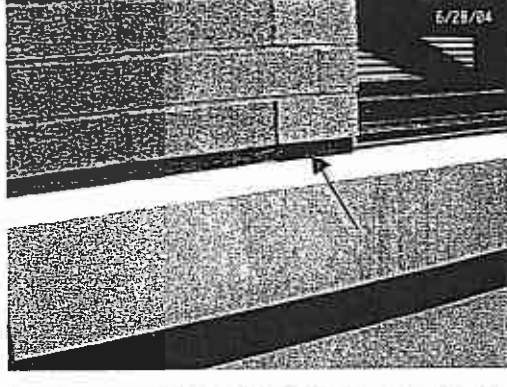
<p>Drop #4 – Tower I East Elevation, 4th Floor</p> <p>Note: Exposed Blueskin.</p>
18

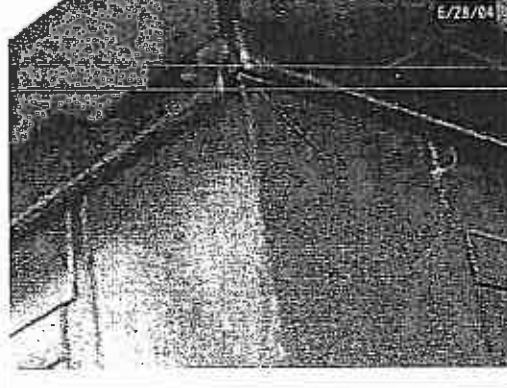
<p>Drop #5 – Tower II East Elevation, 14th Floor</p> <p>Close-up of the mitre corner of deflection header.</p> <p>Note: Separation of the deflection header.</p>

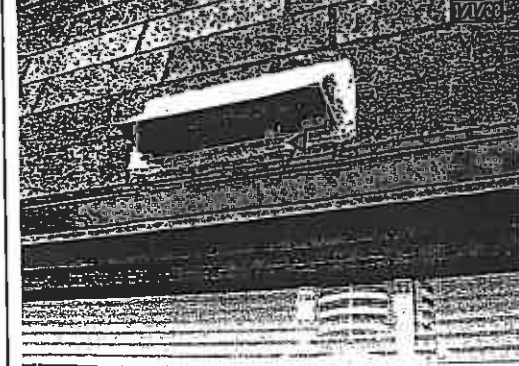
<p>Drop #6 – Tower II North Elevation, 11th Floor</p> <p>Close-up of the vent hood.</p> <p>Note: Metal screen was not provided. Bird's nest was observed behind rubber flap.</p>
22

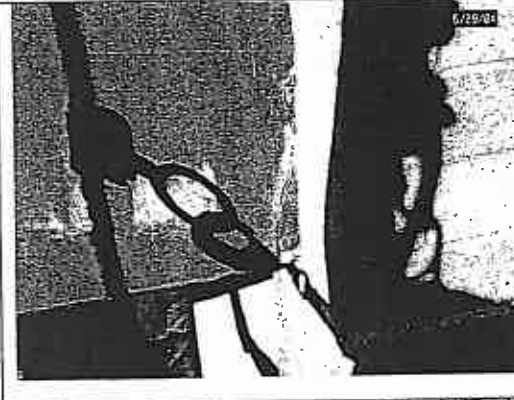
<p>Drop #8 – Tower I North Elevation, 11th Floor</p> <p>Note: Exposed Blueskin at the concrete slab edge</p>
30

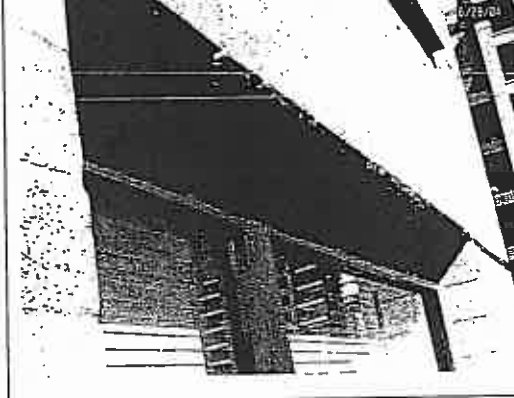
<p>Drop #8 – Tower I North Elevation, 6th Floor</p> <p>Note: Large amount of mortar suspended on the brick underside. Please see comments at Photo 7.</p>

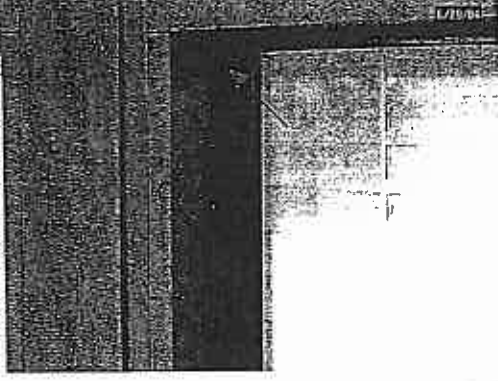
<p>Drop #9 – Tower II South Elevation,</p> <p>Note: Vinyl gasket terminating away from the window corner at the Suite 801.</p> <p>See photo 19.</p>
39

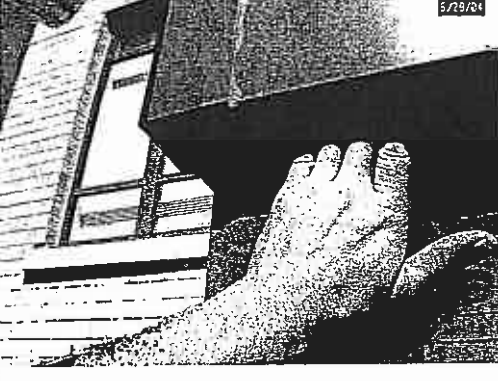
<p>Drop #9 – Tower II South Elevation,</p> <p>Note: Slab band metal panels proud from the window frame around Suite 801.</p>
40

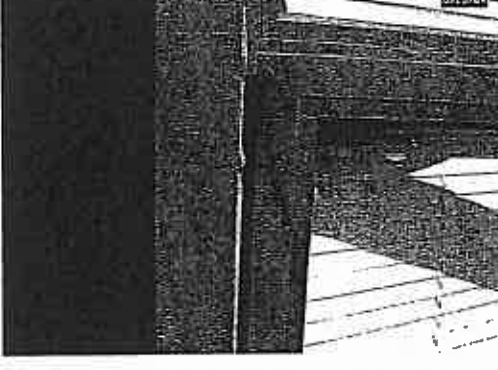
<p>Drop #9 – Tower II South Elevation, 8th Floor</p> <p>Note: Misaligned window vent.</p>
41

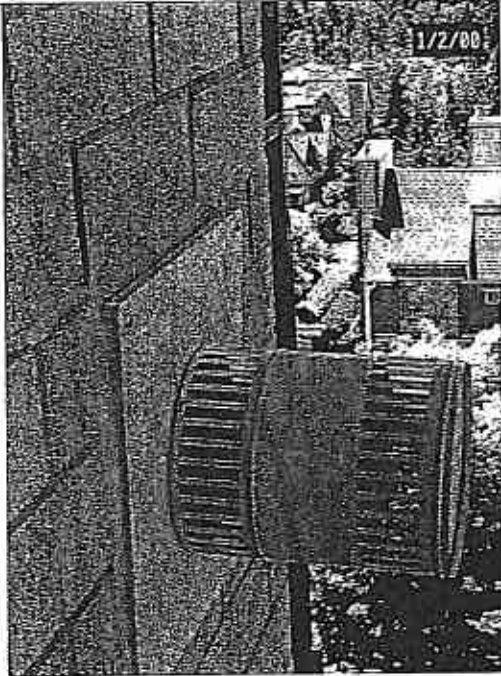
Drop #10 – Tower II West Elevation,

Note: Sealant not properly spanning between the brick and the fireplace outlet on the top of the metal cover.

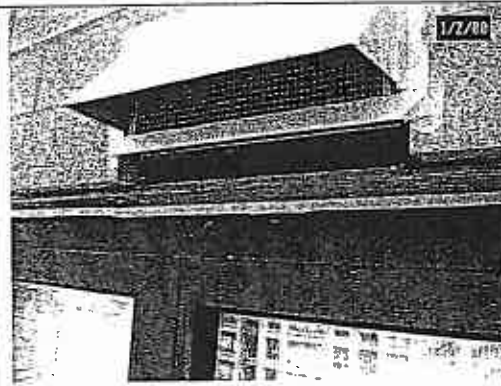
Drop #10 – Tower II West Elevation, 8th Floor

Note: Peel 'n stick membrane was applied on the underside of the vent. The brick was missing underneath the vent hood.

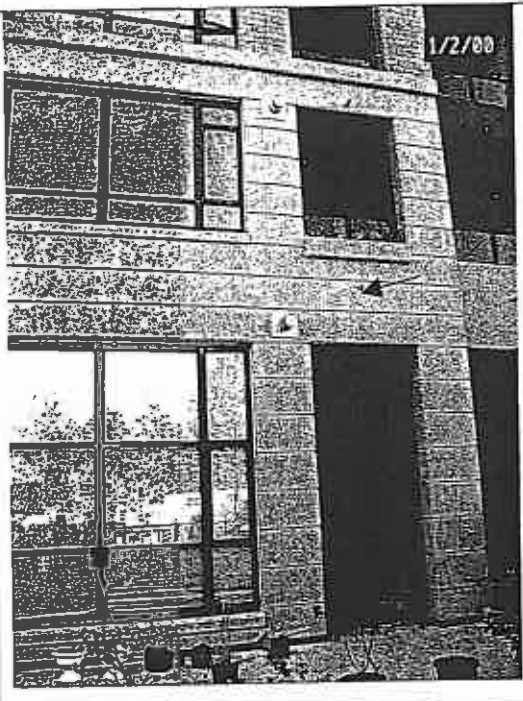
<p>1/2/00</p>	<p>Tower 1 Unit 206</p> <p>General view of the area where the water ingress occurred at the base of the ground floor unit (according to the information provided by the Owner).</p> <p>Note: Scupper discharge is located directly above entrance on the deck from unit.</p> <p>The water from the scupper lands on the deck of the occupants of Unit 206 (as reported by the Owner). This water should be redirected away from the Unit 206 patio.</p>
47

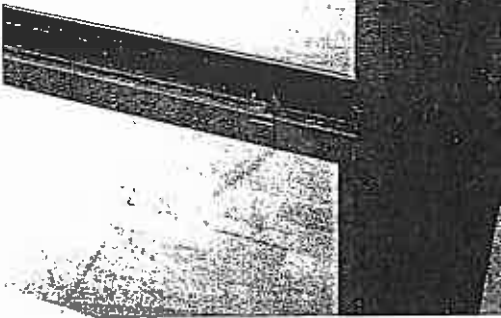
<p>Tower I – Unit 1501</p> <p>View of setting blocks. Inconsistency with setting blocks placement was observed in several locations.</p>
50

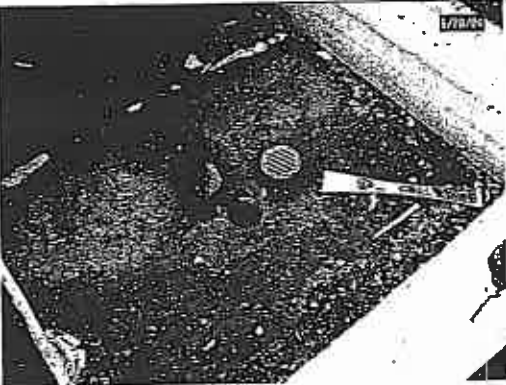
<p>Close-up of deck drain on the North elevation-Tower 1.</p> <p>Note: The deck drain was plugged with filter cloth and some dirt deposit.</p>
53

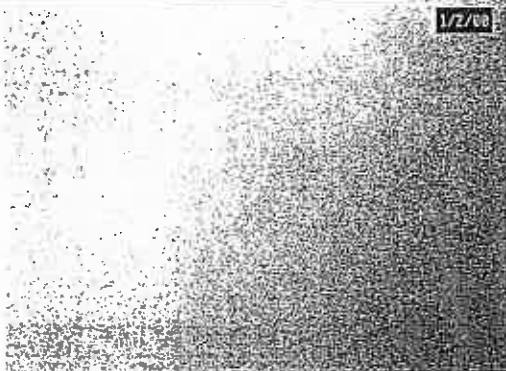
<p>1/2/08</p> <p>Tower II – Unit 1402</p> <p>Staining of the ceiling small bedroom in the line of dryer vent ducting.</p>
58

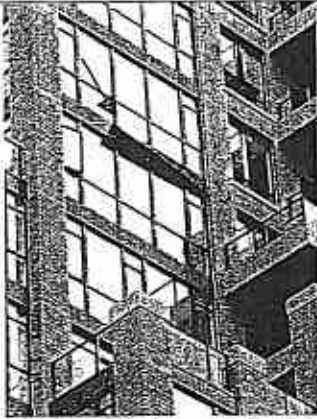
Tower I – East Elevation, 16th floor (This photo was taken by the Owner and was provided to Levelton to document the reported concern).

Note: Metal slab band cover was not properly secured and was blown by the strong wind in the past.

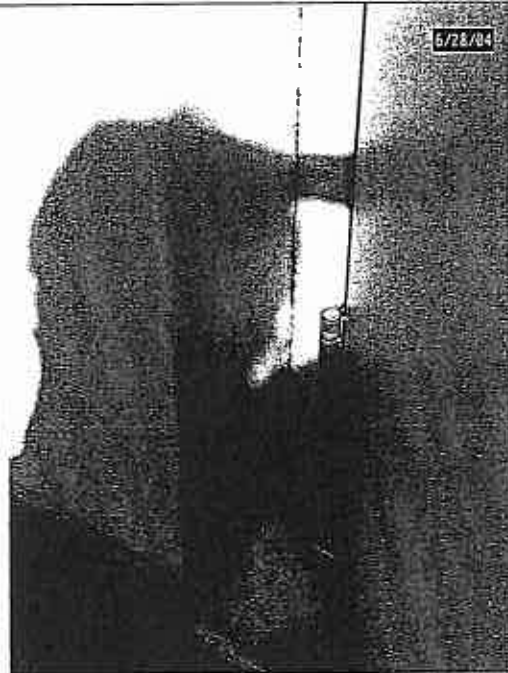
Tower I – East Elevation

Note: Corrosion of the metal frame at the roof access door.

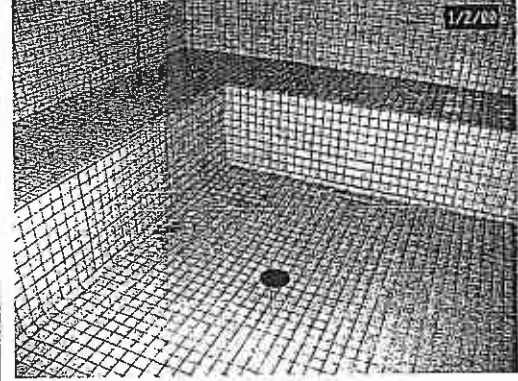
69

<p>Shower in the Main Pool area.</p> <p>Note: Gaps in the grout allow for water ingress underneath the tiles. Some of the tiles were not bonded to the substrate.</p>

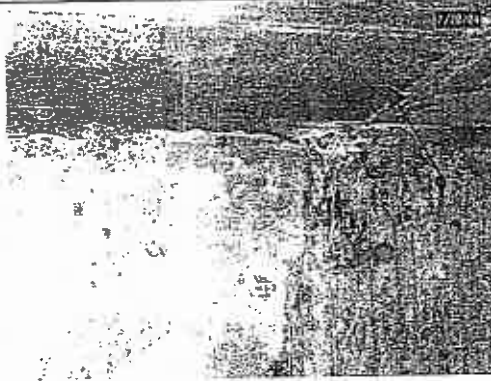
<p>Close-up of minor efflorescent staining at slab and wall interface.</p>
