REPORT

Building Envelope Condition Assessment – The Seastar

1003 Pacific Street
Vancouver, British Columbia

The Owners, Strata Plan LMS 2946

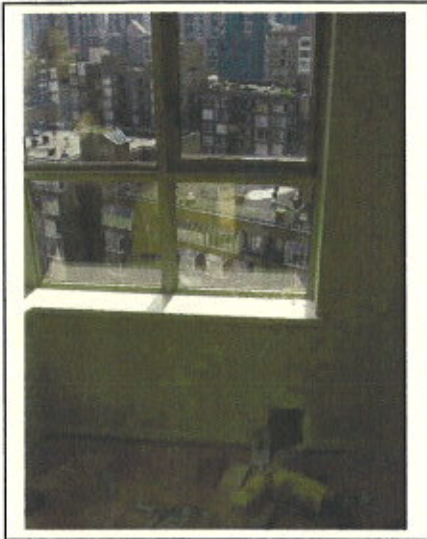
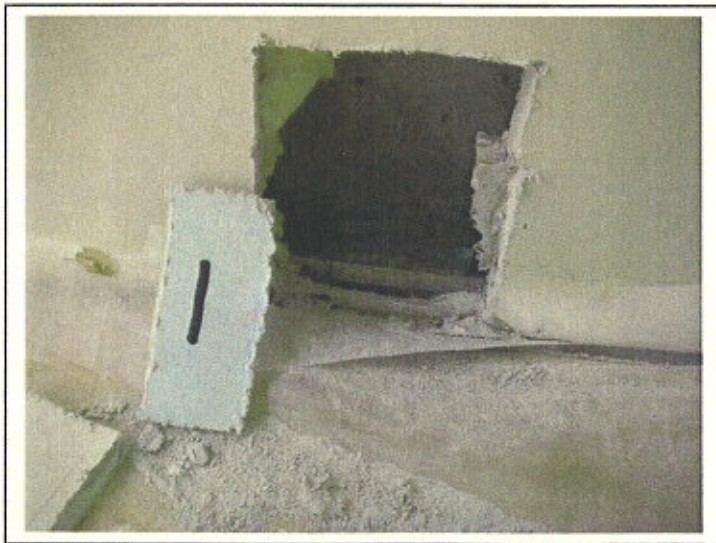
- Stucco cladding and concrete back wall
- 4" steel stud filled with batt insulation
- 2 layers of drywall with polyethylene sheet sandwiched in between.

- Concrete back wall was dry and in good condition.
- Steel stud was in good condition, no sign of corrosion.
- Batt insulation was clean dry.
- Drywall was clean and dry.

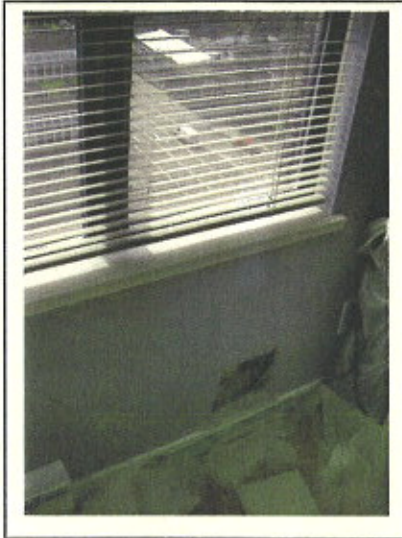
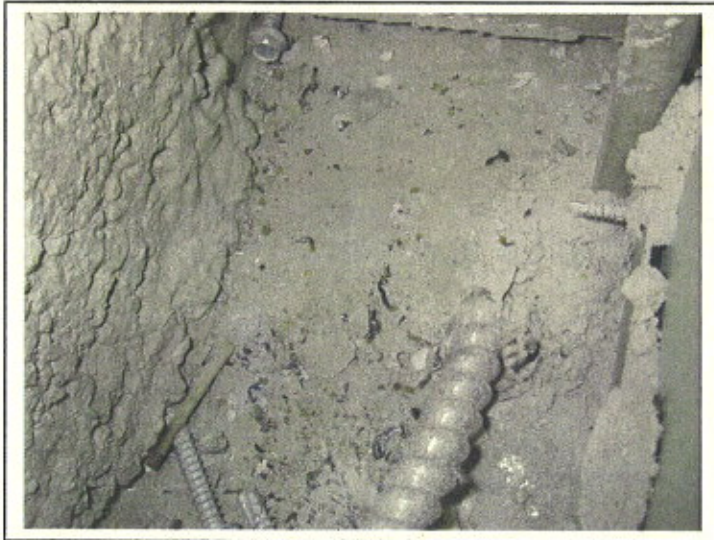
- Concrete back wall was dry and in good condition.
- Steel stud was in good condition, no sign of corrosion.
- Batt insulation was clean and dry.
- Drywall was clean and dry.

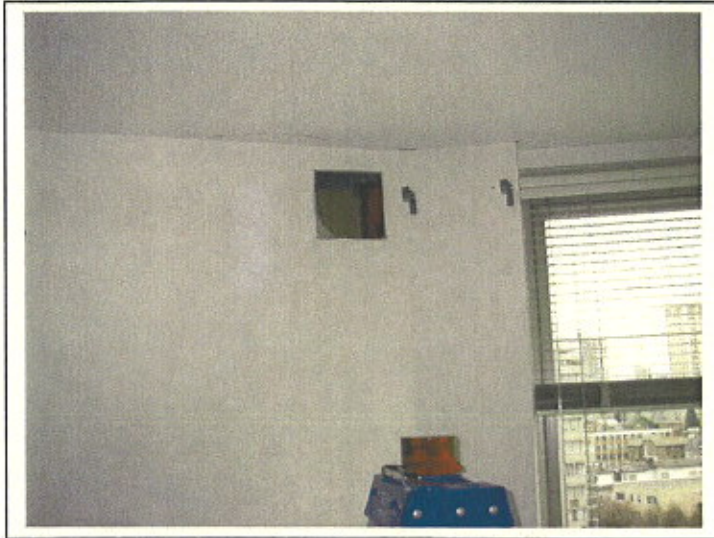
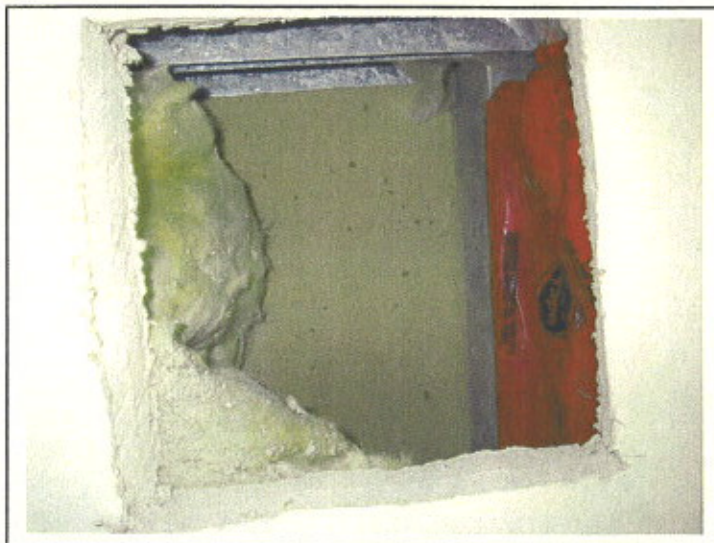
- Crack on the ceiling and wrinkles in the paint on wall/ceiling transition.
- Steel stud was in good condition, no sign of corrosion.
- Batt insulation was clean and dry.
- Drywall was clean and dry.

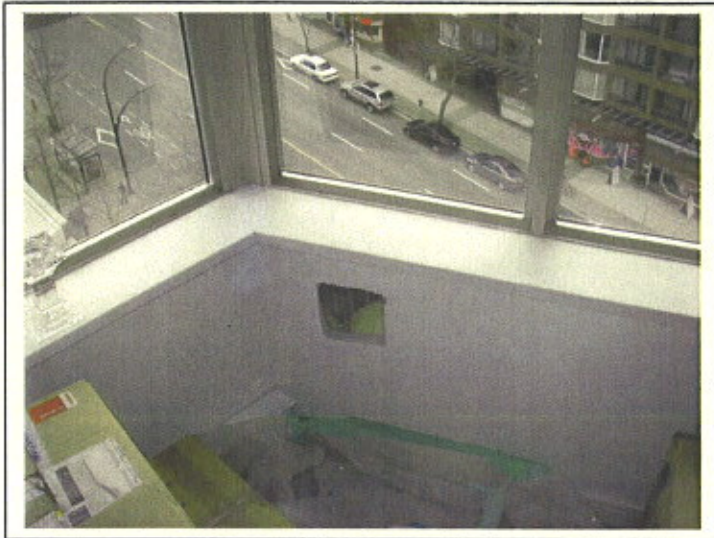
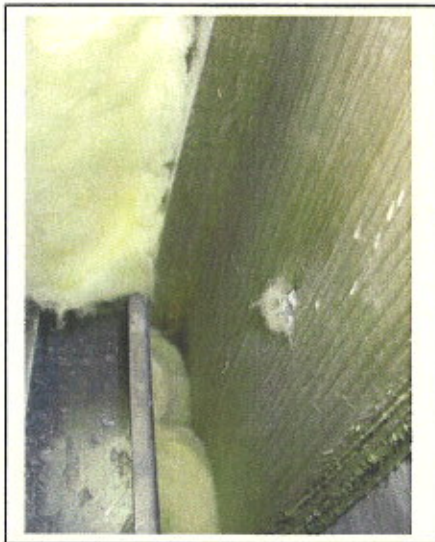
- Staining on the back side of the concrete wall.
- Plywood was dry (11% MC).
- Steel stud was in good condition.
- Batt insulation was clean and dry.
- Drywall was clean and dry.

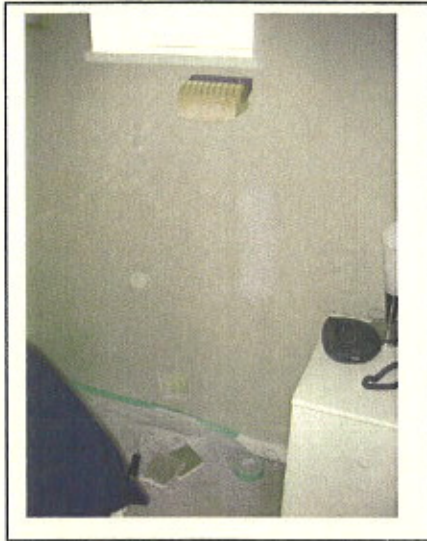
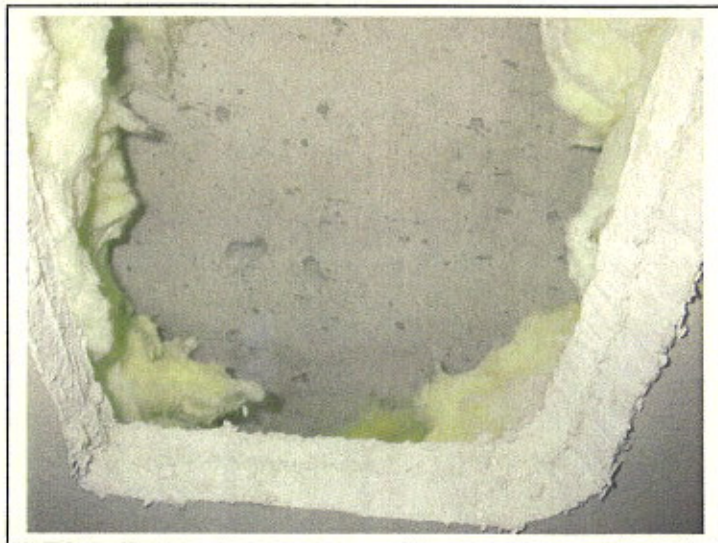
- Concrete wall was dry and in good condition.
- Steel stud was in good condition, no sign of corrosion.
- Batt insulation was clean and dry.
- Drywall was clean and dry.

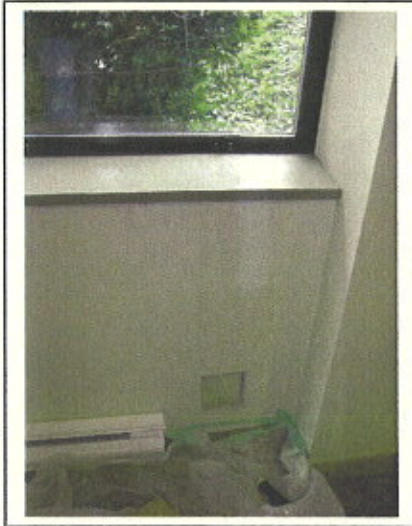
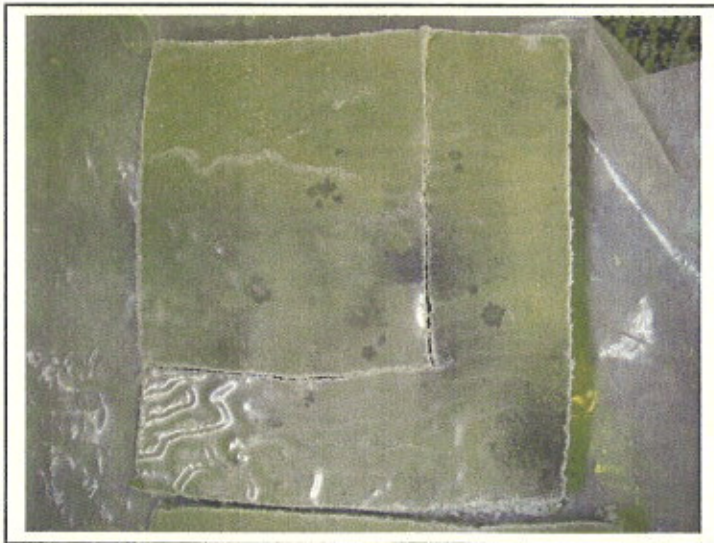
- Concrete wall was dry and in good condition.
- Steel stud was in good condition, no sign of corrosion.
- Insulation was clean and dry.
- Evidence of fungal growth on the backside of the outer layer of drywall.
- Staining on the inner layer of drywall.

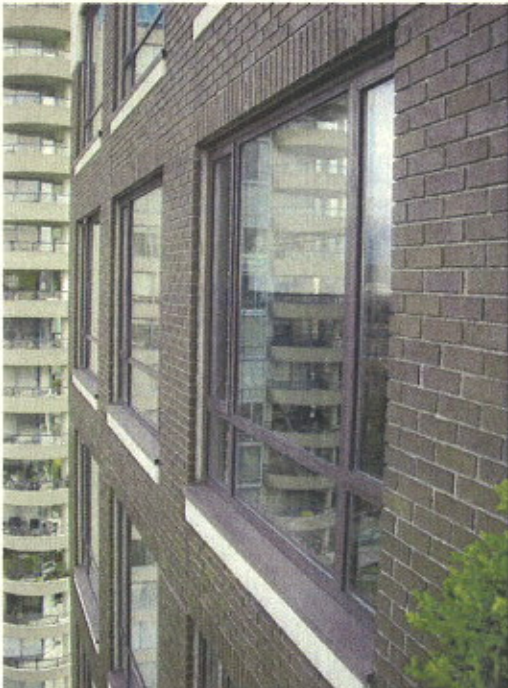
Photo 07 Typical punched window assembly in pre-fabricated panel

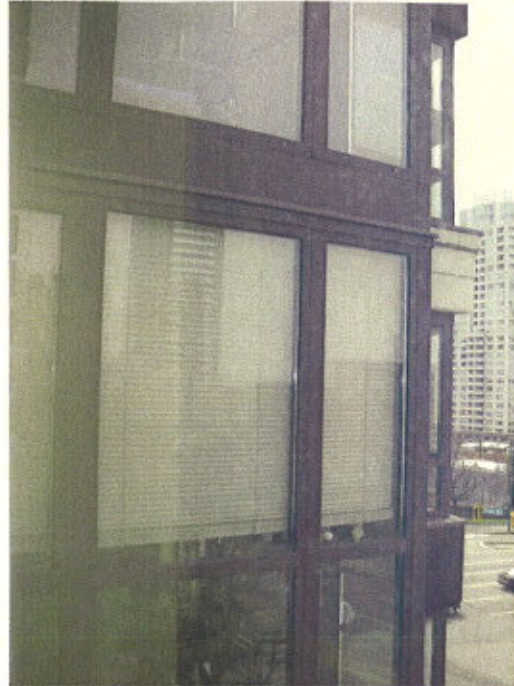
Photo 22 Typical window wall assembly at enclosed balcony
