COURTYARD PLAZA CONDITION EVALUATION

**Marina Place
1181-1199 West 7th Avenue
Vancouver, B.C.**

May 2002

RJC Reference No. 38359-01

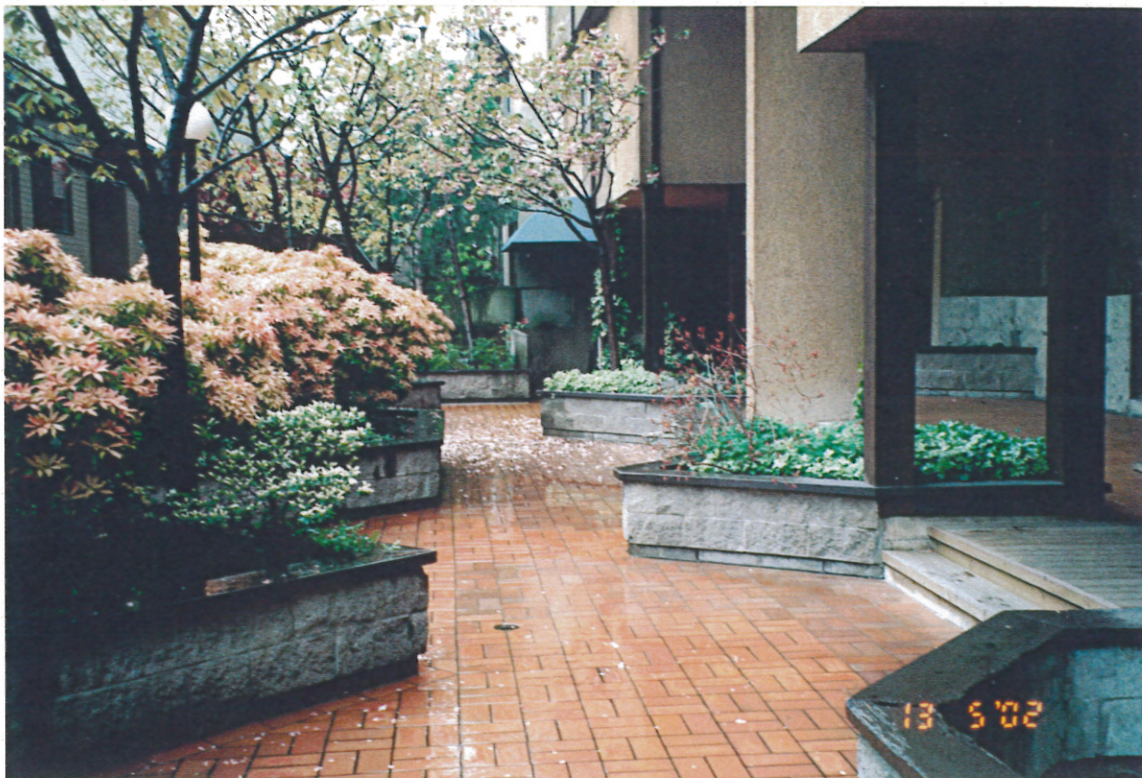
The plaza has a number of concrete block planters that vary in size and shape. One planter had the soil removed prior to our inspection (Photograph 6). No waterproof membrane was observed in this planter (Photograph 7). The block planter walls were generally in good condition with some cracking observed. Moisture and efflorescence staining was noted on the outside face of the block (Photographs 1, 2, and 4-6).

PHOTOGRAPH NO. 1
GENERAL PLAZA AREA LOOKING EAST

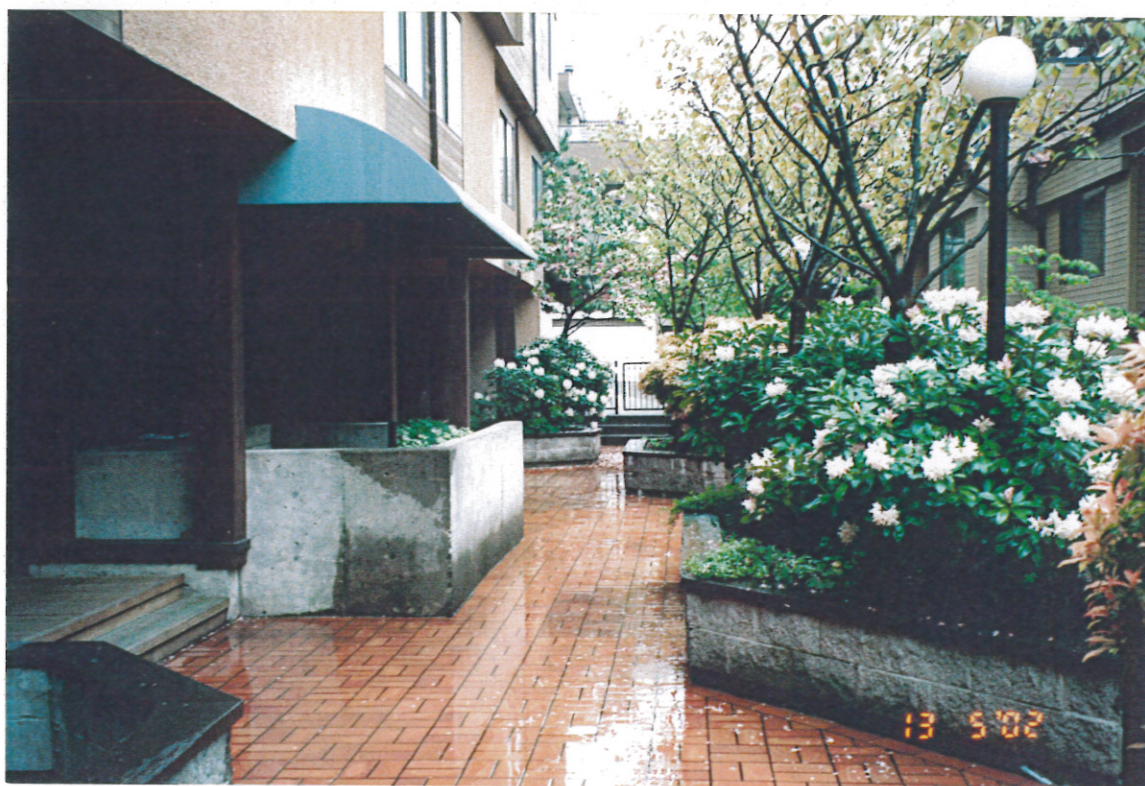
PHOTOGRAPH NO. 2
GENERAL PLAZA AREA, LOOKING WEST TOWARDS ALDER STREET

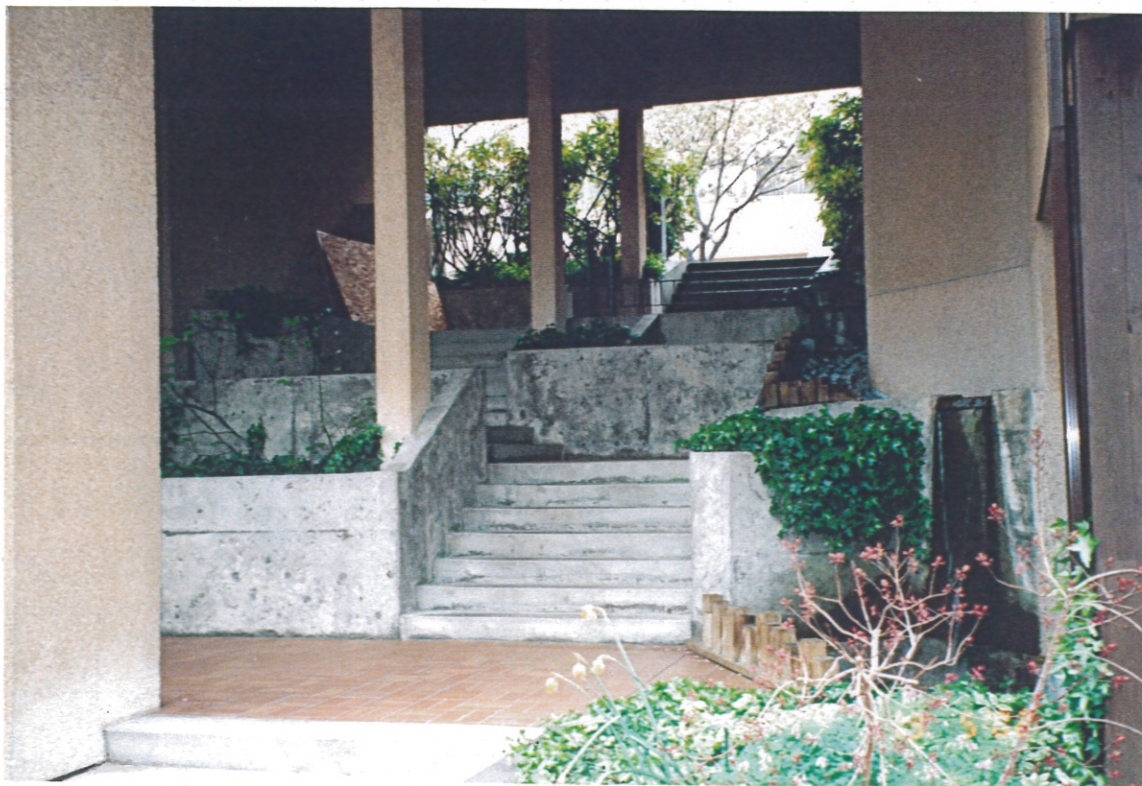
The courtyard plaza suspended slab is a long narrow portion of the development situated between wings of low-rise residential strata units, abutting the north and south edges (Photo 1 & 2). The plaza area is used to access all residential suites. The suspended slab is located over the secured parking for the residential units. The property is situated on a steep upward slope from north to south with vehicle entrance to the parkade located from the back alley on the north side. The pedestrian entrance to the plaza slab is from the side street (Alder Street) or from stairs located in an alcove entrance off 7th Avenue (Photograph 3). Pedestrian access to the parkade below is via two stairwells located within the plaza area.

PHOTOGRAPH NO. 3
ALCOVE ENTRANCE TO PLAZA AREA OFF 7TH AVENUE, LOOKING SOUTH
