**Reserve Fund Study
Marina Place, Strata Plan VR 447
1181 – 1199 West 7th Avenue and
2250 – 2268 Alder Street, Vancouver,
B.C.**

McArthur Vantell Limited Report # 1499.500

July 18, 2012

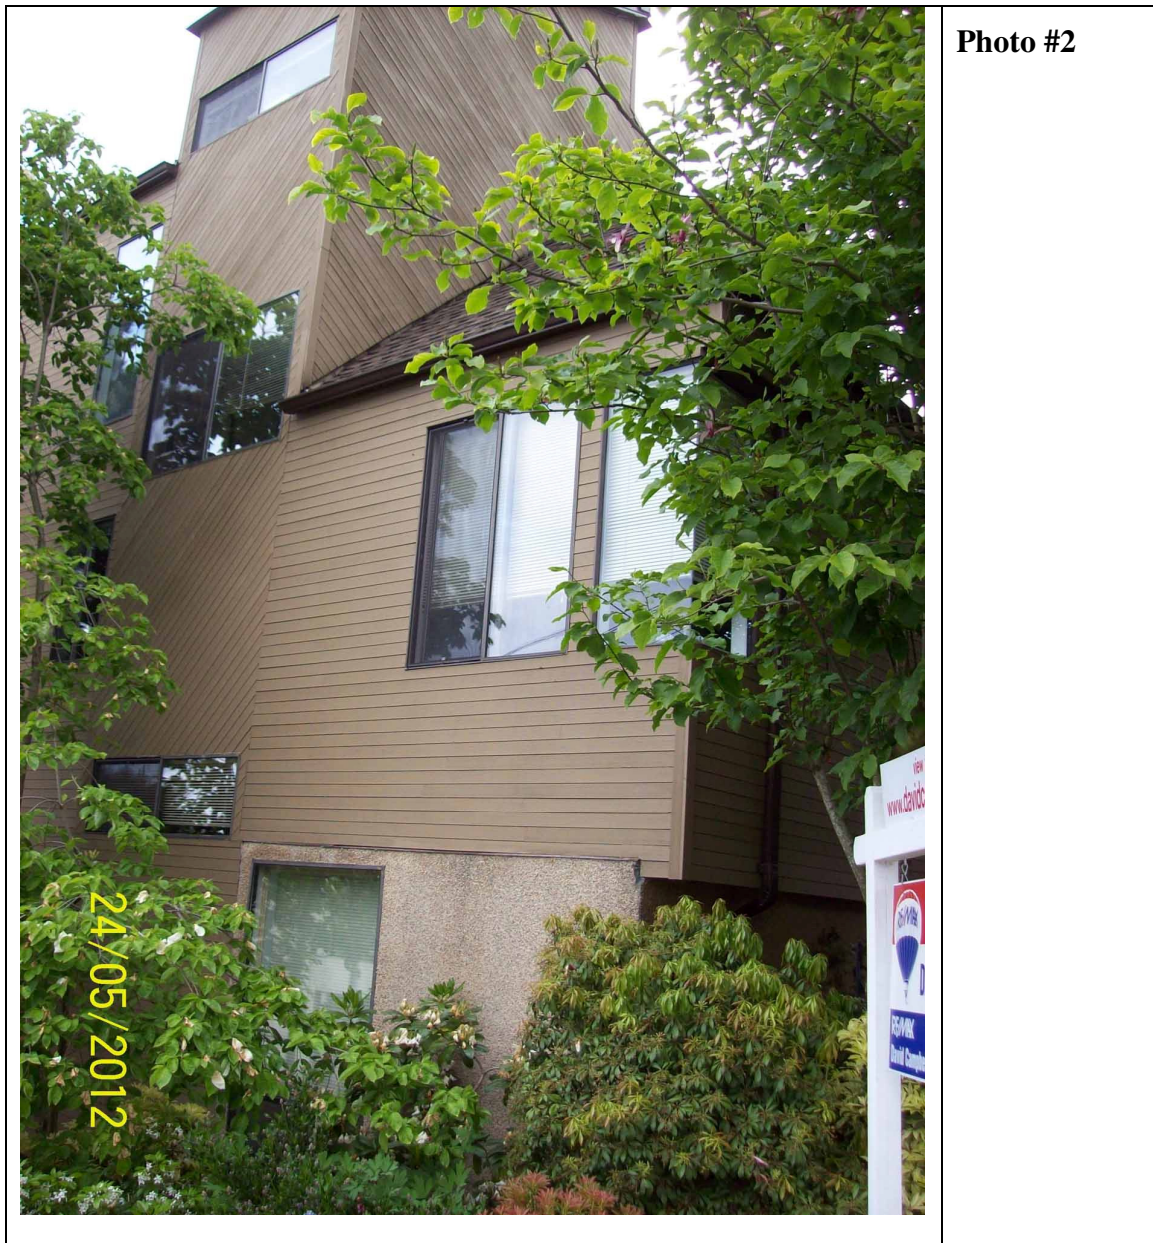
Photo #1

Marina Place, constructed circa 1977, consists of two buildings surrounding a large interior courtyard with a total of 20, two-storey residential townhouse units on a one level parking garage (photo 1 & 2). The exterior cladding is stucco and cedar siding.
