Our File No. GT-006-10-A
May 18, 2010

Re: Strata Plan BCS 2645 – Tapestry
750 West 12th Avenue and 2851 Heather Street, Vancouver, BC
- Building Envelope Maintenance Review Report

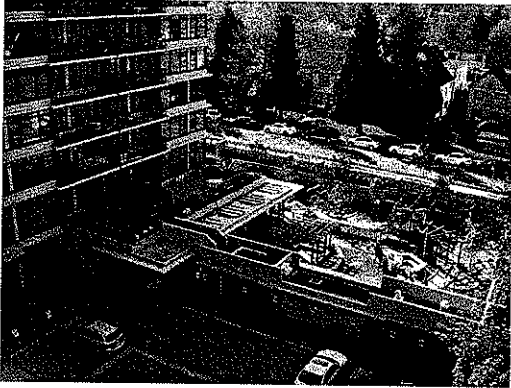
ITEM	DESCRIPTION	PHOTOGRAPH
2.1	Tapestry is a predominantly residential complex including a 10-storey high-rise (building address is 2851 Heather Street) and a six storey mid-rise (building address is 750 W 12 th Ave). Both buildings are constructed over a two level concrete parking garage. The amenity rooms are located on the first floor level. The Tapestry complex has 230 Units (136 in Heather building and 94 in W 12th Ave building). The Child Daycare Centre for 96 children is located at the Heather building.

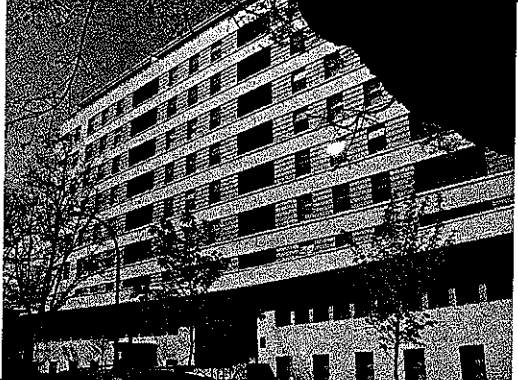
2.2	The exterior walls are mainly of poured concrete with some wall clad with brick and/or stone. Several sections of the building are window walls with spandrel panels. We can not comment how the wall assemblies were constructed and detailed because building envelope details were not provided for our review.

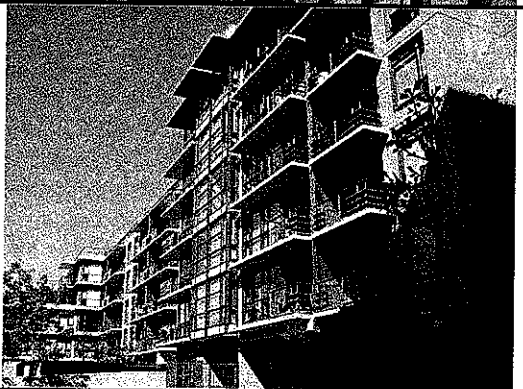
2.3	Most of the Tapestry units have balconies/decks with aluminum and glass guardrails typically secured directly into the balcony/deck slab. Some of the aluminum and glass guardrails were mounted into the interior face of the parapet wall. The balconies are protected with a liquid applied membrane. Some units have decks over conditioned space, which are protected with roof membrane and pavers.

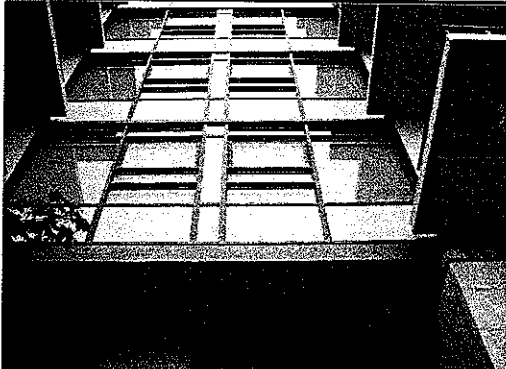
2.4	<p>The residential windows are aluminum frame, thermally broken punched windows with double glazed sealed units manufactured by Starline Windows. The window walls with spandrel are present at many wall sections. Prefabricated metal flashing is installed at the sill. At the head sealant joint was provided at the window and wall interface. The storefront windows are installed at the ground floor areas.</p>

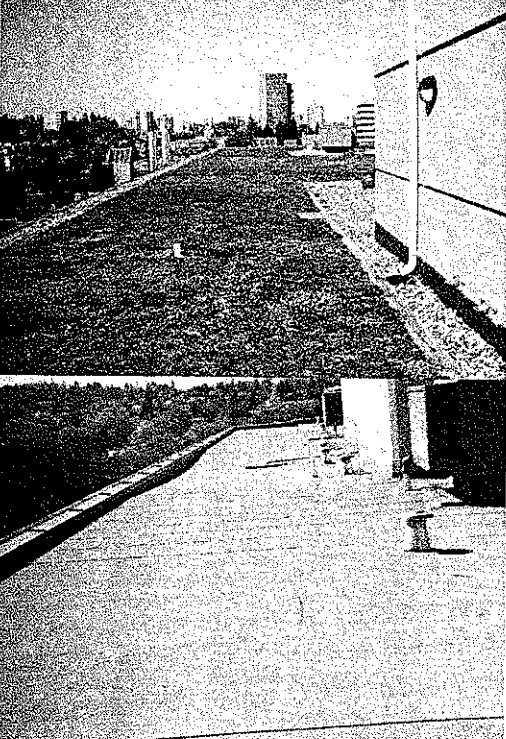
2.5	<p>There are two type of roofs in Tapestry complex:</p> <ul style="list-style-type: none"> • 2851 Heather Street building is covered with a torch on membrane • 750 W 12th Ave building is covered with a green roof. • Various building vents are projecting above the roof surface. Most of the vents discharges are located on exterior walls.
