**Re: Strata Plan VR 2781 – Westpointe
3210-3280 West Broadway, Vancouver, B.C.
- Building Envelope Condition and Moisture Probe Survey**

**REPORT ON
BUILDING ENVELOPE CONDITION
AND
MOISTURE PROBE SURVEY**

**AT
Strata Plan VR 2781 – Westpointe
3210-3280 West Broadway
Vancouver, B.C.**

File No. S03-092

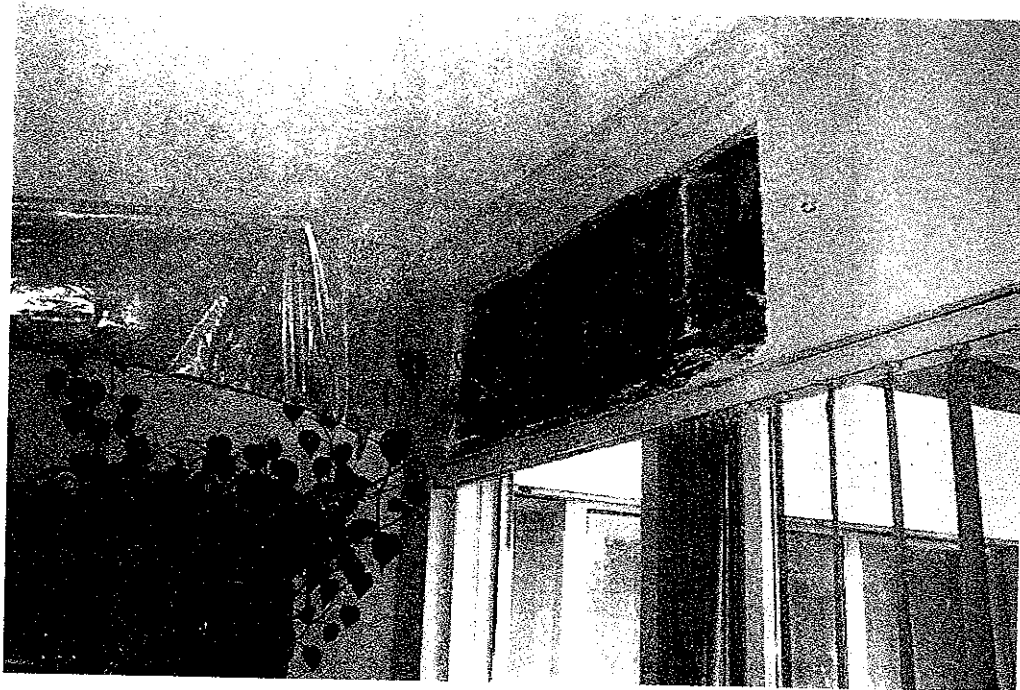
Photo No. 25 and 26

- .1 Advanced fungal growth and wood frame deterioration was observed in the east-facing wall above the patio sliding door header, and in the ceiling approximately three-quarters of the way across the living room at the southwest corner of the building (**Photos No. 25, 26, and 27**).
- .2 It appears that water ingress is occurring through the balcony membrane beneath the patio door of Unit 302, and at the east balcony parapet of Unit 302. Further flood testing of the balcony will confirm the point of ingress, however the wood frame repairs which are required in these wall and ceiling areas will require the replacement of the roof membrane and re-cladding of exterior walls.
