# Building Envelope Assessment

**VR992**  
**Ocean Vista**

June 23, 2013

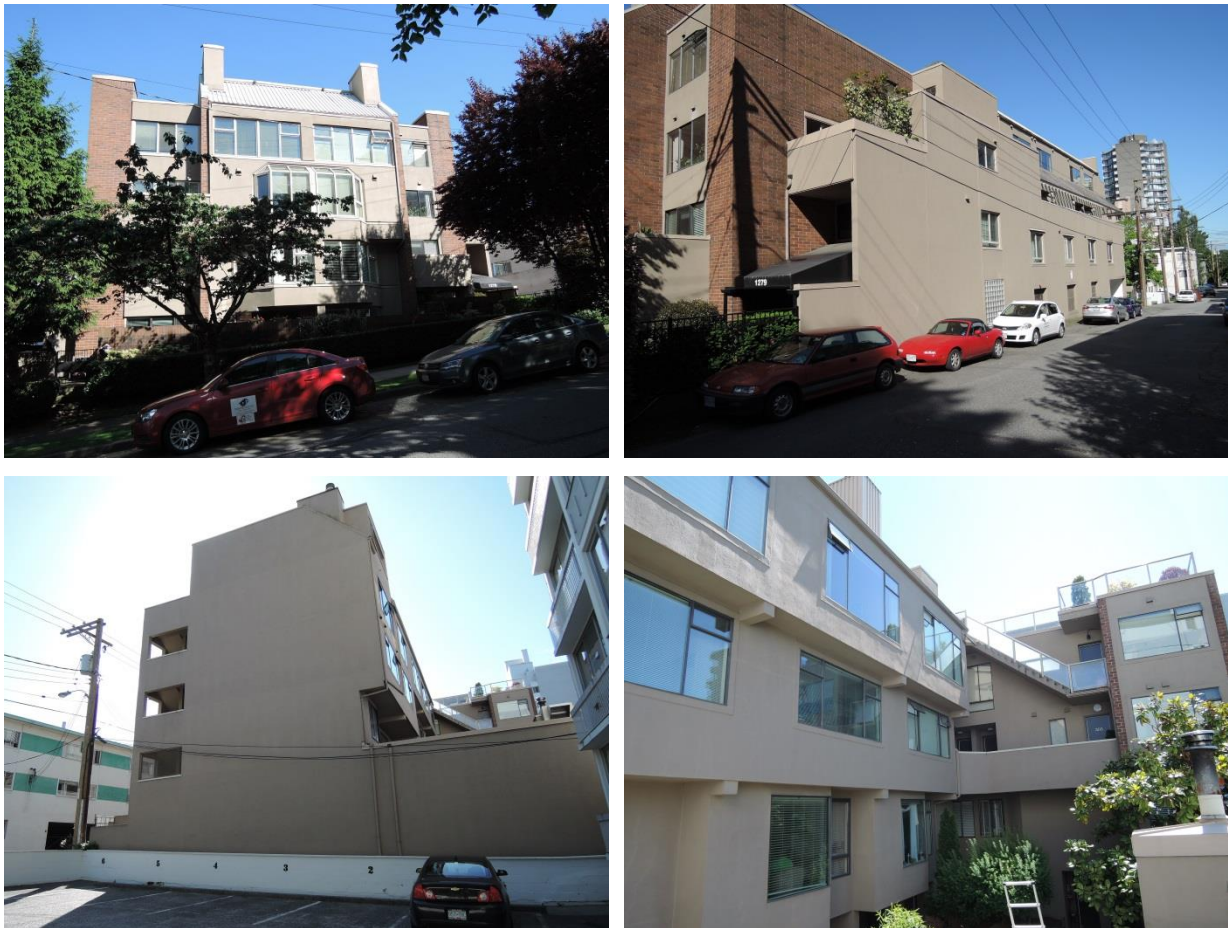
**Fig 1 – East facing front with main entrance (top left), north face with car park entrance (top right), west facing rear profile (bottom left) and central court yard area (bottom right).**

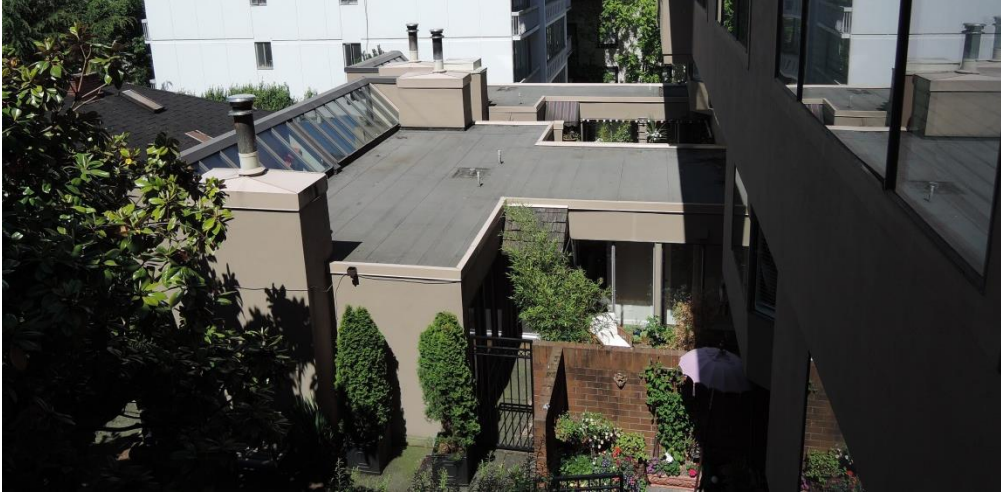
**Fig 2 – View of two single story units (104,106) and the flat roof above them.**

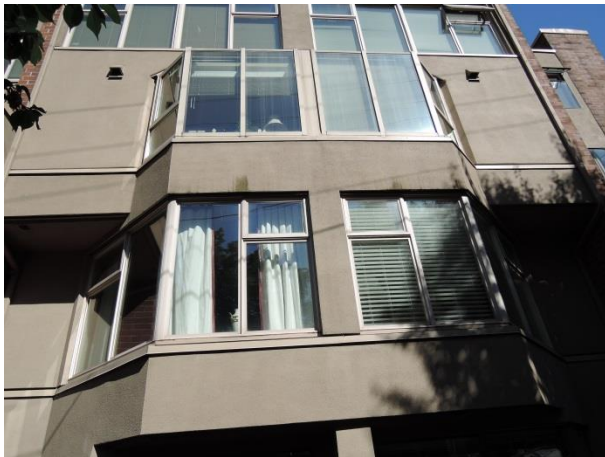
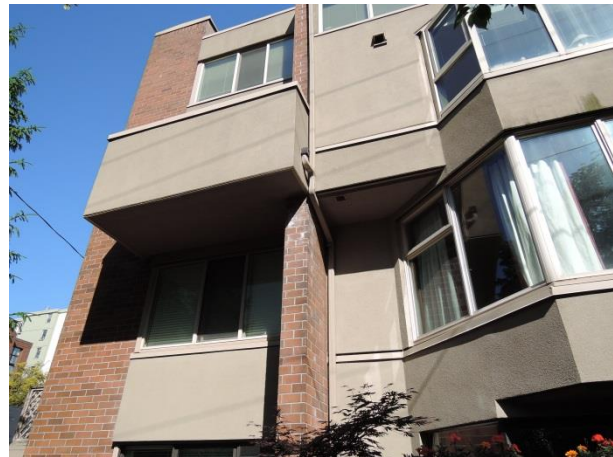
**Fig 11 - Upgraded rain screen system and windows (left). Older window and face screened stucco are shown at upper right. Third floor balcony and window upgrades with brick veneer transitions (right).**

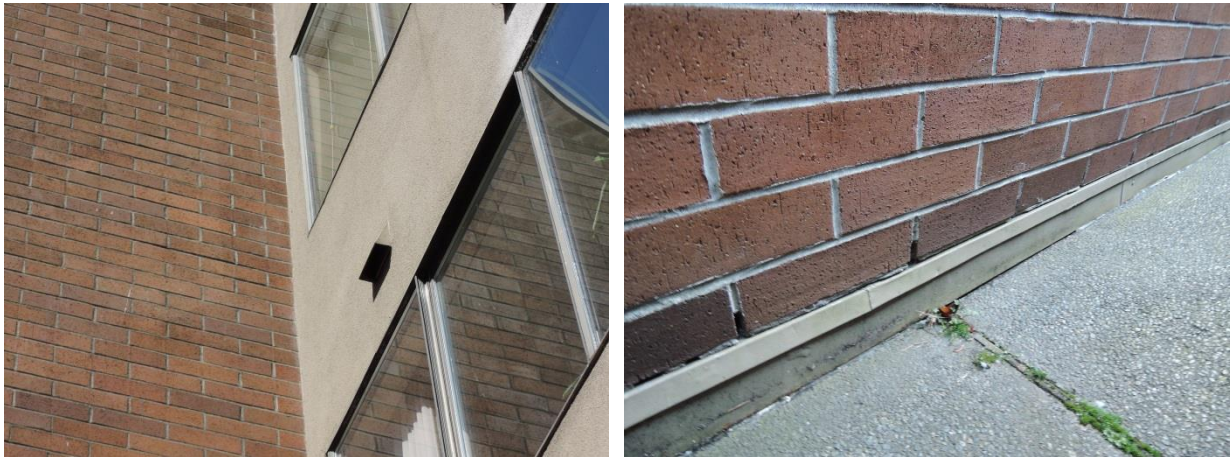
The brick veneer cladding appears to be performing well and there is adequate provision of weep holes and grade flashing to facilitate the run off of water that penetrates the brick surface. Transitions between the stucco and brick veneer are caulked. It is not known if the caulked joints have been replaced as part of a maintenance schedule, but visible caulked joints (see Fig 15) appear to be deficient.

**Fig 13 – Brick veneer and stucco transitions and older windows (left). Weep holes and grade flashing are visible at grade on the south face (right).**

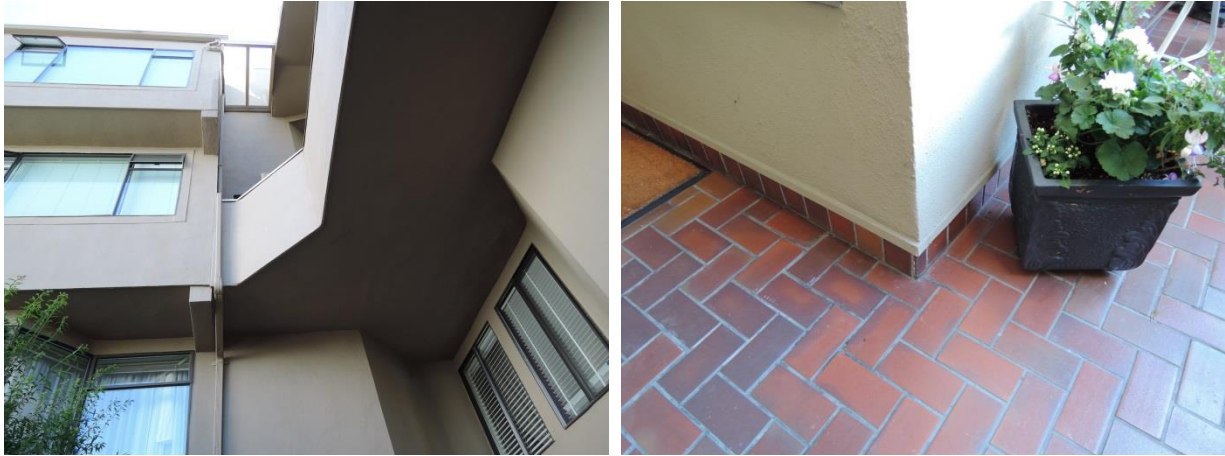
The cladding on the west face of the building that houses units 101-103 and 109 on the 1<sup>st</sup> floor and units 301-303 and 309 on the 3<sup>rd</sup> floor is a combination of stucco and brick veneer. Both wall finishes have base flashings installed and are in reasonably good condition due to the sheltered position.

Fig 15 – South face to the left and west face to the right. Stucco terminated at tile and flashing on the west face (right).

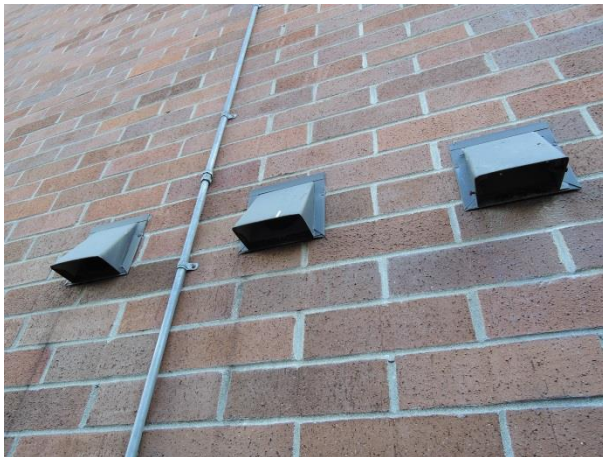
The brick veneer on the other south face (units 101-103, 109 and 301-303, 309) has vents that were installed without caulking provisions. Moisture readings taken adjacent to these penetrations were not significant.

**Fig 24 – Brick veneer on the south face at vents.**

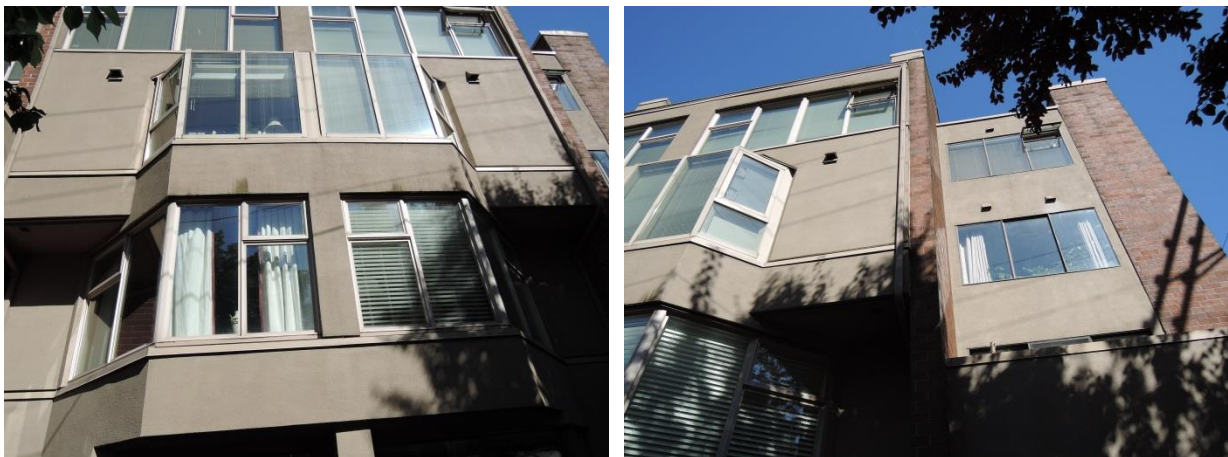
The east face of the building has a complex window arrangement with a combination of newer and original windows. The newer windows are installed into a rain screen wall assembly with suitable flashings and transitions to the stucco face.

**Fig 26 – Complex window installation and flashing details at rain screen assembly (left). Comparison of older style window configuration (right).**

By comparison, the older style windows on the portion of this face that is not rain screened are prone to moisture penetration at transitions and flashings. The stucco finish on the lower edges of the bay windows on the east face shows signs of water retention. The visible signs consist of rust at the drip edge flashings; there is also moss and algae growth.

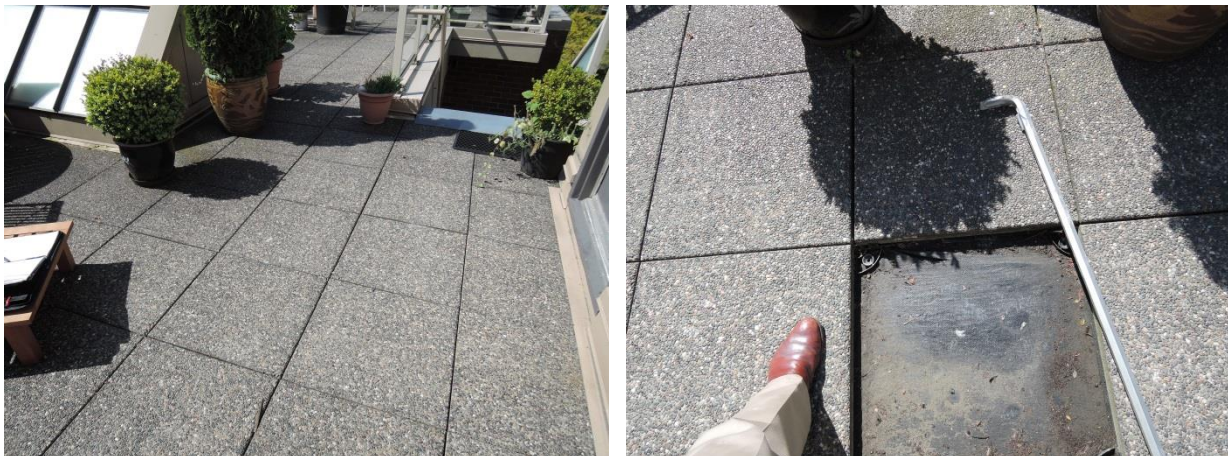
**Fig 28 – Paved roof deck area and stairwell access to a single unit (left). The filter cloth membrane visible under pavers (right).**

The installation of the roof deck pavers was a recommendation from the BEA conducted in 2000. Water penetration of the roof deck has occurred on the south west side, above the stairwell as shown in the left side view in Fig 29. It is difficult to determine the cause of the water penetration at this point but there are many planters that are watered by tenants that may be responsible for increased water levels in the wall assembly in this area.

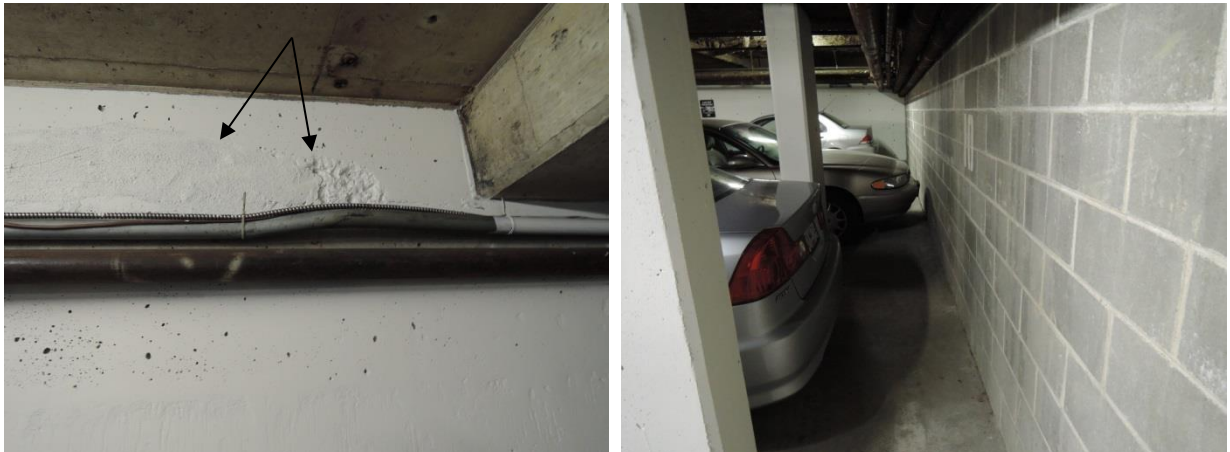
The foundation walls are constructed from poured concrete and concrete blocks. There is one small area of spalling concrete that has been repaired. There was no visible evidence of further deficiencies.

Fig 37 - Foundation wall repair (left at arrows) and the condition of concrete block foundation (right).

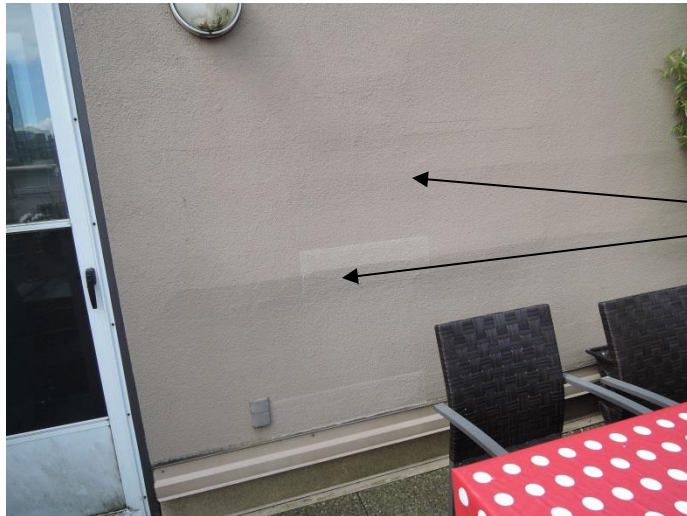
Readings were taken at the peak of the bulge (if present) and 1' above it. If no bulge was present, the readings were taken at similar locations (2' & 3' above grade).

**Fig 43 – Area of stucco where ballooning has occurred.**

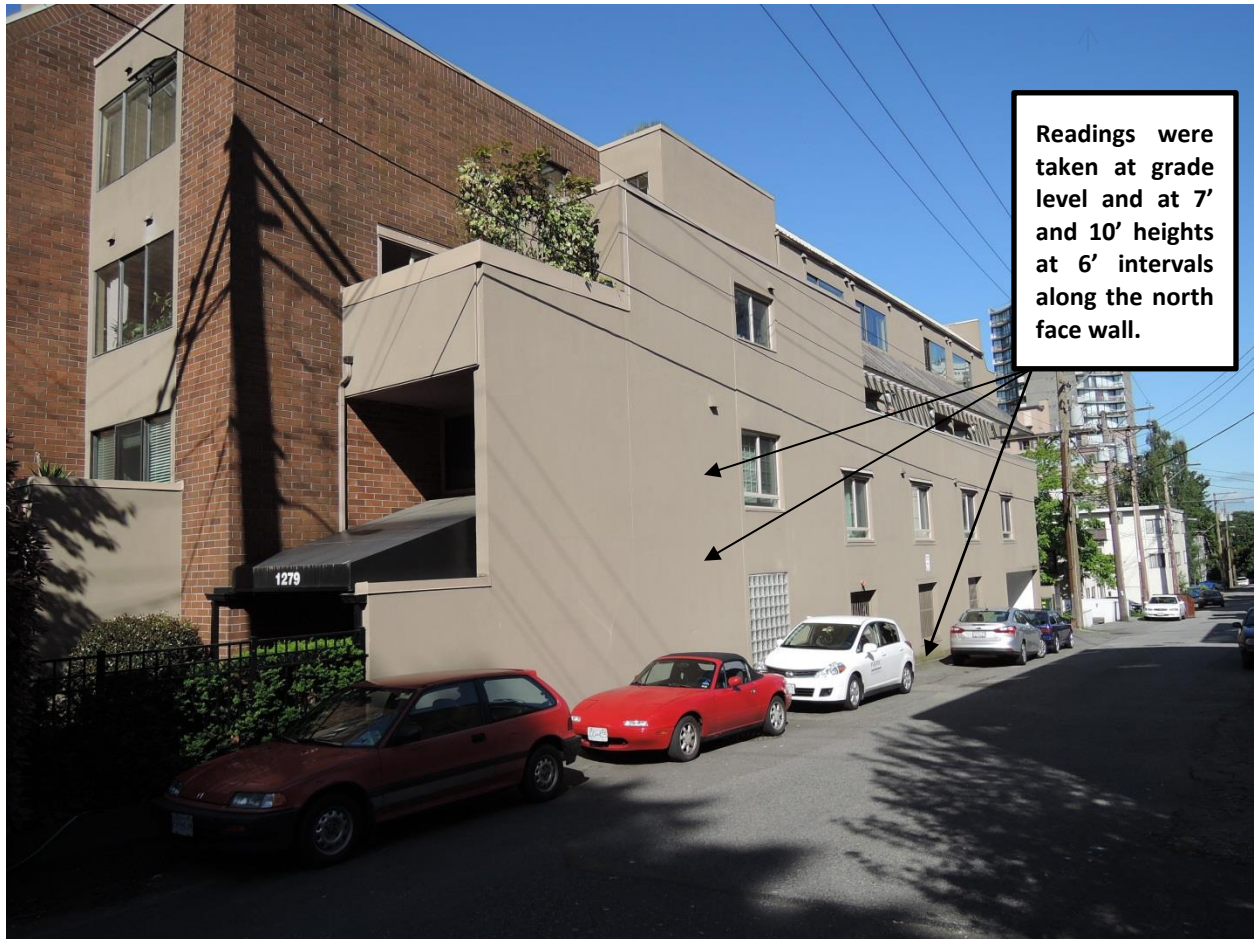
Fig 44 – Readings were taken at various locations on this north wall.

NORTH WALL												
Location	Readings At Multiple Locations											
10'	215	219	210	208	211	-	-	222	-	215	-	209
7'	208	198	208	208	796	243	208	211	180	206	208	191
Grade	628	564	554	728	554	531	779	867	810	726	567	-
