# **VR992 OCEAN VISTA**

**1279 Nicola Street, Vancouver, BC**

**DEPRECIATION REPORT  
NOVEMBER 2013**

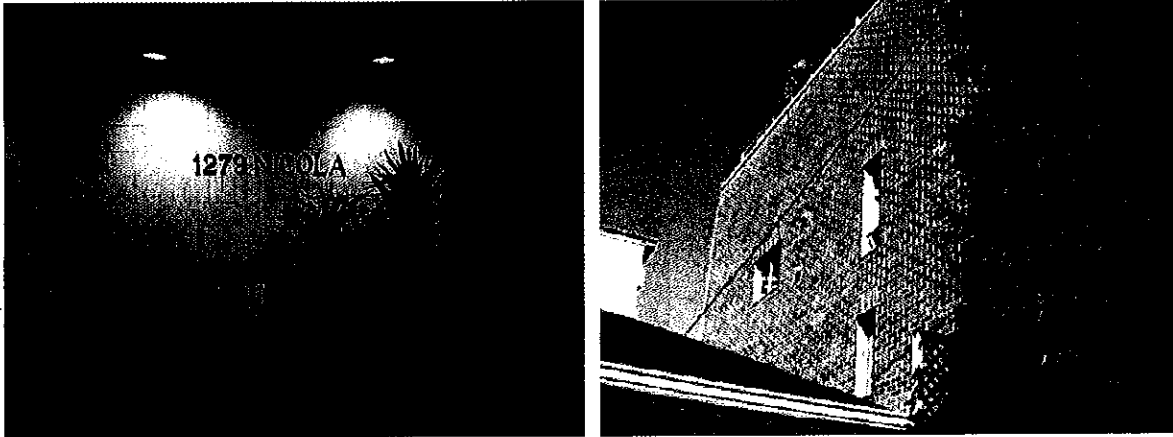
The exterior walls on the south and east sides of the building are red cement brick. The brick walls were power-washed and sealed in August 2013. Transitions are sealed with caulking. Cleaning

Fig 9. Building entranceway (left). Brick exterior wall on the southeast side of the building (right).

and sealing of brick surfaces is recommended every ten years. See the Costs section for the 2013 cost.

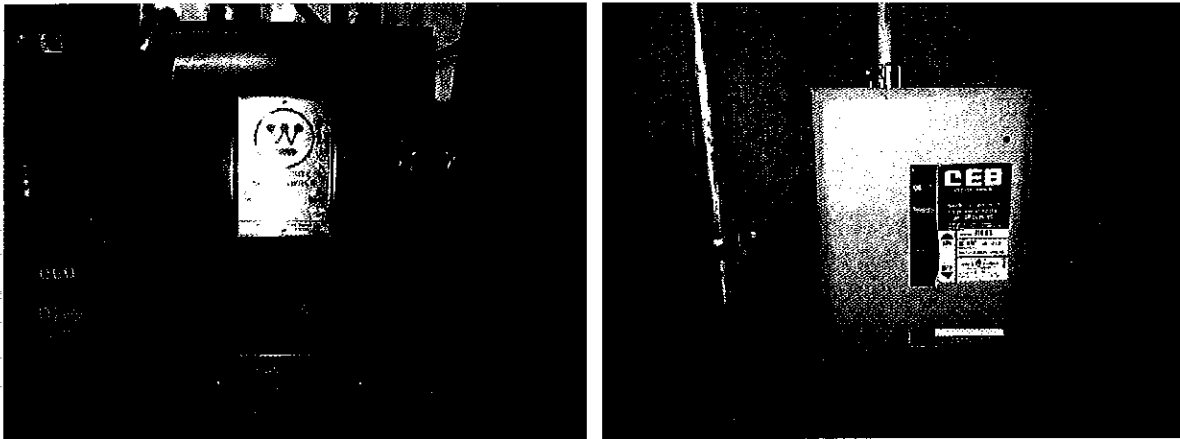
A Westinghouse H1422 60-amp disconnect services the elevator main power supply. It is located in the elevator room of the underground parkade. A CEB model F1010N 30-amp disconnect provides isolation and fuse protection for the elevator controls.

Fig 18. Elevator main disconnect (left). Elevator control disconnect (right).

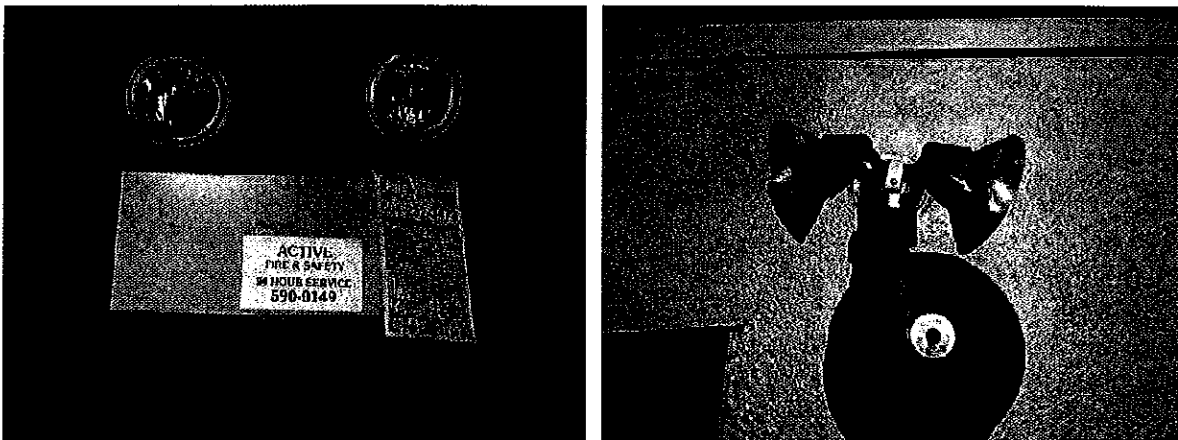
Battery backups with dual head lamps are located throughout the building to provide lighting in the event of a prolonged power outage. Emergency lights were last inspected in May 2013. These are inspected and maintained by Vancouver Fire. Two single head remote lights are also in the parkade stairwell.

Fig 22. Dual head battery back-up emergency light (left). Dual head spot light with motion detector (right).

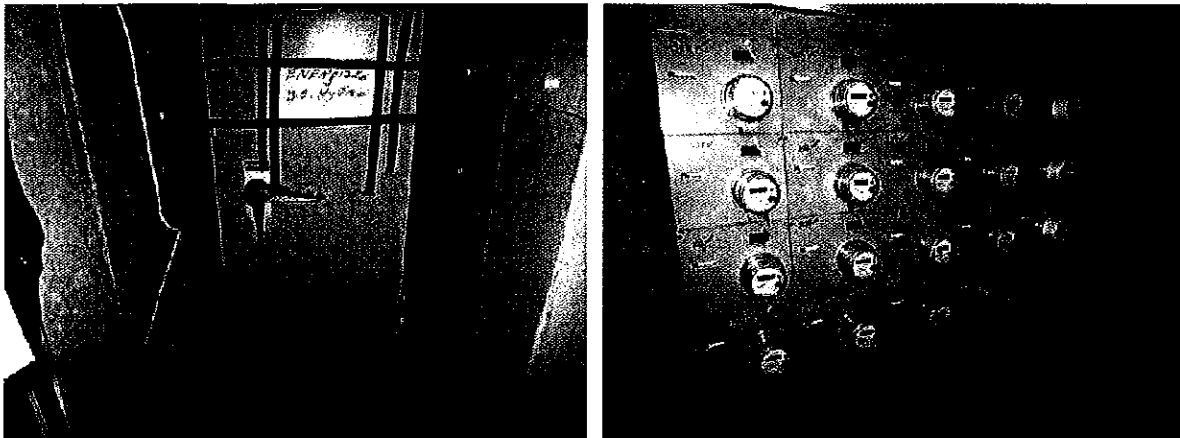
The 600 amp Sylvania model A5036N main building disconnect is the initial point at which electricity enters end-user equipment. It is the heart of the building's electrical system. It is located in the electrical room. We recommend annual tightening of all electrical connections.

The Sylvania model MC1244-200 meter stacks are the point at which building power becomes the end-user's responsibility. They are in the electrical room. Each meter is protected by a 150 - 175 amp breaker. There are no moving parts to this equipment. Wear is commonly caused by loose connections which occur over time from natural expansion and contraction. We recommend annual tightening of all electrical connections.

Fig 26. Main building disconnect (left). Unit meter stacks (right).

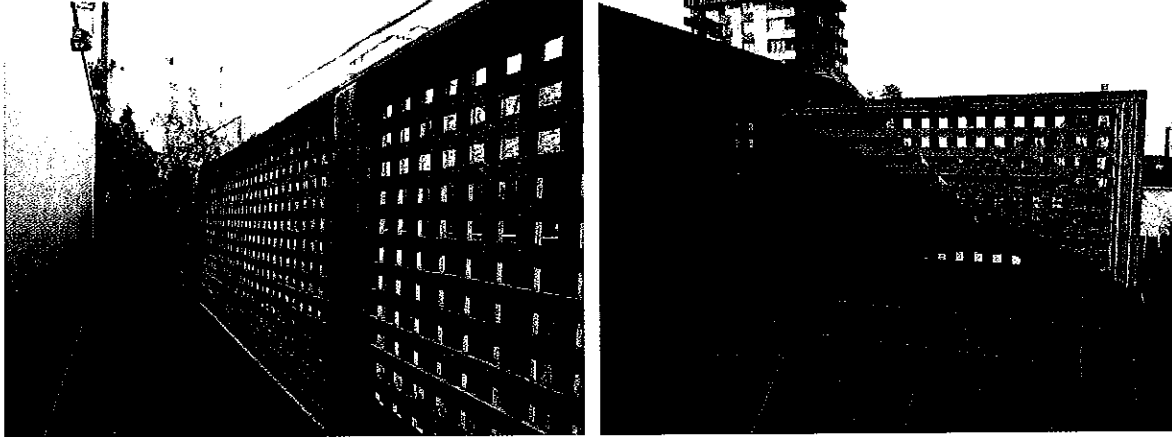
Cedar lattice fencing panels are situated along the south perimeter concrete wall. Some of the lattice panels are covered with plants. There is two cedar privacy fences between patios and at the front of the building. In general the cedar lattice fencing is weathered.

Fig 30. Cedar lattice fencing over south concrete wall (left). A cedar lattice panel between patios (right).

We recommend painting exterior wood components every ten years to extend their life expectancy. See the Costs section for a budget estimate.

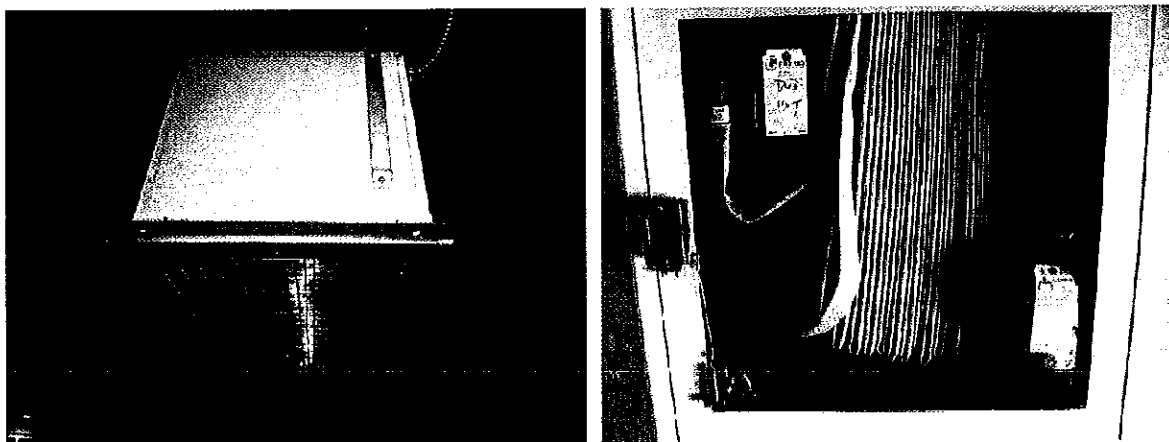
Exhaust fans maintain a negative airflow in the space they are in to ensure there are no noxious gasses present. They also serve to keep the air from getting stale and prevent excessive moisture from building up. A Greenheck SP25 exhaust fan servicing the mechanical room was found to be broken at the time of inspection. A Greenheck SP60 exhaust fan in the elevator room was functioning normally.

Some of the fire extinguishers were inspected by Vancouver Fire in May of 2013. Others have old tags with outdated inspection dates. There is also a single fire extinguisher in the electrical room and two standpipes are located at the building front entrance.

Fig 36. Elevator room exhaust fan (left). Fire hose station located at the west stairwell (right).

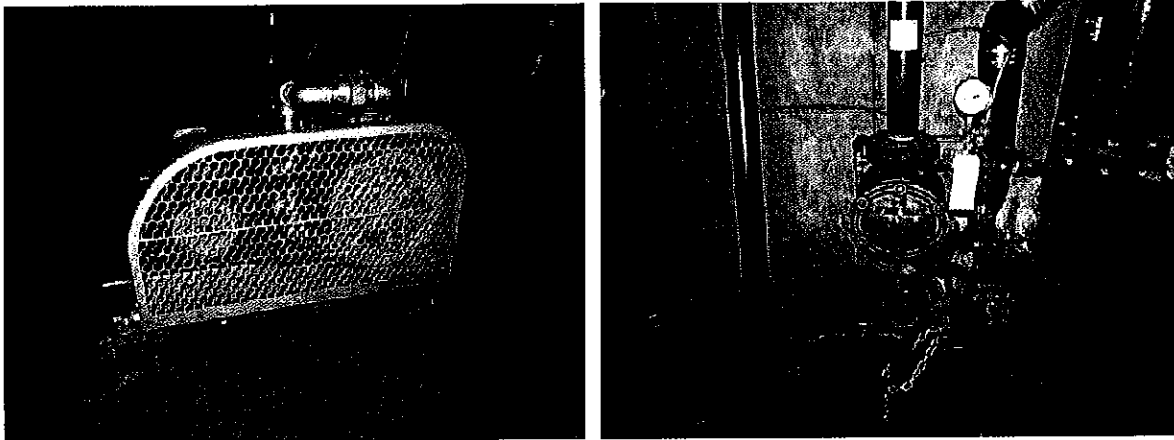
The dry pipe sprinkler system is located in the mechanical room. It services the underground parking area. The system consists of an Astra A175W 3-inch valve and a Swan compressor.

Fig 38. Swan compressor (left). Dry pipe sprinkler system with 3-inch valve (right).

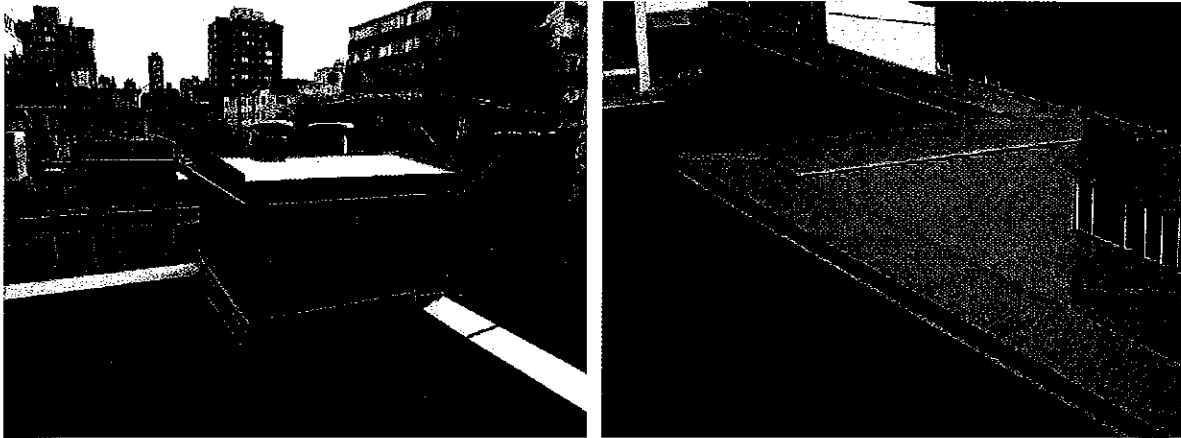
Enamel-coated tan cap flashings cover the parapet walls and chimney chases.

Fig 39. Brick chimney chase with cap and exterior flashings (left). Cap flashings cover the perimeter parapet walls (right).

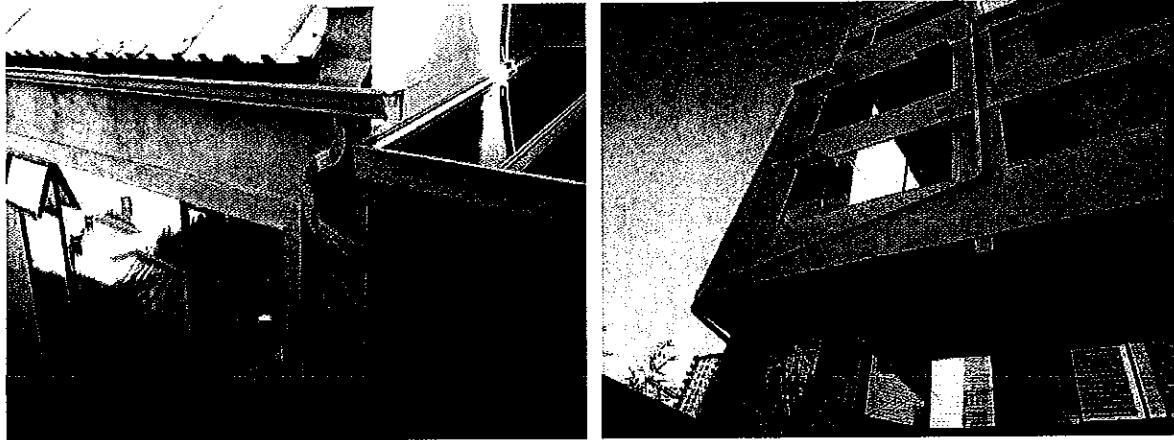
Aluminum gutters with 4" downspouts are installed at the eaves under the sloped roofs. Rounded downspouts are present on the east side. The gutter system is painted tan.

Fig 41. Gutter system under a sloped roof and glass canopy section (left). A view of a downspout on a south facing wall (right).

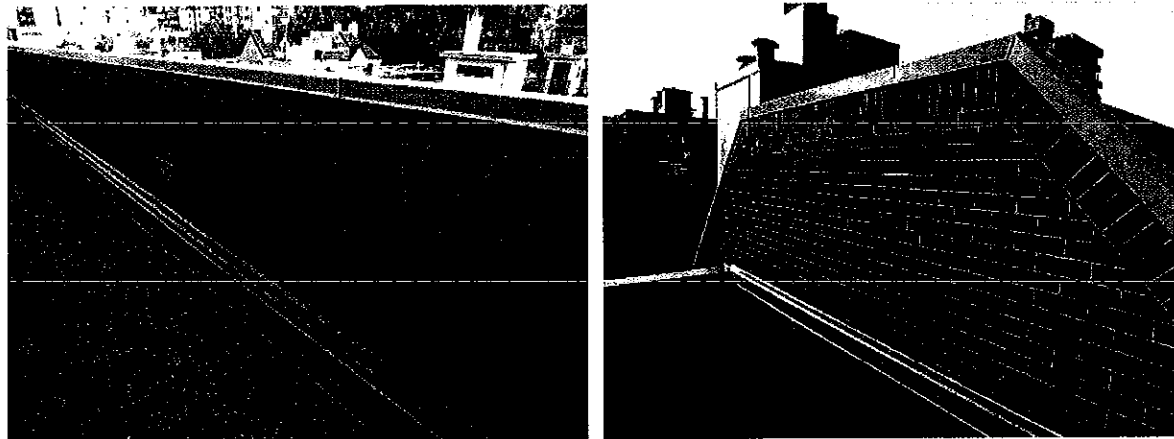
Parapet walls are present around the perimeters of the building at flat roofs and some sloped roof sections. Parapet walls are wood with painted stucco or brick veneer. All walls have tan enamel-coated cap flashings.

Fig 42. Parapet wall adjacent to rooftop common walkway (left). Brick veneer parapet wall (right).

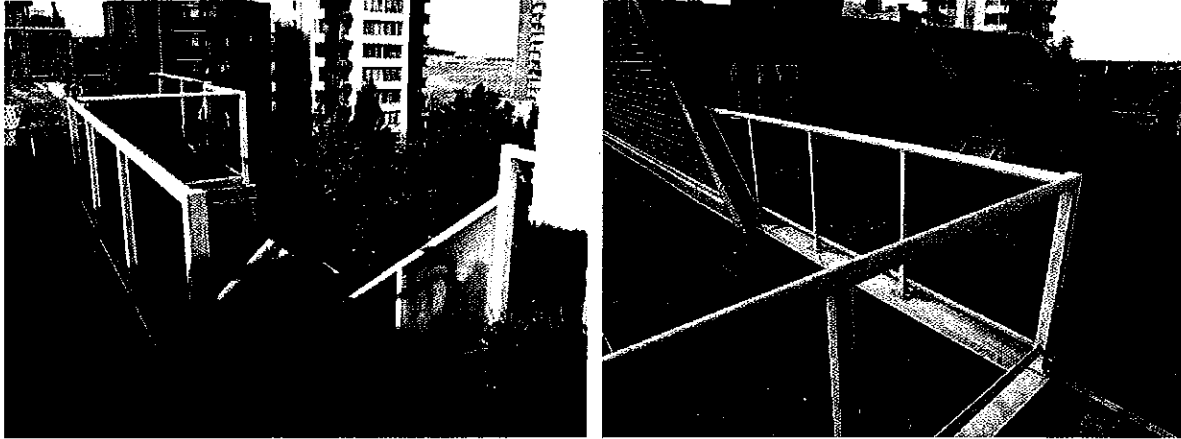
Metal railings with glass panels are mounted to some of the parapet walls on the east side of the rooftop. Railings also safeguard a unit stairwell facing the courtyard and partition between a common area walkway and flat roof section.

Fig 43. Metal railings over parapet walls and back unit stairwell (left). Metal railing between a flat roof and common walkway (right).

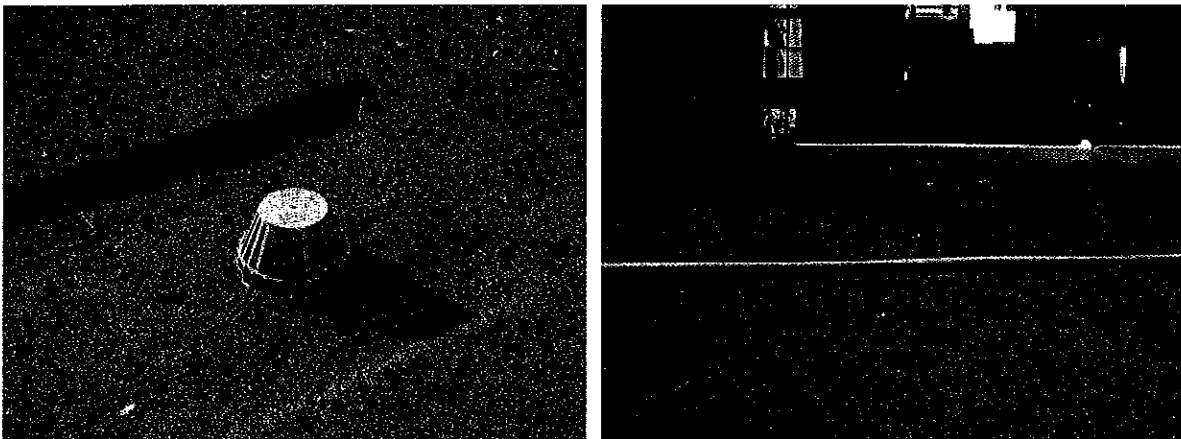
Four of the flat roofs have a single 3-inch spun copper drain that removes water from the section. All drains were clean and free of debris. Flat roofs at the top level have vent ducts to remove rain water to the sloped roof sides. No issues were noted.

Fig 44. Roof drain (left). Rain vent duct on the top level flat roof (right).

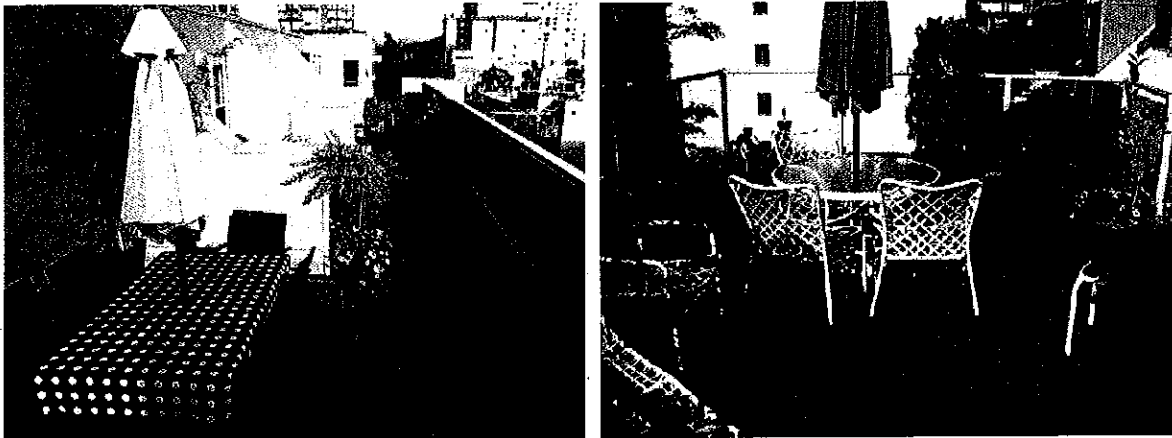
Seven unit patios are on the rooftop. All patios and units are accessible from the east and west stairwells. The patios are separated by walls or metal railings and have concrete pavers for decking. Concrete pavers also make up the common area walkway.

Fig 45. Westward view of a rooftop patio and common walkway (left). Rooftop patio (right).

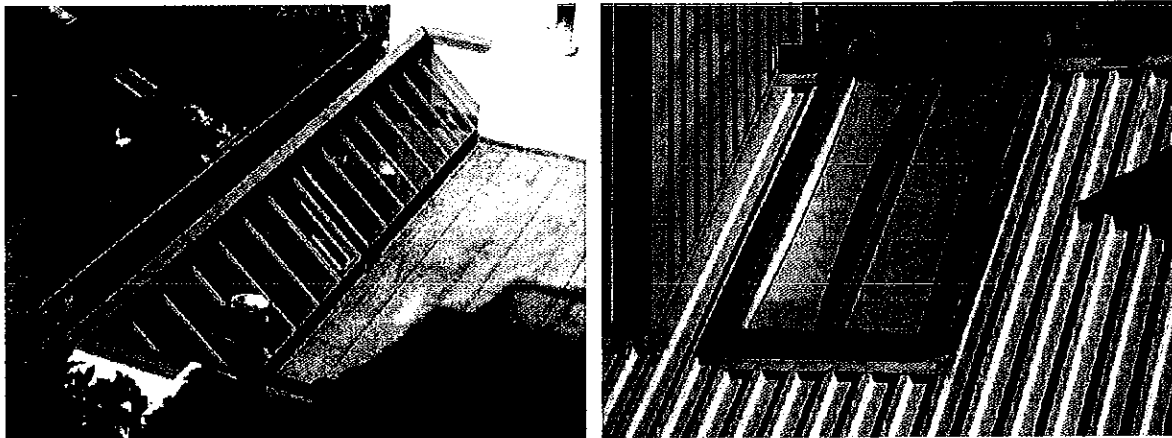
Banked skylights are present on the flat roofs above unit #104 – 106. Four custom skylights in metal frame are also mounted on a sloped roof section of the building. These skylights are approximately 5' x 3'.

Fig 46. Banked skylight section on a flat roof (left). Metal drop-on skylight on a sloped roof (right).

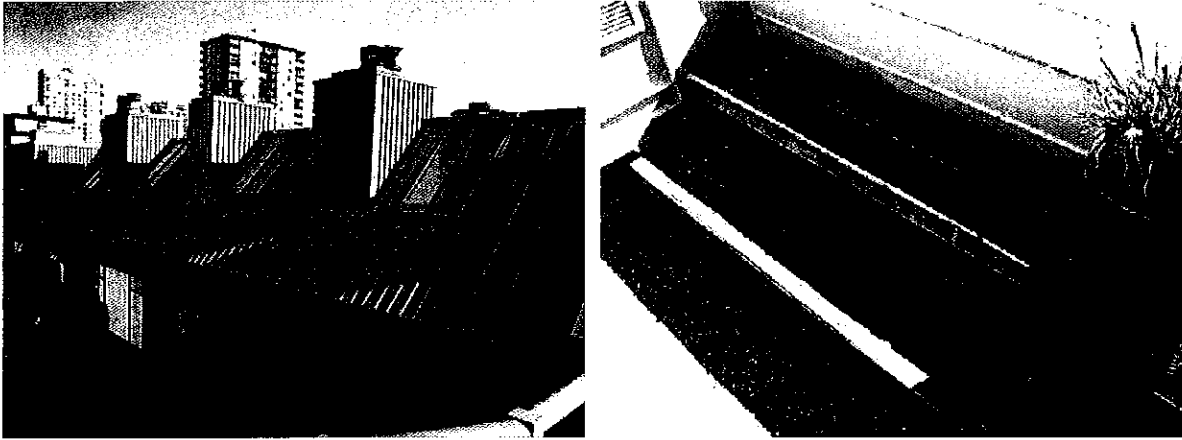
Two sets of pressure-treated wood steps are present on the rooftop. These are located between the north and east sides of the common walkway.

Fig 47. Metal panel sloped roof (left). Wood steps (right).

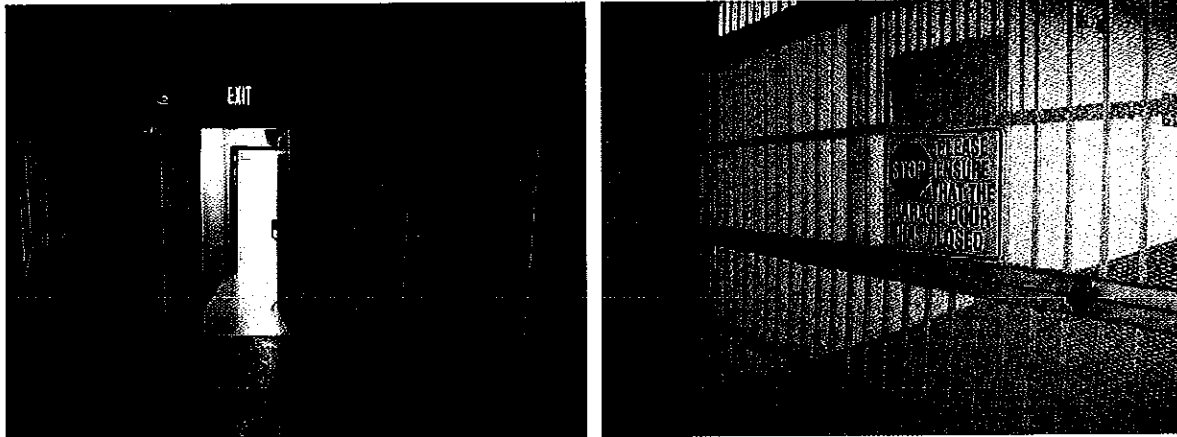
The overhead door is metal, painted white. Overhead doors have an approximate lifespan of 30 years. A budget estimate for future replacement is provided in the Costs section.

Fig 48. Metal interior doors open to the elevator lobby (left). Overhead door (right).

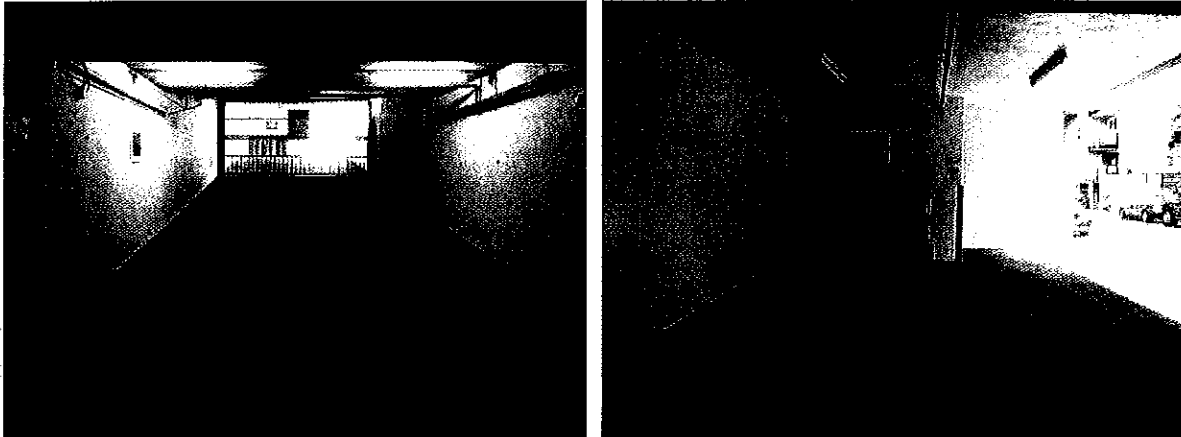
A recycling area is located just outside the overhead door at the parkade entrance. Three large bins are available for disposing of common recyclable materials.

Fig 50. Sloped concrete entrance ramp (left). Recycling area inside the parkade entrance (right).

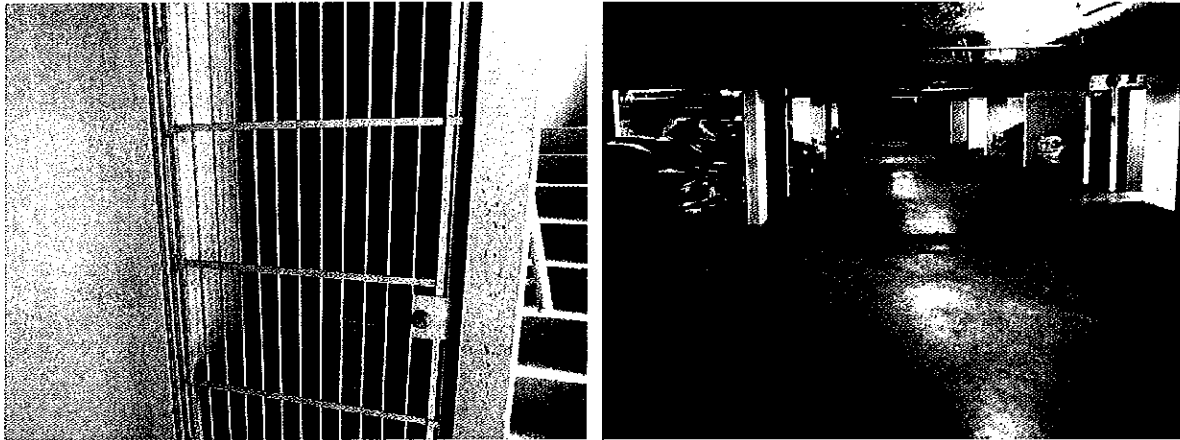
The slab on grade is sealed concrete. It is generally in pretty good condition. There are a few hairline cracks but these are typical of curing and shrinkage after pouring of the slab. No settlement cracks were observed.

Fig 53. Storage space in a corner of the west stairwell (left). Concrete slab on grade (right).

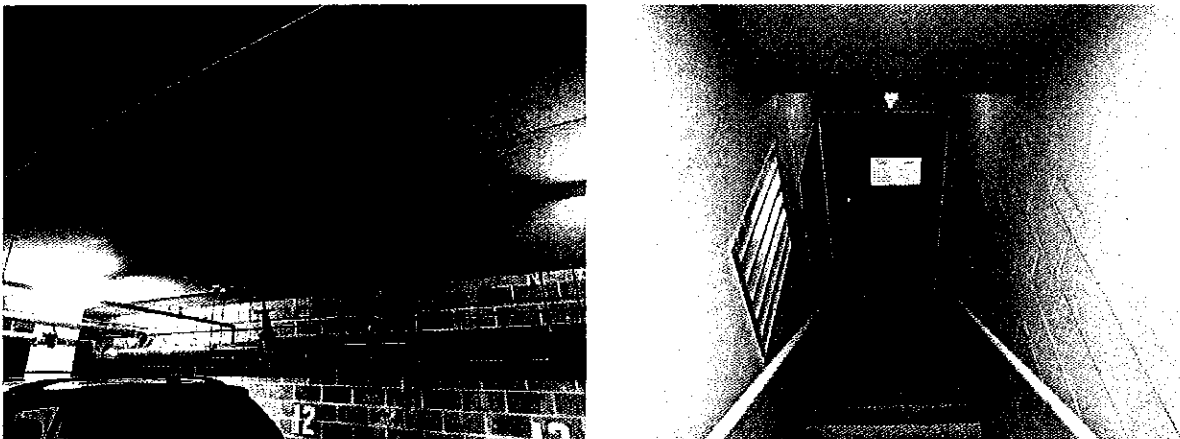
Normal amounts of efflorescence is observed on the suspended slab. Efflorescence is due to water which has passed through the overhead barrier and then deposits its mineralized content upon evaporation or leakage from the suspended slab surface. A small area was observed to have been repaired by epoxy injection.

Two stairwells provide entrance into the underground parkade. The stairwell in the northwest corner provides access to and from the laneway. The stairwell in the courtyard accesses the parkade through the elevator lobby. Both stairwells are clean and well lit. A key is required to enter the parkade from both stairwell doors.

Fig 54. A section of the suspended slab (left). Northwest stairwell at the rear laneway (right).
