## Strata NW 367 Sea Vista Depreciation Report

The Owners, Strata NW 367  
Sea Vista  
15041 Prospect Avenue  
White Rock, BC, V4B 2B5

February 20, 2014

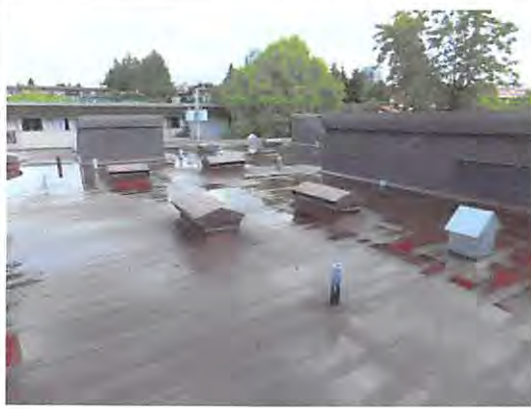
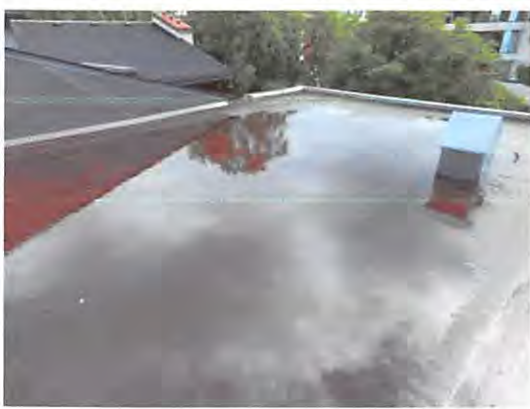
**Financial Review:** Through Strata minutes and financial records, we learned that a roofing project commenced in 2009. Included was the replacement of the torch-on flat roof, the shingled sloped roof, and some inspection work of the roofs. RVB Roofing was contracted for the roof replacement work while Emerald Inspection was contracted for the inspection work. The project cost a total of \$48,147.23 which was funded by a combination of contingency reserve fund (\$15,497.98) and special levies (\$32,649.25). Included was \$5,964 for the replacement of the clerestory windows.

**Visual Review:** It is assumed that the roof was installed according to good building standards.

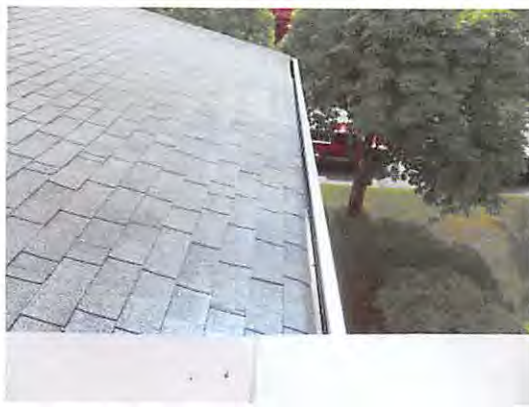
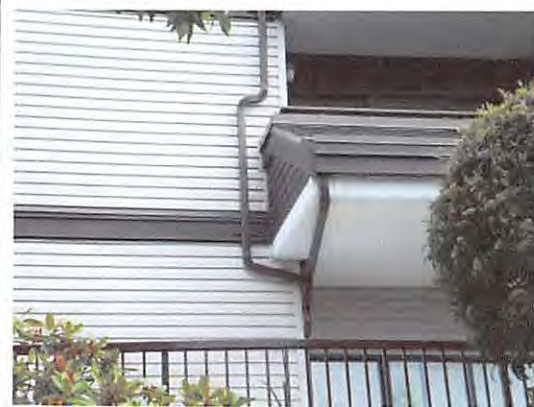
**Financial Review:** Based on the age of the building and the appearance of the gutters and downspouts, we assume that they have all been replaced periodically since original construction. We understand that some realignment and repair work of the gutters were performed by Affiliated Roofers in 2010 for \$3,539.20. Belfor was contracted for some gutter repair work for \$5,592.16 in 2011 to correct some issues found as documented in their Envelope Study dated February 3, 2011. Some more gutter repairs and maintenance work was done later in 2011 by Spanish Banks Renovations for \$1,209.60.

**Visual Review:** Review of the gutters and downspouts was done by visual inspection around the building perimeter and from the top of the flat roof area.

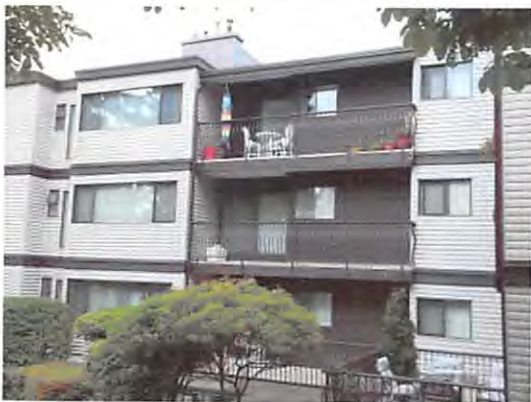
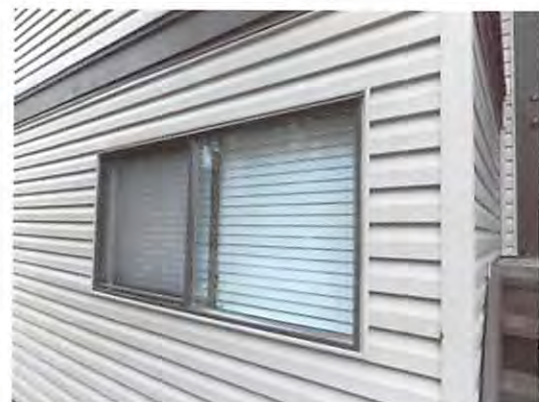
**Financial Review:** We understand that the clerestory windows were replaced in conjunction with the roof replacement project in 2009. Since mid-2009, the Strata has begun prioritizing windows according to their condition in preparation of their replacements. The clerestory windows were replaced as part of the roofing project on 2009 for \$5,964 (refer to EE 1—Flat Roofing). Lundline Glass replaced insulating glazing units (IGUs) for Suites 104, 204, and 205 for \$1,341.76 in 2010 and Belfor replaced windows of the northwest and west back walls as well as the stairway inset where cladding was also replaced. Most recently, White Rock Glass was contracted to replace some window IGUs and patio doors for \$13,007.75 in 2012-2013.

**Visual Review:** We assume that the window design and installation were done in accordance with building code and good construction standards. We were not able to view concealed details behind the window assemblies. We assume there is proper air and vapour barrier provisions and that they were properly installed with sealed seams.

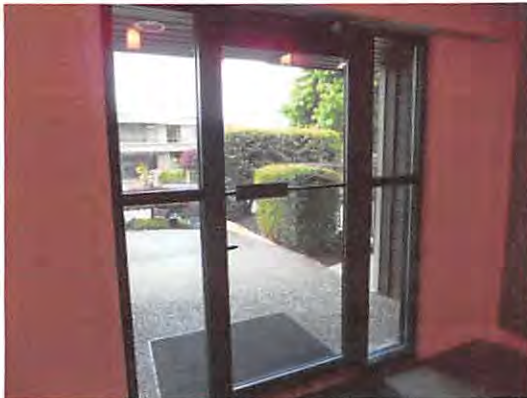
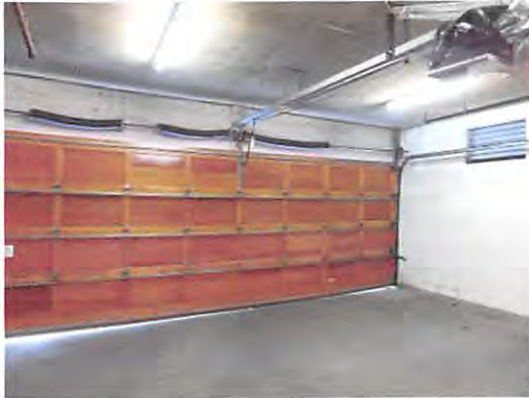
**Financial Review:** With the exceptions of a balcony door IGU that was replaced along with the window IGUs in 2012 by White Rock Glass (refer to EE 5—Windows) and the front door that was replaced during the lobby renovation (refer to I 1—Lobby), we understand all other exterior doors to be original to the building construction in 1975. We are not aware of any major repairs or replacements.

**Visual Review:** We assume all fire-rated doors are consistent with the required fire ratings as required by the local fire authority.

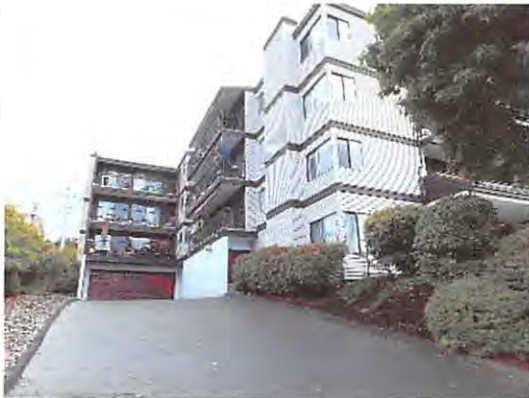
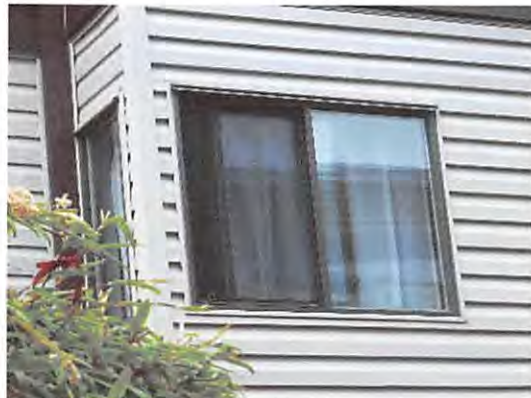
**Financial Review:** Through our review of Strata documents, we learned that Sunrise Painting and Stucco Ltd. was contracted to pressure wash, caulk, and paint the building in 2010. Allside Contracting, a subcontractor to Sunrise, was hired to replace rotten sections of fascia boards on the balconies of Units 201, 203, 204, 301, and 303. The total cost of this project was \$32,130.00 which was funded through a combination of contingency reserve fund (\$700.00) and special levies (\$31,430.00). We understand that the cost also included the painting of the stairwells and parkade.

**Visual Review:** We assumed that the painting and sealant used for the exterior is of an approved material suitable for exterior applications.

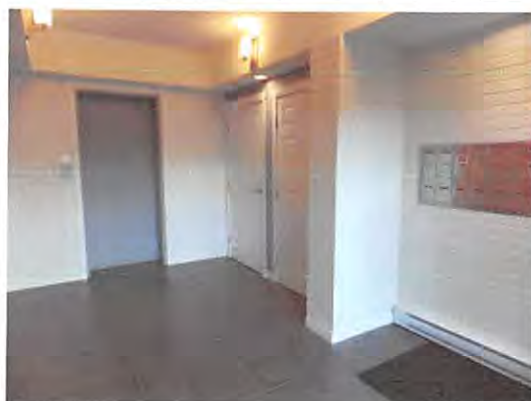
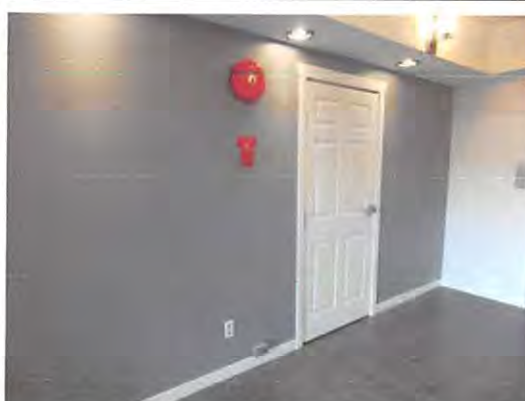
**Financial Review:** We understand the lobby has been renovated in 2013 by Belfor Restorations Ltd. As indicated in the Strata minutes, this project was to be funded from a combination of lobby savings, money from fire safety upgrades, \$3,000 from the money allotted for the building, \$3,000 from the Contingency Reserve Fund and \$8,403 from special levies. We were advised by Council that the work totalled \$21,350.94.

**Visual Review:** Where checked, the walls were free of damage. The flooring was noted to be intact and without missing tiles. We also noted the light fixtures to be consistent and in working order.

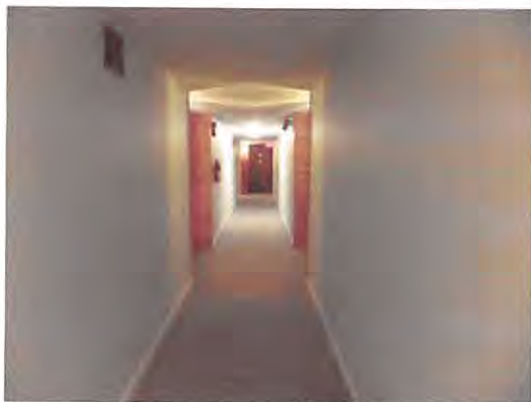
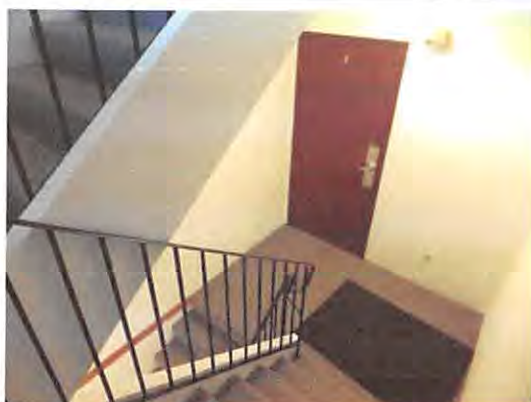
| I 2 – Corridors and Stairwells | | |
|---|---|---|
| <p><b>Financial Review:</b> We were advised by Council that the corridor and stairwell carpets were replaced in 2003 but we are not aware of the costs involved. We understand that stairwells were painted as part of a larger painting project done by Sunrise Painting and Stucco Ltd. in 2010. The total cost of the project was \$32,130 and it included the painting of the stairwells, parkade and exterior of the building as well as some fascia board replacements (refer to EE 7—Painting and Caulking).</p> | | |
| <p><b>Visual Review:</b> Due to the age of the building and the appearance, we assume that the painting of the corridors was also done around 2003.</p> <p>We noted no major damage to the interior finishes within the corridors and stairwells. Where checked, the carpets were free of snags or tears. Where checked, the handrails were secured. The painted walls and ceilings were consistent and we noted no significant discolouration. The lighting of the corridors and stairwells were in working condition and appeared to be sufficient for the corresponding areas. Overall, the corridor and stairwell components appear to be well maintained.</p> | | |

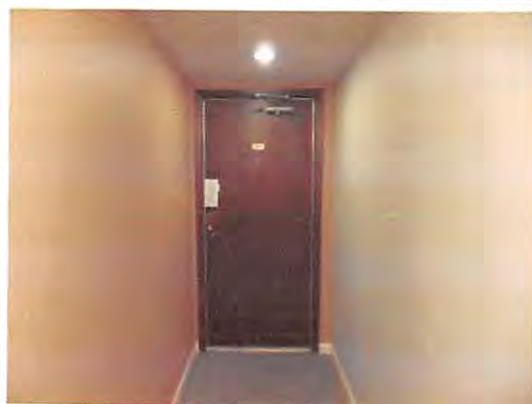
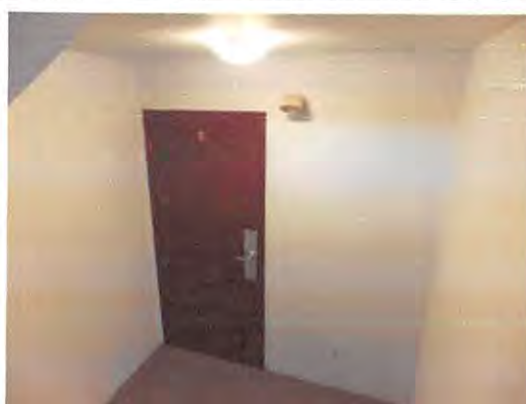
**Financial Review:** We understand the interior doors are original to the building construction in 1975. We are not aware of any major repairs or replacements.

**Visual Review:** Where checked, there were no signs of damage or significant wear to the interior doors. The operation of doors appeared smooth and they closed firmly into the door frames. The suite doors were noted to be consistent and without significant deterioration or damages.

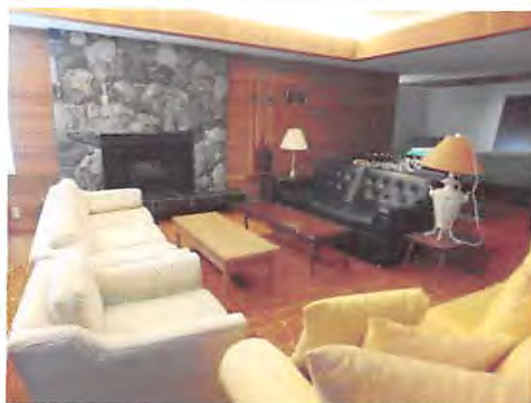
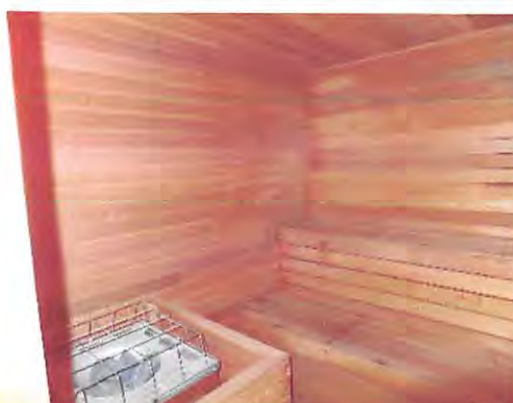
**Financial Review:** We understand the social lounge, games room, sauna, and bathrooms are original to the building construction in 1975. We are not aware of any major repairs or replacements.

**Visual Review:** The sauna and the bathroom vanities were not tested during our inspection. It is assumed that the components were installed in accordance to all building code and plumbing code regulations.

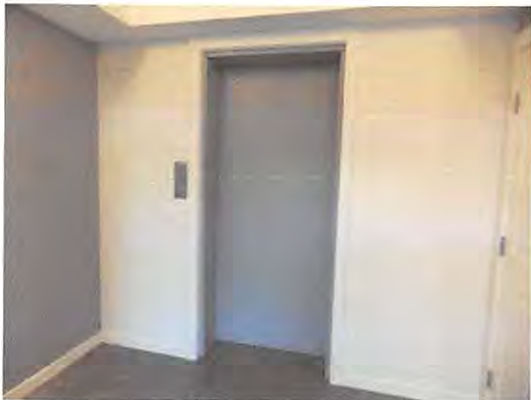
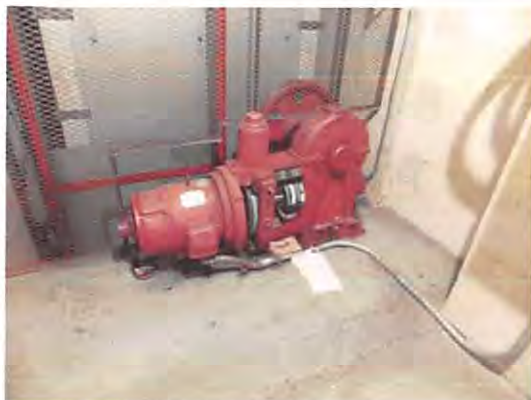
| M 1 – Elevator | | |
|---|---|---|
| <b>Financial Review:</b> We understand an infra-red door-opening mechanism was installed in the original elevator in 2009. Through Strata minutes and financial records, we learned that this work was funded by a special levy and cost \$2,004.45. We are not aware of any other significant repairs or replacements. | | |
| <b>Visual Review:</b> The elevator is currently serviced monthly by Impact Elevator Maintenance. It is assumed that any deficiencies or defects are fixed and maintained, as needed.<br><br>According to the inspection records from the service contractor, there were no outstanding items required for repairs. Routine items such as ride quality, indicator lamps, and door protection were all documented to be in operable condition. | | |

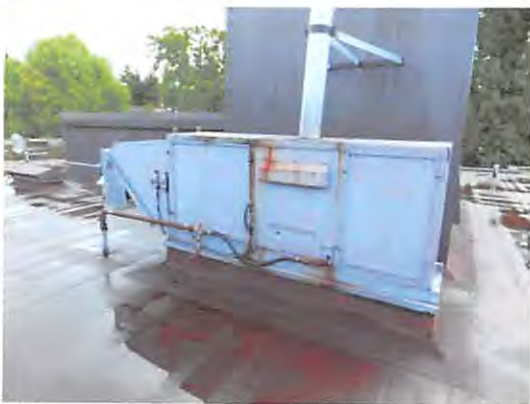
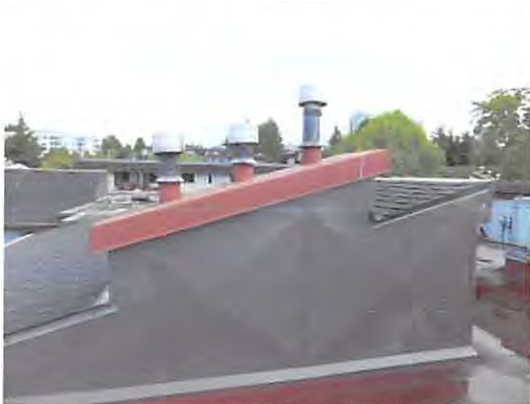
| M 2 – HVAC | | |
|---|---|---|
| <b>Financial Review:</b> We understand the rooftop-mounted make-up air unit and the exhaust fans are original to the building construction in 1975. Through financial records, we learned that repairs and service were done for the make-up air unit and fans in 2009. The work was performed by Dyna-Cool Refrigeration for \$1,750.35. We were advised by Council that the chimney flues are original to the building construction. | | |
| <b>Visual Review:</b> The concealed motor and wirings of the make-up air unit cannot be visually inspected. We noted some rusting of the make-up air unit casing. We also noted the appearance of the chimneys to be consistent and do not appear to show significant wear or deterioration. | | |

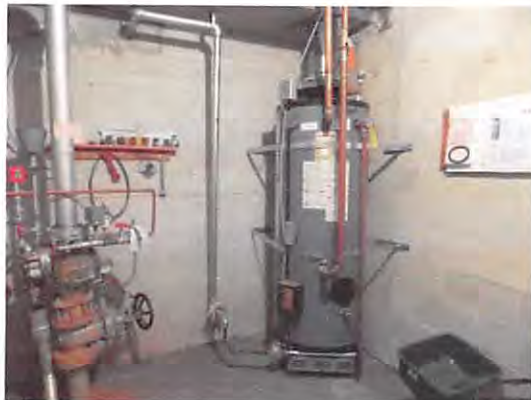
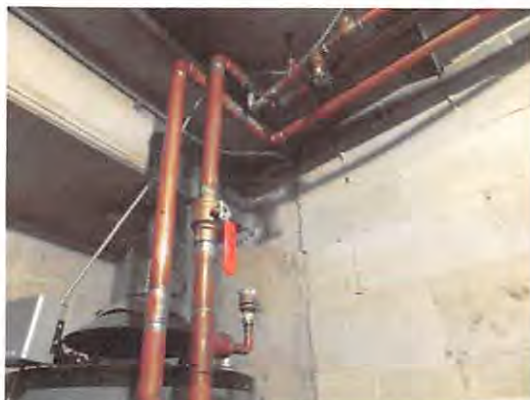
| P 1 — Domestic Water System | | |
|---|---|---|
| <b>Financial Review:</b> To the best of our understanding, the domestic water piping system is original to the building construction in 1975 without any major repairs or replacements since then. As indicated by the label, the hot water tank was manufactured in December 2000 and has been assumed to be installed in the same year. | | |
| <b>Visual Review:</b> Due to the concealed nature of the domestic water system, a limited amount can be visually inspected. Review is based mostly on what is visible from the plumbing plans.<br><br>The domestic hot water heater tank was properly tied into adjacent walls with seismic straps and appeared to be without major signs of wear or deterioration. | | |

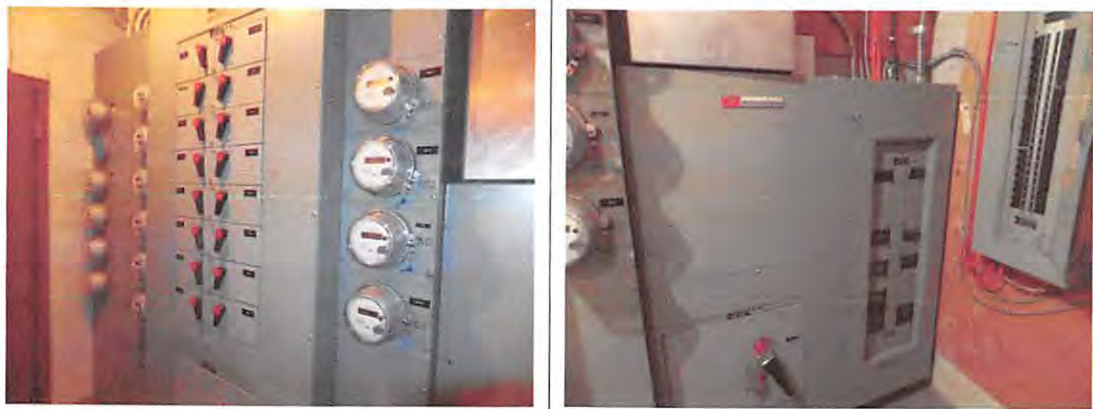
| EL 1 – Electrical Systems | | |
|---|---|---|
| <b>Financial Review:</b> We understand the electrical system is original to the building construction in 1975. We are not aware of any major repairs or replacements. | | |
| <b>Visual Review:</b> It is assumed that the electrical system was installed to good building standards and in accordance to the electrical code.<br><br>Inspections are limited due to the concealed nature of the majority of the electrical system. The switchgear unit and the panels were all clearly labelled with cables neatly clipped and tied onto the walls and is generally an indication of professional workmanship. | | |

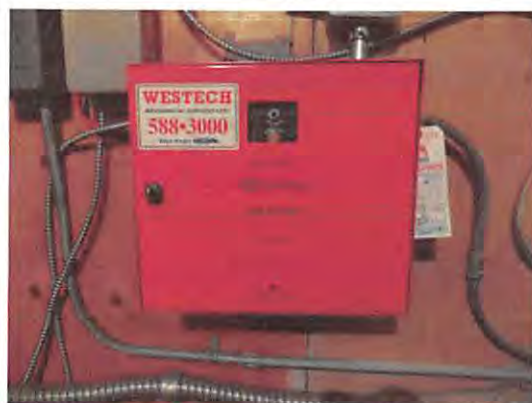
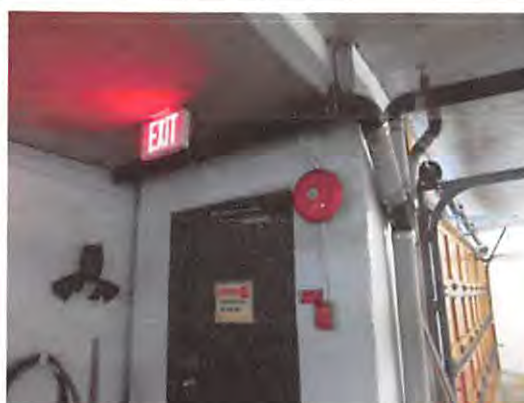
**Financial Review:** To the best of our knowledge, the fire alarm system and the emergency power components are original to the building construction in 1975. We understand the Strata has had service agreements with a service contractor for many years and is currently serviced by Vancouver Fire & Security. We understand there have been some periodic repairs or replacements according to recommendations of the service contractor but we are not aware of any major repairs or replacements.

**Visual Review:** The functionality and operation of the system cannot be commented on as they cannot be tested or reviewed during our site inspection. It is assumed that these systems are installed and maintained to industry standards and in accordance to current fire codes.

**Recommendations:** Fire alarm systems typically have lifespans of 20-25 years. However, some replacement parts are generally available, depending on the model. The fire alarm systems are critical in allowing sufficient time for occupants to escape, should an emergency arise. New, up-to-date systems are less vulnerable to false, nuisance alarms.

Over time, new technologies emerge and older systems become obsolete and become virtually impossible to find replacement parts. Under special circumstances, the system may require replacement earlier at the discretion of the local fire department if there is a significant change in code regulations.

While the system is still functional, we anticipate it is approaching the end of its service life due to its age. We reserved a budget for replacement of the fire alarm system in 2015, and every 30 years thereafter.

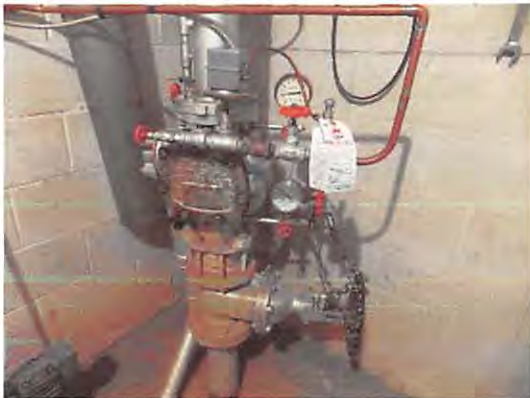
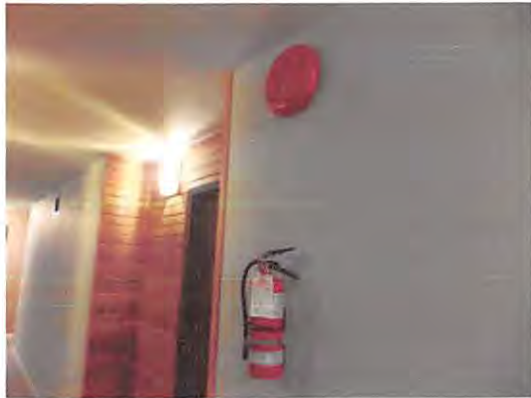
**Financial Review:** We understand the suppression system to be original to the building construction in 1975. We are not aware of any major repairs or replacements.

**Visual Review:** The functionality and operation of the system cannot be commented on as they cannot be tested or reviewed during our site inspection. The inspection tags by Vancouver Fire & Security are taken as a sign of confidence that the systems are installed and maintained to industry standards.

Components that are expected to be installed are all in place and inspection tags are placed in a clearly visible manner. The location of fire extinguishers seems appropriate and sufficient to serve all units of the building. No significant repair has been documented. Inspection tags indicate the upcoming inspection to be due on or before November 28, 2013.

**Recommendations:** Suppression system piping suffers from regular wear. While their lifespans are expected to last beyond the scope of the DR, some localized repairs or replacements are anticipated.

We have reserved an allowance for suppression repairs or replacements in 2027, and every 15 years thereafter. Typically, these repairs would cover some damaged sections of the piping as well as the replacement of some defective sprinkler heads. As the cost of dry valve air compressor is expected to be below the threshold of the DR, it is assumed to be funded through the operating budget.

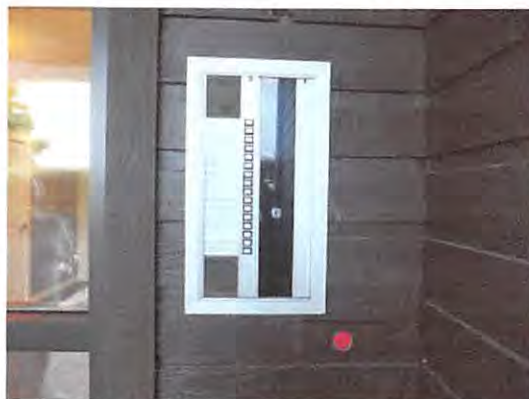
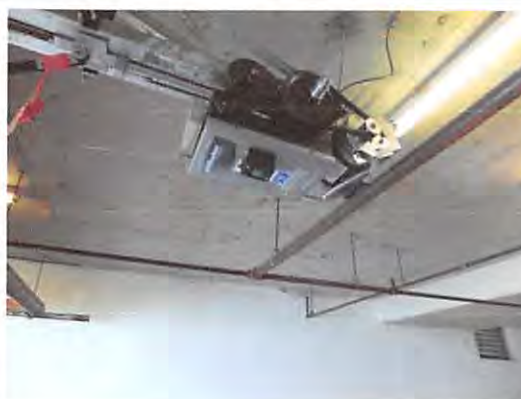
**Financial Review:** We understand the idling mechanism of the parkade gate motor was repaired and the springs were replaced in 2010 by Creative Door Services Ltd for \$1,060.75. We were advised by Council that the garage door motor was replaced in March 2013 for \$2,016. To the best of our knowledge, the enterphone system is original to the building construction in 1975 and we are not aware of any major repairs or replacements since then.

**Visual Review:** There are no known issues with the access control and security systems. Our visual inspection did not uncover any signs of unusual or unexpected wear or deterioration. The systems were both in operational condition on the day of our inspection.

**Recommendations:** We recommend periodic tests of the access control and security system to ensure their uninterrupted operation. Typical access control and security systems phases out in 20-25 years with replacements parts available for up to approximately another 10-15 years after that.

The enterphone system is believed to have surpassed its normal expected lifespan. We understand that the Strata has already quoted for its replacement in 2008 and we recommend its replacement in the near future. We recommend the Strata to consider an upgrade to the system at the time of replacement. The upgrade will typically include cameras and hard drives (for video footage) for added security. However, for the purpose of the DR, we have included a like-for-like replacement.

We reserved for the replacement of the enterphone system in 2015 and every 25 years thereafter. We have included an allowance for some repairs or upgrades parkade gate motor at this same time.

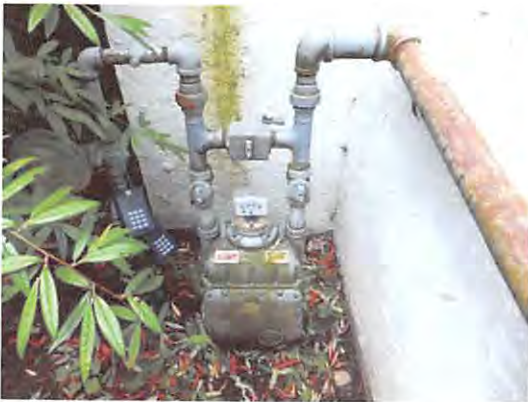
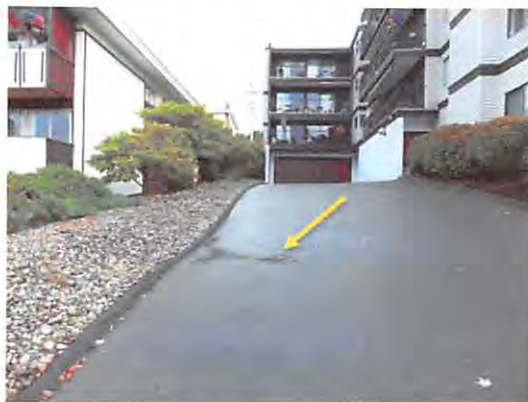
| SRV 1 – Buried Site Services and Drainage | | |
|---|---|---|
| <b>Financial Review:</b> We understand the site services are original to the building construction in 1975. We are not aware of any major repairs or replacements. | | |
| <b>Visual Review:</b> Buried site services were not visually inspected due to their concealed locations. Review of these systems was done by studying the available information from building plans in combination with the limited amount seen. The sanitary drainage systems within the building, including the risers to the suites, are expected to last beyond the scope of the DR so they have not been included.<br><br>Where checked, there were no signs of pooling water. We noted various catch basins throughout the site and they appear to be properly placed to serve the building site. | | |

| SRV 1 – Buried Site Services and Drainage | | |
|---|---|---|
| <b>Recommendations:</b> Buried site service lines endure regular wear. In particular, sanitary and storm piping that are located below grade may experience penetrations by the growth of tree roots. Due to the concealed nature of these components, deficiencies are not easily noticed. Reports from Strata owners about any interrupted services will often be the first and only sign of any defects to the buried site service systems.<br><br>We assume that the buried services and drainage have a remaining life that extends beyond the scope of this DR. Therefore, full replacements have not been considered. Periodic repairs are needed to give these systems their full service life. We have included an allowance in the plan for buried site services with S 2—Parkade and Site 1—Paving. | | |

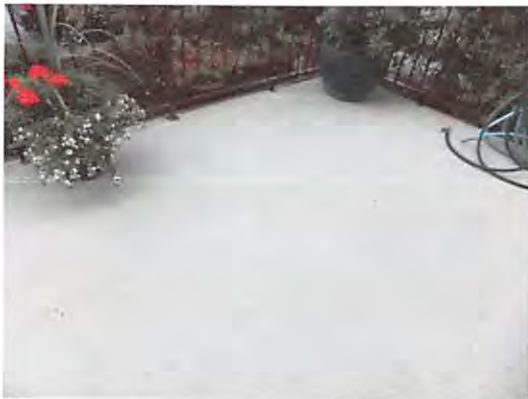
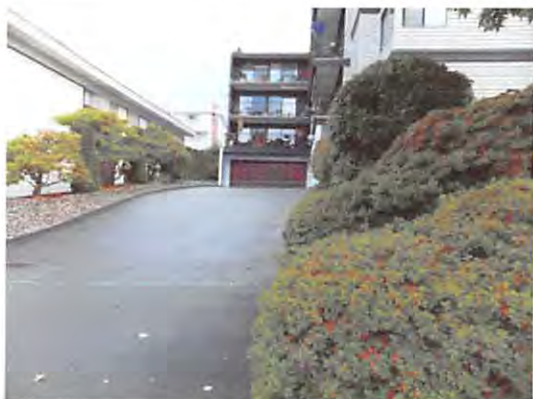
**Financial Review:** Through review of financial records, we understand that the driveway was repaved in 2008 by Rainbow Paving Ltd. for \$5,523.00 which was funded from the operations budget. We understand the concrete patio pad at the front of the building is original to the building construction in 1975 and are not aware of any major repairs or replacements since then.

**Visual Review:** It is assumed that all concrete and asphalt work were designed and constructed in accordance with the building code and good building standards.

We noted the driveway surface was even and without significant spalling or cracking. It appears to maintain a proper slope to drain. We noted no pooling of water in this area. We noted some chipped areas of the concrete pad against the building. We also noted some cracks of the concrete patio pad.

**Recommendations:** Paving is exposed to the elements, particularly in the form of rain and snow. Pressure from vehicles and walking traffic can further deteriorate the paved areas. The longevity of paving components is typically dependent upon the quality of the underlay or foundation. Eventually, these influences can lead to cracking and spalling of the paving surfaces.

We anticipate any repairs or replacements of the front patio pad to be below the threshold of the DR and are therefore assumed to be funded through the operating budget. We have reserved an allowance for the repairs of the driveway in 2037 and every 20 years thereafter. Included is an allowance for the repairs of buried site services (refer to SRV 1—Buried Site Services).

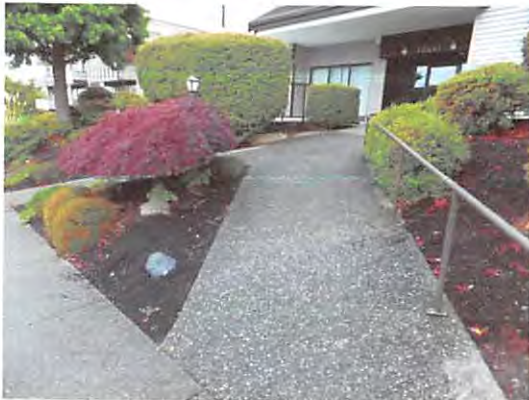
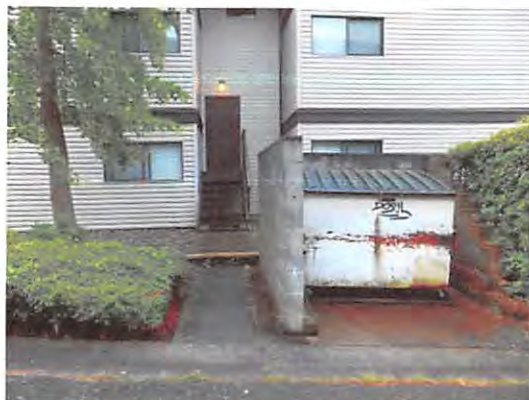
| Site 2 — Walkways | | |
|---|---|---|
| <b>Financial Review:</b> We understand the concrete walkways are original to the building construction in 1975. We are not aware of any major repairs or replacements. | | |
| <b>Visual Review:</b> It is assumed that all concrete work were designed and constructed in accordance with the building code and good building standards.<br><br>The concrete walkways appeared to be level and without major cracking or spalling. The walkways appeared to slope sufficiently to direct water away from the building. We noted no signs of uneven settlement of the walkways. | | |

| Site 2 — Walkways | | |
|---|---|---|
| <b>Recommendations:</b> Walkways are exposed to the elements in addition to walking traffic. The quality and extent of subgrade preparations will often determine the lifespan of the overlaying surface.<br><br>We do not expect a full replacement of the sidewalk and walkways to be required within the scope of the DR. However, we anticipate periodic repairs will be necessary. Typically, repairs would include some compacting or adjustments to the subgrade prior to installation of the topping.<br><br>The repairs of the walkways are anticipated to be below the threshold of the DR and are therefore assumed to be funded through the operating budget. | | |

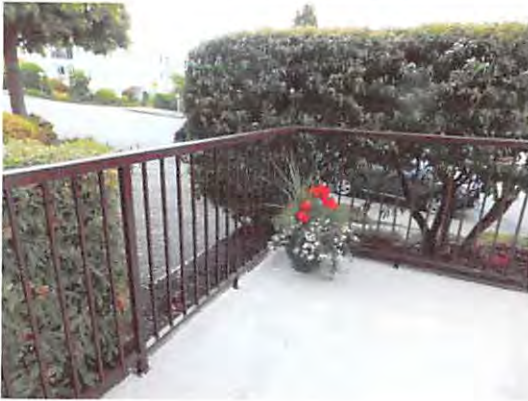
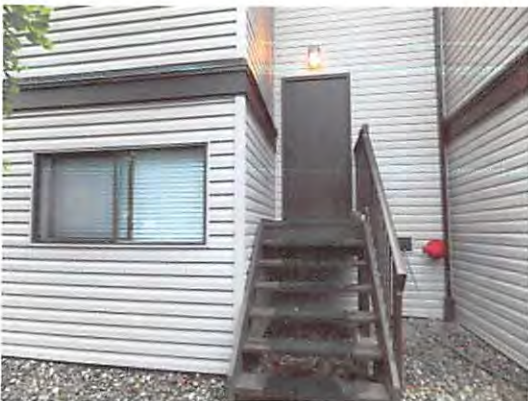
**Financial Review:** We were advised by Council that the site guards around the concrete patio at the front of the building were replaced. Through financial records, we understand that Goldstar Railing Ltd. was contracted for the job in 2008 and the replacement cost was \$945.

**Visual Review:** Where checked, we noted no significant rusting of the site guards. The guards were surface-mounted and were secured where inspected.

**Recommendations:** Site guards serve both a functional and cosmetic purpose. Their upkeep is required to maintain their serviceability and appeal.

We recommend the regular inspection of the guards to ensure their firm attachment. We also recommend a water-resistive coating of these components to inhibit any progression of rust.

Repairs or replacements as well as the coating of the site guards are expected to be below the threshold of the DR and are therefore assumed to be budgeted through the operating fund.

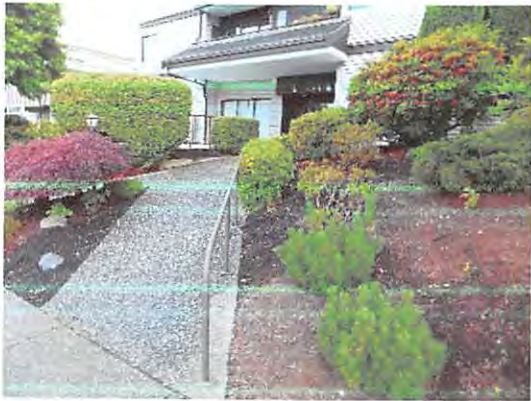
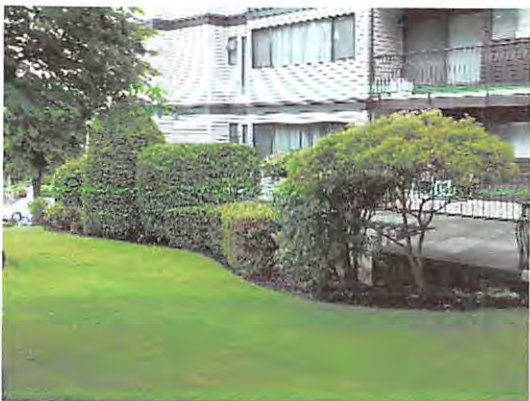
| Site 4 – Landscaping | | |
|---|---|---|
| <b>Financial Review:</b> We learned through Strata minutes that the west wall (concrete cinder blocks) of the garbage enclosure was repaired in 2008 due to damages by garbage trucks. We understand the Strata has an agreement with the City of White Rock for reimbursement for the repairs as the damages were deemed to be the City's responsibility. Through financial records, it appears that the Strata was reimbursed for \$927.63. We understand the exterior lights have been replaced in 2011. However, we did not see a work contract and are unaware of the scope of work and the costs involved. | | |
| <b>Visual Review:</b> We assume the maintenance of the irrigation system to be included with the contract with the landscaping contractor. The irrigation system was not tested during our site inspection.<br><br>We noted the irrigation sprinkler heads to be in place and appeared to be sufficient for the soft landscaping areas. Plants and flowerbeds appear to be well maintained. | | |

| Site 4 – Landscaping | | |
|---|---|---|
| <b>Recommendations:</b> Plants are seasonal and require ongoing maintenance in order to look vibrant and appealing. Continued work with a qualified landscaper is recommended.<br><br>The concrete walkways have been included with Site 3—Walkways. We have reserved an allowance for the renewals of landscaping components in 2019, and every 15 years thereafter. The allowance is planned to include some repairs with the irrigation system and lamp post, repairs to the rear-side wooden stairs, as well as some re-seeding of flowers and plants. | | |
