DEPRECIATION REPORT

PREPARED FOR:	SEMIAHMOO PLACE
STRATA #:	BCS 401
STRATA NAME:	SEMIAHMOO PLACE
ADDRESS:	15323 17A Avenue Surrey, BC
DATE OF REPORT:	June 25, 2015
INSPECTION:	June 12, 2014

SEMIAHMOO PLACE CONDOMINIUM

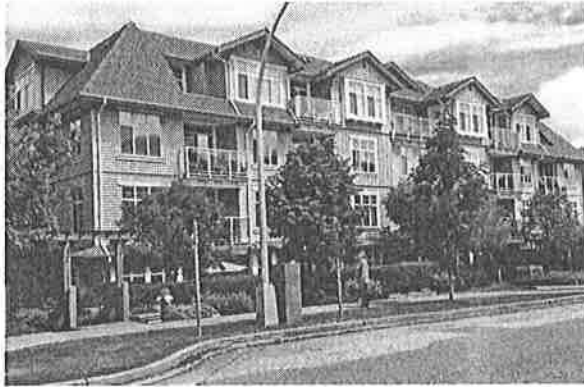
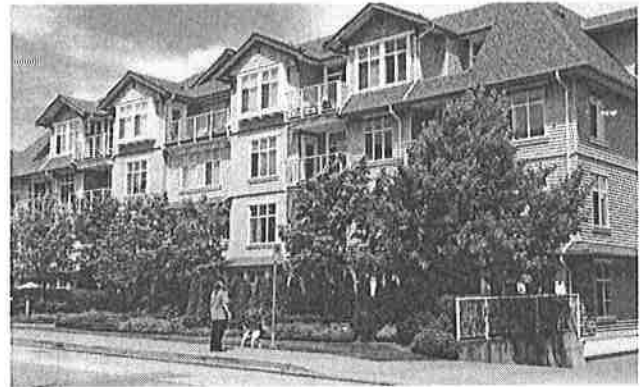
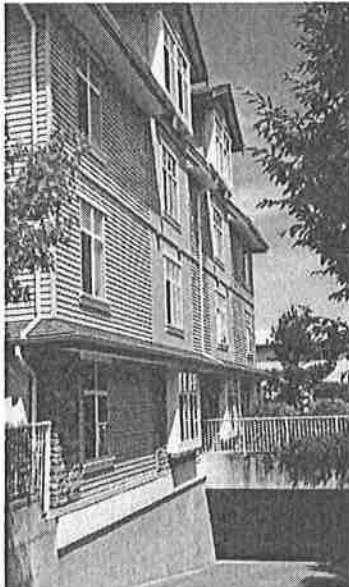
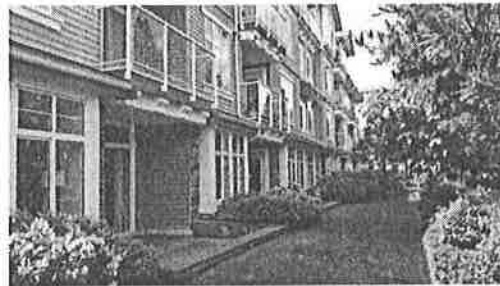
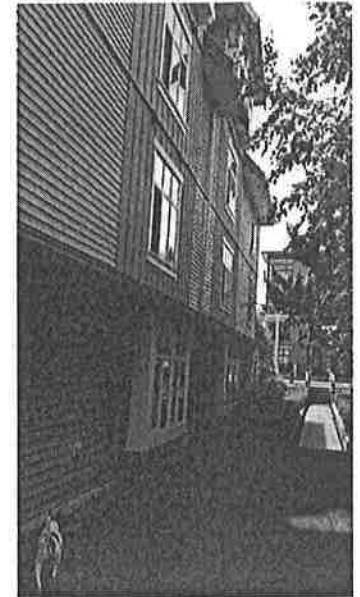
As the photos illustrates the building is well maintained.

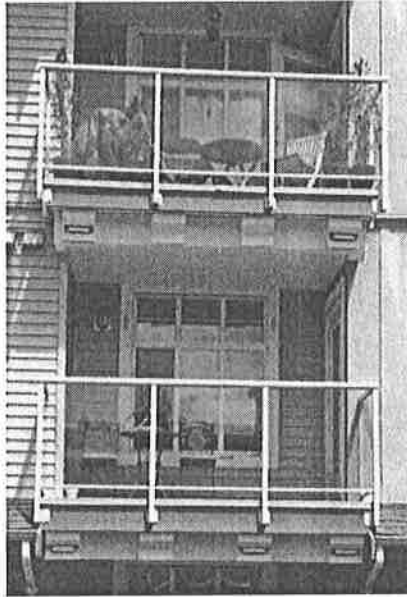
(15) – Front Elevation

The doors are in good condition and benefit by having overhangs protecting them from rain. The life span of these units is approximately 30 years. There is potential for some of the glazed seals to fail after 15 years.

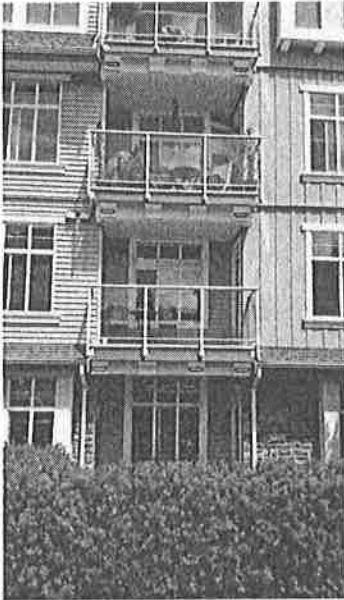
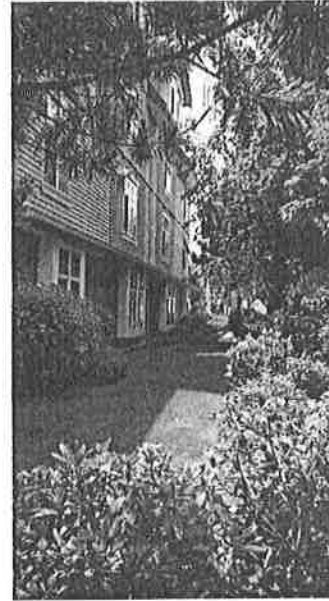
Windows and patio doors are vinyl construction with double glazing which is an ideal installation for this building. The installation of the windows utilize various rain screen principals that are conducive to the surrounding materials and architectural details. In general where flashing have been utilized in the system the windows would require minimum maintenance. There are conditions where caulking is used and this should be replaced every few years under regular maintenance. The life span of these units is approximately 30 years, the double glazed unit seals could fail after 15 years, and should be replaced.

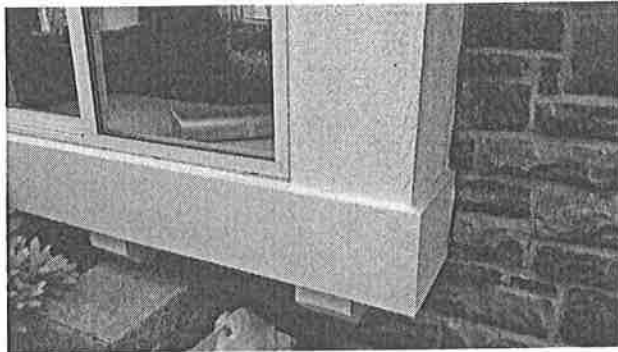
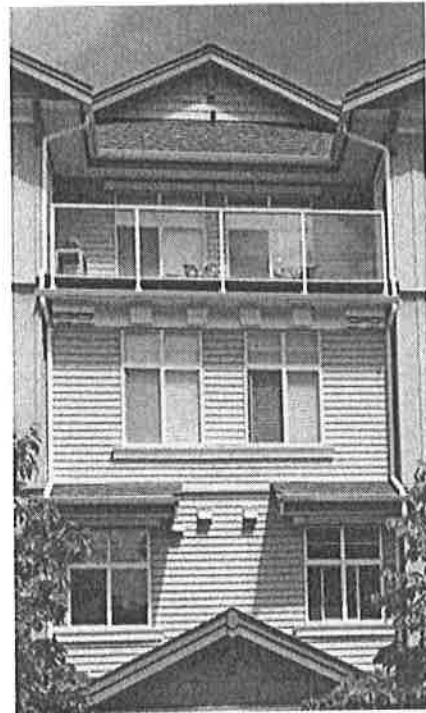
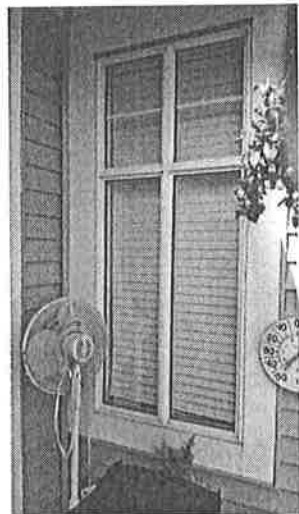
The exterior of the buildings has been clad using rain screen technology.

The primary materials are vinyl siding, hardi board, wood trim, simulation stone, glass and balcony railings. Normal maintenance of cleaning, caulking and painting at its present level should ensure that no replacement of materials will be required until age 30 at which time some of the wood trim and vinyl may need replacing.

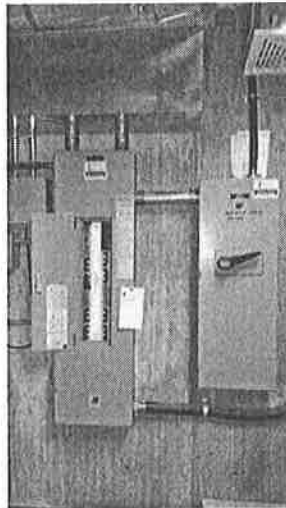
(24) – Common Property Panel

The main electrical distribution switch (800 amp Horizon) is in the Electrical Room located in the underground parking (see above photo (23)) as is the distribution panel for the common areas (see above photo (24)). The individual Strata Units have their own electrical meters which are grouped in electrical closets in the corridors (see above photo (27)) with the telephone and cable distribution panels (see above photo (25)). Each unit has its own circuit breaker panel located within the unit (see above photo (26)).

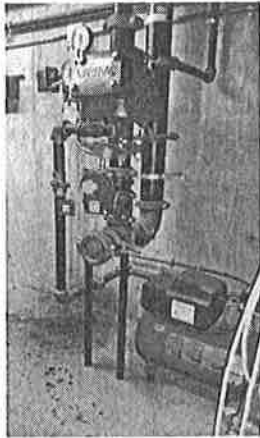
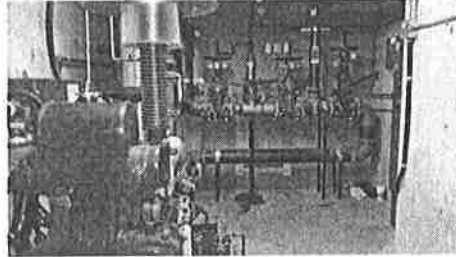
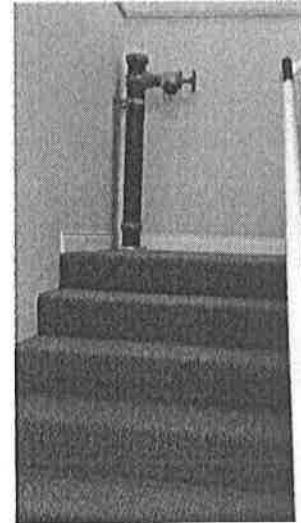
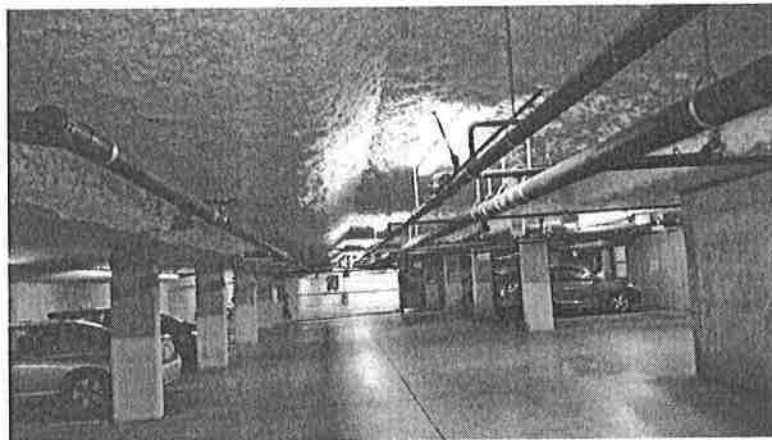
The individual condominium units have fire sprinklers. All common areas including hallways and parking structure also have sprinklers. The entire fire suppression systems are well maintained. The life span for sprinkler systems is approximately 50 years. Sprinkler heads should be changed within 30 years and compressors within 20 years.

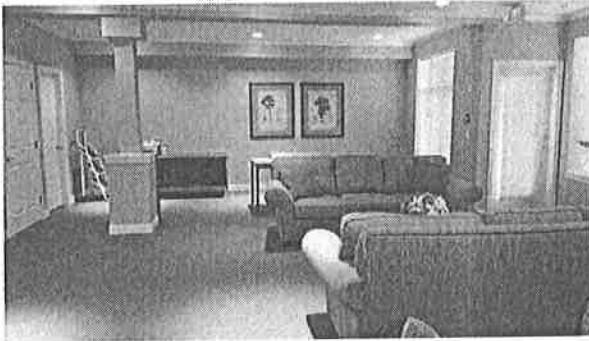
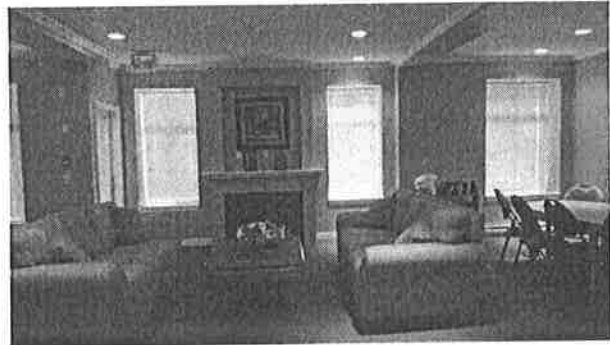
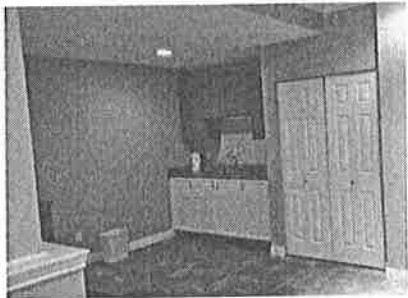
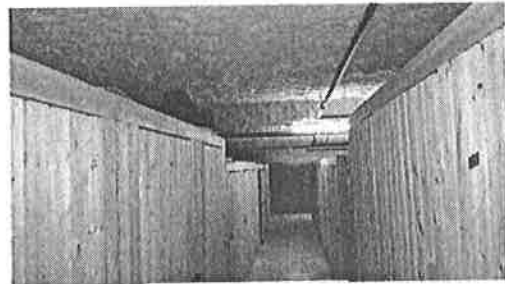
The Entry Lobby and Hallways are well maintained. Normal maintenance is required in these areas. The carpeting in the hallways and stairwell are showing wear and we recommend replacement in 5 years. No allowance for replacement has been made for hallway carpeting as it will be funded by the operating budget.
