DEPRECIATION REPORT

PENINSULA VILLAGE

2500 – 152ND STREET

DATE: **OCTOBER 15, 2014**

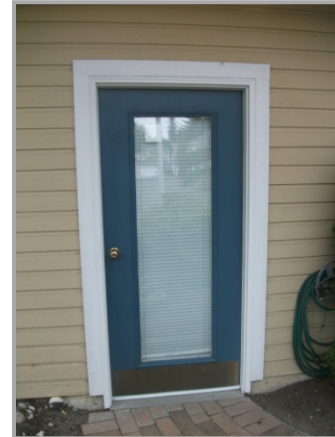
Description: Insulated metal clad door located at unit 29.

Condition: Door appear to be in serviceable condition.

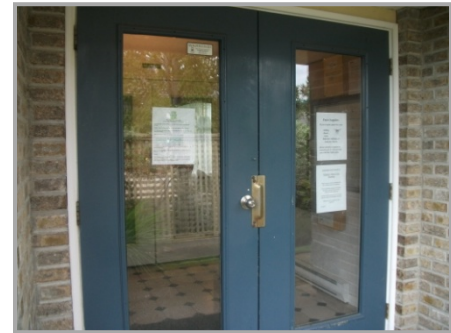
Description: Insulated metal clad, glass infill, swing doors provide access to the clubhouse at the front and rear of the building.

Condition: Doors appear to be in serviceable condition.

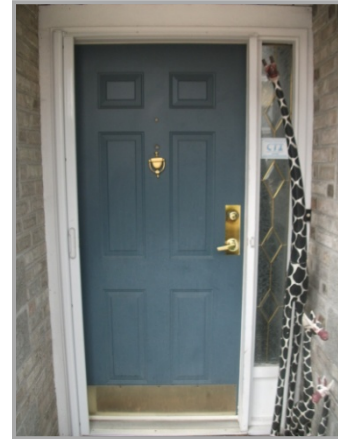
Description: Insulated metal clad entry doors provide access to the units.

Condition: Doors appear to be in serviceable condition.

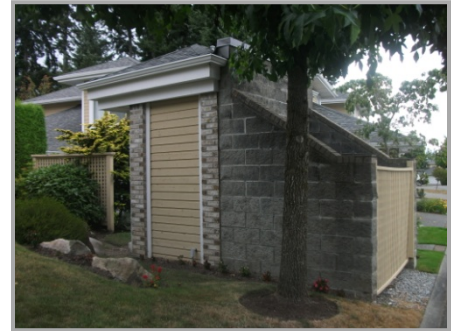
Description: Service doors provide access to the nine utility rooms on the property.

Condition: Doors appear to be in serviceable condition.

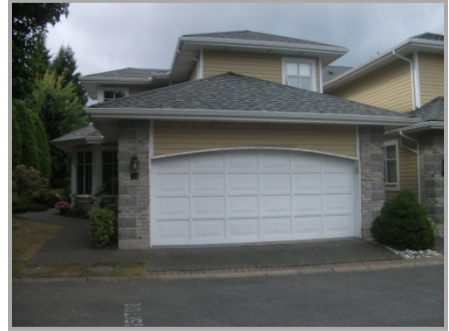
Description: Overhead roller sliding garage doors provide access to garages attached to the units.

Condition: Doors are nearing the end of their service lives.

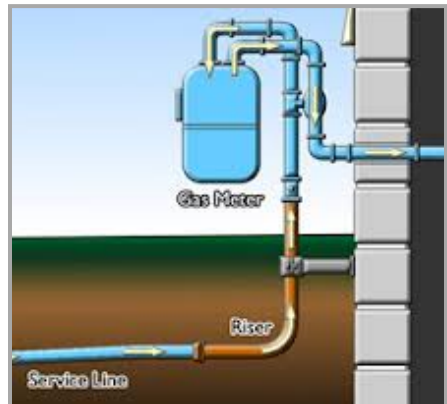
Gas Pipes

Description: Gas piping provides gas to each unit.

Condition: The pipes were not reviewed; however no issues have been reported.

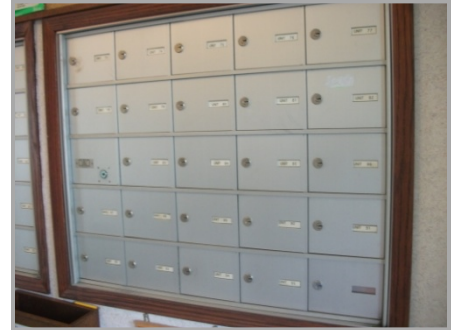
29**Mailboxes**

Description: Mailboxes are located in the lobby of the clubhouse.

Condition: Mailboxes are in serviceable condition.

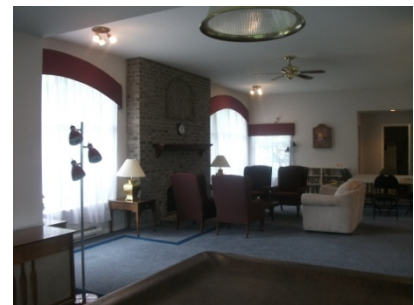
30**Clubhouse**

Description: Clubhouse includes a kitchen, bathroom, seating and games area.

Condition: Clubhouse appears to be in serviceable condition.

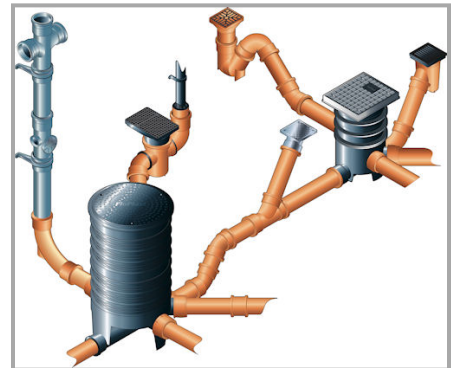
Description: This includes the main water and sewer lines connecting each unit to the city mains. Also included are the perimeter drainage pipes that surround the buildings

Condition: Were not visually reviewed at this time; however, no issues were noted.

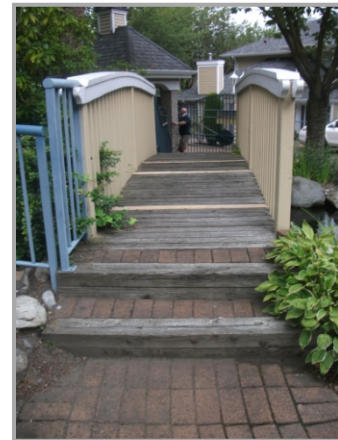
Description: Footbridge located over the pond at the west entrance to the property.

Condition: Appears to be in serviceable condition.
