DEPRECIATION REPORT

MIRAMAR TOWERS C & D

1411 JOHNSTON ROAD AND 15165
THRIFT AVENUE, WHITE ROCK

Sense's Project No. 21vA119C

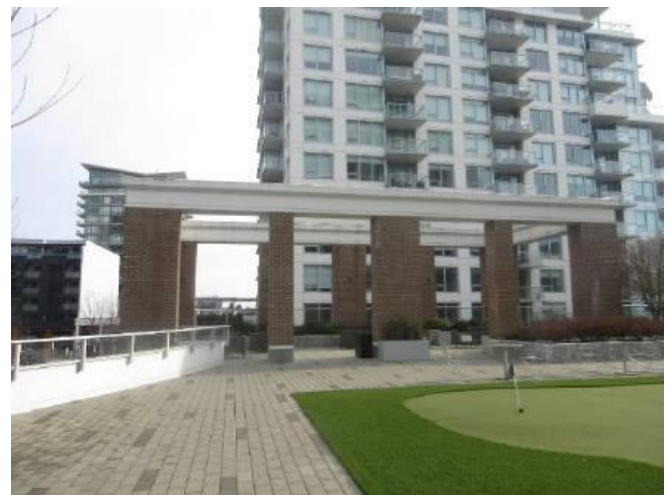
Most of the structural components are concealed from view. We did not see any evidence of unusual settlement, displacement or structural cracking in the areas we reviewed.

Photo 2: Brick-clad pergola structure.

We assume that the glass panels at the canopy will be individually replaced on an as-needed basis funded from the operating budgets. Repainting and repair of the pergola, trellis and canopy structures are expected to be completed as part of general exterior wall repair programs (see the *Exterior Walls* section for further discussion and budgets).

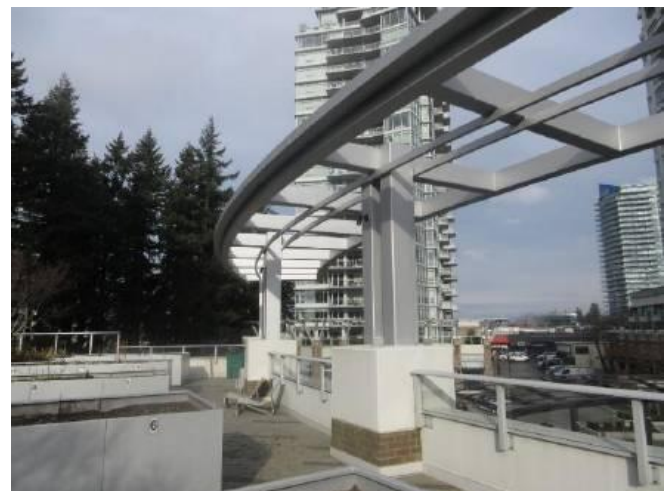
Photo 3: Third floor aluminum trellis.

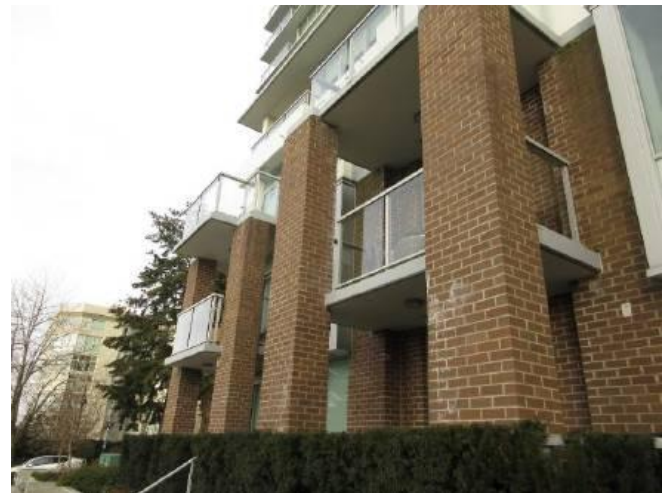
Photo 5: Typical townhouse balconies.

- The coating on the top surface of the balconies and eyebrows generally appeared to be in good condition, where reviewed.
- There is a large crack with evidence of water leakage at the eyebrow above the roof deck of Suite 304 at Tower.

- There is a crack in the eyebrow above the balcony of Suite 1207 at Tower C.

As the cracking appears to be localized, we assume that there are no systemic issues and expect that the cracks can be repaired as needed funded from operating budgets, or as part of general balcony and eyebrow repair programs.

We have budgeted for periodic application of a new wear course of waterproofing over the existing balcony and eyebrow waterproofing. The budgets include allowances for local repairs to the concrete, base course of waterproofing, and slab underside re-paint. The project costs shown also include for installation of additional roof anchors to allow suspended access to the balconies and eyebrows. Should other means of access be required (i.e., scaffold, boom etc.) additional costs will apply.

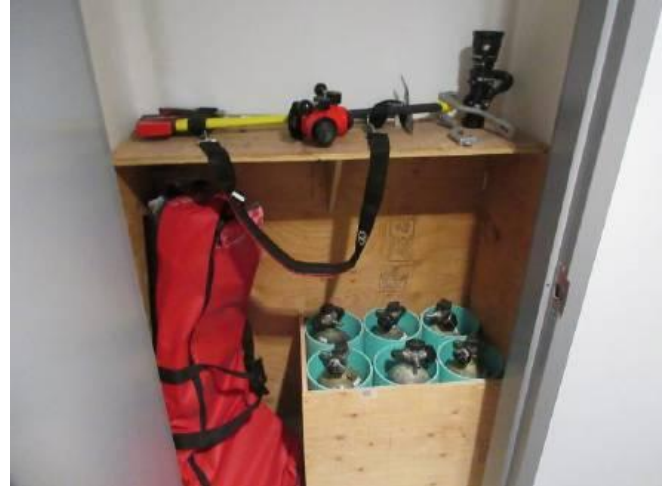
As part of our site review, we noted that there was no fire stopping at the floor-to-wall interfaces in the electrical closets typical throughout the buildings, and that there are multiple locations with no fire stopping where the standpipes penetrate through the floor slabs in the stairwells. These defects were reported as part of our 2 Year and 15 Month Common Property Warranty Reviews. We assume that these conditions will be addressed funded out of operating budgets or by the Builder as this condition was noted as part of *Sense Engineering's* 2 Year Common Property Warranty Review Report.

Photo 15: Typical firefighter's closet.

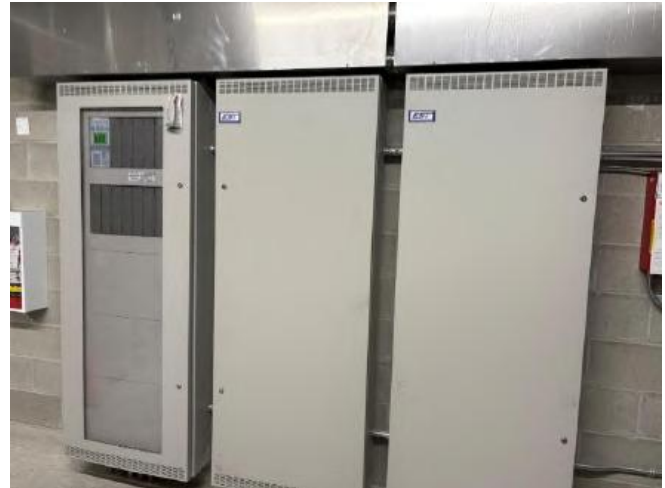
Radius Fire Protection presently maintains the detection/alarm system. The latest annual inspection report was not provided for our review. Based on the inspection tag noted on site, the fire detection/alarm system at Tower D failed its inspection dated May 2024. We assume that these conditions will be addressed as part of the Strata's comprehensive maintenance contract or funded from the operating budgets.

Photo 17: Fire alarm control panel.

While the systems are presently performing well, we have budgeted for eventual replacement of the control panels and front-end systems. The project assumes that the panels will be replaced with a similar, compatible system such that the majority of the existing field devices and wiring can be reused. The replacement timing will depend on the performance of the system and the service contractor's ability to continue to find replacement parts. The replacement cost will depend on what system components require replacing and what upgrades are necessary to meet Code requirements at the time. This should be re-evaluated as part of future updates to this Depreciation Report as further information from the service contractor and/or a life safety consultant are available.

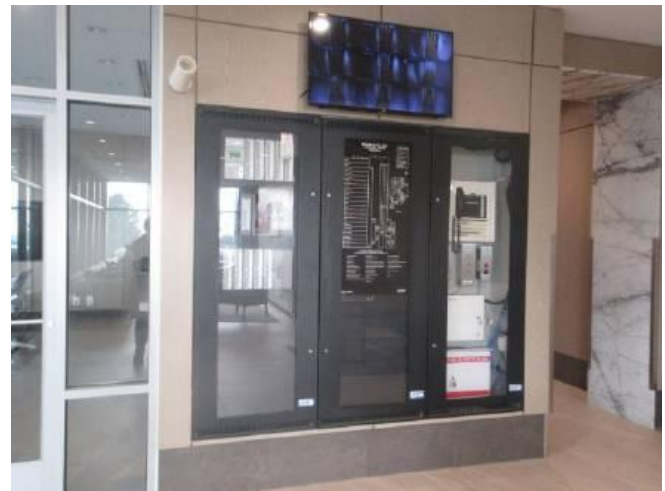
Photo 18: Typical annunciator panel.

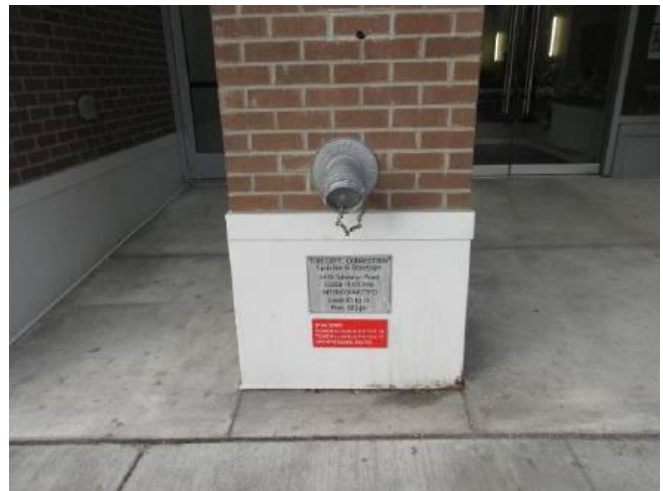
Photo 20: Fire department connection.

Dry-pipe systems are vulnerable to corrosion from the inside out. As such, we cannot determine the condition of the piping from a visual review alone. Repair and eventual replacement of the various individual components (e.g. valves, piping, sprinkler heads, etc.) should be expected. We assume this work, as well as other minor repairs identified by the annual testing and the testing itself, will be funded out of operating budgets.

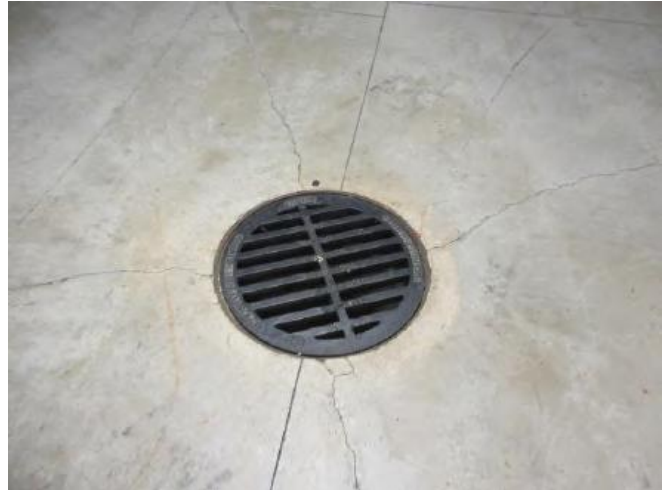
We were not made aware of any problems with the drainage systems, and we did not identify any signs of leakage or flooding.

Photo 36: Typical catch basin.

Garage internal drains, catch basins and trench drains are reasonably durable. That said we have budgeted for periodic replacement of the drains as part of suspended slab and garage roof slab waterproofing replacement projects (see the *Parking Garage* section of this report for further discussion and budgets).

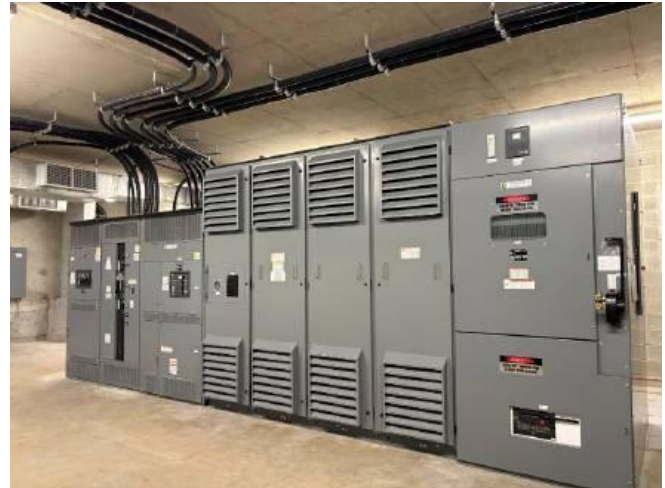
Photo 37: Incoming electrical equipment.

We recommend that all electrical panels and major equipment, including the electric charging station distribution panels and switches be thermally scanned every three years as a minimum. This is to identify hot spots that require repair. The scans and related required repairs (such as minor tightening, etc.) are assumed to be funded out of the operating budgets. The BC Government has mandated that all Strata Corporations located in the Metro Vancouver

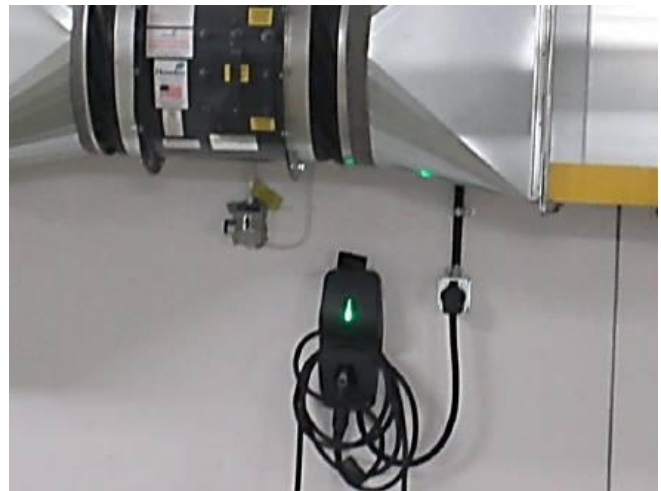
Photo 38: Electrical vehicle charging station.

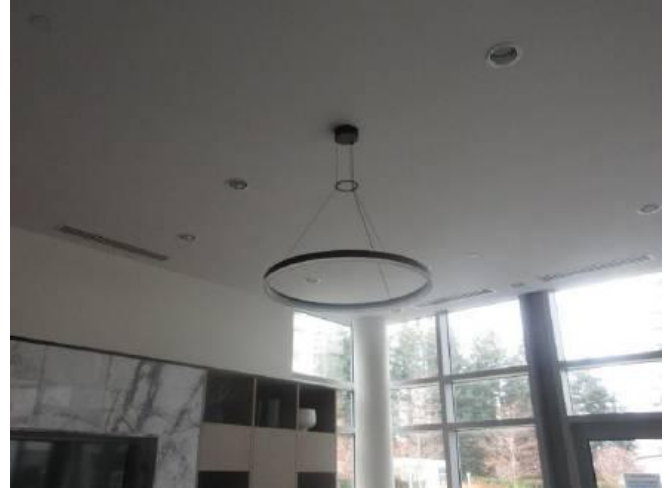
Photo 39: Lounge pot lights and ceiling mounted fixture.

The light fixtures are in serviceable condition, where reviewed. The current interior lighting levels appeared to meet minimum by-law requirements and are reasonably energy efficient.

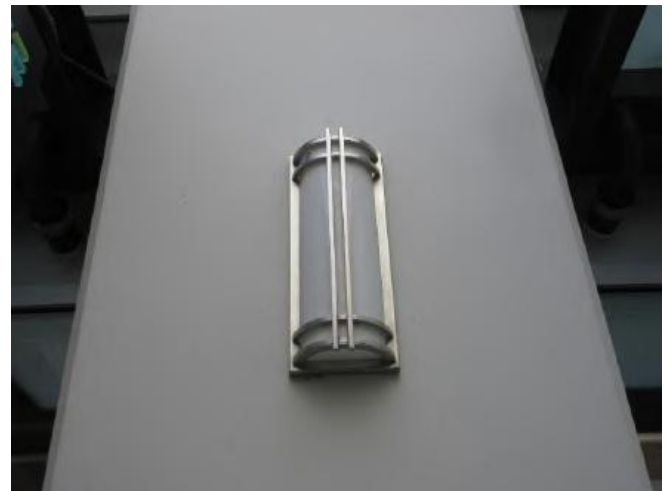
Photo 40: Typical exterior wall sconce.

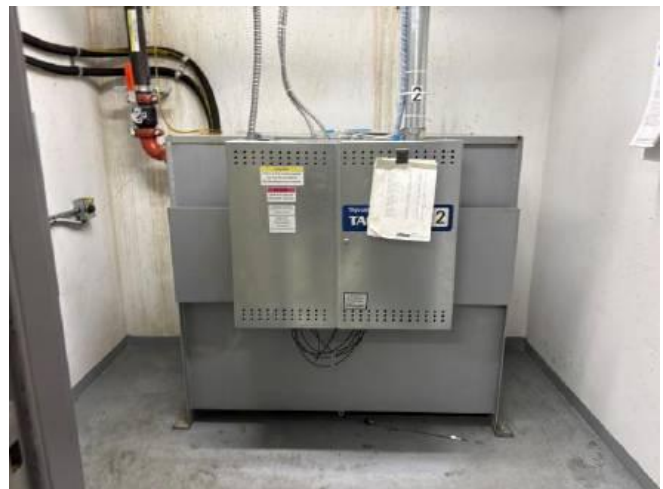
The elevators are presently maintained under a comprehensive maintenance contract with TK Elevator. Based on discussions with TK Elevator, we understand that there is an oil leak with the hydraulic amenity elevator this is slated to be repaired under the terms of the comprehensive maintenance contract. TK Elevator is monitoring conditions prior to the repair completion.

Photo 42: Hydraulic elevator equipment.

All buried hydraulic cylinders are at risk of rupturing due to corrosion. Based on the age of the elevator, the buried cylinder is likely encased in a PVC liner. This protects the entire buried surface of the cylinder from exposure to the surrounding soil. This cylinder should have a service life of 40 to 50 years before it will be necessary to replace it.

Buried cylinders have failed catastrophically in some buildings, causing serious injury. It is important to note, however, that in all instances, the failure was preceded by a history of unaccounted oil loss. It is therefore critically important that maintenance personnel clearly record appropriate oil levels on the equipment and diligently monitor for unaccounted oil loss. If maintenance personnel encounter unexplained oil loss, the elevator should be immediately taken out of service and the provincial safety authorities advised.

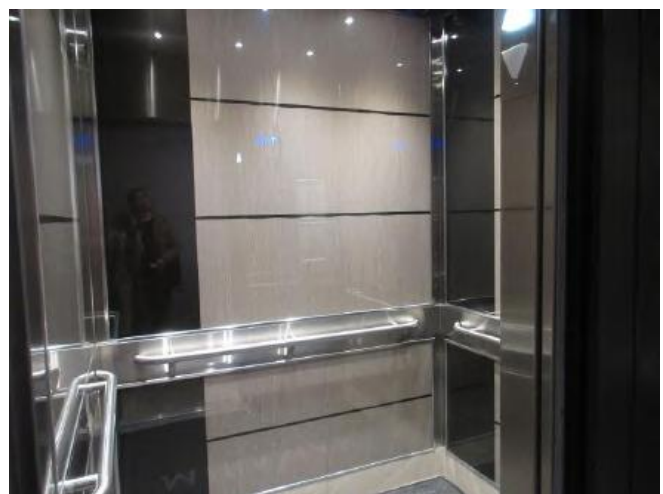
Photo 43: Typical elevator cab finishes.

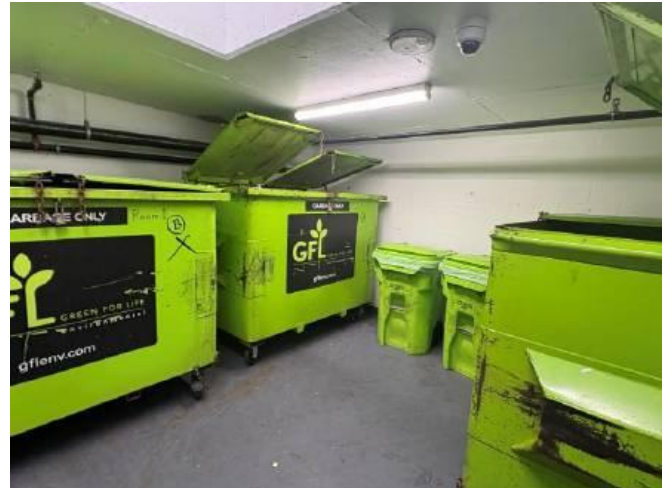
Photo 44: Typical garbage, recycling and organic waste containers.

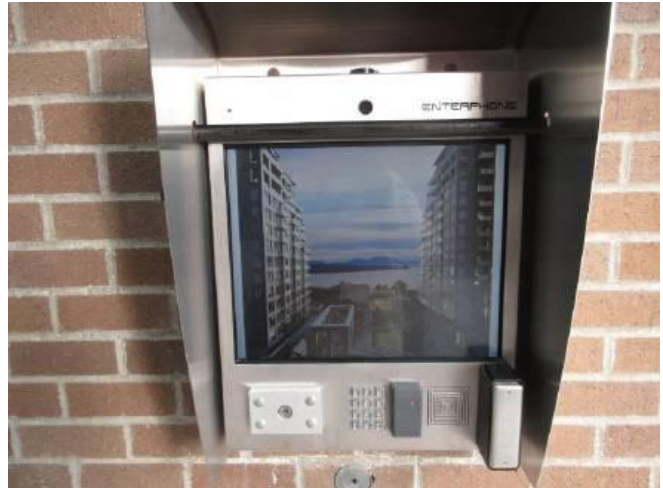
Although the existing systems are operational and no concerns were reported or noted, we have budgeted for eventual replacement of the enterphone panels at the end of their expected service life.

Photo 45: Typical tower entrance enterphone panel.
